# NATIONAL TRANSPORTATION SAFETY BOARD

## MATERIALS LABORATORY FACTUAL REPORT

Report No. 22-067

Place : Coalinga, California  
Date : August 19, 2020  
Vehicle : UH-1H, N711GH  
NTSB No. : WPR20LA280  
Investigator : Van McKenny (AS-40)

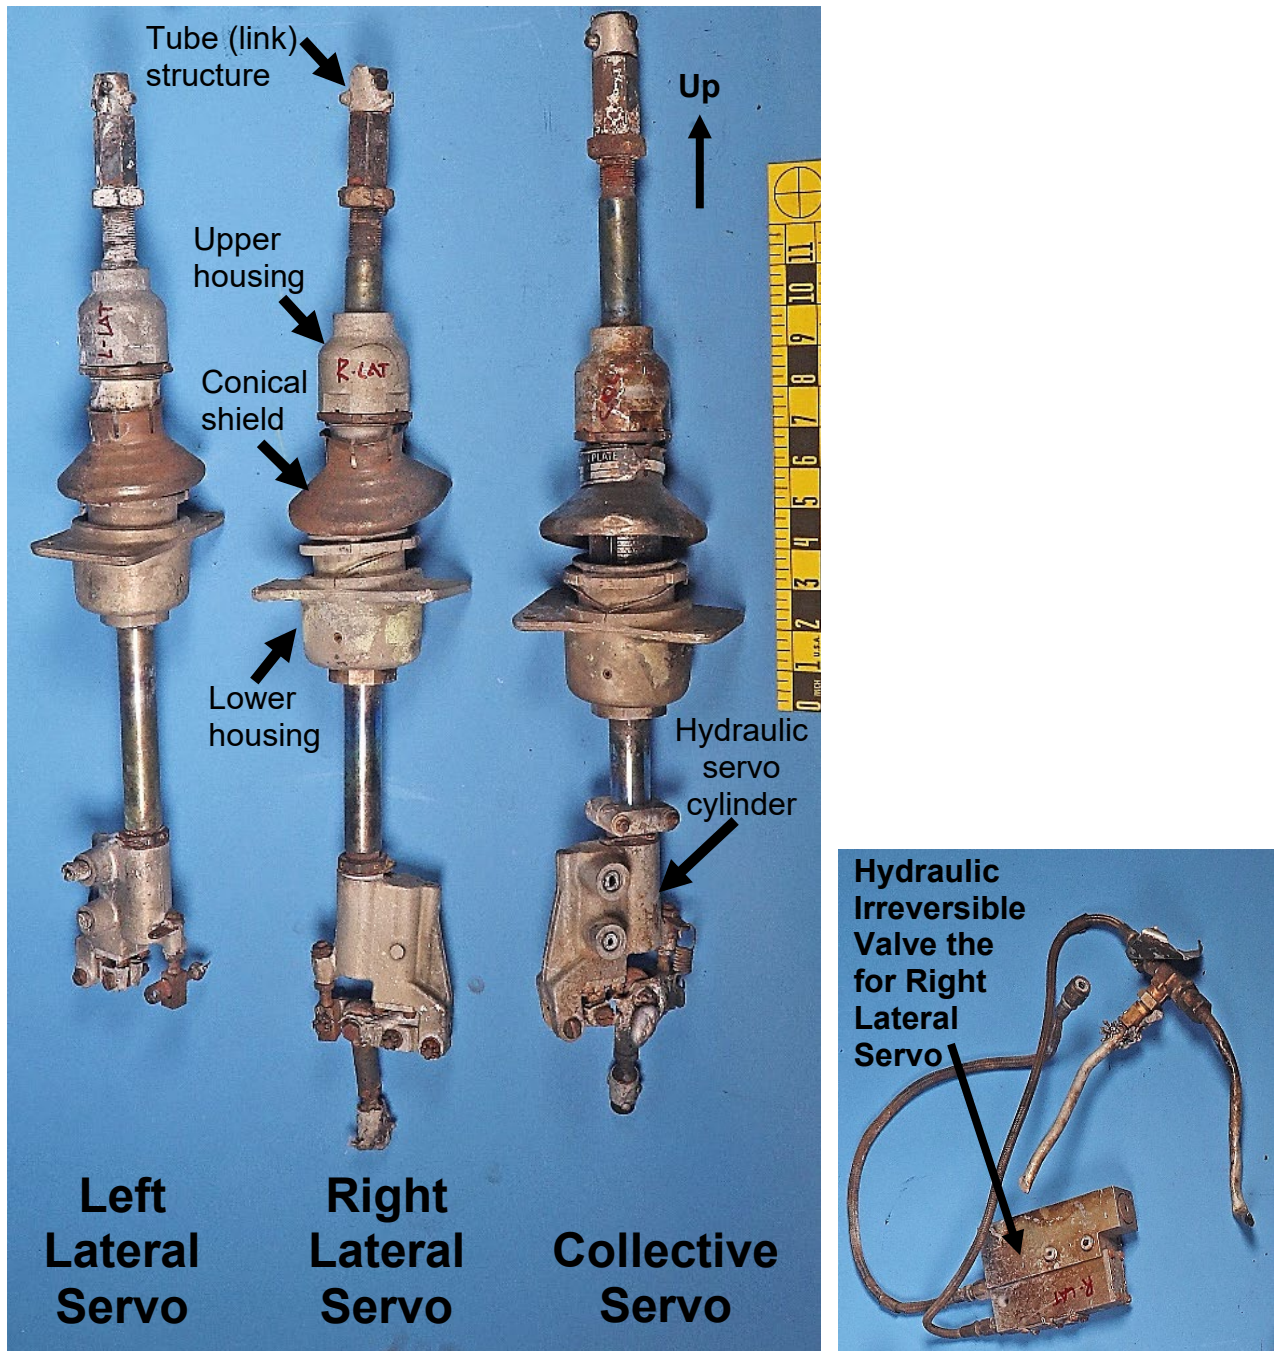
Figure 1 show photographs of the as-received left lateral servo; right lateral servo and irreversible valve assembly for the right lateral servo; and collective servo. The servos could not be moved up and down by hand relative to their respective rods. The as-received pieces were disassembled to document their condition, such as for evidence of heat damage and fracture.

Figure 1. As-received left lateral servo; right lateral servo and hydraulic irreversible valve for the right lateral servo; and collective servo.

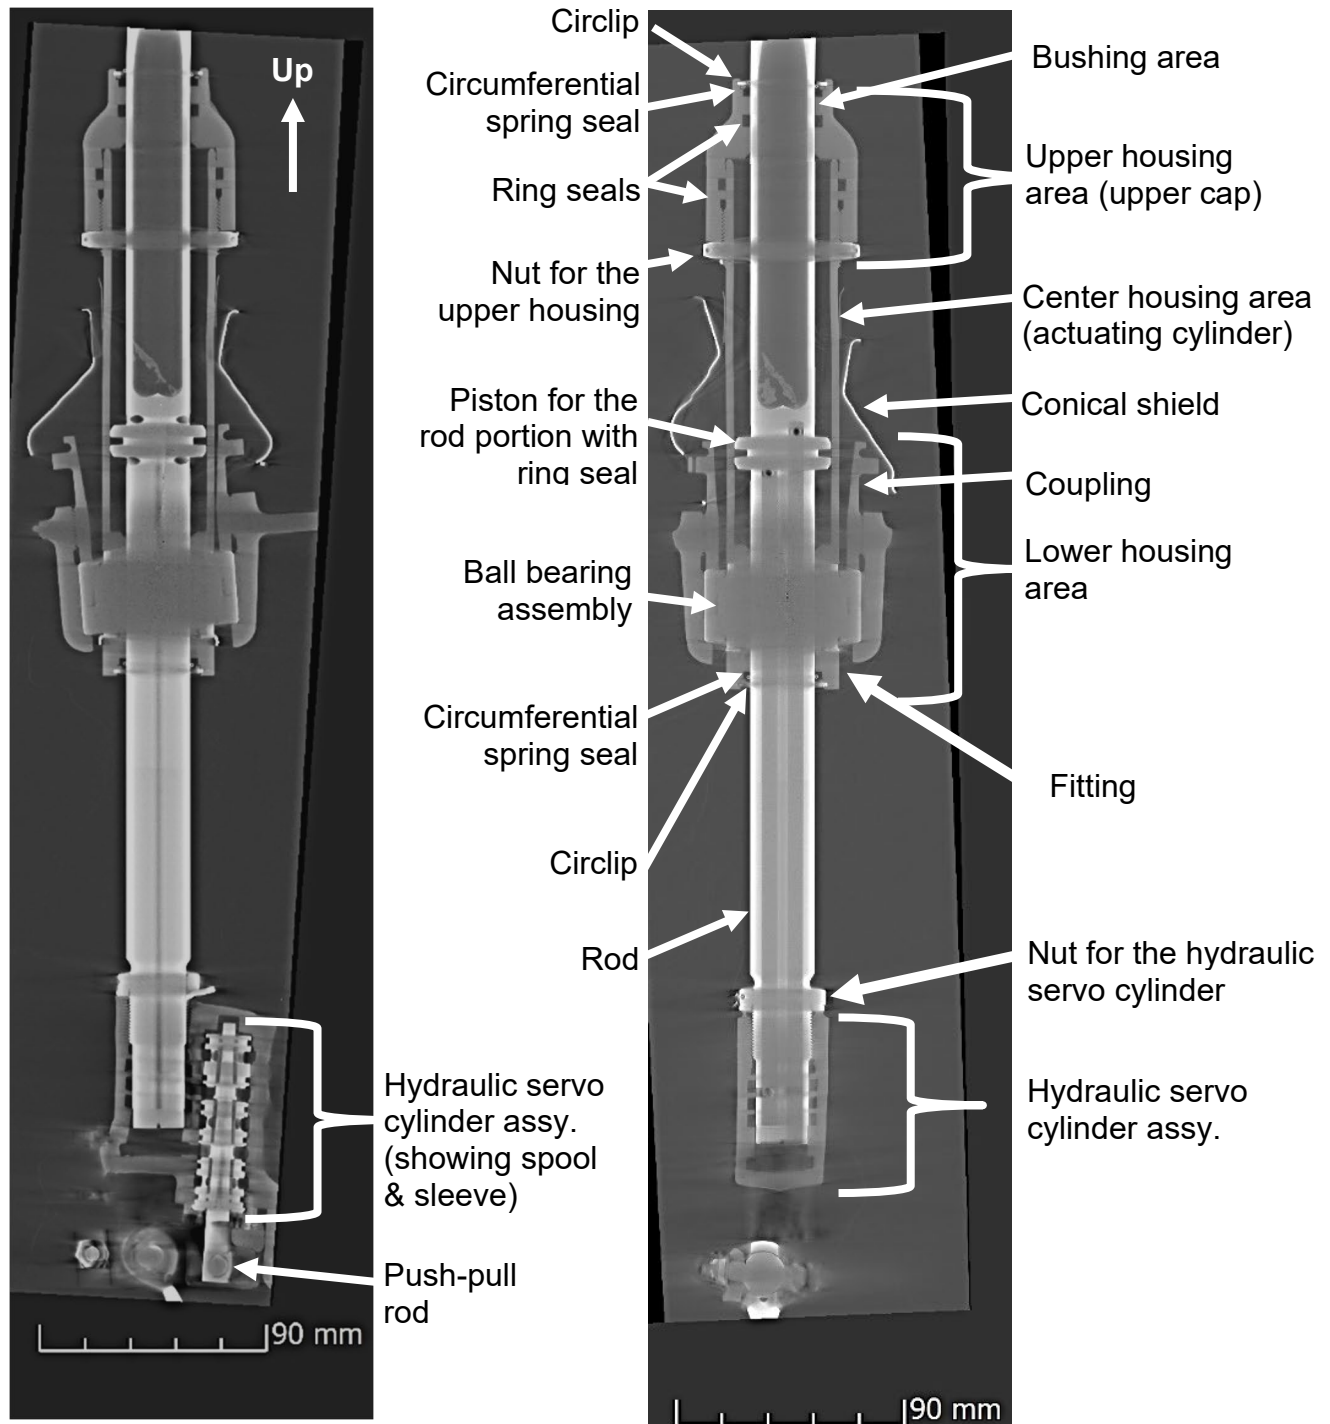
The tube (link) structure that was attached to the upper end of the rod (including nut and safety wires) were disassembled, clearing a path for the upper housing to be removed from the rod. As shown in the X-ray CT images of the servo (Figure 2), the inner surface of the upper housing in the areas of the reduced inner and larger diameter portions contained ring seals. The circlip and circumferential spring seal were intact and covered with debris. The circlip, circumferential spring seal, and nut were removed from the upper housing (while the housing was attached to the rod). The upper housing did not slide off the rod. The lower end of the upper housing was lightly struck multiple times with a hammer to assist with removal of the upper housing from the rod.<sup>3</sup> As the upper housing was removed from the rod, fractured pieces of the ring seals fell out of the housing. All the ring seals fractured into multiple pieces (none of ring seals were intact).

Figure 2. Two reconstructed X-ray CT images of the right lateral servo assembly. The image on the right side of the page was rotated 90 degrees about the axial length of the rod, relative to the image on the left side of the page.

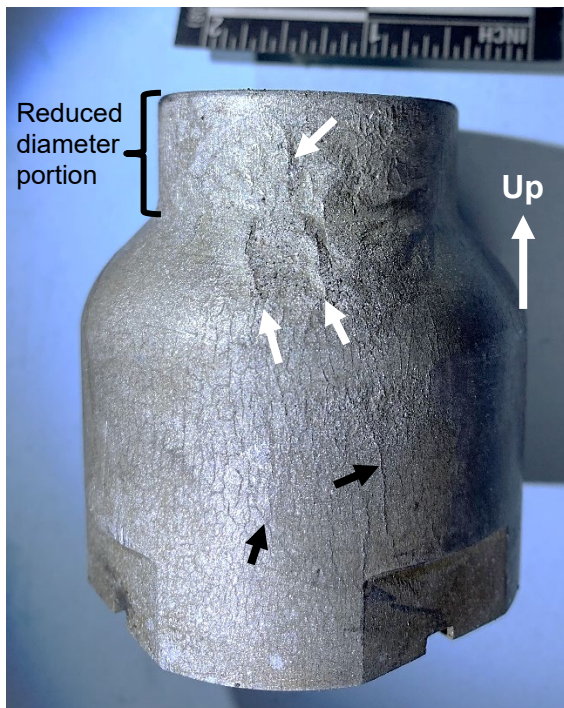
Examination of the disassembled upper housing (see Appendix 1A) revealed the outer surface exhibited evidence of localized re-solidification and micro-cracks in the oxide layer. The surface in the general area of re-solidification contained wrinkles. The inner wall was covered with dry black soot and exhibited evidence of re-solidification (including wrinkles on the surface), as shown in Appendix 1B, consistent with exposure to severe heat from a fire. The bushing area (reduced inner diameter portion) of the housing and corresponding surface on the rod contained no evidence of embedded metal fragments, corrosion, gouge, or wear damage.<sup>4</sup>

Appendix 1A. Outer surface of the upper housing for the right lateral servo after disassembly showing wrinkle marks (white arrows) and micro-cracks (black arrows).

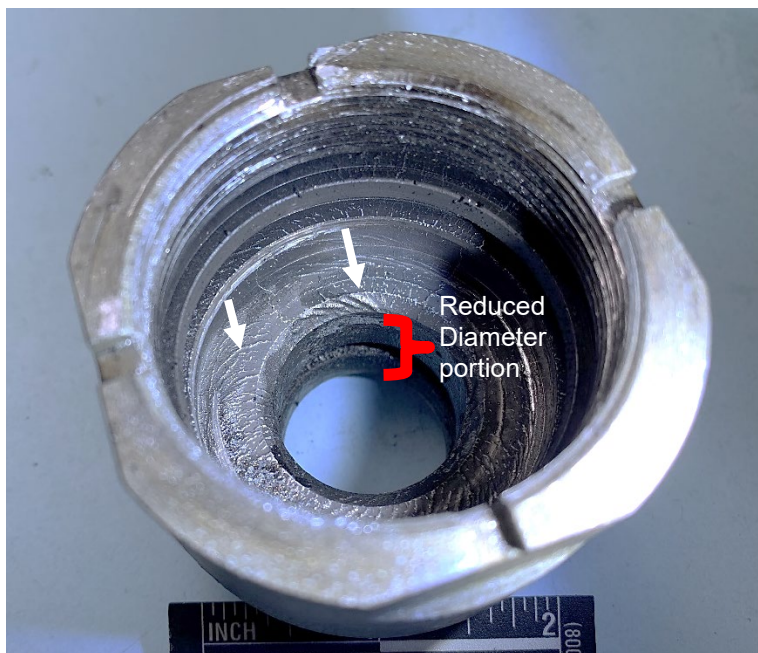
Appendix 1B. View looking up at the inner surface of the upper housing after disassembly showing wrinkle marks indicated by arrows and reduced inner diameter portion.

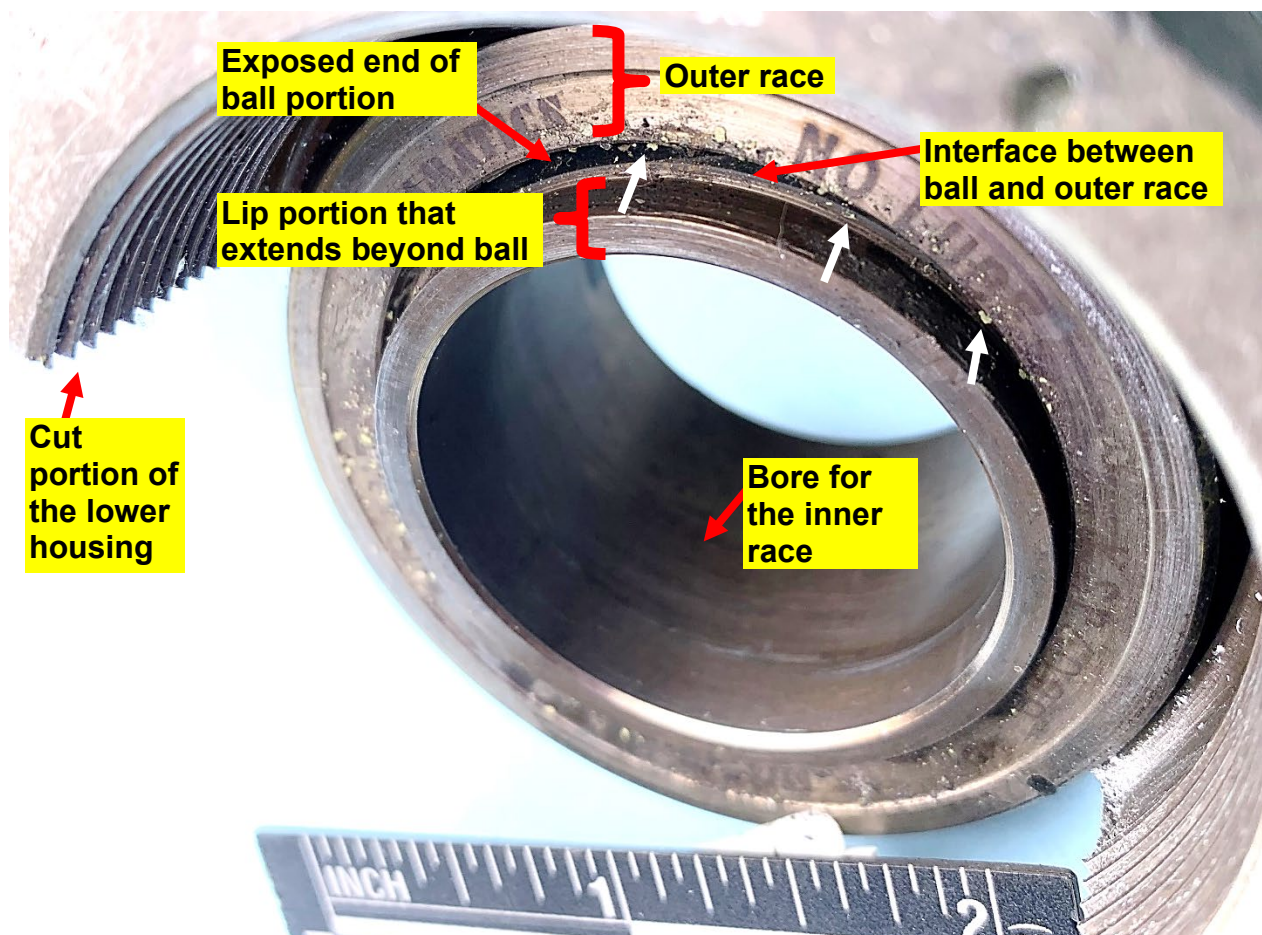
Appendix 1C. Oblique view of the bottom surface of the ball bearing assembly for the right lateral servo showing debris outside of the ball portion, such as in the areas indicated by arrows. The ball contains a bore through the center portion. The lip portion is part of the ball and extended beyond the ball. See appendix 1E for a view of a fully disassembled and exposed ball. The bore portion of the ball is attached to the bottom end and outer face of the center housing.

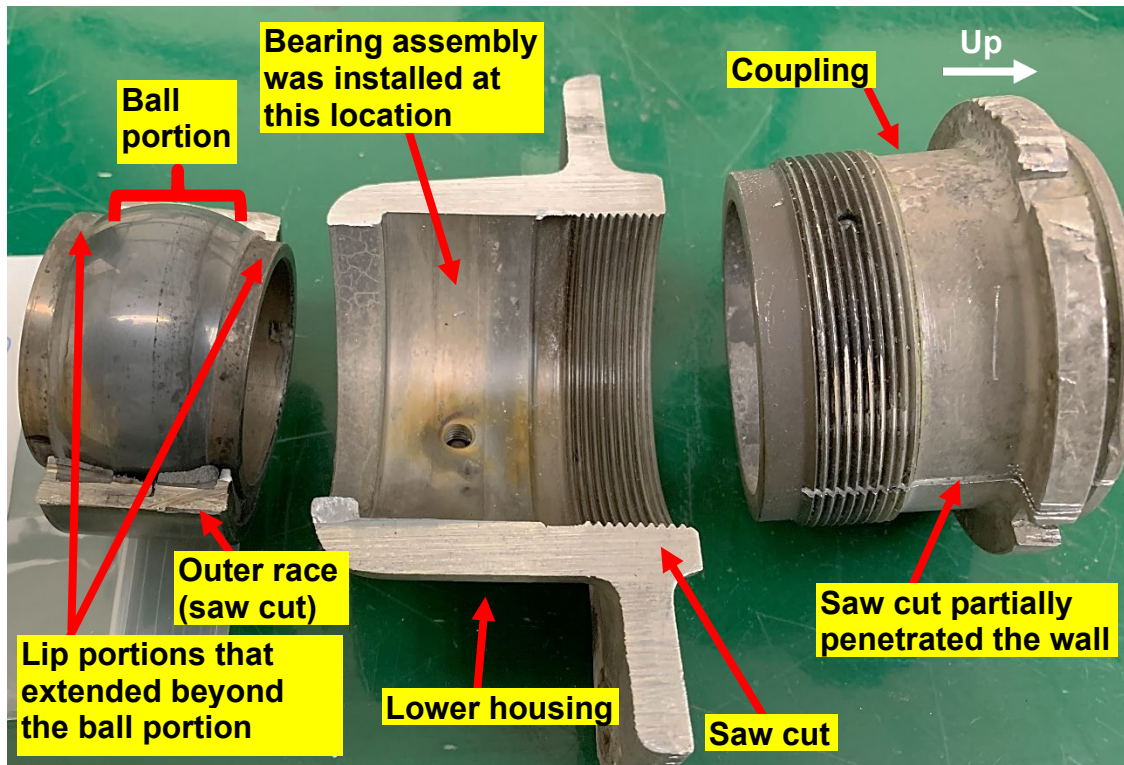
Appendix 1D. Inner surface of the lower housing for the right lateral servo after disassembly and exposed ball bearing assembly. Saw cuts were made through diametrically opposite sides of the outer race and circumferential inserts to expose the outer face of the ball portion.

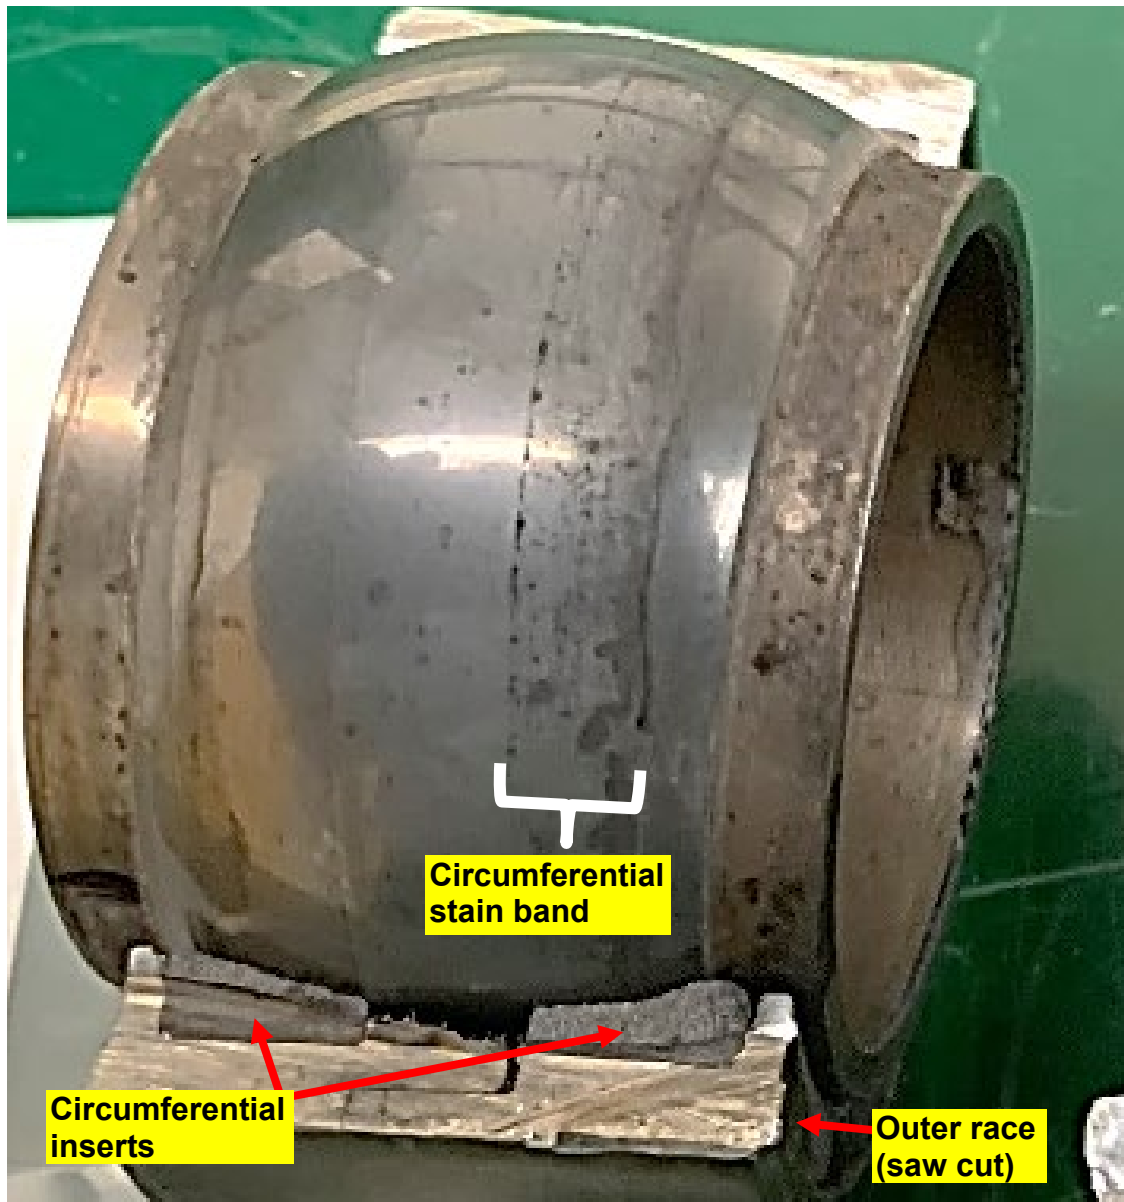
Appendix 1E. Exposed ball portion for the right lateral servo showing a dark stain band that extended all around the ball. The band coincided with the location of one of the inserts. The surface of the ball showed no evidence of scratch, gouge, or wear damage. Dark stain spots were noted in other areas of the ball and lip portions.

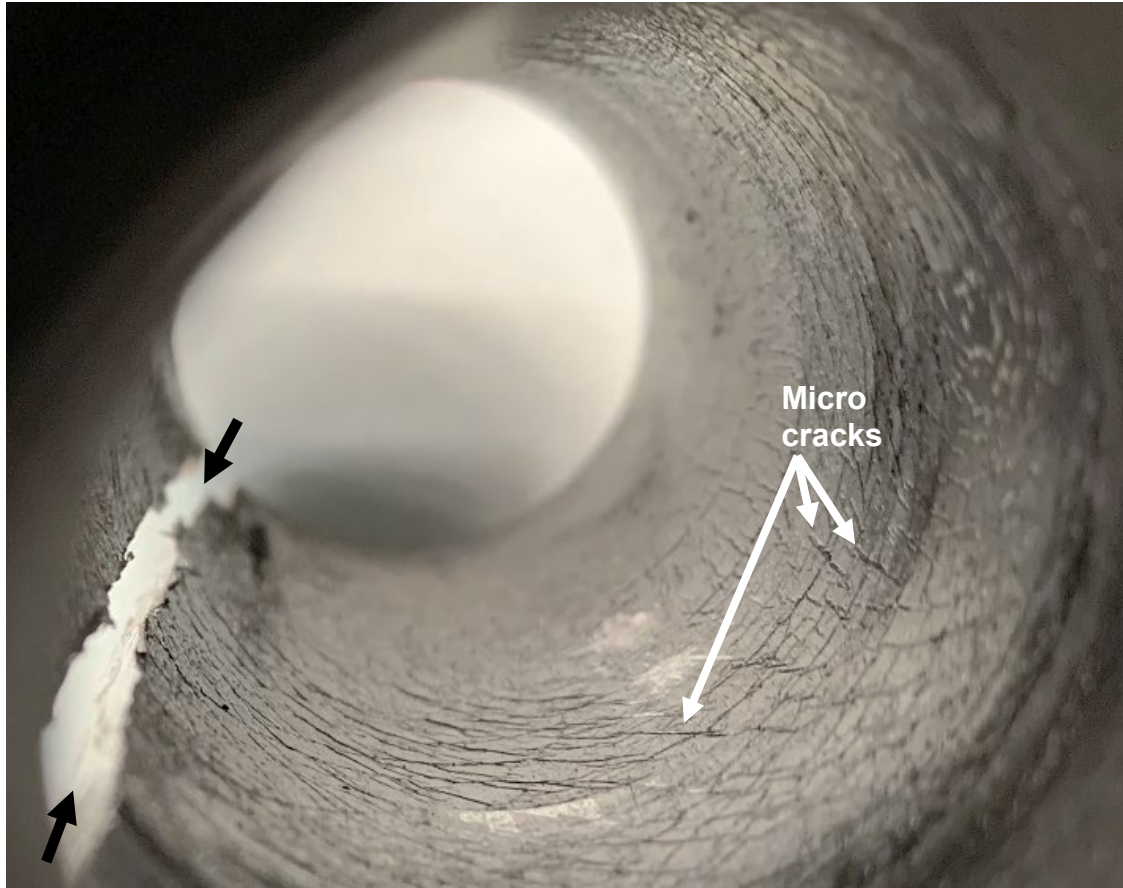
Examination of the inner surface of the center housing revealed evidence an oxide layer that contained micro- cracks consistent with exposure to severe heat from a fire (see Appendix 1F). The inner face of the center housing was covered with a black soot; and showed no evidence of axial marks that would have indicated the extent of piston travel within the center housing. No evidence of embedded metal fragment, corrosion, gouge, or wear damage was found at the inner face of the center housing.

Appendix 1F. Inner surface of the center housing for the right lateral servo after disassembly showing a severely oxidized surface with micro-cracks that extended all around the inner surface. Axial saw cut was made through the center housing to facilitate disassembly (between arrows).

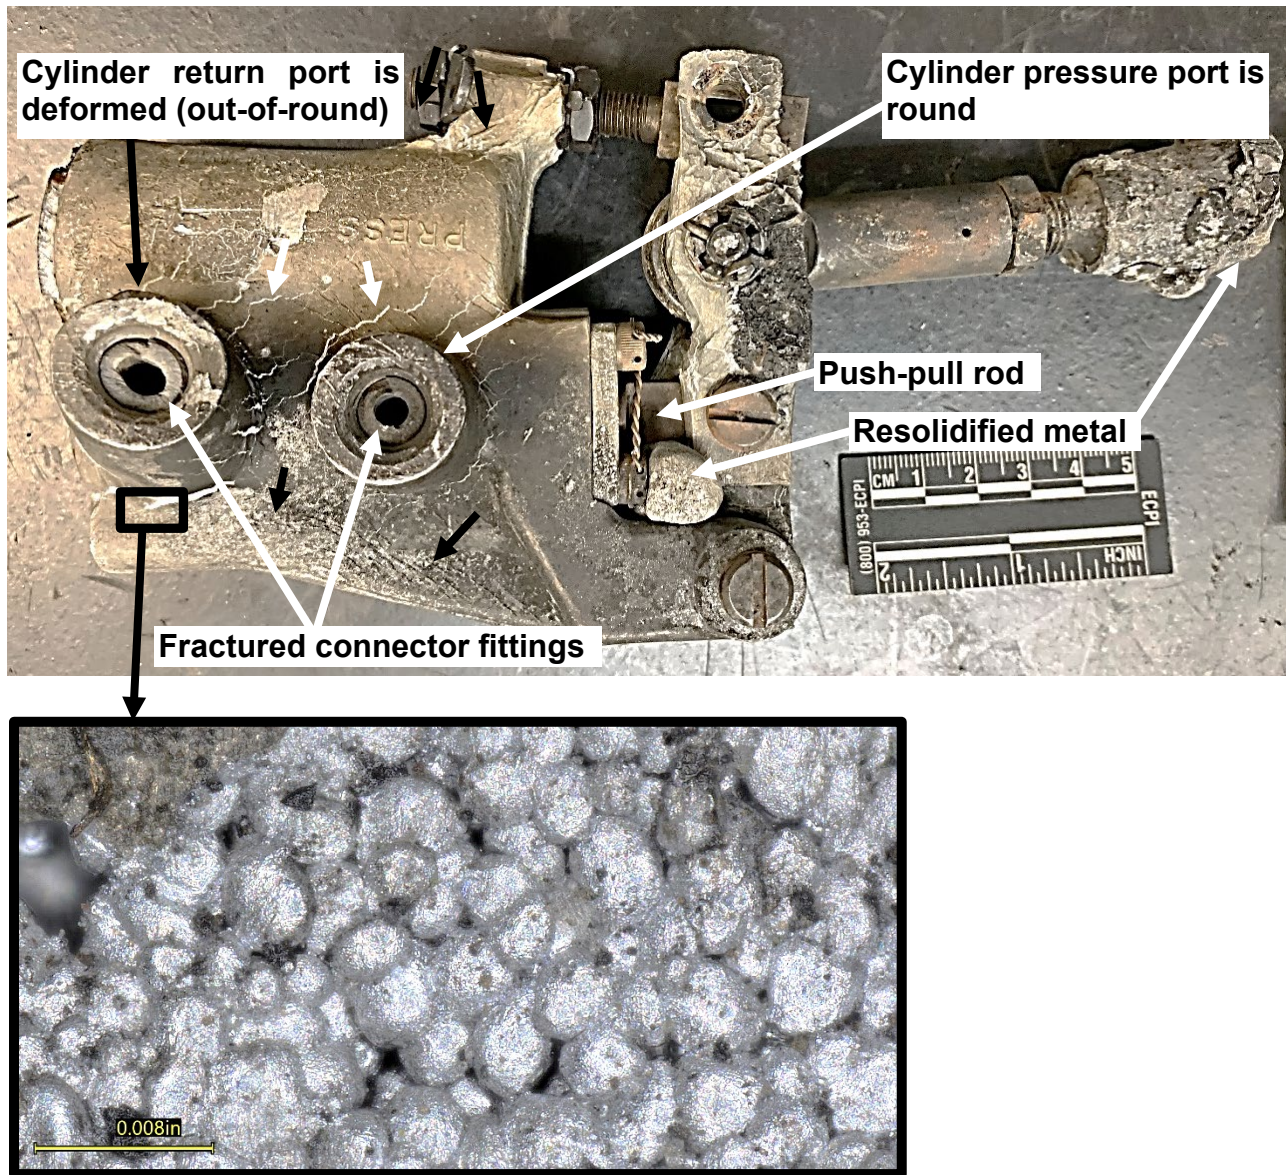
Appendix 1G shows a side view of the hydraulic servo cylinder for the right lateral servo. The hydraulic servo cylinder contained an internal spool and sleeve assembly. A push-pull rod is attached to the spool portion. Several external links to the push-pull rod were cut in the laboratory to prepare for extraction of the spool. Four screws were removed from the cover. The exposed end of the push-pull rod was secured to the end of a needle-nose pliers. An attempt was made to pull the push-pull rod out of the port. The internal spool and sleeve could not be extricated from the port.

Appendix 1G. Outer surface of the hydraulic servo cylinder (upper side of page) showing micro-cracks in the oxide layer indicated by white arrows; and wrinkle marks indicated by black arrows. Upon closer examination with a bench binocular microscope, the re-solidified areas exhibited adjoining micro-spheres or micro-globules (lower side of page) which are consistent with re-solidification. The cylinder return port and respective fractured connector fitting are deformed (out-of-round) compared to those from the cylinder pressure port which are round.

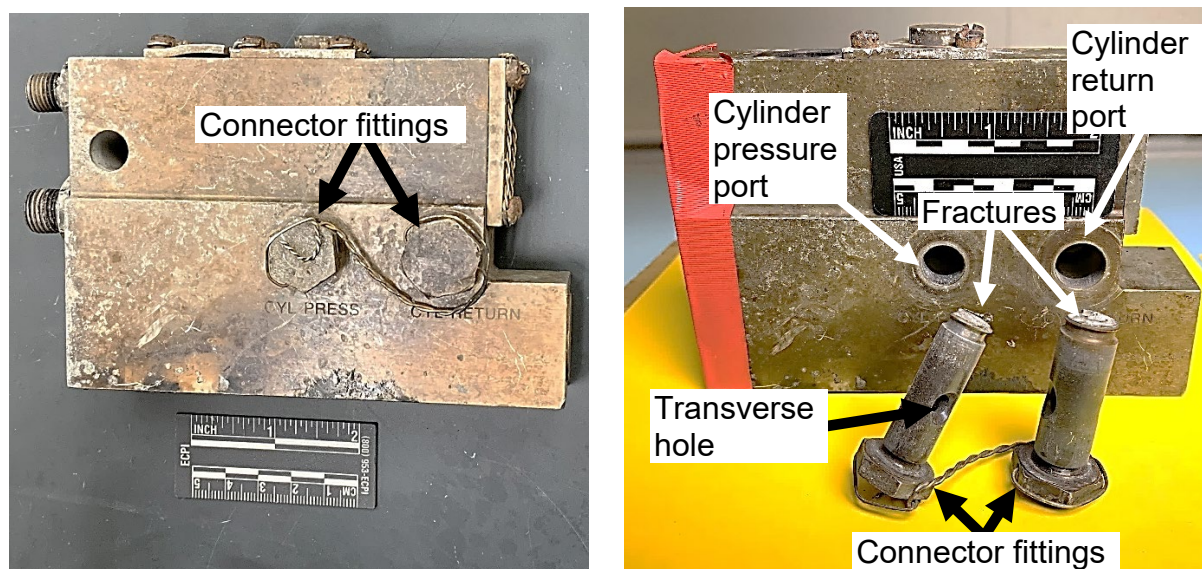
The pressure and return ports for the hydraulic servo cylinder and their respective ports on the irreversible valve are connected to each other by connector fittings (see Attachments 1G through 1I). A connector fitting resembles a bolt but it contains a hollow shank. The hollow portion of the shank is axial oriented and extended along the length of the shank and threaded portion. A transverse hole is located within the shank portion of the connector fitting that intersects the axial hollow portion. The hollow passages within the connector fitting allows hydraulic fluid to transfer between the hydraulic servo cylinder and the irreversible valve assembly. The diameter of the connector fitting for the cylinder return port was greater compared to the one for the cylinder pressure port. The connector fittings were fractured. Bench binocular microscope examination of the connector fittings for the right lateral servo revealed the fractured ends exhibited a rough texture on a slanted planes consistent with overstress separation.

Appendix 1H. Views of the irreversible valve from the side containing the head portion of the connector fittings before and after removal of the connector fittings, left side and right side of page, respectively.

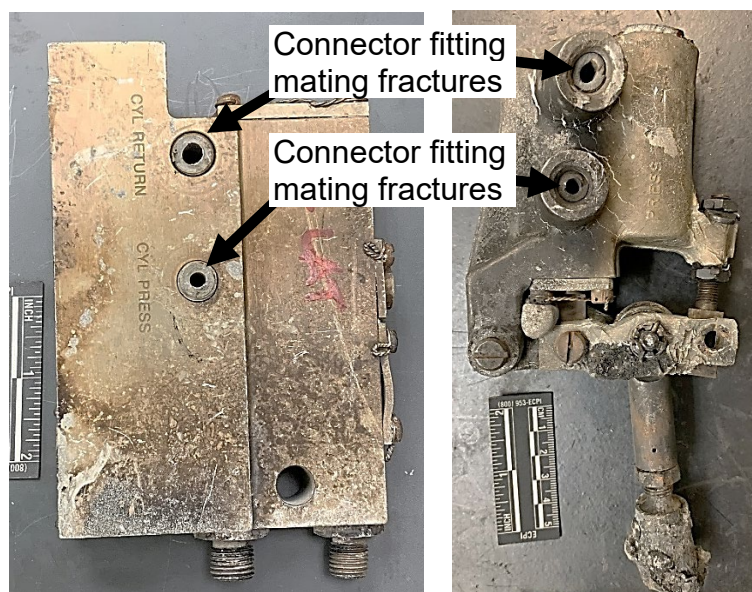
Appendix 1I. View of the irreversible valve (left side of the page) and the hydraulic servo cylinder (right side of the page) showing the mating ends of the fractured connector fittings.

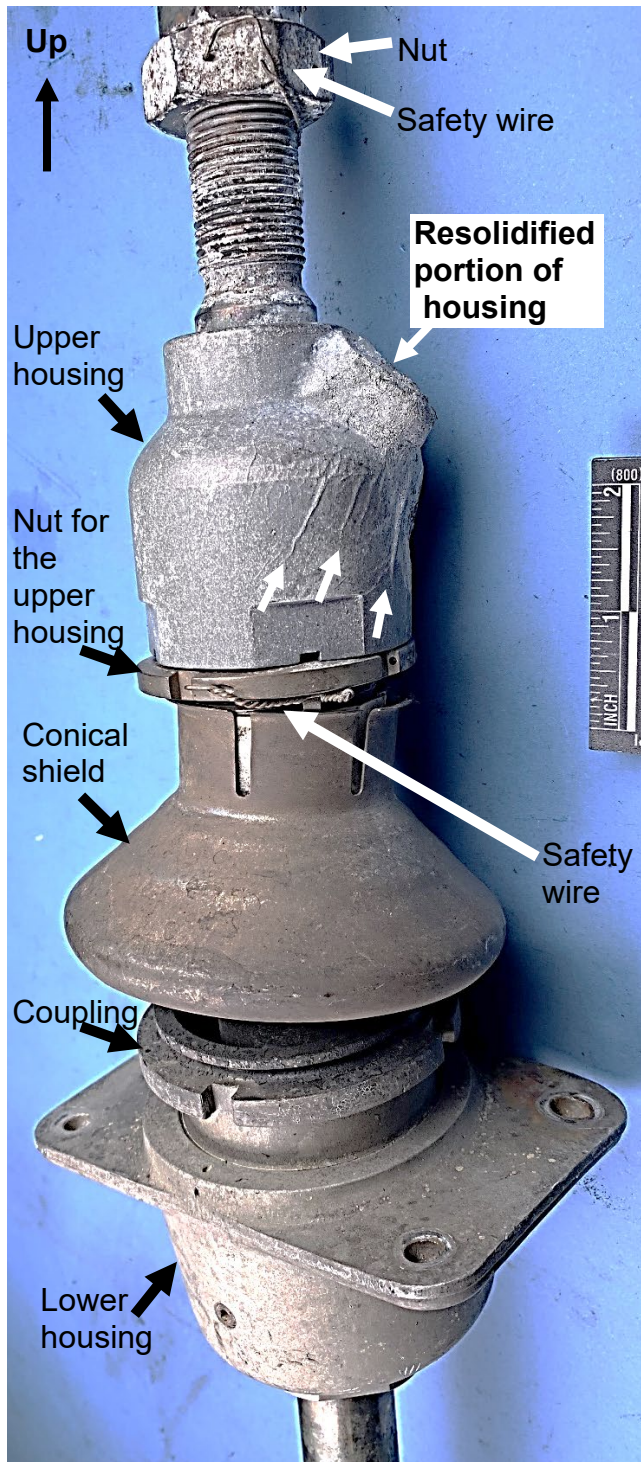
Appendix 2A. Side view of the left lateral servo showing resolidified portion of the upper housing and wrinkle marks indicated by white arrows that extended from the resolidified area.

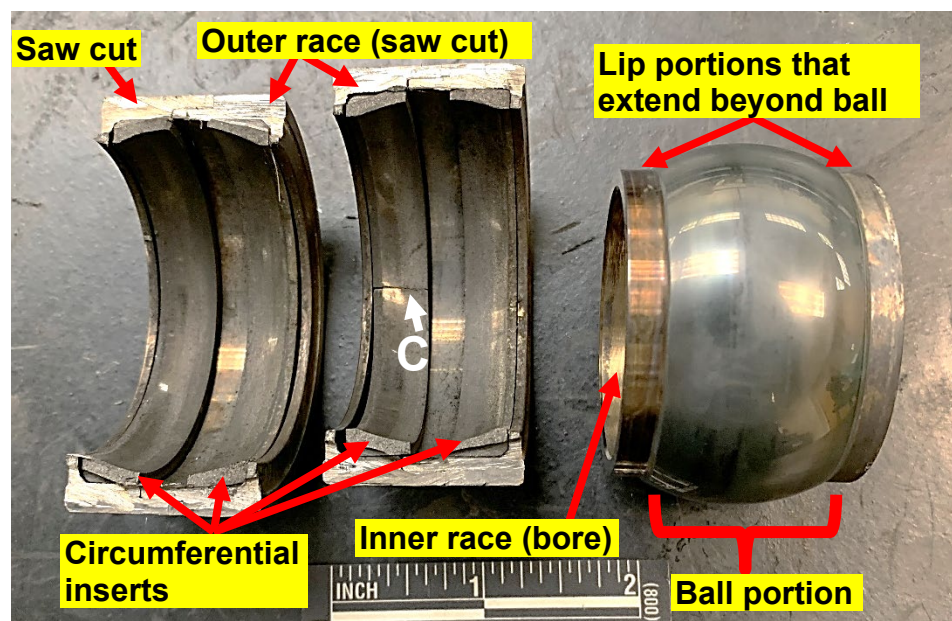
Appendix 2E. View of the disassembled ball bearing and exposed inner surface of the outer race. Saw cuts were made through diametrically opposite sides of the outer race and circumferential inserts to expose the ball portion. Crack in one circumferential insert (area indicated by arrow “C”) occurred during disassembly in the laboratory.

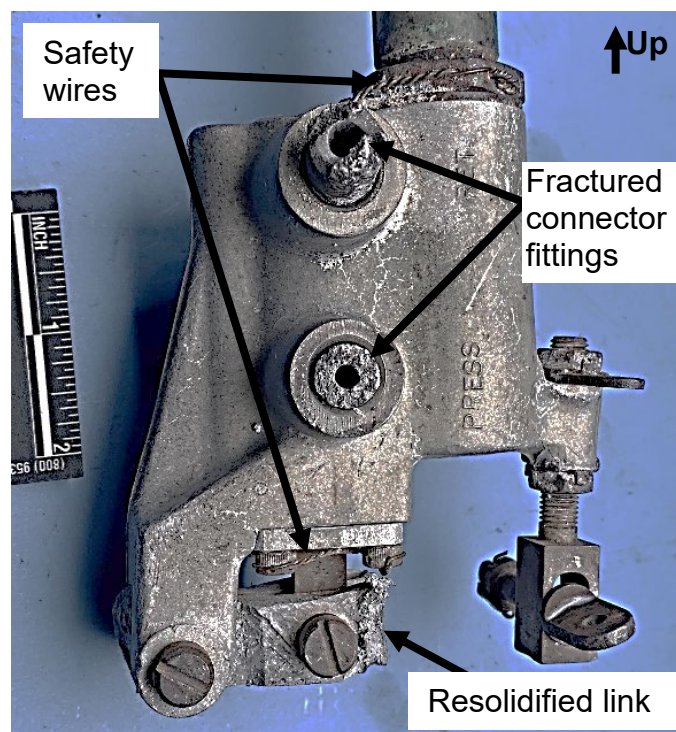
Appendix 2F. Photograph of the hydraulic servo cylinder for the left lateral servo showing a link that had separated and resolidified; fractured ends of the connector fittings, and intact safety wires.

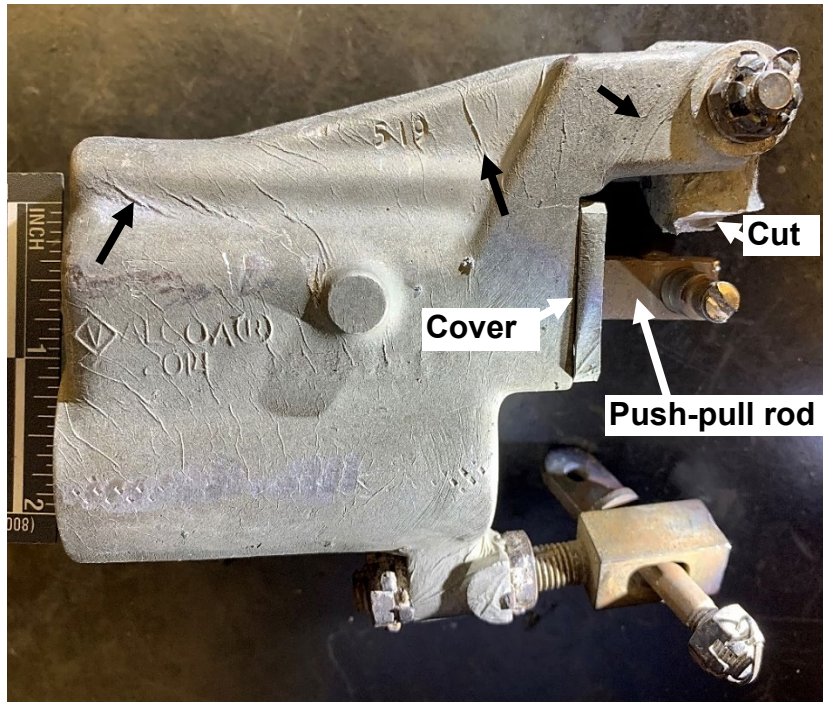
Appendix 2G Outer surface of the hydraulic servo cylinder for the left lateral servo showing wrinkle marks on the outer surface, indicated by arrows. The cover is attached by four screws to the body of the hydraulic servo cylinder. In this photograph, the external links to the push-pull rod were cut and disassembled; and the four screws (with intact safety wires) were removed from the cover, clearing the way for the internal spool and sleeve to be pulled out of the port.

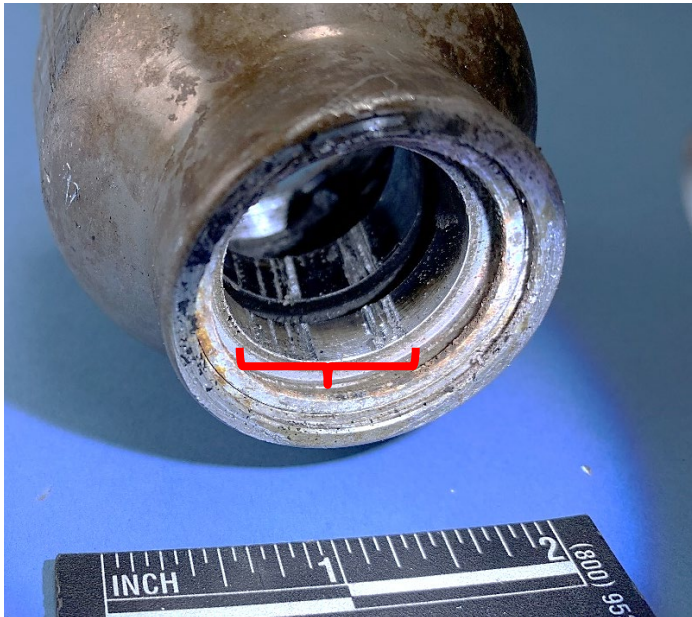
Appendix 3A. View looking down at the inner reduced diameter portion of the upper housing showing nearly axial gouge marks in an isolated area indicated by a bracket. A bench vice was utilized to secure the rod portion during disassembly. The grip portion of the bench vice left teeth marks on the rod portion. The nearly axial gouge marks on the inner face of the upper housing correspond to location of teeth marks on the rod.

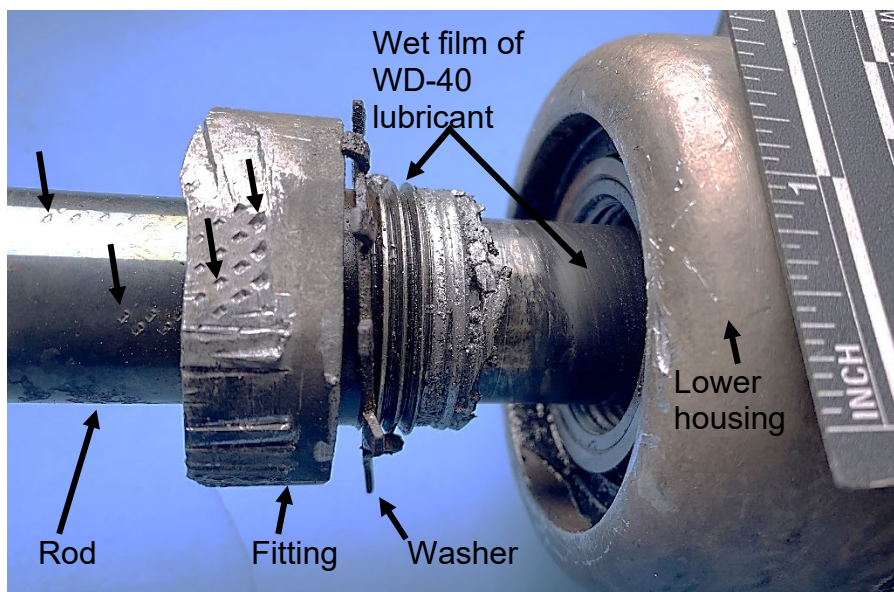
Appendix 3B. Side view of the fitting after it was removed from the lower housing while it remained attached to the rod portion. Prior to disassembly, WD-40 lubricant was sprayed into the rod and threaded area of the fitting to assist disassembly. A bench vice was used to grip the rod end during disassembly which left teeth marks on the rod. Example of teeth marks from the bench vice are indicated by arrows.

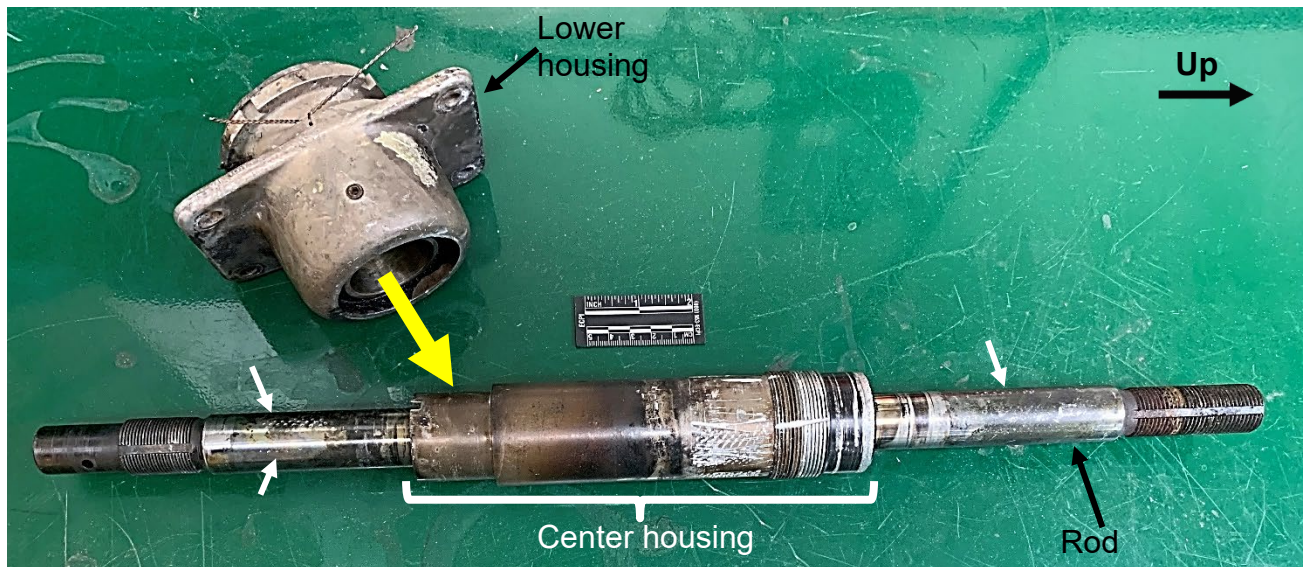
Appendix 3C. Side view of the rod with the center housing attached. The bore portion (inner race) for the ball bearing was attached to the outer reduced diameter portion of the center housing in the area indicated by an arrow. The surface of the rod showed evidence of staining. A bench vice was used to grip the rod ends during disassembly which left teeth marks on the rod. Example of teeth marks from the bench vice are indicated by arrows. With the exception of teeth marks left by the bench vice to assist disassembly, the surface of the rod was smooth and showed no evidence of gouge or corrosion damage.

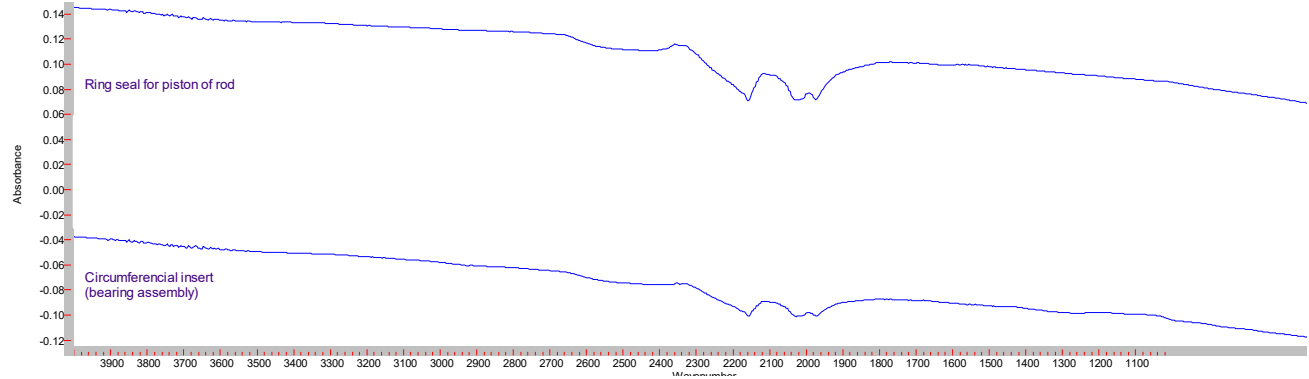
The circumferential inserts and ring seal for the piston rod from the right servo valve were black and their outer surfaces exhibited a smooth texture. These pieces were placed next to a magnet and they were not attracted to the magnet. To determine whether these pieces were flexible or brittle, they were intentionally bent with a needle-nose pliers. These pieces fractured easily and showed no evidence of flexibility. The fracture face of all these pieces exhibited a brittle fracture feature. This XRF alloy analyzer cannot detect the element carbon, so a sample of the circumferential insert and ring seal for the piston portion of the rod was analyzed by other analytical method to determine whether carbon was present. Energy dispersive spectroscopy (EDS) analysis of each sample produced a spectrum that contained one major elemental peak of carbon. Fourier Transform Infrared (FTIR) spectroscopy was used to analyze these two materials. The FTIR spectra of each sample showed no hydrocarbon peaks and each contained only a single peak ( $\sim 2100\text{ cm}^{-1}$ ) consistent with carbon. The FTIR spectra is indicative of either a carbon-based material such as graphite or the material was significantly heat damaged leaving only carbonize<sup>5</sup> residue (Appendix 4 shows a typical FTIR spectrum).

Appendix 4. Overlapping FTIR spectra (Absorbance vs. Wavenumber [ $\text{cm}^{-1}$ ]) of examined samples.
