# NATIONAL TRANSPORTATION SAFETY BOARD

## MATERIALS LABORATORY FACTUAL REPORT

Report No. 22-068

Place : Coalinga, California  
Date : August 19, 2020  
Vehicle : UH-1H, N711GH  
NTSB No. : WPR20LA280  
Investigator : Van McKenny (AS-40)

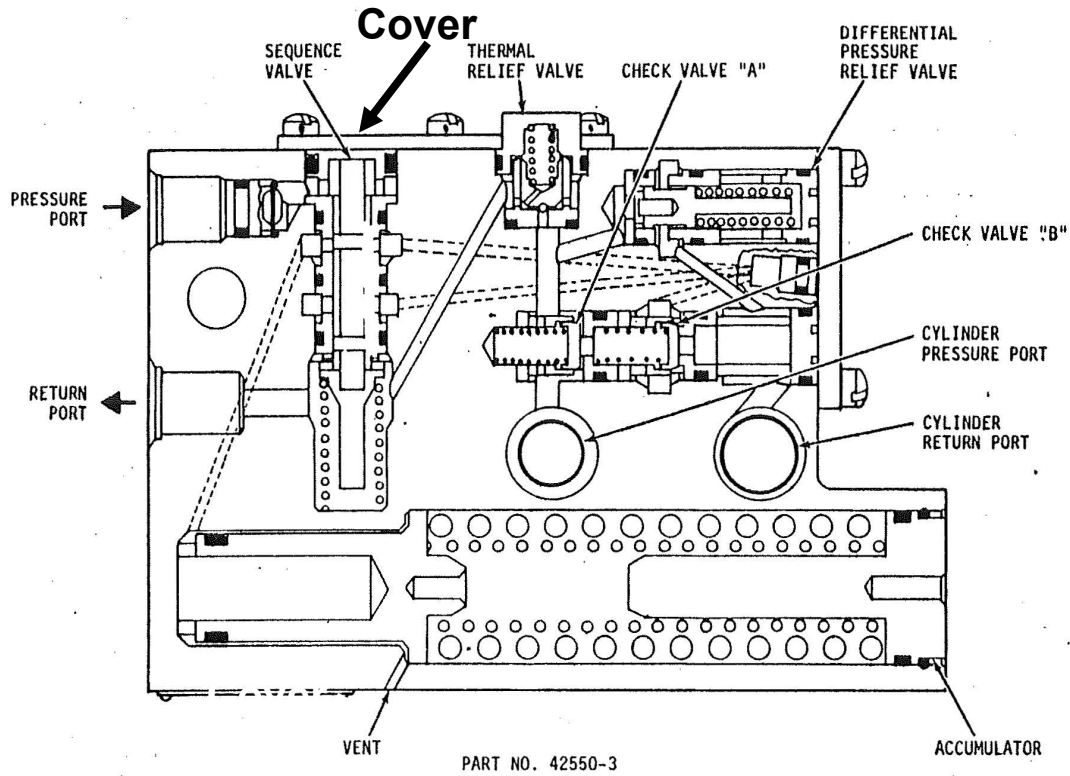
The irreversible valve assembly contained several internal valves (sequence; thermal relief; differential pressure relief; check valves "A" and "B; and an accumulator valve). Appendix 1A shows a cross section diagram of the irreversible valve assembly and Appendix 1B shows a reconstructed X-ray computed tomography (CT) image of the same valve.<sup>1</sup> The internal valves were disassembled from their respective ports with the exception of the thermal relief and accumulator valves. The inner and outer surfaces of the servo assembly were dry and contained no evidence of hydraulic fluid (liquid).

Appendix 1A. Cross section diagram of the hydraulic irreversible valve assembly.

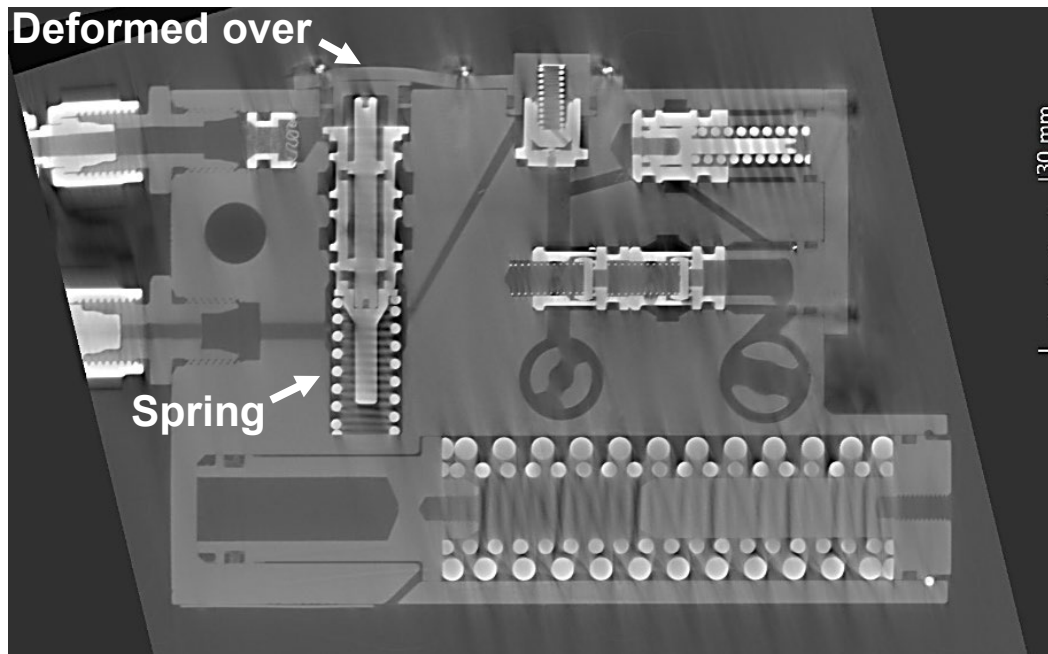
The sequence valve contained an internal spring, as shown in Appendix 1B. This spring applies tension stress to the inner surface of the cover. Prior to removing the cover from the

Appendix 1B. Reconstructed X-ray computed tomography image of the irreversible valve assembly showing the deformed cover for the internal sequence valve. The sequence valve and other internal valves each contain at least one spring (appear similar to lined up spheres).

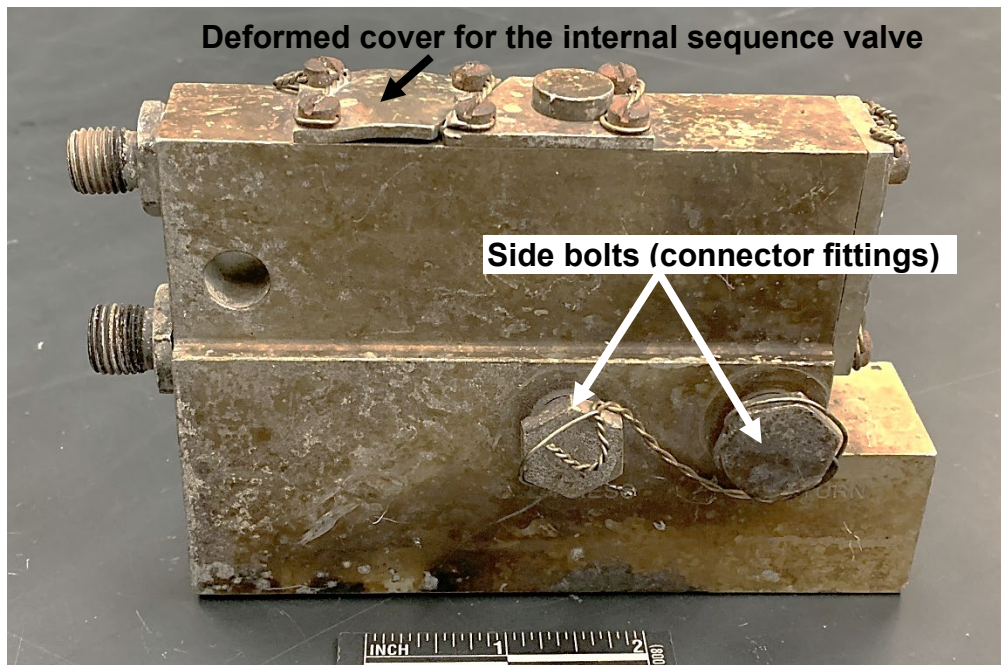
The cover for the sequence valve was attached by three screws to the body of the irreversible valve assembly. The screws were secured by safety wire and, in turn, the safety wires were intact. The cover showed bending deformation damage that was oriented away from the body of the irreversible valve assembly, see Appendices 2A and 2B. The outer face of the cover exhibited evidence of an oxide layer (tint color was brown) and micro-cracks within the oxide layer that followed the bending contours adjacent to the holes for the screw, see Appendix 2C.

Appendix 2A. Overall view of the irreversible valve assembly showing the deformed cover for the internal sequence valve.

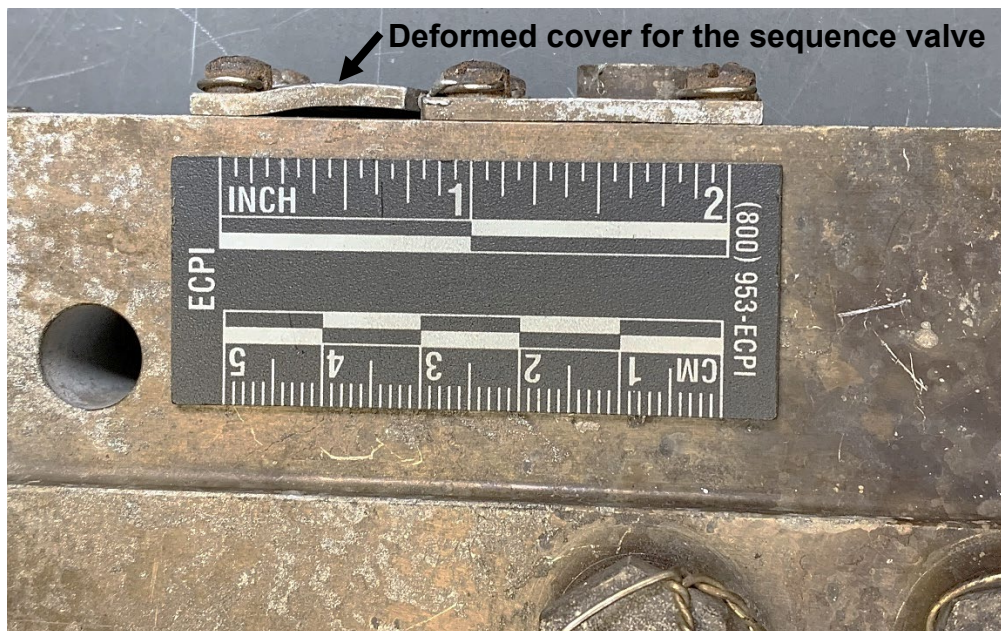
Appendix 2B. Side view of the deformed cover for the internal sequence valve.

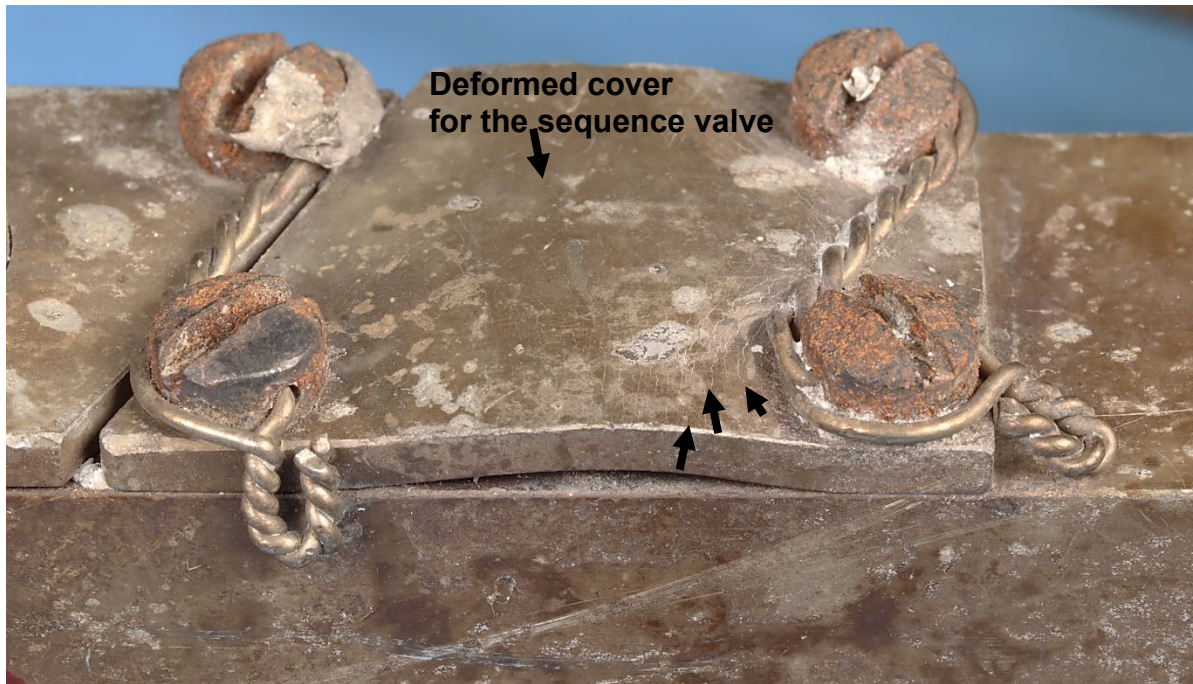
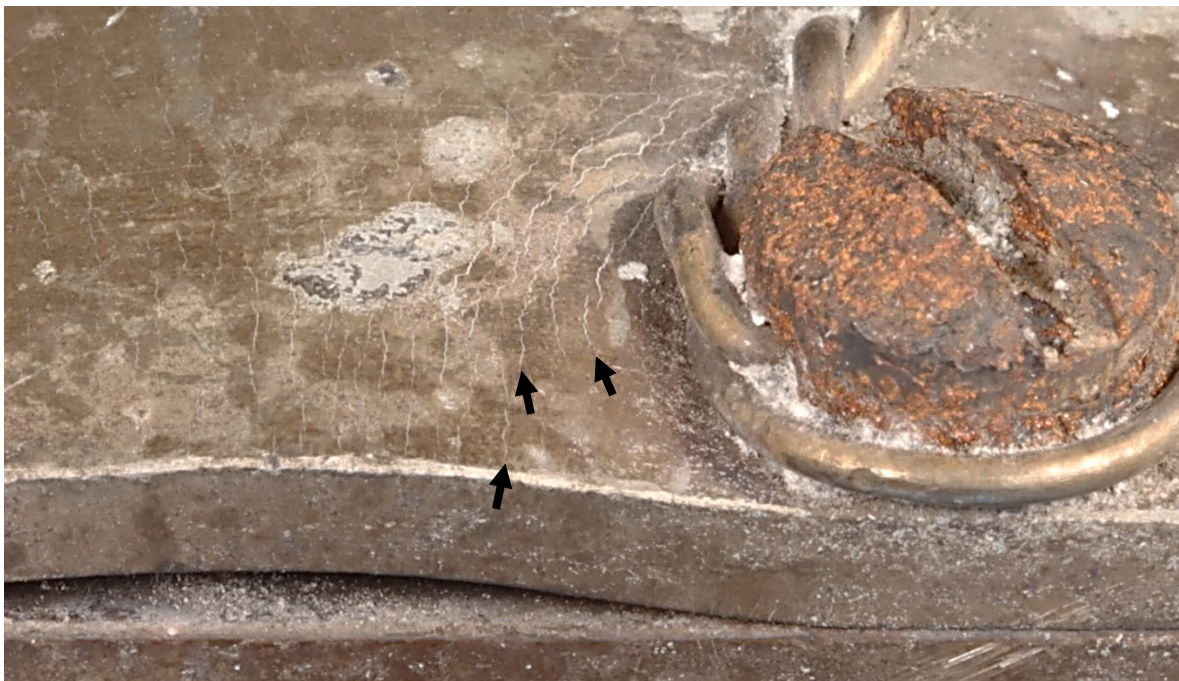
Appendix 2C. Views of the outer face of the deformed cover for the sequence valve showing micro-cracks in the oxide layer (areas indicated by black arrows).

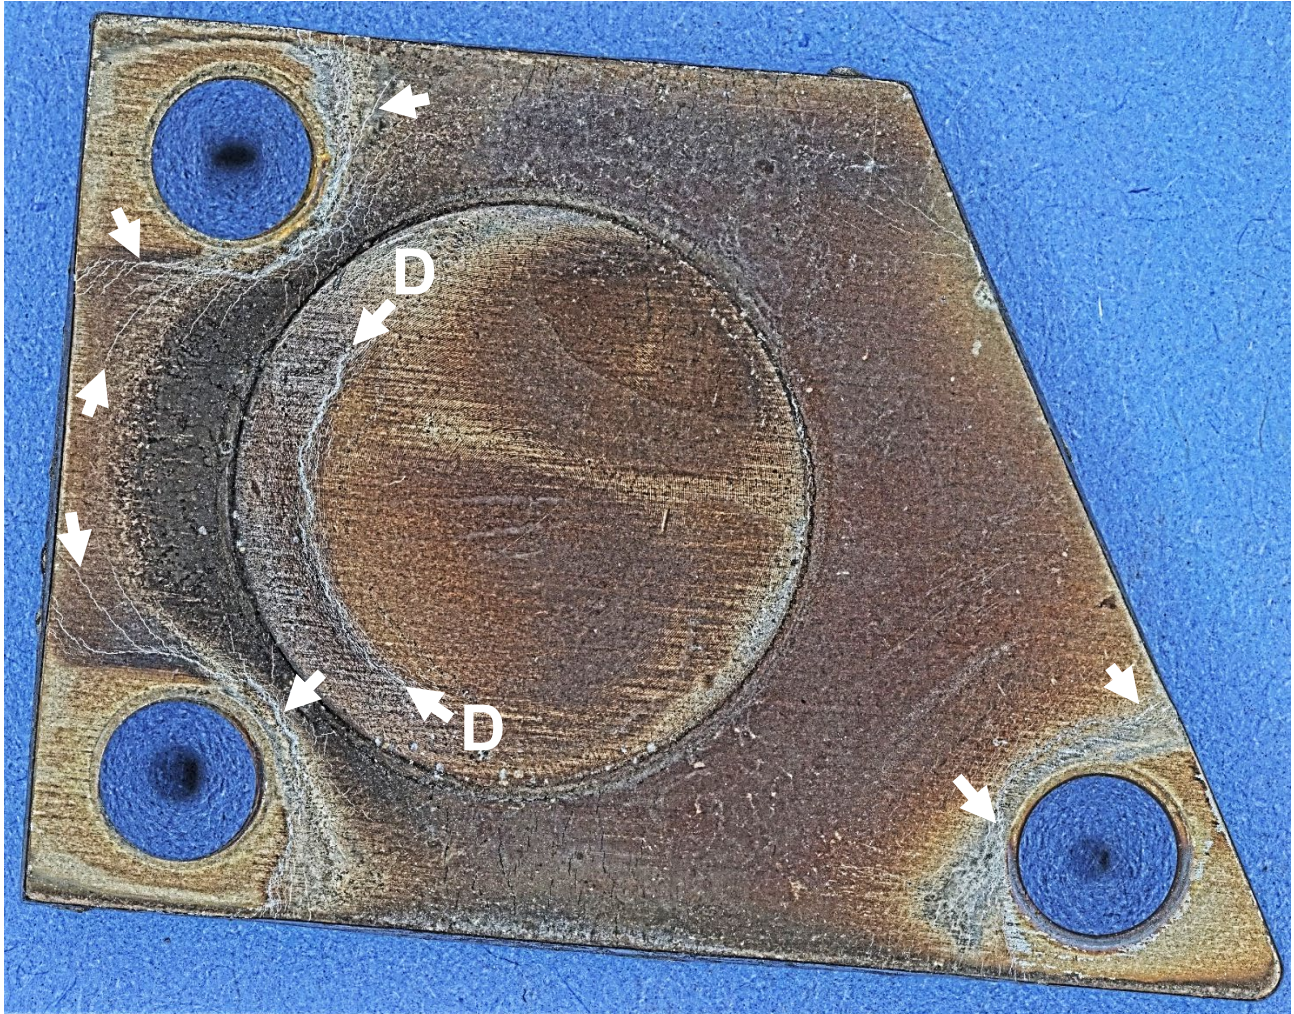
Appendix 2D. Inner face of the deformed cover for the sequence valve showing micro-cracks in the oxide layer in the areas around the bolt holes, indicated by unmarked arrows, and an area corresponding to the deformed head of the piston, between arrows "D".

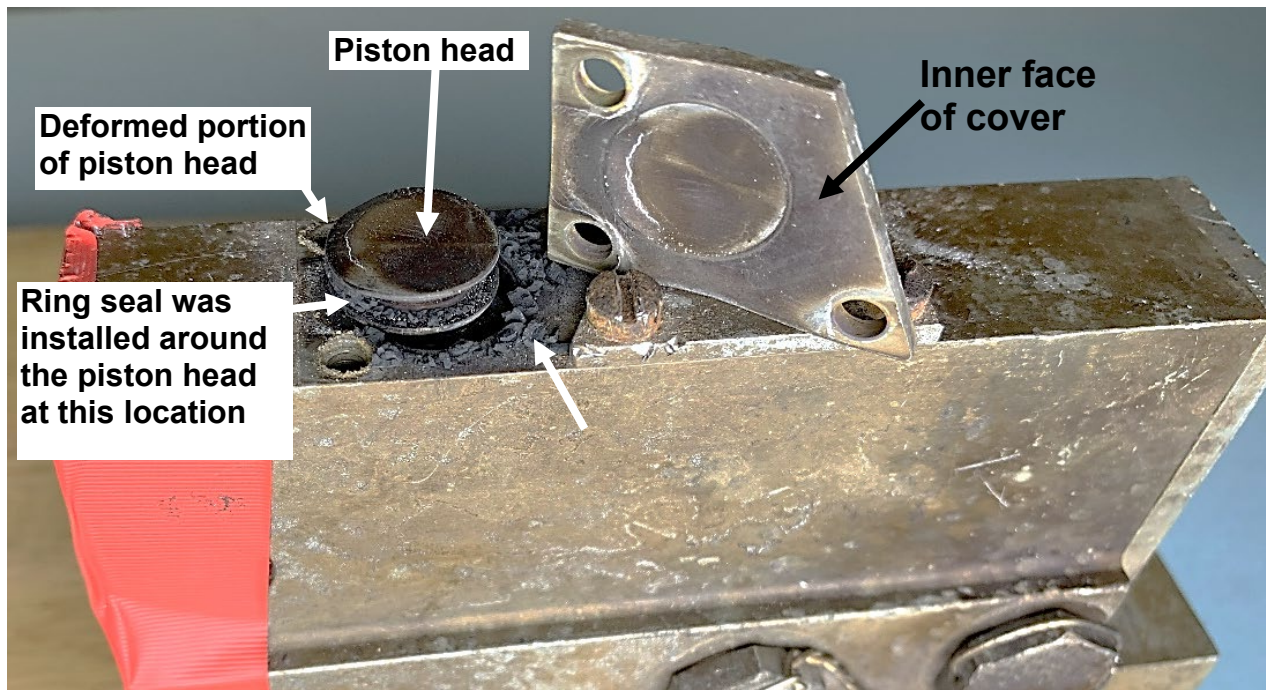
Appendices 2E and 2F show photographs of the exposed piston head. Appendix 2F shows a portion of the exposed spool and sleeve. The piston head and sleeve contained ring seals. As the piston head and sleeve were removed from the port, fractured pieces of the ring seals fell out of the port. Appendix 2G shows a side view of the spool and sleeve and fractured pieces of the ring seals. All the ring seals within this port fractured into multiple pieces (none of them were intact). The extracted parts of the sequence valve were examined (Appendices 2G through 2I). With the exception of the ring seals, the internal parts of the sequence valve were intact and showed no evidence of fracture, corrosion, or wear damage. An attempt was made to manually pull (with needle-nose pliers) the spool out of the sleeve. The needle-nose pliers was secured to one end of the stem (rod portion) of the spool. This action was repeated for the opposite end of the spool. The spool could not be removed from the sleeve by using pliers.

Appendix 2E. Disassembled cover for the sequence valve port showing exposed piston head. White arrow indicates fractured fragments of the ring seal. In this stage of disassembly, the hydraulic lines were removed from the irreversible valve assembly (left side of page) and their respective ports were covered with red adhesive tape. The tape was applied to prevent particles from entering or departing the ports.

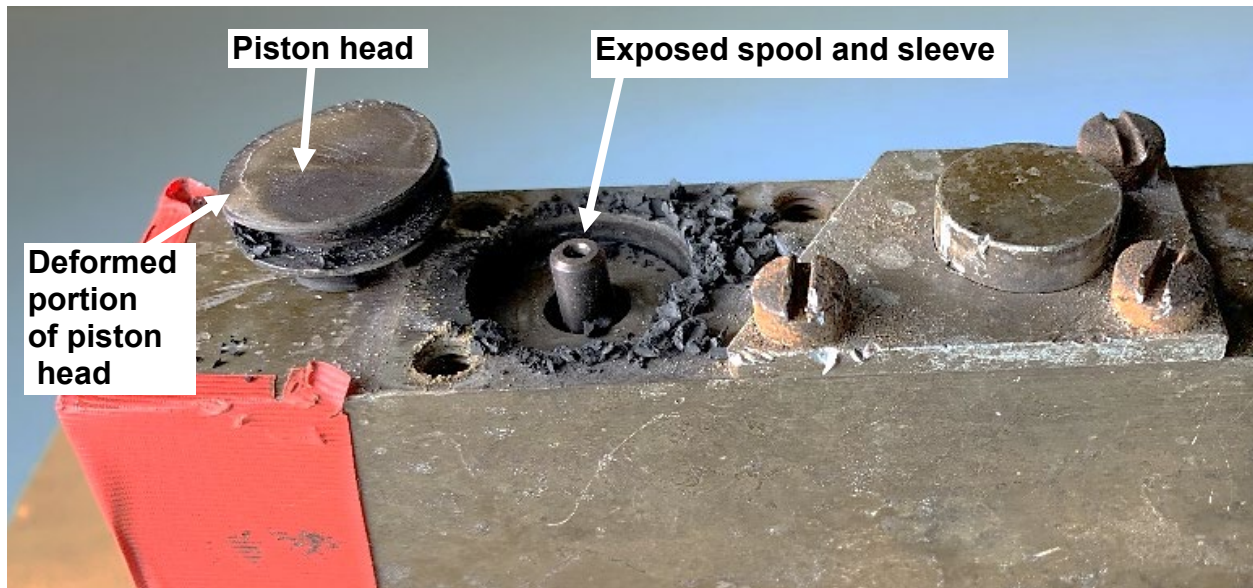
Appendix 2F. Piston head that was extracted from the sequence valve port and exposed top portion of the spool and sleeve.

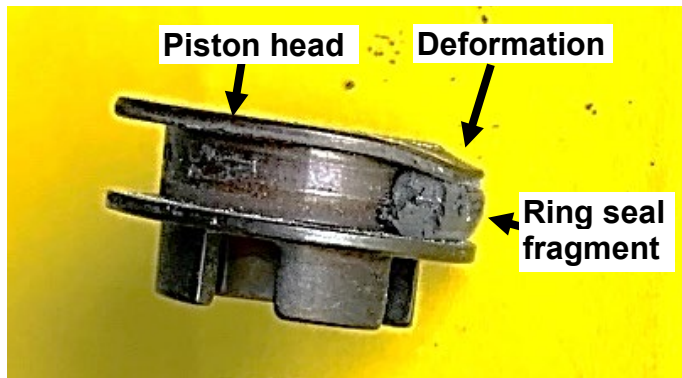
sequence valve, the irreversible valve assembly was placed on the table frame of a hydraulic shop press and the ram portion was positioned against the outer face of the cover. The three screws and safety wires were disassembled from the cover while the ram was positioned above the cover. After removing the three screws, the ram was raised with the cover, allowing the piston head and portion of the spool<sup>2</sup> and sleeve to be exposed. Appendix 2D shows a photograph of the inner face of the deformed cover after disassembly. The inner face of the deformed cover exhibited evidence of an oxide layer (tint color was brown). The oxide layer contained micro-cracks in areas following the bending contours adjacent to the screw holes. The inner face of the cover also contained deformation that coincided with that on the deformed head of the piston (see Appendix 2G).

Appendix 2G. Side view of the piston head that was extracted from the sequence valve showing deformation at the upper end of the head. A small fragment of the ring seal remained attached to the piston head.

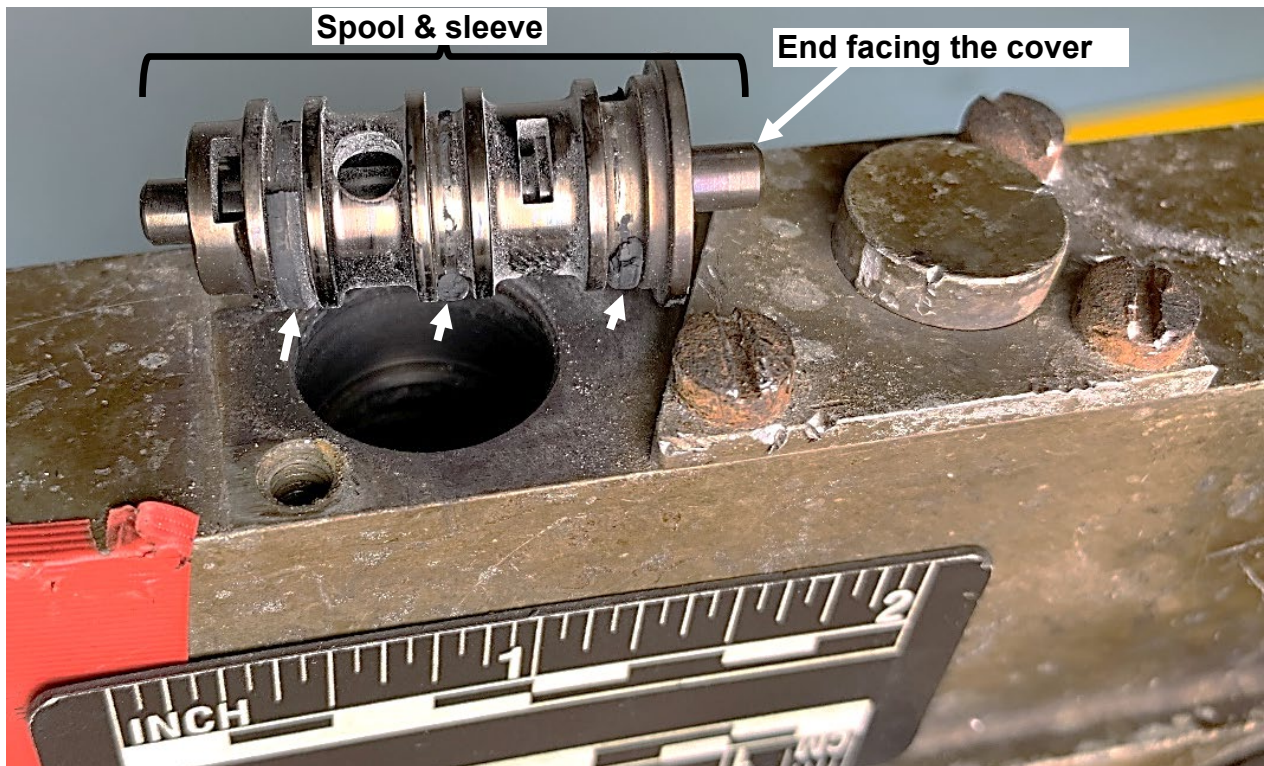
Appendix 2H. Spool and sleeve assembly that were extracted from the sequence valve port. Fractured portions of the ring seals are indicated by arrows.

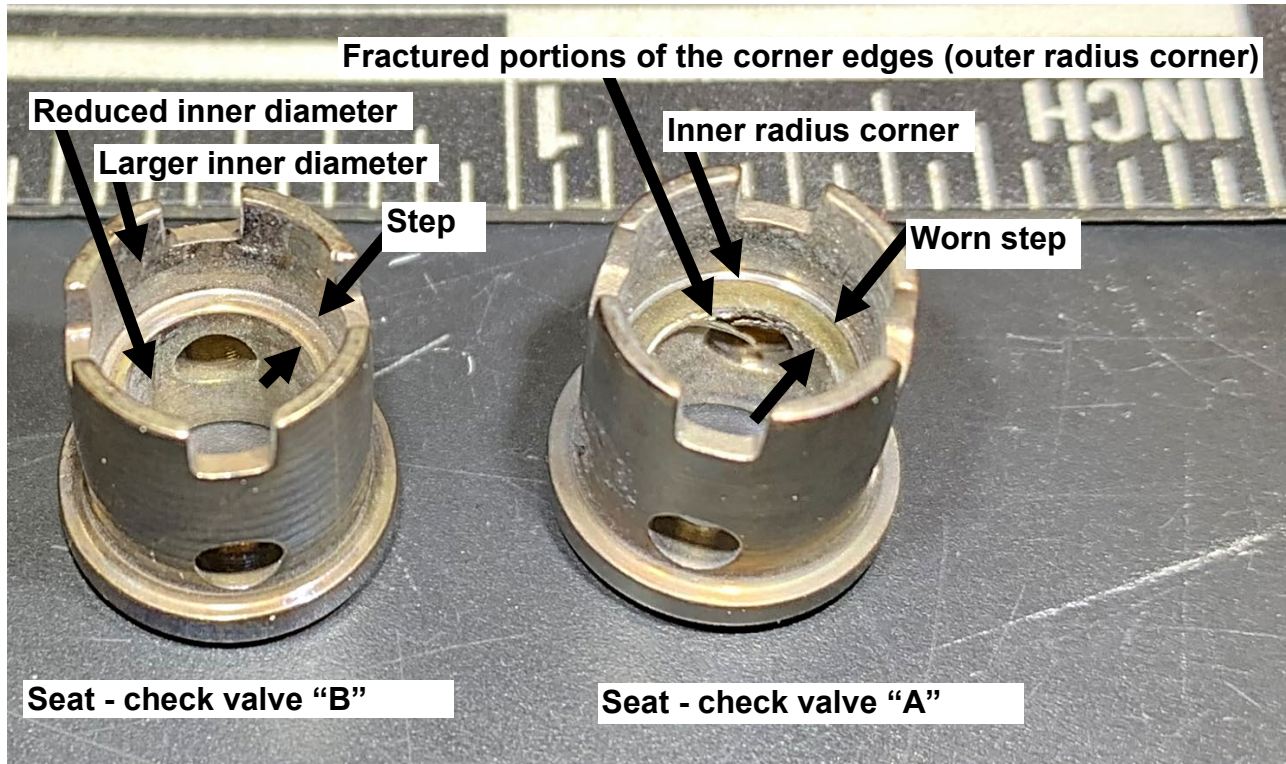
wear but the step portion for the seat of check valve “A” showed evidence of wear damage that extended all around its circumference. The step portion contained an outer radius corner that intersected the reduced inner diameter portion and an inner radius corner that intersected the larger inner diameter portion. Examination of check valve “A” revealed outer radius corner in many areas were fractured and portions of the fractured corners remained attached to the seat. The fractured corners that remained attached to the seat showed evidence of deformation. The amount of material that separated from the outer radius corner was not determined.

Appendix 3C. Seat portions from check valves "B" and "A".

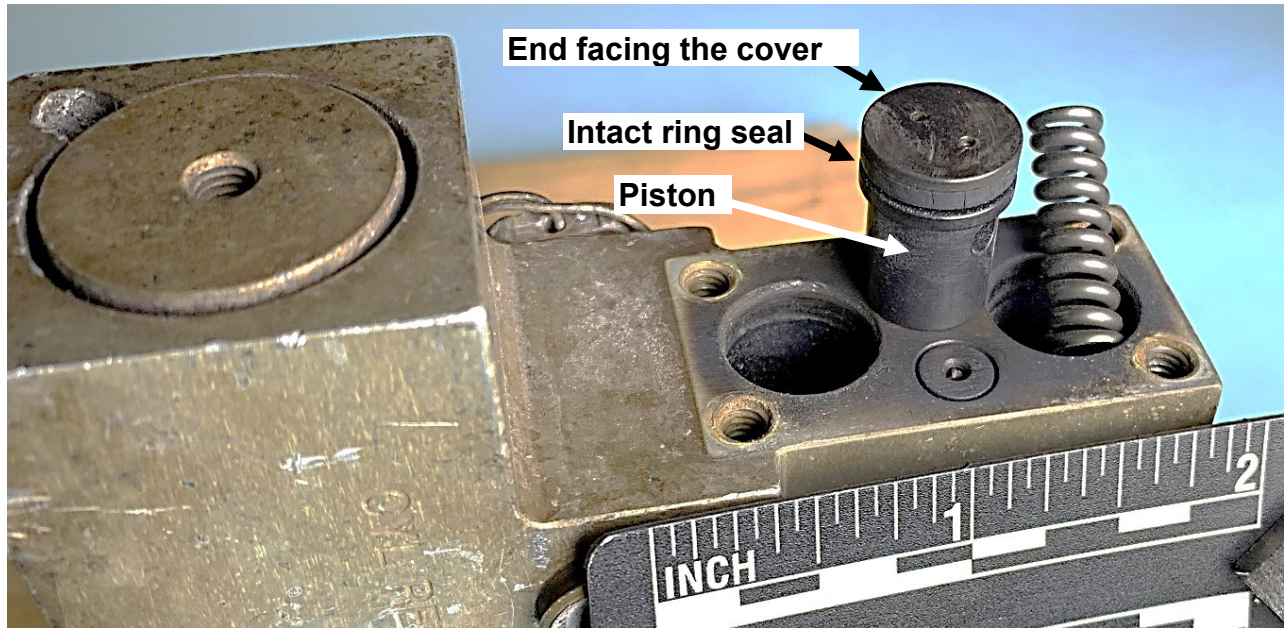
The differential pressure relief valve was removed from the irreversible valve assembly in the same manner as in check valves “A” and “B”. The piston portion and spring located under the piston were removed from the assembly. The ring seal for the piston was intact and it contained several micro-cracks, see Attachments 4A and 4B.

Appendix 4A. Piston and spring that were extracted from the differential pressure relief valve (port located on the right side of the page).

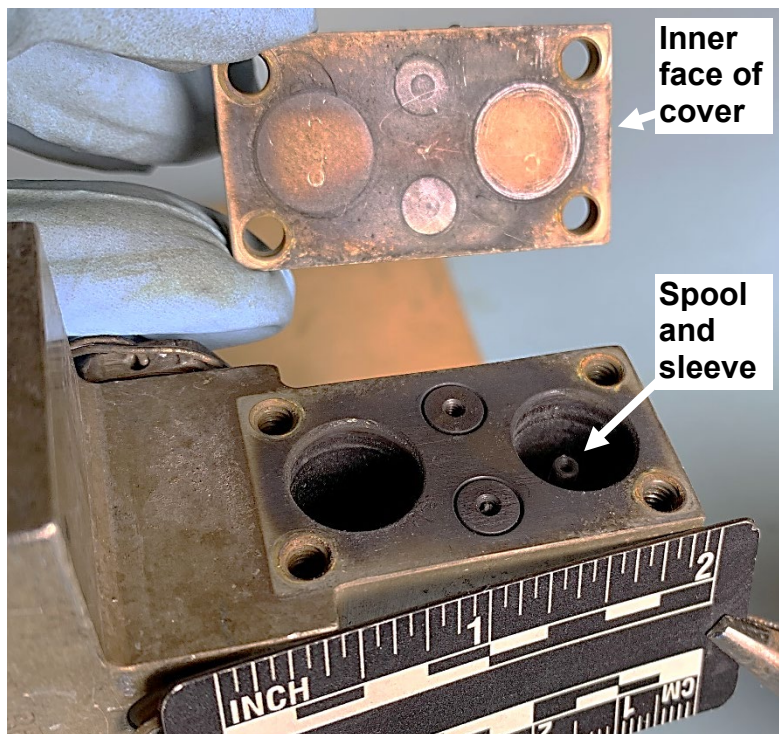
Appendix 4B. Cover that was disassembled from the differential pressure relief valve.

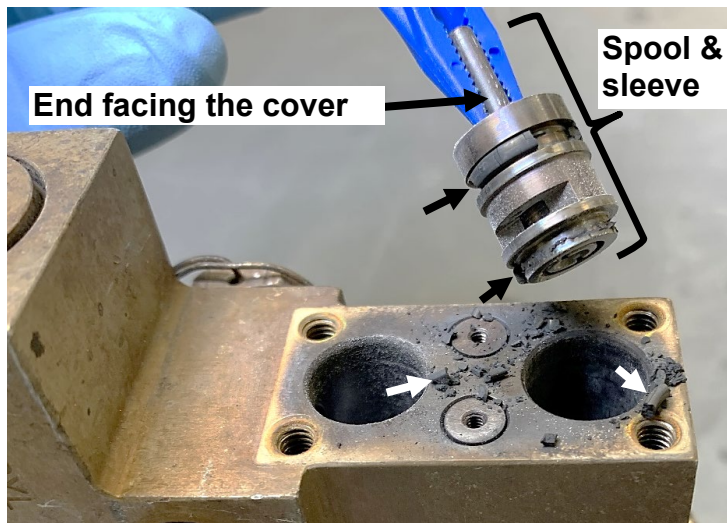
As the differential pressure relief valve parts were removed from the port, fractured pieces of the ring seals fell out of the port, see Attachment 4C and 4D. The other two ring seals fractured into multiple pieces. The other extracted parts of the valve were intact and showed no evidence of wear damage, see Attachments 4E and 4F.

Appendix 4C. Spool and sleeve that were removed from the differential pressure relief valve port showing ring seal fragments that remained attached to the sleeve (indicated by black arrows); and pieces of the ring seal that fell off the sleeve (indicated by white arrows).

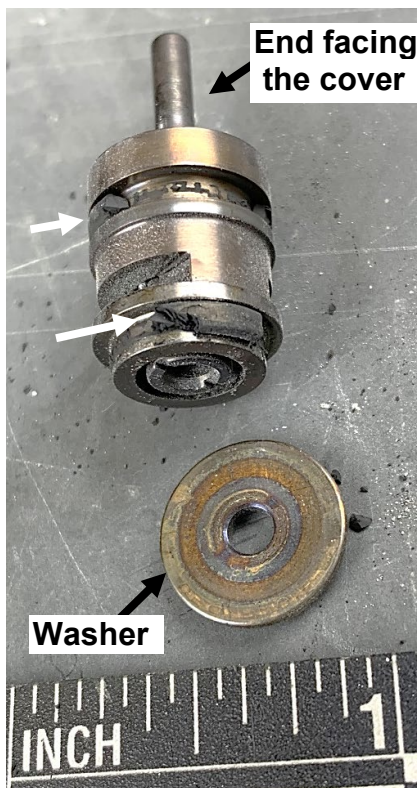
Appendix 4D. Spool and sleeve, and washer, that were removed from the differential pressure relief valve. Fractured ring seals are indicated by white arrows.

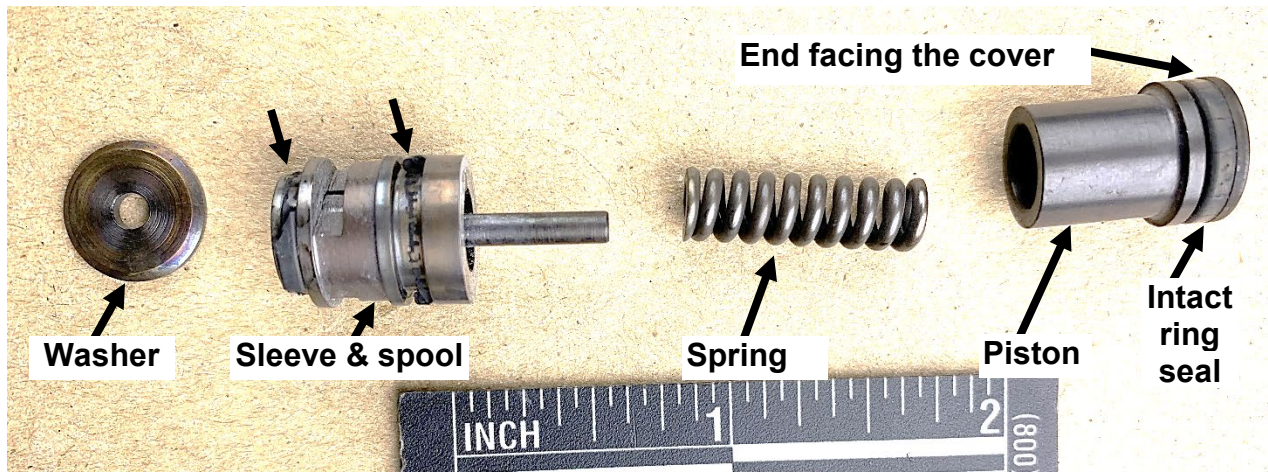
Appendix 4E. Pieces removed from the differential pressure relief valve. Fractured ring seals pieces that remained attached to the sleeve and spool are indicated by arrows.

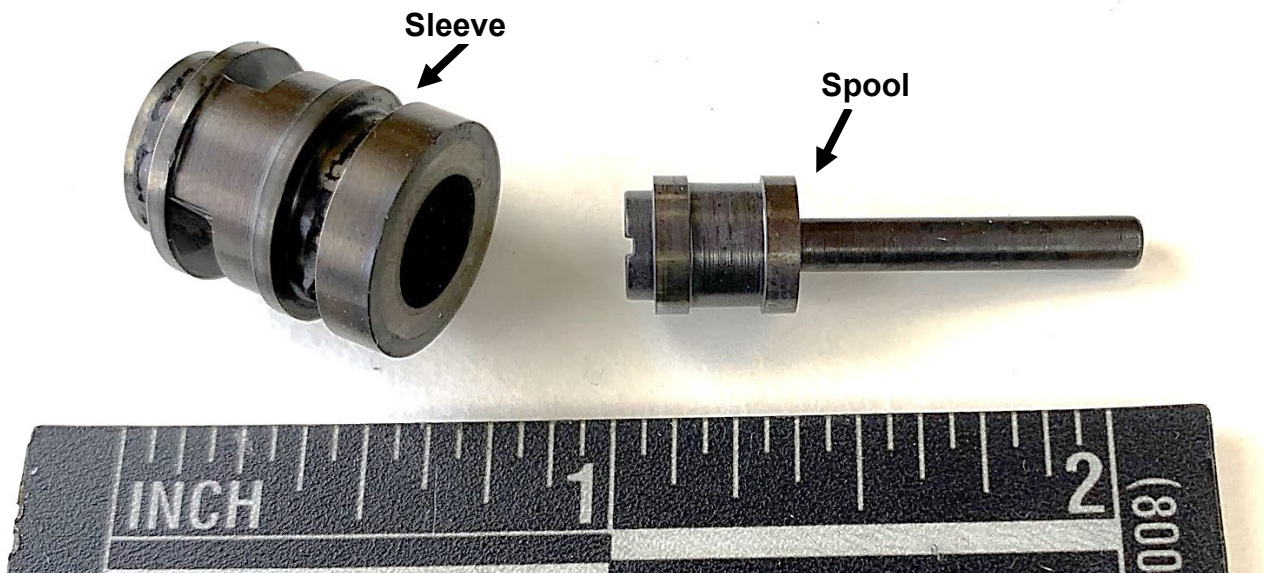
Appendix 4F. Disassembled sleeve (left) and spool (right) from the differential pressure relief valve.

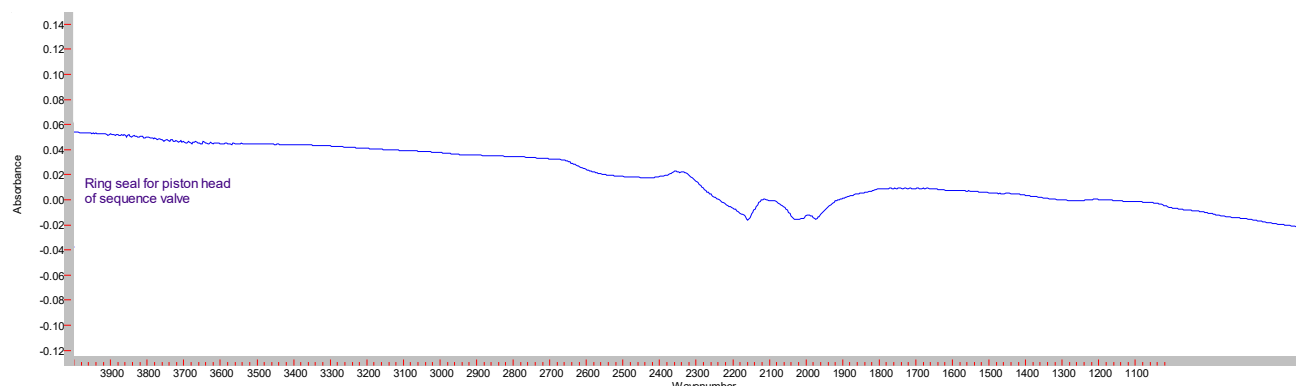
the ring seal. It was not attracted to a magnet. To determine whether this piece was flexible or brittle, it was intentionally bent with a needle-nose pliers. This piece fractured easily and showed no evidence of flexibility. The fracture face of this piece exhibited a brittle fracture feature. The XRF alloy analyzer cannot detect the element carbon, so the ring seal for the piston was analyzed by other analytical methods. Energy dispersive spectroscopy (EDS) analysis of the ring seal produced a spectrum that contained one major elemental peak of carbon. Fourier Transform Infrared (FTIR) analysis of the same sample showed a spectrum that contained no evidence of hydrocarbon peaks and each contained only a single peak ( $\sim 2100\text{ cm}^{-1}$ ) consistent with carbon.<sup>3</sup> This type of FTIR spectrum is indicative of either a carbon-based material such as graphite or the material was significantly heat damaged leaving only carbonize<sup>4</sup> residue (Appendix 6 shows a typical FTIR spectrum).

Appendix 6. FTIR spectrum (Absorbance vs. Wavenumber [ $\text{cm}^{-1}$ ]) of a sample from the ring seal for the piston head of the sequence valve.
