**Photo 1 – N314 at the accident site. Photo courtesy of the Operator.**

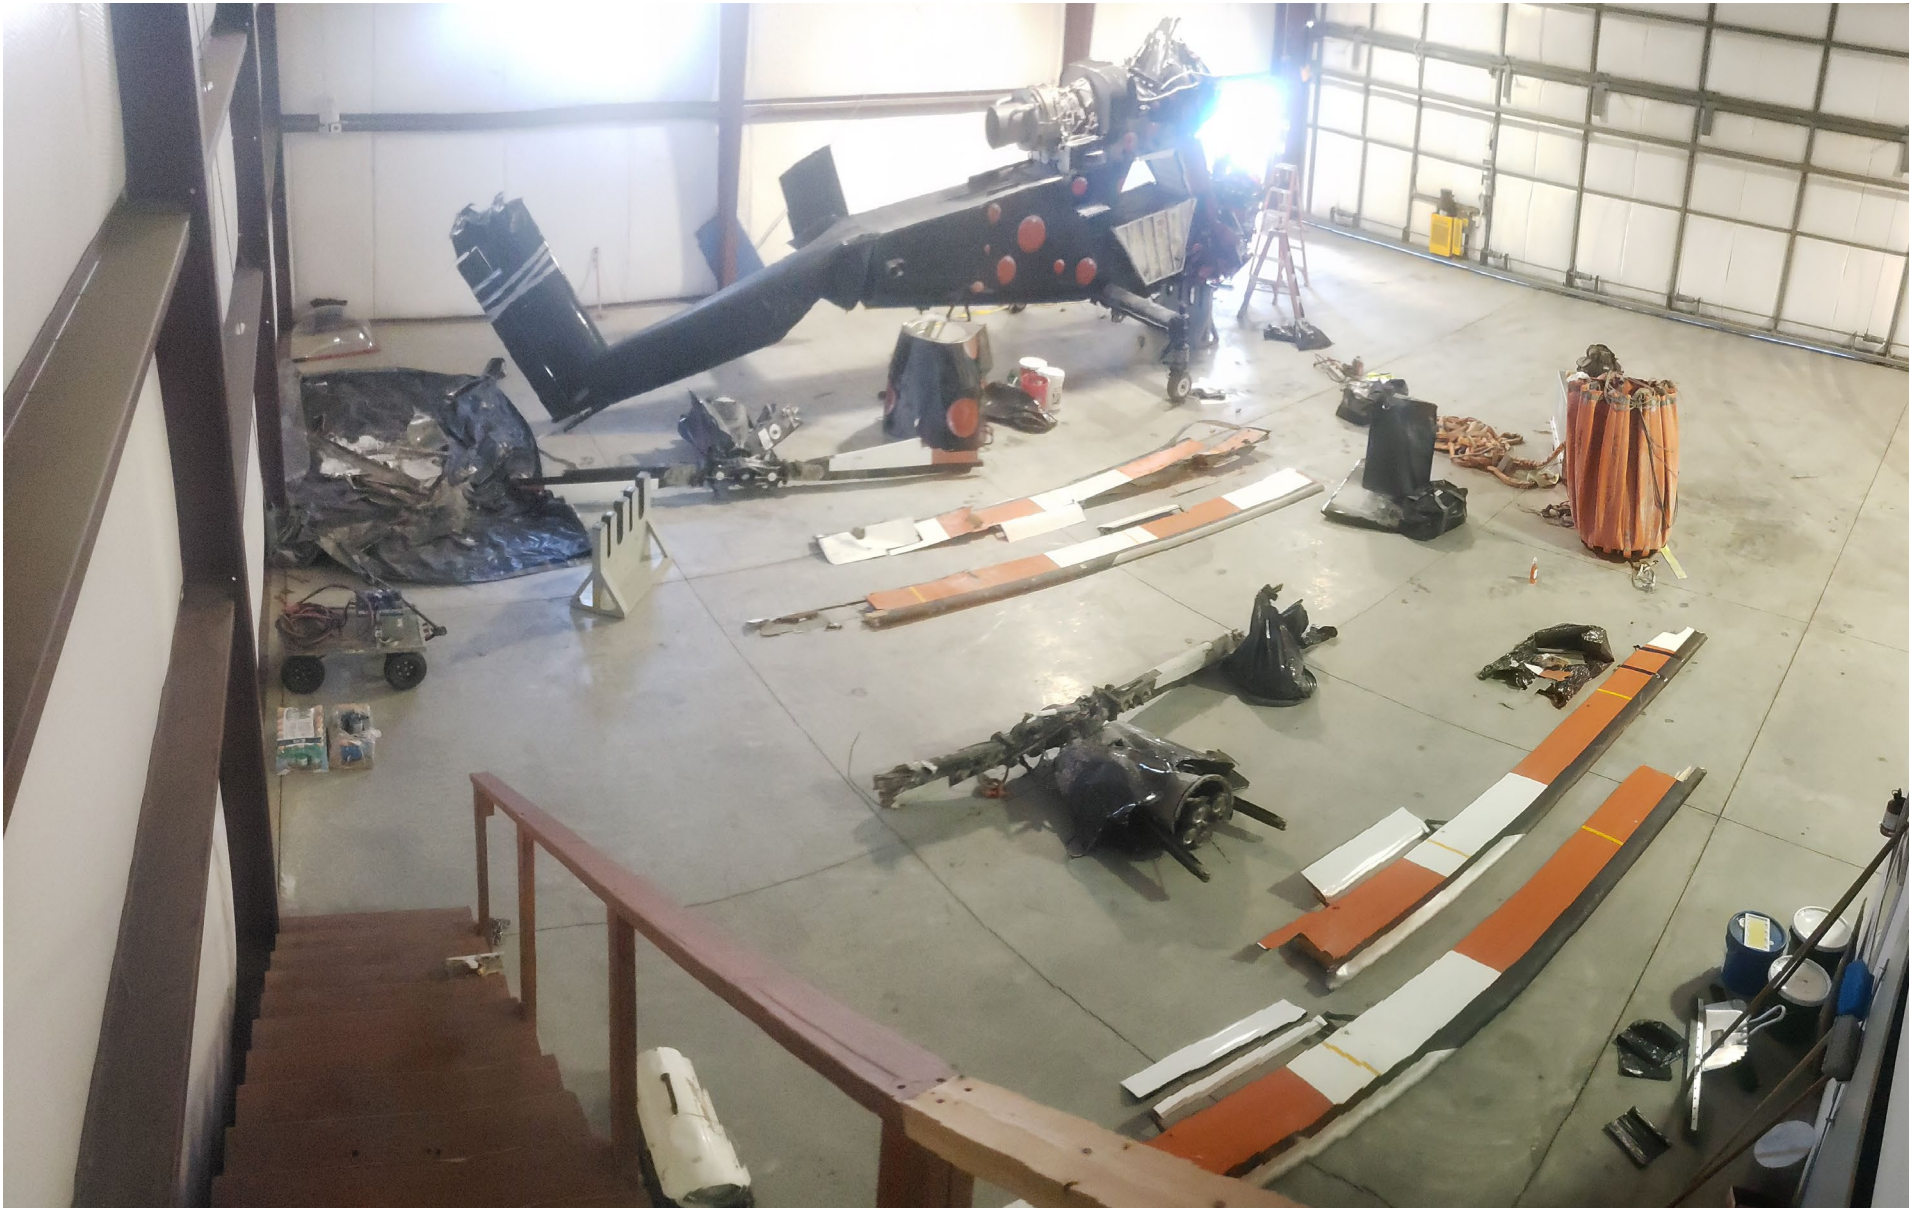
**Photo 4 – Wreckage at the recovery site.**

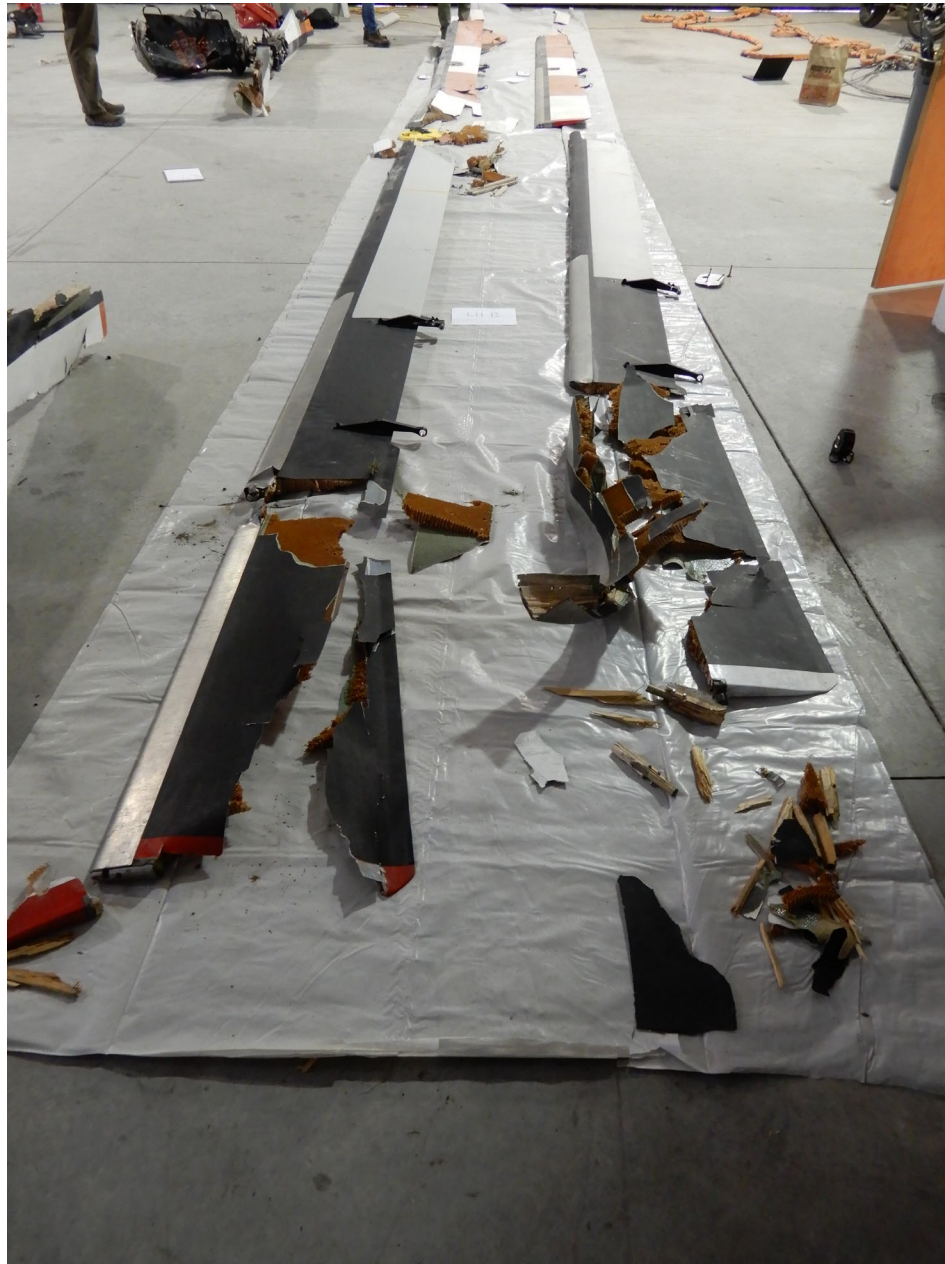
**Photo 9 – Left-side rotor blades. Red blade is on the left, and the white blade in on the right.**

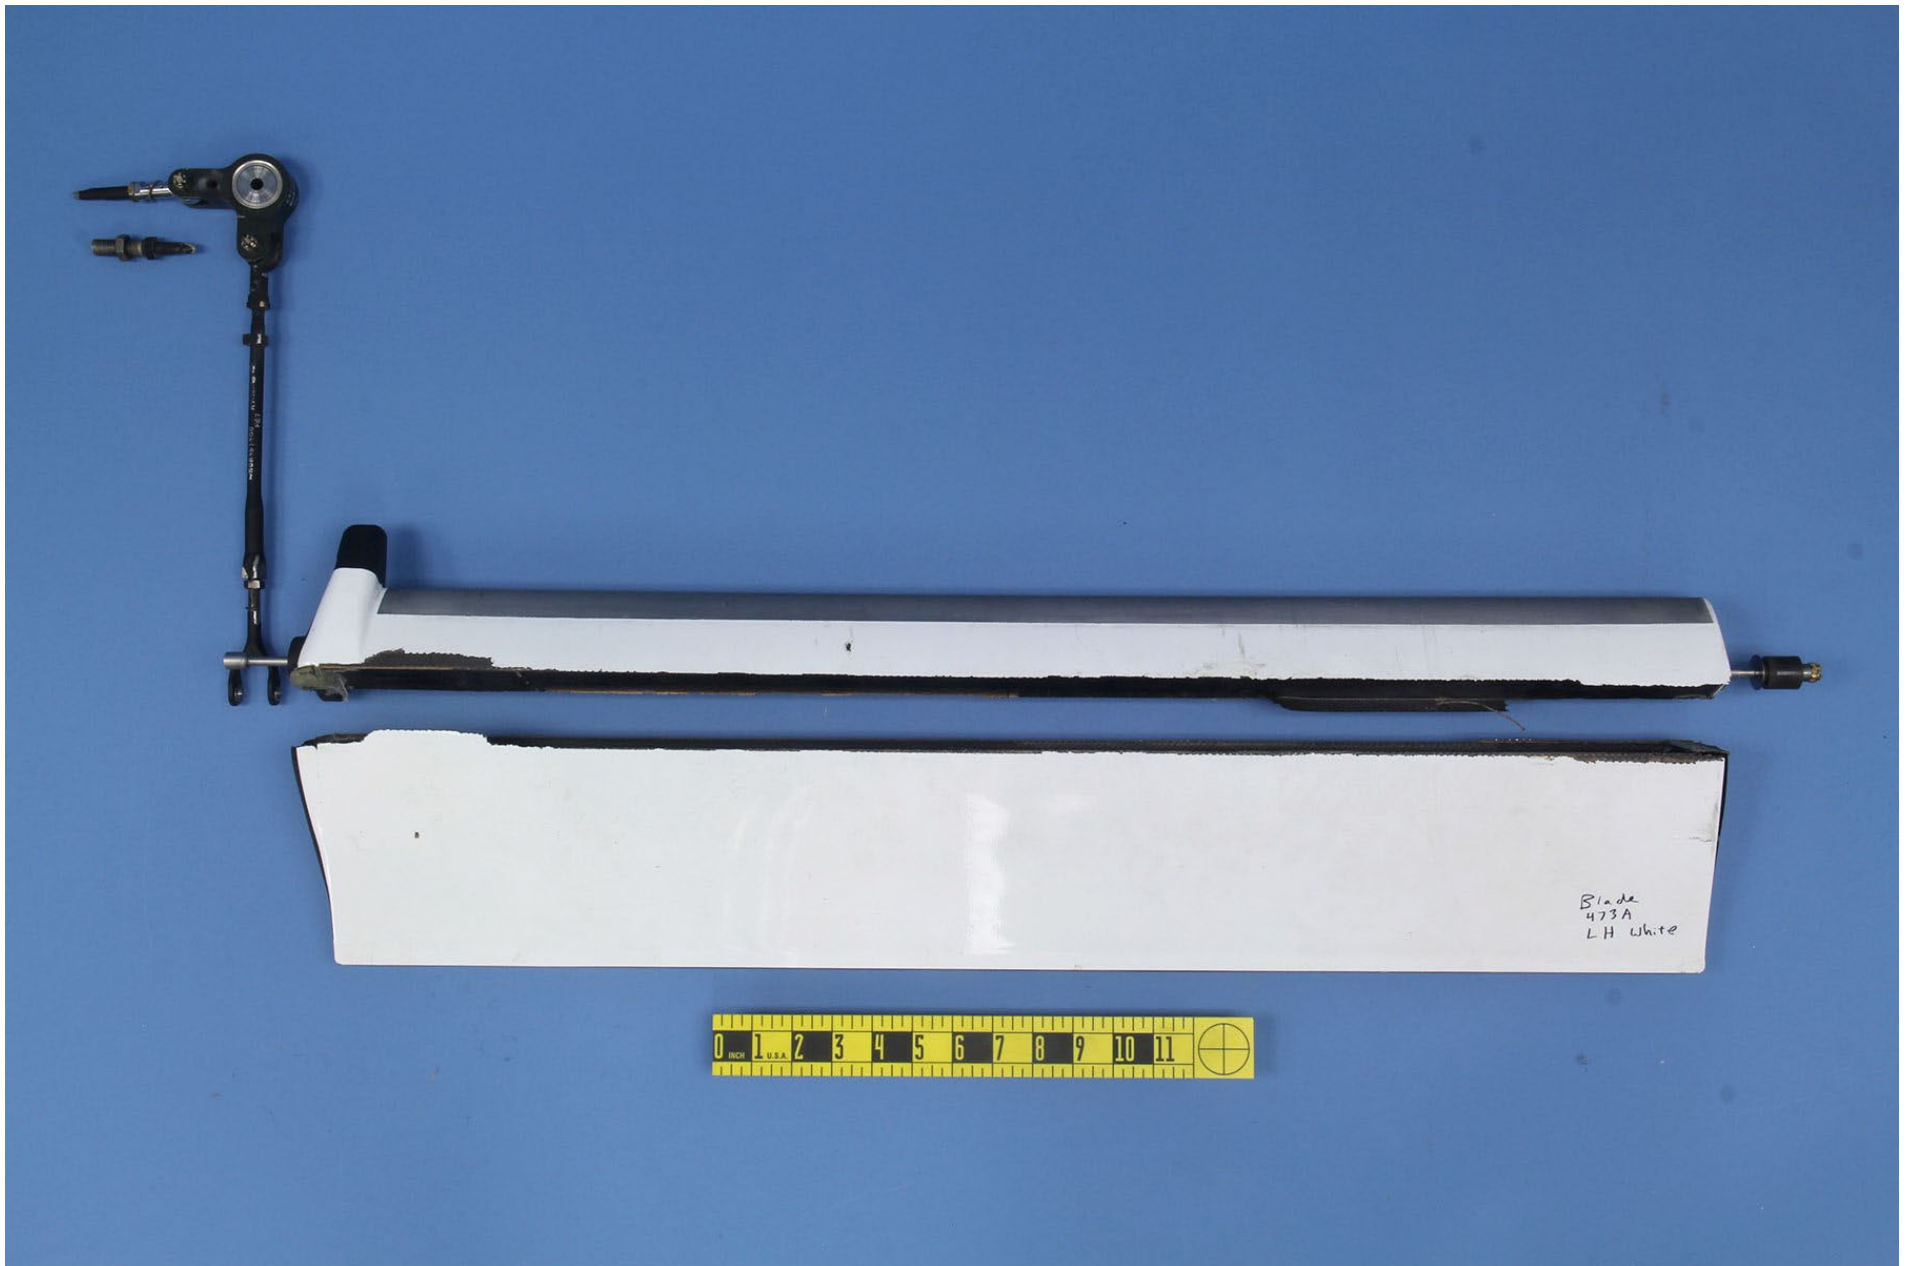
**Photo 10 – Left-side, white rotor blade servo flap assembly.**

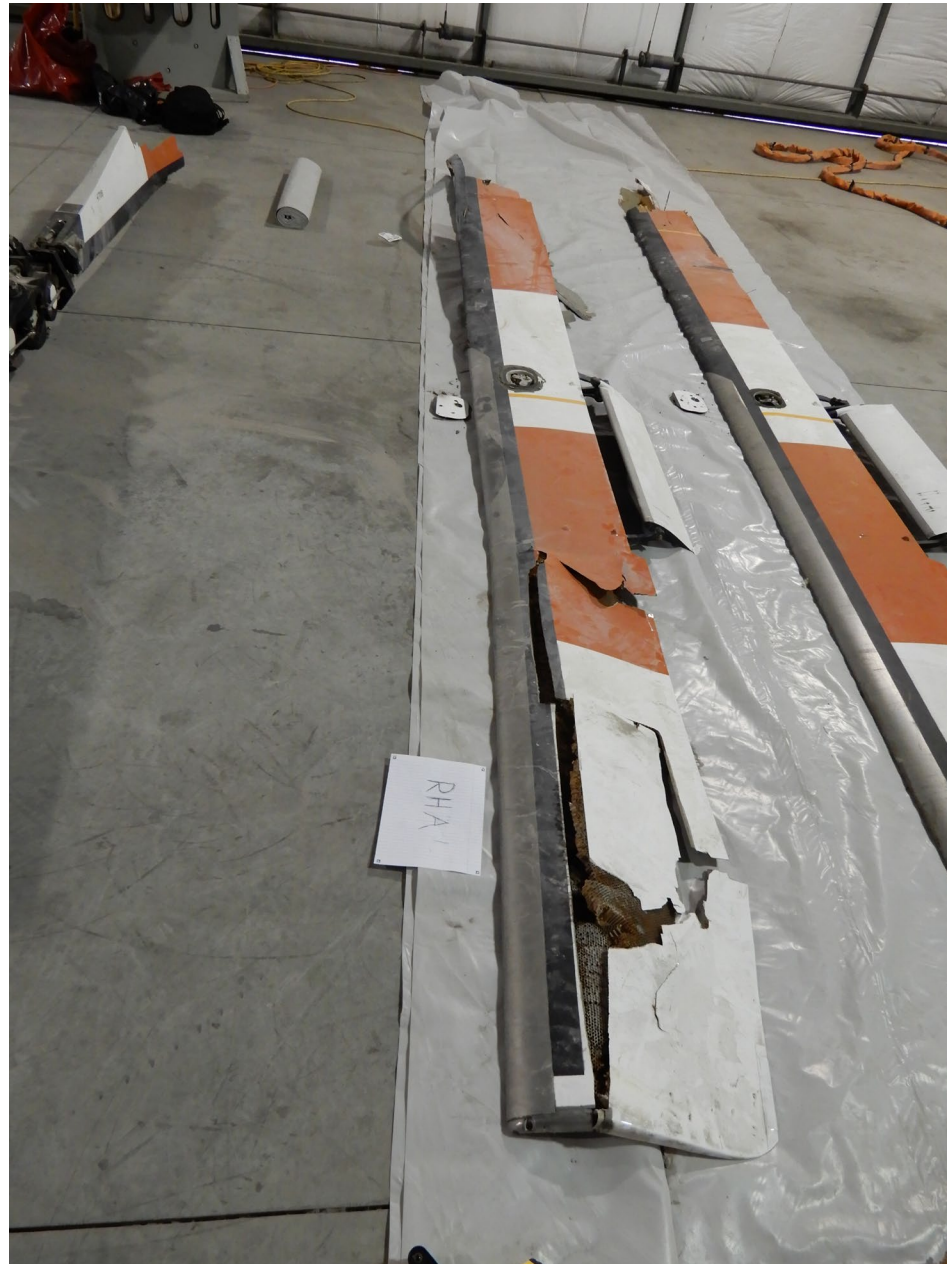
**Photo 11 – Right-side white rotor blade as seen from the tip end.**

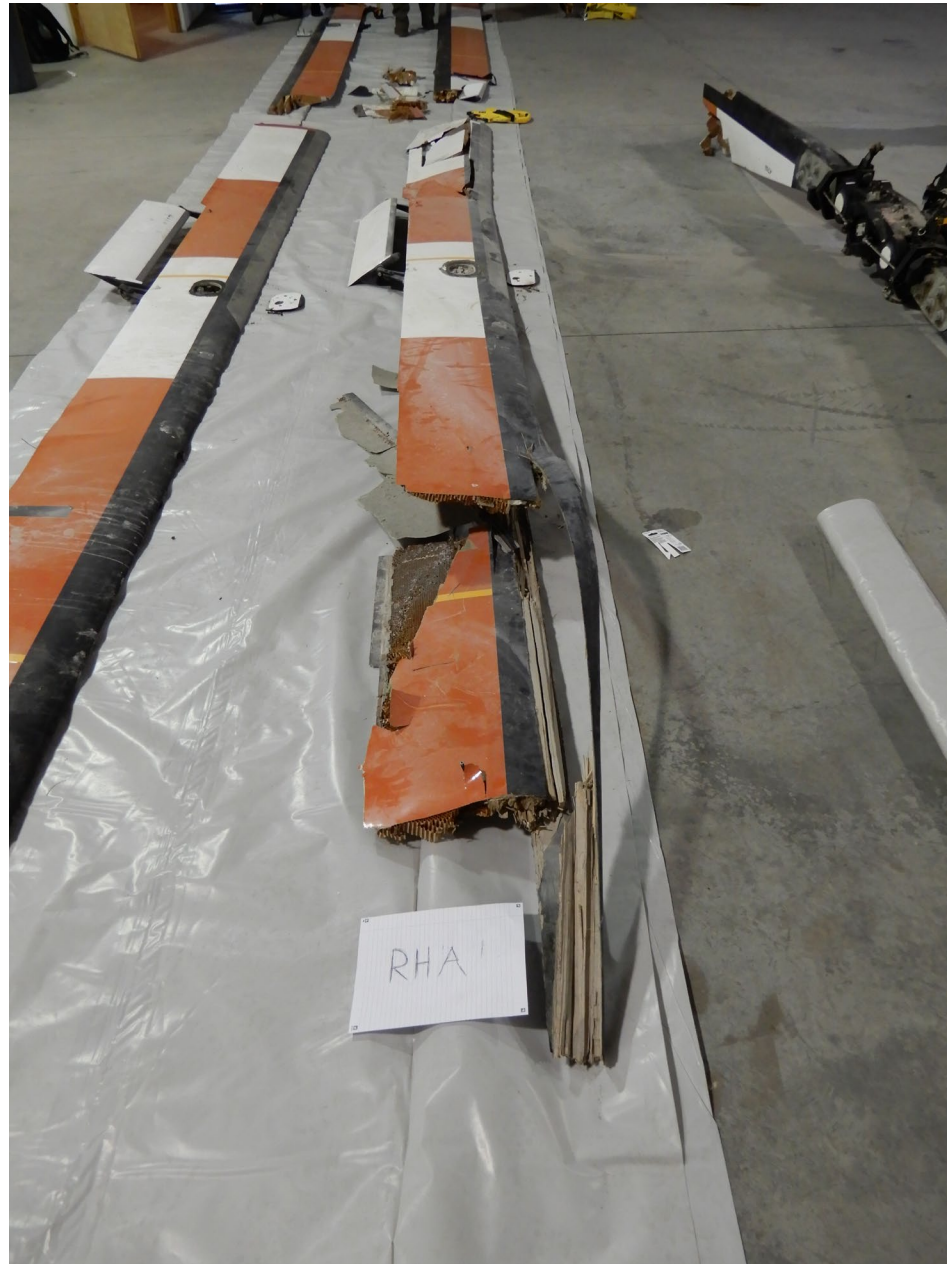
**Photo 12 – Right-side white rotor blade, as seen from the root end.**

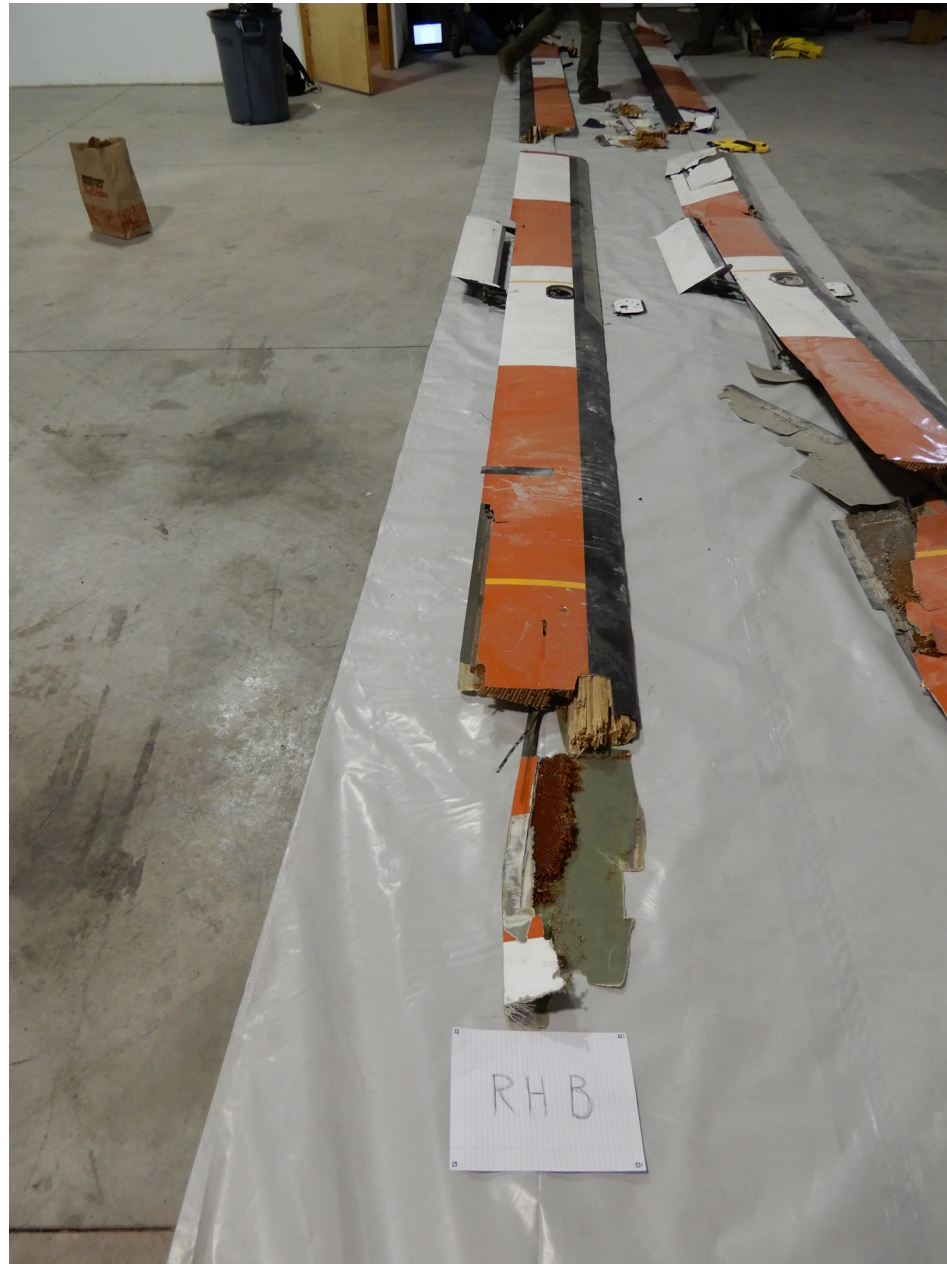
**Photo 13 – Right-side red rotor blade, as seen from the root end.**

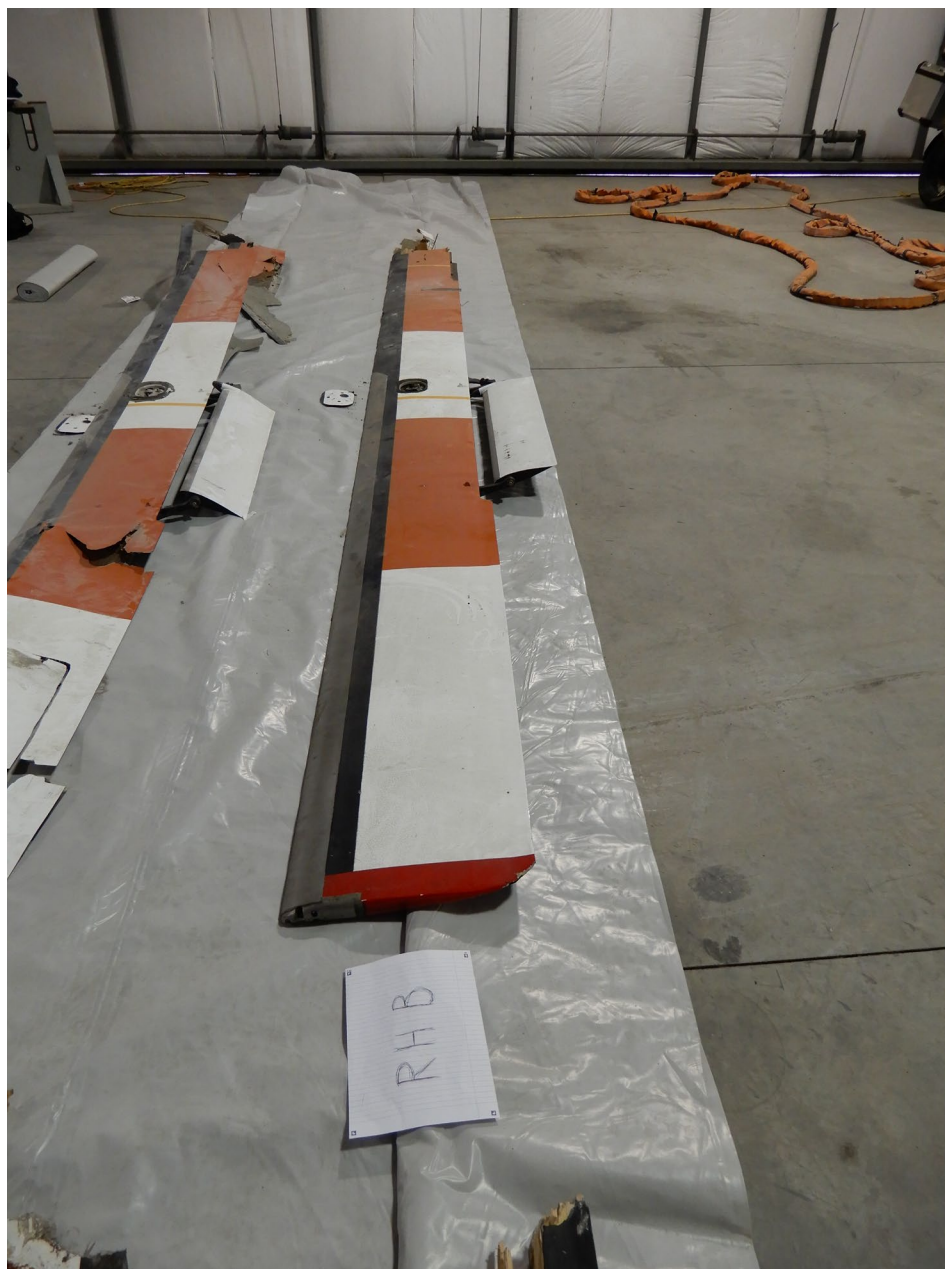
**Photo 14 – Right-side red rotor blade, as seen from the tip end.**
