# NATIONAL TRANSPORTATION SAFETY BOARD

## MATERIALS LABORATORY FACTUAL REPORT

Report No. 21-004

Place : Benson, Arizona  
Date : August 19, 2020  
Vehicle : Diamond DA-40, N386MA  
NTSB No. : WPR20LA290  
Investigator : Zoë Keliher, AS-WPR

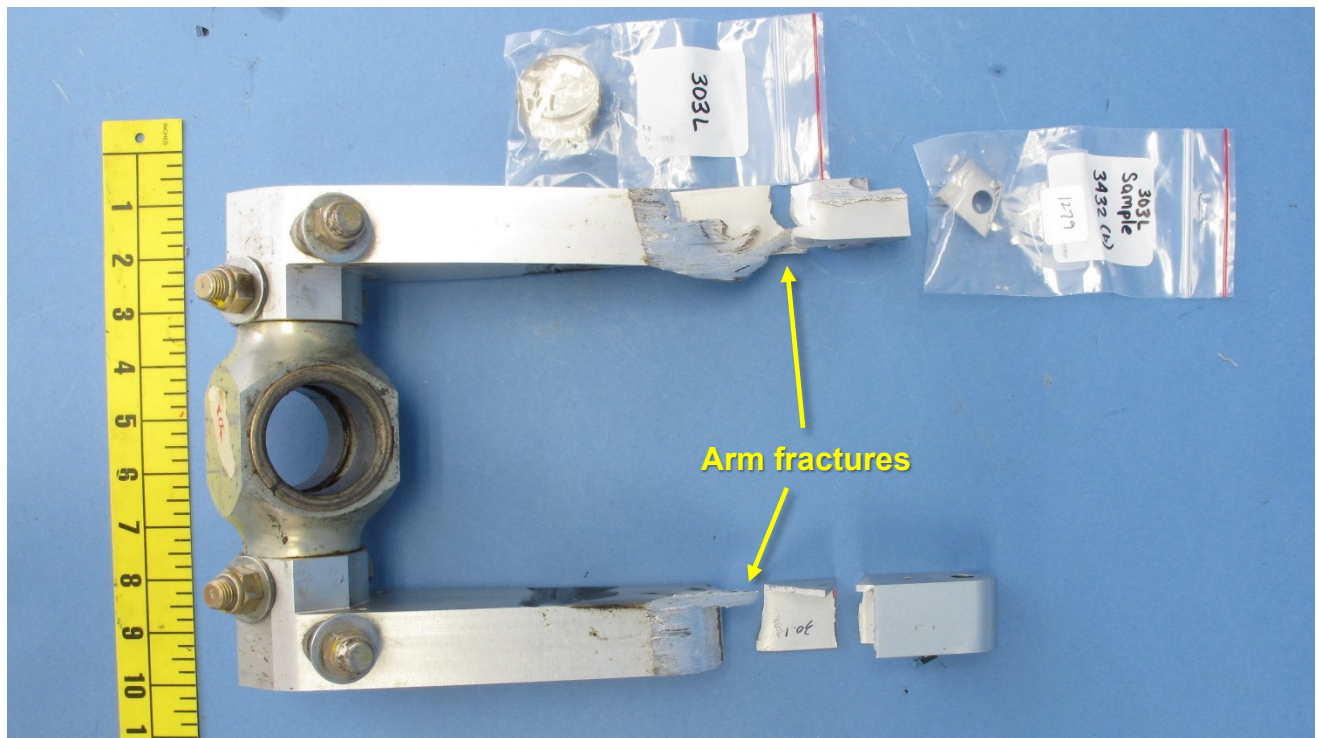
Figure 1 shows the nose landing gear (NLG) fork arms, which were still connected to the center fork. Each arm had broken in two places. The fractures were slanted in orientation, with material plastically deformed and exuding towards one side. The fractures themselves were shiny, with streaks parallel to the direction of the aircraft fuselage. These features were consistent with fracture of the arms from scraping along the runway during landing.

Figure 1 – Closer view of the fractured NLG fork arms, shown connected to the center fork.

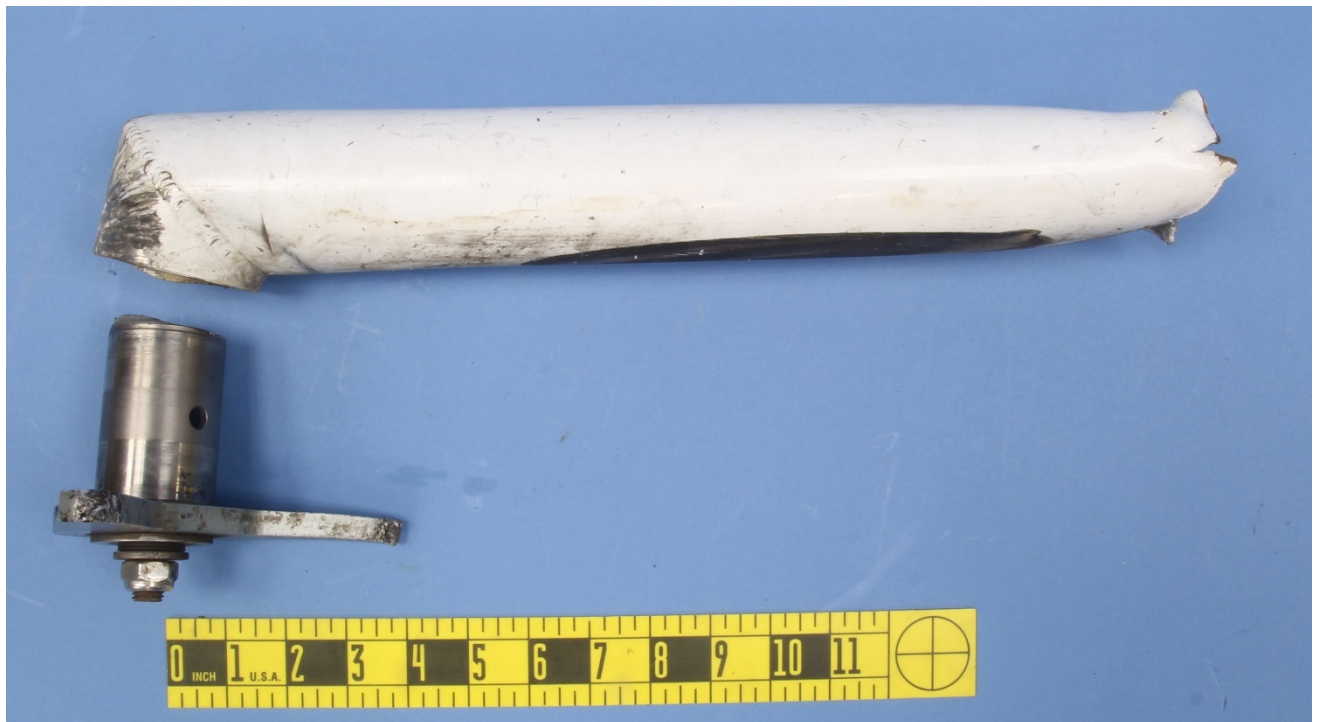
Figure 2 shows the remnant from the nose landing gear leg assembly. This leg assembly had fractured at a welded joint with the fork collar insert. There was a stop plate still attached to the collar remnant. The plate had been attached by a series of washers and a self-locking nut.

Figure 2 – Remnant of the NLG leg welding assembly, which fractured at the fork collar location. The stop plate was still attached to the leg collar remnant.

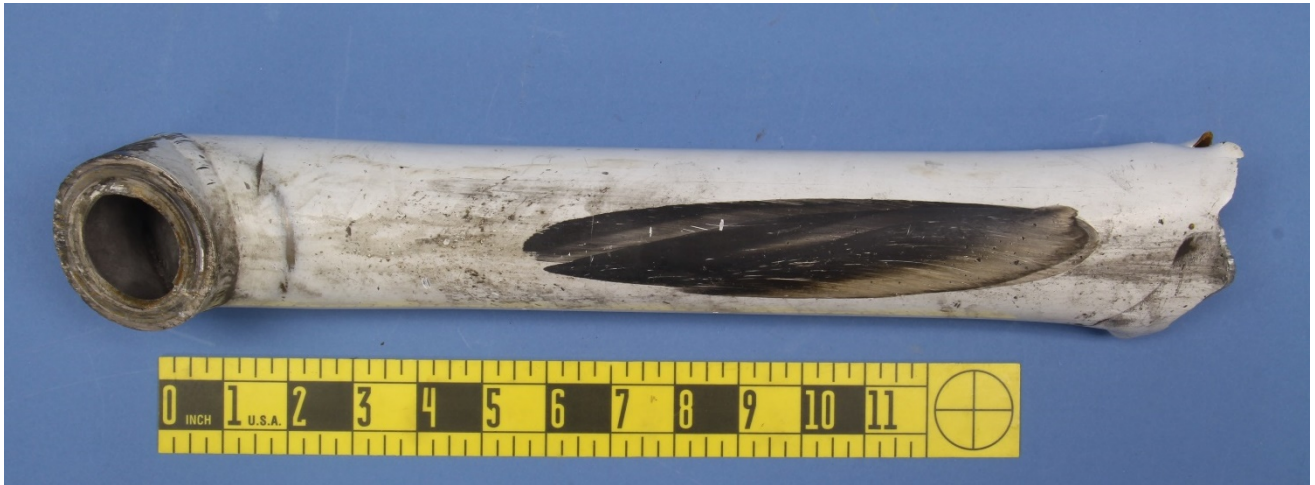
The leg side of the fractured NLG leg assembly is shown in Figure 3, from the underside looking upward. The tube remnant exhibited several witness marks, the most prevalent being the large, black-colored streak which contrasted against the white paint of the tube. This streak was parallel to the tube direction, consistent with scraping or rubbing against the rotating NLG tire during landing and after fracture.

Figure 3 – View of the leg remnant, showing the collar fracture surface and witness marks on the bottom side.

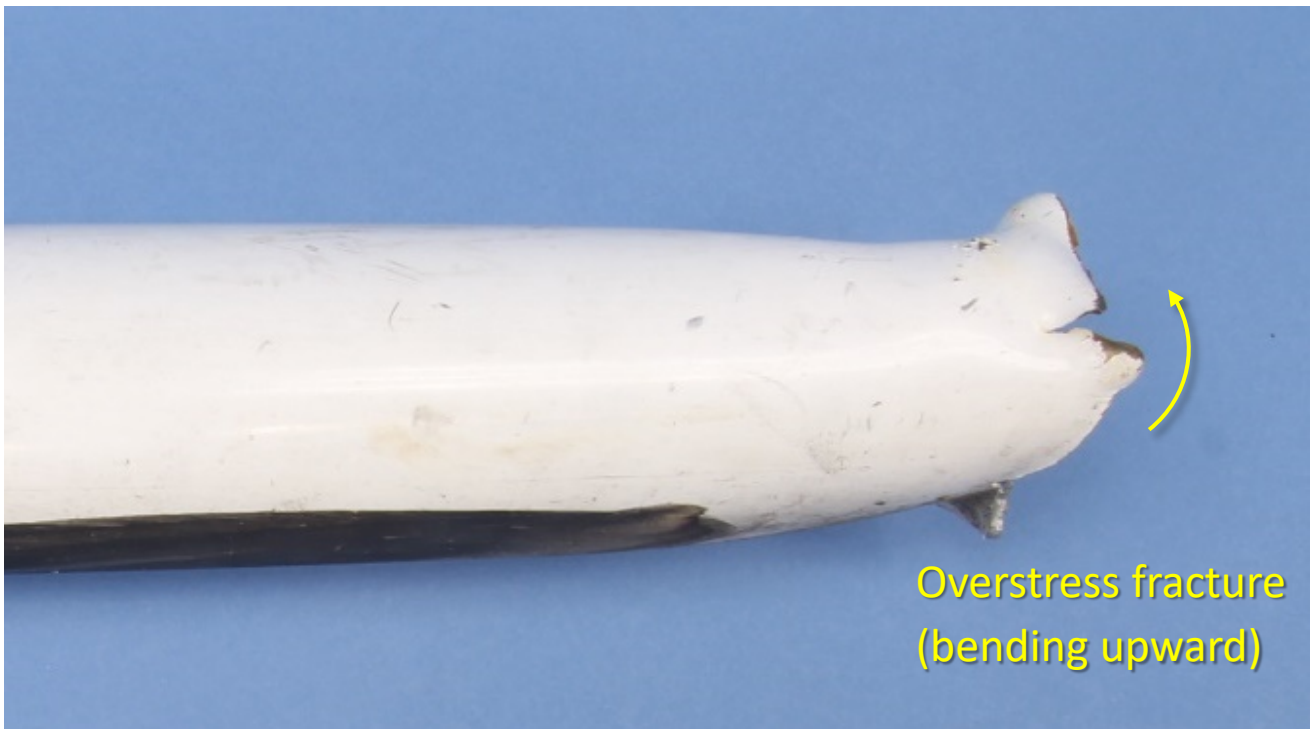
The aft portion of the leg tube fracture is shown from the side in Figure 4. The underside of the fracture exhibited flattening and deformation toward the back and the upward directions. The upper surface of the tube fracture exhibited buckling consistent with compression. The fracture surface exhibited a generally rough, fibrous texture, with a reddish-color, consistent with post-fracture corrosion of the exposed metal (rusting). These features were consistent with having fractured from overstress in upward bending.

Figure 4 – View of the side of the leg remnant tube fracture surface, showing buckling on the upper side and tension features on the bottom side, consistent with upward bending in the figure.

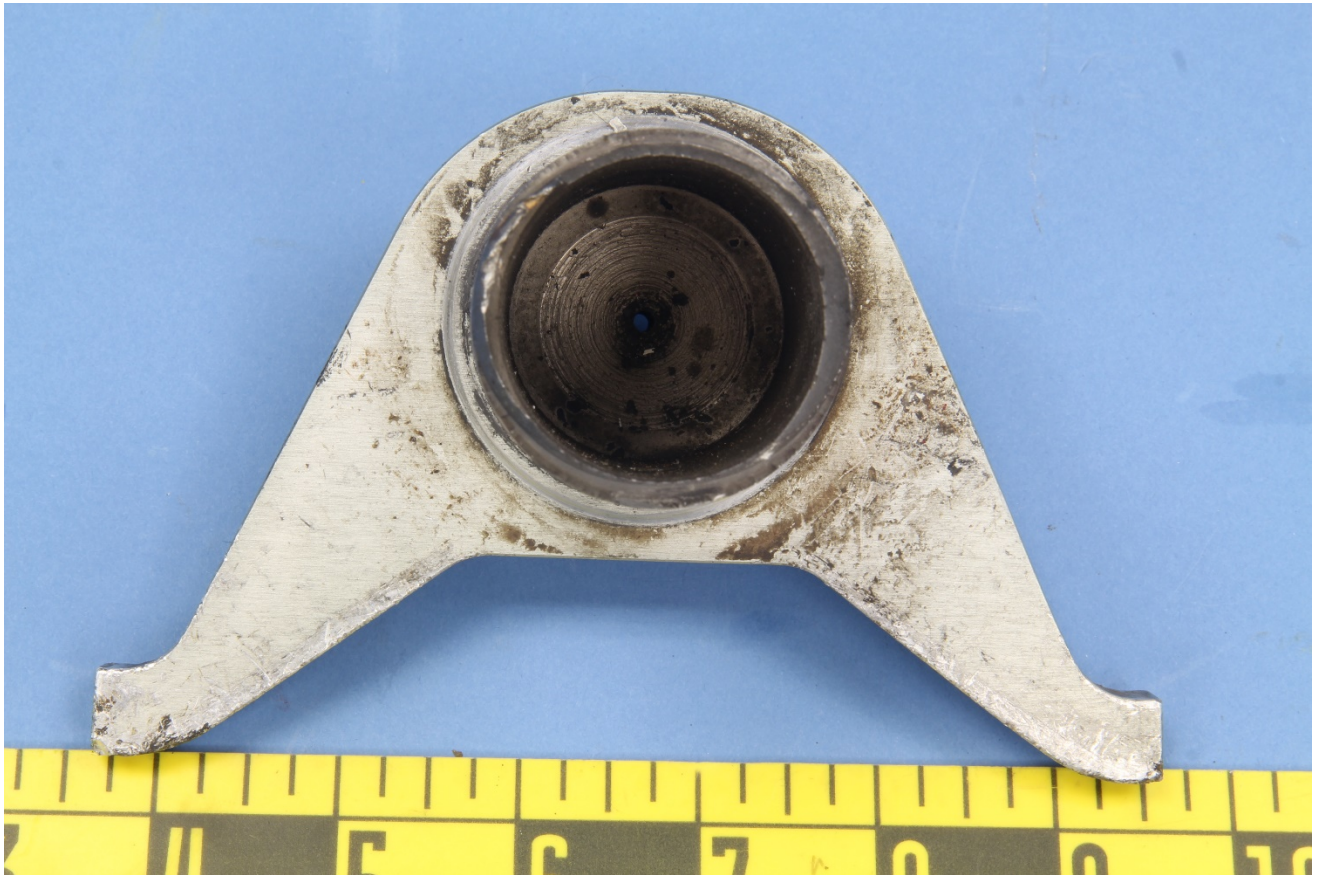
As shown in Figure 2, the NLG leg assembly had also fractured in the forward area, at the weld with the fork collar. Figure 5 shows the mating fracture surface from the fork collar side, as received with the stop plate still attached. This fracture surface exhibited less post-fracture damage than the leg side, and it was therefore the focus of this examination. As can be seen in Figure 5, the fracture surface was located on the hollow cylindrical collar, exhibiting two crescent-shaped fracture features.

Figure 5 – The fracture surface of the fork collar as received, still attached to the stop plate affixed via bearing washers and a nut.

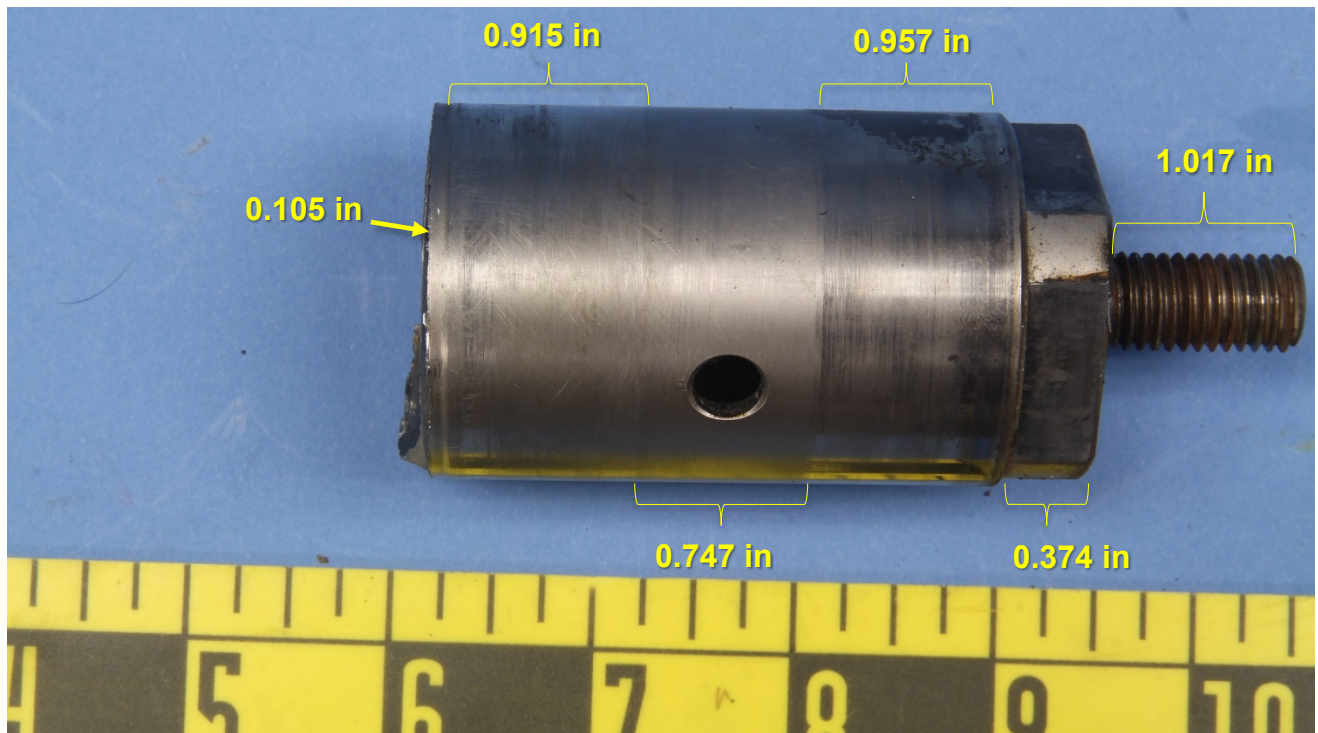
The collar remnant was disassembled from the adjacent washers and stop plate. The collar is shown on its side in Figure 6, after disassembly and cleaning with acetone in an ultrasonic cleaner. The collar consisted of a cylindrical section, then a semi-square taper, followed by a threaded portion. The cylindrical section exhibited two areas of circumferential wear, as annotated in Figure 6. These different regions on the collar fragment were measured using calipers, as annotated in Figure 6.

Figure 6 – The collar after removal of the stop plate and adjacent components. Various measurements are annotated on the figure.

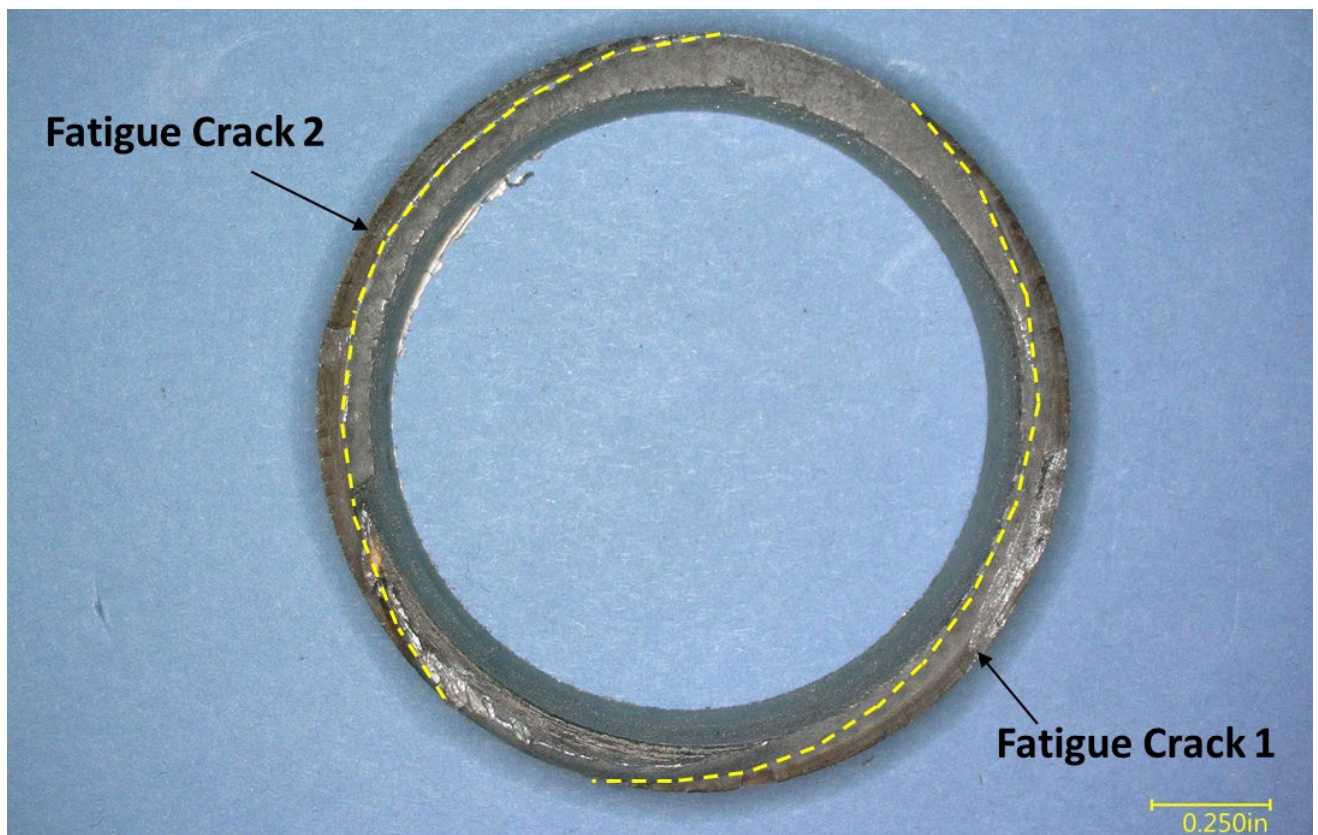
The collar fragment fracture surface, facing leftward in Figure 6, was sectioned for microscopic examination. Figure 7 shows the fracture surface after sectioning. As annotated in the figure, there were three different areas containing different features on the fracture surface—two were crescent-shaped and exhibited a flatter, shinier profile, and a third in the middle that was rougher and dull in luster. The crescent-shaped cracks were later determined to be consistent with fatigue, as described below. For the purposes of this report, the two crescent-shaped cracks were called fatigue Cracks 1 and 2.

Figure 7 – View of the collar fracture, after sectioning, annotated to show the fatigue areas.

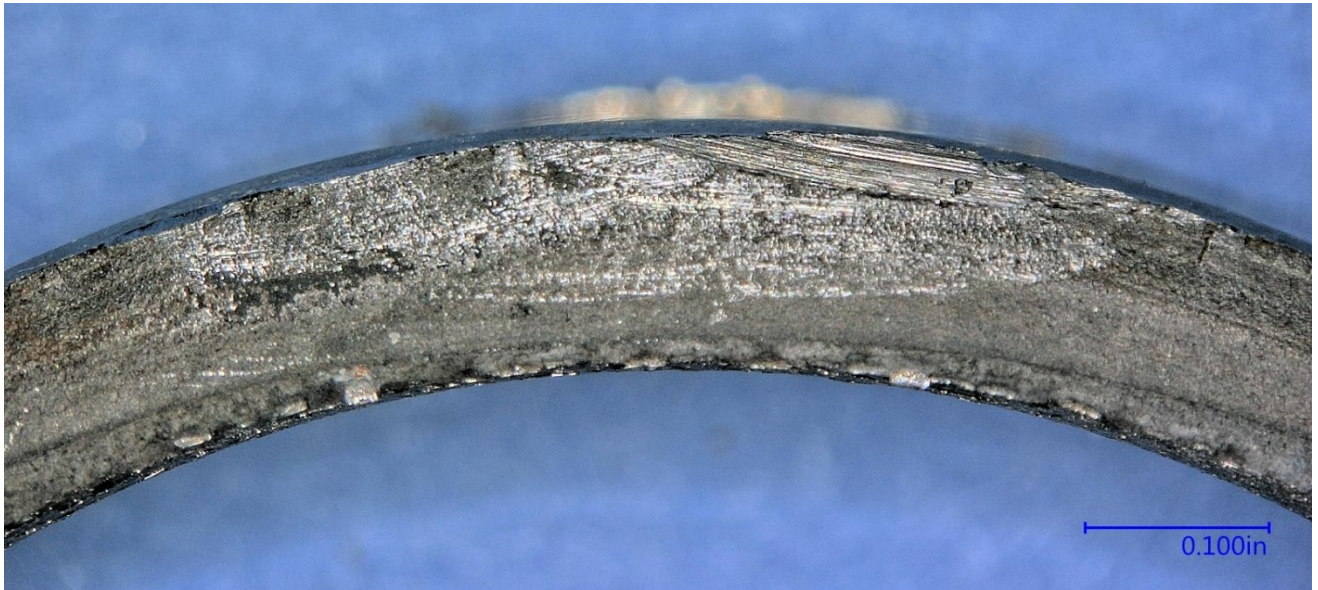
Figure 8 and Figure 9 illustrate the largest depths of the cracks for Crack 1 and Crack 2, respectively. Crack 1, which was the larger crack, was approximately 2.0 inches long in circumference with a depth of 0.10 inches at final fracture. The collar thickness was approximately 0.12 inches at this location. As demonstrated by the figures, these regions of the cracks exhibited various types of post-fracture damage, such as from smearing or corrosion. The undamaged regions exhibited ratchet marks and crack arrest marks, consistent with multiple crack initiation sites and progressive crack propagation, respectively (Figure 10). Figure 11 shows the side outer face of part of the fracture surface edge, showing a stepwise morphology, consistent with multiple crack initiation sites. Figure 12 shows several of the crack initiation sites at an angle, consistent with multiple parallel cracks present on the surface (Figure 12). As mentioned earlier, there was extensive post-

Figure 8 – View of fatigue crack 1, showing the depth of crack propagation, and post-fracture smearing on the surface.

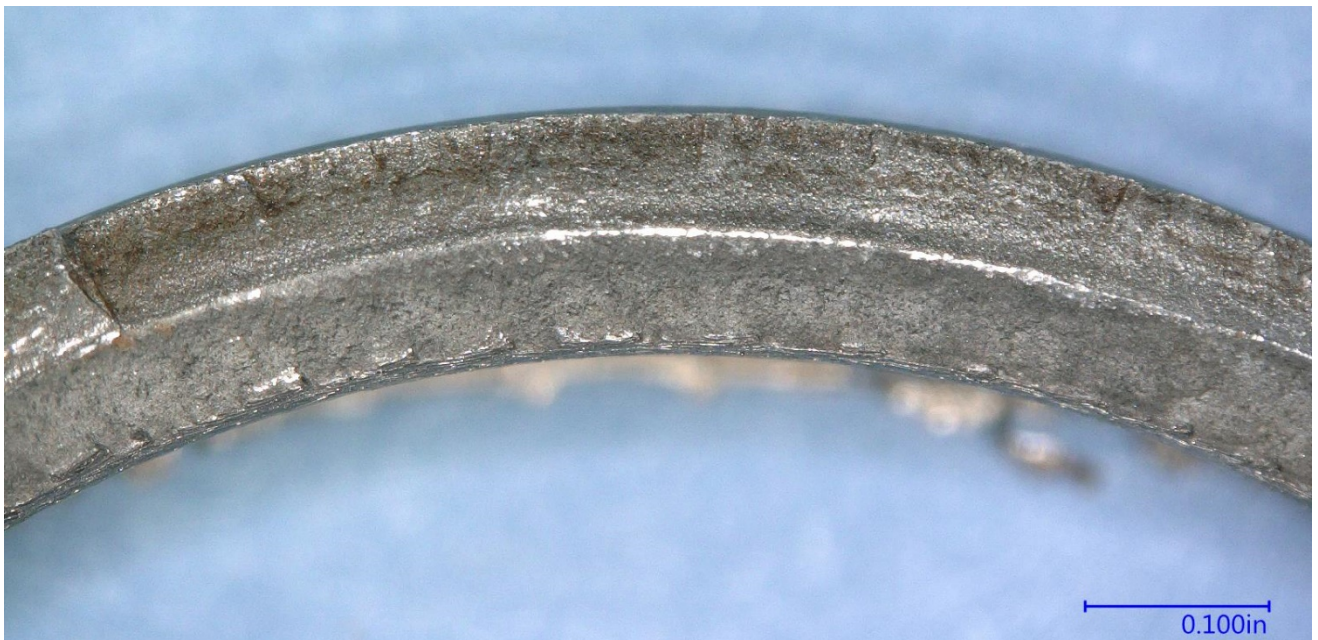
Figure 9 – View of the fatigue crack 2, showing the depth of fatigue crack penetration through the collar cross section.

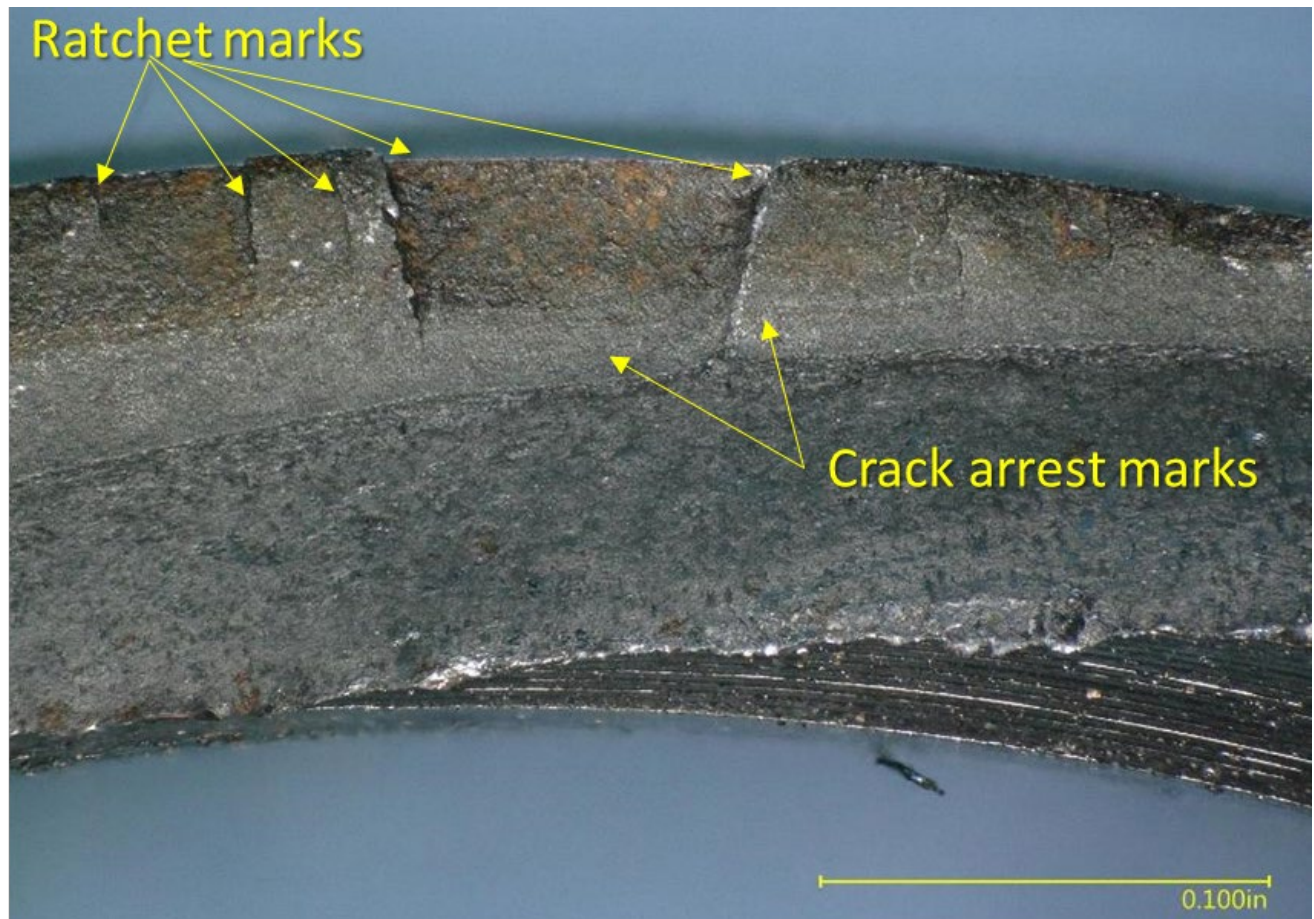
Figure 10 – View of the side of the fatigue crack 1, showing ratchet and crack arrest marks.

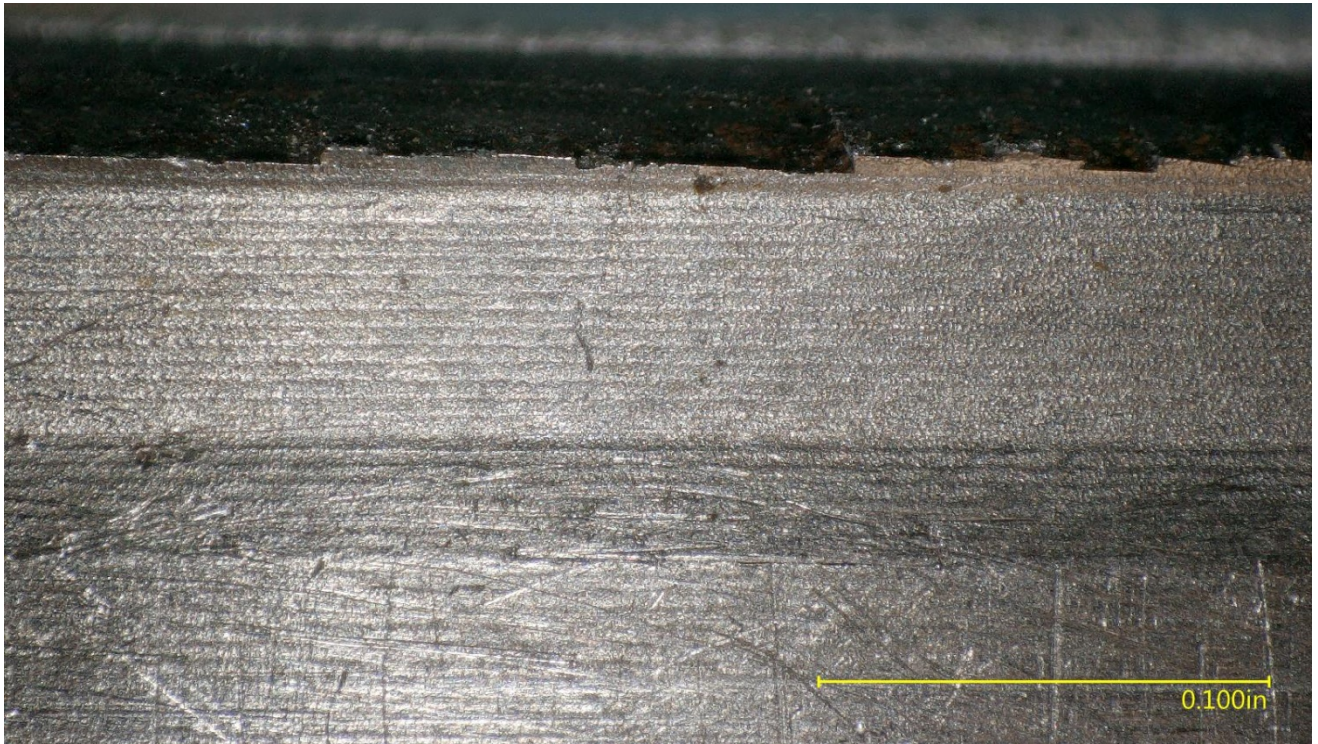
Figure 11 – View of the crack initiation sites on the reverse side from Figure 13.

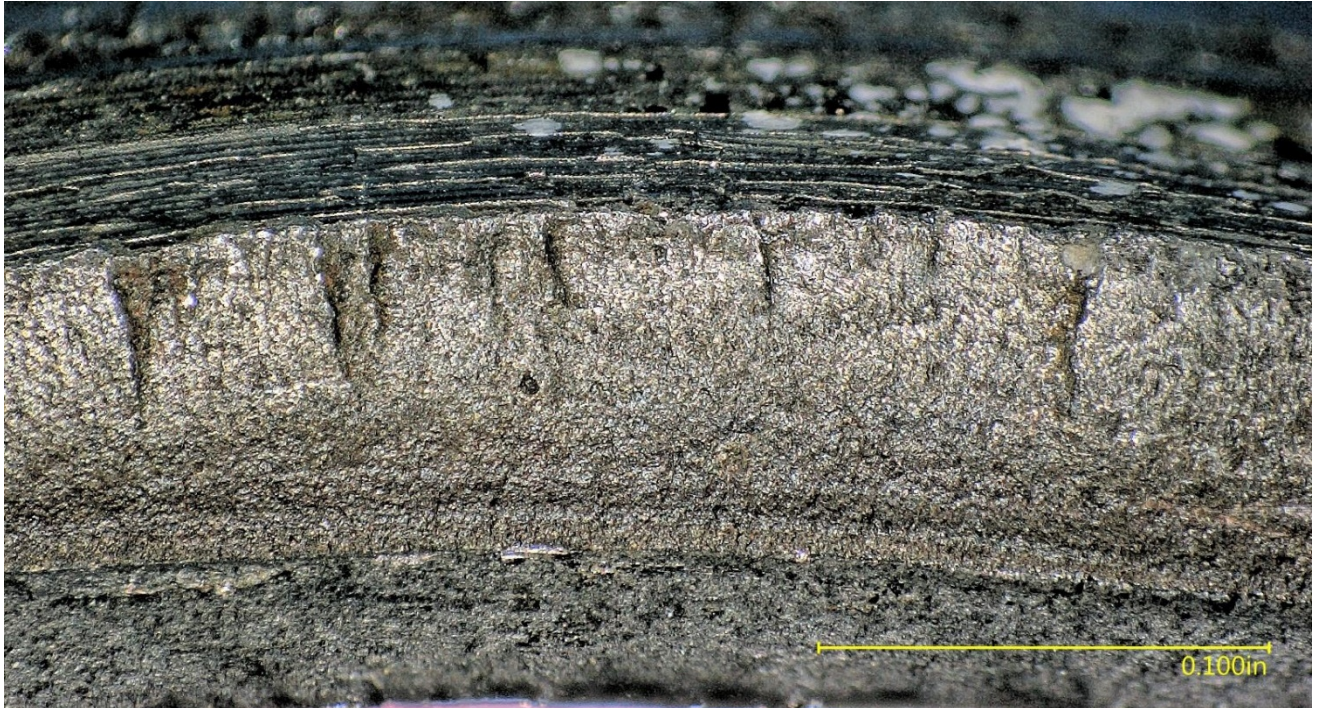
Figure 12 – Angled view of the initiation sites of the fatigue Crack 2, showing wear marks along the outside of the collar.

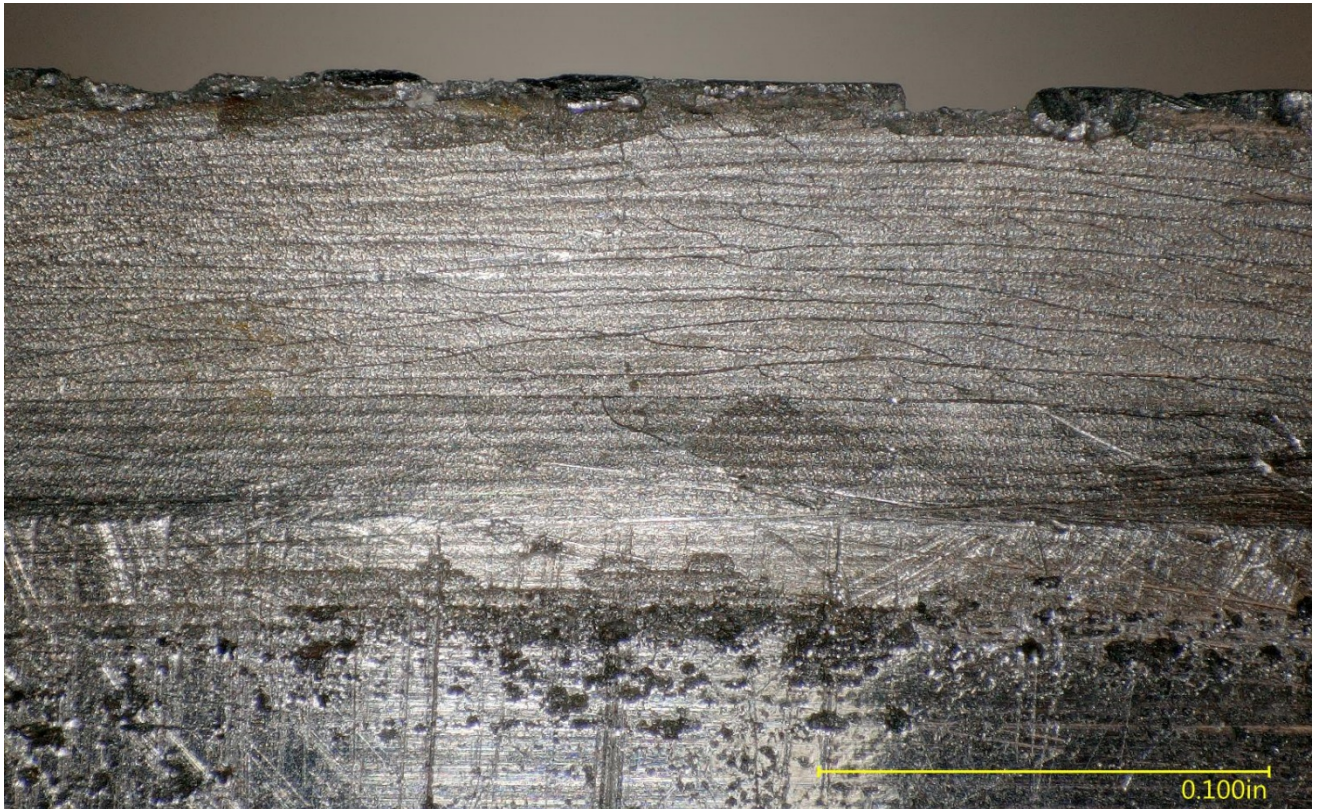
fracture damage to these initiation sites, as shown by the edge rounding and smearing in Figure 13.

Figure 13 – Closer view of the worn side of the collar below the crack initiation sites.

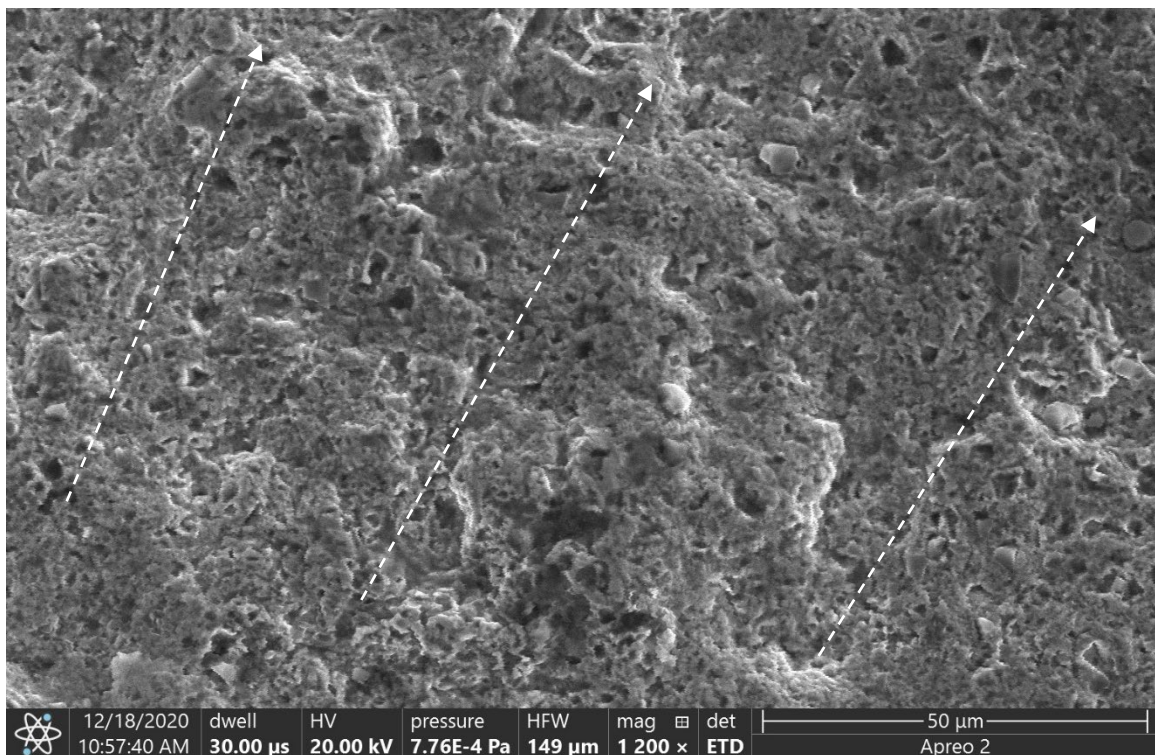
The fracture surface was examined using a scanning electron microscope (SEM). Figure 14 shows features typical of most areas on the fracture surface cracks—fatigue striations with numerous pock-marked features, consistent with post-fracture corrosion damage after the crack had propagated. Figure 15 shows a transition region at the end of one of the fatigue cracks, showing clearer less-damaged fatigue striations, followed by an area of dimpled rupture (see Figure 16) consistent with the subsequent overstress fracture of the inner regions of the collar.

Figure 14 – Secondary electron (SE) micrograph of the fatigue region of the collar fracture surface. The crack propagation direction is denoted by the arrows.

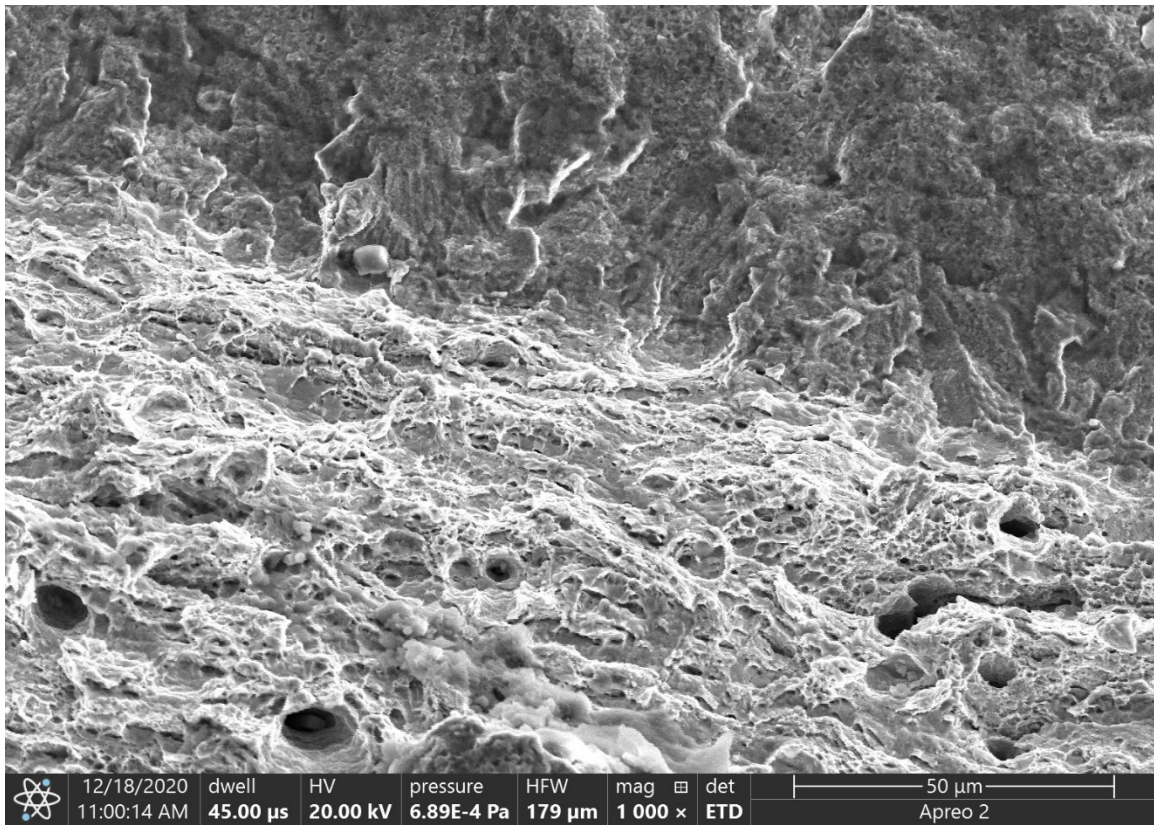
Figure 15 – SE micrograph of the end of one of the fatigue cracks on the collar.

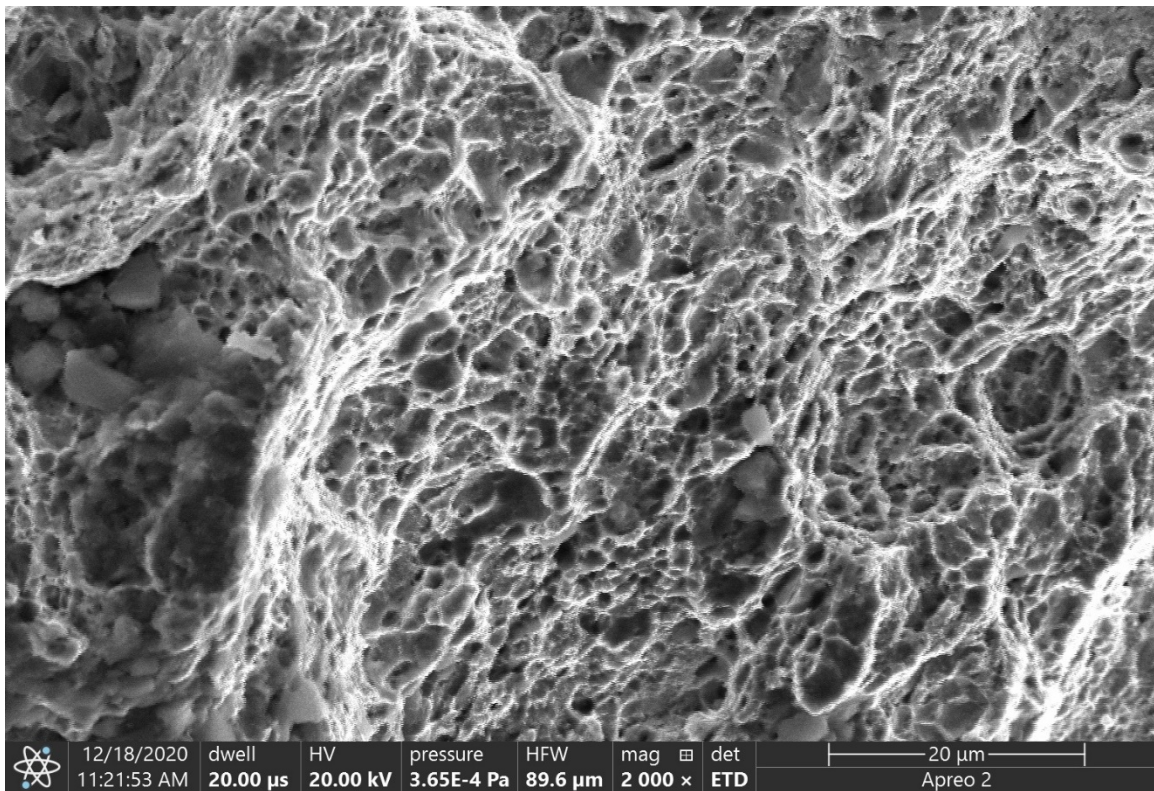
Figure 16 – SE micrograph of dimpled rupture on inner regions of the fracture.

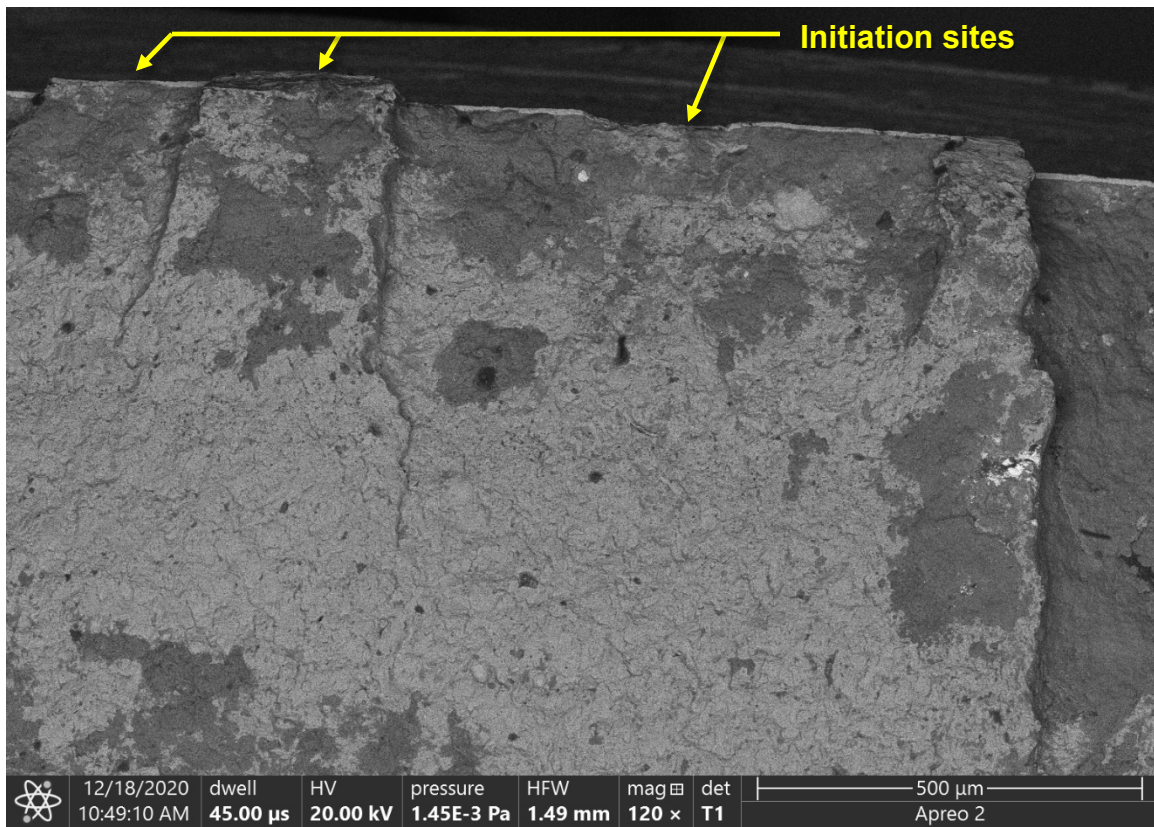
Figure 17 shows a backscattered SEM micrograph of some of the less-damaged fatigue crack initiation sites and their subsequent ratchet marks.<sup>1</sup> The darker regions on the fracture surface in Figure 17 were indicative of lower atomic number compounds, areas consistent with post-cracking or post-fracture corrosion products. These products were more ubiquitous closer to the initiation sites, suggesting they had been present during the crack propagation prior to final fracture.

Figure 17 – Backscattered electron (BE) micrograph of the initiation sites of one of the fatigue cracks, showing multiple ratchet marks.

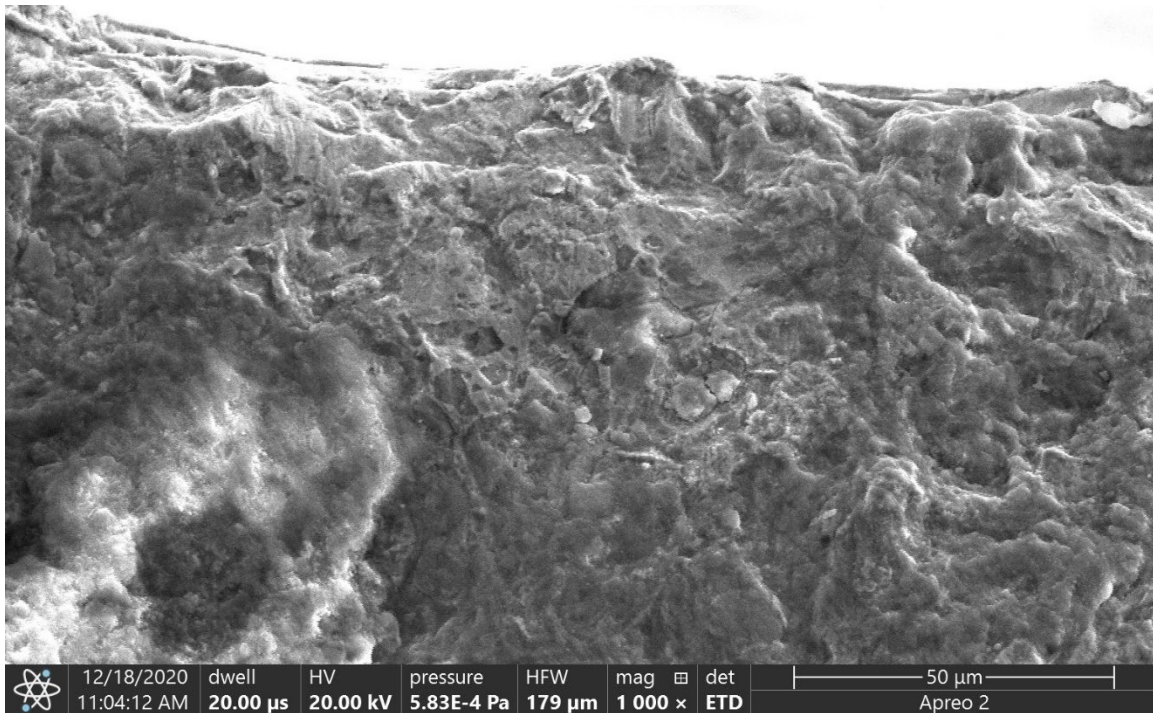
Figure 18 shows one of the less-damaged crack initiation sites. While there were radial patterns and striations consistent with initiation at the surface, there were no material defects present such as inclusions, pores, or pits. Figure 19 shows a reverse and angled image of another initiation site, showing parallel cracks in the outer collar surface. Several of these cracks exhibited gaps consistent with parallel progressive cracks. As demonstrated in Figure 20, these initiation sites exhibited surface contamination consistent with post-cracking corrosion products and lubricant derivatives. There were several parallel cracks below this initiation site, as annotated in Figure 19.

Figure 18 – SE micrograph showing one of the fatigue crack initiation sites.

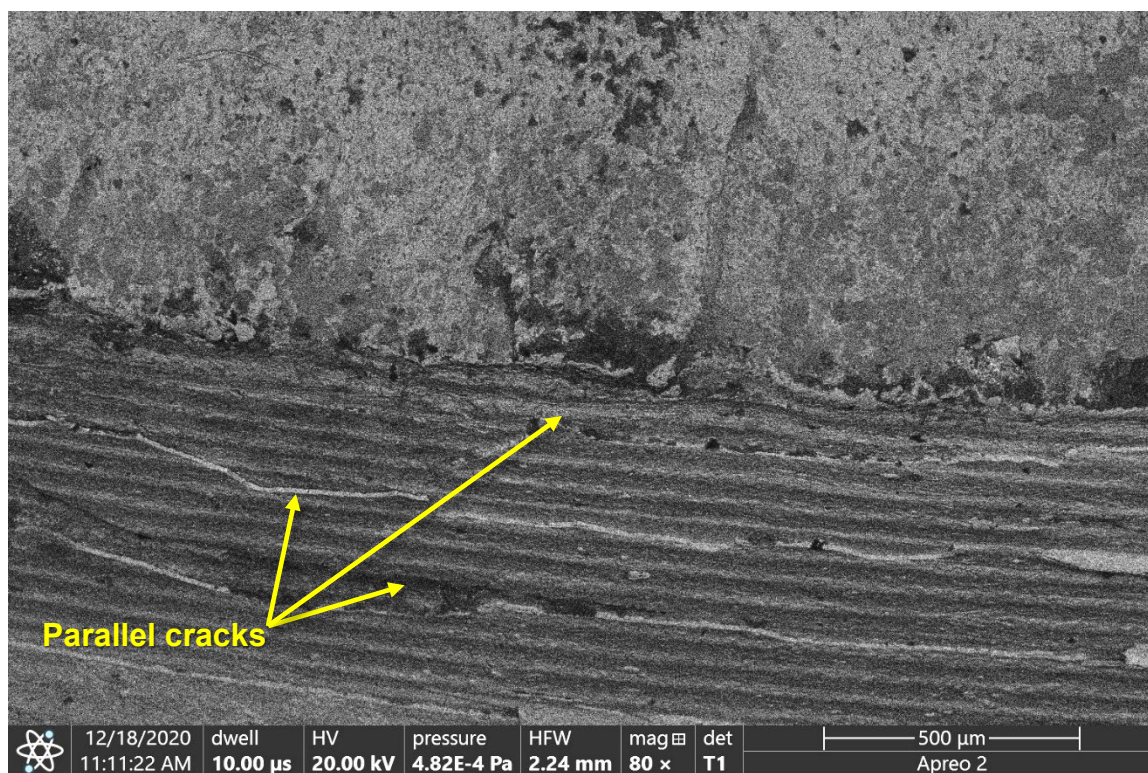
Figure 19 – BE micrograph of an angled view of the crack initiation sites, at a reverse view from Figure 18. The figure shows additional cracks below the fracture.

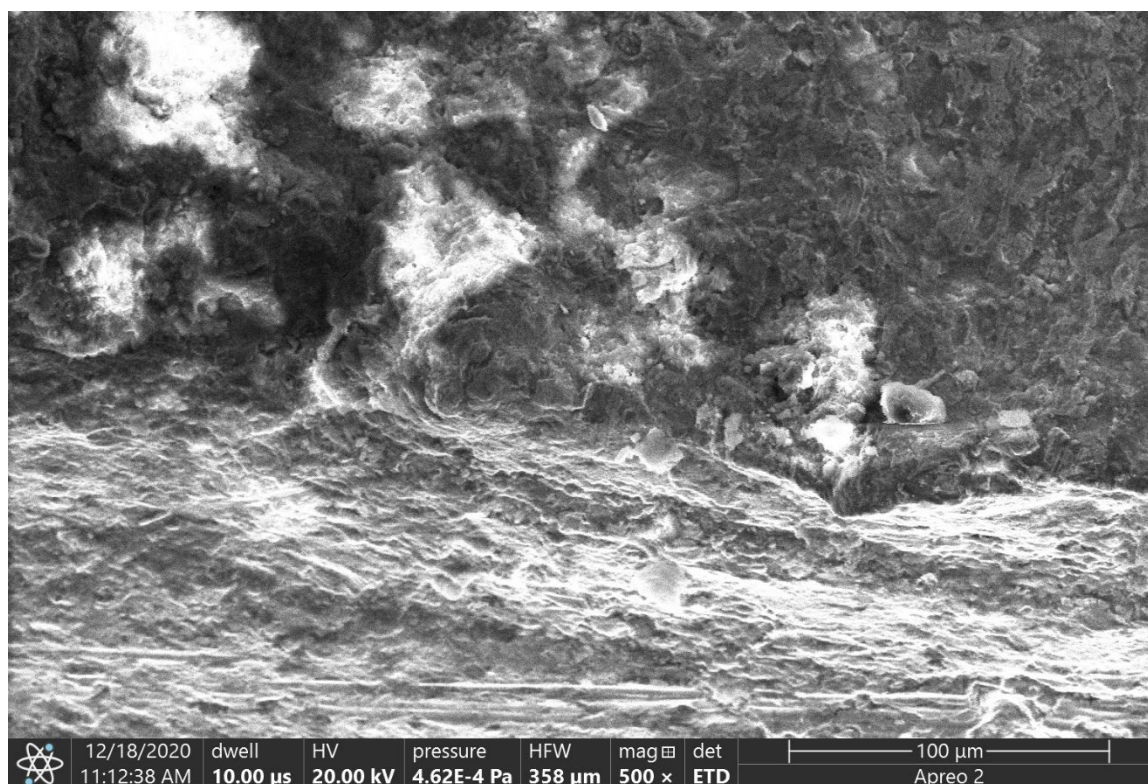
These features were consistent with two opposite facing fatigue cracks propagating inward on the collar due to reverse bending, consistent with landing forces and cycles. The cracks propagated until the remaining collar cross section could not withstand the loads on the last landing cycle and succumbed to fracture from overstress. With the collar having separated, the adjacent NLG components would be subject to fracture from overstress.

Figure 20 – SE micrograph showing a closer view one of the initiation sites in Figure 19.
