# NATIONAL TRANSPORTATION SAFETY BOARD

## MATERIALS LABORATORY FACTUAL REPORT

Report No. 21-004

Place : Benson, Arizona  
Date : August 19, 2020  
Vehicle : Diamond DA-40, N386MA  
NTSB No. : WPR20LA290  
Investigator : Zoë Keliher, AS-WPR

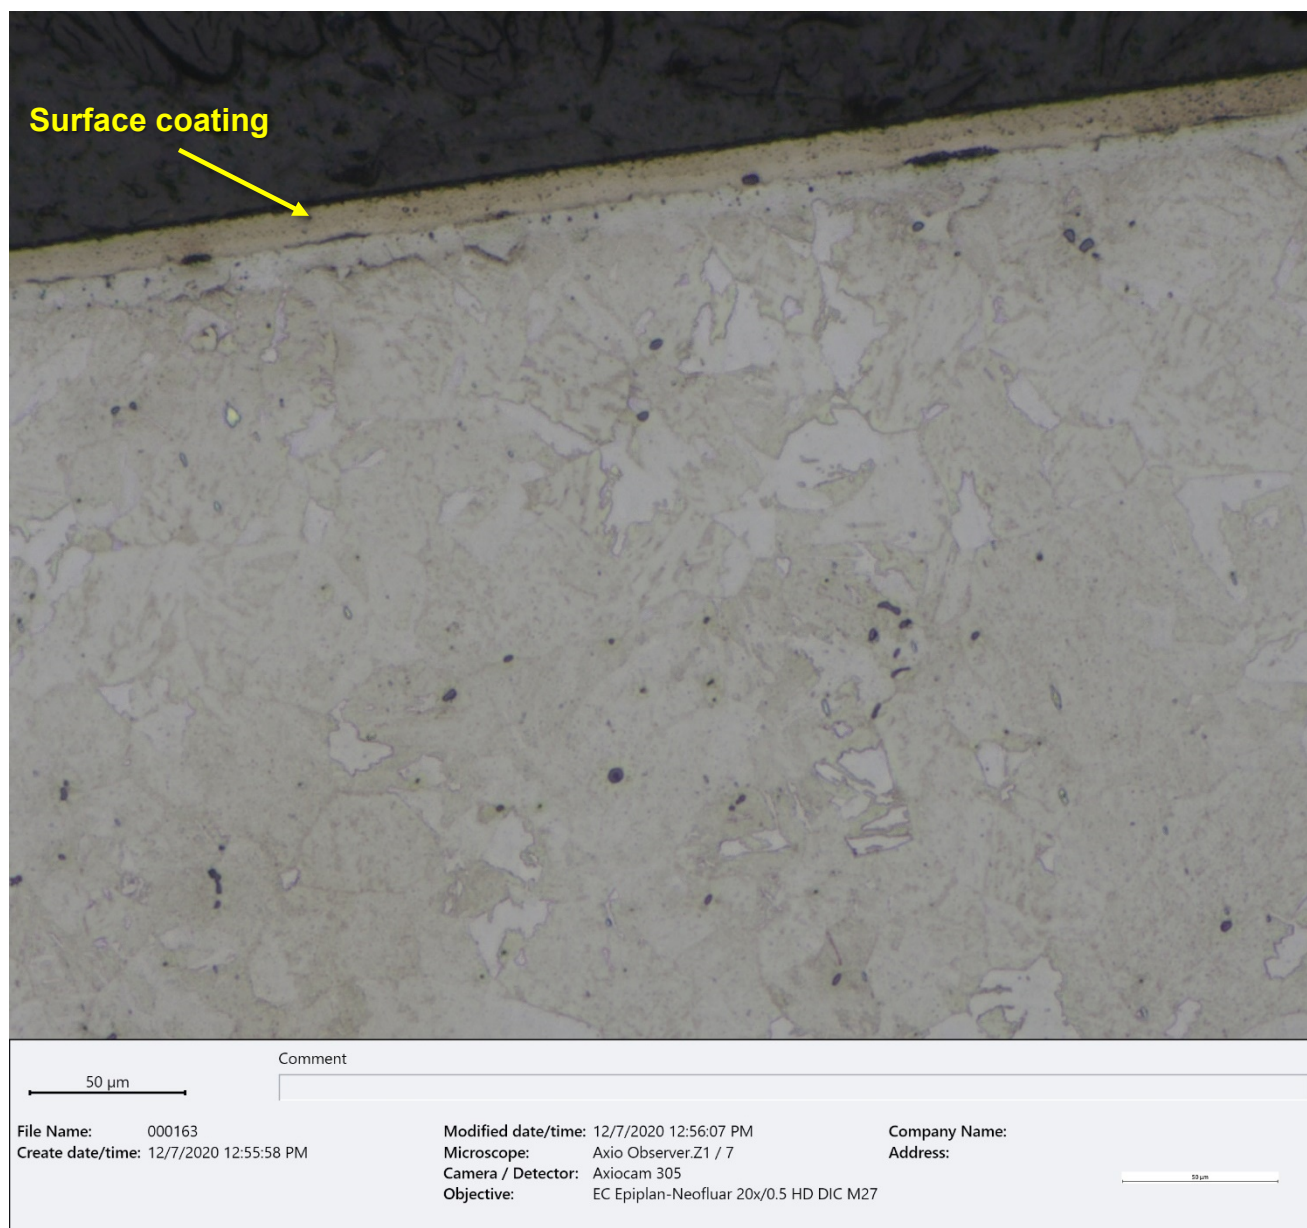
A portion of the collar was sectioned parallel to the fracture surface, mounted, and polished for metallographic examination. A cross section of the surface is illustrated in Figure 21. The surface exhibited a coating approximately 10  $\mu\text{m}$  (0.0004 inches) thick. The coating was generally uniform in thickness and was adherent, with some small gaps between itself and the substrate. The cross-section was examined using energy dispersive x-ray spectroscopy (EDS), and was found to contain mostly Ni with some P, consistent with elements typical of an electroless nickel coating.

Figure 21 – Bright-field (BF) optical micrograph of a cross section of the collar surface, parallel to the fracture surface, showing the adherent surface coating (~200X, etched 2% Nital).

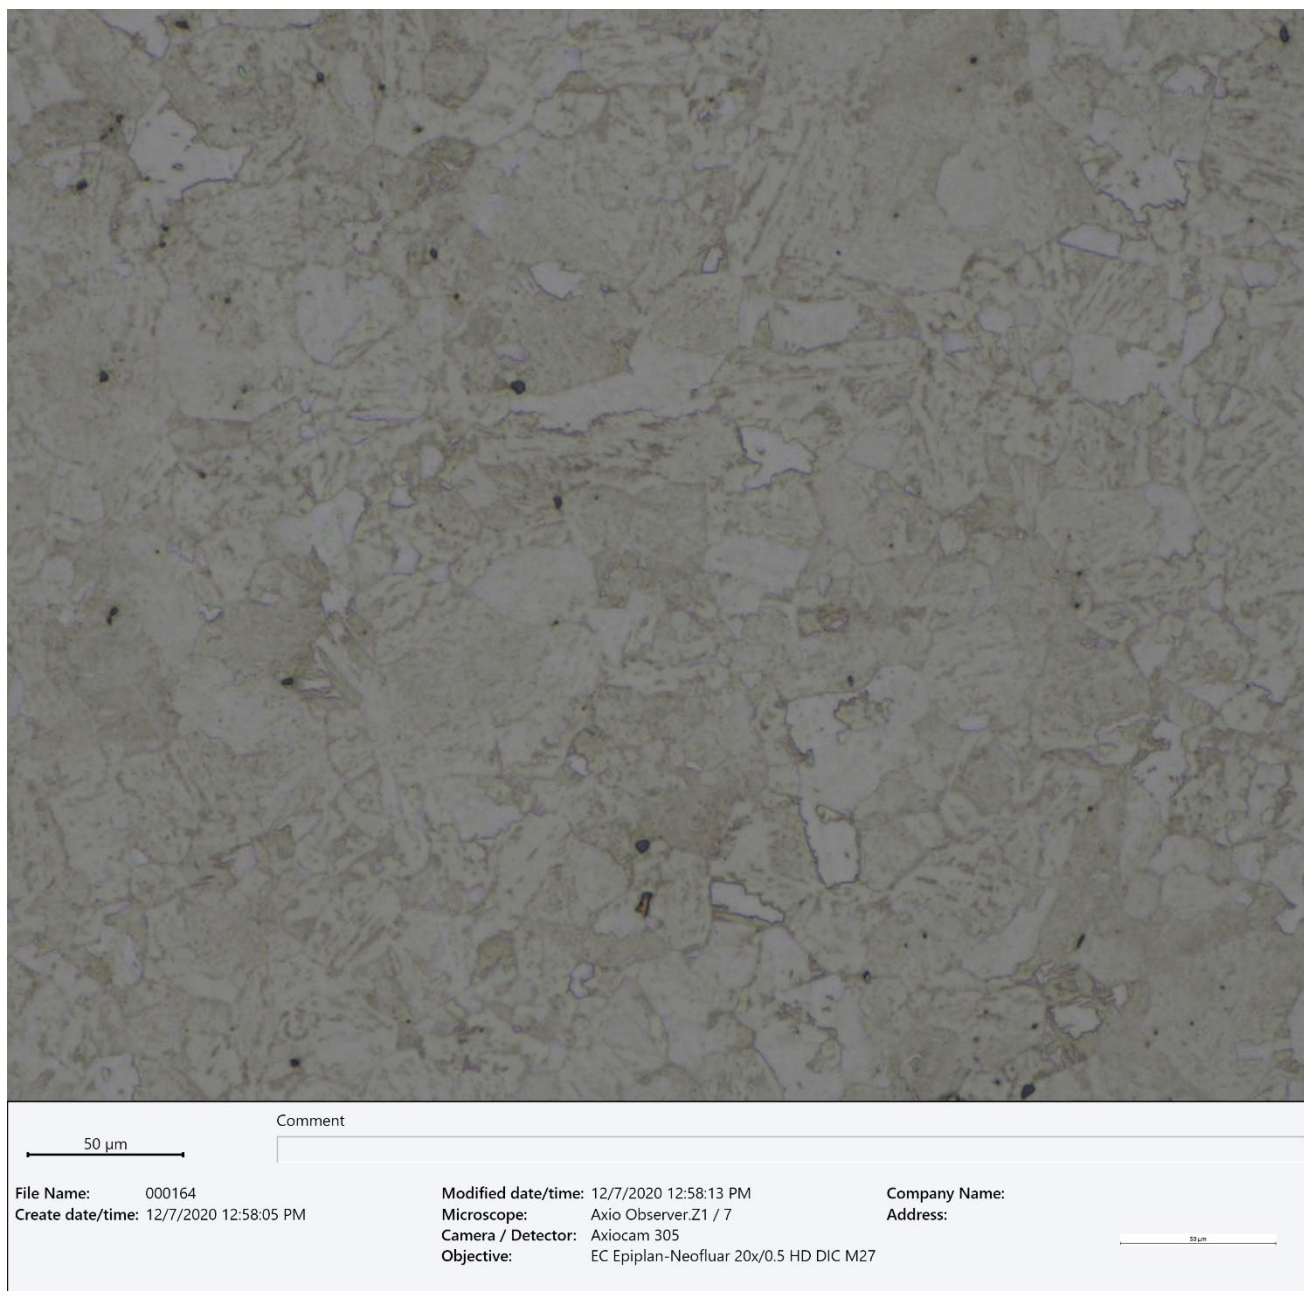
The underlying microstructure revealed equiaxed grains, similar to that found in the core in Figure 22. The chemical composition of the sectioned collar was examined using x-ray fluorescence (XRF) and EDS. From the data obtained using these techniques, the collar was found to be consistent with alloy steel. The hardness was inspected per ASTM E18.<sup>2</sup> The hardness averaged 99 HRBW.

Figure 22 – BF optical micrograph of the core microstructure of the collar cross section (~500X, etched 2% Nital).

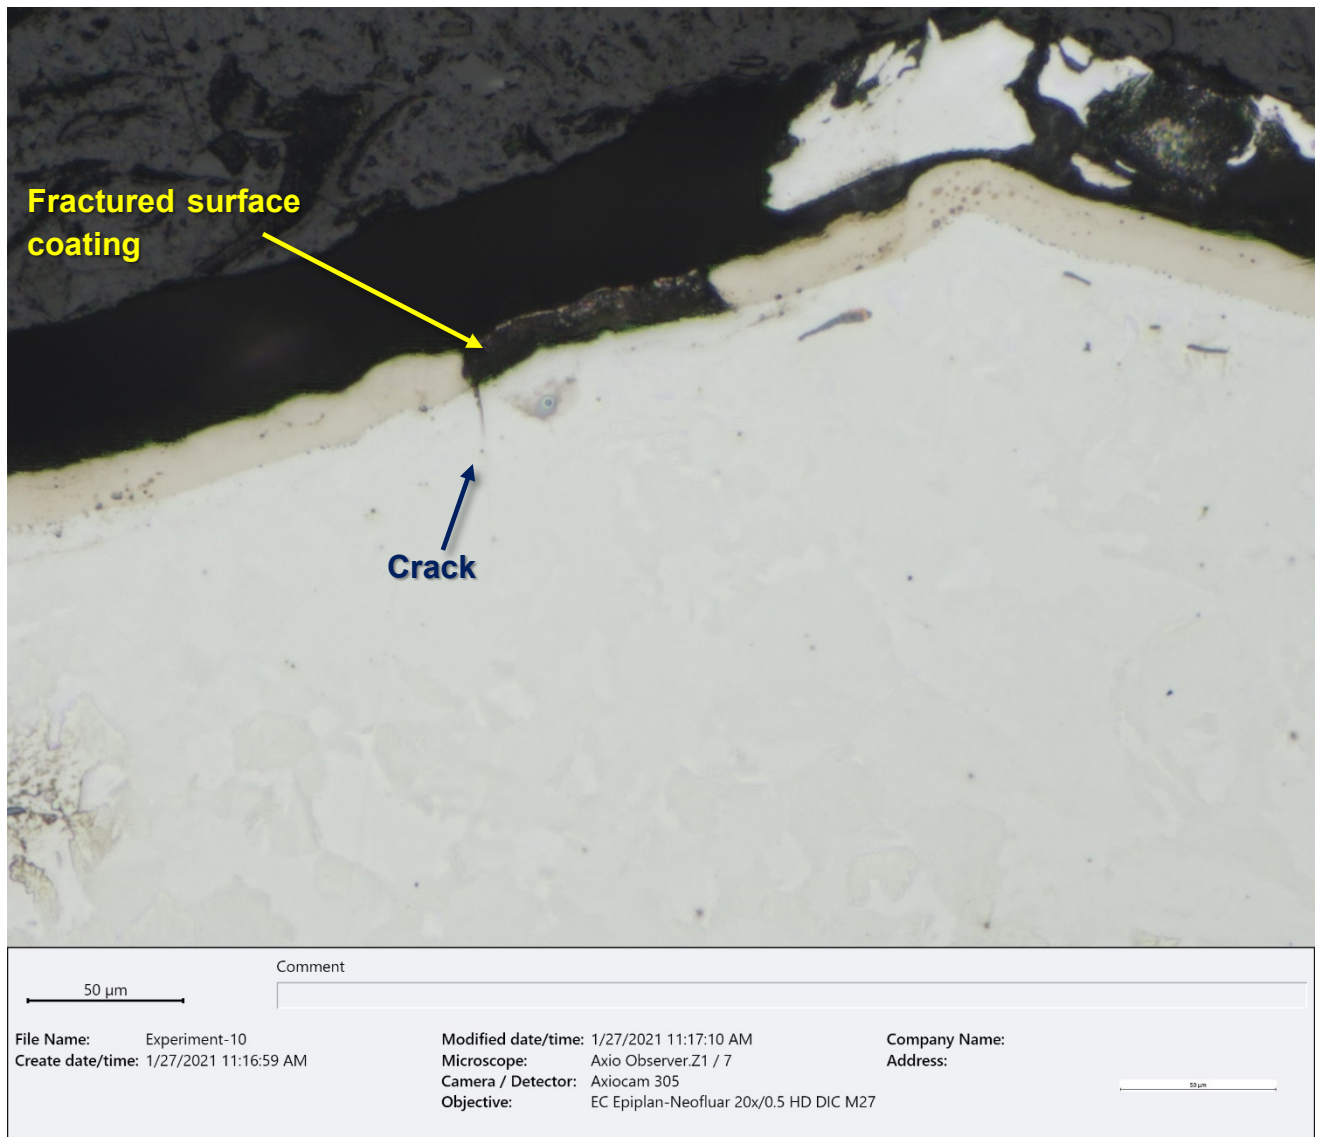
Another cross section was taken perpendicular to the fracture surface, which was also mounted, polished, and etched. Figure 23 shows a typical view of the cross section. There were secondary cracks present perpendicular to the fracture surface. These cracks were co-located at areas where the Ni-coating was missing. While the parallel cross section showed a mostly adherent coating, the perpendicular coating revealed areas of spalled coating, or areas where the coating was buckled or present with gaps against the substrate (Figures 24 and 25). These features were consistent with cracks having initiated at the surface where the outer coating was cracked, missing, or otherwise compromised.

Figure 23 – BF optical micrograph of a perpendicular cross section of the collar below the fracture surface, showing missing Ni coating and a small crack (~500X, as polished).

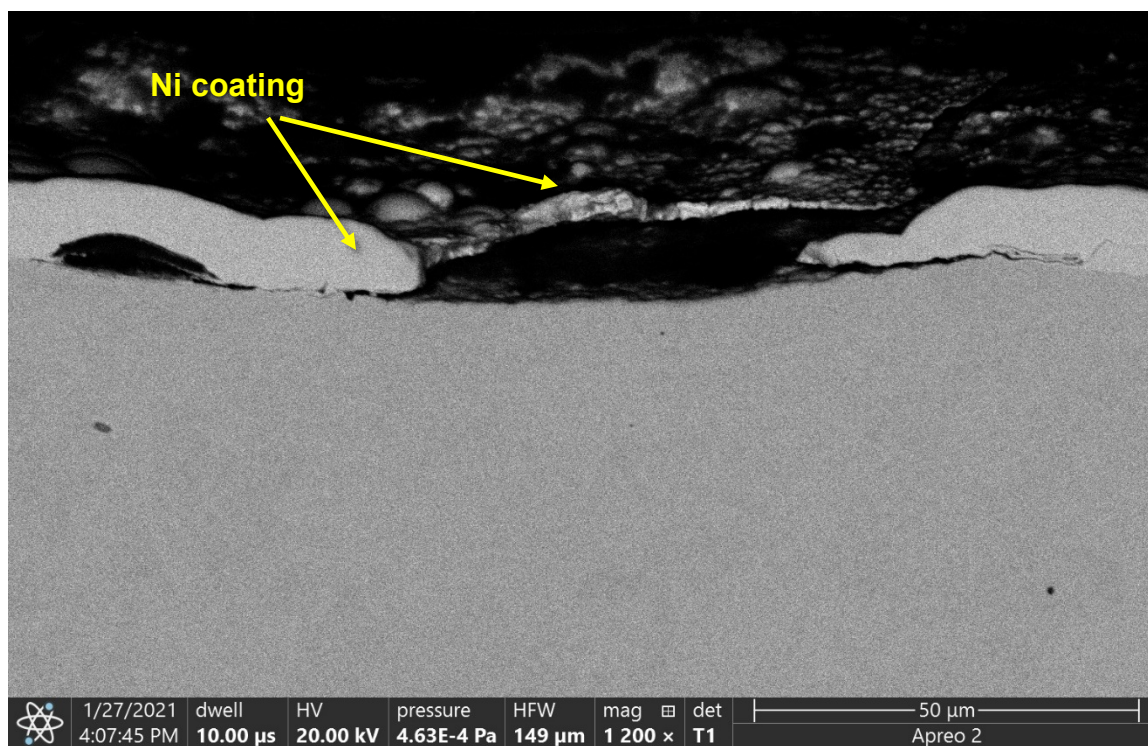
Figure 24 – BE micrograph of a fractured and missing portion of the collar Ni coating, cross-sectioned perpendicular to and below the fracture surface.

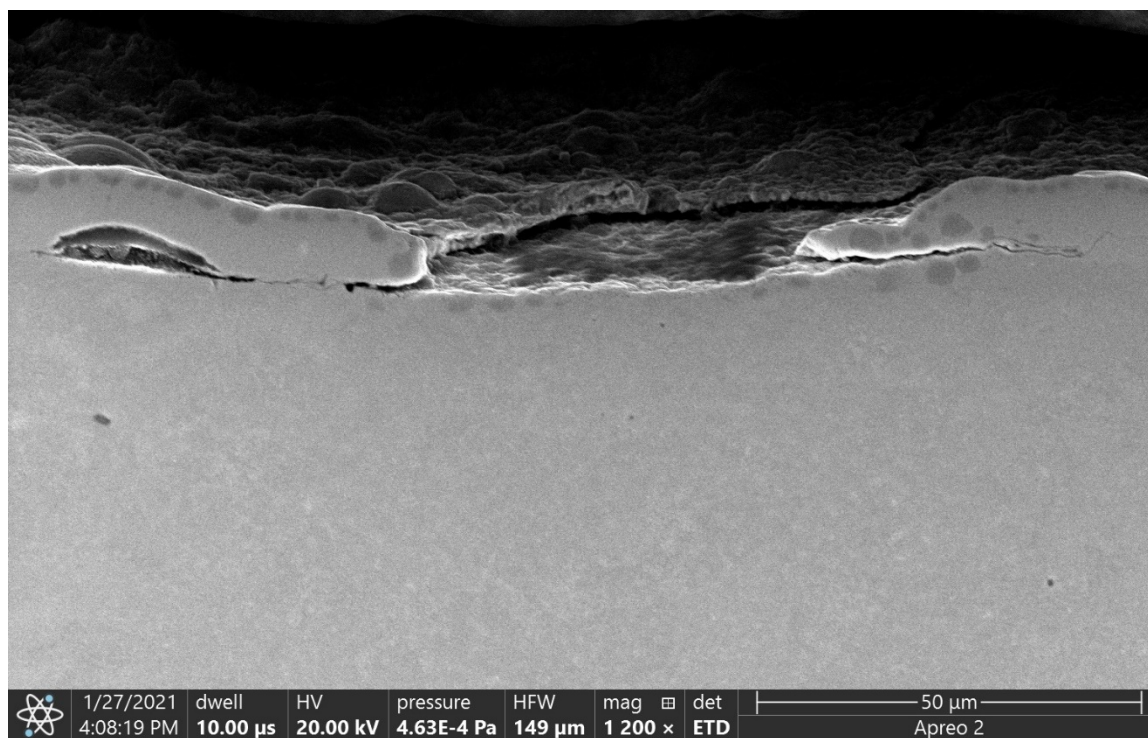
Figure 25 – SE micrograph showing the missing Ni coating in Figure 24.
