## **NATIONAL TRANSPORTATION SAFETY BOARD**

### **AIRFRAME / ENGINE EXAMINATION SUMMARY**

**WPR20LA291**

Location: Grand Canyon, Arizona  
Date: August 28, 2020  
Aircraft: Cessna TU206, N3422L  
NTSB Investigator-in-Charge: Thomas Little

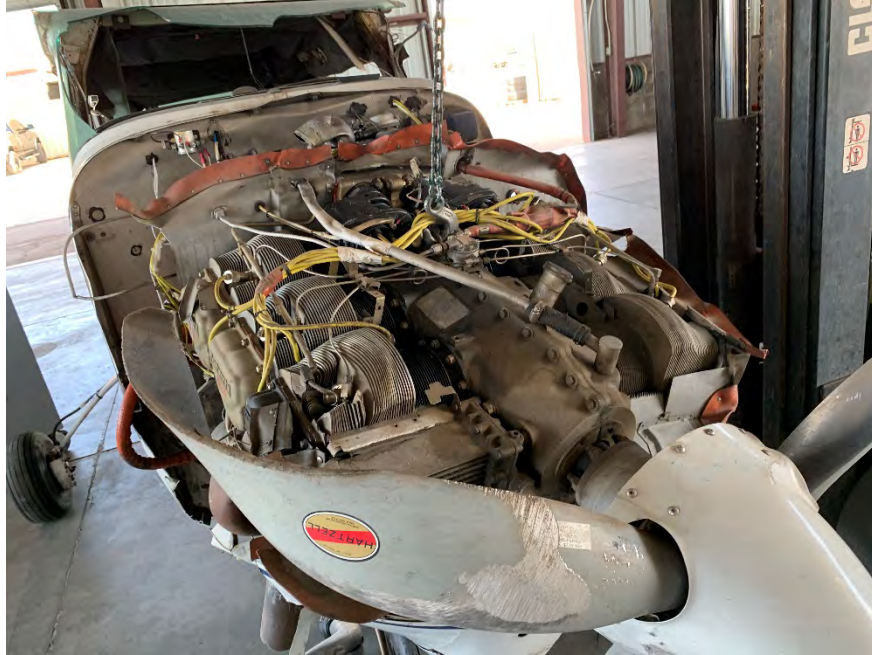
Examination of the recovered engine revealed that the engine remained attached to the airframe via 3 of the 4 engine mounts. The number 5 cylinder was impact damaged. No evidence of any fuel system breaches or damage to the fuel system was observed.

**Figure 1: View of the engine on the airframe.**

All engine accessories remained attached. All fuel lines were intact and undamaged. One oil line was impact damaged and separated at the hose fitting.

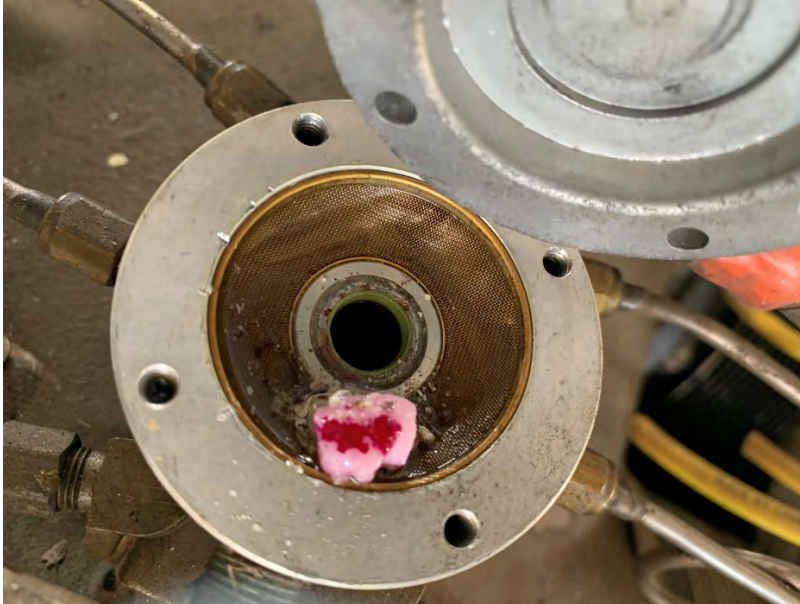
The fuel manifold valve was intact with all of the fuel lines and injector lines attached and secure. The fuel manifold valve was disassembled. The internal spring and diaphragm were intact. The diaphragm was difficult to remove, however, once removed, exposed a liquid within the fuel manifold housing and a slight amount of debris within the screen. The liquid was tested with water finding paste with positive results.

**Figure 2: View of the fuel manifold valve, with water finding paste.**

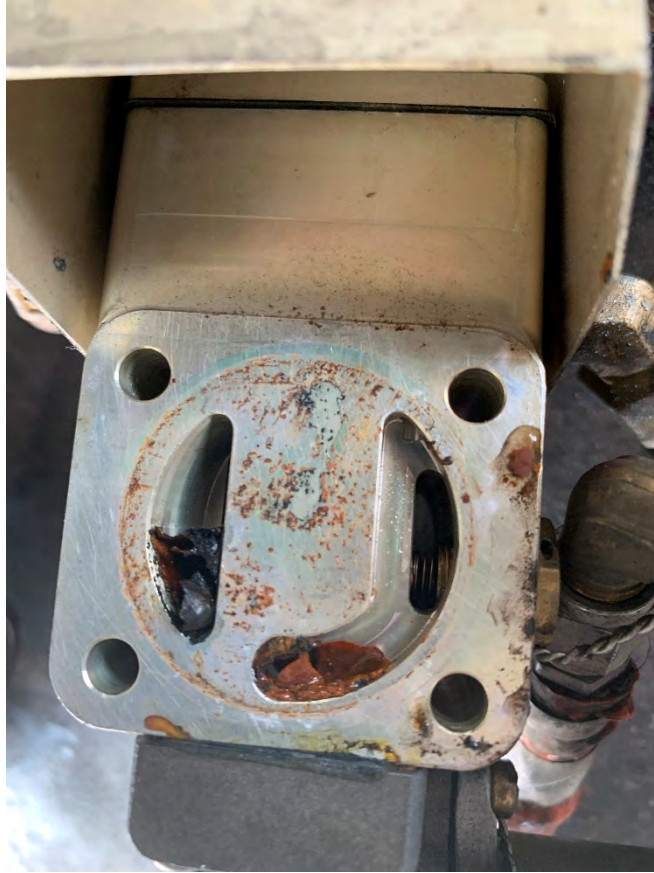
The fuel pump was intact and undamaged with all fuel lines secure to their respective fittings. The fuel pump was removed from the engine and the drive coupling was found intact. The fuel pump drive shaft partially rotated by hand. The fuel pump was disassembled. Corrosion and dirt like debris was observed throughout the entire fuel pump. Some liquid was recovered from one of the fuel pump cavities and tested with water finding paste with positive results.

**Figure 3: View of the fuel pump with corrosion and dirt like debris within the internal cavities.**

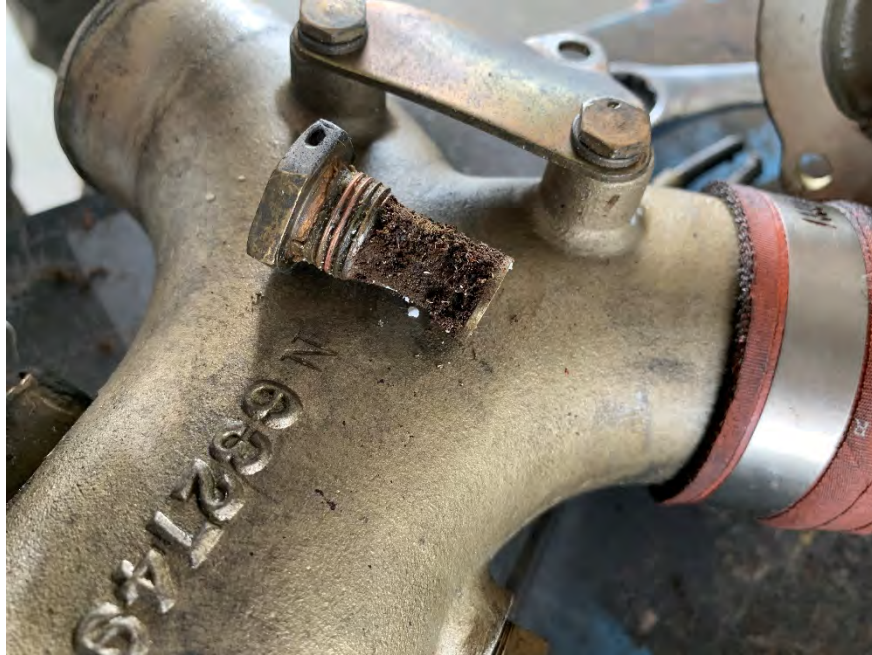
The throttle body fuel control was removed from the engine and found intact. The throttle arm was impact damaged. The mixture lever moved by hand. The throttle plate interconnect was intact. The fuel inlet screen was removed and round mostly clogged with what appeared to be dirt and corrosion.

**Figure 4: Fuel control unit inlet filter.**

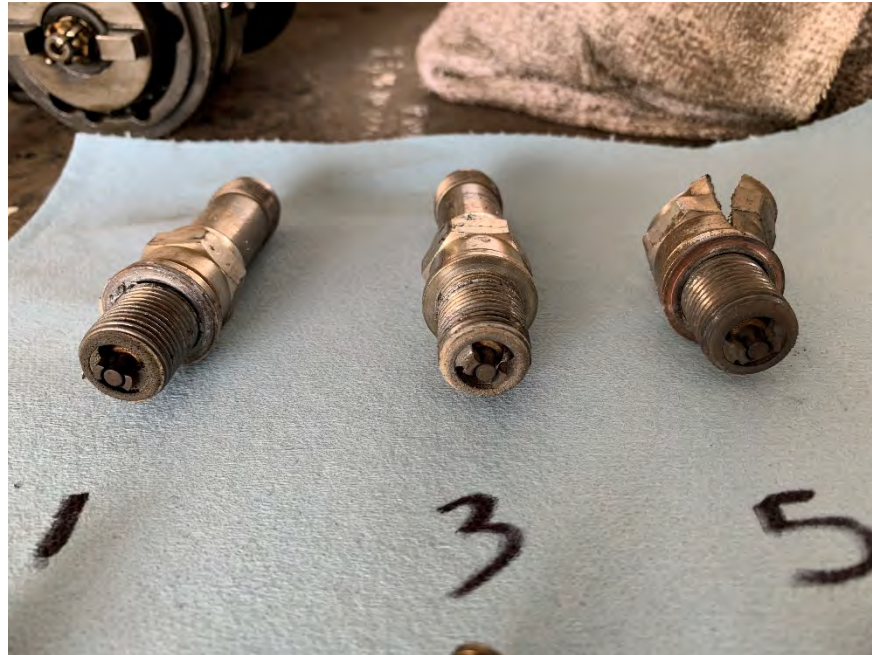
The upper spark plugs were intact with the exception of the number 5 cylinder, which exhibited impact damaged. All six upper sparkplugs exhibited normal operational signatures and gray deposits within the electrode area.

**Figure 5: Upper 1, 3, and 5 spark plugs.**

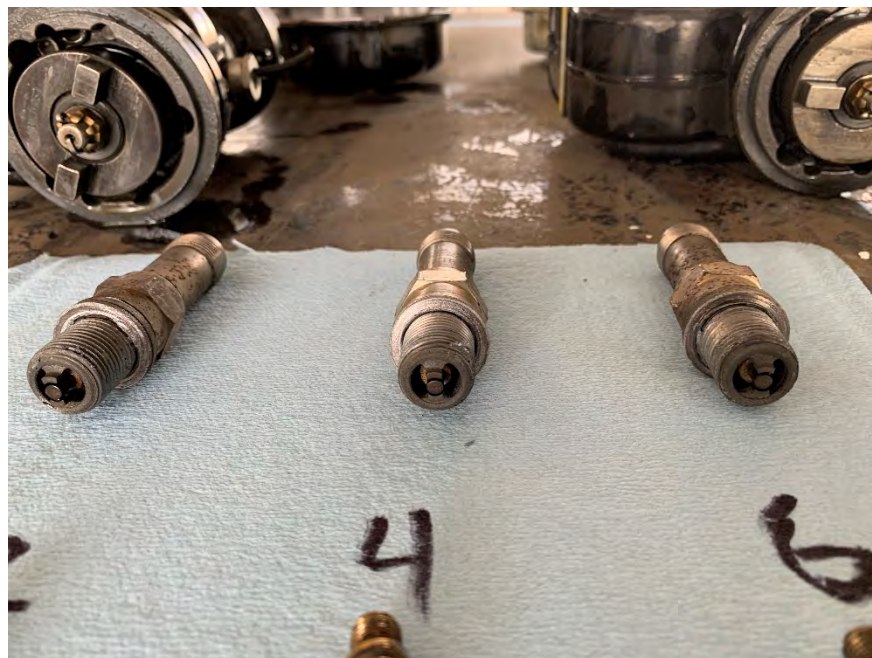
**Figure 6: Upper 2, 4, and 6 spark plugs.**

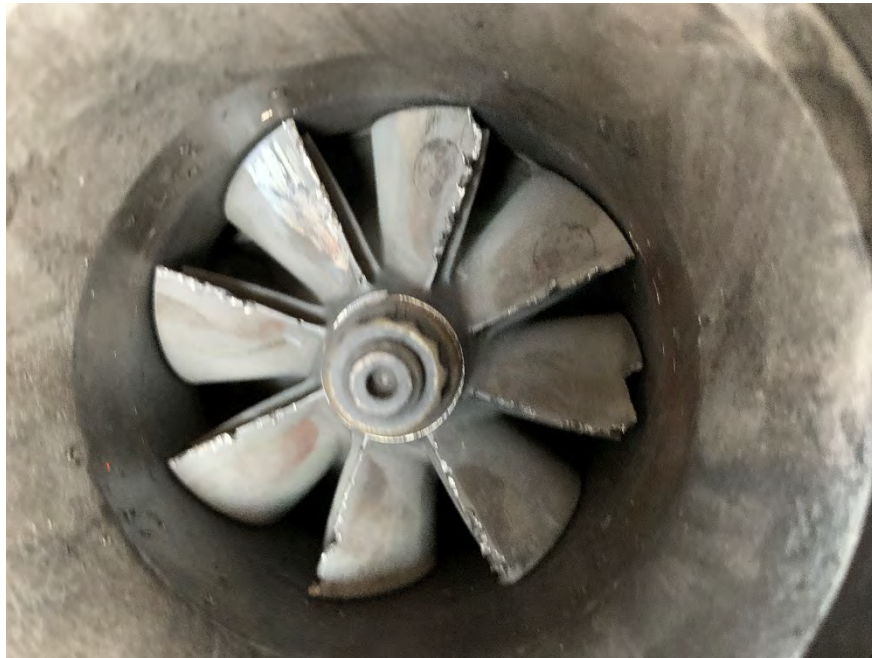
The turbocharger and waste gate was intact. The cold side (intake) of the turbo charger exhibited blade erosion consistent with hard particle passage.

**Figure 7: View of the cold side of the turbine wheel.**

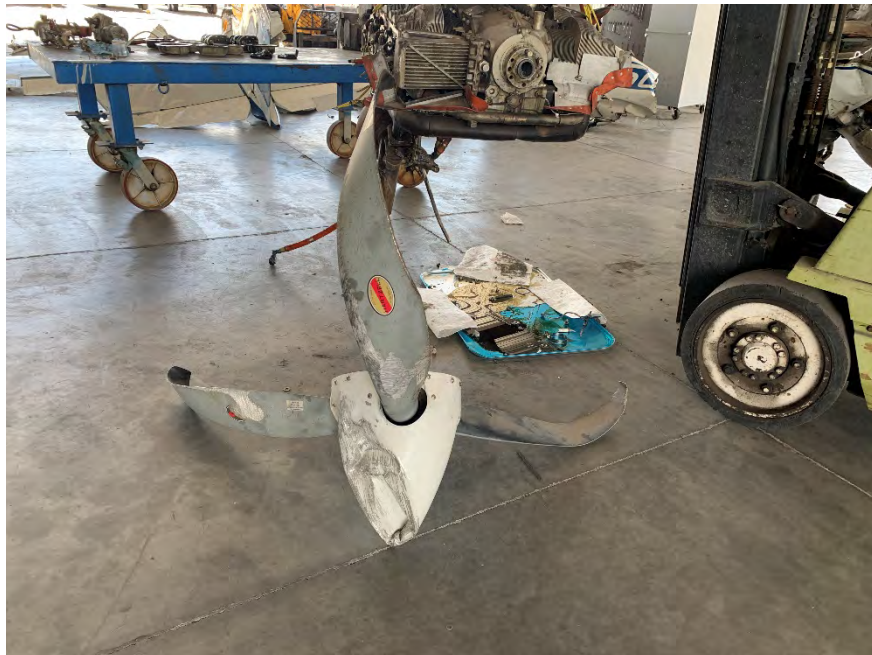
All three propeller blades remained attached to the propeller hub and exhibited bending opposite direction of rotation, with aft bending near the blade tips.

**Figure 8: Propeller Blades**
