**NATIONAL TRANSPORTATION SAFETY BOARD**  
Office of Aviation Safety

**WRECKAGE AND ENGINE EXAM FIELD NOTES**

**A. ACCIDENT**      **WPR20LA295**

Location:      Three Rivers, CA  
Date:      September 4, 2020  
Time:      1148 Pacific Daylight Time (PDT)  
Operator:      Private  
Aircraft:      Beech V35B  
Registration:      N818S

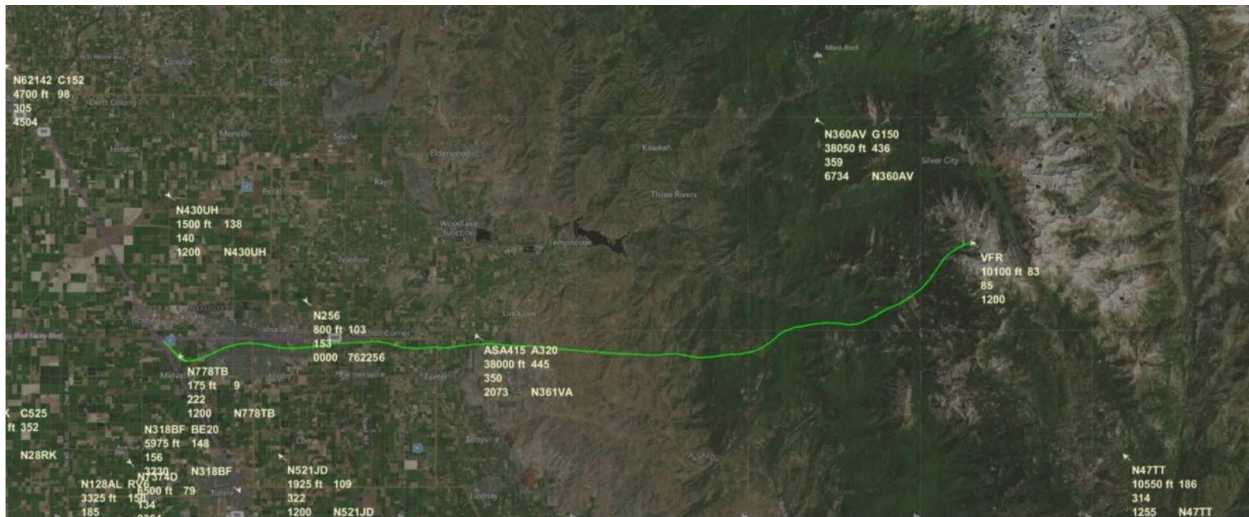
Figure 1 - Preliminary Radar Track

Preliminary radar data depicted a primary target consistent with the accident airplane depart Visalia Municipal Airport (VIS), Visalia, California, about 1125 and flew east on a 1200 non-discreet code. The airplane flew toward rising terrain south of Silver City, California, and the last recorded radar target was about 1148. The pilot was flying in an area of reduced visibility due to smoke from nearby wildfires. There were no reported witnesses to the accident sequence.

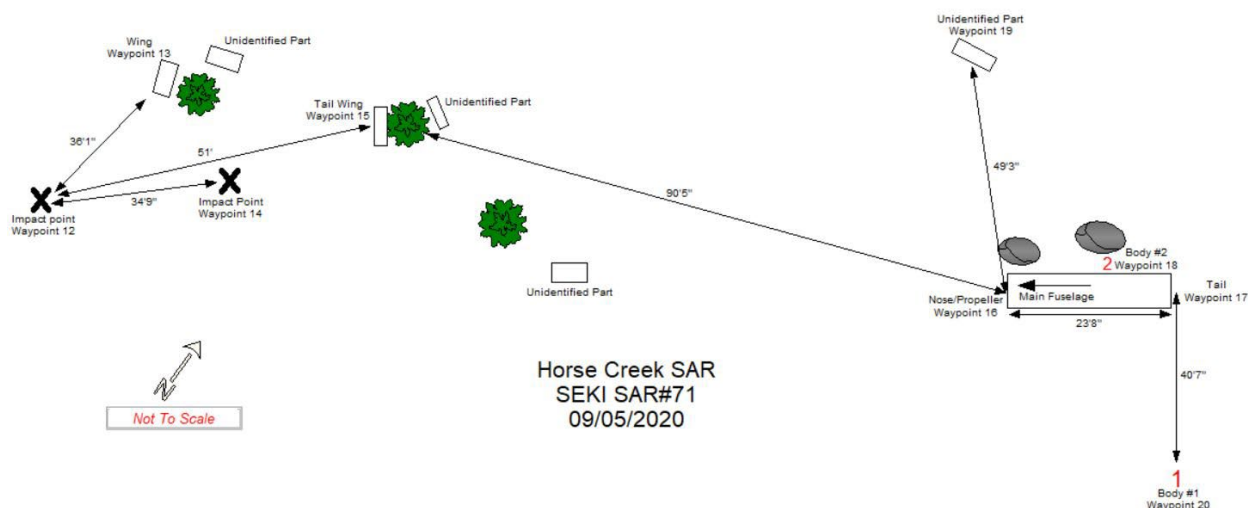
Figure 2 - Main Accident Site Diagram (SAR)

The accident site was not visited by NTSB or FAA investigators. A wreckage diagram was provided by the Nat'l Park Service, who conducted an independent investigation into the accident.

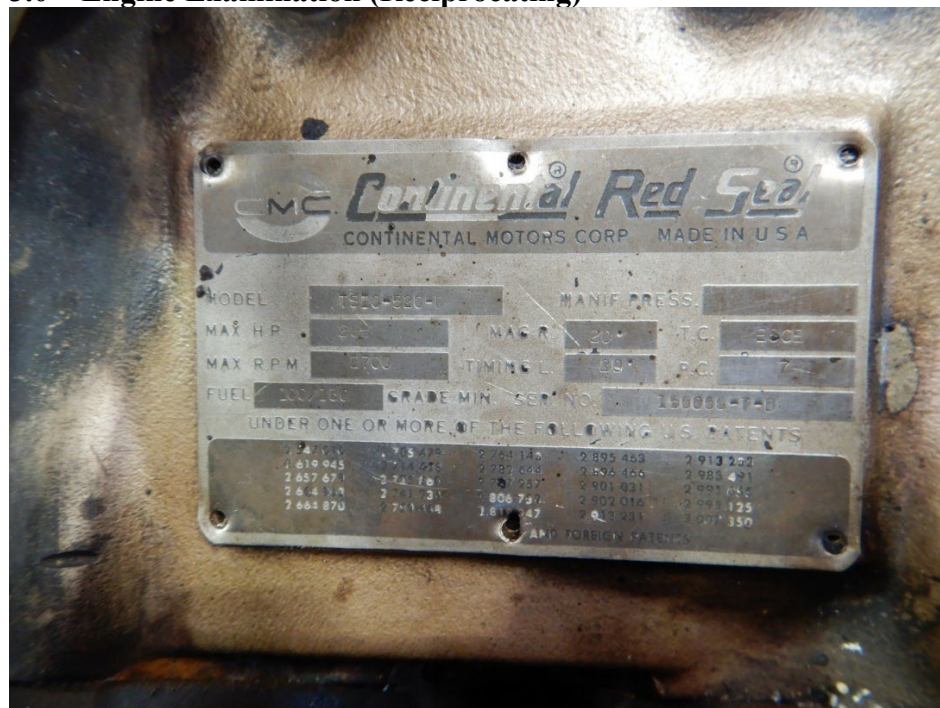
TSIO-520-D, 285 Hp

Summary of damage: When first observed, the engine was stored in a large storage container. The engine was removed from the container and suspended in order to complete the examination. Two turbochargers were observed separated from the engine and thermally damaged. The wastegate valves were observed in the open position. The engine and all observed components exhibited fire damage, corrosion, and some impact damage. All three propeller blades were attached to the propeller hub which remained attached to the engine. Both turbocharger units were partially impact separated from the engine and were removed from the engine to facilitate the engine examination. Attempts to verify engine continuity were unsuccessful.

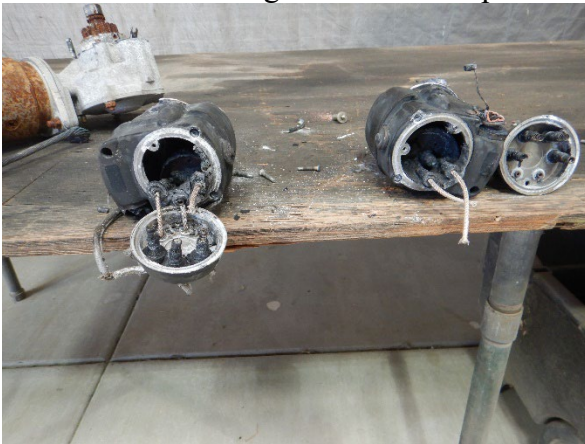
Both the left and right magnetos were attached to the engine and exhibited exposure to heat. Both magnetos were removed from the engine. Neither Magneto would turn or produce spark. Both units were partially disassembled, and their internal components exhibited heat damage, to include the melting of internal components. Functional testing of the units was not possible.

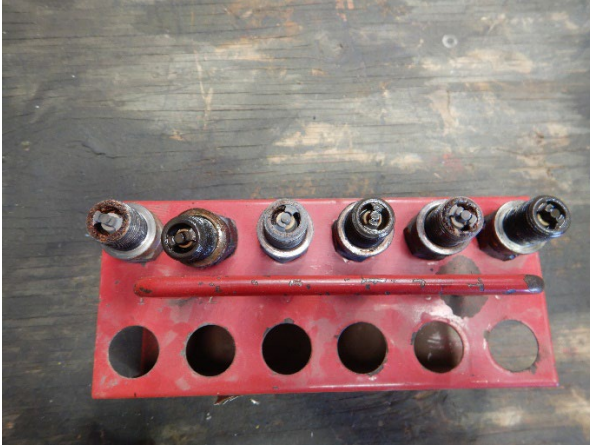
Harness -the ignition harness exhibited heat damage and exposure to fire.

Spark Plugs-condition/appearance

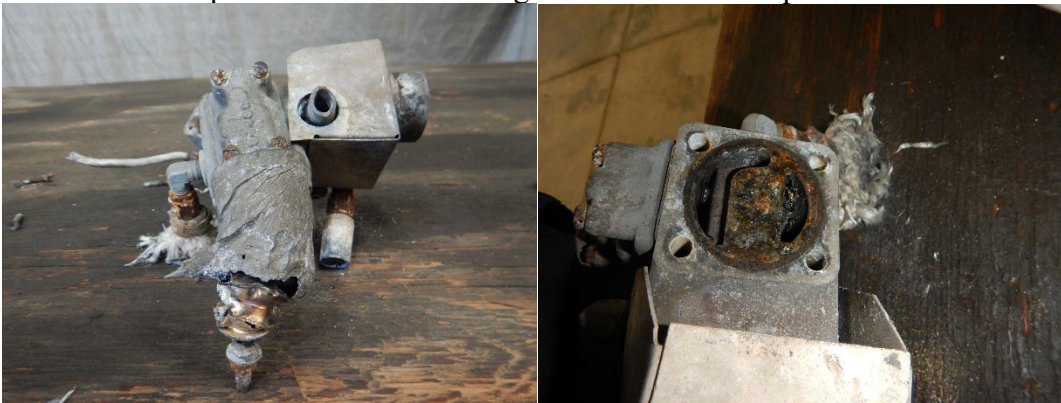
Fuel Pump - the fuel pump exhibited exposure to heat and fire. The pump was removed from the engine and the pump drive coupler was intact. The pump was partially disassembled and the internal components exhibited damage consistent with exposure to extreme heat.

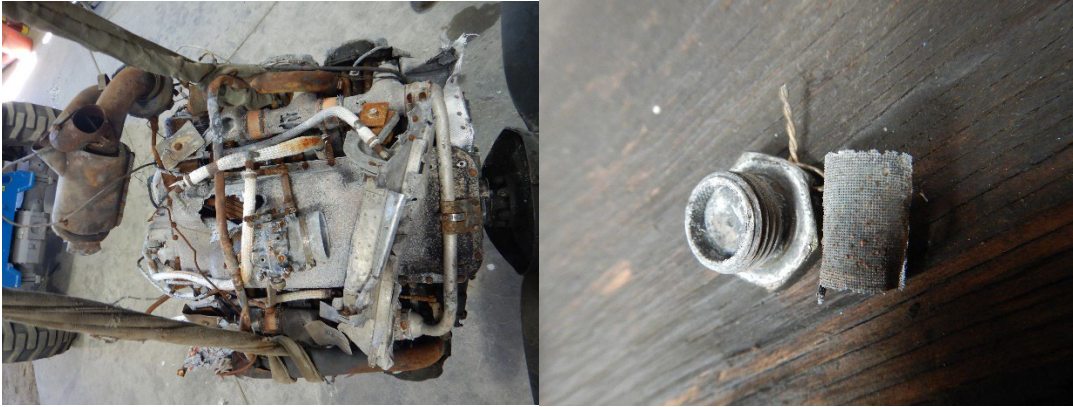
Oil Sump- The oil sump had a large hole in the bottom of the sump due to heat and fire damage.

Pick up tube/Screen were removed. The screen was heat damaged and brittle during removal.
