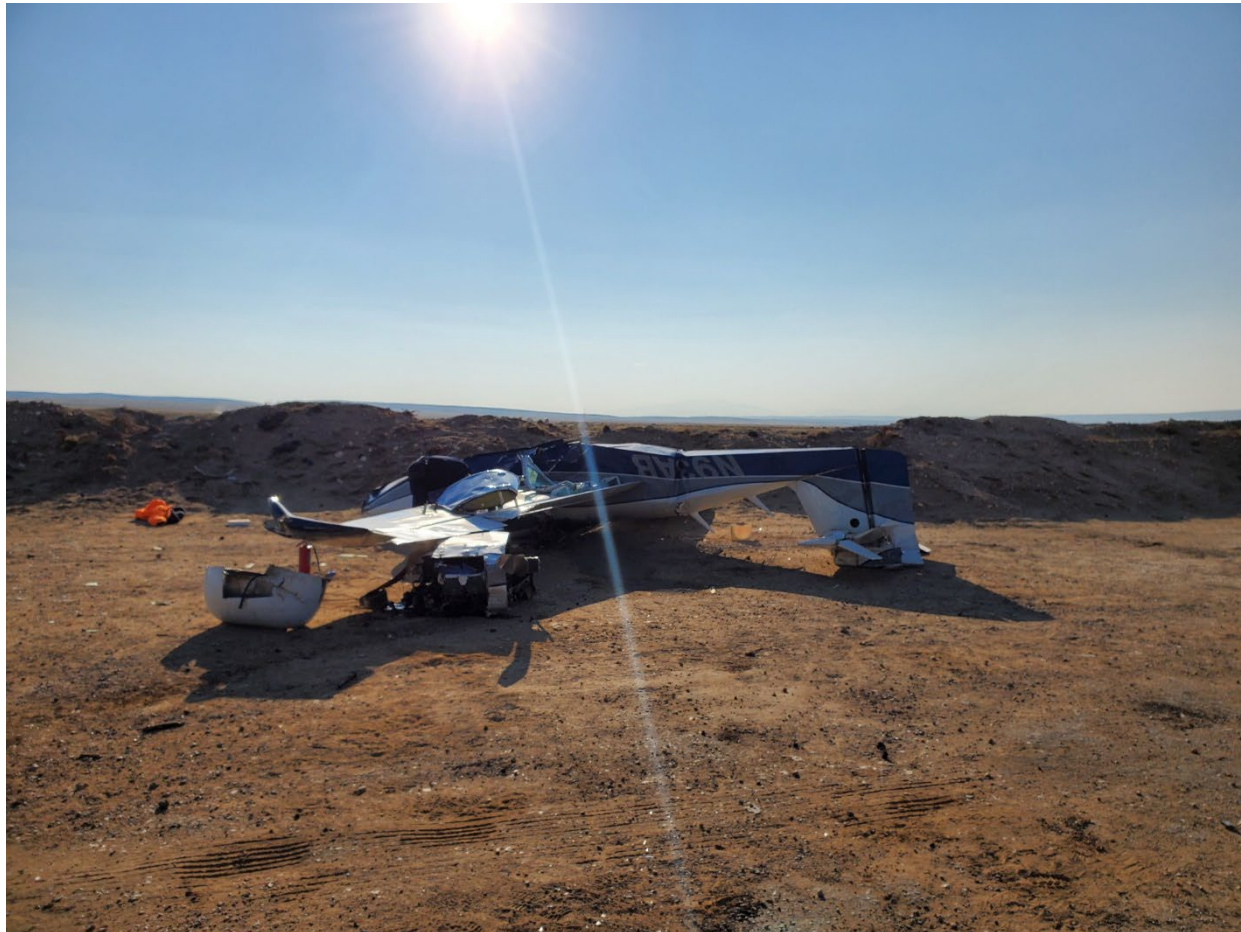
**Photo 1 – View of damage to N93AB (Courtesy of Law Enforcement)**

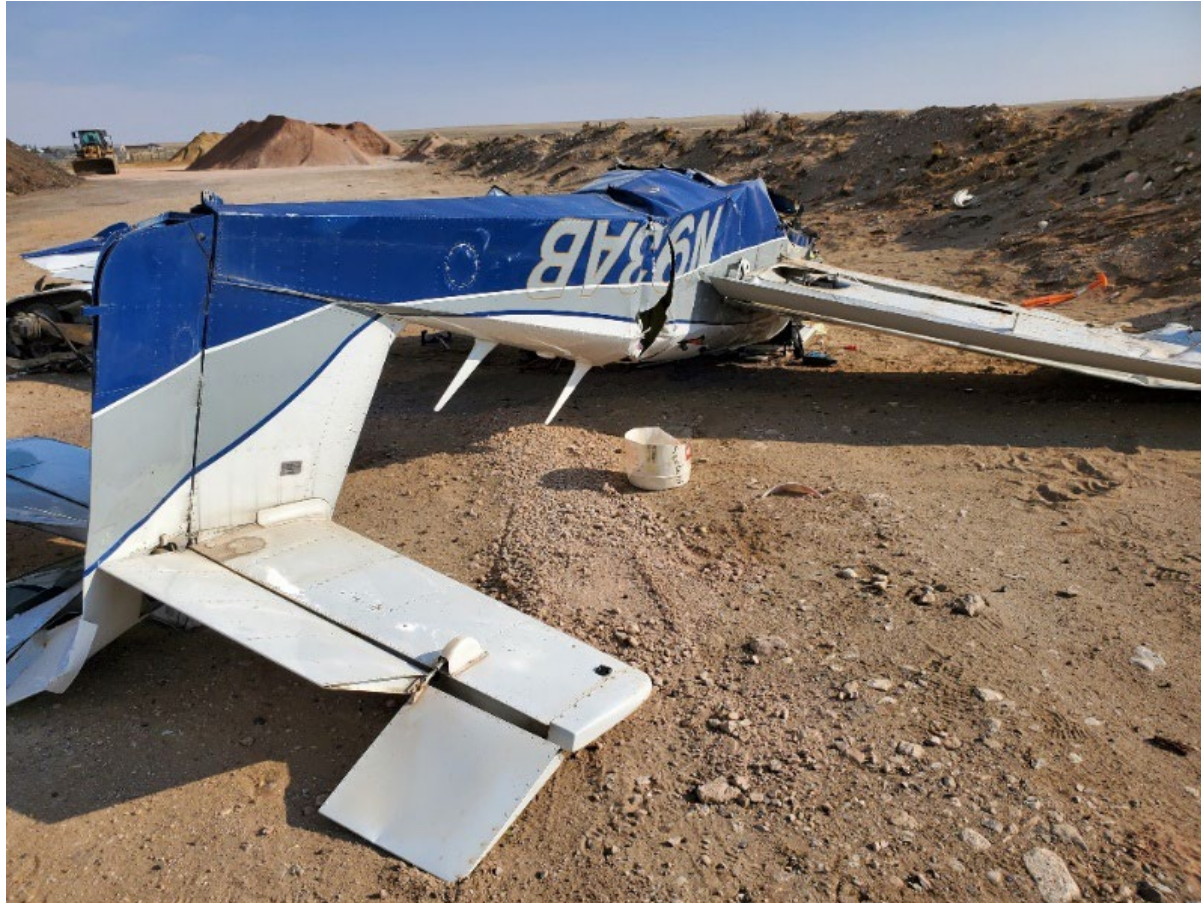
**Photo 2 – Post-accident view of left trim surface (Courtesy of Law Enforcement)**

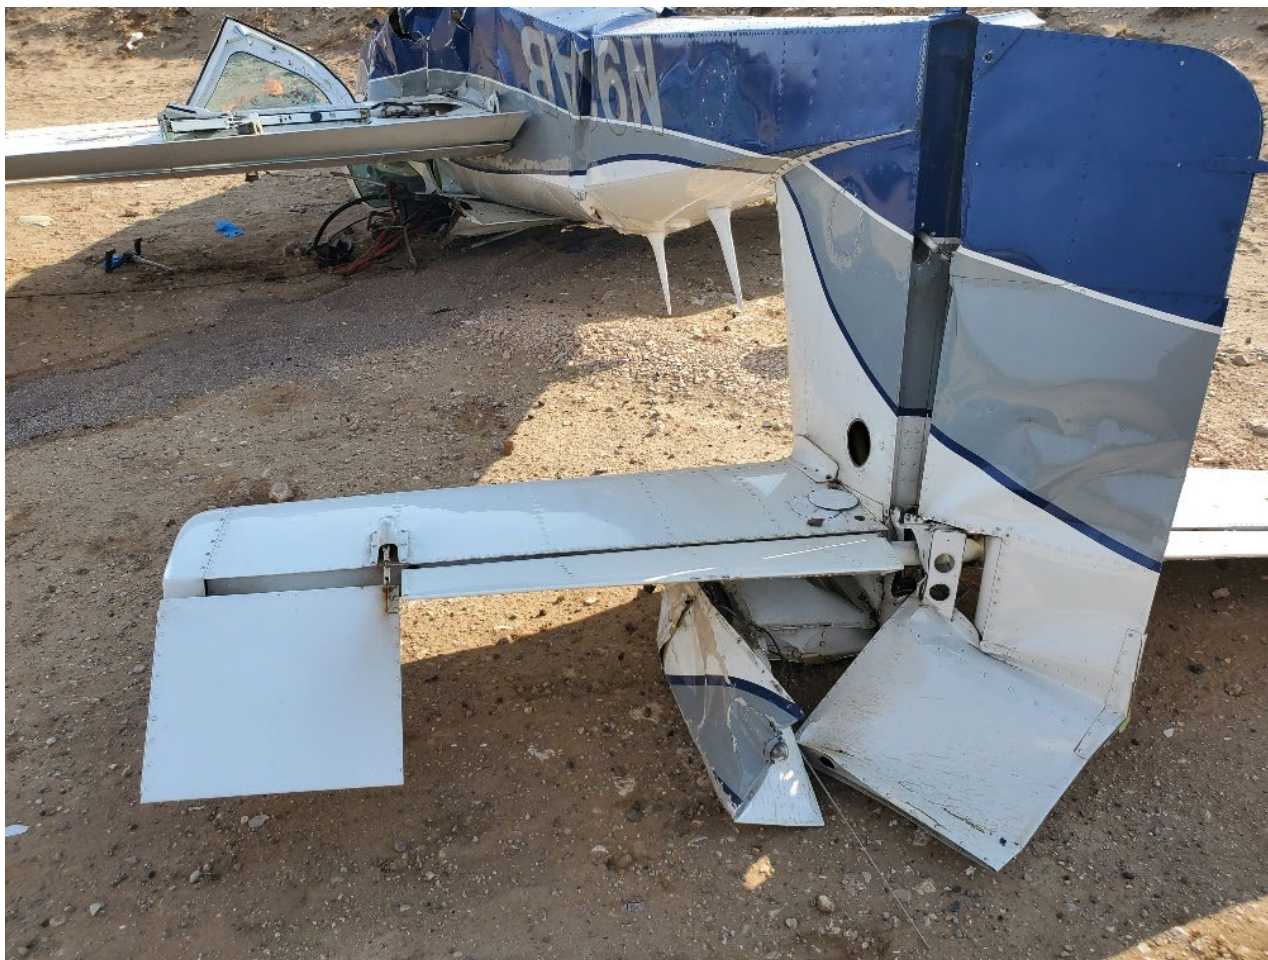
**Photo 3 – Post-accident view of right trim surface (Courtesy of Law Enforcement)**
