## RECORD OF CONVERSATION

**Samantha Link**  
**Aviation Accident Investigator**  
**Western Pacific Region**

**Date: September 11, 2020**  
**Person Contacted: Mr. Curtis Calabrese (FAA Aviation Safety Inspector)**  
**NTSB Accident Number: WPR20LA303**

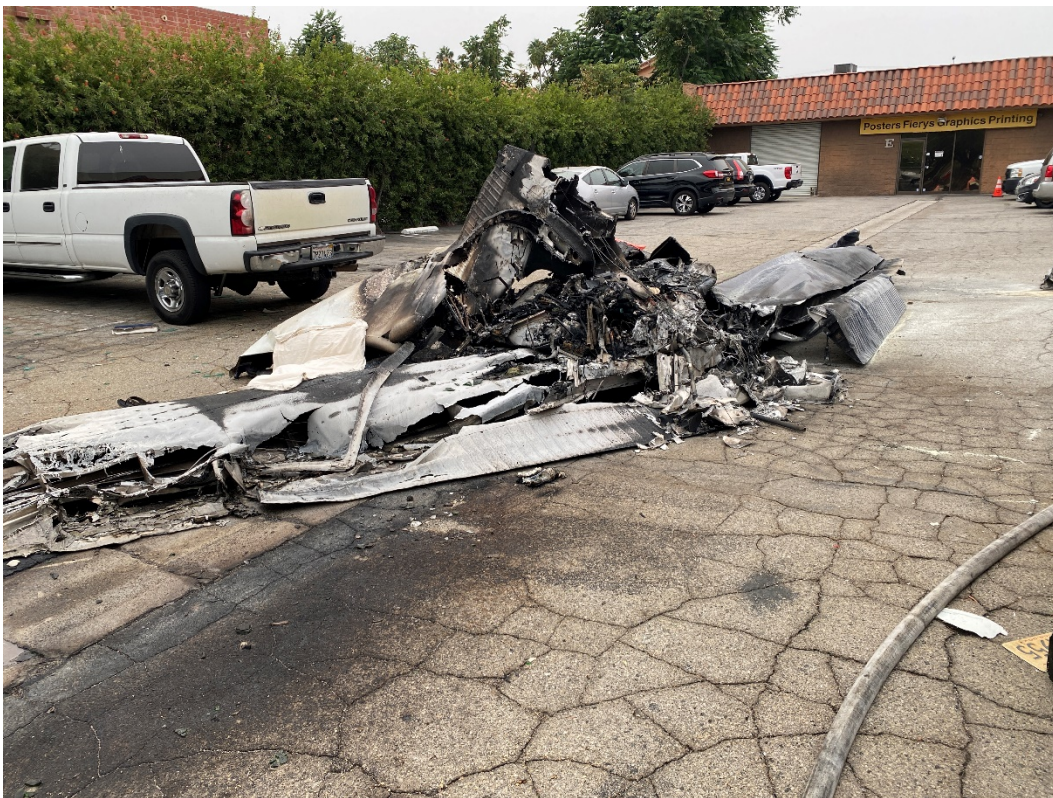
*Figure 2: Overall View of Airplane*

The airplane impacted nose low in a narrow parking lot about ½ mile from the runway surface. The airplane wreckage was contained to a small area in between two rows of vehicles. A post crash fire ensued; a large portion of the fuselage and aft fuselage were consumed by fire. The engine, cabin area, and wings all exhibited extensive aft crush and thermal damage. The empennage was present but exhibited extensive thermal damage.
