## **NATIONAL TRANSPORTATION SAFETY BOARD**

# **AIRFRAME AND ENGINE EXAMINATION SUMMARY**

**WPR20LA303**

Location: Van Nuys, California  
Date: September 11, 2020  
Aircraft: N37C; North American, Navion

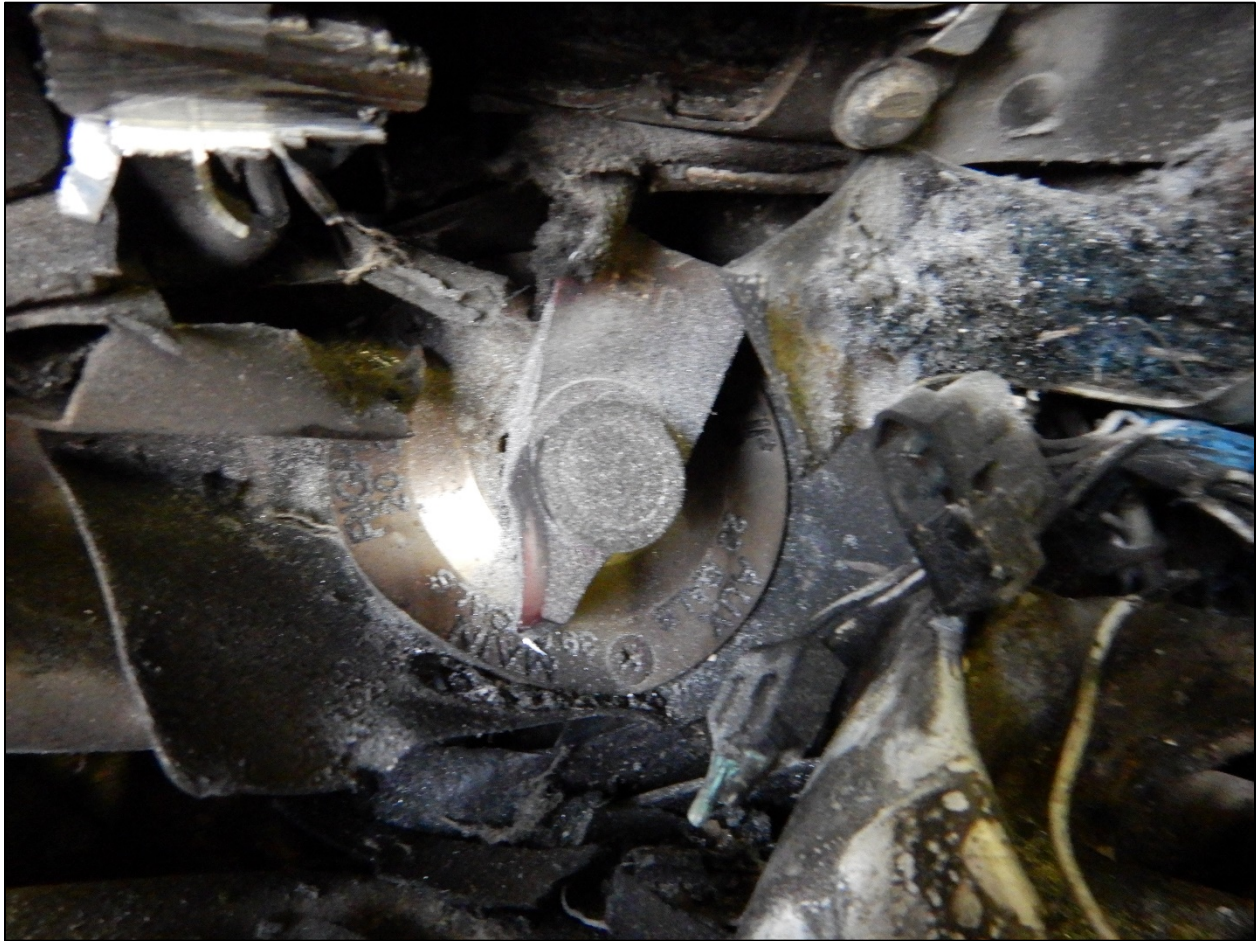
The airframe was previously examined at the accident site, where flight control continuity was established. The cabin floor had excessive crush damage preventing view of the fuel selector valve. The airframe cabin floor was opened with a cutting saw to gain access to the fuel selector valve. The fuel selector handle remained attached to the valve and was undamaged. The fuel selector valve was found in the 'MAIN' position. The valve handle was operated by hand and handle operation and valve detents worked normally.

Figure 1-Wreckage Layout, Forward Left Side View

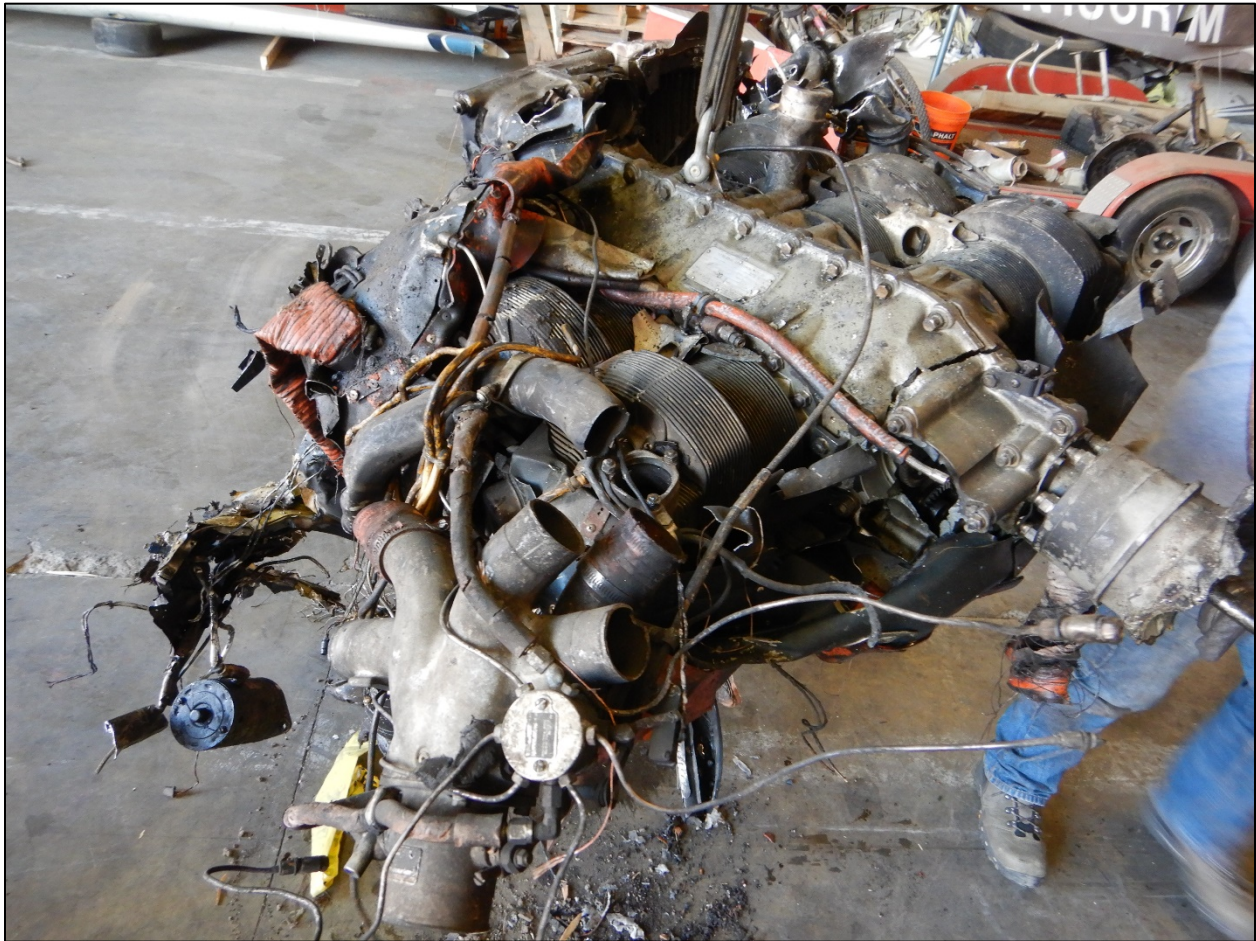
The engine was separated from the airframe during the relocation of the wreckage. The propeller assembly had impact damage and only a section of the hub remained attached to the crankshaft flange. A partial section of the firewall remained attached to engine control cables. The crankcase had impact damage and a large crack was visible near the gear driven alternator mount, crossing over the crankcase split-line to the propeller governor mount area. The accessory section had impact damage. The oil filter separated from the oil filter adapter housing and remained attached to the engine with safety wire. The fuel pump remained attached to the engine and had impact damage to its adjustment screw. The starter separated from the starter adapter housing. The upper accessory section rear mounts had separated components. The magnetos separated from the engine and one was found with the main wreckage. One of the magnetos remained attached to the damaged ignition leads.

Figure 2-Engine, forward right side view.

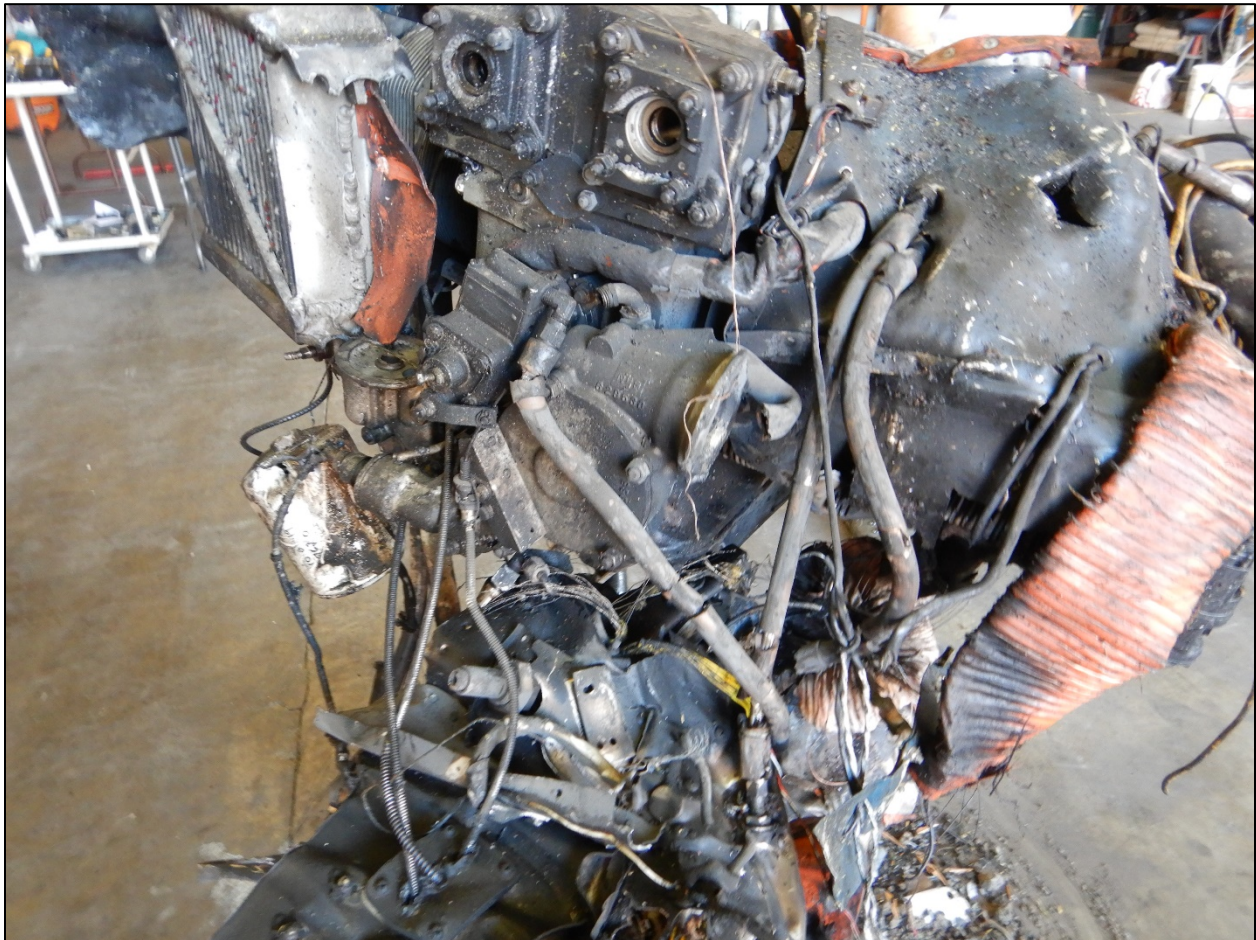
The gear driven alternator separated from the engine. Internal engine surfaces were visible through the gear driven alternator mount. The internal engine surfaces were undamaged and had a light residue of oil. The exhaust assembly had impact damage and only a few stacks remained attached to the cylinders. The induction assembly separated from the cylinders and the plenum remained partially attached to the engine. The fuel manifold valve remained attached to the intake plenum. The throttle cable had impact damage remained attached to the throttle linkage on the intake plenum. The oil sump had impact damage with large cracks along the left side. The propeller governor had impact damage and only the governor housing remained attached.

**Figure 3-Accessory Section**

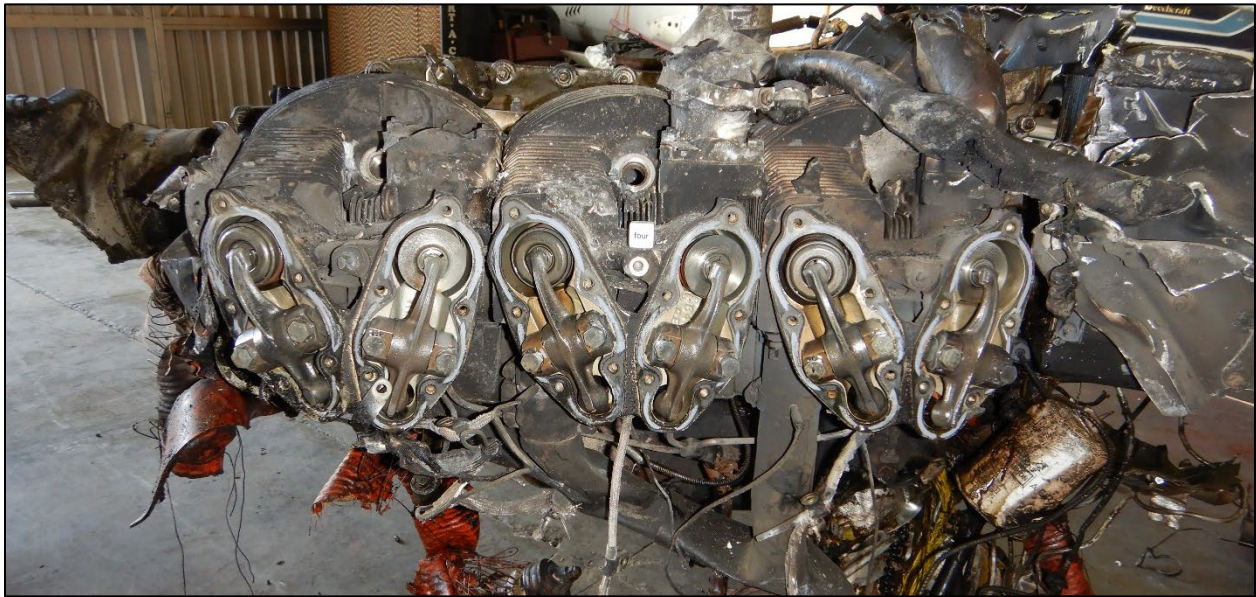
The cylinder valve covers were removed exposing the overhead components. The no. 5 cylinder intake valve assembly, including the rocker and push rod, had impact damage, and separated from the engine. The upper sparkplugs were removed from the cylinders. The sparkplug electrodes were undamaged and showed normal wear and combustion deposits. The cylinders were boroscoped and the combustion chambers revealed normal operating signatures. The valve heads were undamaged and normal combustion deposits were found on the piston head surfaces.

Figure 4-Engine, left side view.

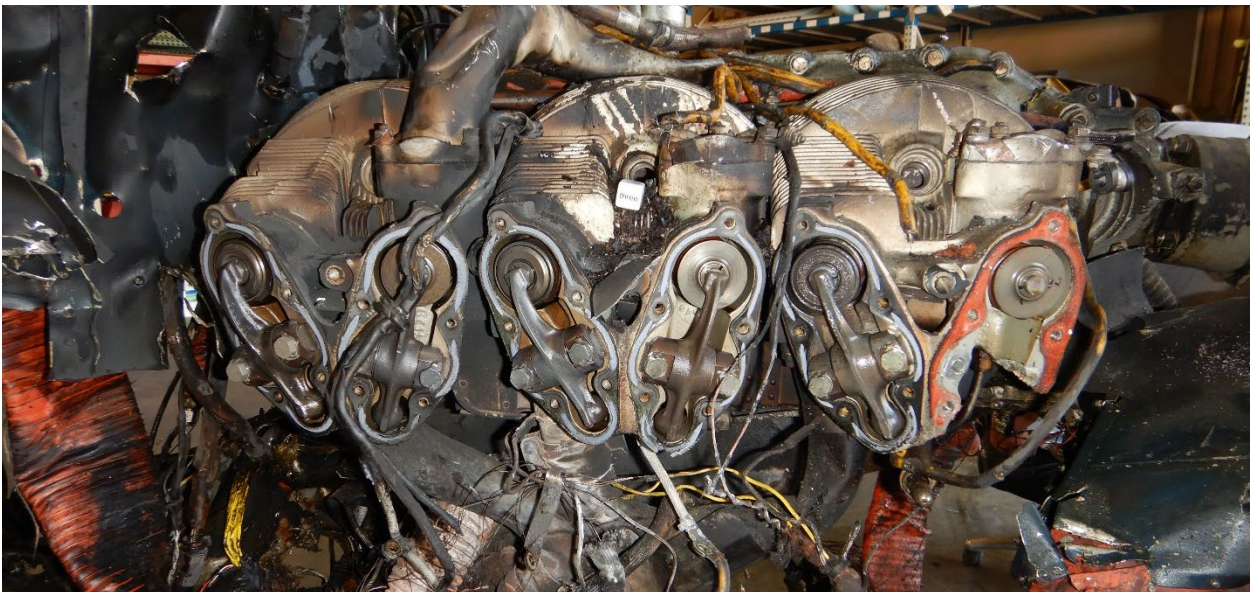
Figure 5-Engine, right side view.

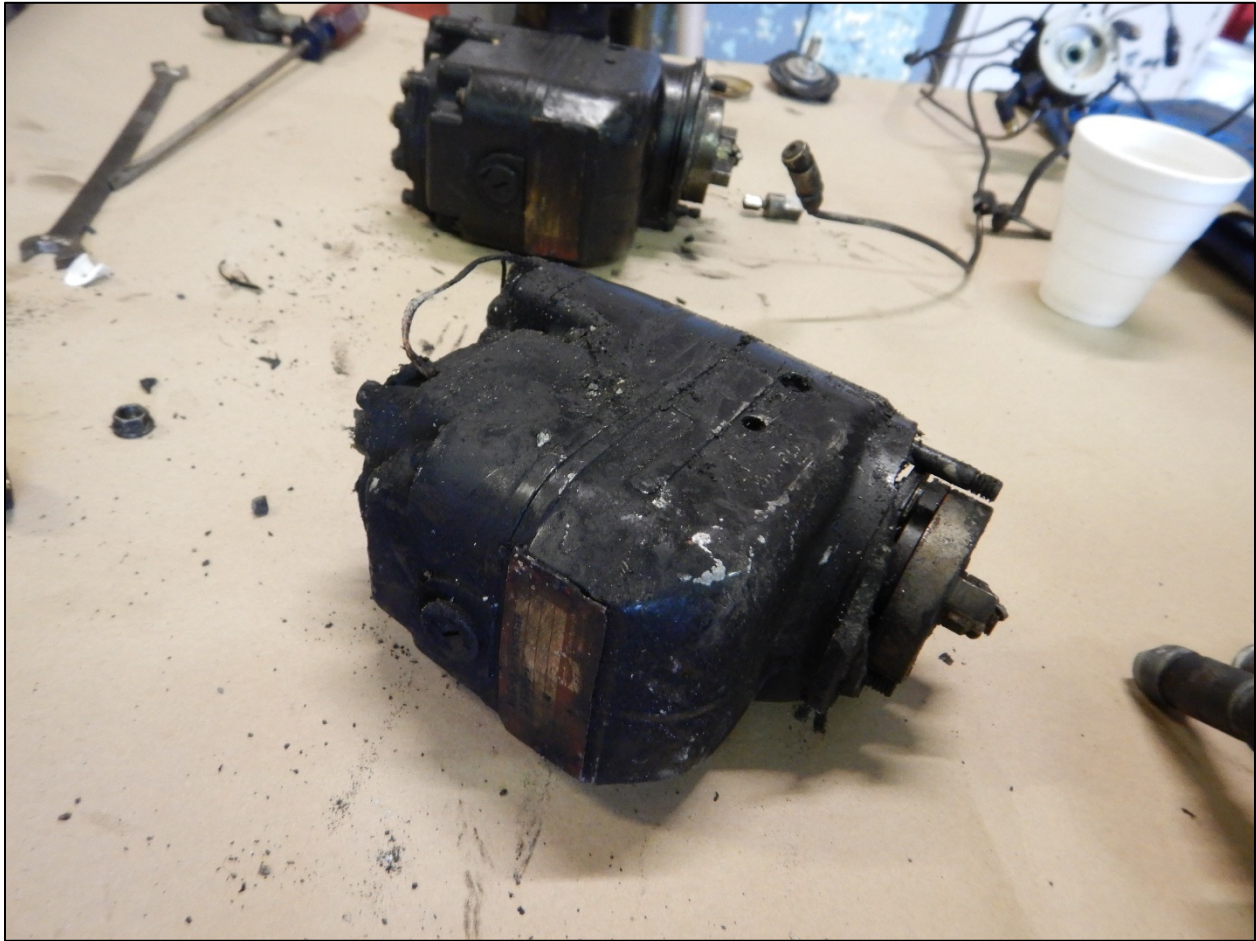
The magneto was removed from the engine and the other magneto was found with the main wreckage. The magneto housings had thermal discoloration and damage at their mounting flanges. The ignition leads were cut near the distributor cap and the magneto drive shafts and impulse couplings rotated freely by hand. Spark was visible at each ignition lead end.

**Figure 6-Magnetos**

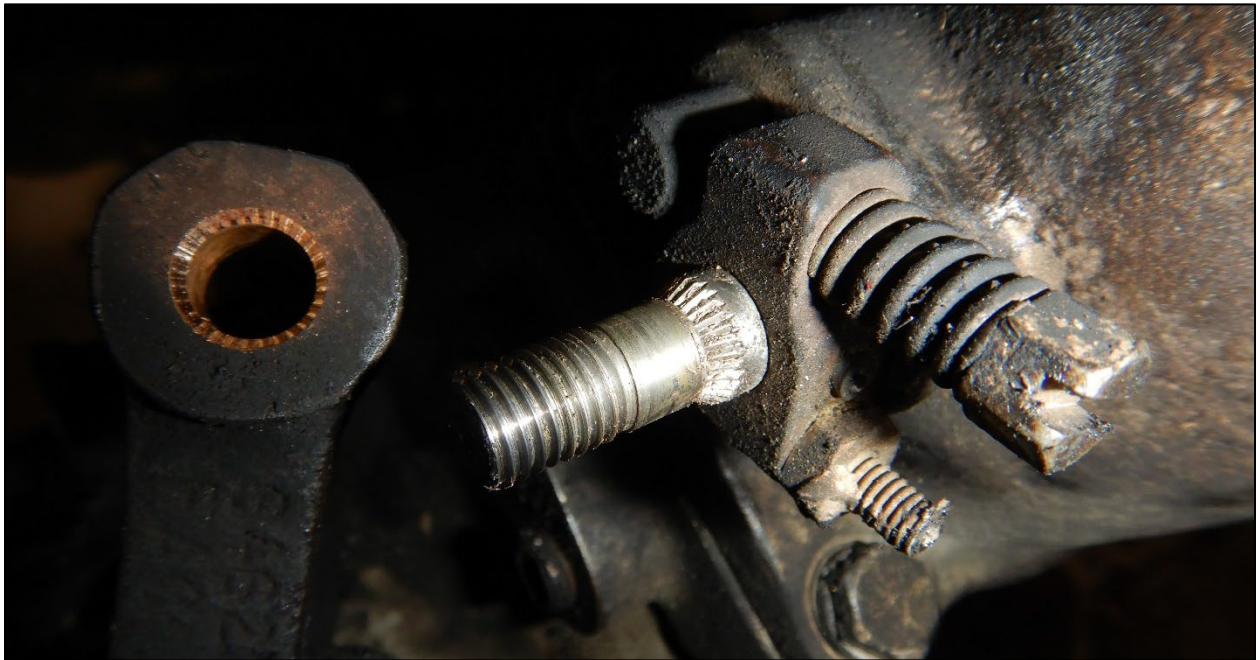
The fuel control valve was disassembled, and internal surfaces showed normal operational signatures. The o-ring attached to the cam unit was undamaged. The throttle linkage arm was undamaged and was loose on the control valve shaft. The throttle linkage arm retaining nut was tight when removed. b material shavings were found at the shaft and the bronze linkage arm mating surface. The bronze linkage arm showed material deformation of the serrated mating surface.

**Figure 7-Fuel control linkage arm and shaft.**

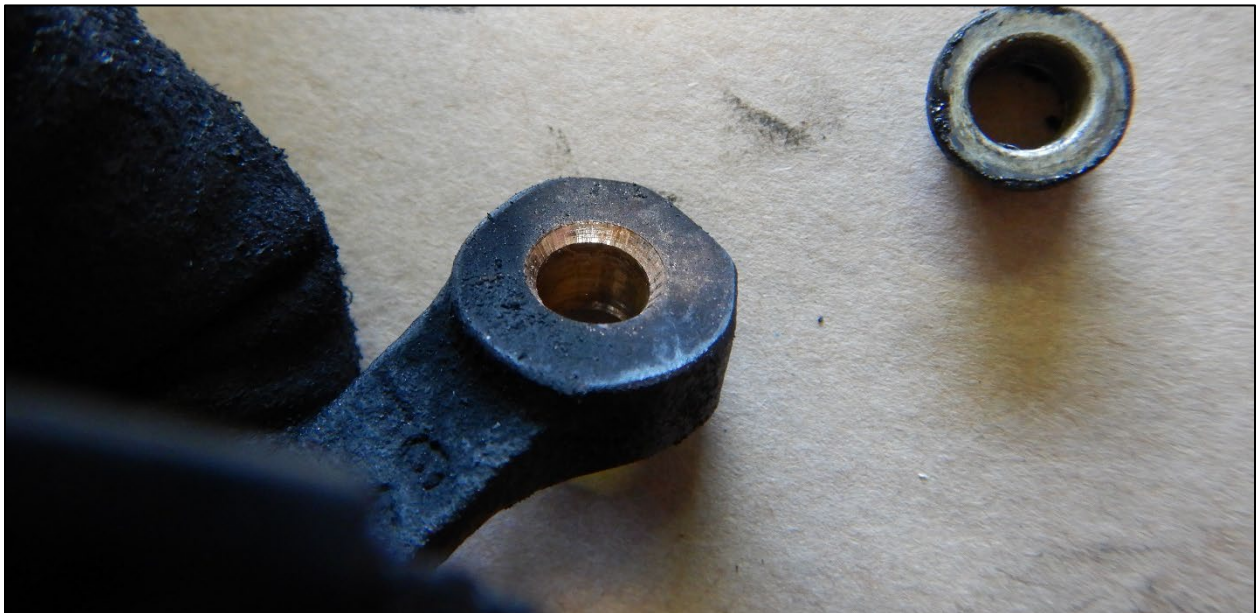
**Figure 8-Fuel linkage arm.**

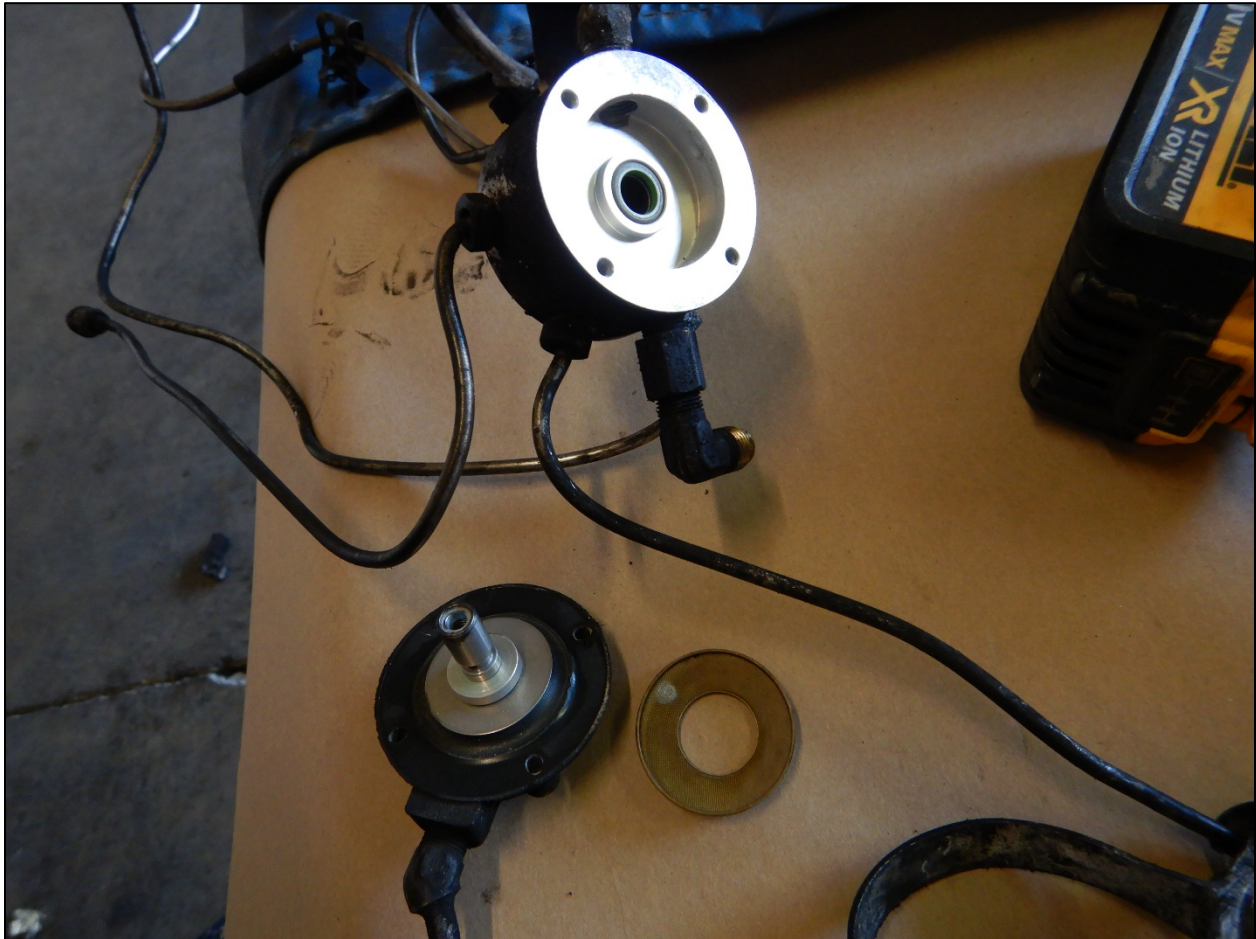
The fuel manifold valve was removed from the engine and disassembled. Fuel was noted in the valve chamber and the screen was clear of debris. The valve diaphragm was undamaged and there were no anomalies noted with the valve.

**Figure 9-Fuel manifold valve.**

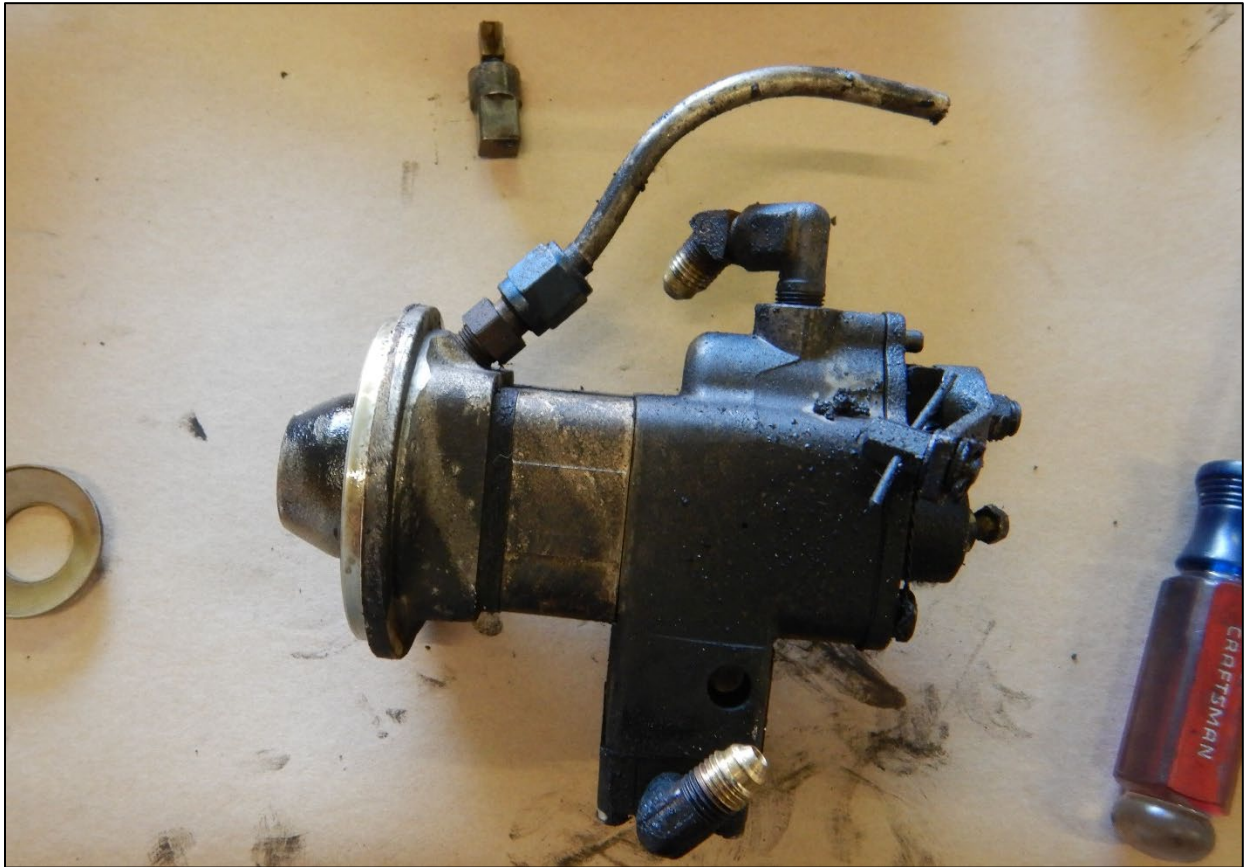
The fuel pump was removed from the accessory section of the engine. The drive coupling was intact and the pump linkage arm was bent. A section of the linkage cable remained attached to the linkage arm.

**Figure 10-Fuel pump.**
