## **NATIONAL TRANSPORTATION SAFETY BOARD**

# **AIRFRAME AND ENGINE EXAMINATION SUMMARY**

**WPR20LA304**

| Aircraft: | N3270R, Cessna 172H |

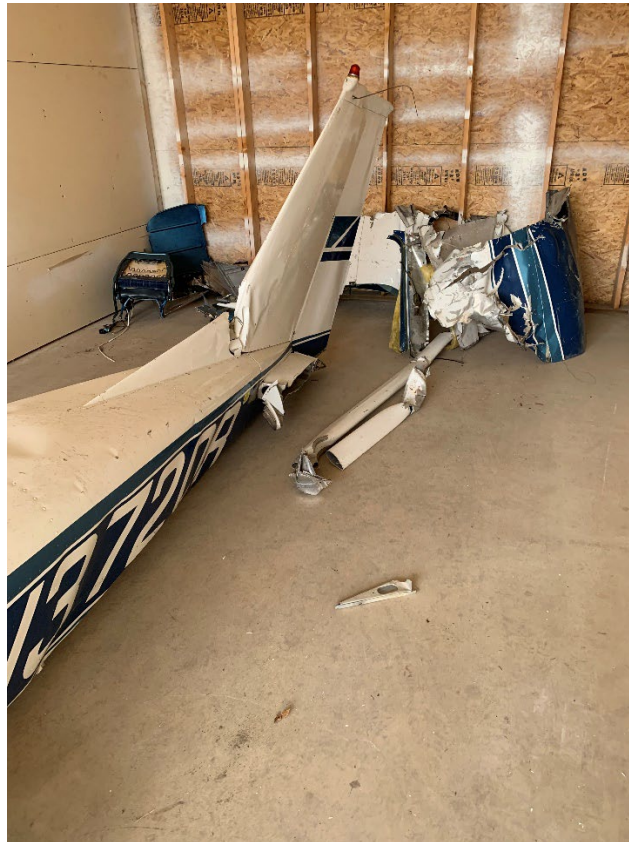
The airframe sustained impact damage to the fuselage and cabin area. The top of the cabin was separated. The left side of the fuselage was bent inward. Impact damage was evident to both wings and the horizontal stabilizers. The horizontal stabilizers and wings were cut during the recovery. The engine and propeller assembly were separated from the main wreckage.

Figure 1-Wreckage layout, rear left side view.

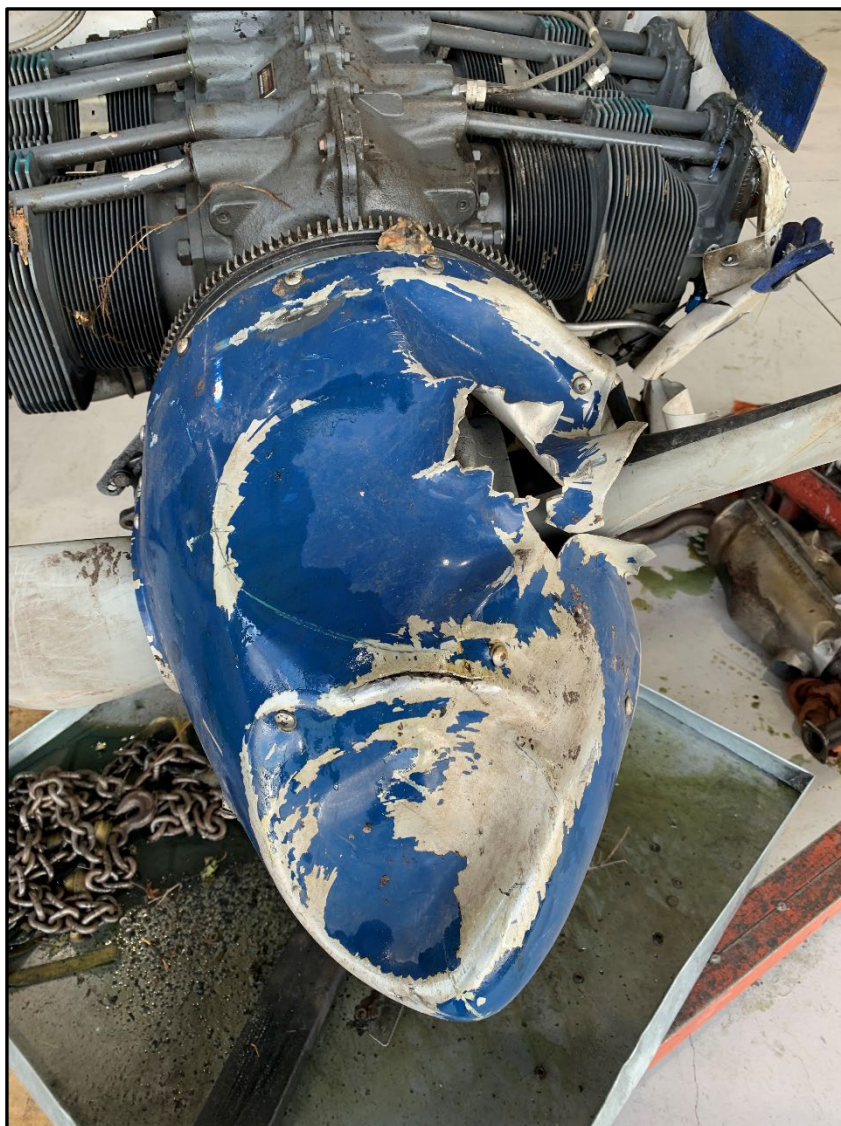
Figure 2: Engine and propeller as viewed from the front.

The engine was separated from the fuselage engine mount assembly and was relatively undamaged except for the bottom portion. No catastrophic damage was noted. The rocker covers were removed, and no evidence of heat distress was observed, and the areas were appropriately lubricated. Internal valve train continuity was established by hand rotation of the propeller valve train. Thumb compression was observed on all cylinders in proper firing order. The spark plugs were removed, and electrodes were undamaged and exhibited coloration consistent with normal wear.

The propeller remained attached to the engine. One blade had a slight aft twist about 3/4 the length of the blade. The other blade was bent aft and twisted near the tip. Both blades exhibited chordwise scoring and leading edge gouges. The spinner dome was crushed with torsional deformation.
