## WPR20LA304 Propeller Damage Observations Rev. A

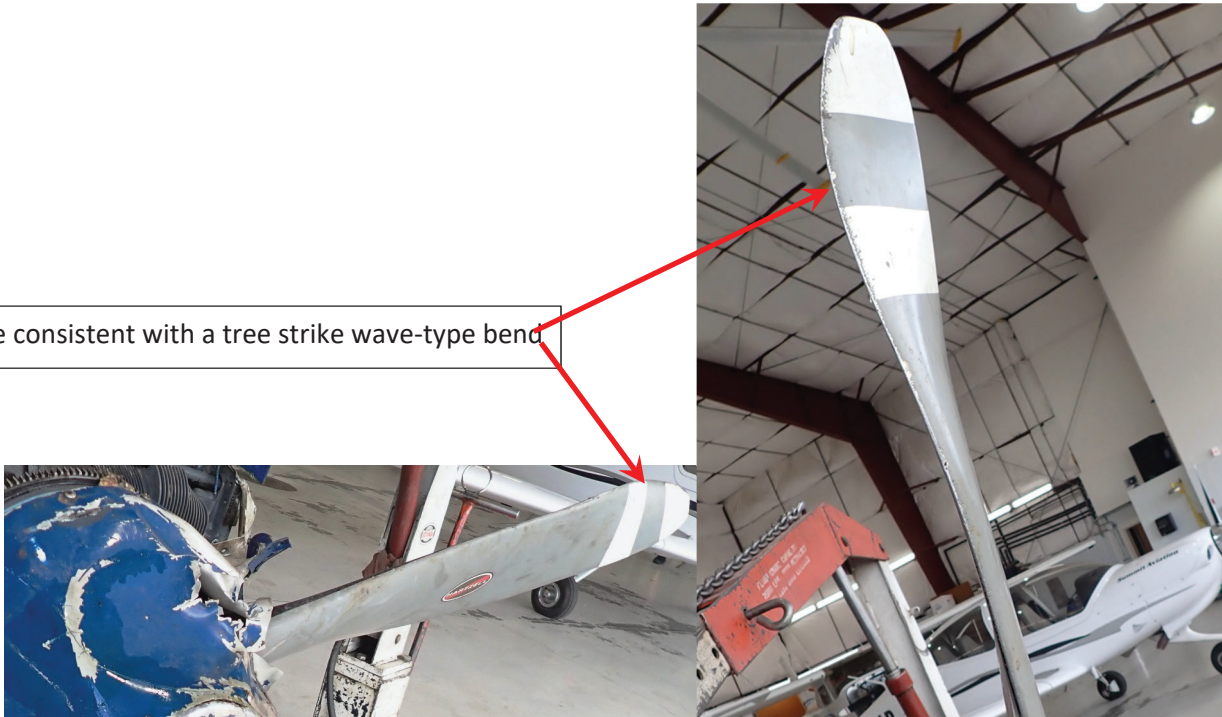
Damage consistent with a tree strike wave-type bend

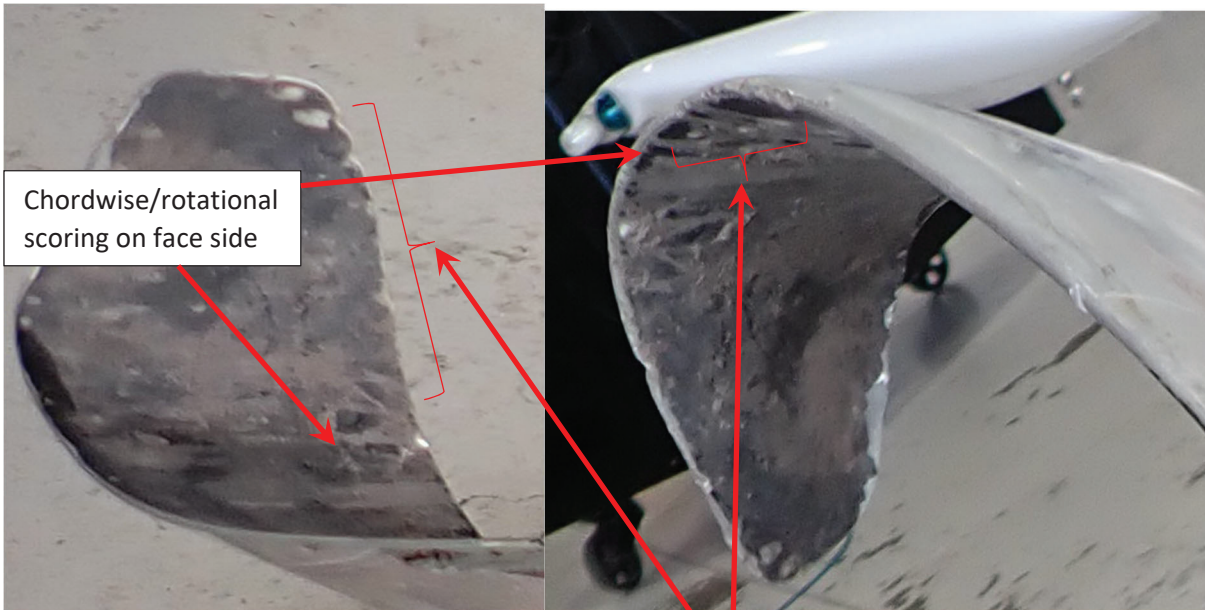
Chordwise/rotational  
scoring on face side

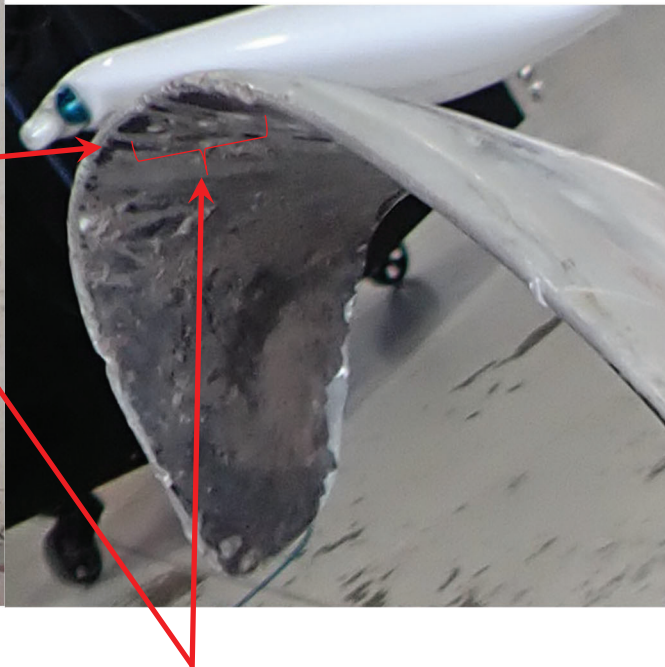
Leading edge gouges with material  
deformation suggesting near-zero  
angle of attack

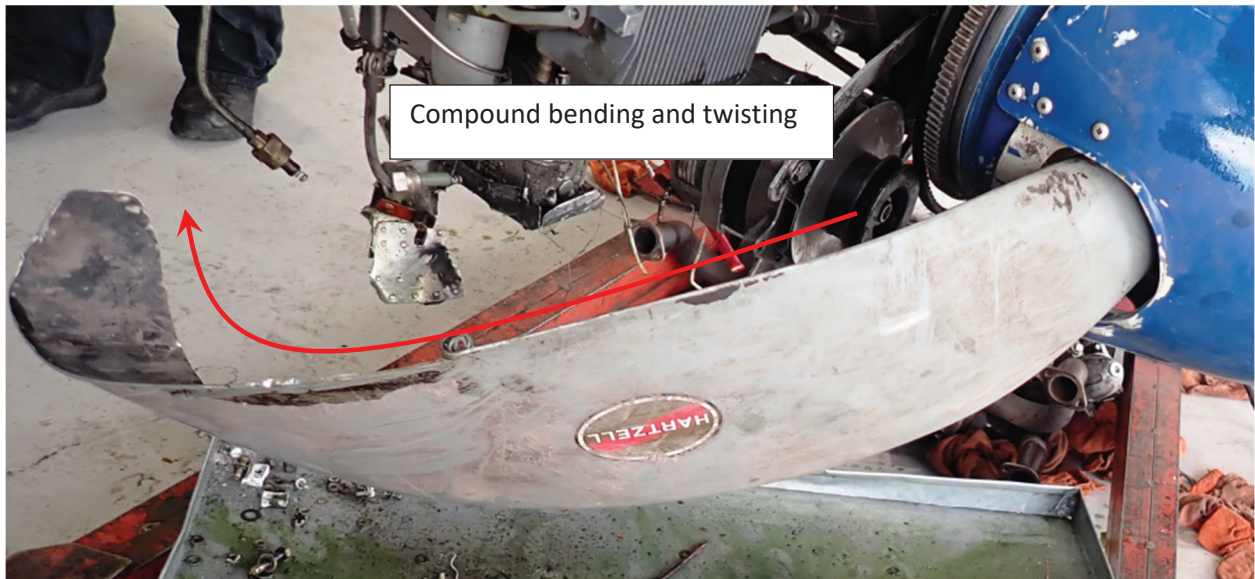
Compound bending and twisting
