## **NATIONAL TRANSPORTATION SAFETY BOARD**

# **AIRFRAME EXAMINATION SUMMARY REPORT**

**WPR20LA308**

Location: Billings, CA  
Date: September 12, 2020  
Aircraft: N7602Y  
NTSB IIC: Samantha Link

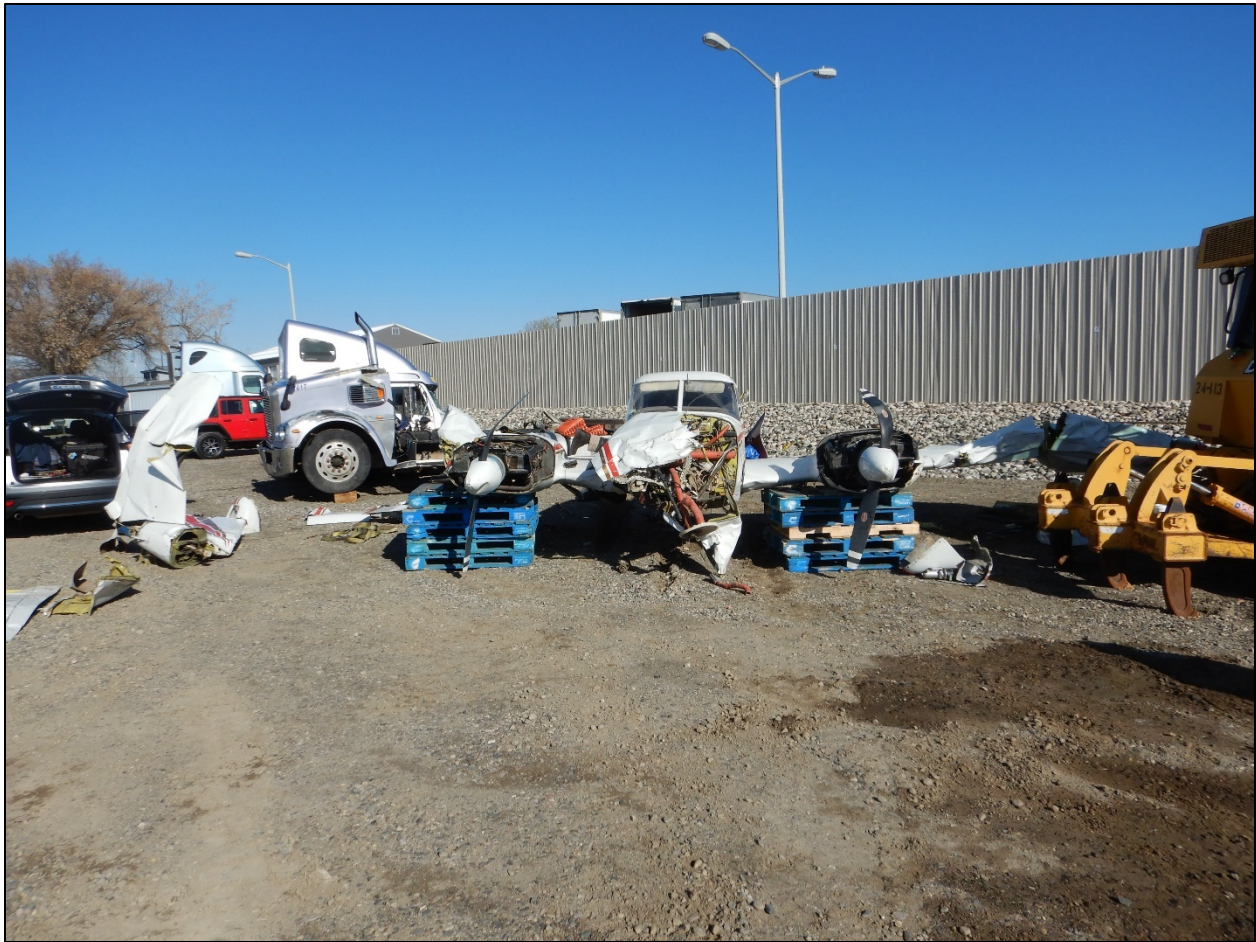
The airplane was positioned on pallets during the examination. The empennage, aft fuselage, right outboard wing and sections of the forward fuselage separated from the main wreckage. The empennage was separated, and flight control cables were cut during the wreckage recovery process. The left wing had impact damage and was folded over the top of the midsection of the wing. The cabin entry door was not attached to the cabin and the windshield was broken. The main landing gear had impact damage and remained loosely attached. The engines remained attached to their engine mounts and were secured to the wing structure. The cowlings remained attached and secured. The propeller assemblies including the spinners had impact damage.

**Figure 1-Main wreckage positioned during the examination.**

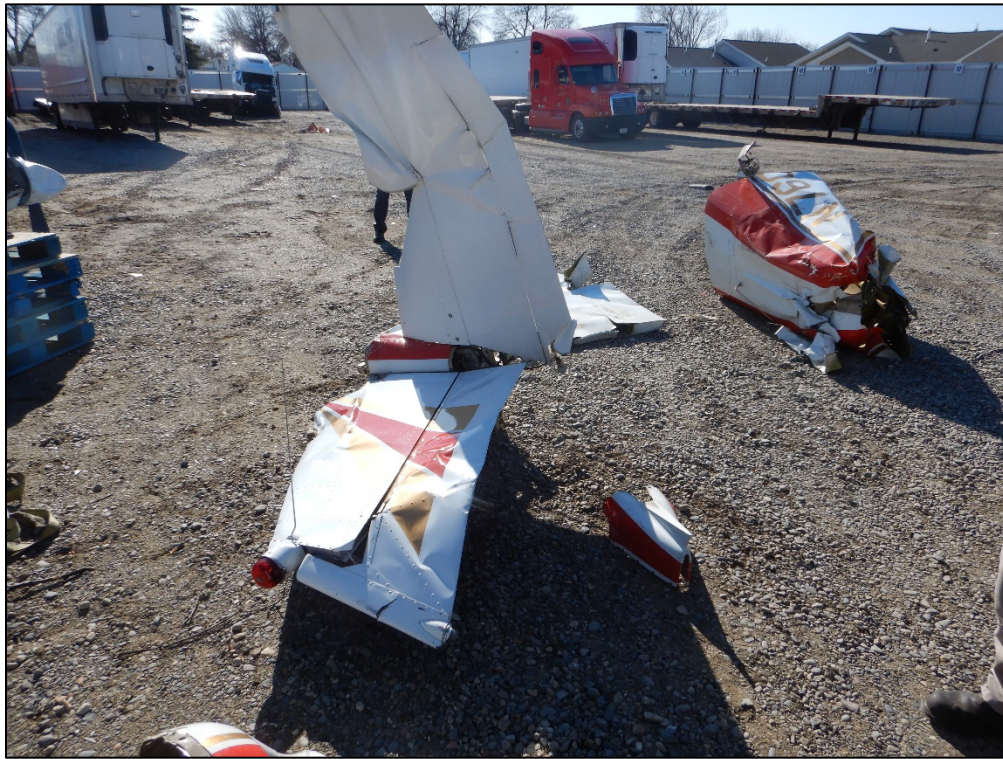
Flight control cable continuity was obtained from the rudder and elevators to the cabin controls. The rudder and elevator cables were cut during the wreckage recovery process. Flight control cable continuity was obtained from the left aileron to the cabin controls. Flight control cable continuity was obtained from the right aileron through tension overload separations, to the cabin controls. The flaps were found in the retracted position.

Figure 2-Empennage and aft fuselage.

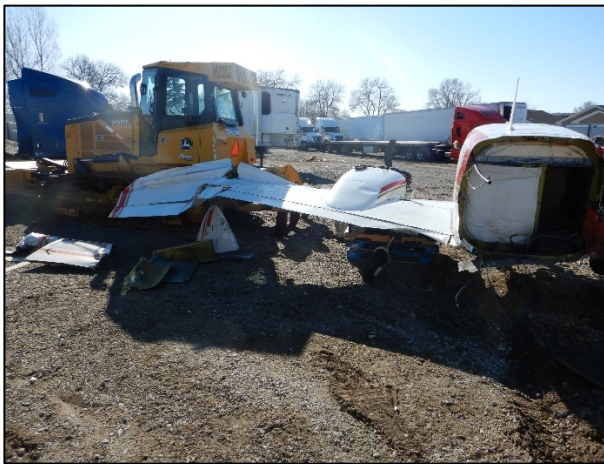
Figure 3-Left wing.

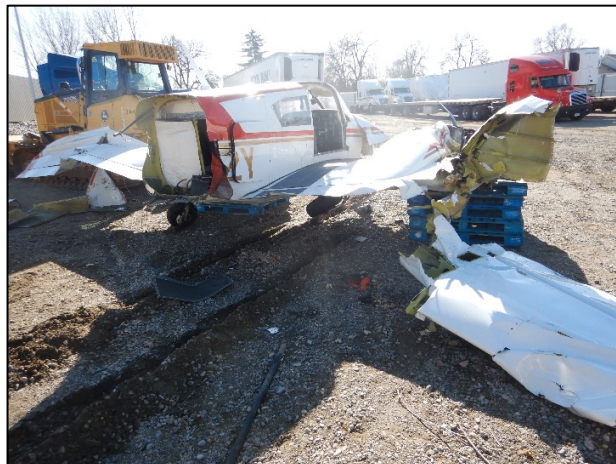
Figure 4-Right wing.

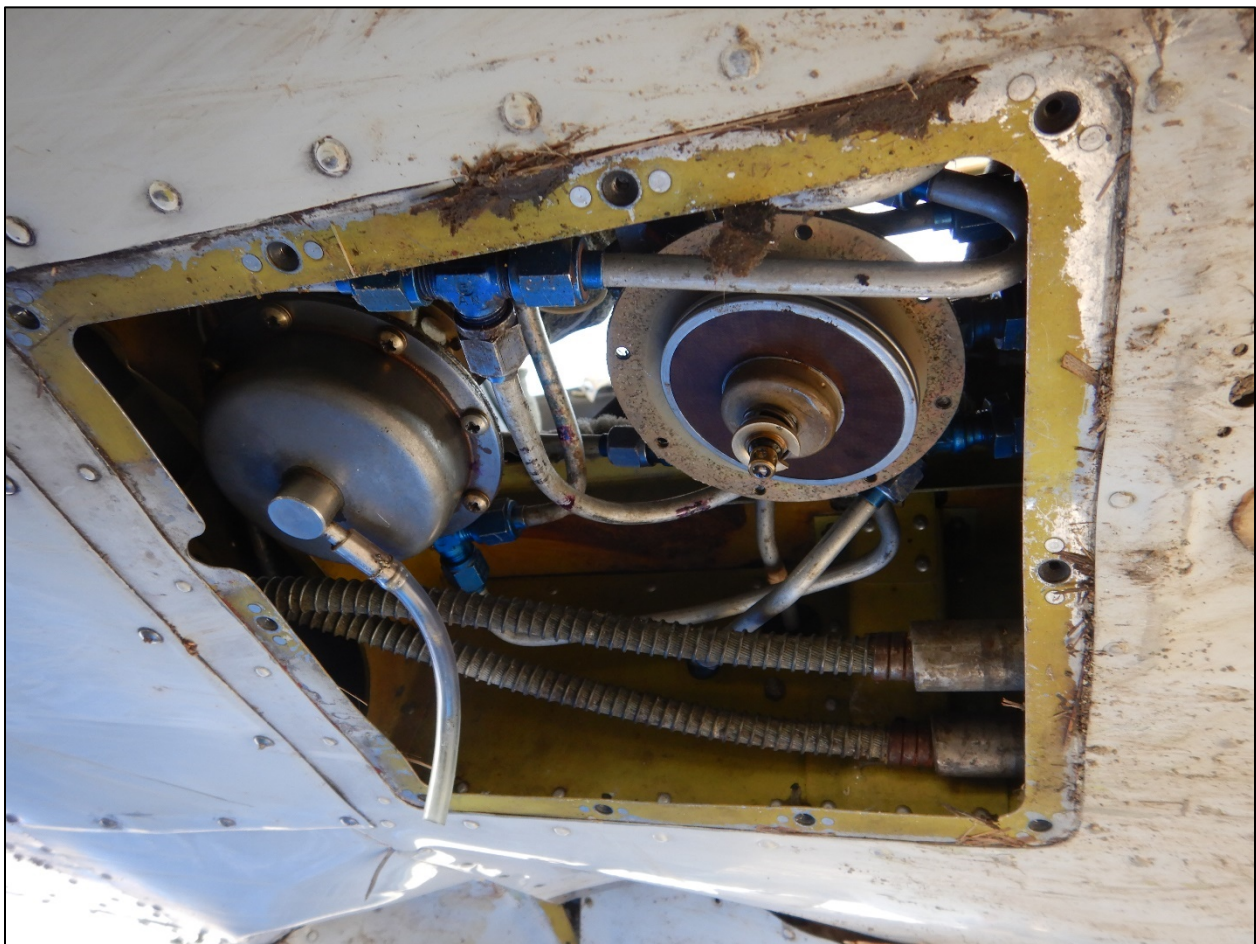
The right-wing outboard tank cap was found loose in the filler neck. The cap was removed, and the lever arm worked normally. The cap seal was pliable and undamaged. The tank bladder was not in its inboard bay area and was breached. The right-wing inboard, left-wing inboard, and left-wing outboard tank caps were loose in their filler necks and removed. The cap seals were pliable and undamaged. The tank bladders were empty. The fuel strainers were drained, and a small amount of uncontaminated fuel exited. The strainer bowls were removed, and no anomalies were noted. The fuel selector valve handles were undamaged. The selector valve handles moved freely by hand and detents were normal. The auxiliary pumps would not operate when the switches were positioned to 'ON.' The aircraft structure near the auxiliary pumps was pushed aft into the pump's location. The pumps were unable to be removed due to airframe deformation.

Figure 5: Fuel Strainers

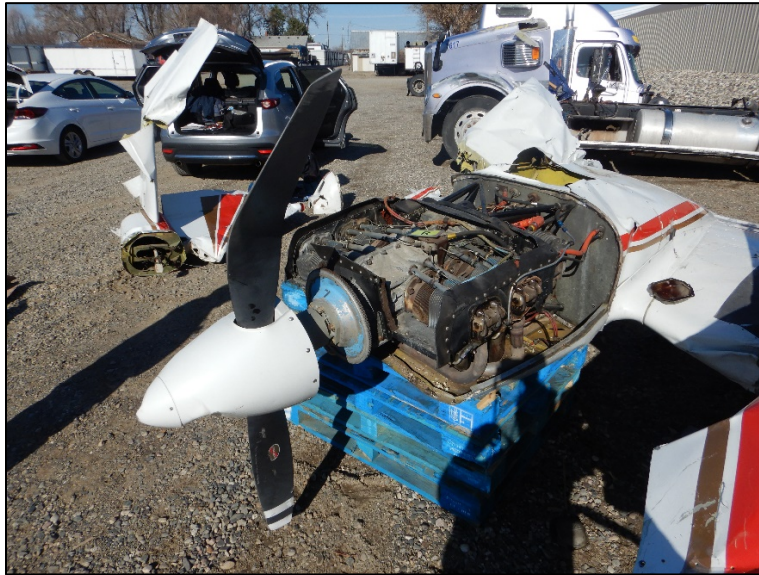
The upper engine and nose cowling were removed from the right engine. The right engine was undamaged and contained about 7 quarts of oil. There was no damage to the accessory section of the engine. The upper spark plugs were removed and the finewire electrode areas had light grey deposits and normal wear conditions. The cylinder rocker covers were removed, and the overhead components were undamaged and lubricated with a light brown oil. The crankshaft was rotated by hand from the propeller assembly and thumb compression was attained from each cylinder. During the crankshaft rotation, normal cylinder overhead valve movement was noted during the crankshaft rotation. Also, the magneto impulse couplings engaged, and spark was obtained from each of the ignition lead ends. The left and right engine magneto switches (4) on the instrument panel were switched to the 'ON' position prior to the magneto operational check.

Figure 6-Right Engine

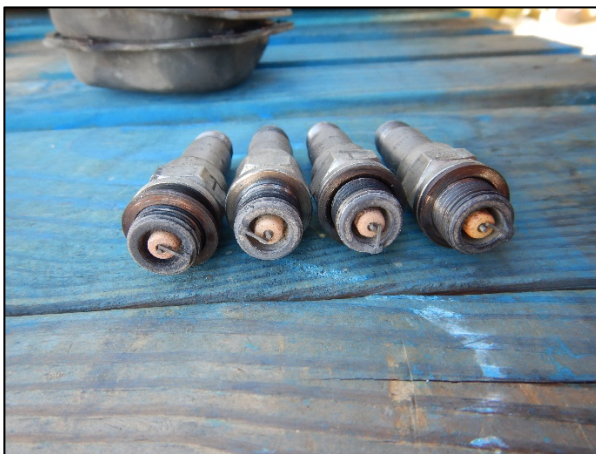
Figure 7-Right engine upper sparkplugs.

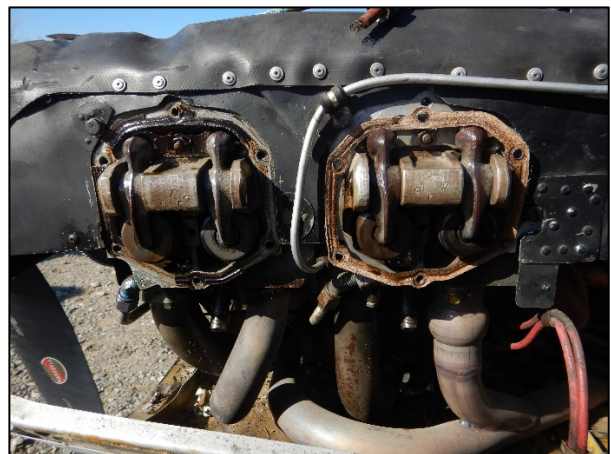
Figure 8-Right engine cylinder overhead.

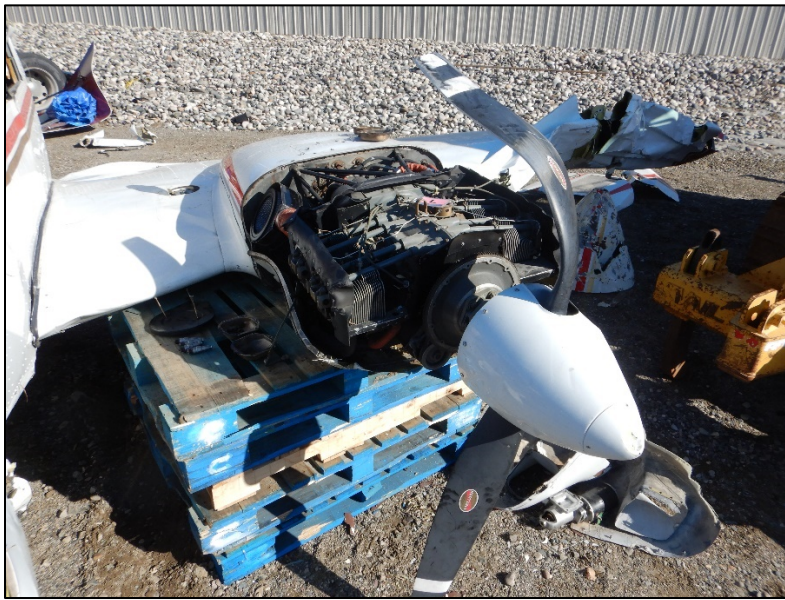
The upper engine and nose cowling were removed from the left engine. The left engine was undamaged and contained about 7 quarts of oil. There was no damage to the accessory section of the engine. The upper spark plugs were removed and the finewire electrode areas had light grey deposits and normal wear conditions. The cylinder rocker covers were removed, and the overhead components were undamaged and lubricated with a light brown oil. The crankshaft was rotated by hand from the propeller assembly and thumb compression was attained from each cylinder. During the crankshaft rotation, normal cylinder overhead valve movement was noted during the crankshaft rotation. Also, the magneto impulse couplings engaged and spark was obtained from each of the ignition lead ends. The left and right engine magneto switches (4) on the instrument panel were switched to the 'ON' position prior to the magneto operational check.

Figure 9-Left Engine

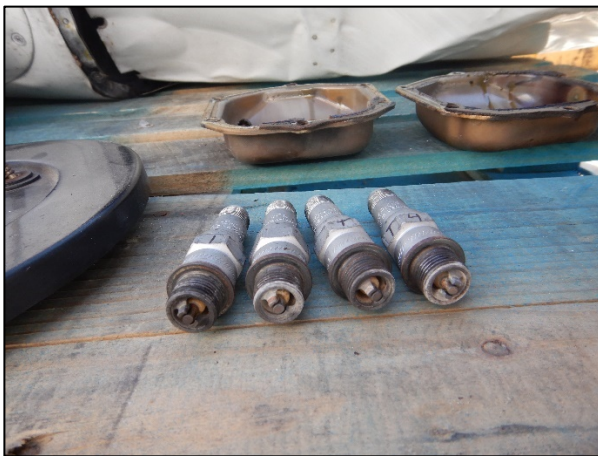
Figure 10-Left engine upper sparkplugs.

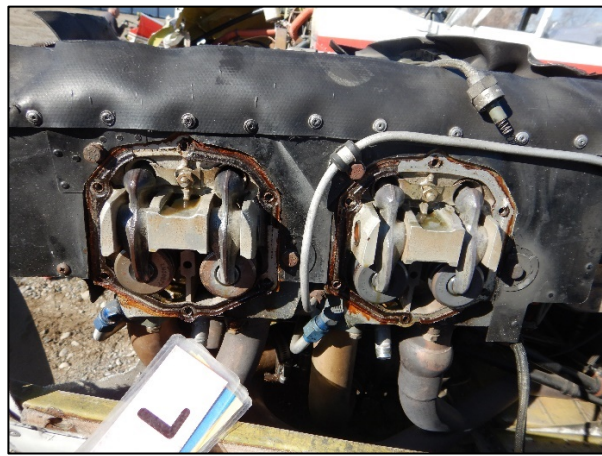
Figure 11-Left engine cylinder overhead.

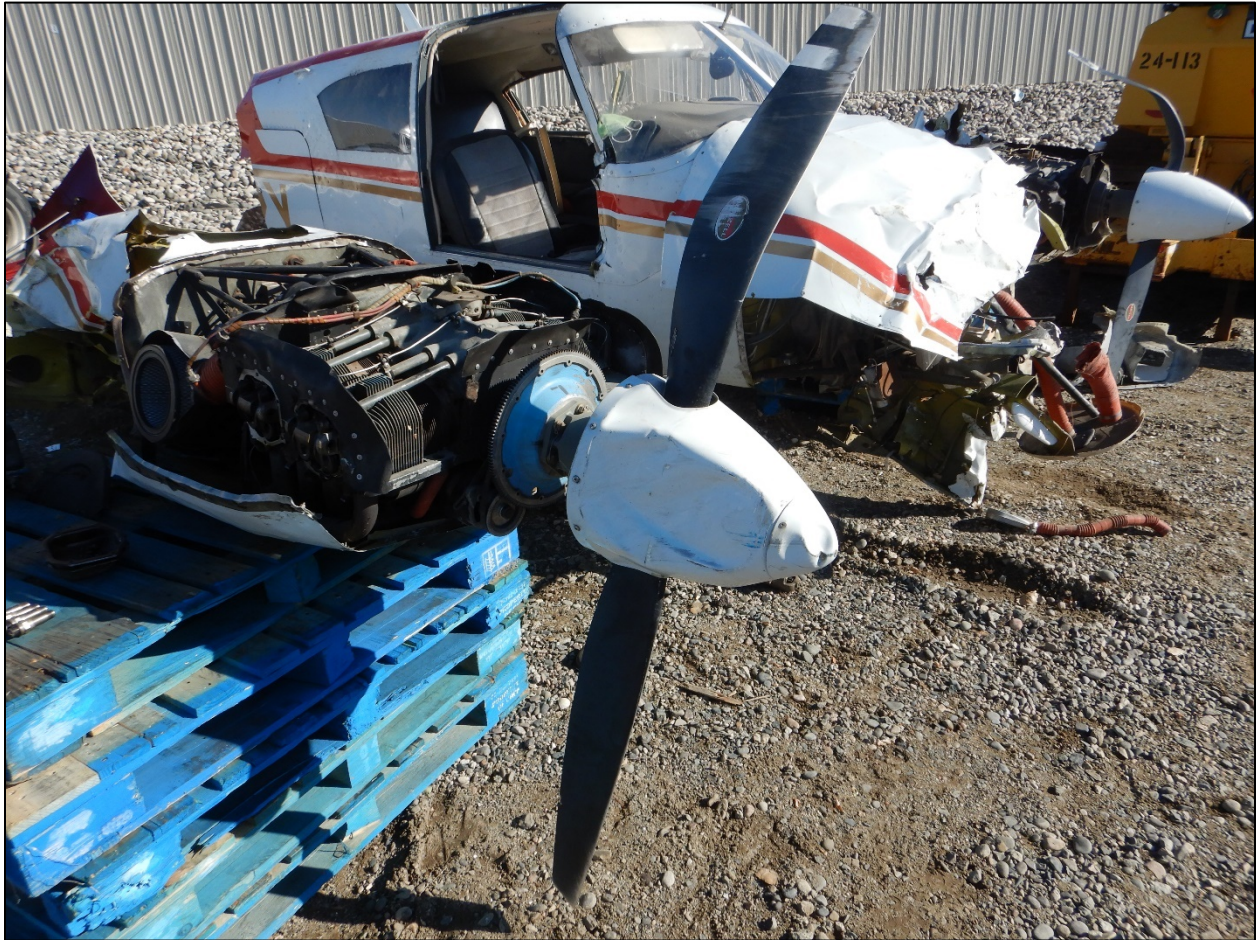
The propeller assemblies remained attached to each engine and were not removed during the examination. The right propeller assembly was found in the feathered position and one blade was bent near its midsection. The bent blade had multidirectional scuffing near its leading edge. The other blade was damaged consistent with the relocation of the wreckage. The spinner had impact damage to one side.

Figure 12-Right propeller assembly.

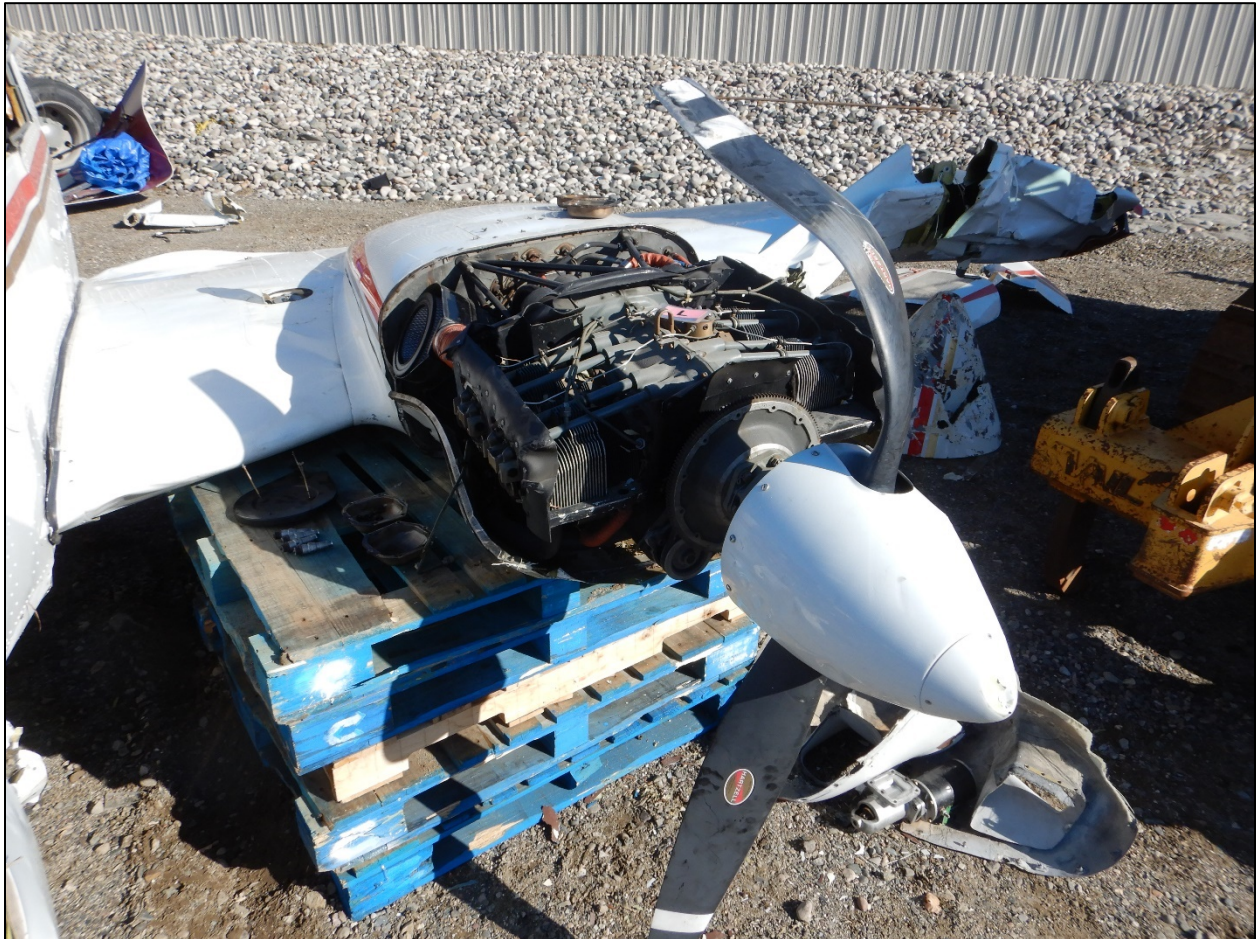
The left propeller blade assembly was found in the low pitch position and one blade was bent aft near the shank. The bent blade was scuffed on its cambered side and near the leading edge. The other blade was unremarkable.

Figure 13-Left propeller assembly.
