Nicholas Coutches  
N7946C  
9/19/20 narrative

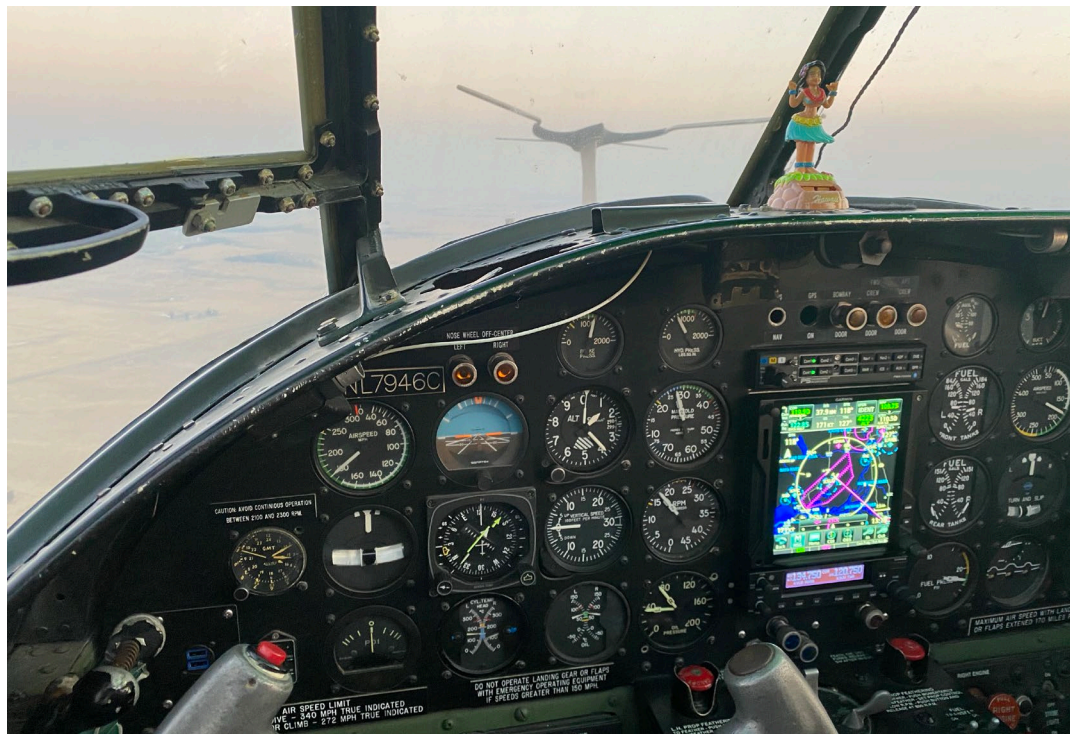
On September 19th, 2020 following the aircraft's arrival from Chino to the Nut Tree, I boarded the aircraft to act as SIC. I questioned the PIC, Mr. Ramey about the fuel load on the aircraft, which he calculated to be in excess of 200 gallons, which was more than enough for our 20 minute flight to Stockton. This was also shown on the fuel gauge, of which I have attached a picture. Startup, taxi, run up, take off, and climb were all normal.

In flight picture of fuel gauges
