## SUMMARY OF FINDINGS

**Person Contacted: Casey Love, Textron Aviation**

**NTSB Accident Number: WPR20LA319**

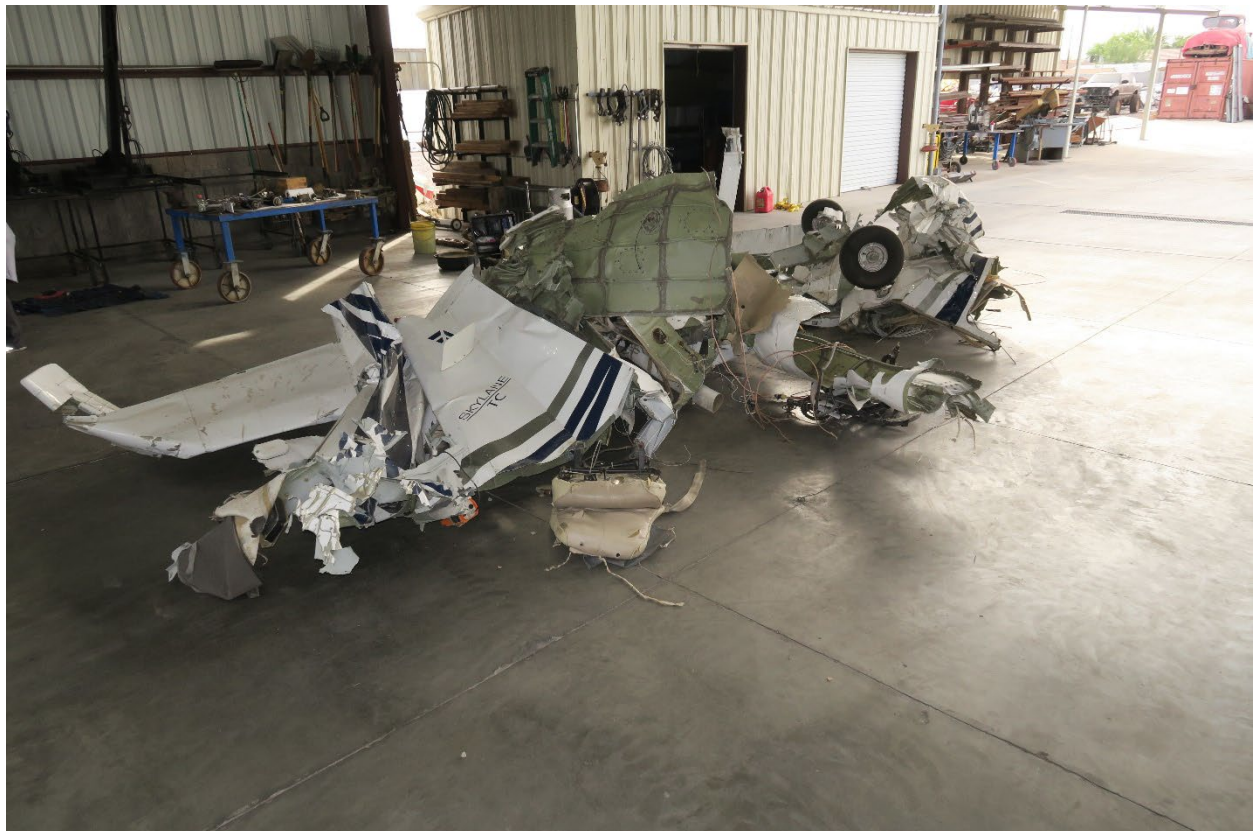
Photo 1 - Wreckage Layout

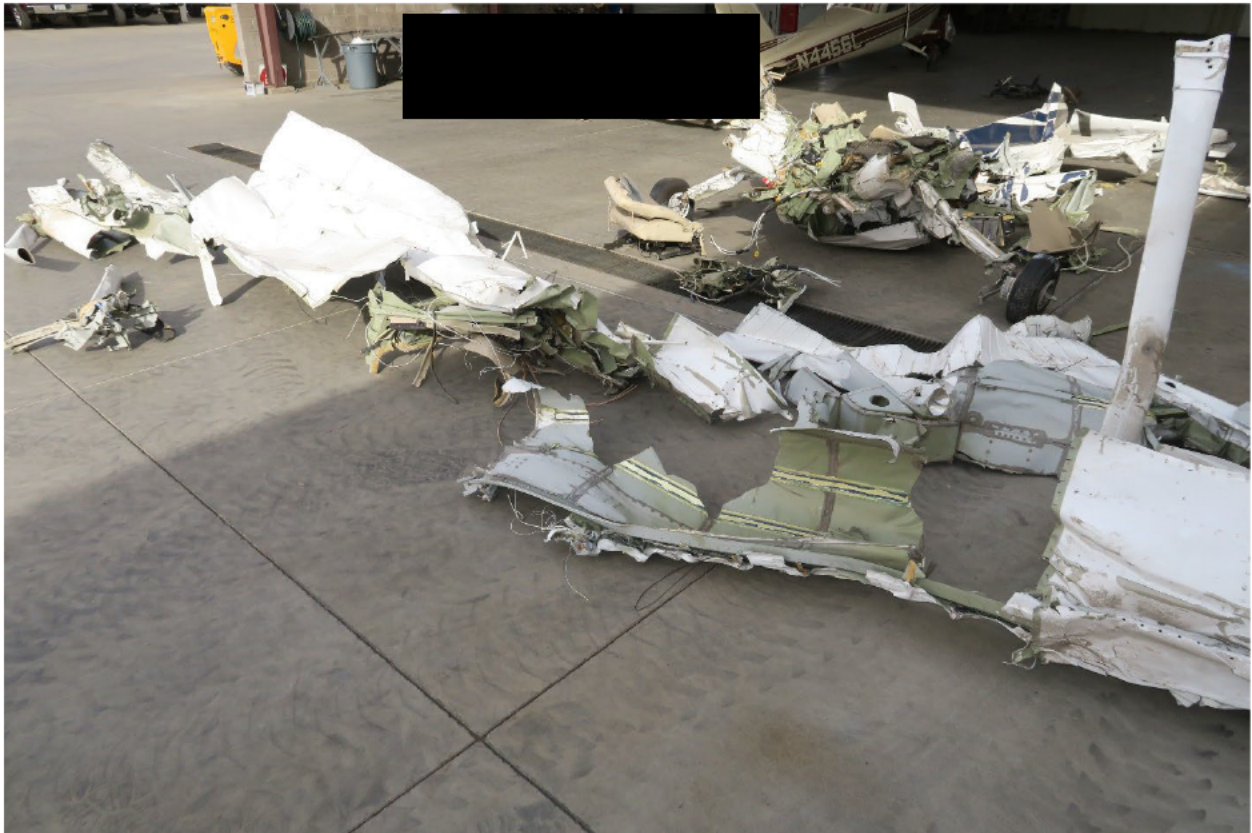
Photo 2 - Main Wreckage

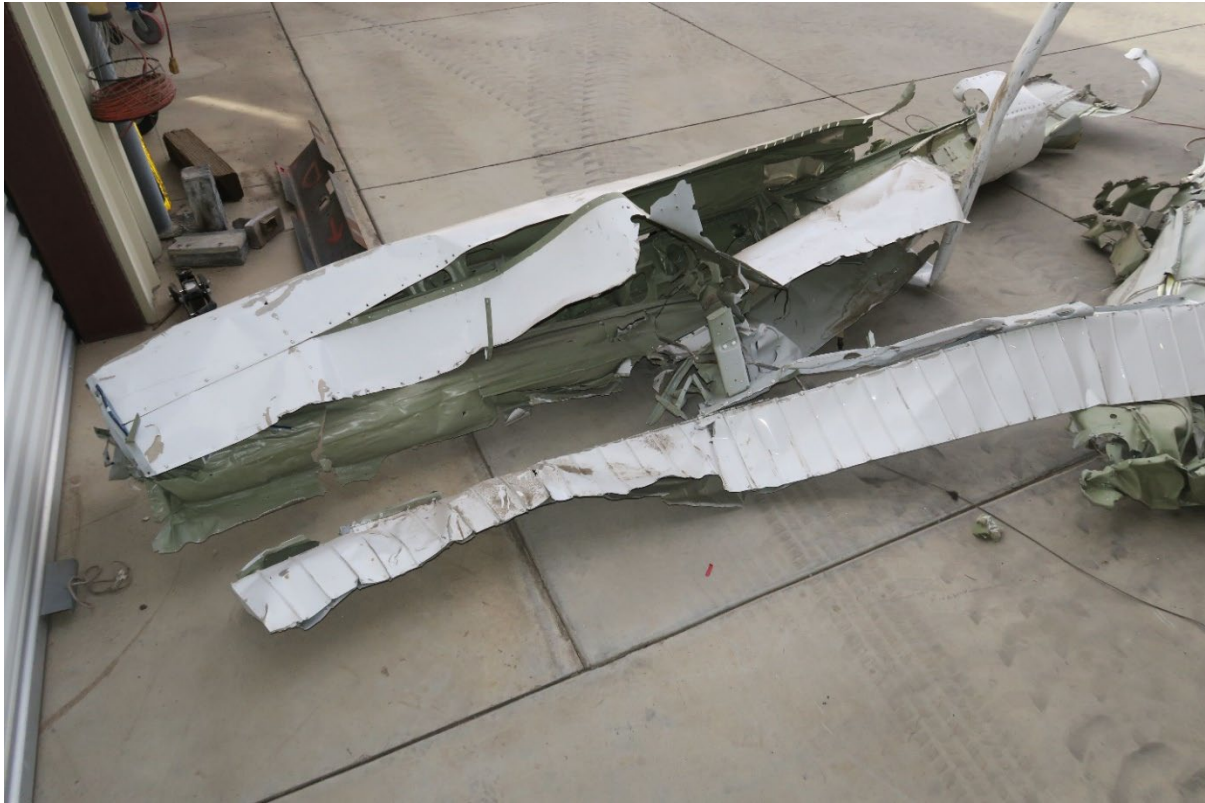
The wings were fracture separated at the wing attach fittings. Each wing was fragmented. The ailerons remained attached to the wing spar attach points.

Photo 3 - Left Wing

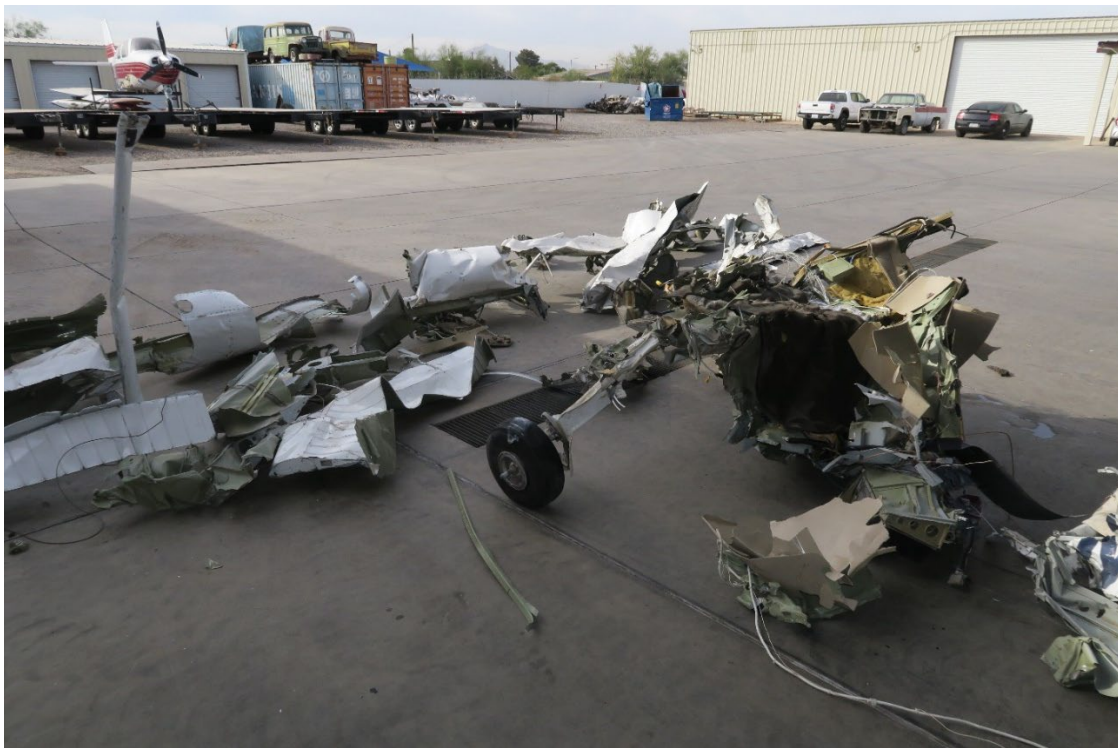
Photo 4 - View of the left side of the wreckage

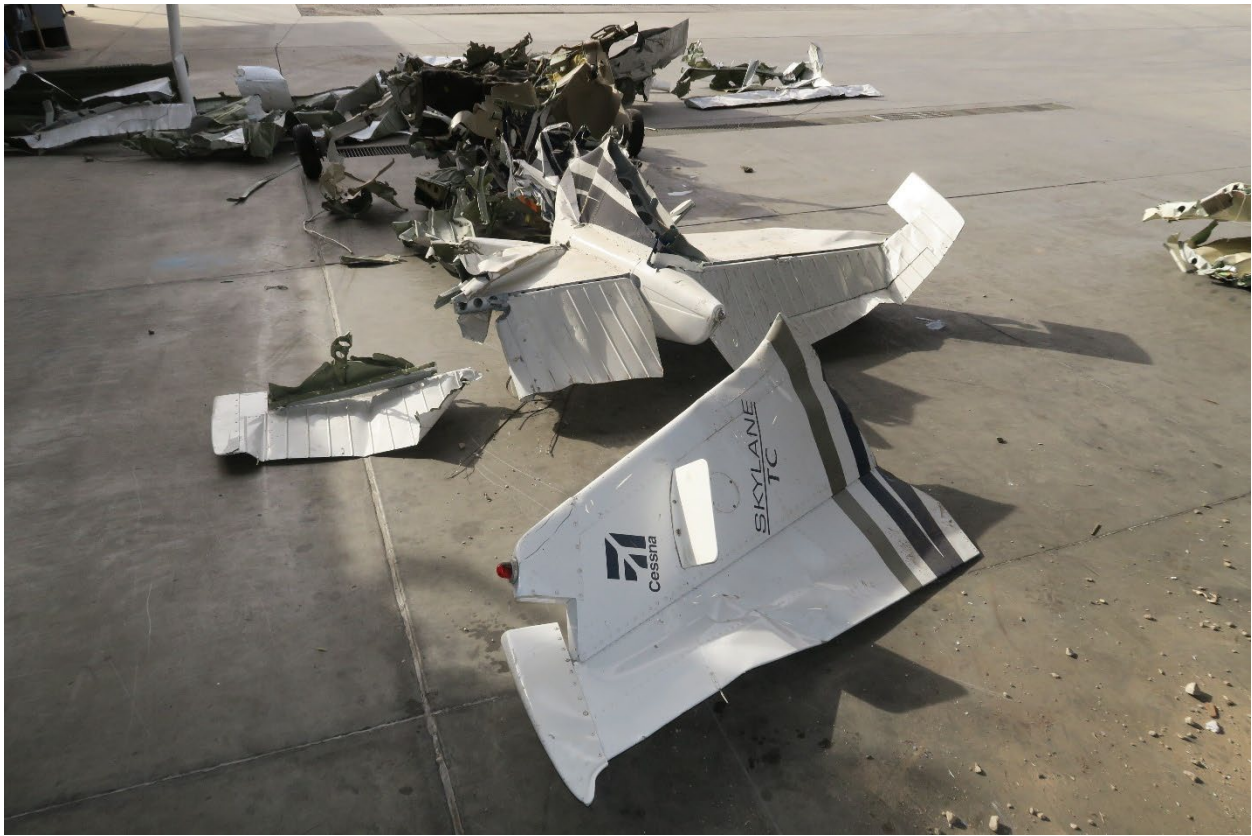
Photo 5 - Rear view of Airplane
