# National Transportation Safety Board

WPR20LA319

## **AIR TRAFFIC CONTROL**

Specialist's Factual Report

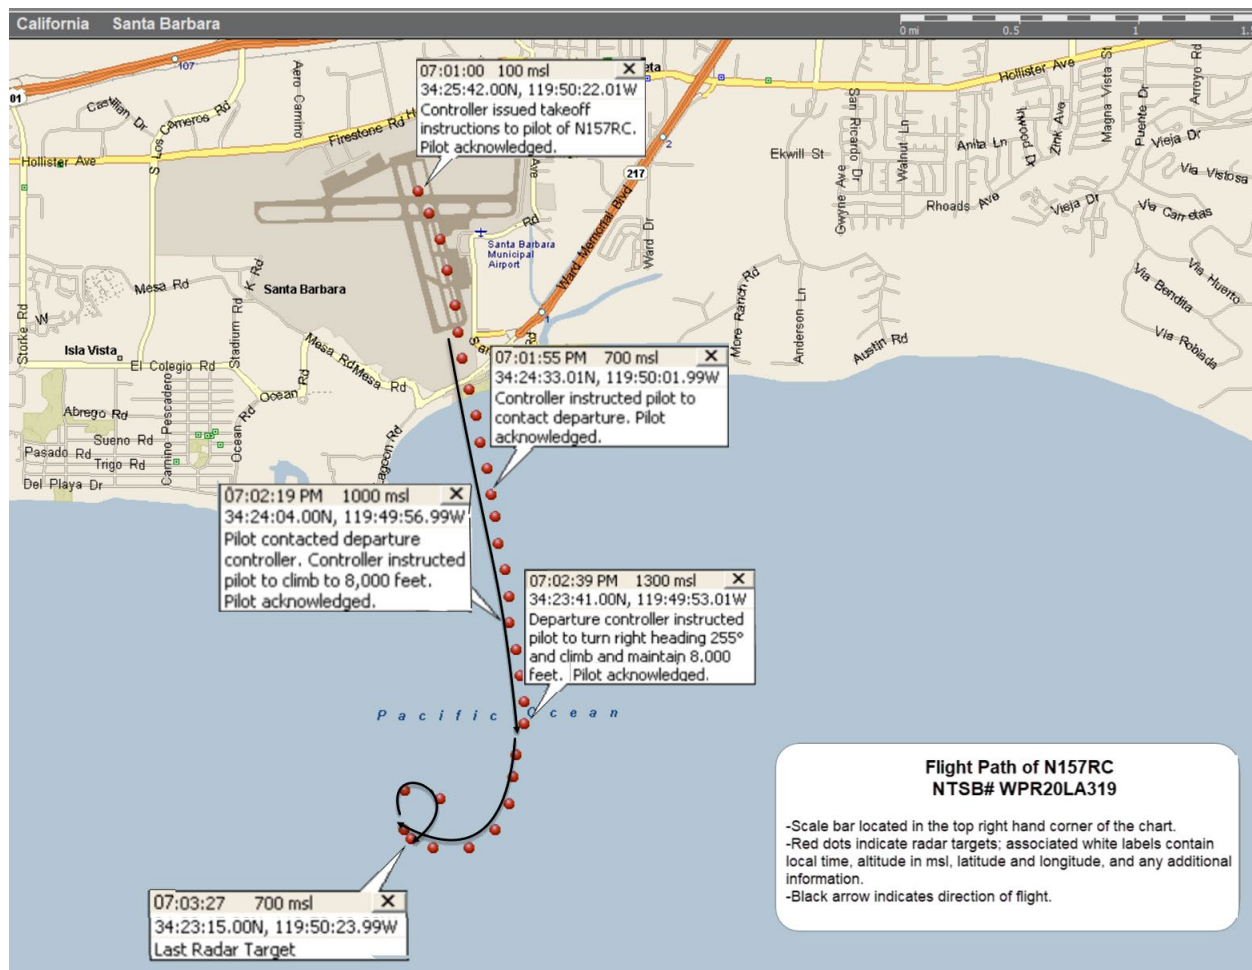
Figure 1 is a screen capture<sup>5</sup> that illustrates the flight path of N157RC from the time the local controller issued takeoff instructions until the last radar target was recorded. Pertinent flight information and pilot/controller communications are included in the white boxes.

Figure 1. Screen capture illustrates N517RC's flight path and pertinent pilot/controller communications.
