## **NATIONAL TRANSPORTATION SAFETY BOARD**

# **AIRFRAME AND ENGINE EXAMINATION**

**WPR19LA320**

Location: Montgomery Gibbs Executive, San Diego, CA  
Accident Date: 9/24/2020  
Aircraft: Great Lakes 2T-1A-2 N3617L  
NTSB IIC: James Bledsoe

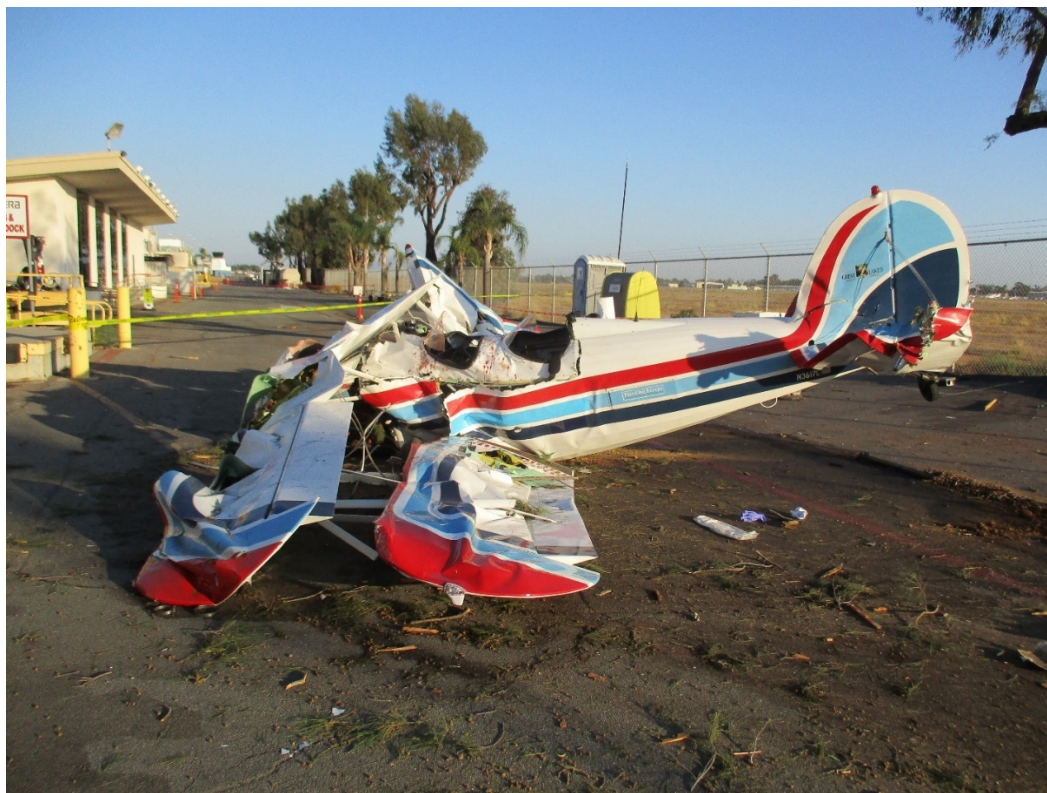
Figure 2 - Photo 2 of 11, N3617L Left Side, courtesy of Airport Ops

LEFT WING. The left wings suffered significant impact damage with deformation to upper and lower wings. All major components from each wing were located on site.

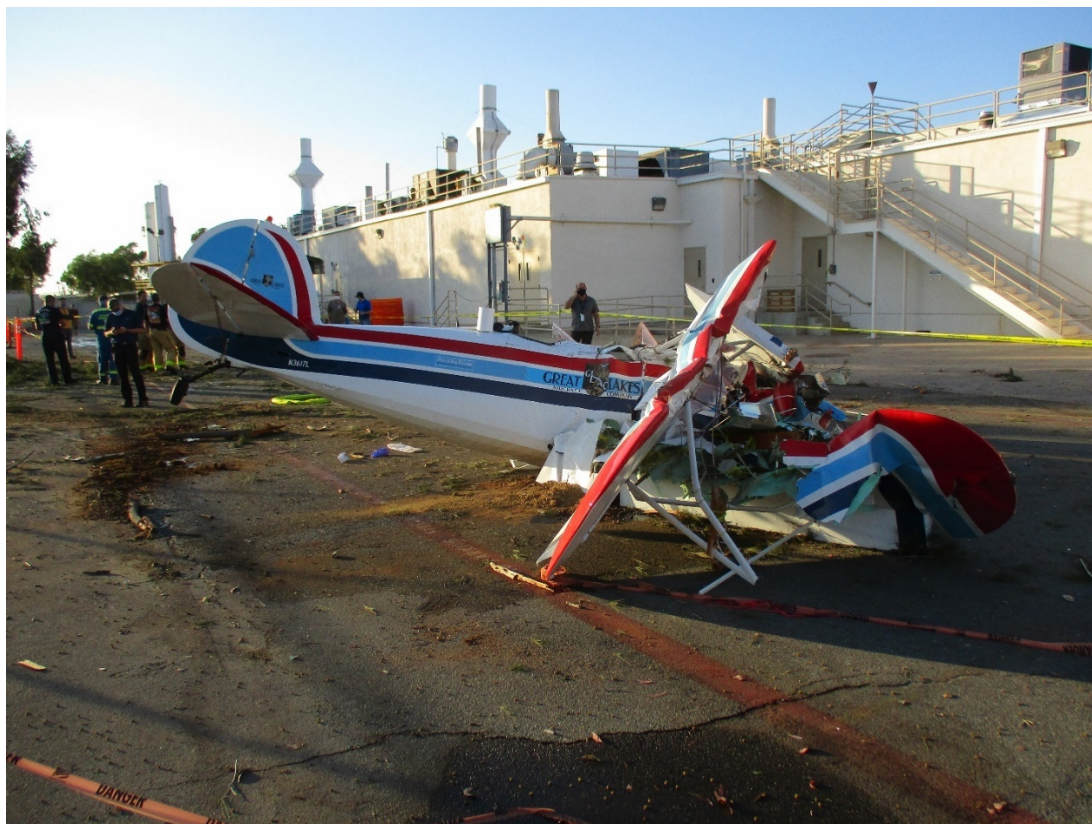
Figure 4 - Photo 4 of 11 N3617L Right Side, courtesy of Airport Ops

RIGHT WING. The biplane wings received significant damage especially to the lower wings. The right upper wing separated and folded up and over on top of the lower wing. All major components from each wing were located on site.

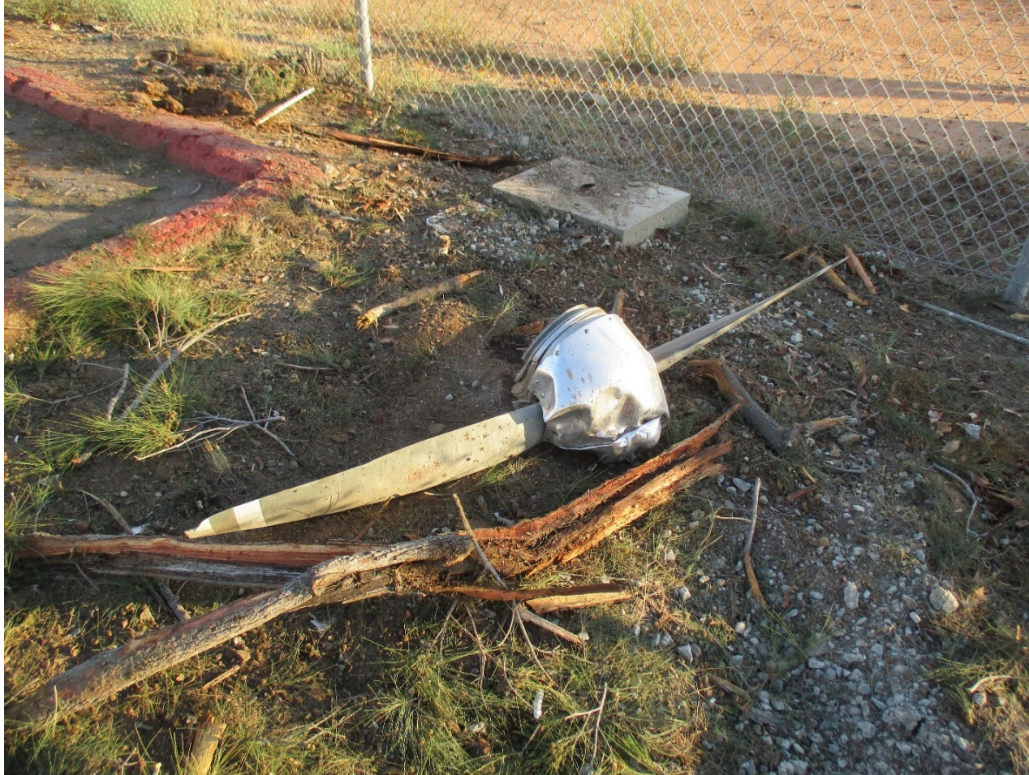
Figure 5 - Photo 5 of 11, N3617L Propellor, courtesy of Airport Ops

PROPELLOR. It was found that the propeller struck a hard surface almost directly center of the nose cone and separated from the crankshaft of the engine. The separation from the crankshaft

occurred approximately one-inch rear of the propeller flange radius and approximately one-half inch forward of the front face slinger radius parallel to the nose seal. The propeller governor tested favorably although the shaft adaptor was broken from impact.

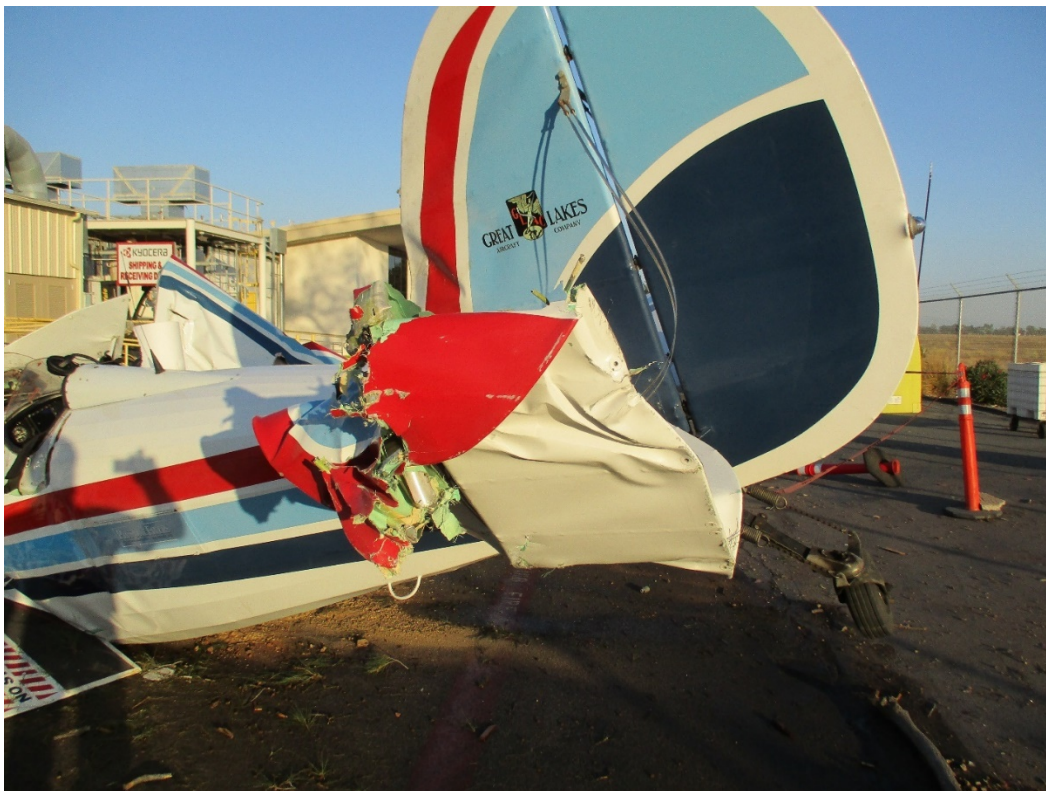
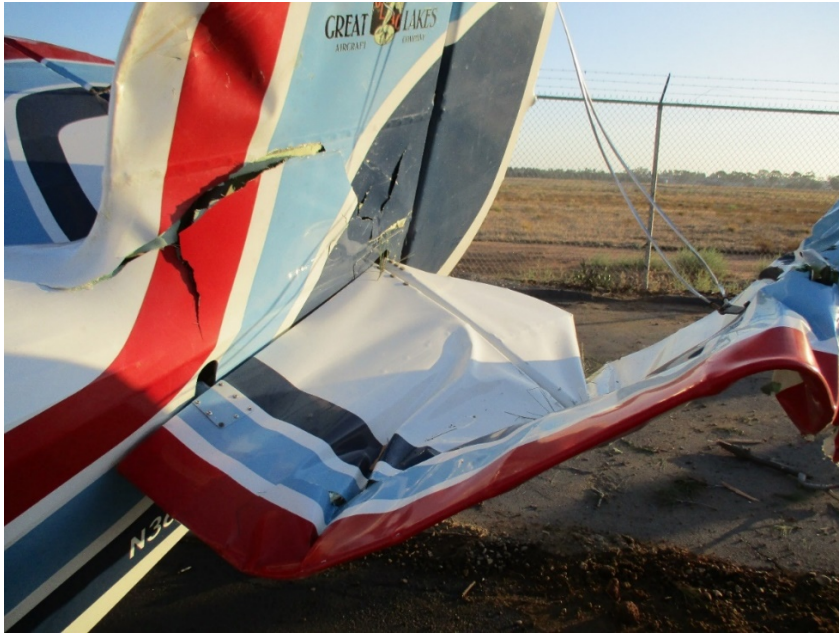
EMPENNAGE. The empennage received significant impact damage. The right side was fully intact but the left side received major impact damage. All major components from the empennage were located on site.

Figure 6 - Photo 6 of 11, N3617L Empennage, courtesy of Airport Ops

Figure 7 - Photo 7 of 11, N3617L Empennage, courtesy of Airport Ops

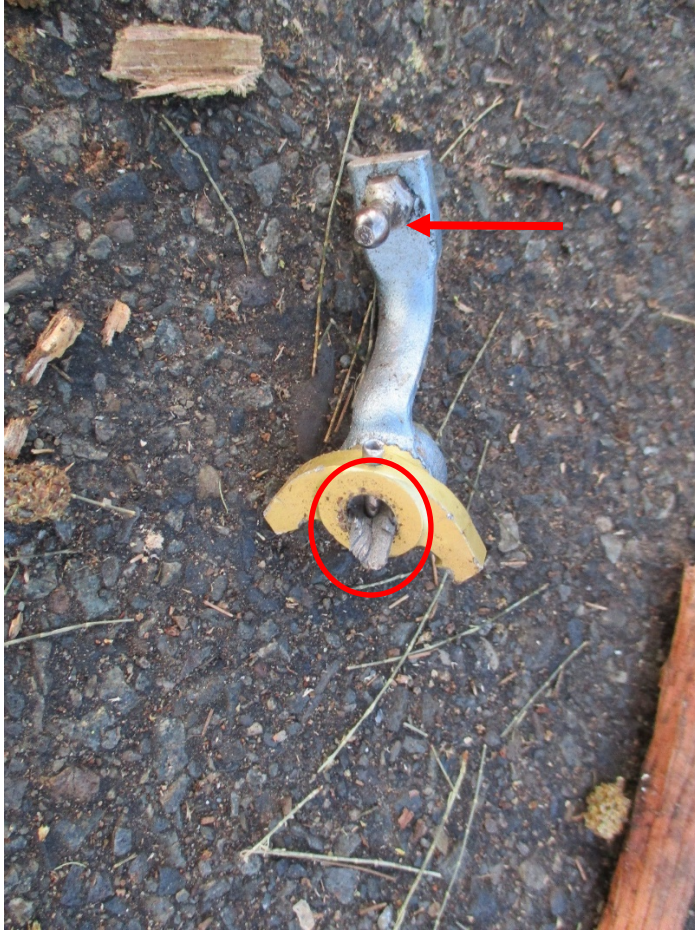
The mixture control arm broke off and came to rest on the ground next to the airplane. It separated in two places, both from the broken servo mixture control arm and from the quick release ball. The mixture control arm appeared to be sheared off of the mixture shaft from impact forces. Using the orientation of the roll pin to line up the mixture control it was determined the mixture setting was at 3/4 full rich setting. The mixture control shaft was able to be moved and no binding was detected. Both the mixture and throttle control arms utilize quick release ball end connections. The connection to the control cable has a spring-loaded socket that fits over a ball joint bolt into each control arm on the fuel servo. There is no additional security on this type of control connection, enough side load force given on these connections could easily pry them loose from their ball. Again, the mixture control arm was separated in two places, one at the mixture control arm at the servo and again at the ball joint then connecting to the mixture cable assembly. This ball joint appeared to be slightly bent which could have occurred during the separation of it from the shaft connection. It is unknown if the bent ball joint pre-existed the accident making it easier for the shaft end to separate.

Figure 8 - Photo 8 of 11, N3617L Mixture Control Arm, courtesy of Airport Ops

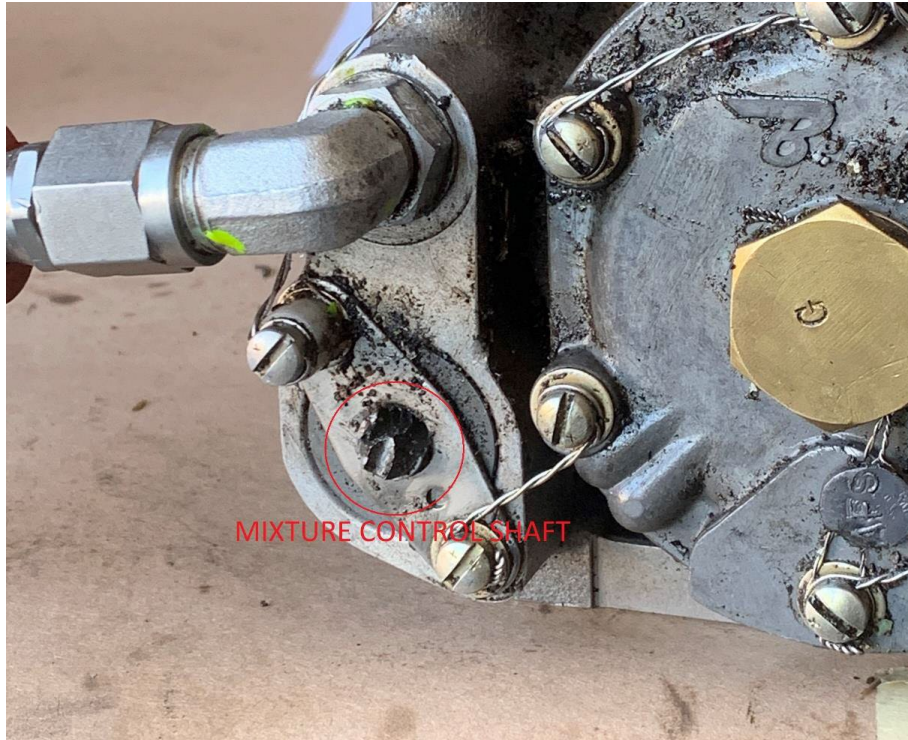
Figure 9 - Photo 9 of 11, N3617L Broken Mixture Control Shaft, courtesy of NTSB

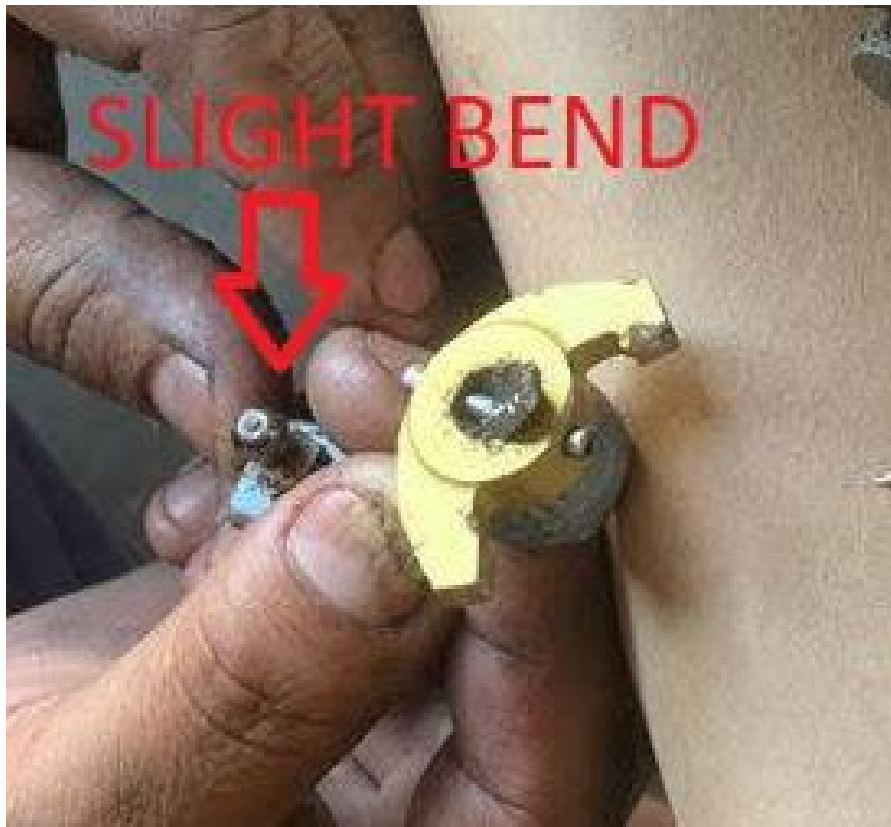
Figure 10 - Photo 10 of 11, N3617L Bent Ball Joint, courtesy of NTSB
