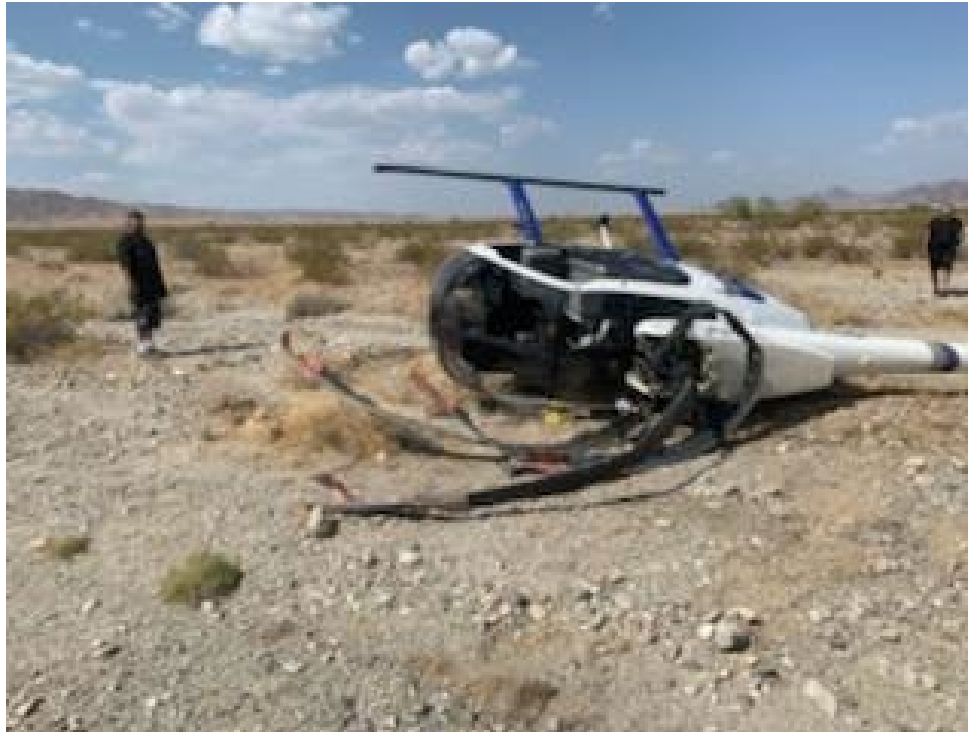
**Photo 1 –N509CG, Top view, showing man rotor blade damage. Photo courtesy of the pilot.**

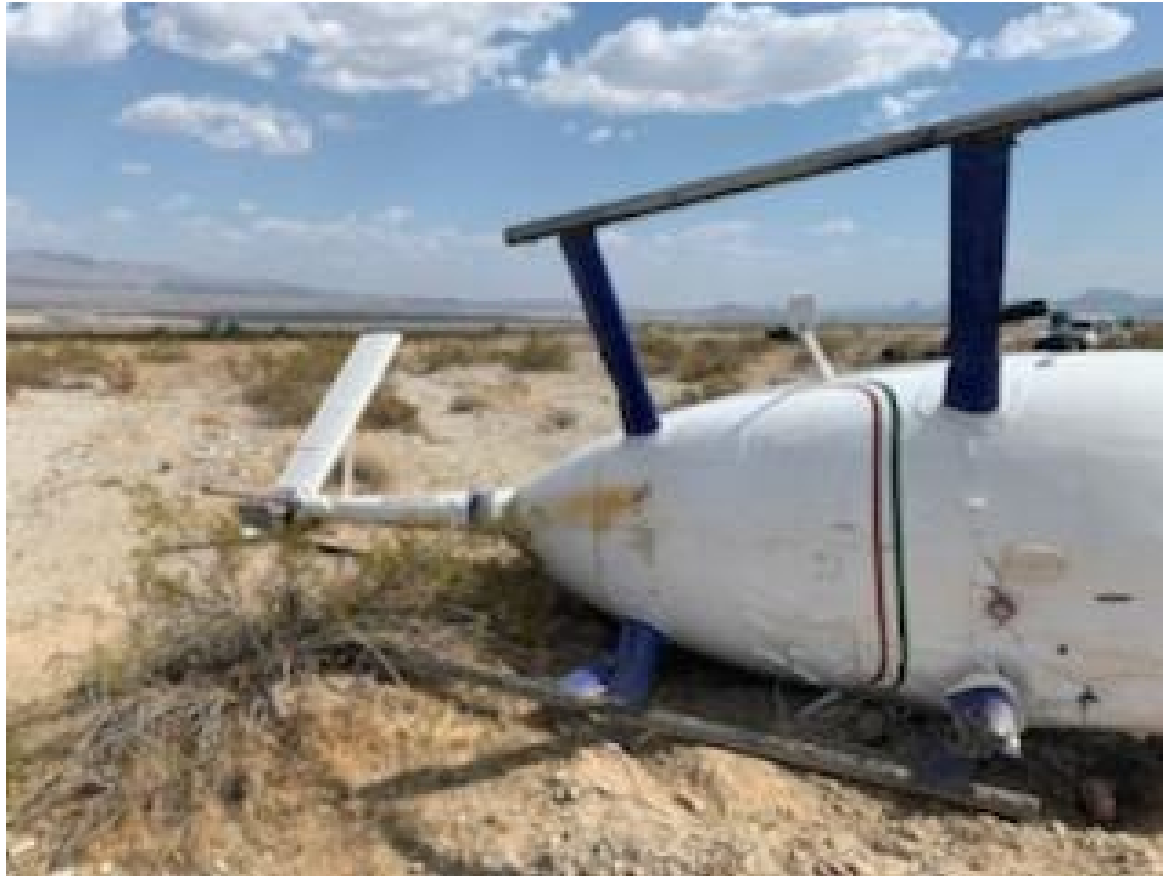
**Photo 2 – N509CG, Bottom view, showing damage to the lower-right fuselage. Photo courtesy of the pilot.**

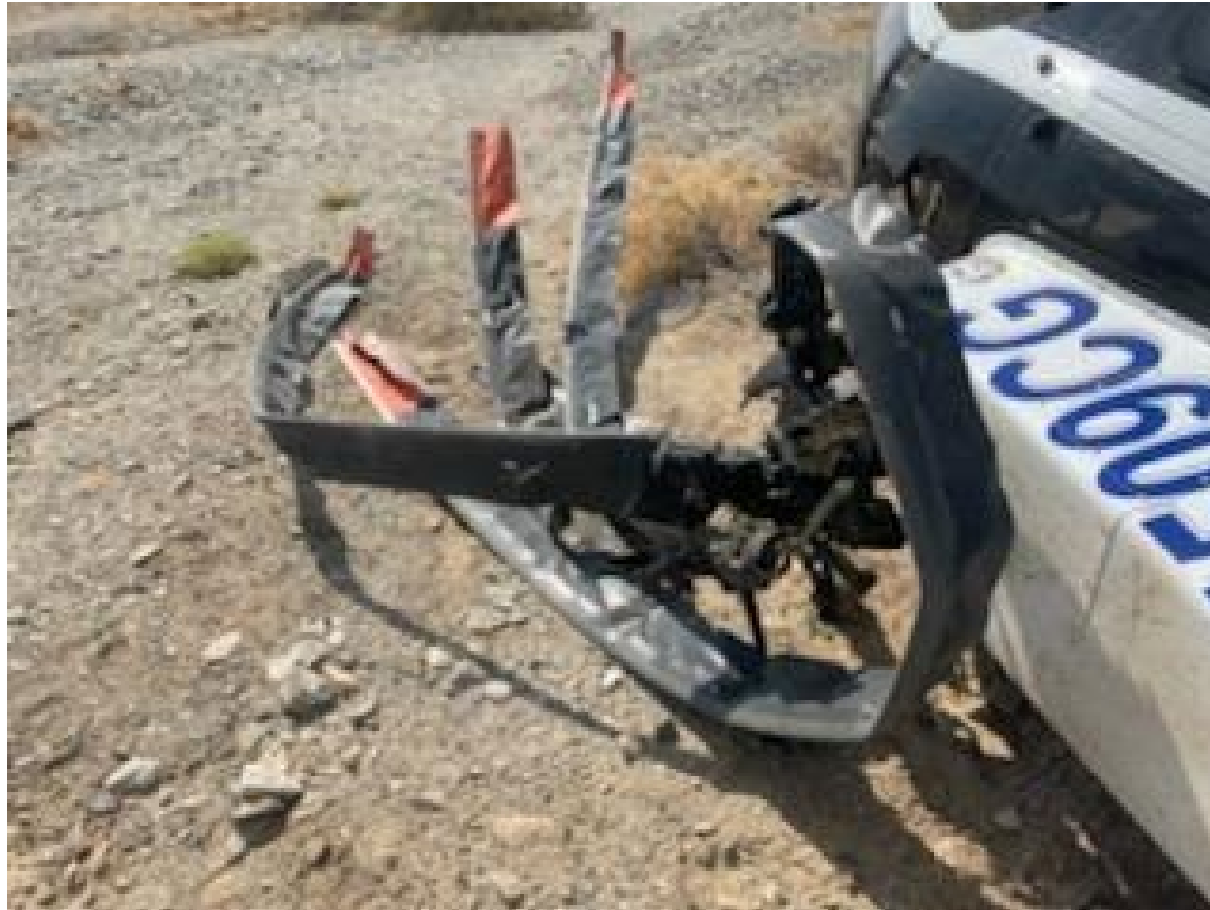
**Photo 3 – N509CG, top view, showing main rotor blade damage. Photo courtesy of the pilot.**

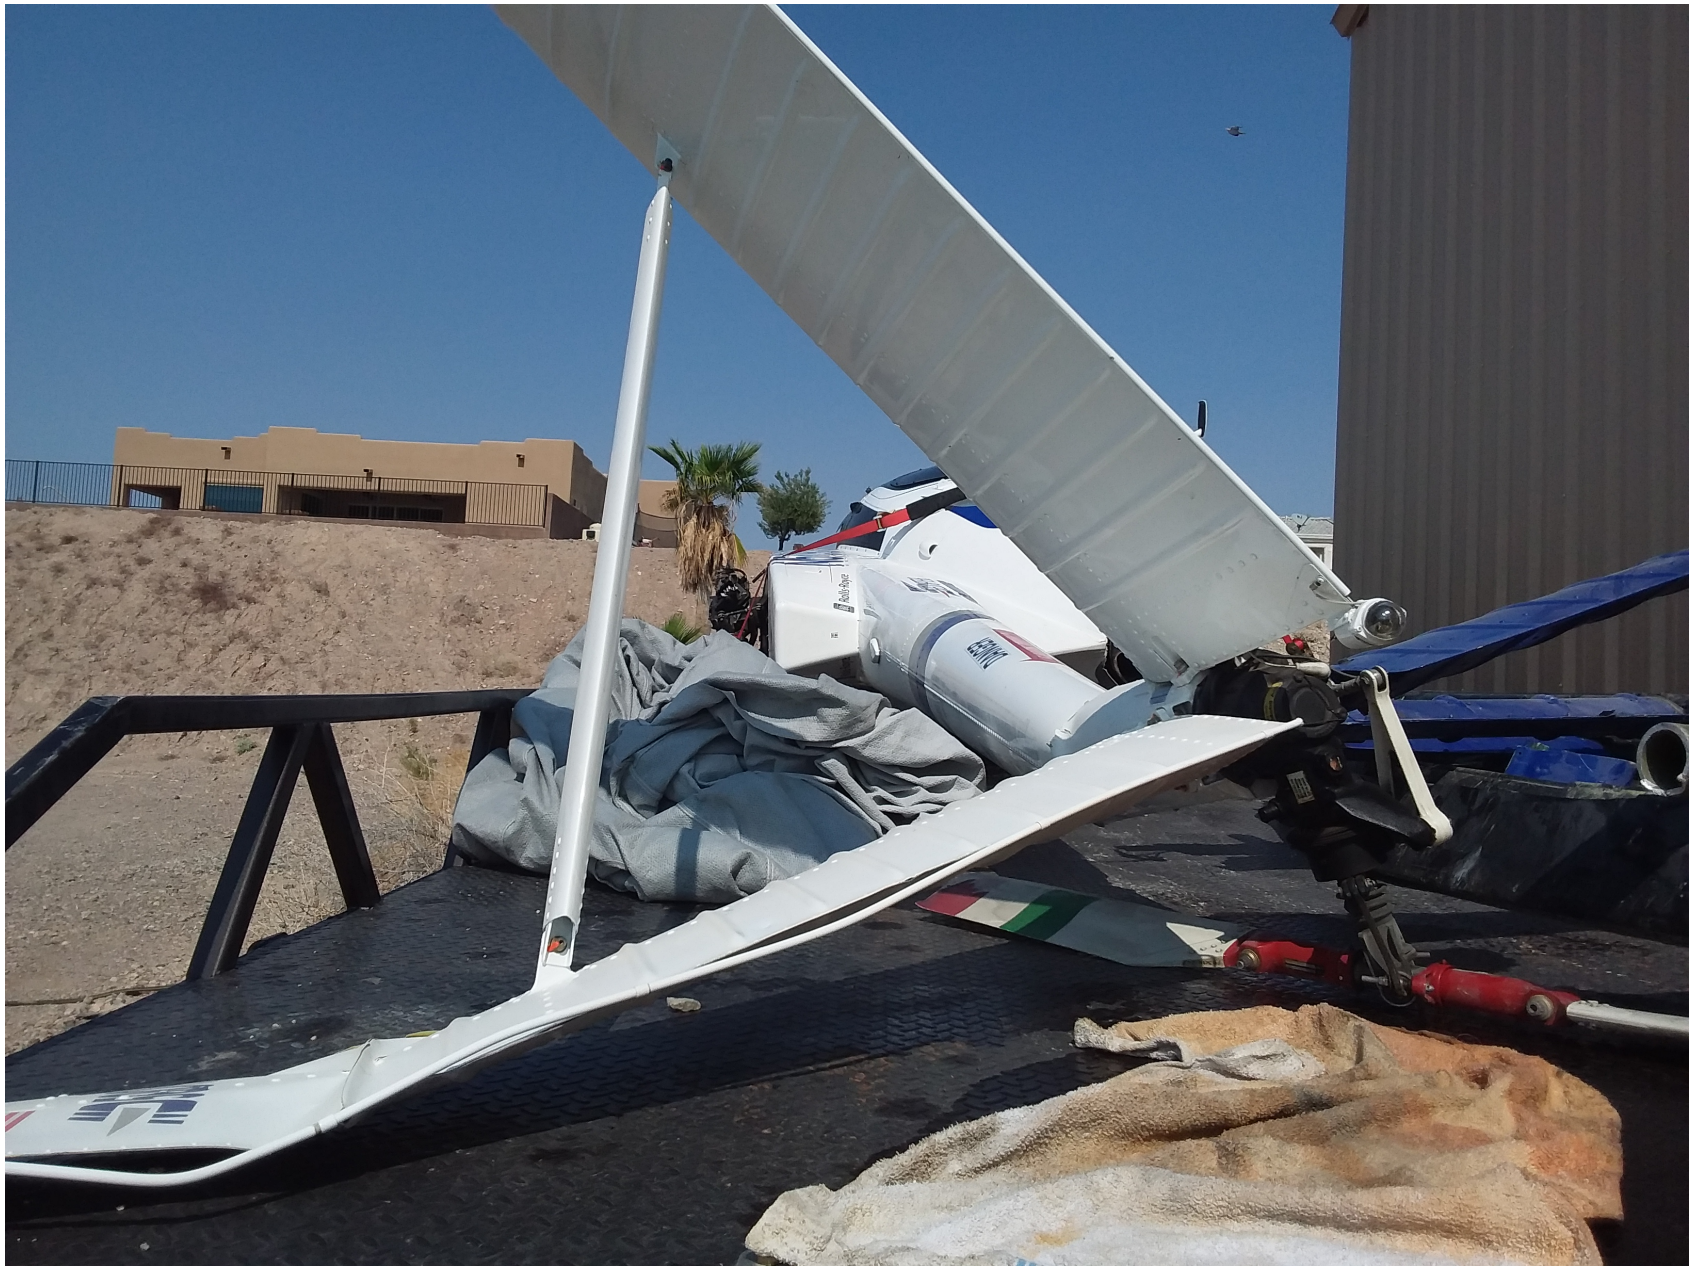
**Photo 4 – N509CG, Rear view, showing damage to the tail boom. Photo courtesy of the pilot.**
