## **NATIONAL TRANSPORTATION SAFETY BOARD**

# **AIRFRAME AND ENGINE EXAMINATION**

**WPR20TA039**

Aircraft: Enstrom F28F / N65RS

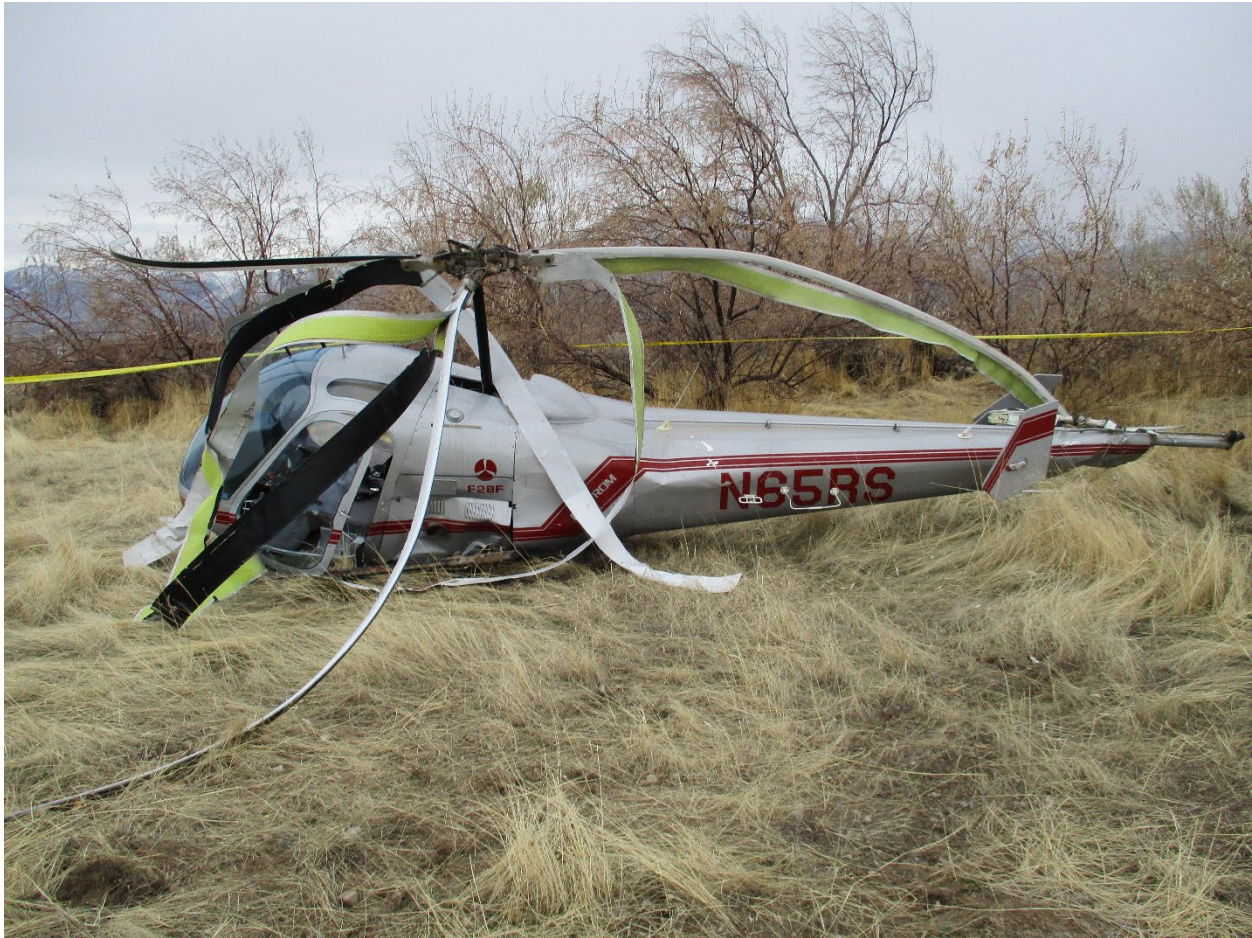
Figure 1. N65RS, left-side view. Photo courtesy of the FAA.

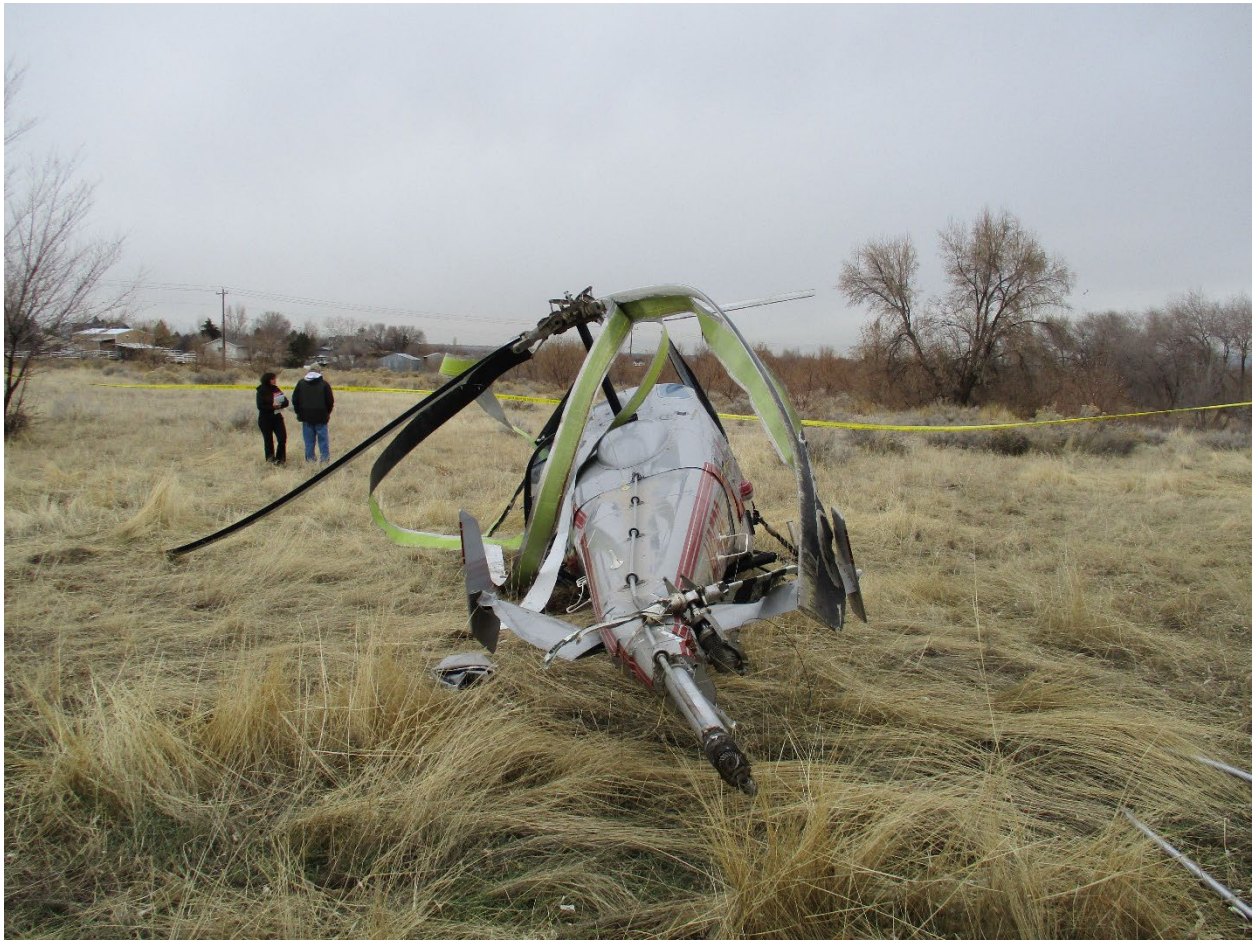
Figure 2. N65RS, rear view. Photo courtesy of the FAA.

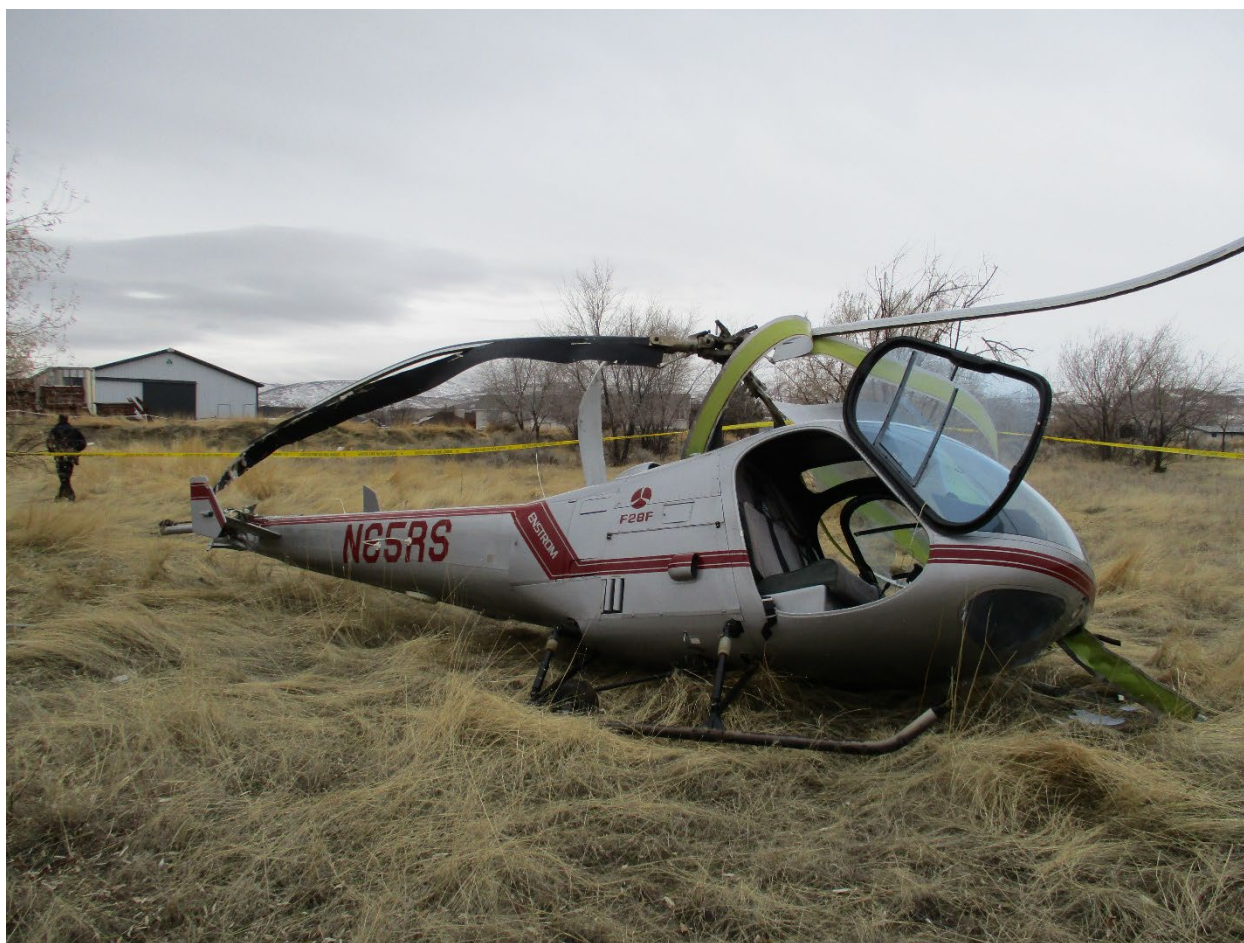
Figure 3. N65RS, right side view. Photo courtesy of the FAA.

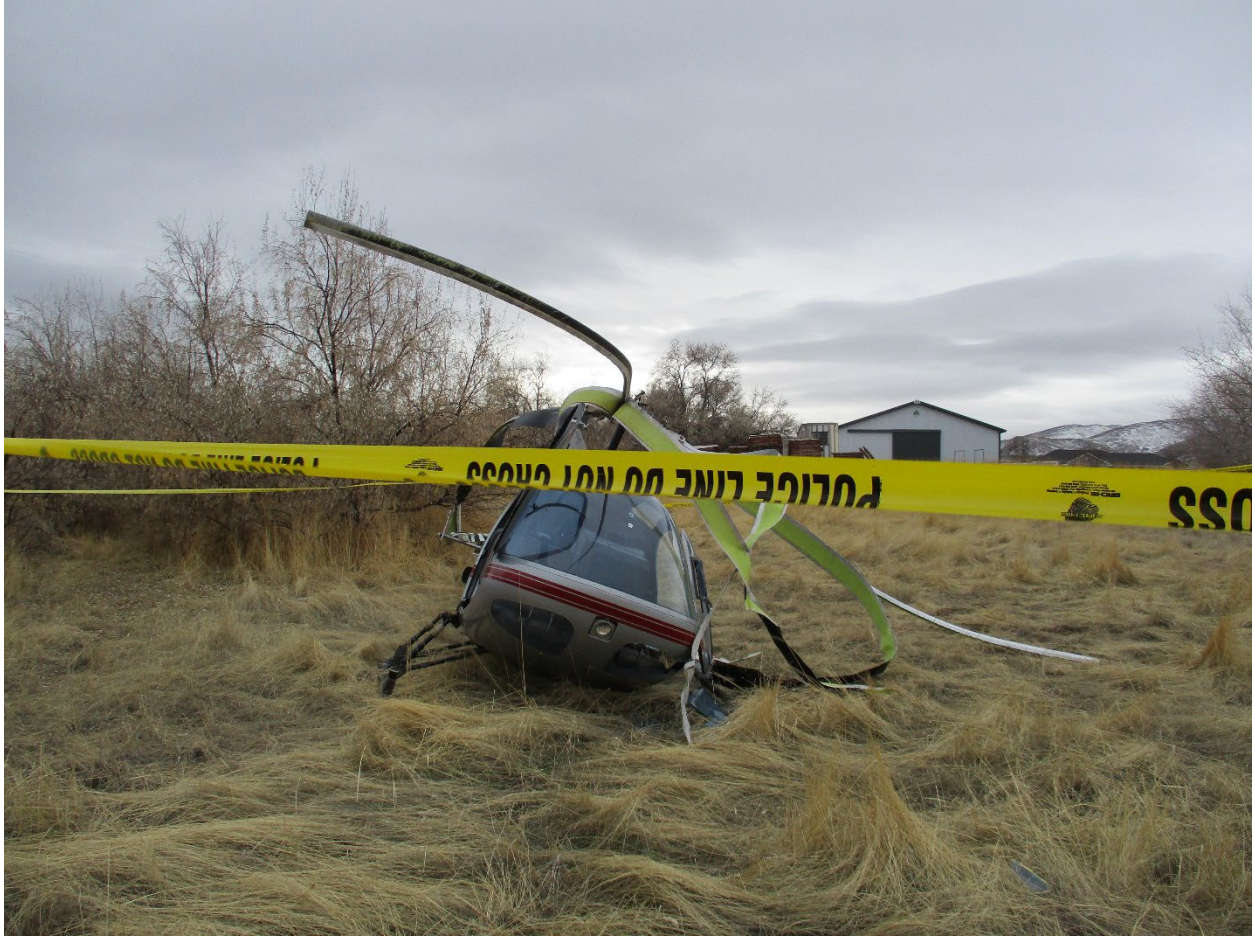
Figure 4. N65RS, front view. Photo courtesy of the FAA.

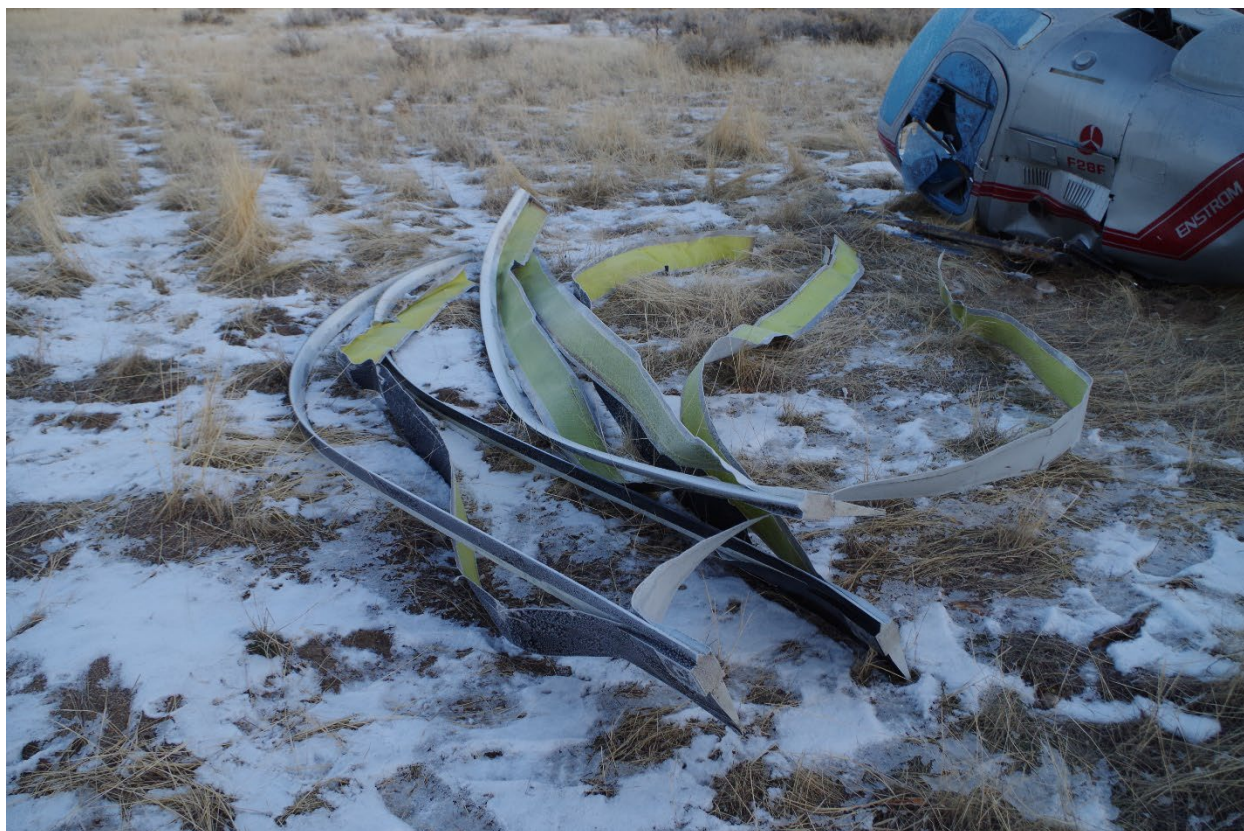
All three main rotor blades exhibited upward bending at the blade grips, consistent with a severe ground strike. All three blades were bent upwards and exhibited opening up of the skin/spar joint.

Figure 5. Main rotor blades from N65RS. Photo courtesy of the FAA.

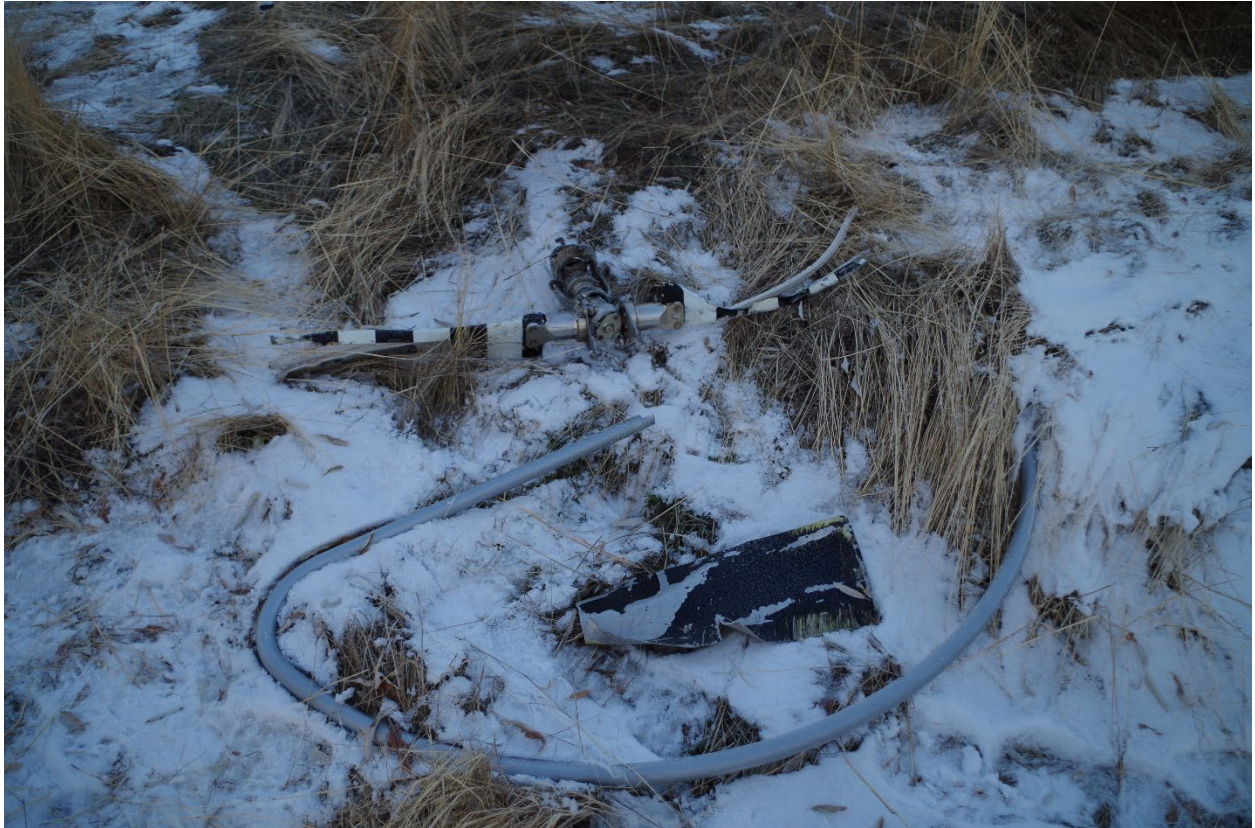
The tail rotor gearbox housing was broken across the gear interface, consistent with a severe ground strike while the tail rotor was turning. The input gear assembly was in the part that was still attached to the stinger tube and the output gear assembly, including the tail rotor assembly was in the half that left the aircraft. There were no broken teeth on either gear. Both the input and output assemblies turned freely in their housings. The control cable on the left side was separated and the cable on the right side was intact. Both cables were unbolted from the tail rotor controls. The owner reported that he disconnected both cables to simplify recovering the wreckage.

Both tail rotor blades were still attached to the hub, but they were damaged to the extent that the skins were separated from the spars. The bending was consistent with a severe ground strike while they were being driven. One of the blades had significant out-of-plane bending consistent with the aircraft rotating during the impact. The tail rotor control system from the cable attachments through the blades was intact and operated smoothly.

Figure 6. Tail rotor assembly. Photo courtesy of the FAA.

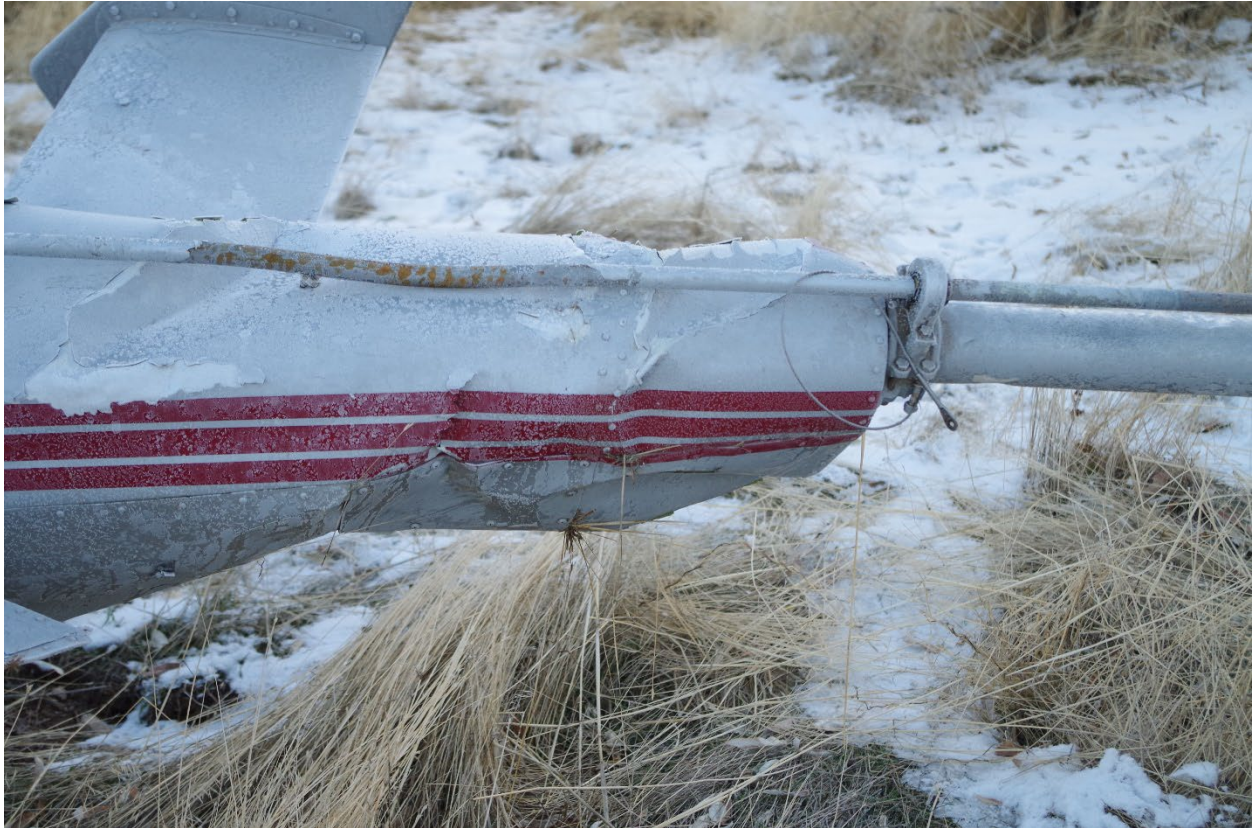
Figure 7. View of the damaged area of the tailboom bear the location of the tail rotor blades. Photo courtesy of the pilot.

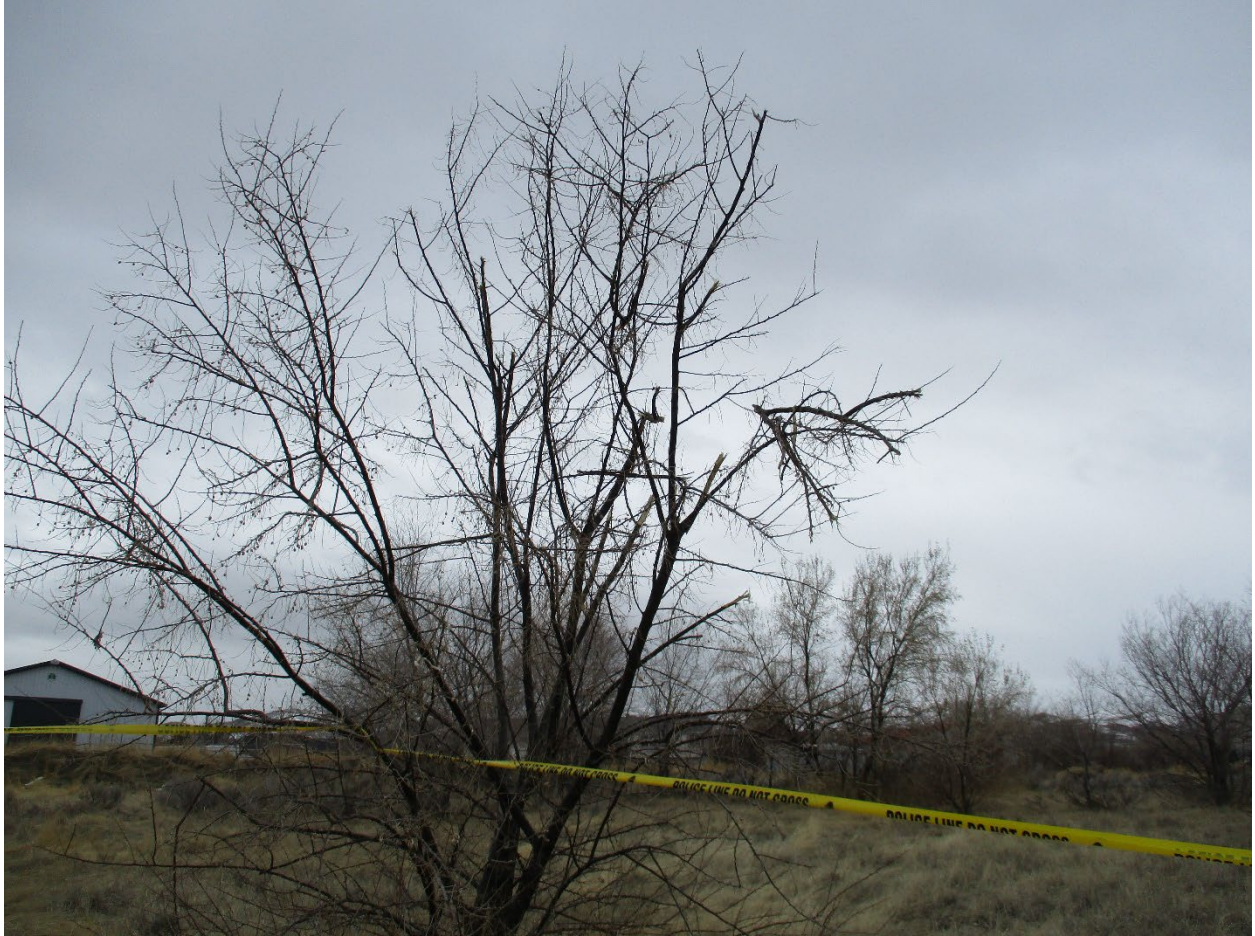
Figure 8. Tree located near the wreckage, showing broken branches. Photo courtesy of the FAA.

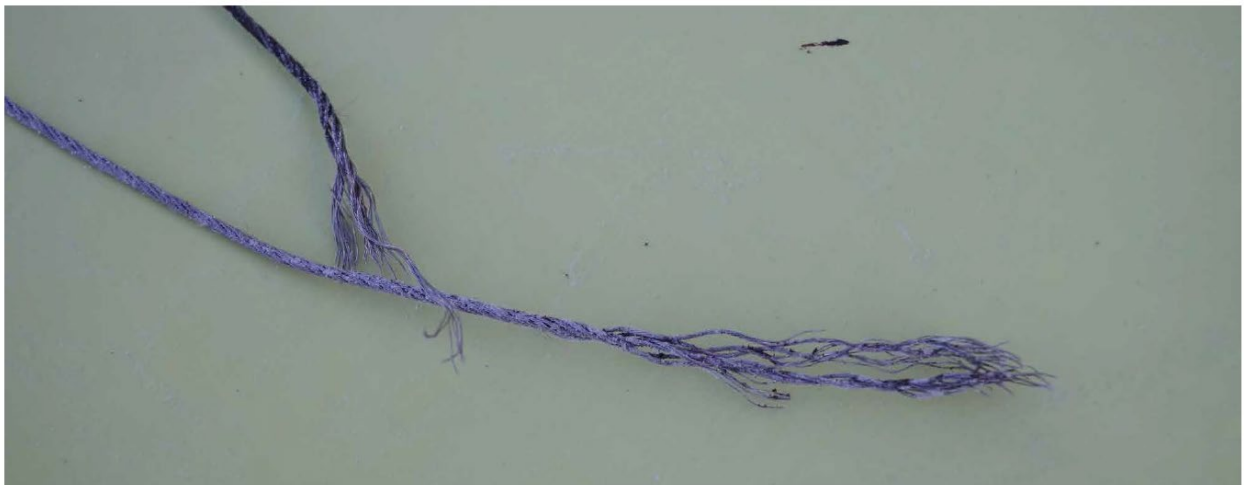
The tail rotor cable on the left side of the aircraft was separated. The separation was located roughly in line with the tip of the tail rotor blade. Superficially, the separation was consistent with being cut by a blunt object with relatively high energy, such as a tail rotor blade. There were marks on the tail rotor drive shaft that appeared to match the tail rotor cable. These marks would be consistent with a section of tail rotor cable having contacted the drive shaft while it was rotating. Except for the separation of this cable and the fact that both cables had been disconnected at the tail rotor control yoke, the tail rotor control system was continuous.

Figure 9. Left-side tail rotor control cable, showing the fracture. Photo courtesy of the airframe manufacturer.
