# National Transportation Safety Board

WPR21FA025

Performance Study

Location: Cordes Lakes, Arizona  
Date: October 24, 2020  
Time: 10:28 mountain standard time (MST)  
17:28 UTC  
Aircraft: Lancair 235, N25NL

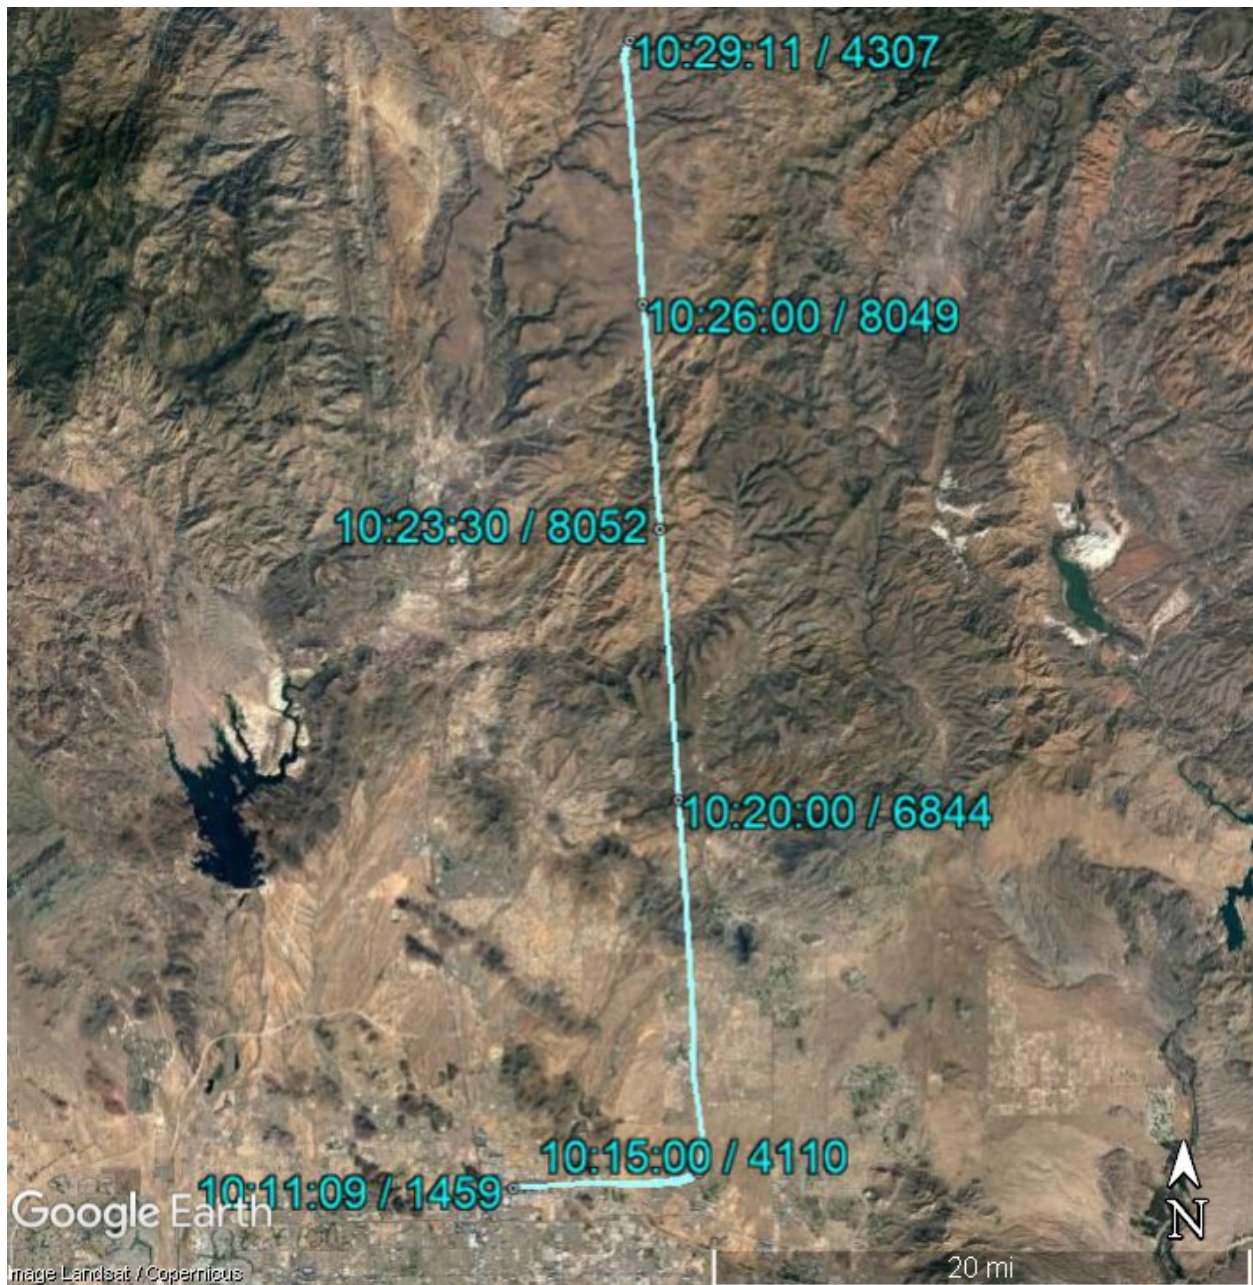
The airplane took off from Phoenix Deer Valley Airport (KDVT) in Phoenix, Arizona at about 10:11 (Figure 1). At 10:15, while climbing, the airplane turned left onto a northerly heading. The airplane continued to climb until it reached an altitude of 8,000 ft above mean seal level (msl) after 10:23 (Figure 2). The airplane's speed increased to between 130 and 150 kts of indicated airspeed at altitude.

**Figure 1.** Aircraft flightpath in blue with selected times and altitudes (msl) marked.

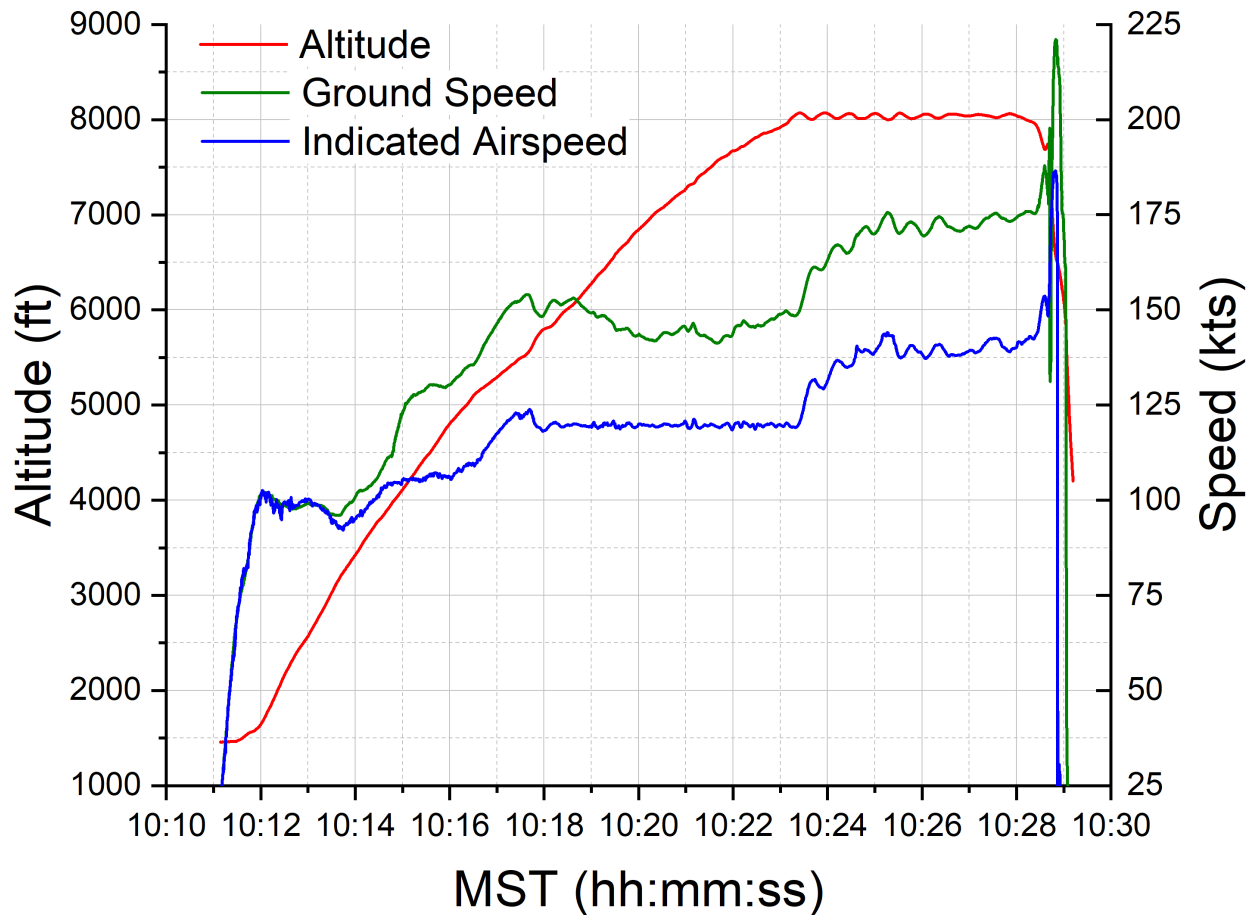
**Figure 2.** Recorded altitude (msl), groundspeed, and indicated airspeed for flight.

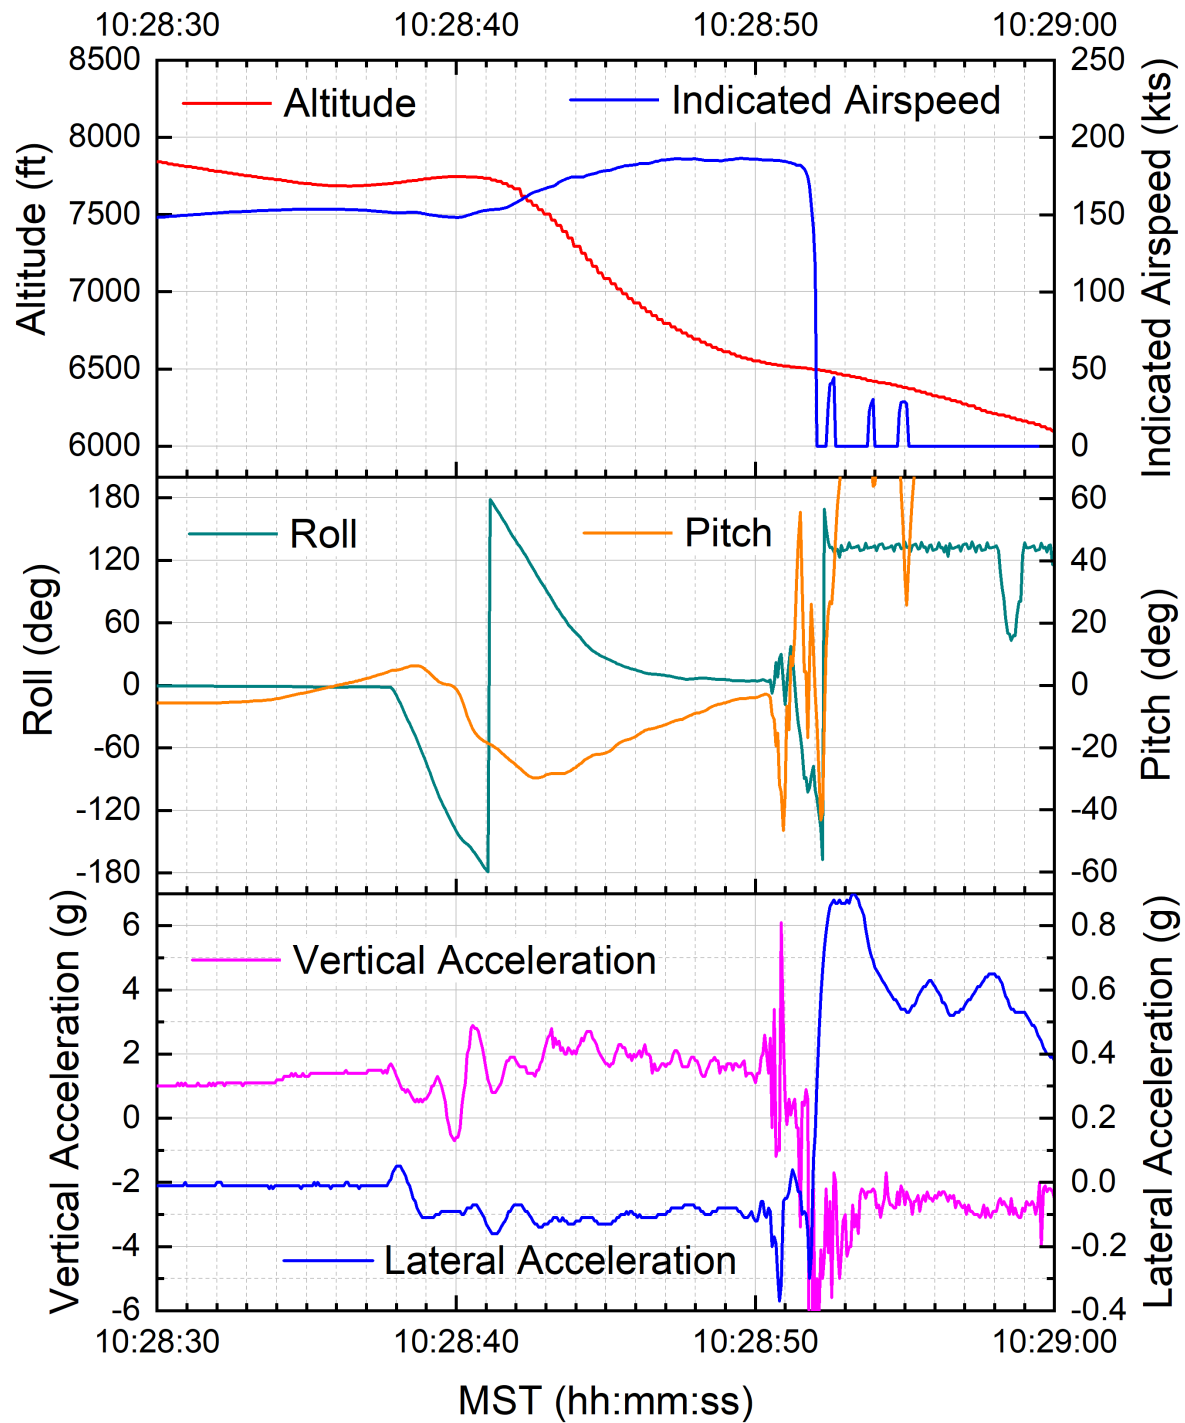
At 10:28:38 (Figure 3), the airplane executed a left 360° roll. The airplane descended over 1,000 ft during the maneuver. During the roll, the vertical acceleration varied between -0.7 g and 2.9 g. Figure 4 shows the roll and a number of engine parameters. During the roll, many engine parameters dropped or changed. After 10:28:50, a few seconds after the completion of the roll maneuver, engine RPM and oil pressure dropped to zero while airplane attitude, accelerations, and airspeed parameters became unreliable.

**Figure 3.** Altitude (msl), airspeed, roll, pitch, and vertical and lateral accelerations for 360° roll.

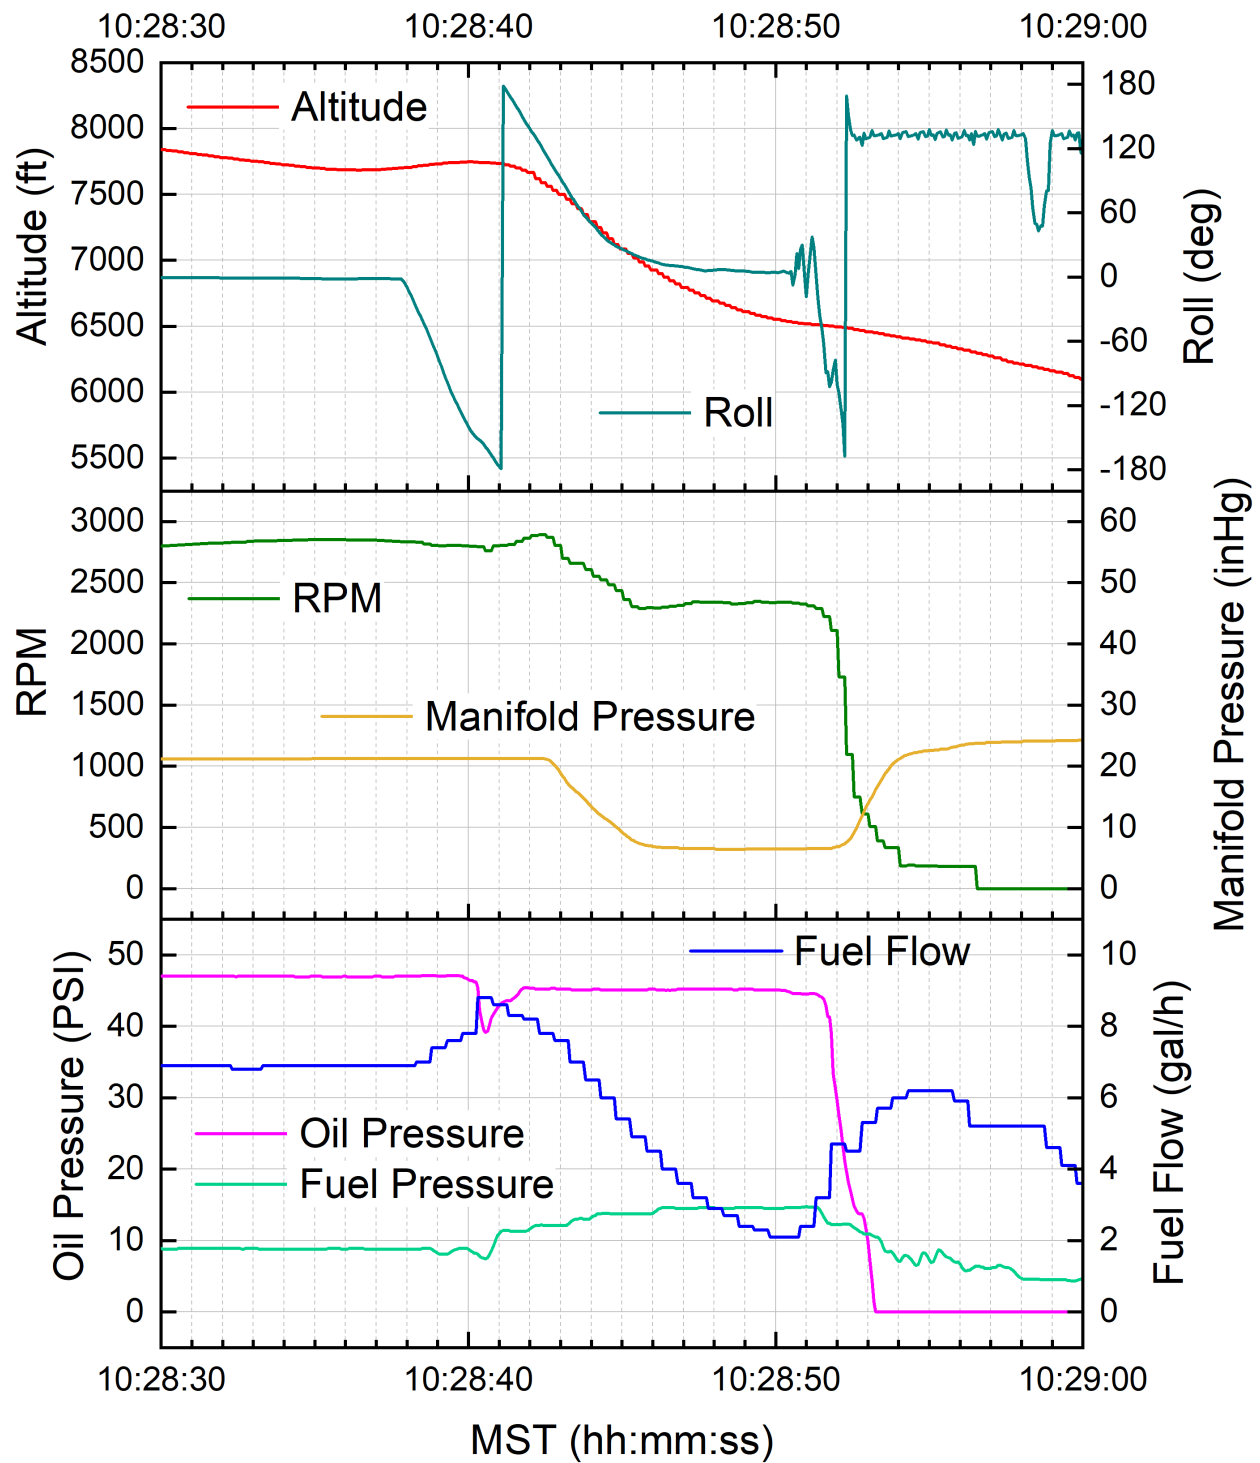
**Figure 4.** Altitude (msl), roll, and engine parameters at the end of flight.

The flight proceeded normally from take-off at 10:11 until 10:28. About 10:28:38 the airplane performed a 360° left roll during which it lost over 1,000 ft of altitude. After 10:28:50, RPM and oil pressure dropped to zero and the attitude data became unreliable. The GPS position data continued until 10:29:11, shortly before impact.

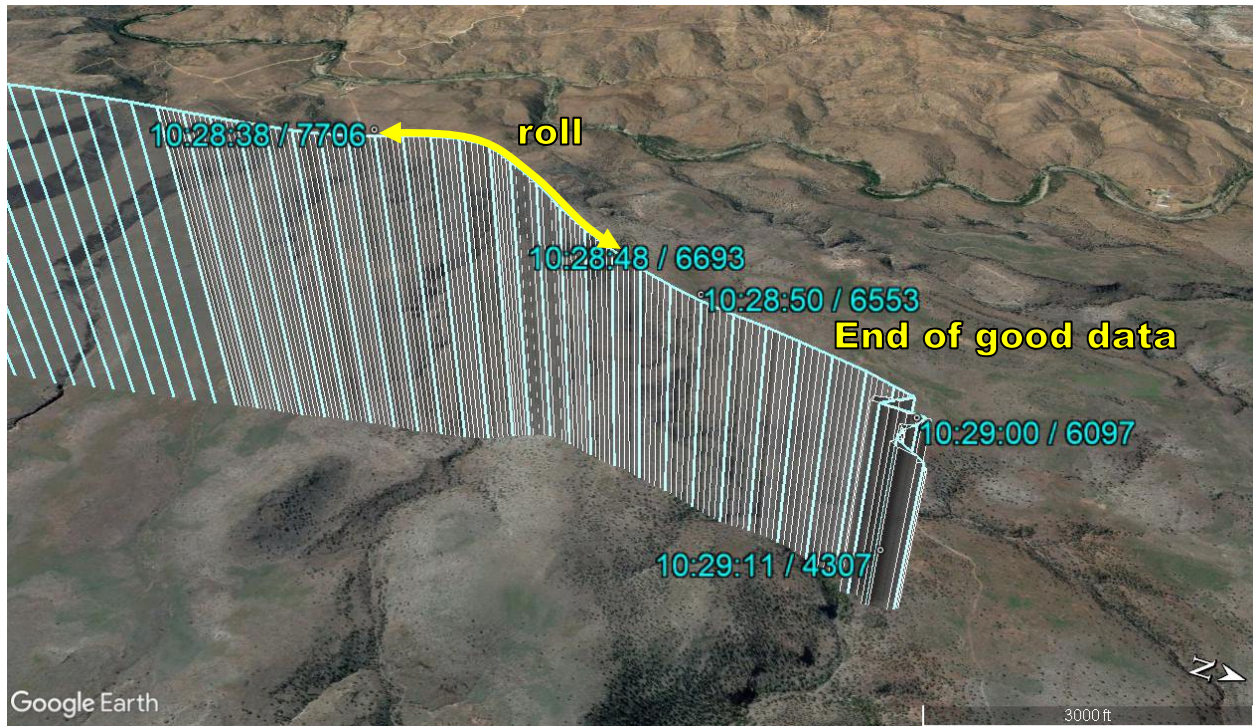
Data continued to be recorded until 10:29:11 (Figure 5). Terrain elevation in the area of the accident was between 3,700 and 3,800 ft. The last GPS position and altitude recorded was approximately 600 ft above the ground.

**Figure 5.** End of flight with selected times and altitudes (msl) noted.
