## **NATIONAL TRANSPORTATION SAFETY BOARD**

### **ONSITE EXAMINATION NOTES**

**WPR21FA025**

Location: Cordes Lake, AZ  
Date: October 24, 2020  
Aircraft: N25NL  
NTSB IIC: Joshua Cawthra

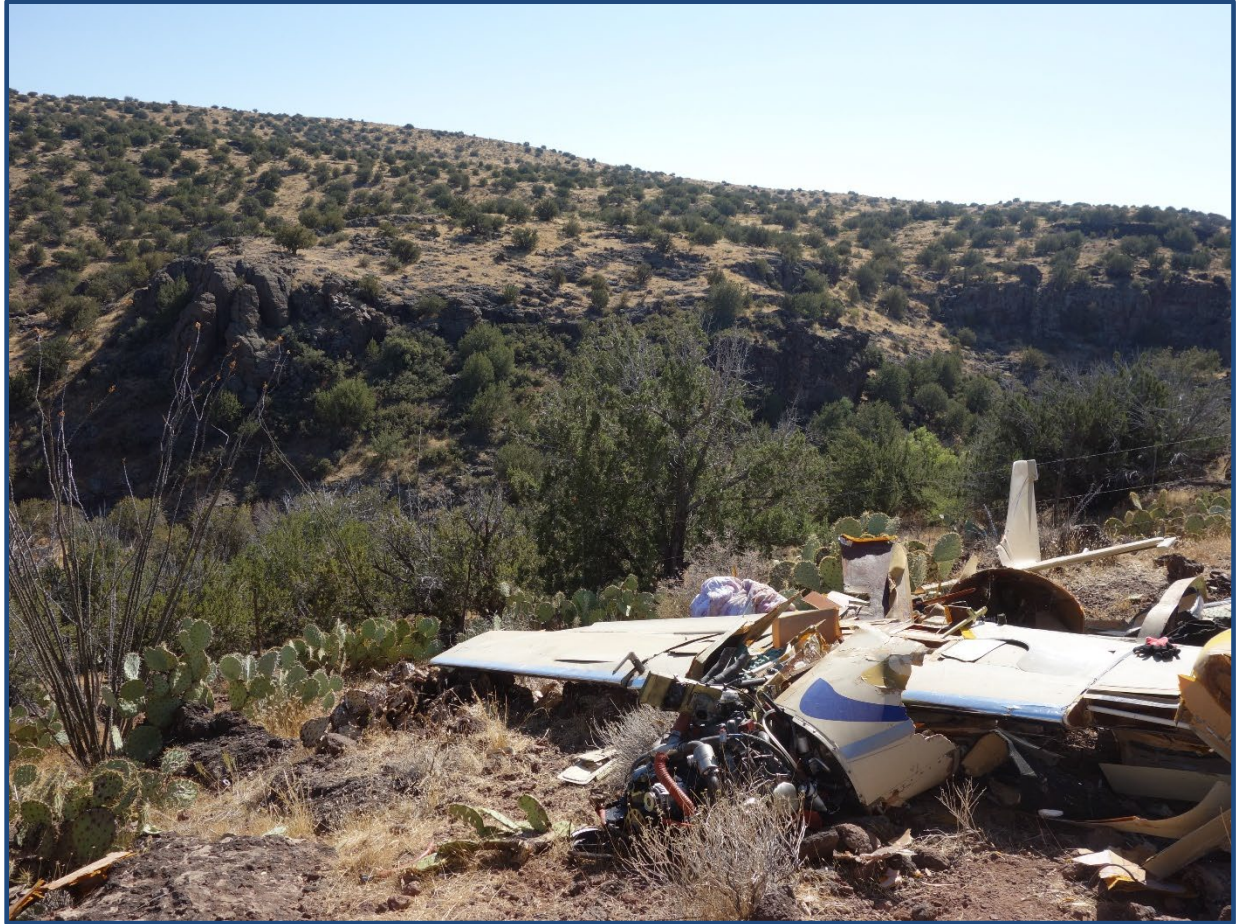
Examination of the accident site revealed that the airplane impacted in remote hilly desert, rocky terrain with moderate brush and trees about 34° 17' 54" North and -112° 0' 58" West. The airplane impacted about halfway up the ridgeline, on a hillside slope of about 30°. The airplane came to rest inverted on about a 045° magnetic heading and at an elevation of about 3,720 ft. mean sea level. There was no ground disturbance prior to where the airplane came to rest. A barbed wire fence behind the airplane, and several trees and cactus surrounding the airplane were not damaged. All major components of the airplane were contained within the main wreckage site. No debris trail was present with the exception of the propeller, starter gear fragments, and a fuel line, located about 15 ft in front of the airplane and a small fragment of the airplane located about 10 ft behind the wreckage. There was no postimpact fire.

Figure 1: Airplane wreckage at accident site.
