**NATIONAL TRANSPORTATION SAFETY BOARD**

**ONSCENE EXAMINATION**

**WPR21FA044**

Aircraft: Piper PA-38-112

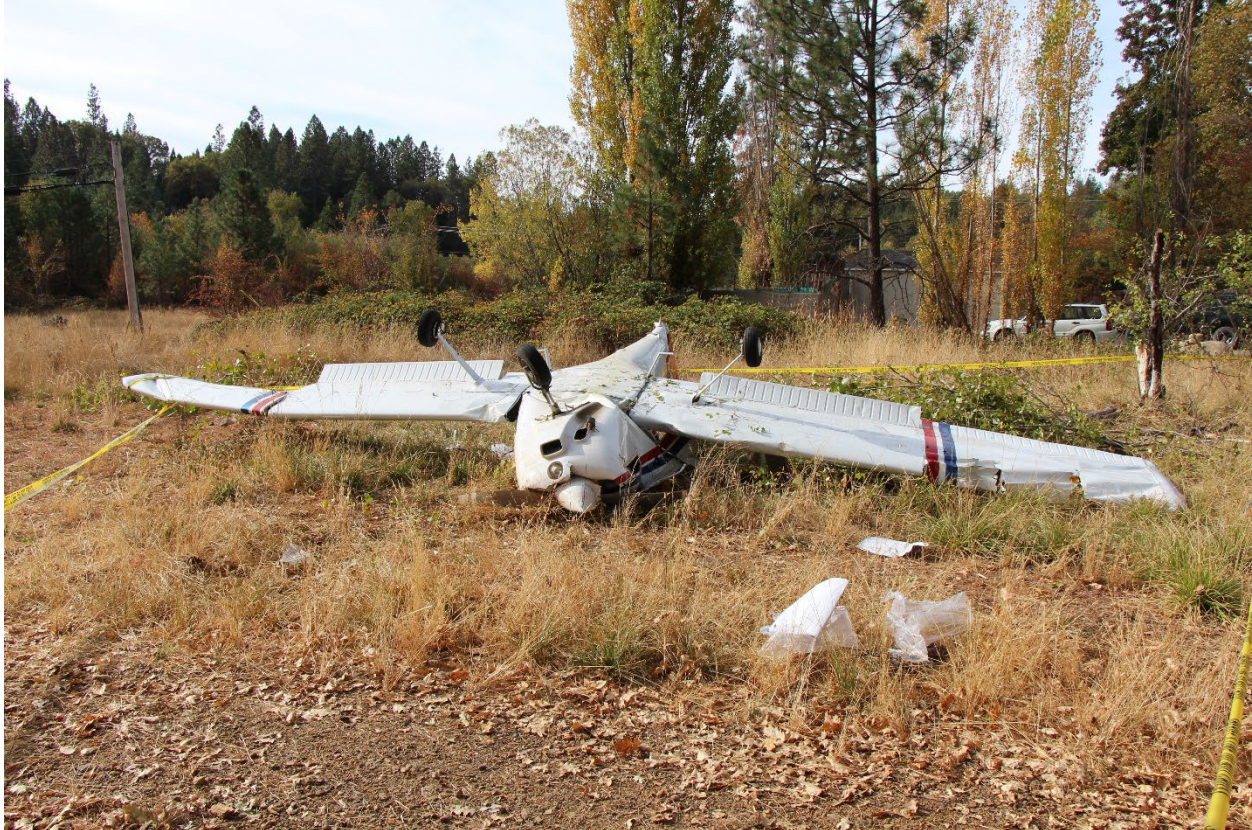
The airplane was located in wooded terrain at an elevation of about 2,710 ft mean sea level. All major sections of the airplane were accounted for at the accident site. The initial impact point (IIP) was marked by a severed tree that displayed an impact mark about 15 ft up from its base. The accident airplane was inverted and intact, oriented on a heading of 048° magnetic. The orientation between the IIP and main wreckage was 094° magnetic.

Photograph 1: Main wreckage

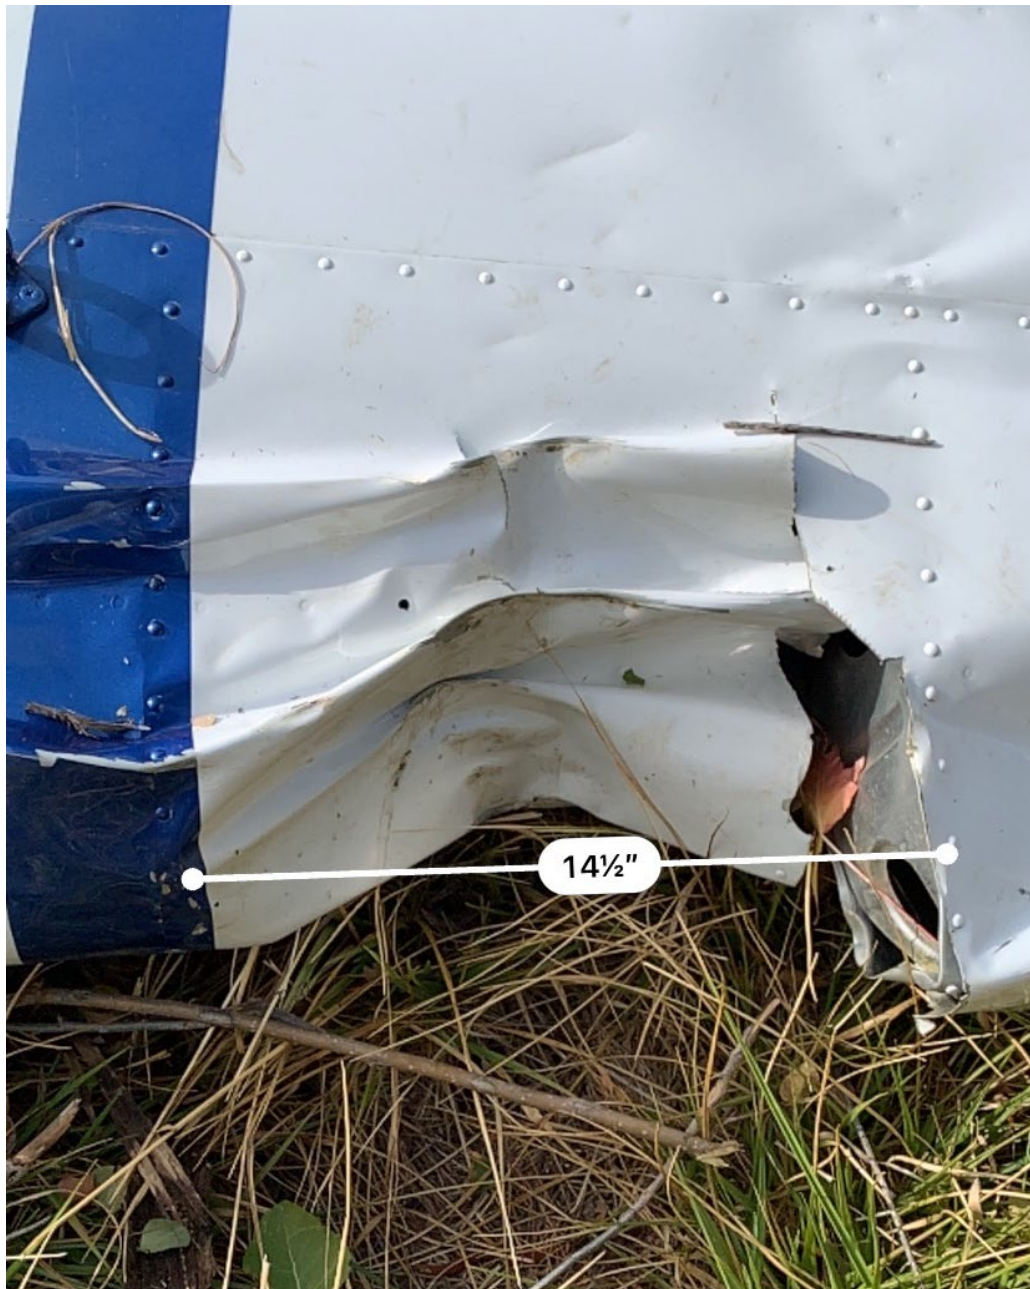
The right wing was intact and remained attached to the fuselage, but exhibited deformation throughout its lower and upper skins. A depression that measured about 14.5 inches was observed about midspan and collocated with several broken tree branches. The outboard leading edge was crushed. The left wing was intact and remained attached to the fuselage and exhibited a

Photograph 2: Depression in right wing and tree remnants

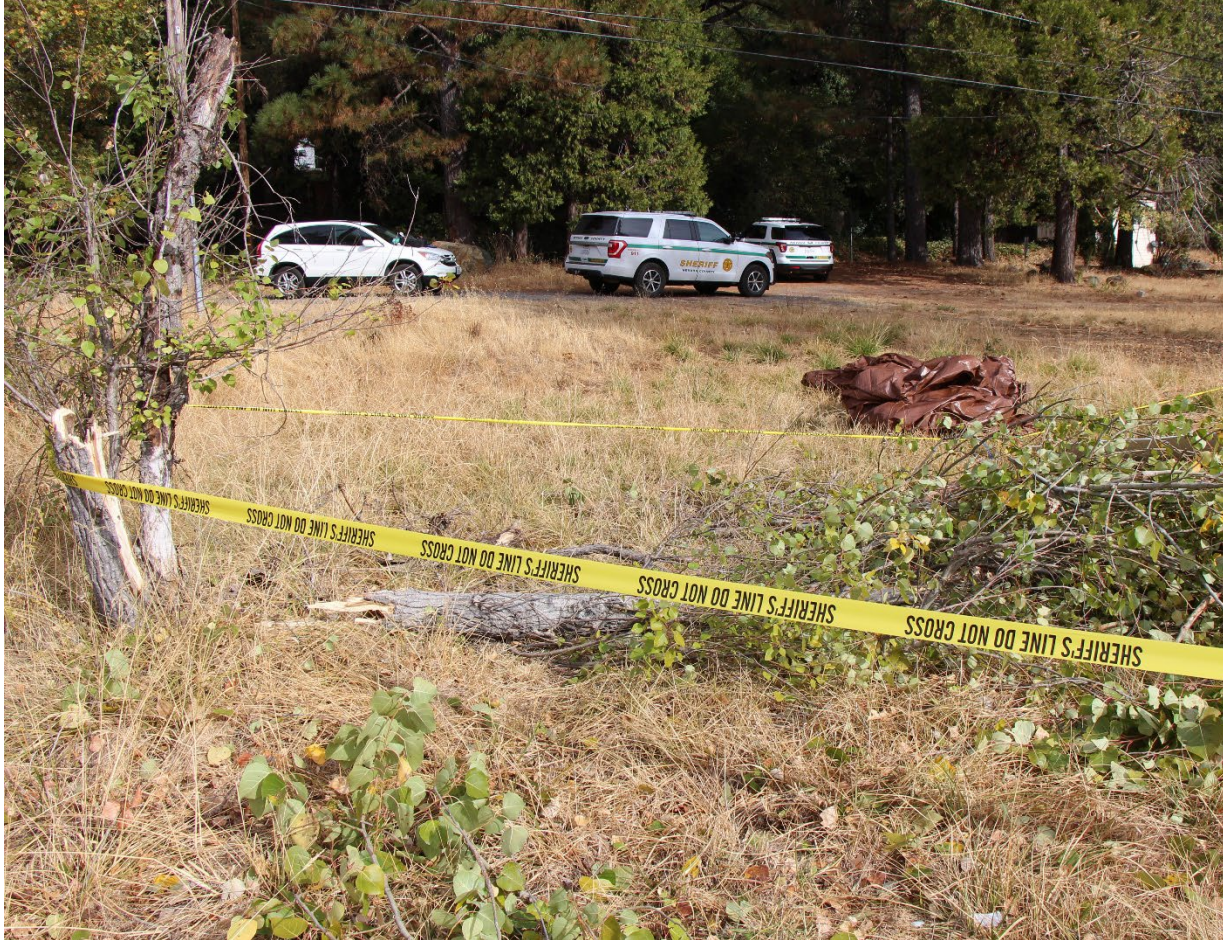
Photograph 3: Initial impact point (tree)

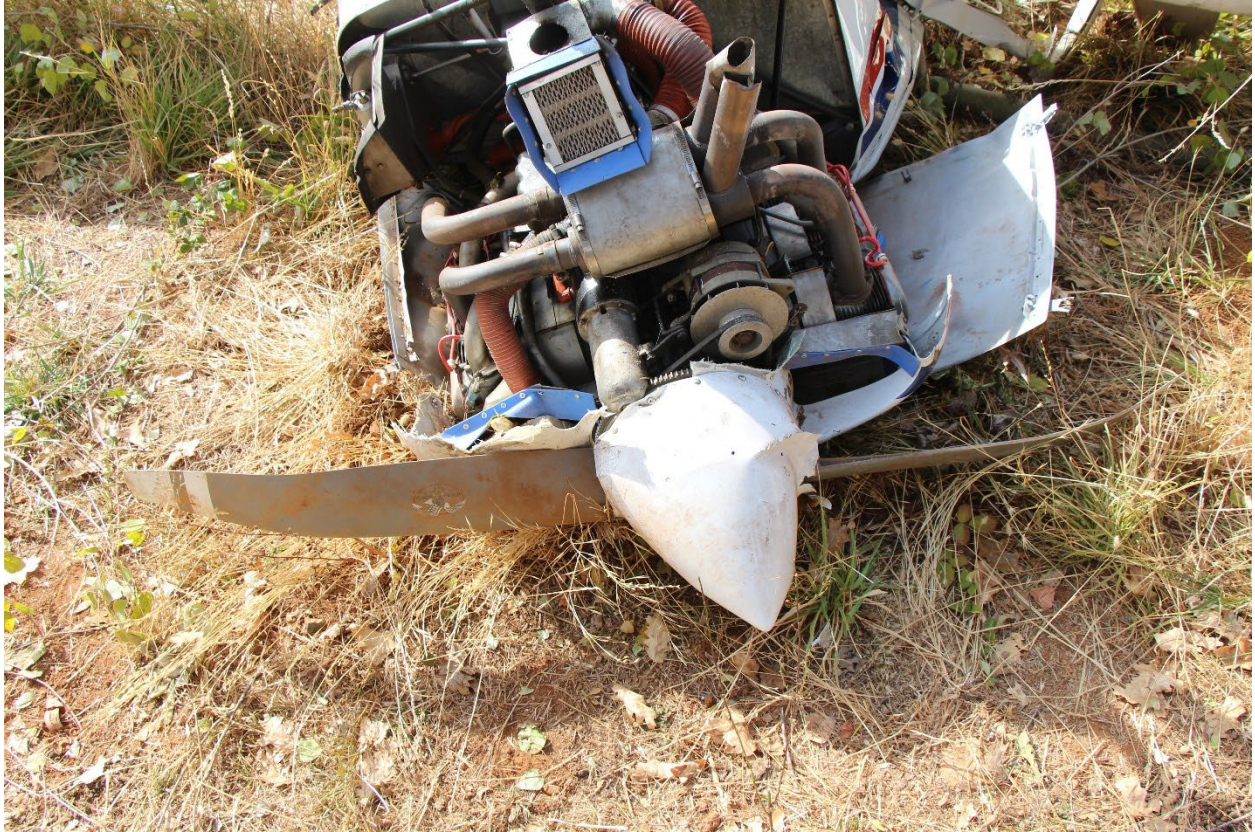
Both propeller blades remained attached to the engine crankshaft and were each bent aft slightly. However, neither blade exhibited any nicks, gouges, or chordwise striations.

The propeller rotated with ease by hand, but its movement was restricted due to their proximity to the ground.

Photograph 4: Propeller blades and uncowed engine
