**NATIONAL TRANSPORTATION SAFETY BOARD**

**AIRFRAME AND ENGINE EXAMINATION**

**WPR21FA044**

Aircraft: Piper PA-38-112

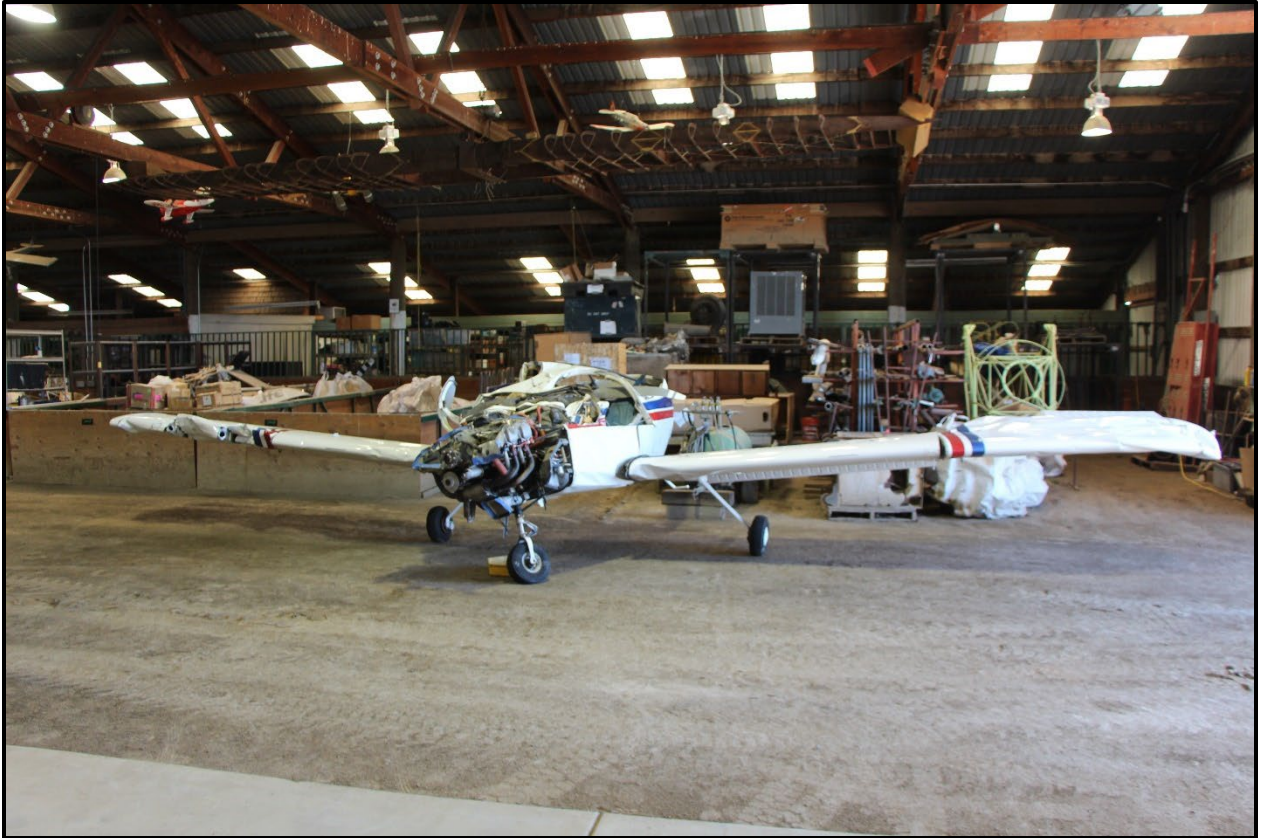
Photograph 1: Airplane Prior to Wreckage Examination

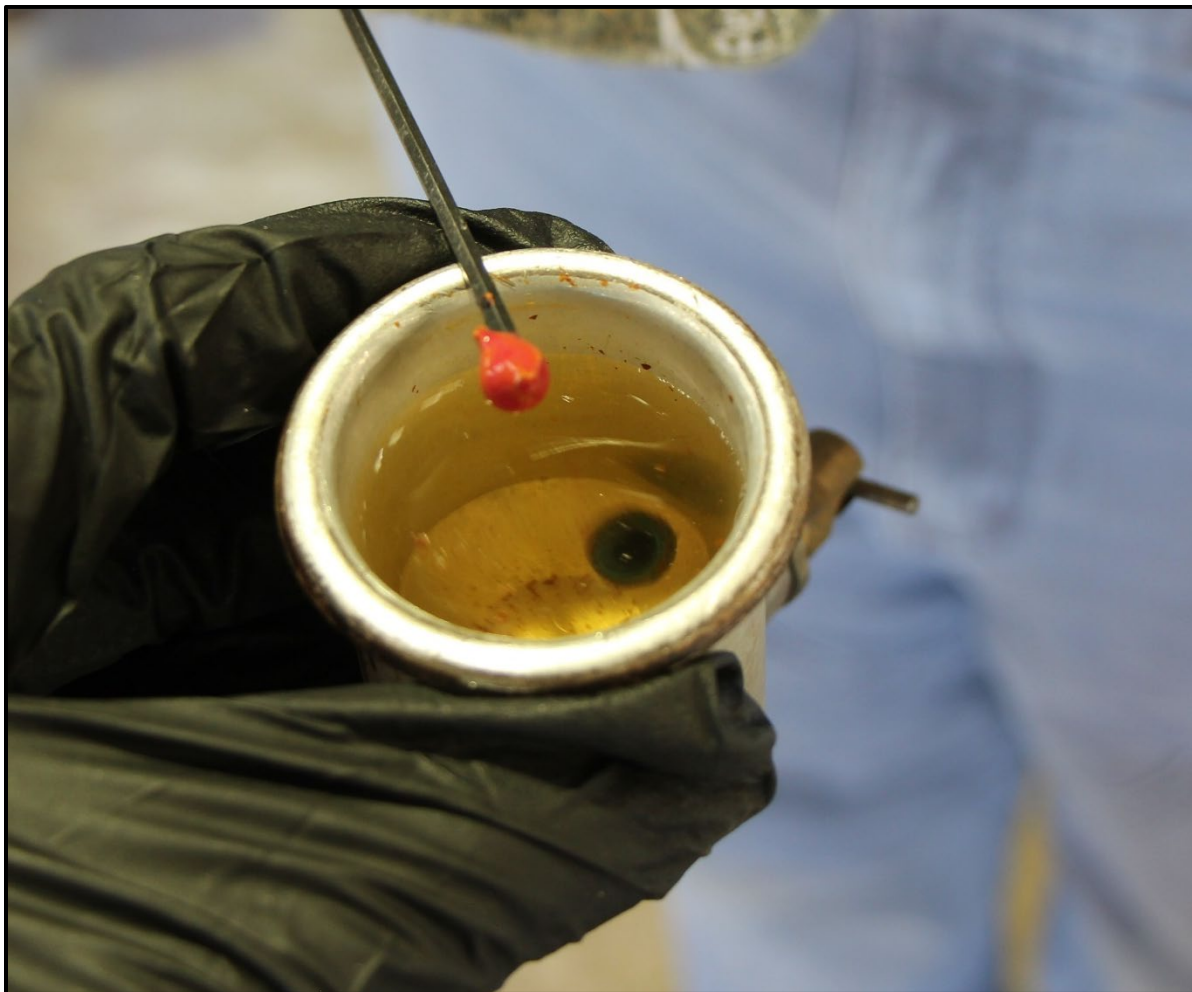
The fuel gascolator bowl was full of a yellow, rust-colored liquid and a Kolor Kut water finding paste test was positive for water contamination. The nut on the gascolator was noted as finger tight, but the bowl was otherwise sealed. The gascolator filter displayed a trace amount of debris.

Photograph 2: Gascolator Bowl and Kolor Kut Water Finding Paste Test

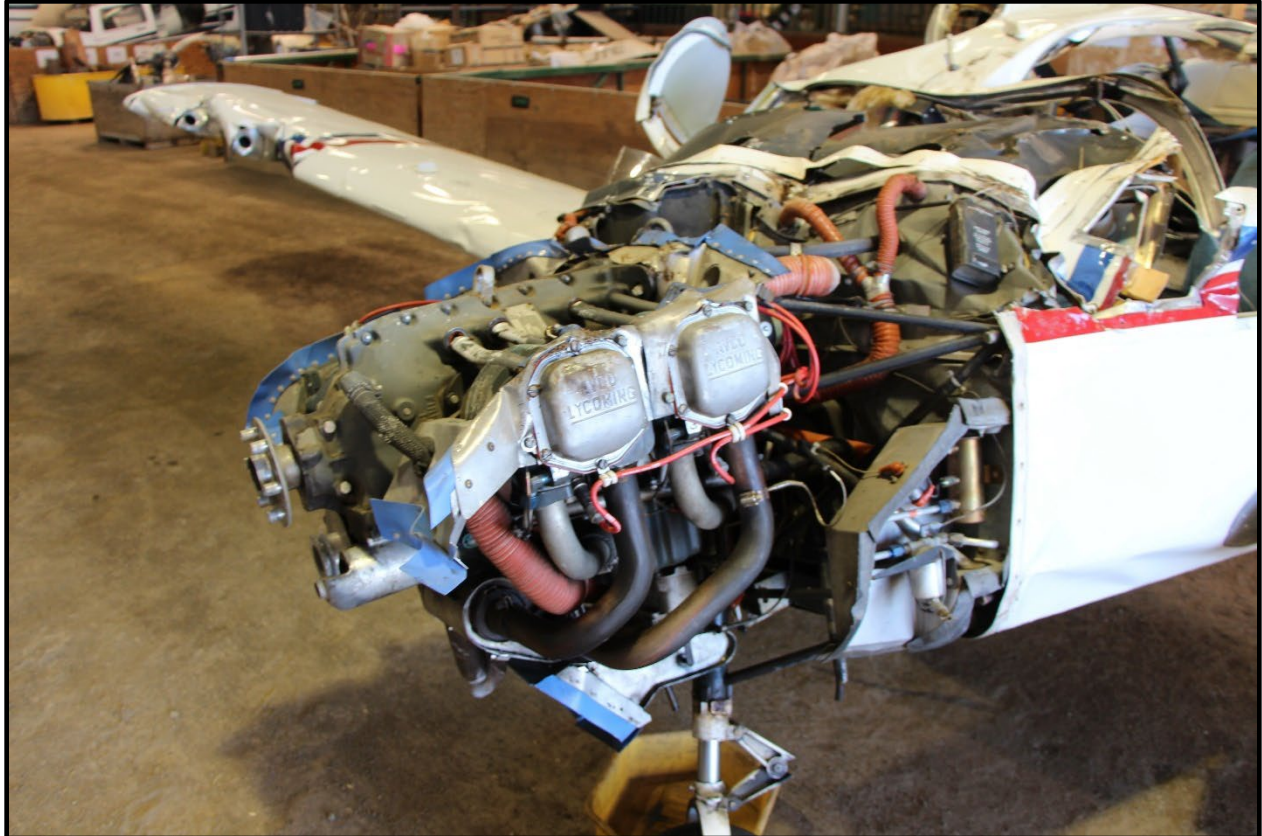
Photograph 3: Engine Prior to Examination

The engine was a Lycoming Engines O-235-L2C, s/n L-16209-15, an air-cooled, 115 hp reciprocating engine. The baffling was damaged, the cylinder 2 valve push rods were displaced and the cylinder 2 rocker was damaged.

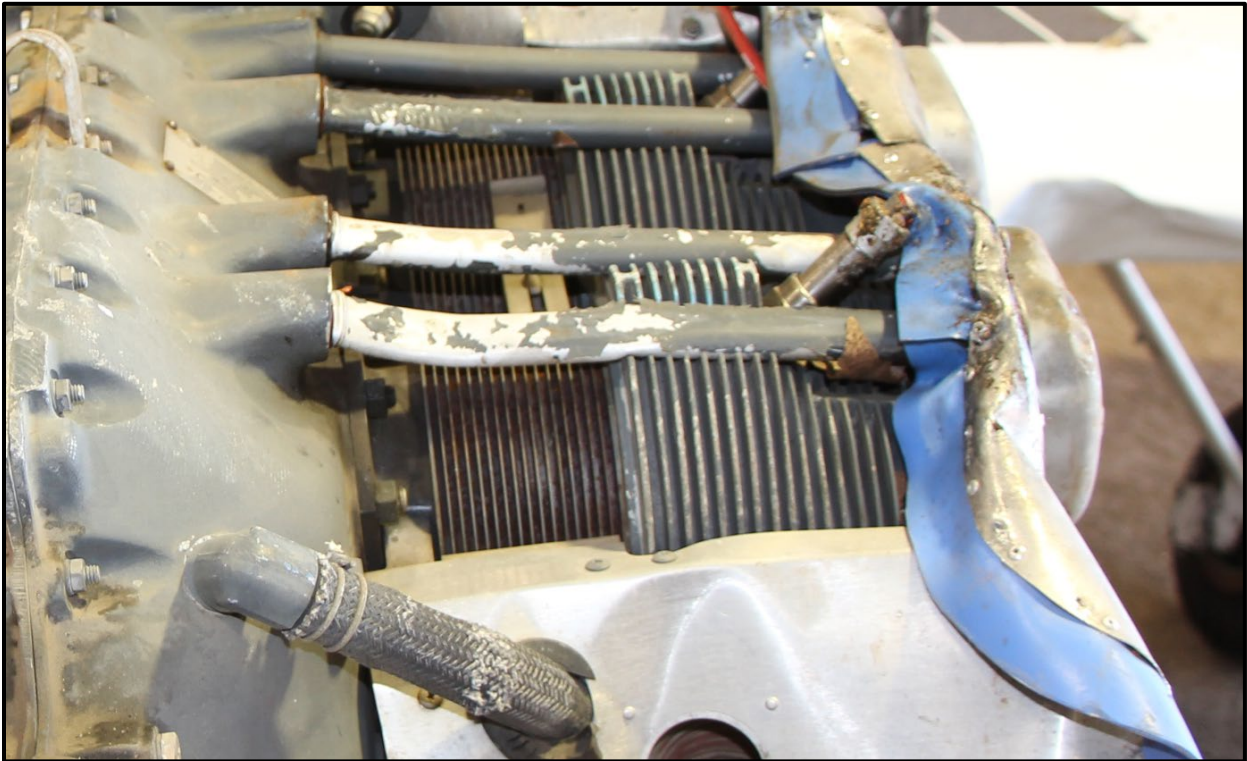
Mechanical continuity was established throughout the rotating group, valve train and accessory section as the crankshaft was manually rotated with a drive tool. Thumb compression in the proper firing order was observed at cylinders 1, 3, and 4. Cylinder 2 exhibited low compression due to a crushed intake push/pull tube; however, thumb compression was achieved after the intake tube rocker arm was removed. Most of the rocker arms displayed normal lift when the crankshaft was rotated, with exception of the cylinder 2 intake valve rocker. Examination of the interior components using a lighted borescope revealed no indications of catastrophic engine failure.

Photograph 4: Cylinder 2 Intake and Exhaust Push Rods

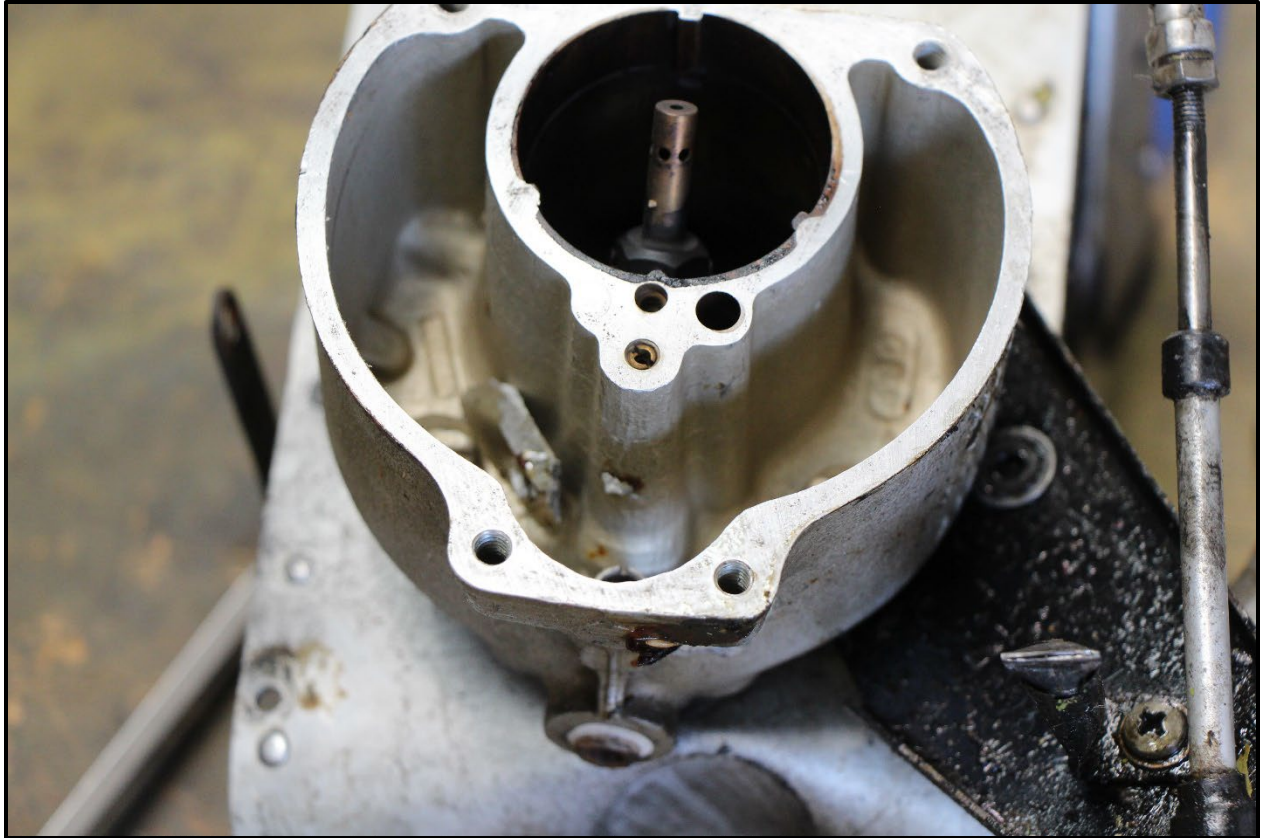
The carburetor was partially fractured at the mount, but remained attached to the engine. A trace amount of water was contained within a rubber seal at the fuel pressure transmitter, but no water observed inside the carburetor. The fuel bowl did not contain any residual fuel, corrosion, or white residue to indicate water contamination. The carburetor fuel screen was free of debris, the floats were unremarkable with no evidence of hydraulic deformation.

Photograph 5: Carburetor Fuel Bowl
