## **NATIONAL TRANSPORTATION SAFETY BOARD**

### **ACCIDENT SITE EXAMINATION**

**WPR21FA045**

Location: Whidbey Airpark (W10), Langley, Washington  
Date: November 11, 2020  
Aircraft: Cessna 177, N34633  
NTSB Investigator-in-Charge: Samantha Link

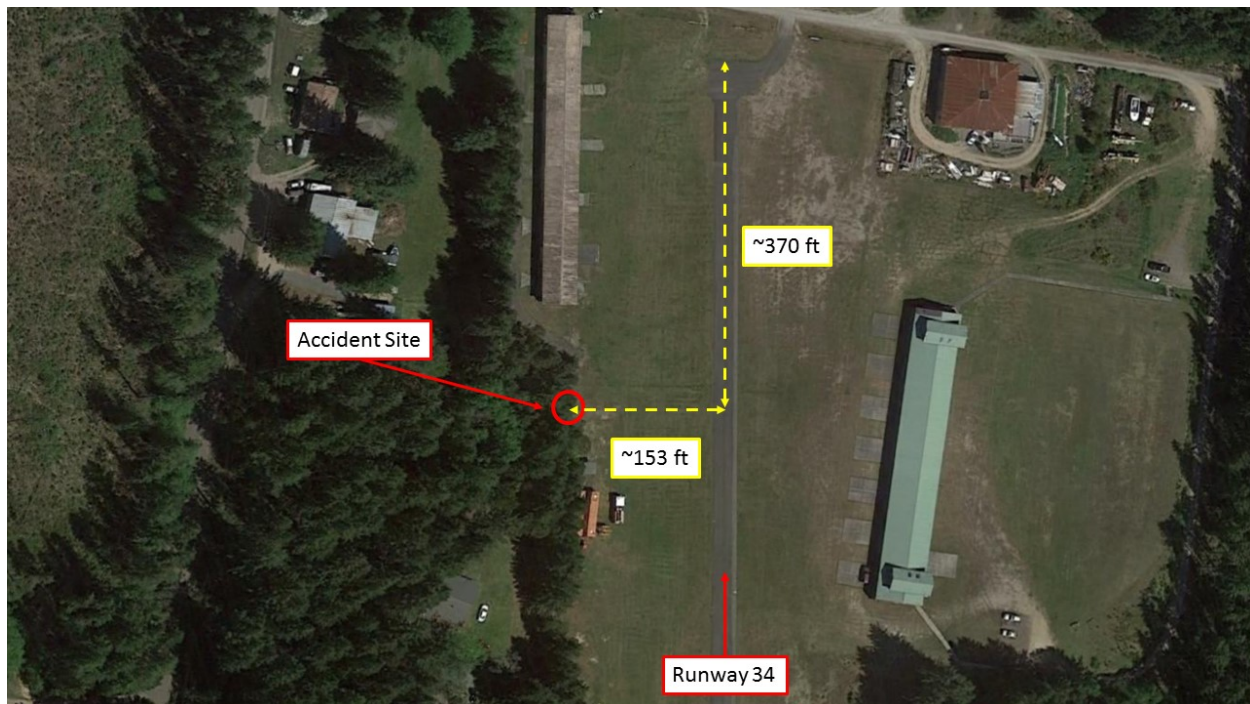
Examination of the accident site revealed that the airplane impacted trees and terrain about 153 ft west and 370 ft south of the departure end of runway 34 at an elevation of about 271 ft mean sea level (msl). The airplane came to rest in a near vertical attitude on a heading of about 277° magnetic. Several trees, about 60 to 70 ft in height surrounded the main wreckage. One tree exhibited impact marks on the eastern side of the tree from about mid height and extended downward to the main wreckage along with several broken branches. Two adjacent trees had several broken or damaged branches.

Figure 1: Diagram of accident site location.

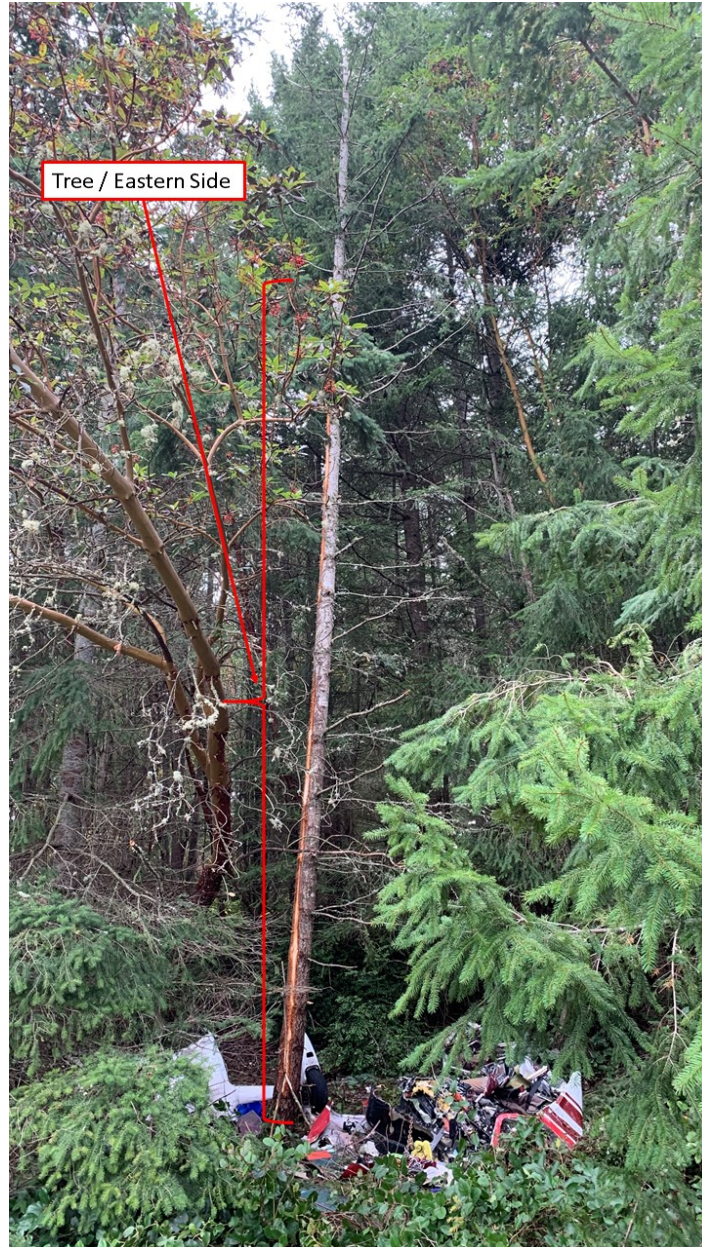
Figure 2: Damaged tree with main wreckage.

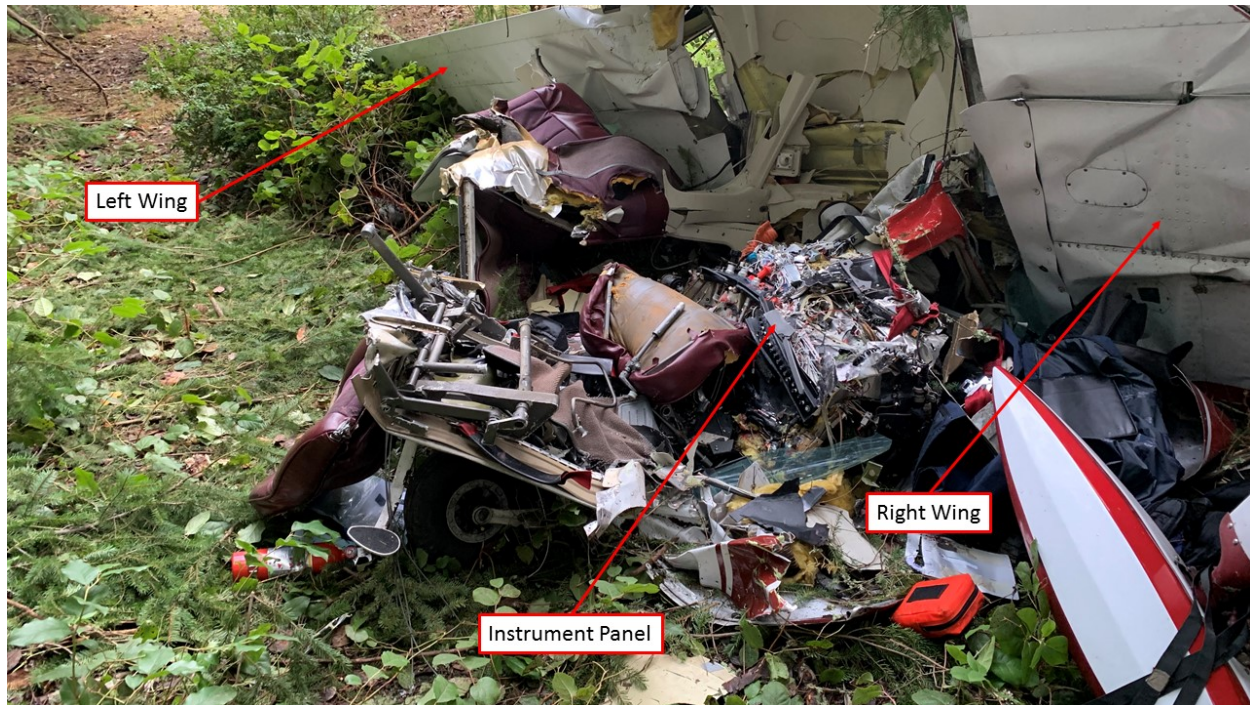
Examination of the airframe revealed that the center section of the fuselage slightly forward of the gearbox to just aft of the rear seats was cut by first responders. The cabin area, including the instrument panel and glareshield exhibited aft buckling and bending. Both forward doorposts were impact damaged and separated from the wing and cabin roof structure.

Figure 3: Cabin area, instrument panel, and wings.

The instrument panel was fragmented into multiple sections with numerous instrument displacement.

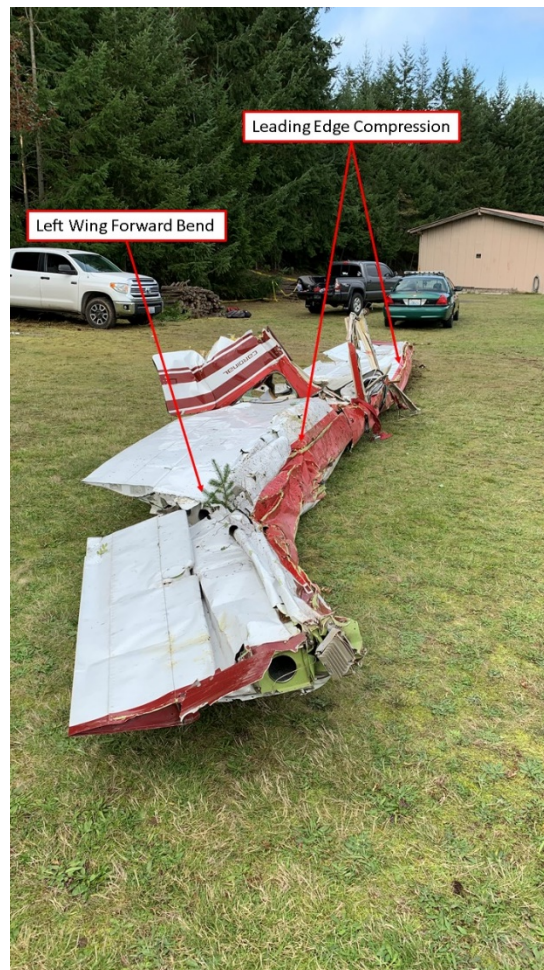
The left wing remained attached to the fuselage. The flap and aileron remained attached to their respective mounts. The leading edge was compressed aft throughout its span to the forward spar. The left wing was bent slightly forward at the flap / aileron junction. The left fuel tank was breached, and the left fuel tank cap was found secure and in place.

The right wing remained attached to the fuselage. The flap and aileron remained attached to their respective mounts. The leading edge was compressed aft throughout its span to the forward spar. A circular indention on the bottom side of the wing was observed about 2 – 3 ft outboard of the wing root area, consistent with impact with a tree. The right fuel tank was breached, and the right fuel tank cap was found secure and in place.

**Figure 4: Left and Right Wings**

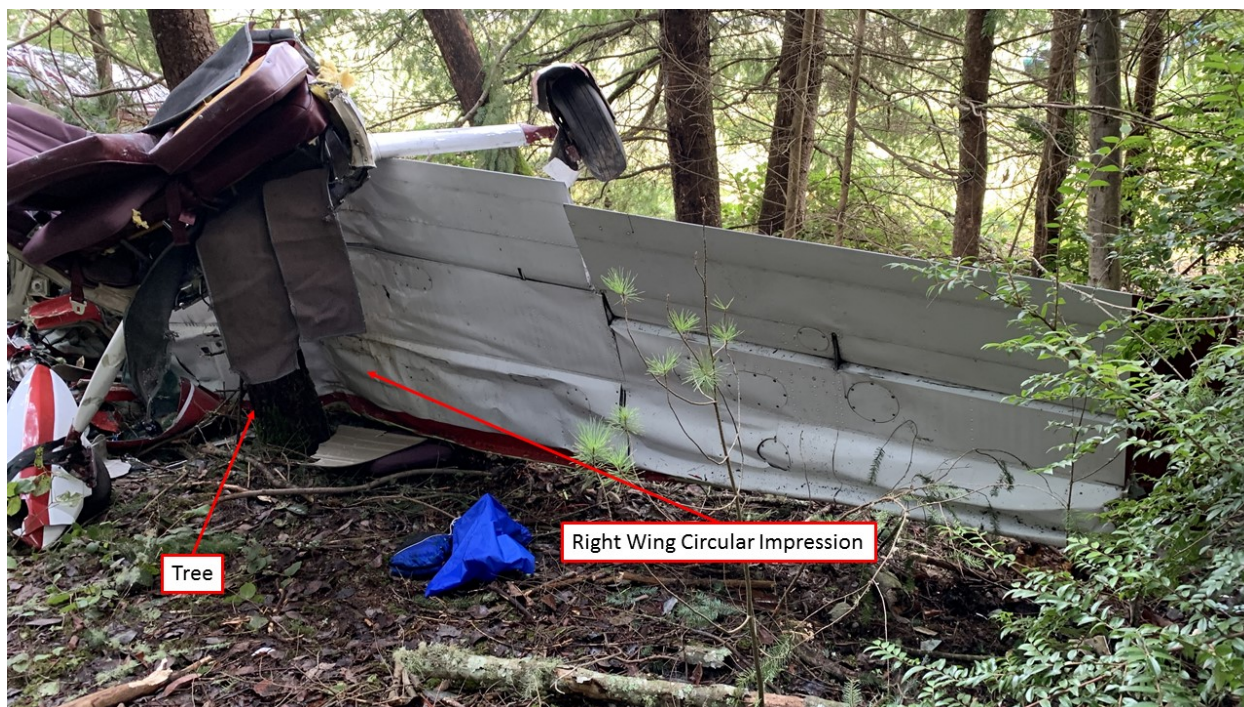
**Figure 5: Right Wing and Tree**

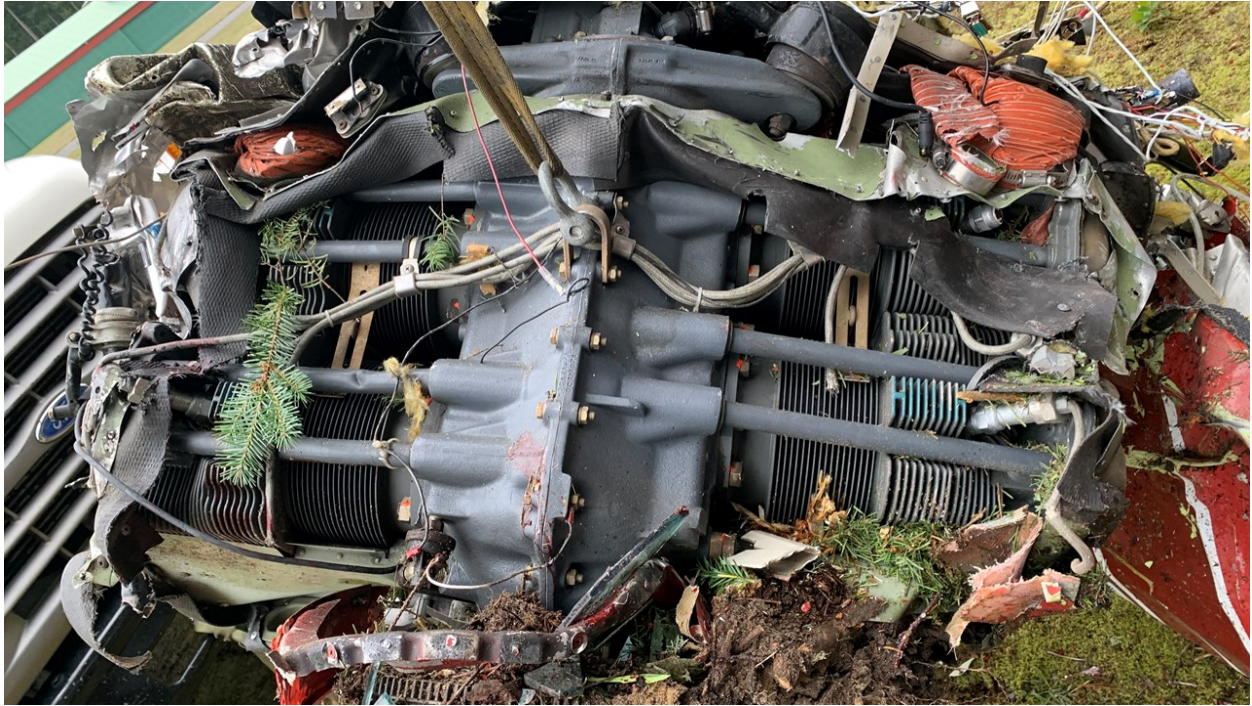
The engine remained attached to the airframe engine mounts. The firewall was compressed into the aft side of the engine, with portions of the magneto protruding through the firewall. All four cylinders remained attached to the engine crankcase. No damage to the upper side of the engine crankcase was observed. The carburetor remained attached to its mount and the throttle lever and cable remained attached. The induction airbox was impact damaged. The exhaust and induction system were impact damaged. The ignition harness was impact damaged. The oil dipstick was displaced and bent. The dipstick tube was impact damaged and separated from the engine.

Figure 6: Upper portion of the engine.

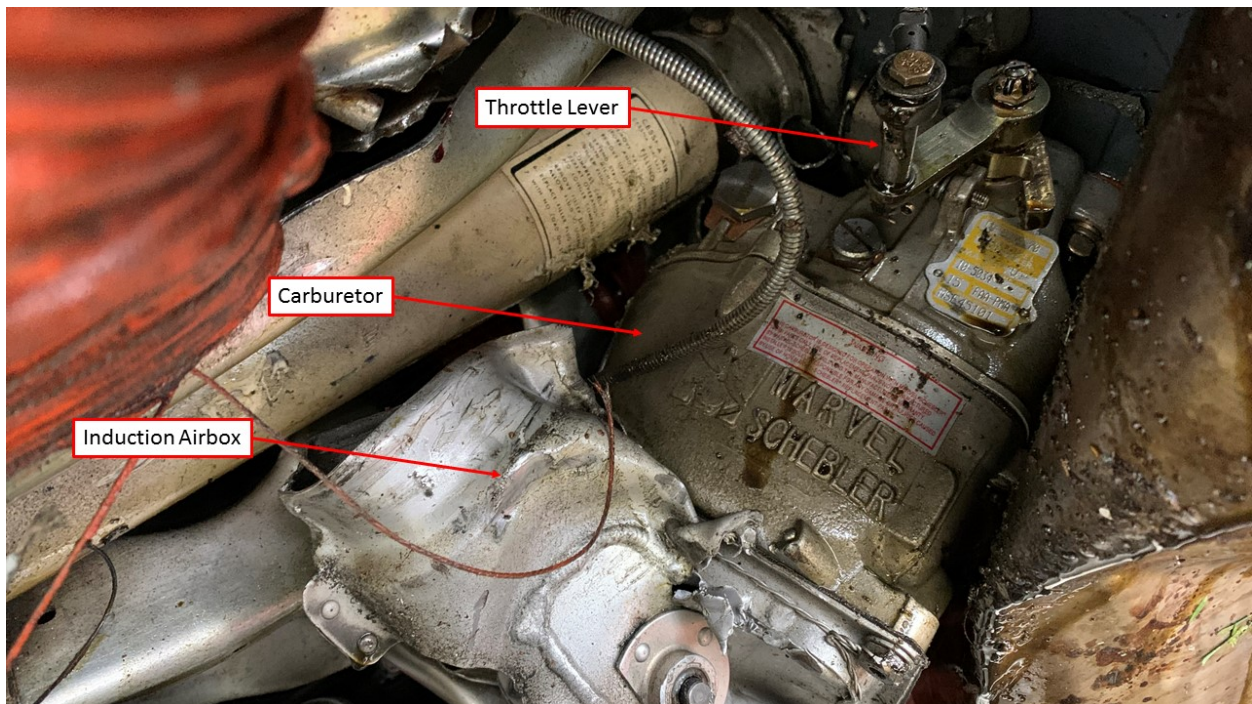
Figure 7: View of the Carburetor and Induction Airbox

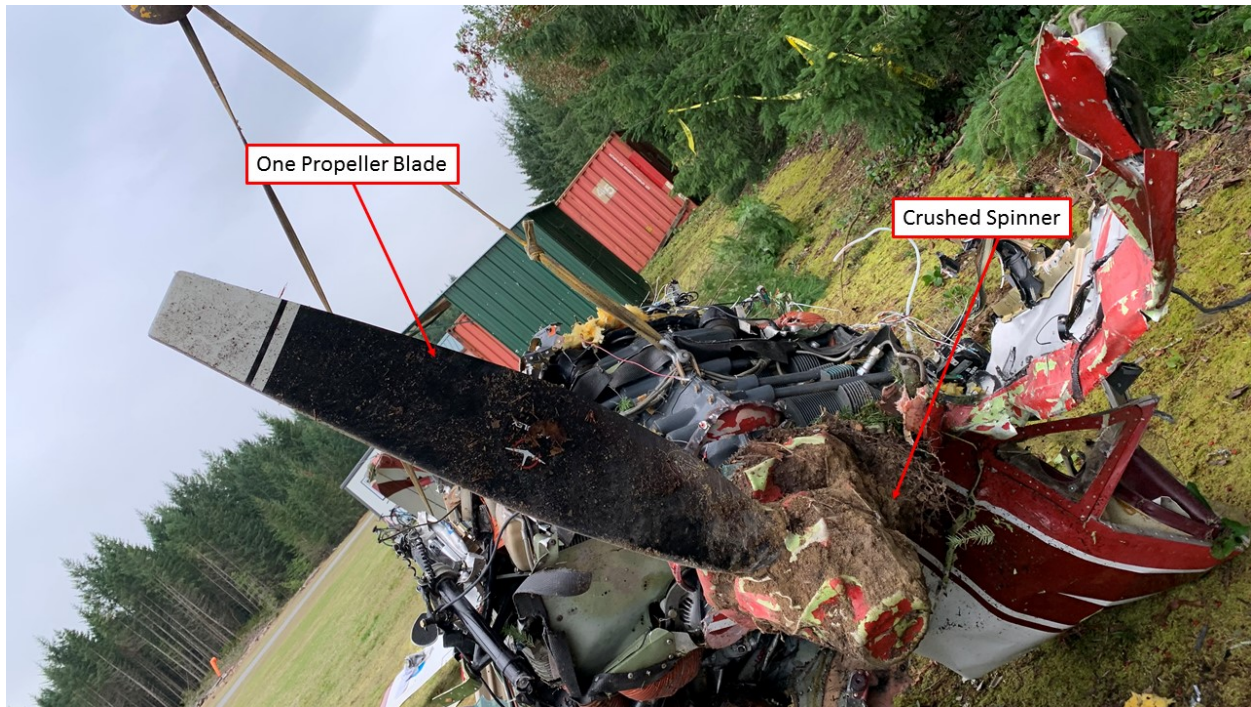
The propeller remained attached to the crankshaft. One blade was bent aft underneath the engine. The opposing blade appeared straight with no damage observed. The spinner was crushed aft around the propeller hub.

**Figure 8: View of the engine, one propeller blade, and spinner.**
