## RECORD OF EMAIL

**Date: November 22, 2020**  
**Person Contacted: Mr. Ryan Maxfield (Witness)**  
**NTSB Accident Number: WPR21FA045**

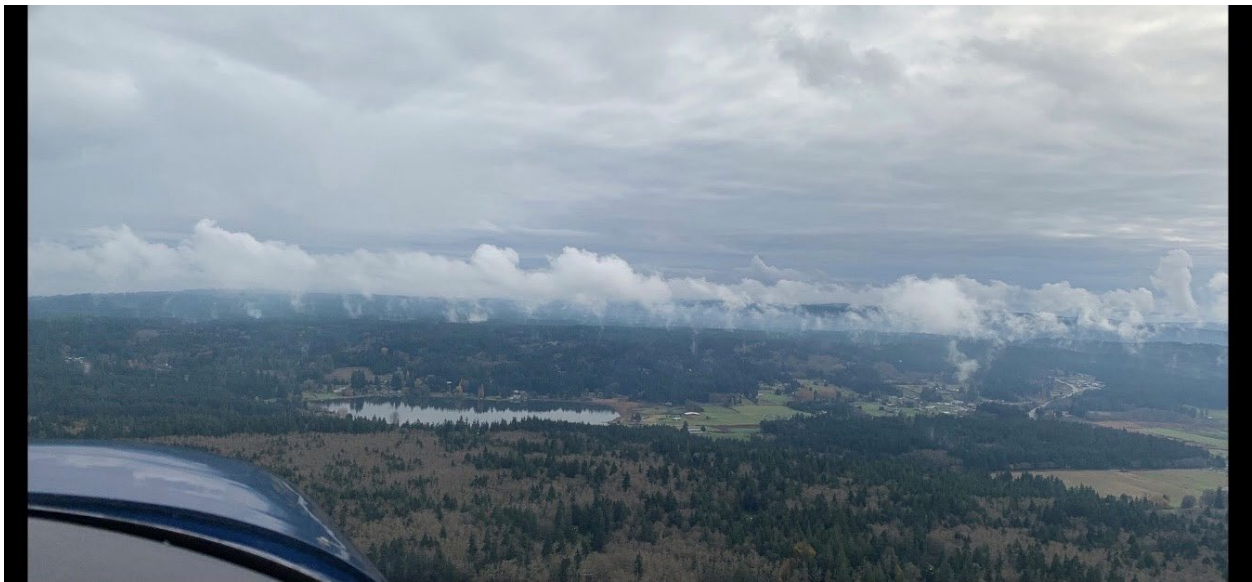
I also attached a photo of our approach from the Northwest. [See below] Photo was taken about 10am PST, water seen is Lone Lake as we head east to enter the left pattern for 34.

Figure 1: A photo of the witness's approach from the Northwest. Photo was taken about 10am PST, water seen is Lone Lake as we head east to enter the left pattern for 34.
