## **NATIONAL TRANSPORTATION SAFETY BOARD**

# **AIRFRAME AND ENGINE EXAMINATION**

**WPR21FA045**

Location: Whidbey Airpark (W10), Langley, Washington  
Date: November 11, 2020  
Aircraft: Cessna 177, N34633  
NTSB Investigator-in-Charge: Samantha Link

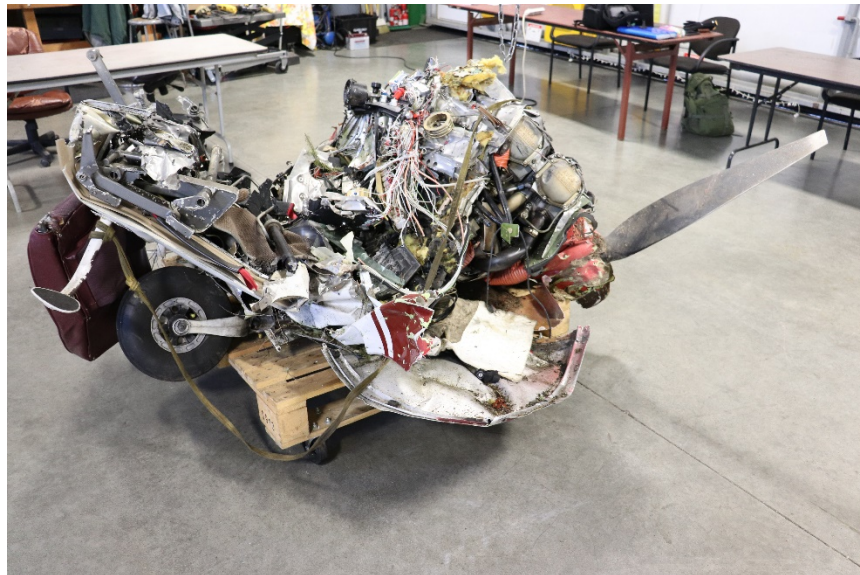
Examination of the recovered airframe revealed that the wings, cabin roof were separated from the fuselage. The fuselage was separated into multiple pieces.

**Figure 1: Recovered engine/cabin area.**

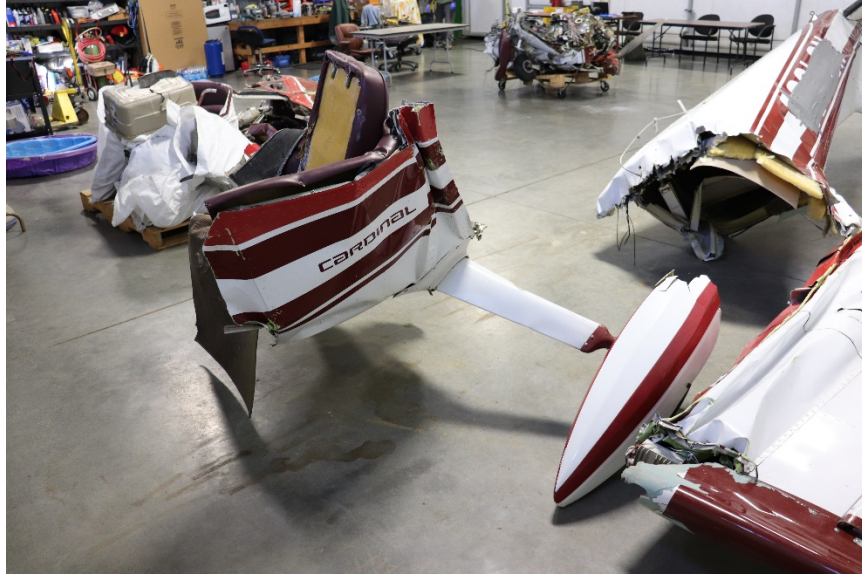
**Figure 2: View of the recovered wreckage.**

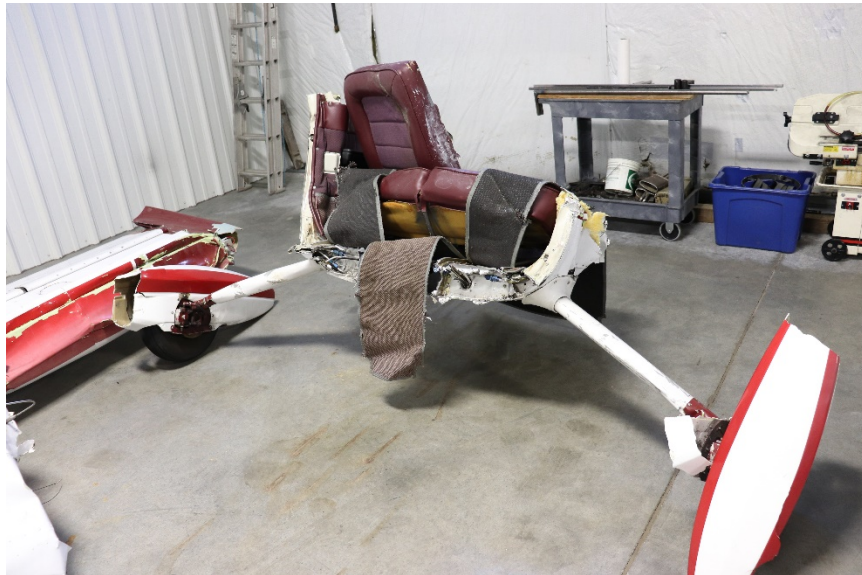
**Figure 3: View of the recovered wreckage.**

Flight control continuity was established throughout. All areas of separation were consistent with overload or cut by recovery personnel.

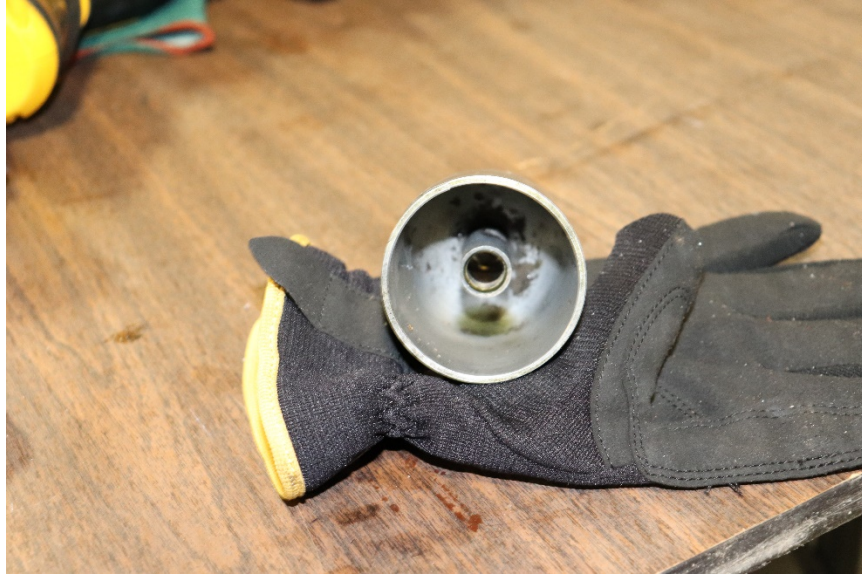
The gascolator (airframe fuel filter) was disassembled and examined. The gascolator bowl exhibited a slight amount of debris. The screen was clear.

**Figure 4: Gascolator bowl**

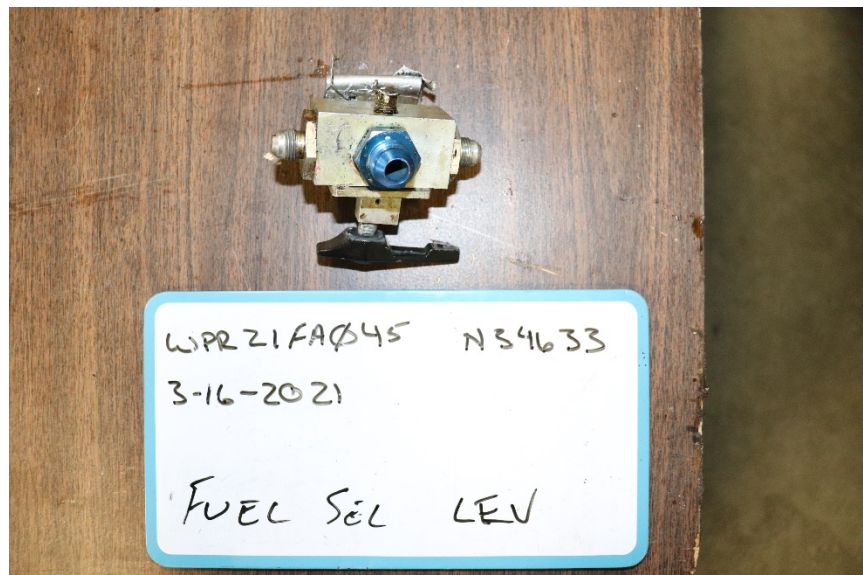
Fuel selector valve was in the “right” position. All ports were free of debris.

**Figure 5: Fuel selector valve**

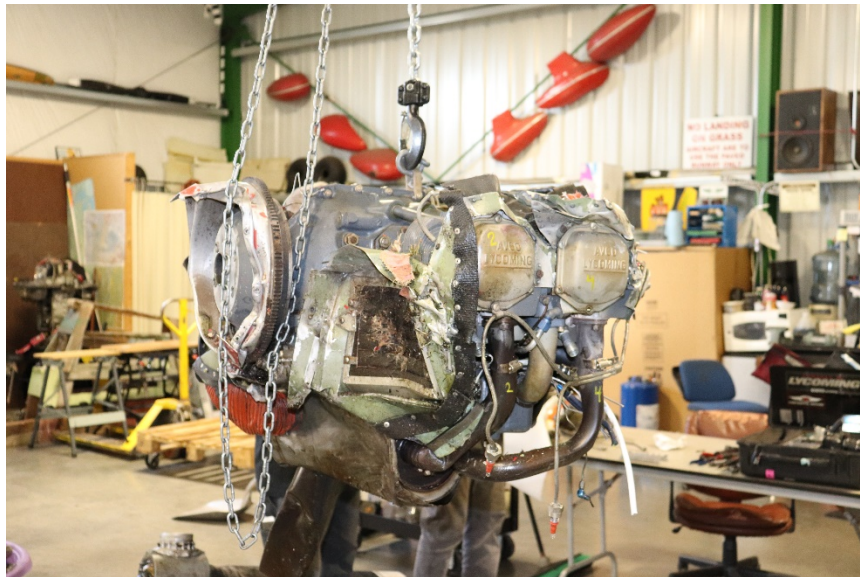
Examination of the recovered engine revealed that it remained attached to the fuselage firewall via its mounts. The carburetor was separated from the oil sump. The induction system and exhaust exhibited impact damage.

**Figure 6: View of the recovered engine**

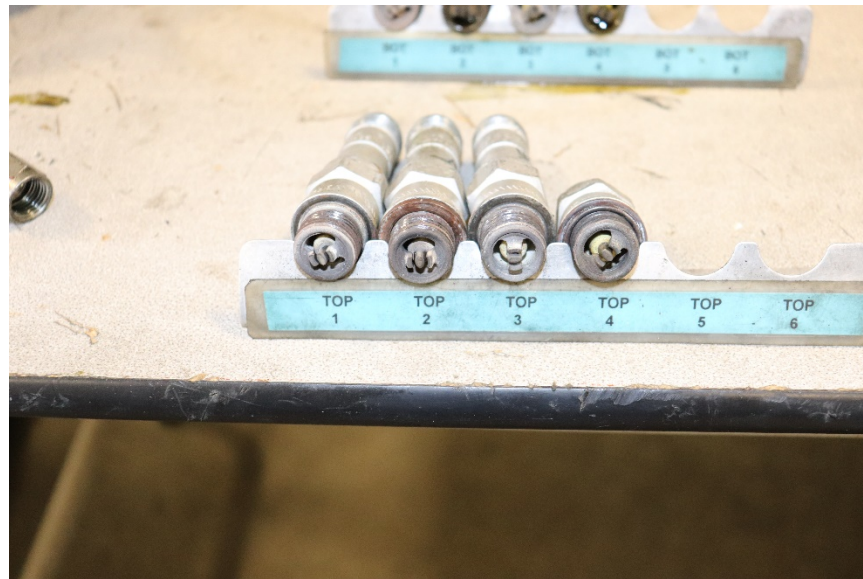
The upper and lower spark plugs were removed. All 8 spark plugs exhibited severe worn-out signatures. Bottom cylinder spark plugs 1 and 3 exhibited light gray deposits within the electrode area. Bottom cylinder spark plugs 2 and 4 were oil soaked. Upper spark plugs 1, 2, 3, and 4 exhibited gray deposits within the electrode areas.

**Figure 7: View of the top spark plugs**

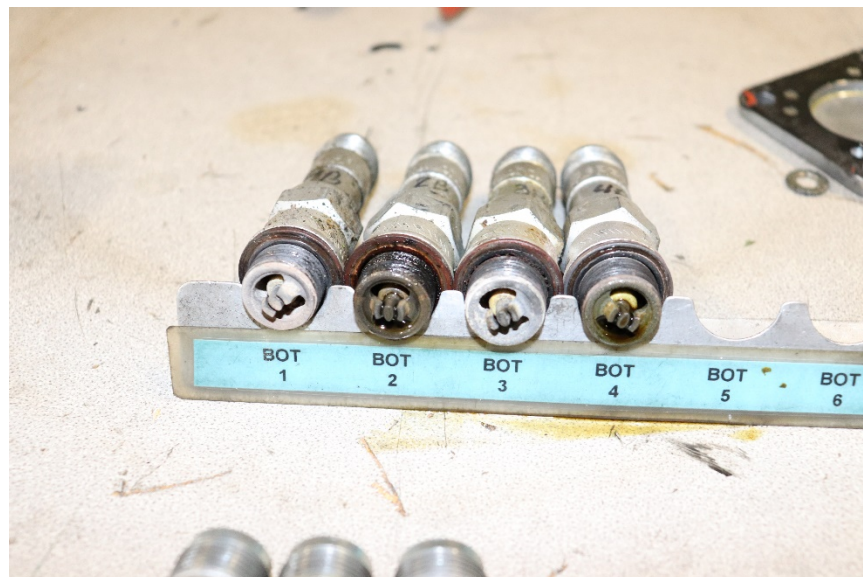
**Figure 8: View of the bottom spark plugs**
