# NATIONAL TRANSPORTATION SAFETY BOARD

## MATERIALS LABORATORY FACTUAL REPORT

Report No. 21-055

Place : Langley, Washington  
Date : November 11, 2020  
Vehicle : Cessna 177B, N34633  
NTSB No. : WPR21FA145  
Investigator : Samantha Link, AS-WPR

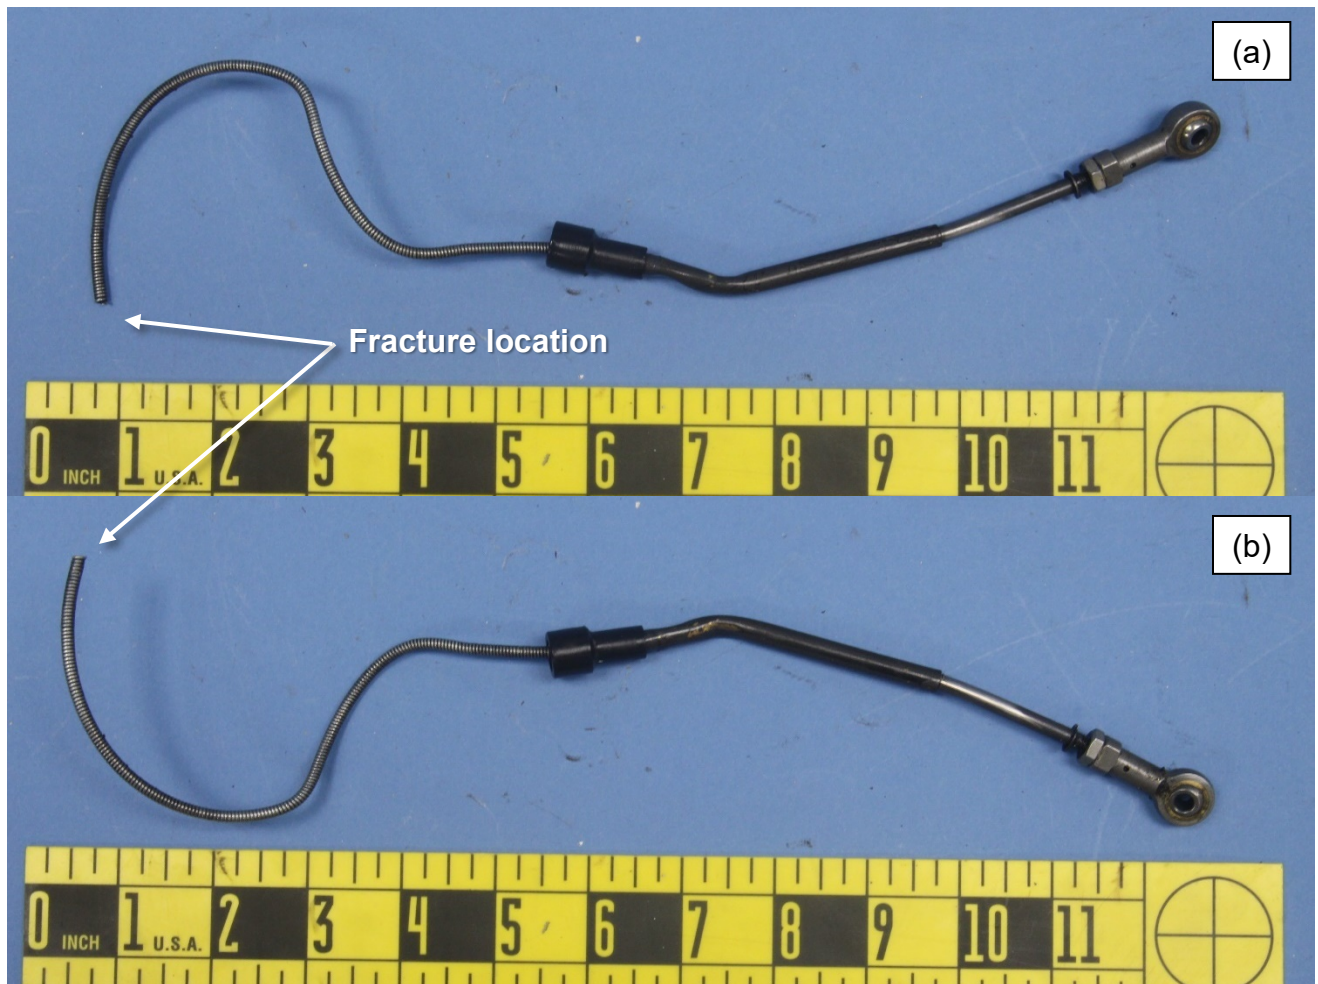
Figure 1 shows the throttle cable remnant submitted to the NTSB Materials Laboratory, as received. The cable consisted of six internal strands wrapped around a seventh internal strand, surrounded by an external thicker coiled wire acting as a sheath. The cable had fractured at one distinct location, illustrated in Figure 2. This was located approximately 7.75 inches from the end of the rubber boot shown in Figure 1.

Figure 1 – The throttle cable remnant, as received, viewed from opposite 180° sides (a), (b).

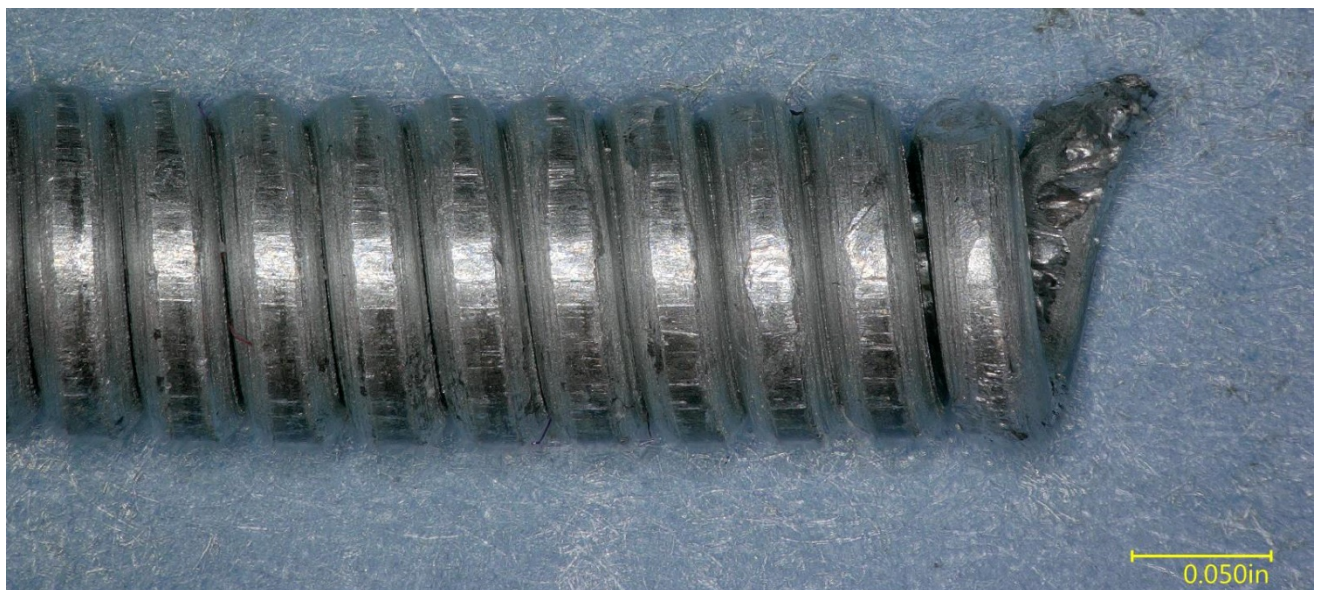
Figure 2 – Side view of the throttle cable remnant, showing the fracture surface.

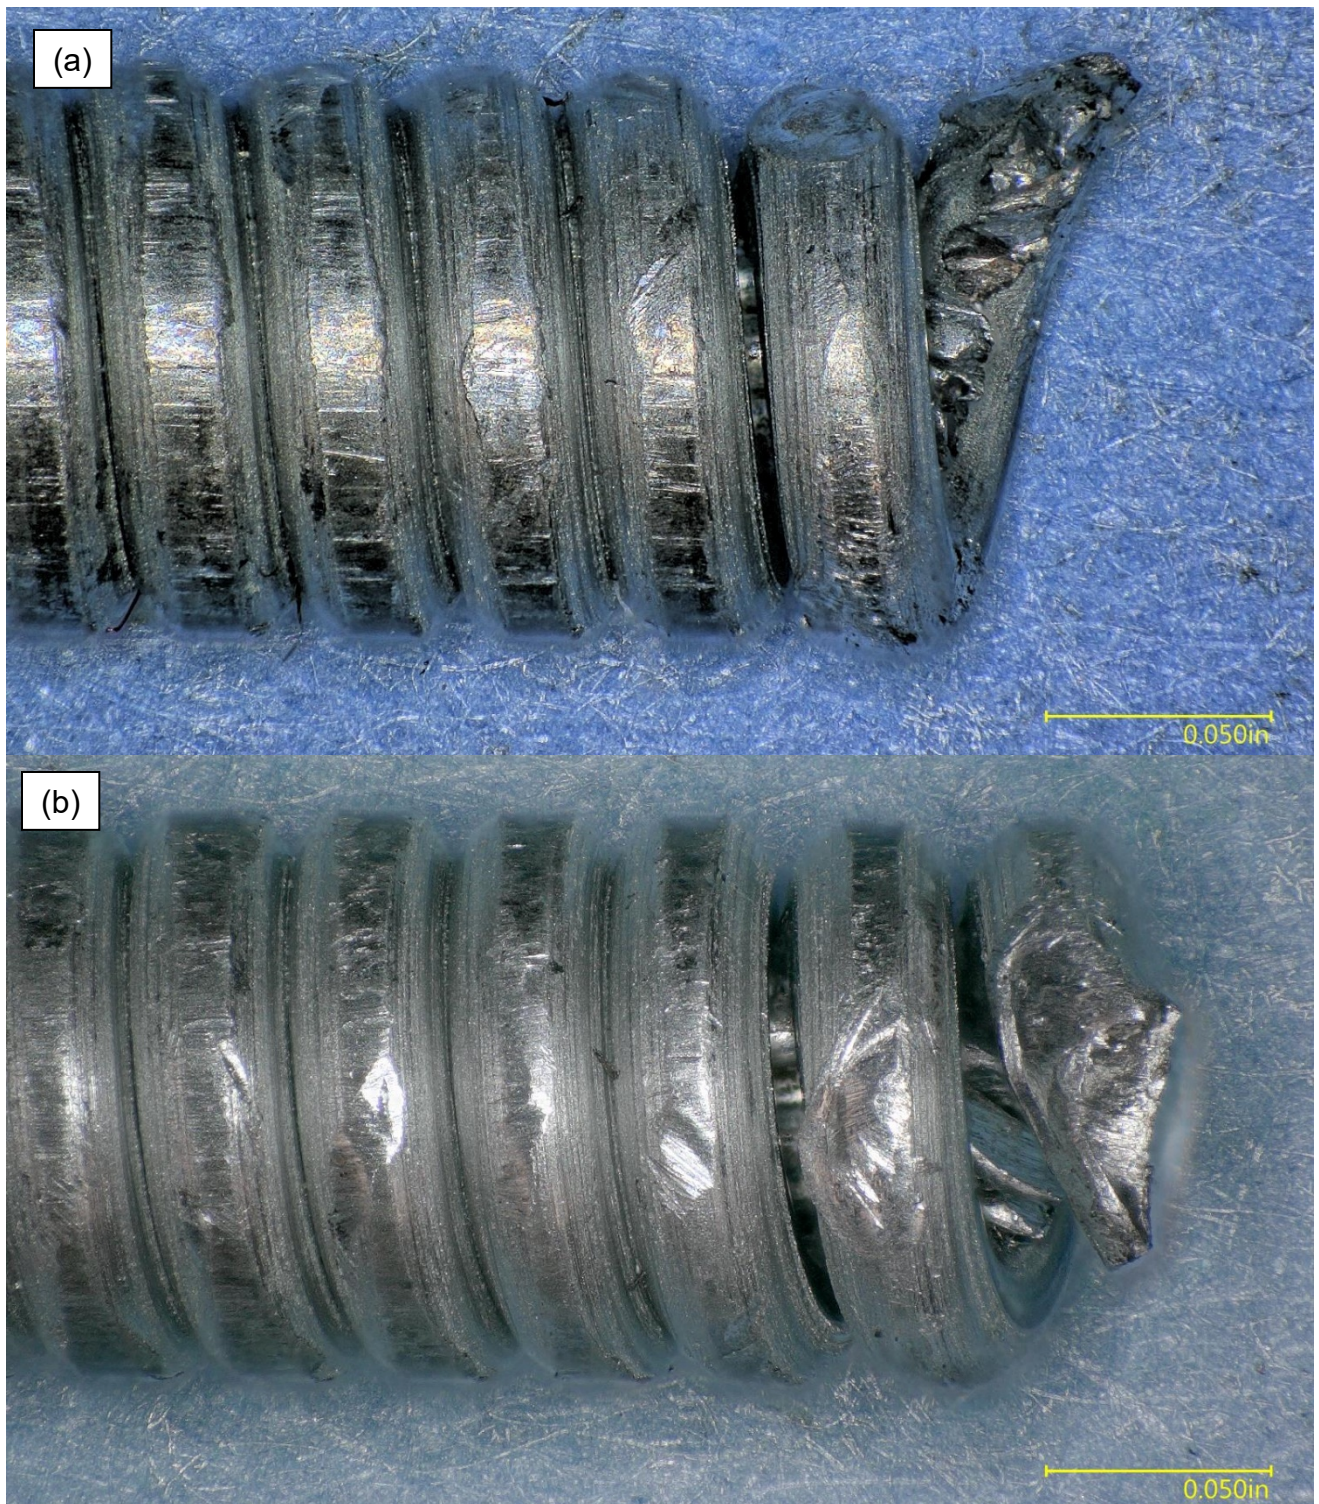
Figure 3 shows a closer view of the side of the cable near the fracture location. The outer surfaces of the coiled sheath showed flattening of the cylindrical wire, consistent with plastic deformation in a primarily longitudinal direction. The fracture of the outer coil sheath was generally perpendicular to the cable direction, but at an angle to the sheath. The inner strand had fractured at the same location as the outer coil sheath. Figure 4 shows the fracture surface of the strands and outer sheath in a planar view.

Figure 3 – Closer view of the fractured end of the cable, viewed from 180° opposite views (a), (b).

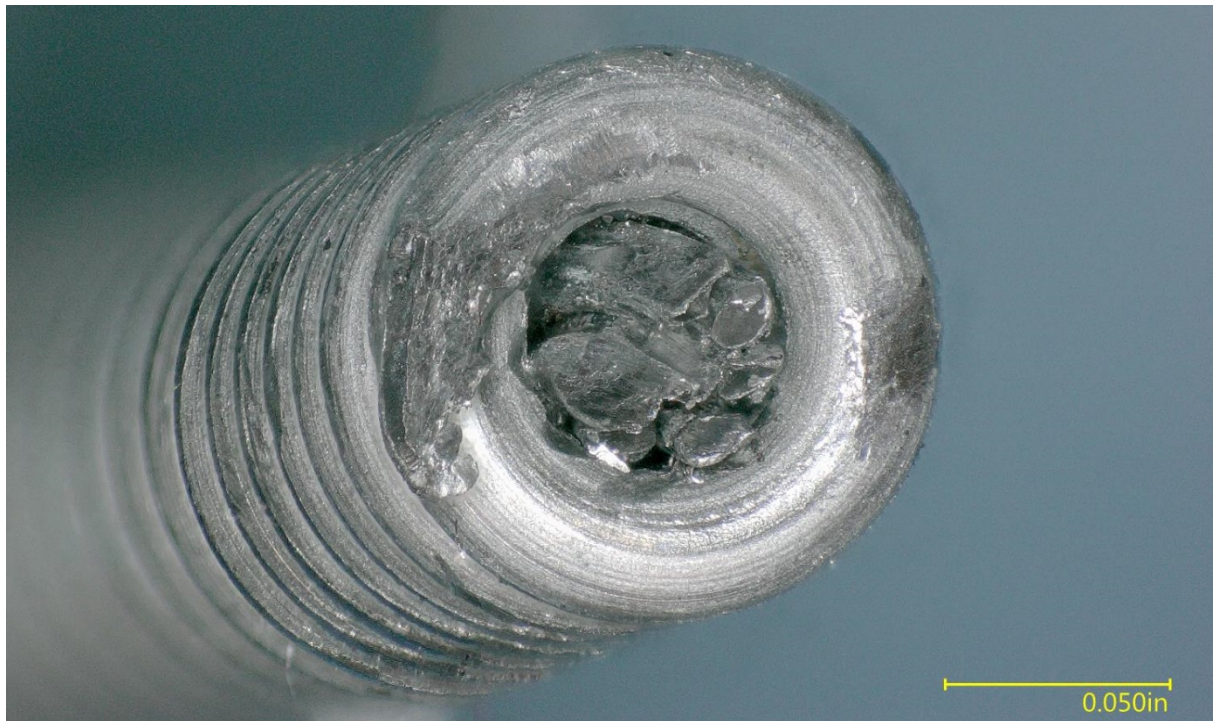
Figure 4 – Optical view of the throttle cable fracture surface.

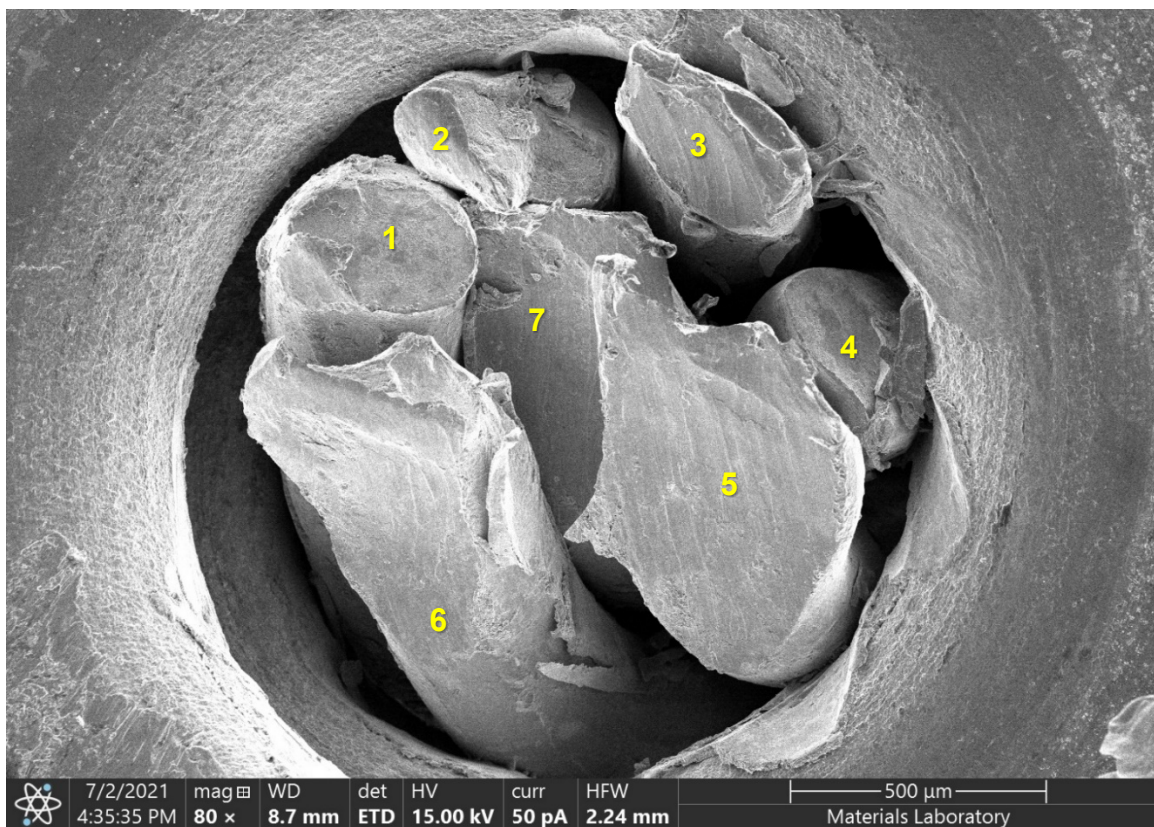
electron microscope (SEM). Figure 5 shows the fractured cable strands, which were numbered 1 through 6 for the purposes of this report. The center strand was labeled as 7.

Figure 5 – Secondary electron (SE) micrograph of the fractured cable strands of the throttle cable, numbered for the purposes of this report.

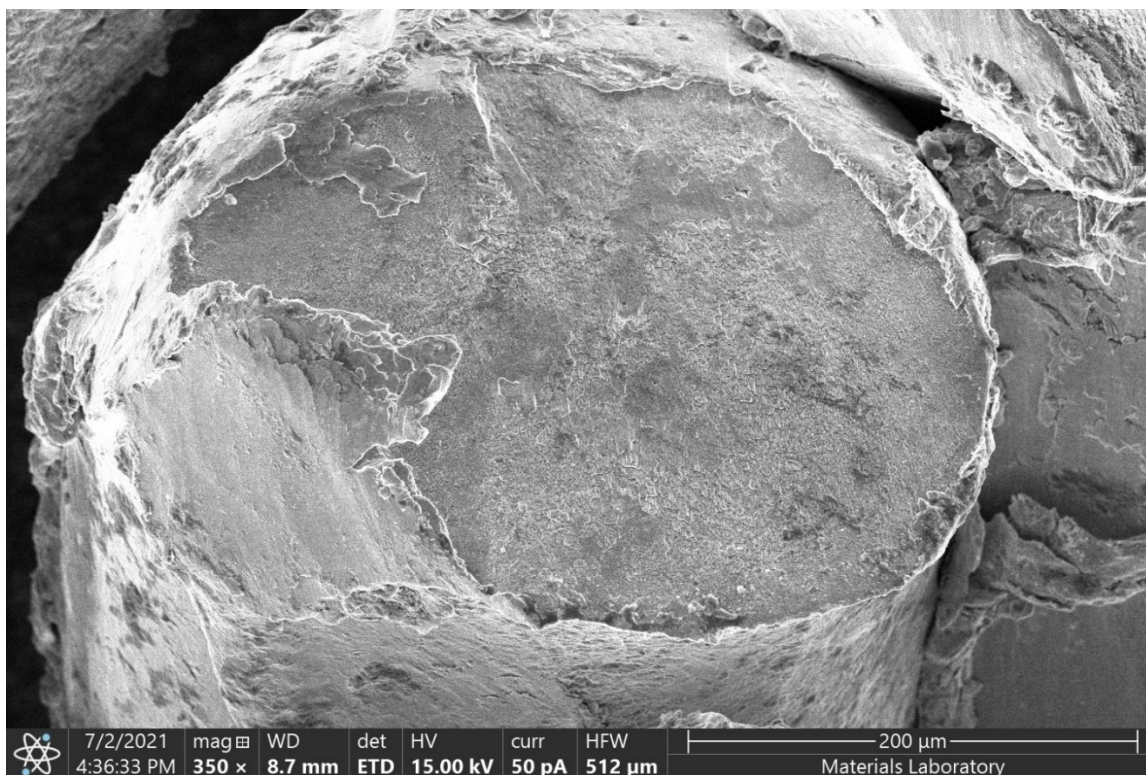
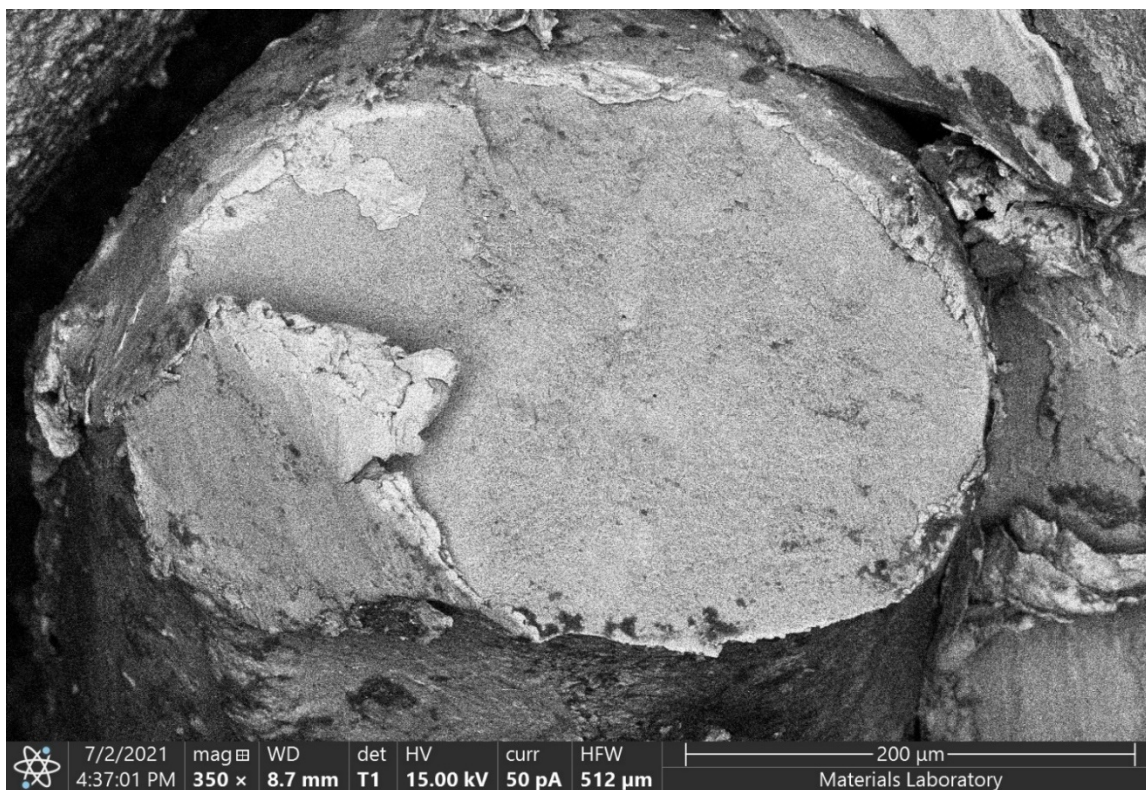
Figure 6 and Figure 7 show the overall fracture surface of Strand 1. The backscattered micrograph in Figure 7 more readily displays the areas of post fracture damage, which appear lighter in contrast.<sup>1</sup> As such, most of this strand fracture surface was relatively undamaged. The overall shape of the strand at the fracture surface was ovoid, as opposed to circular. The lower area of the figures showed the length of the strand surface, with the upper areas absent the strand, consistent with bending deformation, oriented towards the reader in the figures.

Figure 6 – SE micrograph of the Strand 1 fracture surface.

Figure 7 – Backscattered electron (BE) micrograph of the Strand 1 fracture surface.

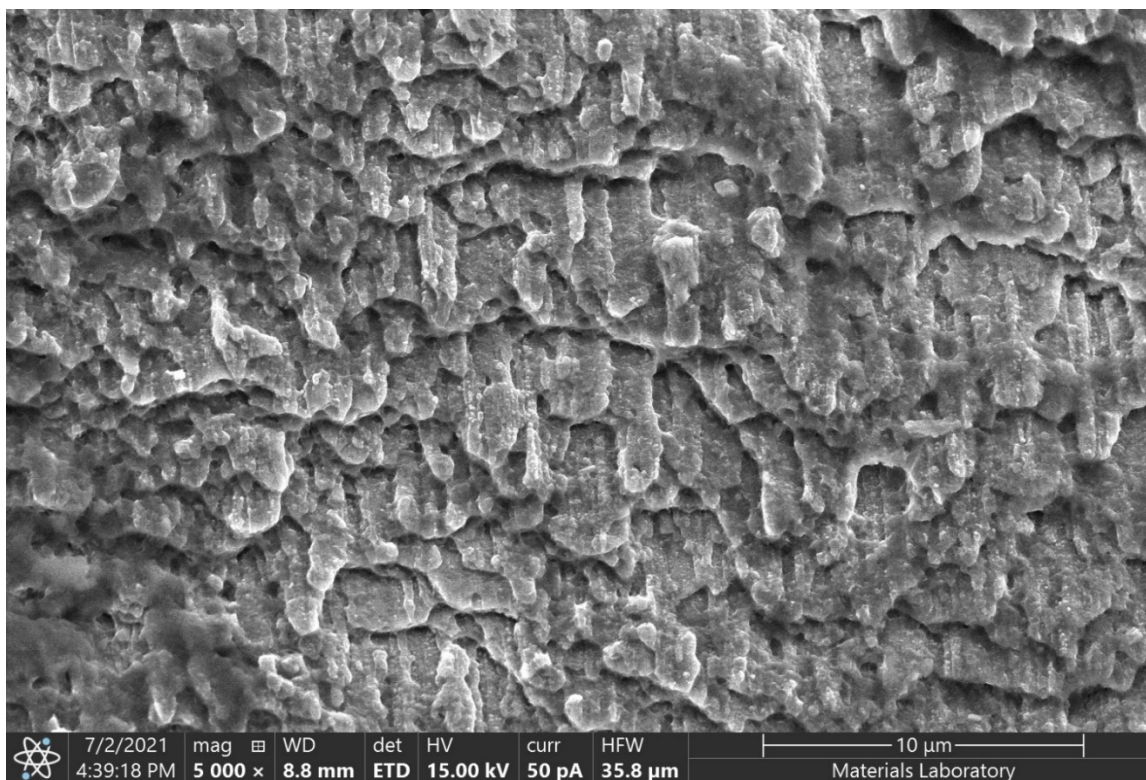
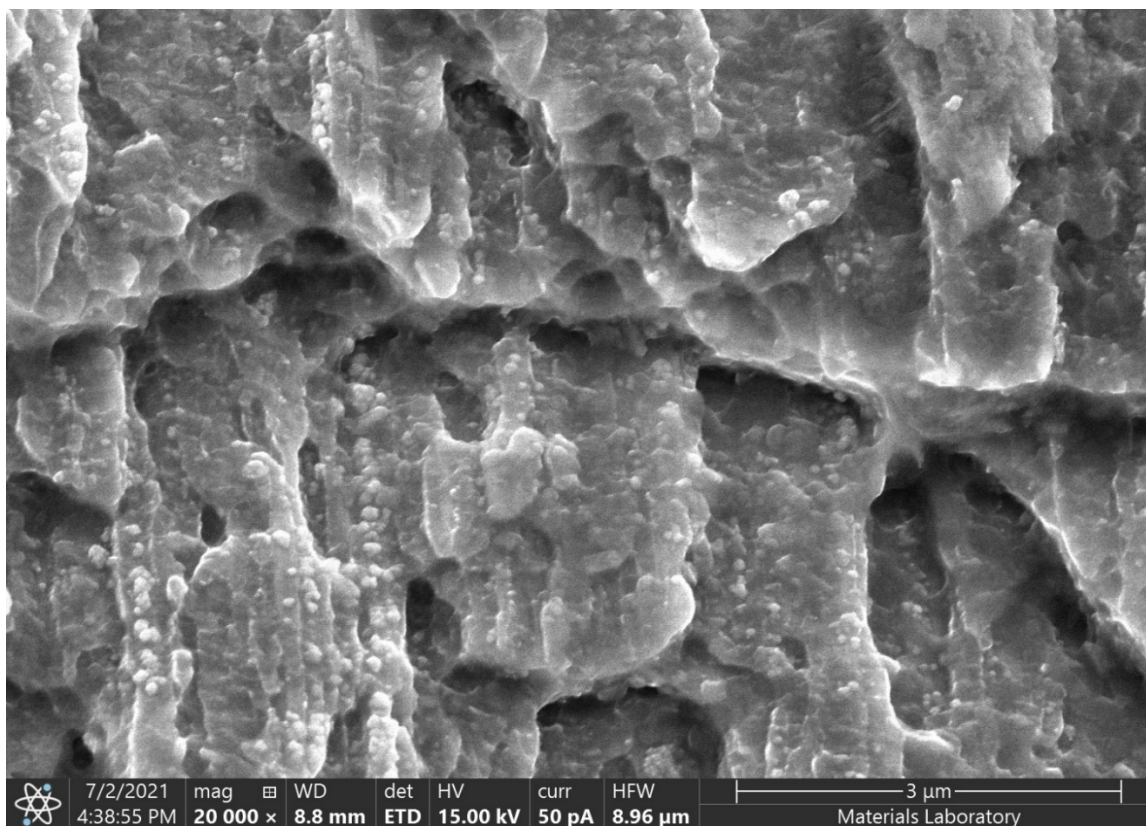
Figure 8 shows a closer view of the strand fracture surface, which exhibited a rough, fibrous morphology. A closer view of the fracture surface in Figure 9 revealed dimple rupture, consistent with overstress fracture. No other features indicative of other fracture modes were found on this strand.

Figure 8 – SE micrograph of a typical undamaged area of the Strand 1 fracture.

Figure 9 – SE micrograph of a closer view of Figure 8, showing dimpled rupture.

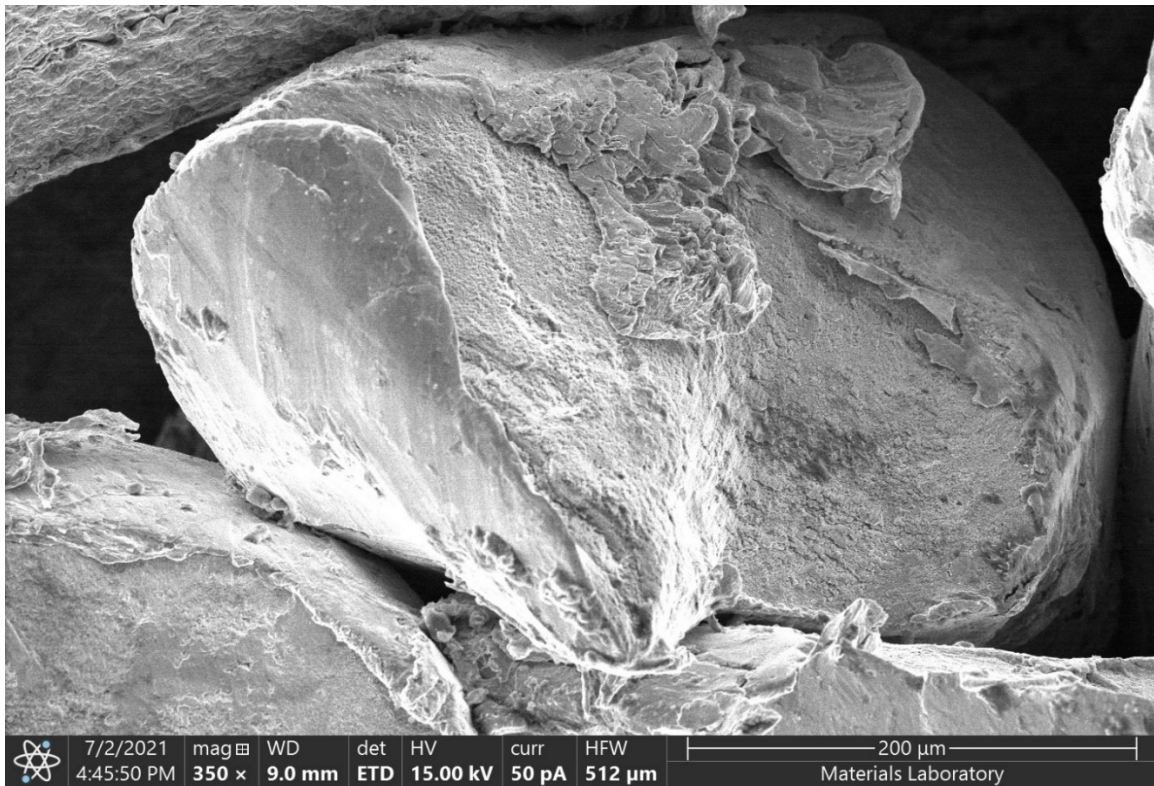
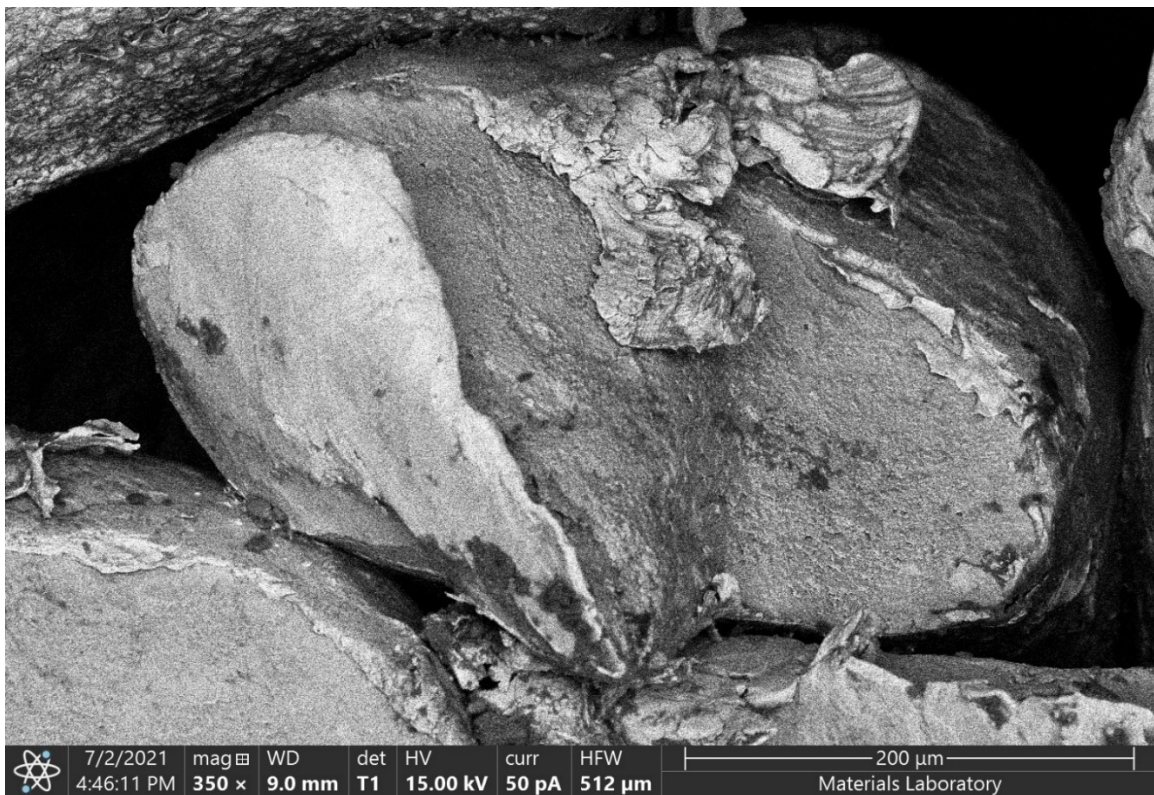
Figures 10 and 11 show the fracture surface of Strand 2. This fracture was generally ovoid in shape, with two major steps comprising the fracture. The step closest to the reader had been obliterated by post-fracture damage, consistent with outward smearing (upward in Figure 11). In addition, several outside areas exhibited smeared material towards the fracture surface, consistent with post-fracture smearing damage.

Figure 10 – SE micrograph of the Strand 2 fracture surface.

Figure 11 – BE micrograph of the Strand 2 fracture surface.

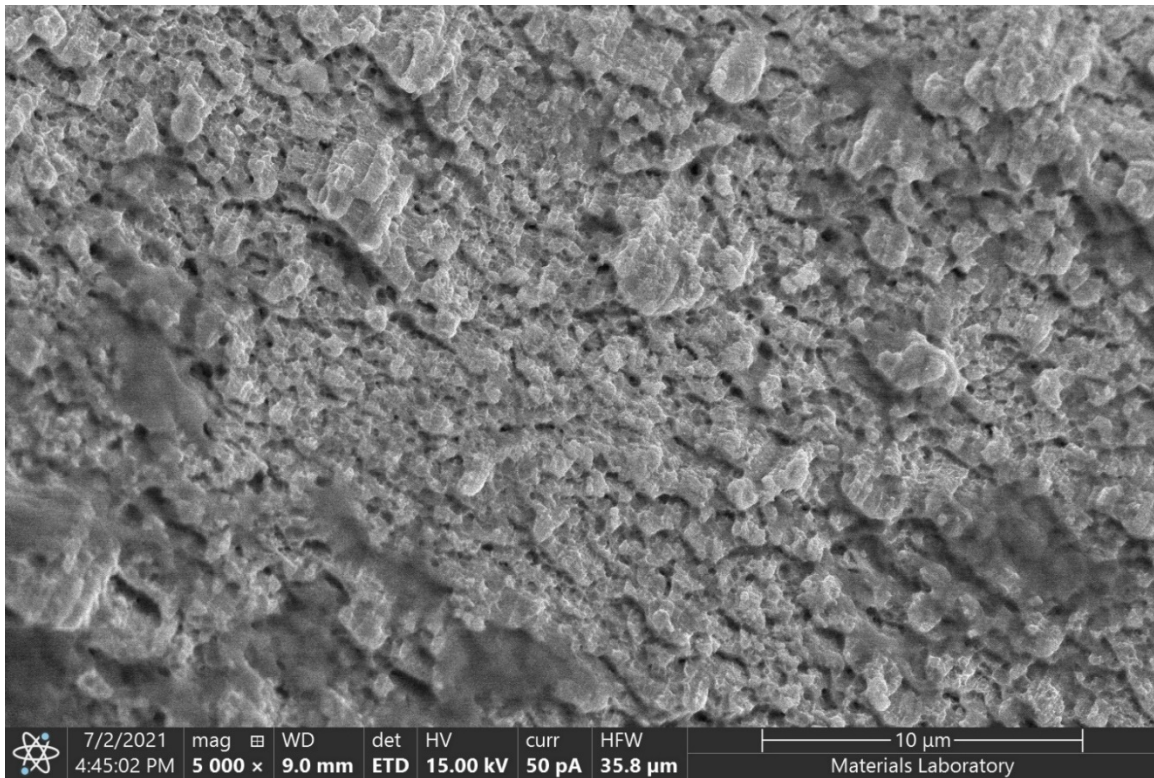
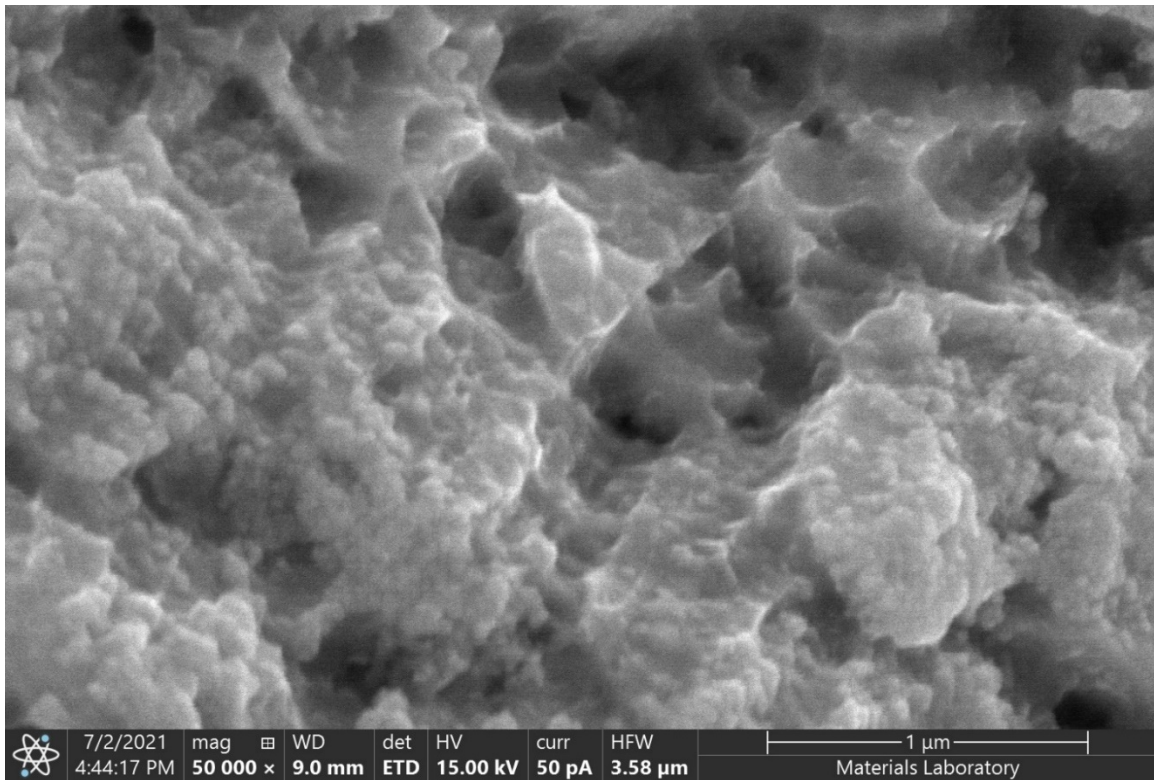
Figure 12 shows a closer view of the strand fracture surface, which exhibited a rough, fibrous morphology, albeit flatter than Strand 1. A closer view of the fracture surface in Figure 13 revealed dimple rupture, consistent with overstress fracture. No other features indicative of other fracture modes were found on this strand.

Figure 12 – SE micrograph of a typical undamaged area of the Strand 2 fracture.

Figure 13 – SE micrograph of a closer view of Figure 12, showing dimpled rupture.

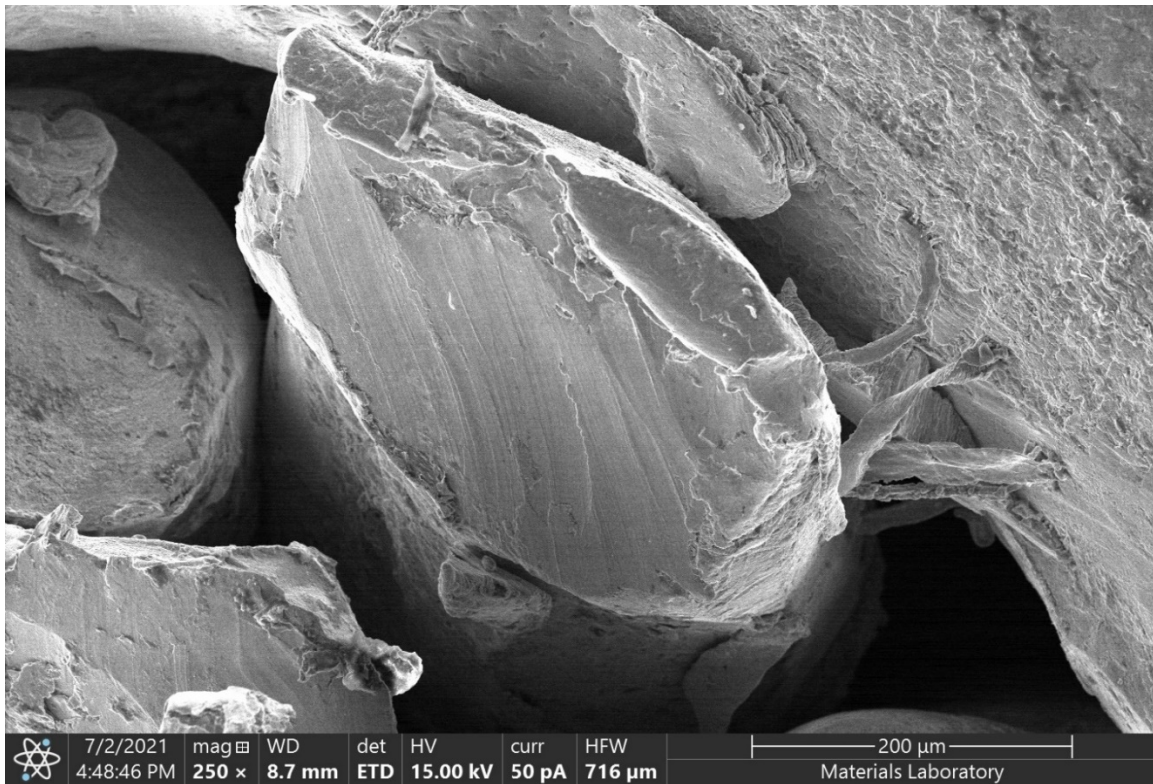
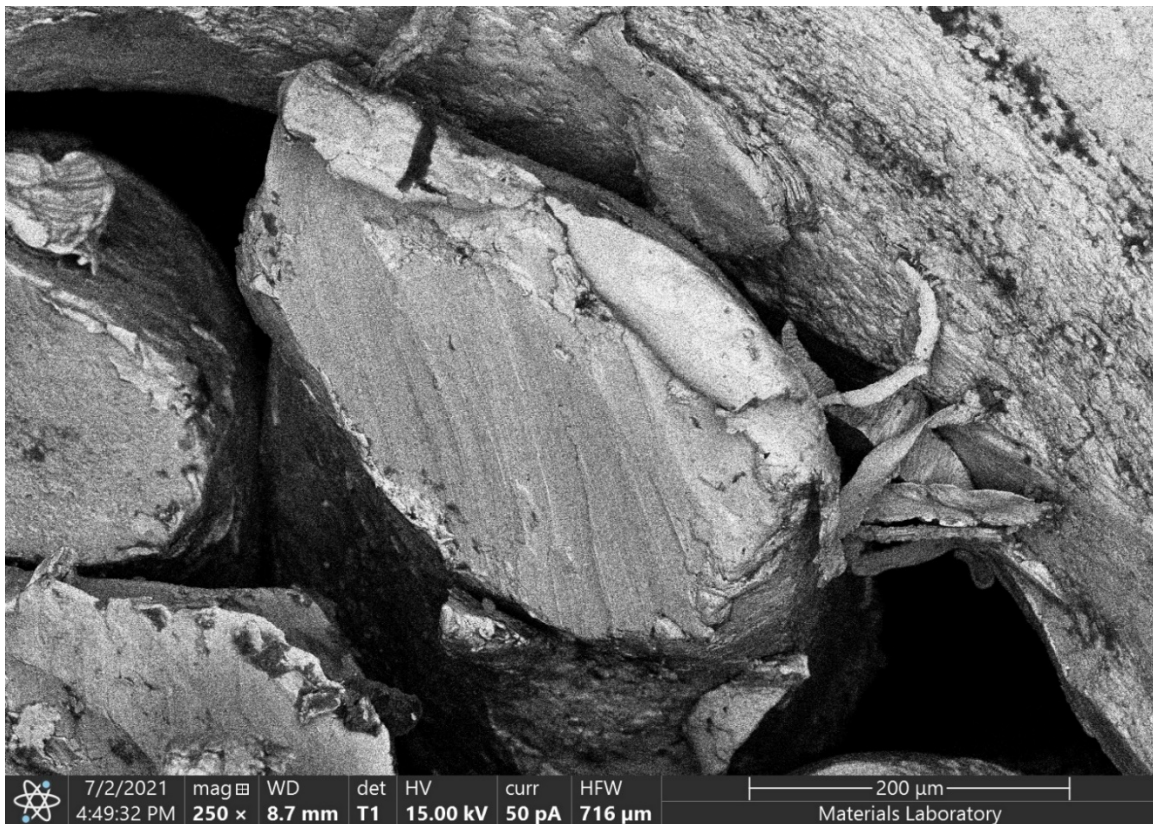
Figure 14 and Figure 15 shows the fracture surface of Strand 3. This fracture surface exhibited a slanted or angled orientation, with a small protrusion that had folded over itself (upper part of the figures). These streaks and the deformation were consistent with post-fracture damage. As such, no discernible fracture features were present on this strand's surface.

Figure 14 – SE micrograph of the Strand 3 fracture surface.

Figure 15 – BE micrograph of the Strand 3 fracture surface.

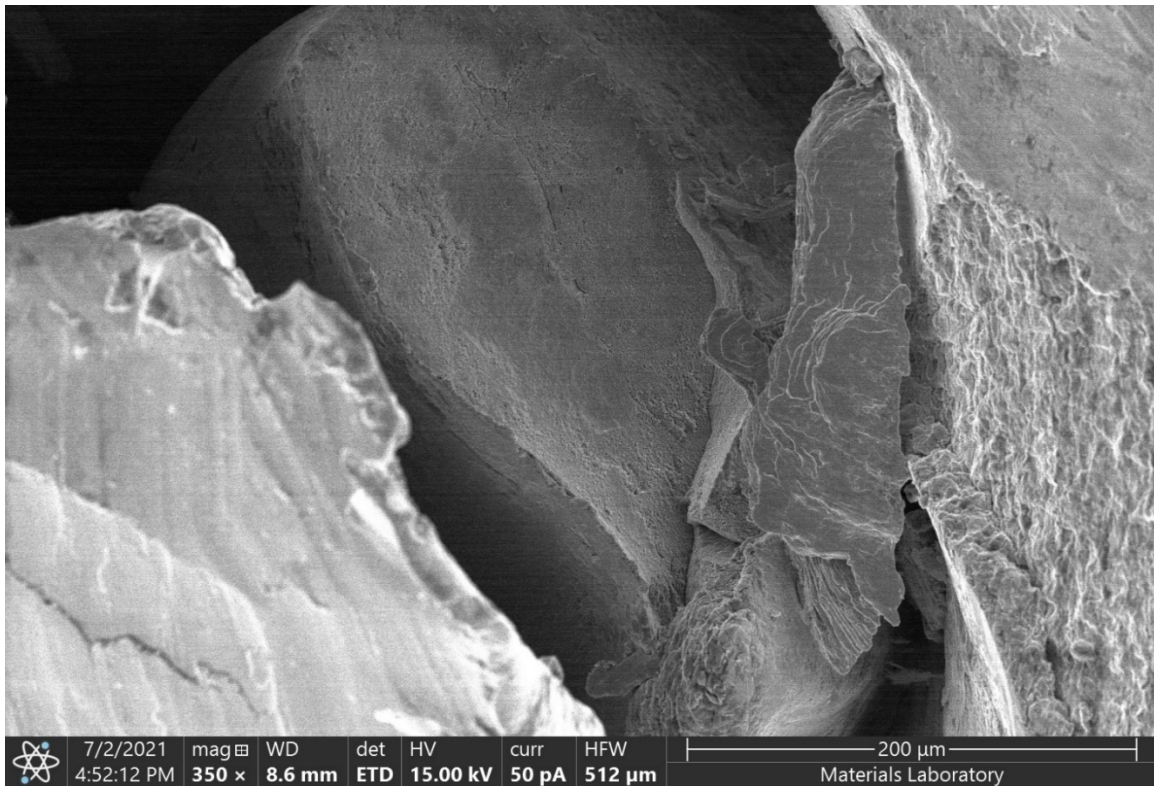
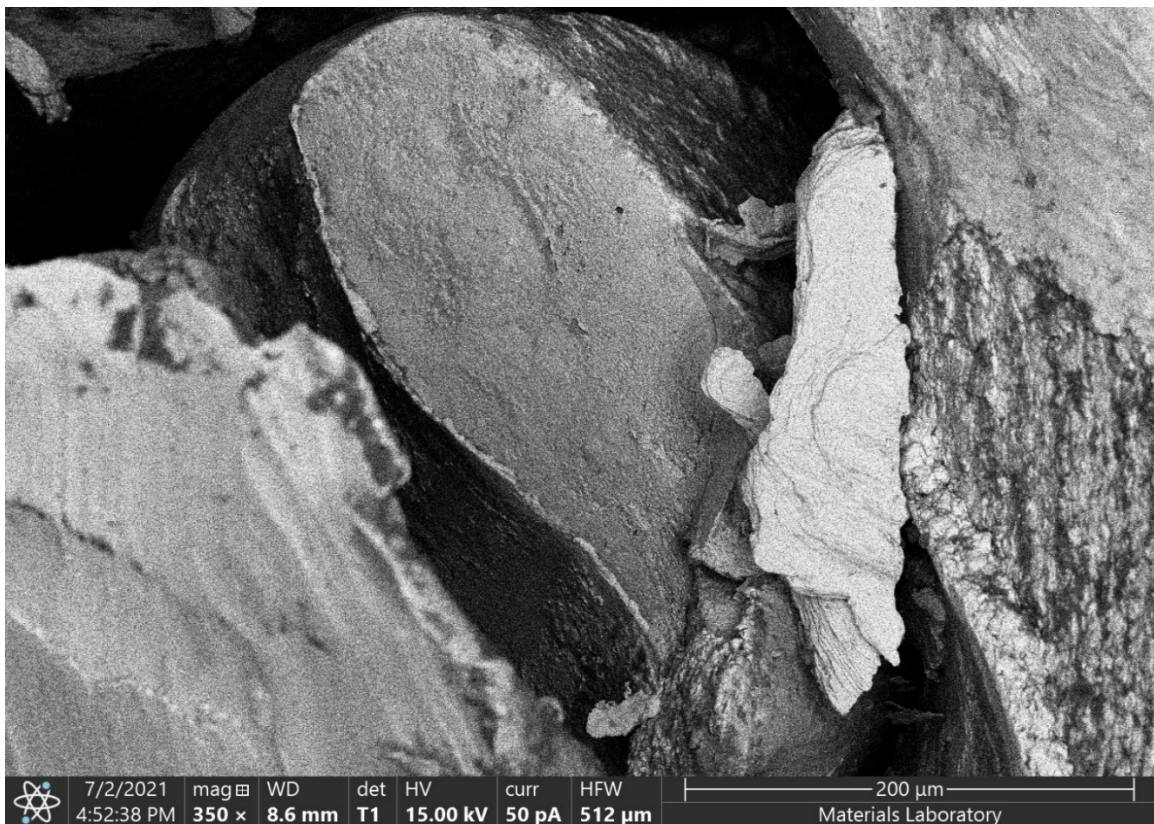
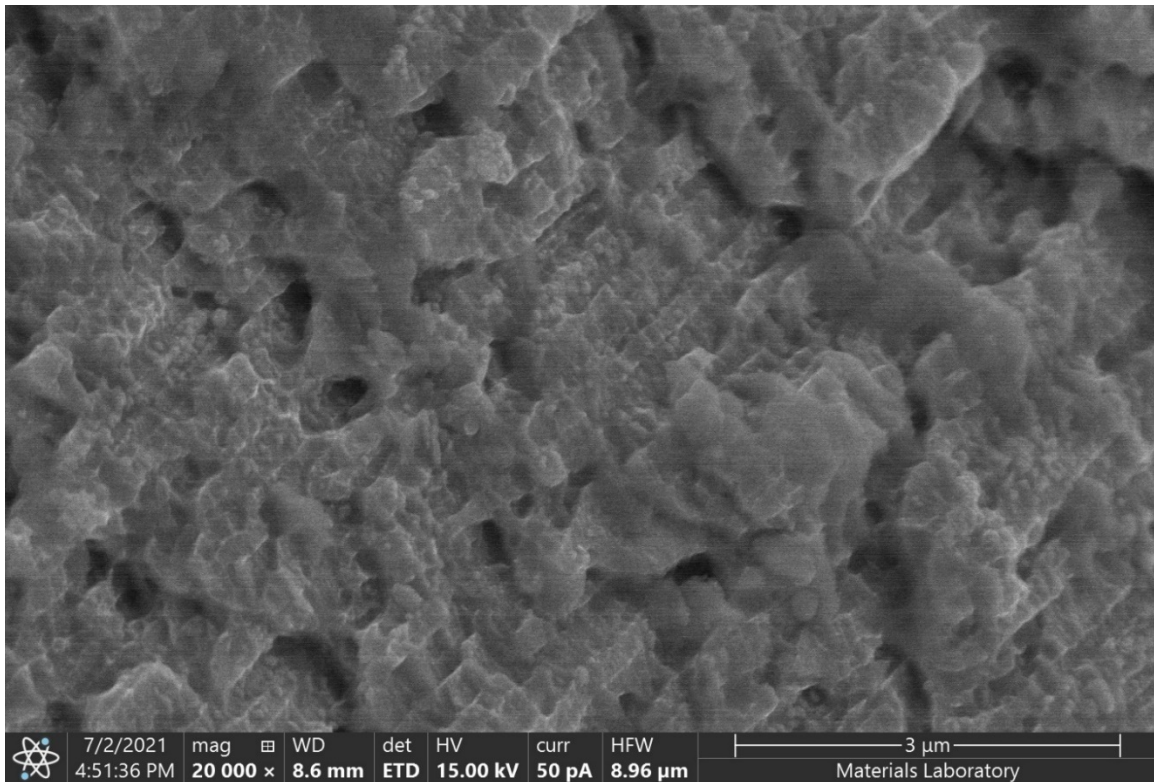
In contrast, the fracture surface of Strand 4, pictured in Figures 16 and 17, exhibited a rough, fibrous surface morphology. In addition, the ovoid-shaped fracture surface was smaller than the cross section of the wire strand. This was consistent with localized plastic deformation, or necking, adjacent to the fracture surface. A closer view of a typical area of the fracture surface is shown in Figure 18. The surface exhibited dimpled rupture, consistent with fracture in tensile overstress. No other features consistent with other fracture modes were observed on Strand 4.

Figure 16 – SE micrograph of the Strand 4 fracture surface.

Figure 17 – BE micrograph of the Strand 4 fracture surface.

Figure 18 – SE micrograph of a typical dimpled rupture of the Strand 4 fracture.

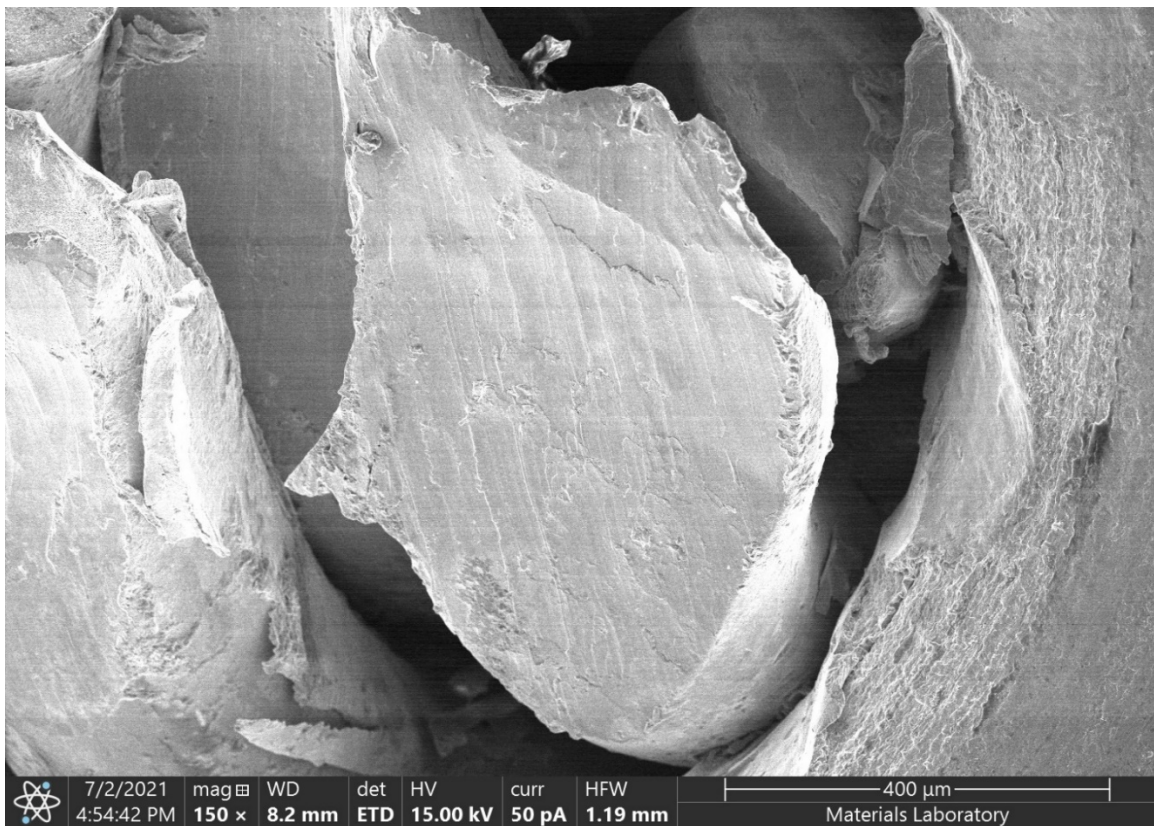
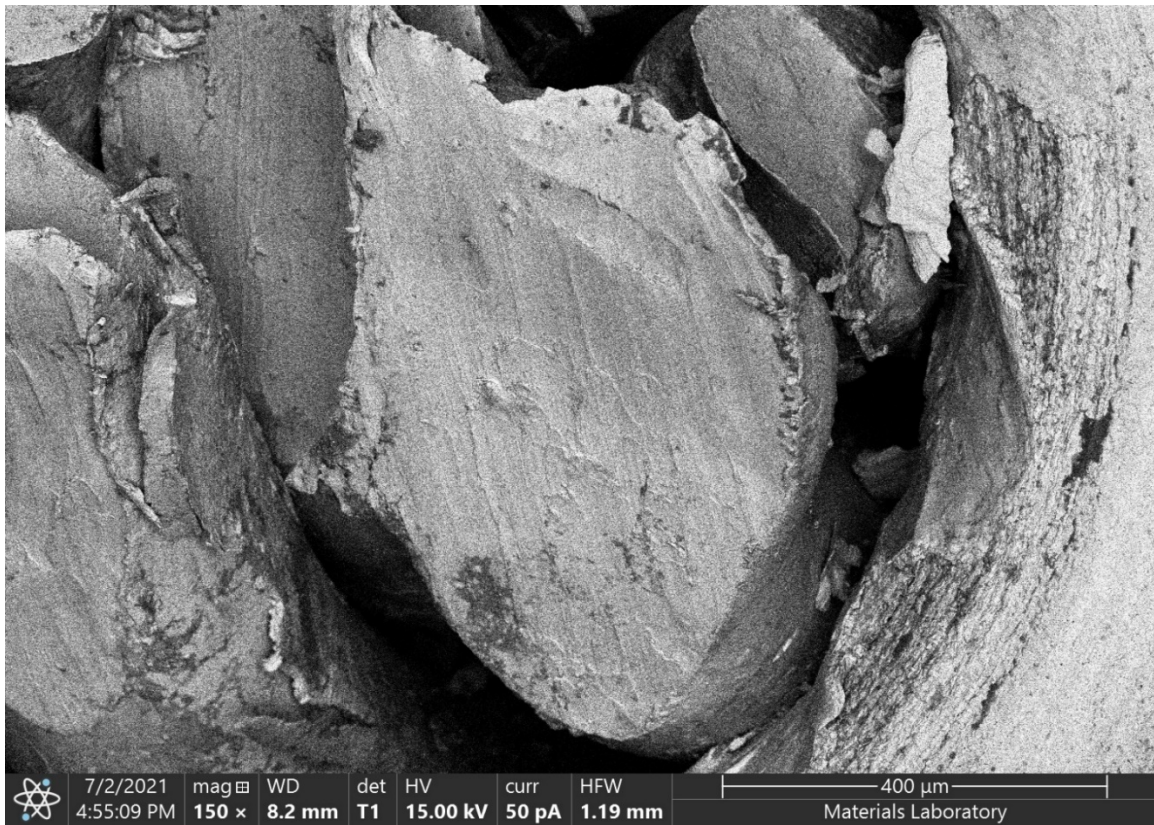
The fracture surface of Strand 5 is illustrated in Figures 19 and 20. Like Strand 3, this fracture surface was slanted in orientation, with unidirectional parallel streaks. These features were consistent with extensive post-fracture damage to the fracture features, which had been obliterated. No features consistent with a known fracture mode were present on the Strand 5 fracture surface.

Figure 19 – SE micrograph of the Strand 5 fracture surface.

Figure 20 – BE micrograph of the Strand 5 fracture surface.
