# NATIONAL TRANSPORTATION SAFETY BOARD

## MATERIALS LABORATORY FACTUAL REPORT

Report No. 21-055

Place : Langley, Washington  
Date : November 11, 2020  
Vehicle : Cessna 177B, N34633  
NTSB No. : WPR21FA145  
Investigator : Samantha Link, AS-WPR

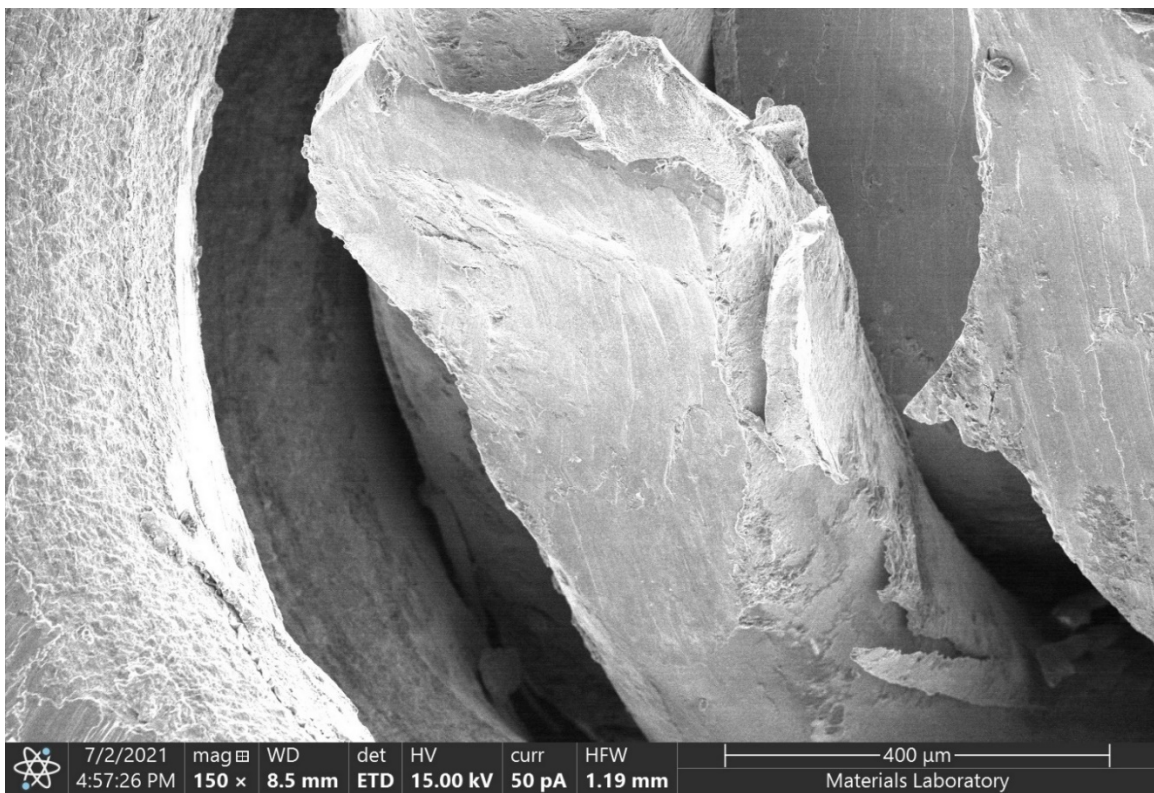
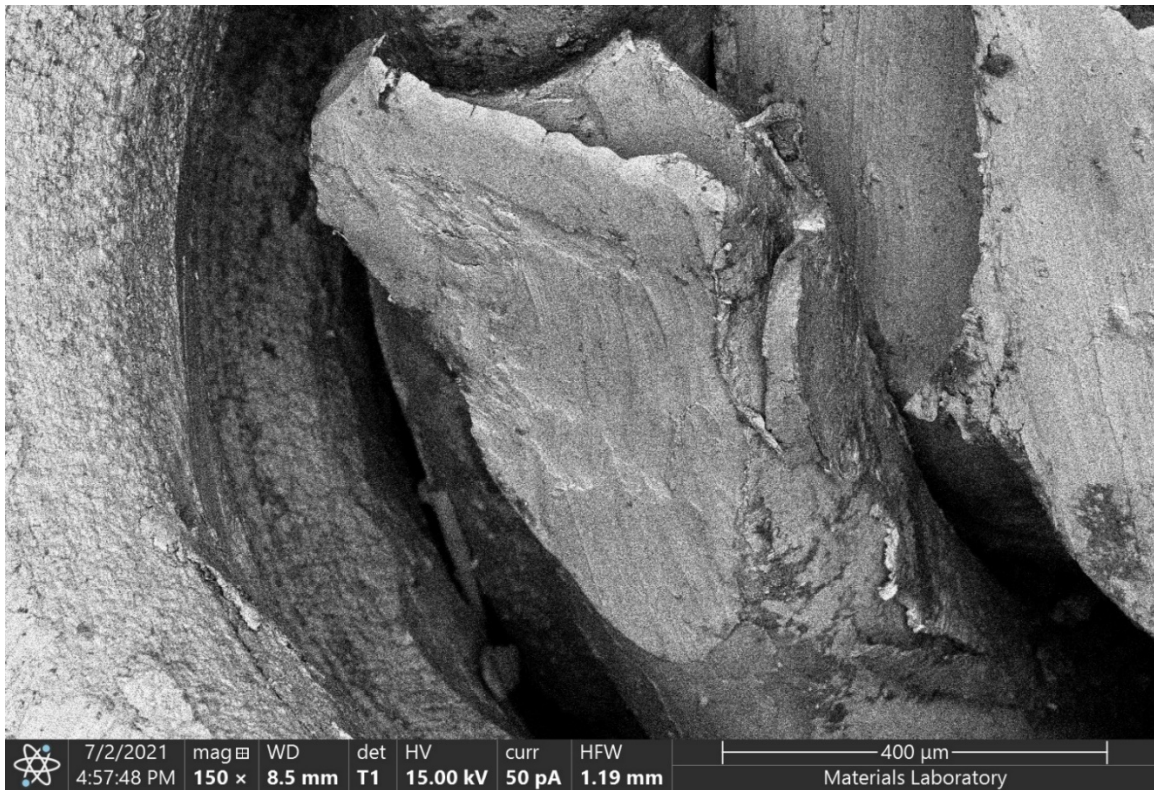
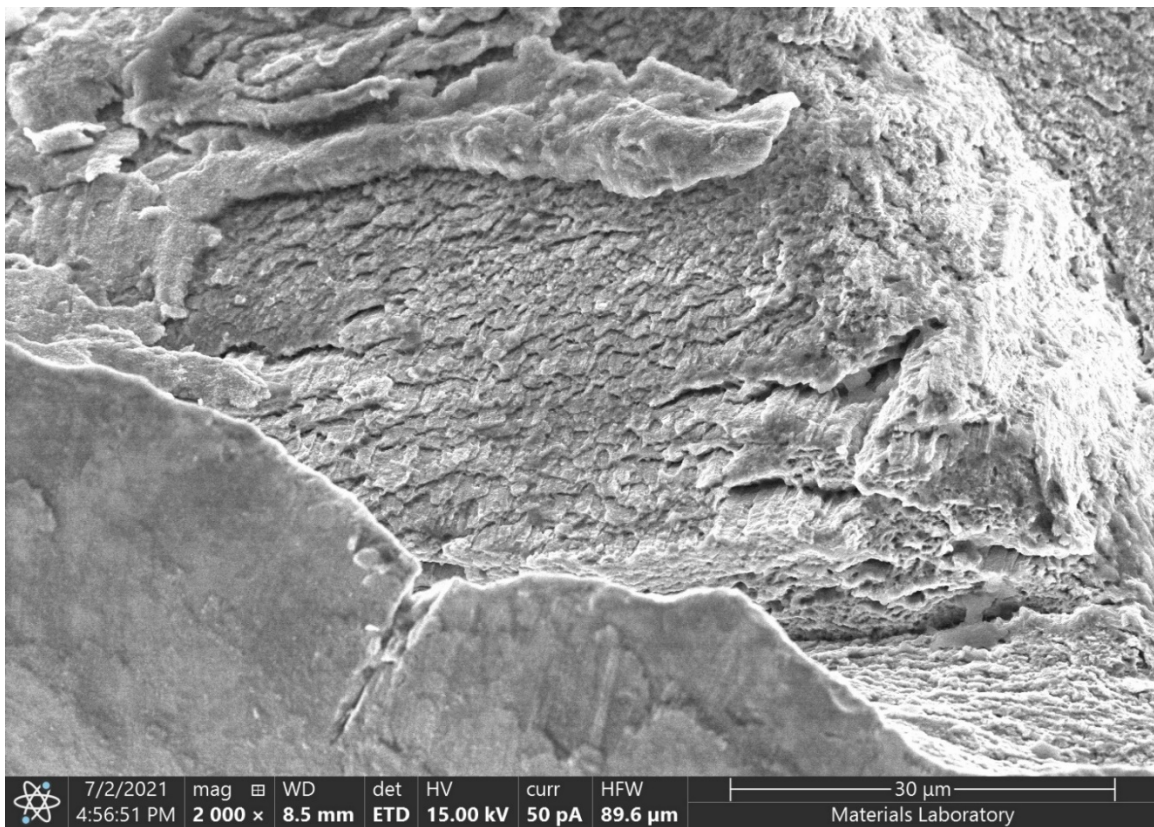
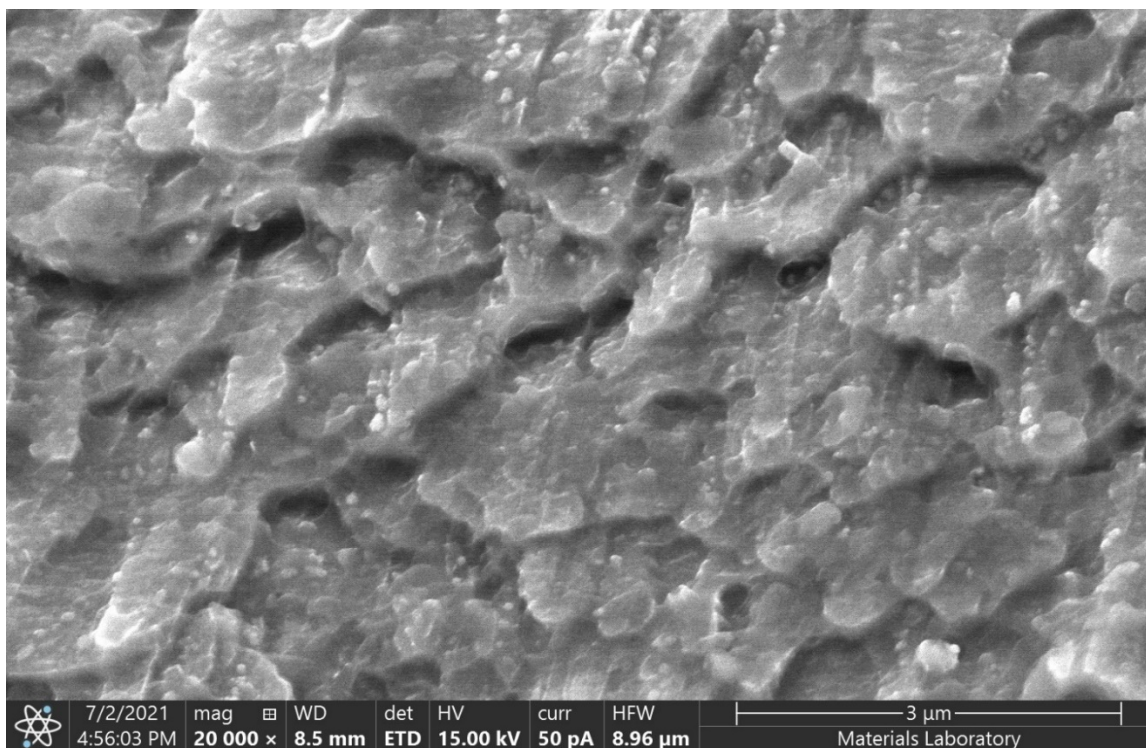
Likewise, the Strand 6 fracture surface also exhibited a slanted orientation (Figure 21 and 22). While most of the surface had been obliterated from smearing, a small area was found undamaged, and is highlighted in Figure 23. As shown in Figure 24, these features were found to be dimpled rupture, consistent with overstress fracture.

Figure 21 – SE micrograph of the Strand 6 fracture surface.

Figure 22 – BE micrograph of the Strand 6 fracture surface.

Figure 23 – SE micrograph of a typical undamaged area of the Strand 6 fracture.

Figure 24 – SE micrograph of a closer view of Figure 23, showing dimpled rupture.

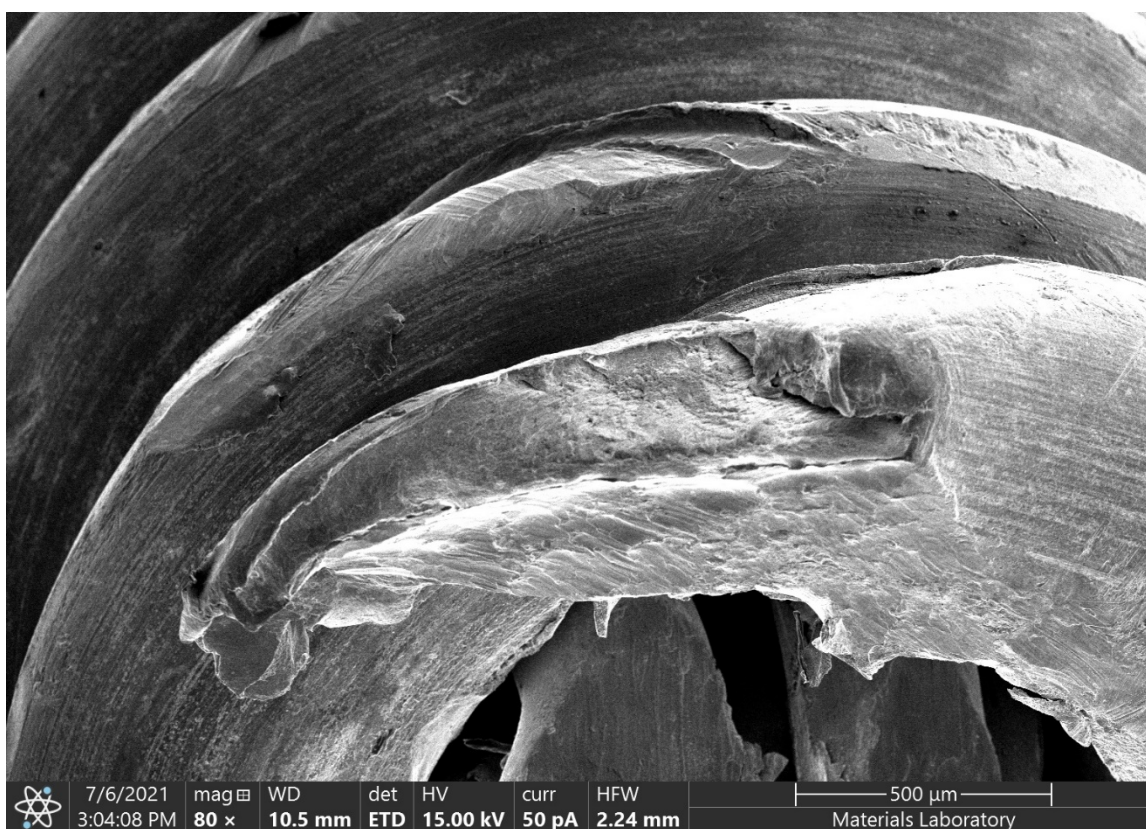
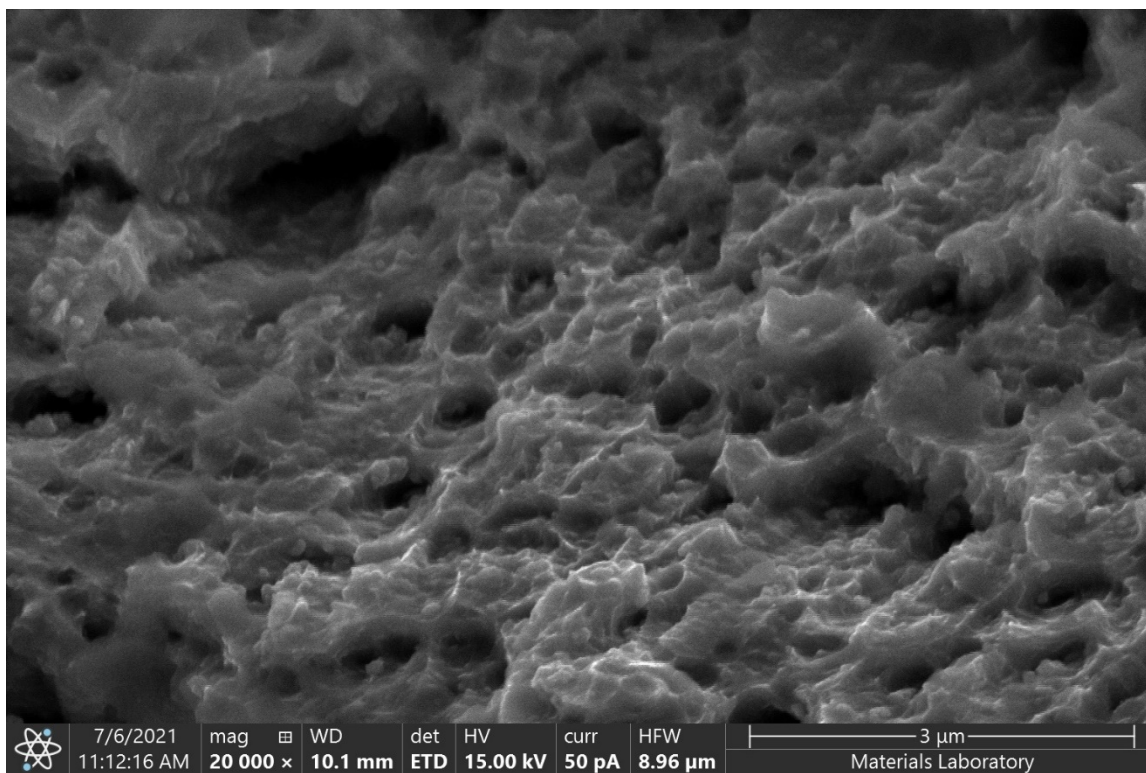
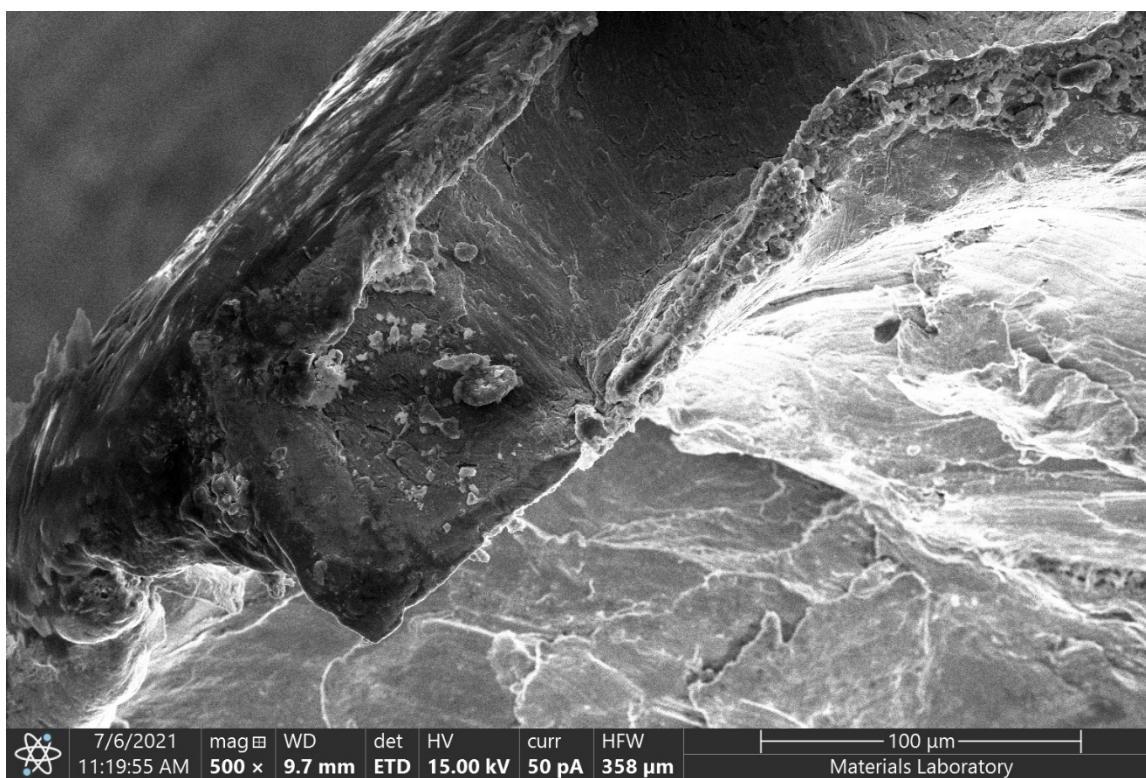
Figure 25 shows an angled view of the outer sheath coil, showing parallel areas of wear or rubbing damage on the outer surface parallel to the fracture surface. The fracture surface exhibited a slanted area toward the fractured internal strands, and an outer facing flatter area, shown facing the reader in Figure 25. The slanted area was primarily consistent with post-fracture damage—no discernible fracture features were observed in this area. The flatter area did exhibit fracture features, as typified in Figure 26. These features were consistent with dimpled rupture, consistent with overstress fracture.

Figure 25 – SE micrograph of an angled view of the outer sheath coil fracture surface and wear damage along adjacent coils.

Figure 26 – SE micrograph of a typical area of dimpled rupture on the sheath fracture.

Figure 27 – SE micrograph of an area with radiating marks on the outer sheath fracture.

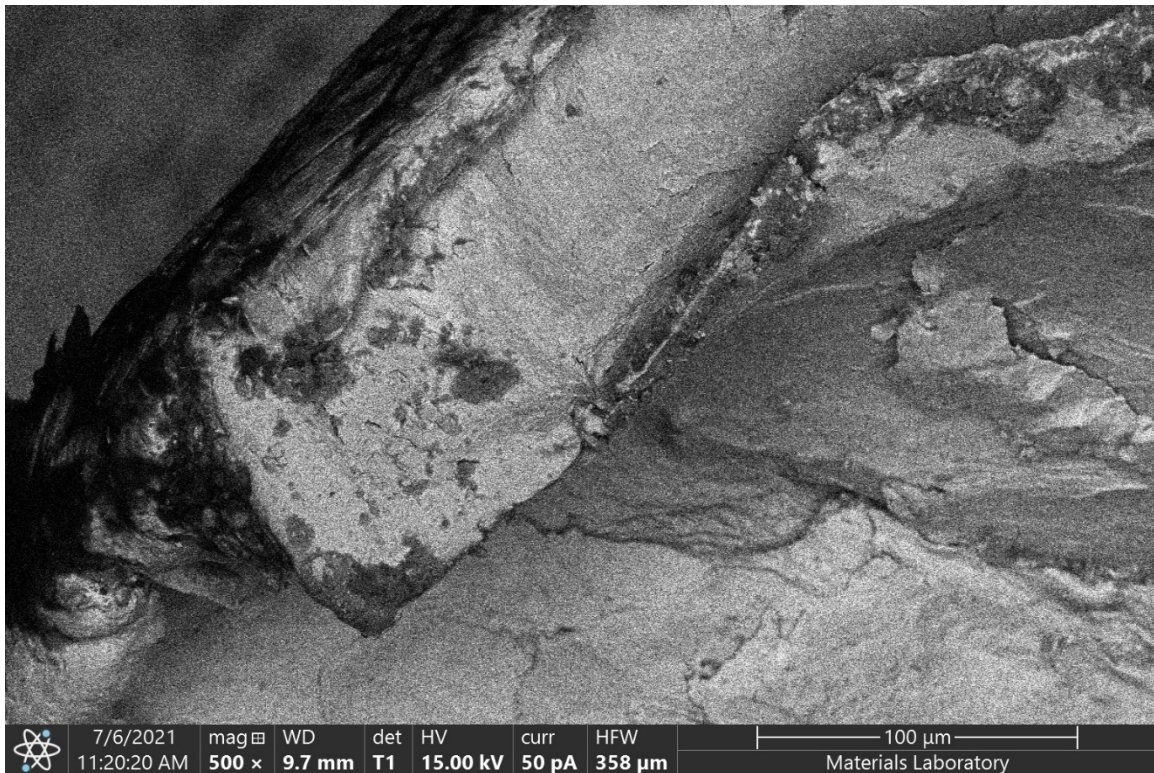
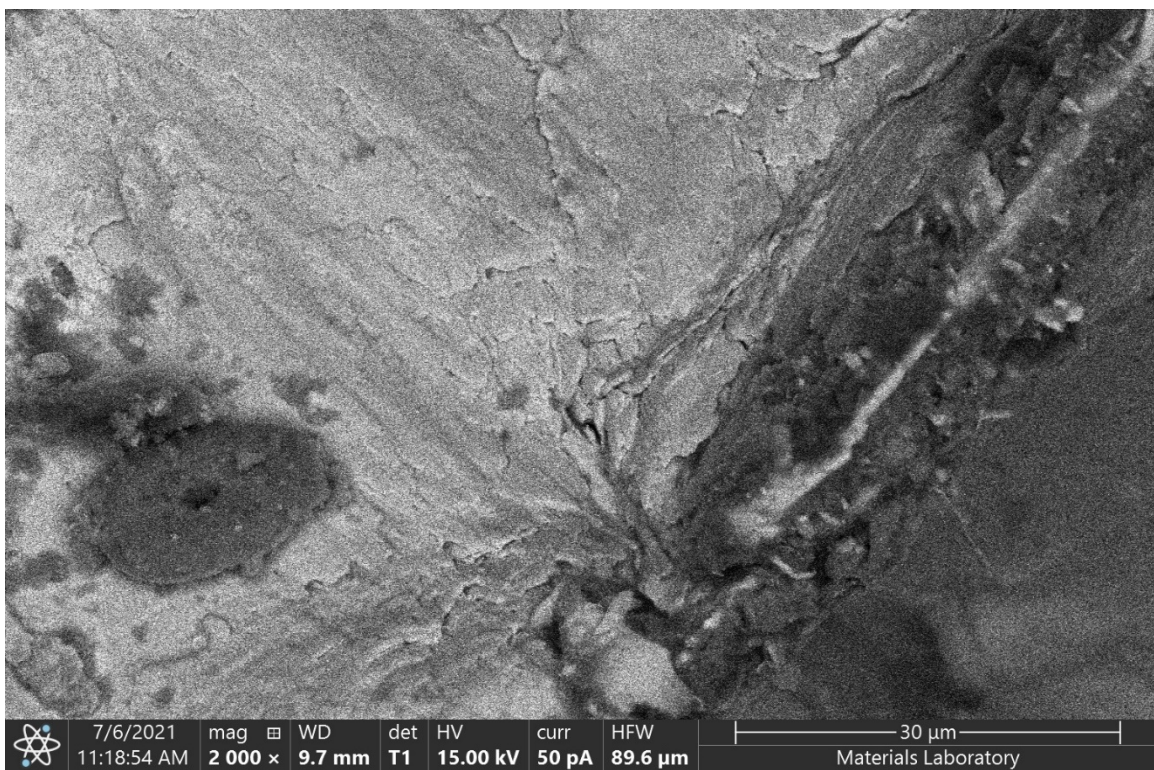
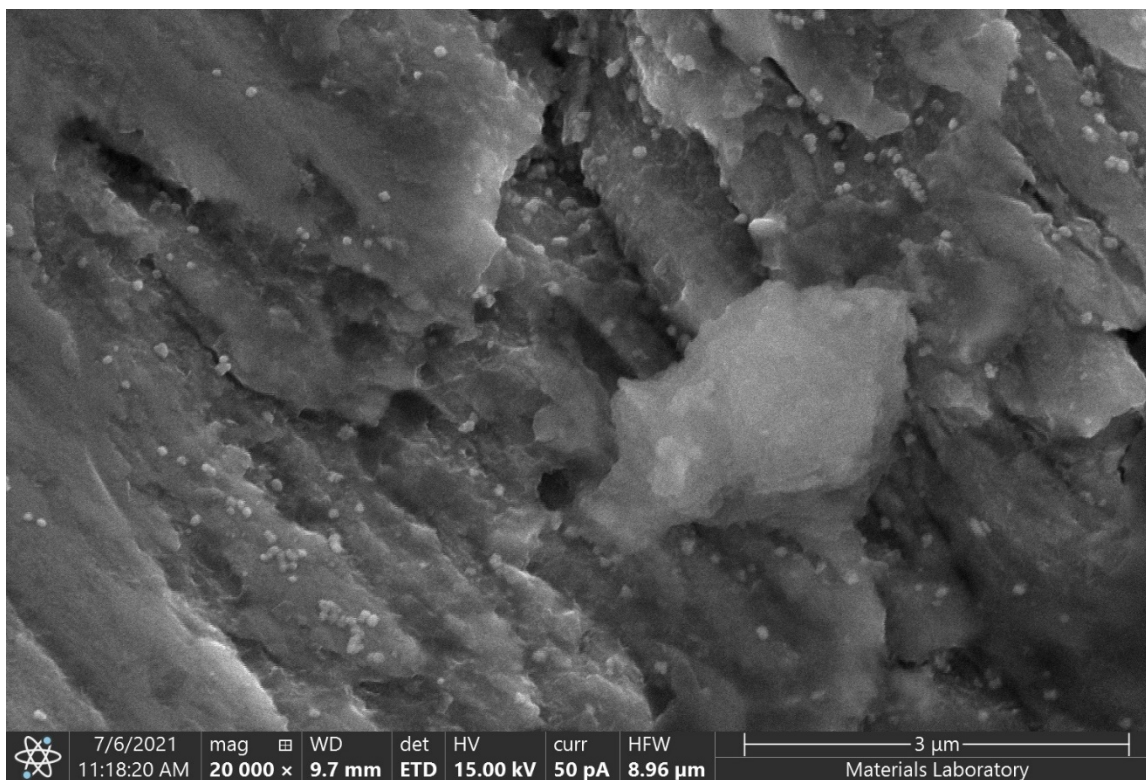
One area near the tip of the sheath fracture surface exhibited a feature near the interior edge, which contain radiating marks appearing to emanate from the surface (shown in Figures 28 and 29). These features were found protruding out of a quasi-linear impression near the inner edge, as shown in Figure 29. A closer view of these radiating streaks found them to be mostly featureless. However, some areas between the streaks exhibited dimpled rupture, as illustrated in Figure 30. These features were consistent with an overstress fracture that had been damaged after the fracture sequence began.

Figure 28 – SE micrograph of an area with radiating marks on the outer sheath fracture.

Figure 29 – BE micrograph of a closer view of the radiating marks in Figure 28.

Figure 30 – SE micrograph of dimpled rupture between streaks in Figure 29.

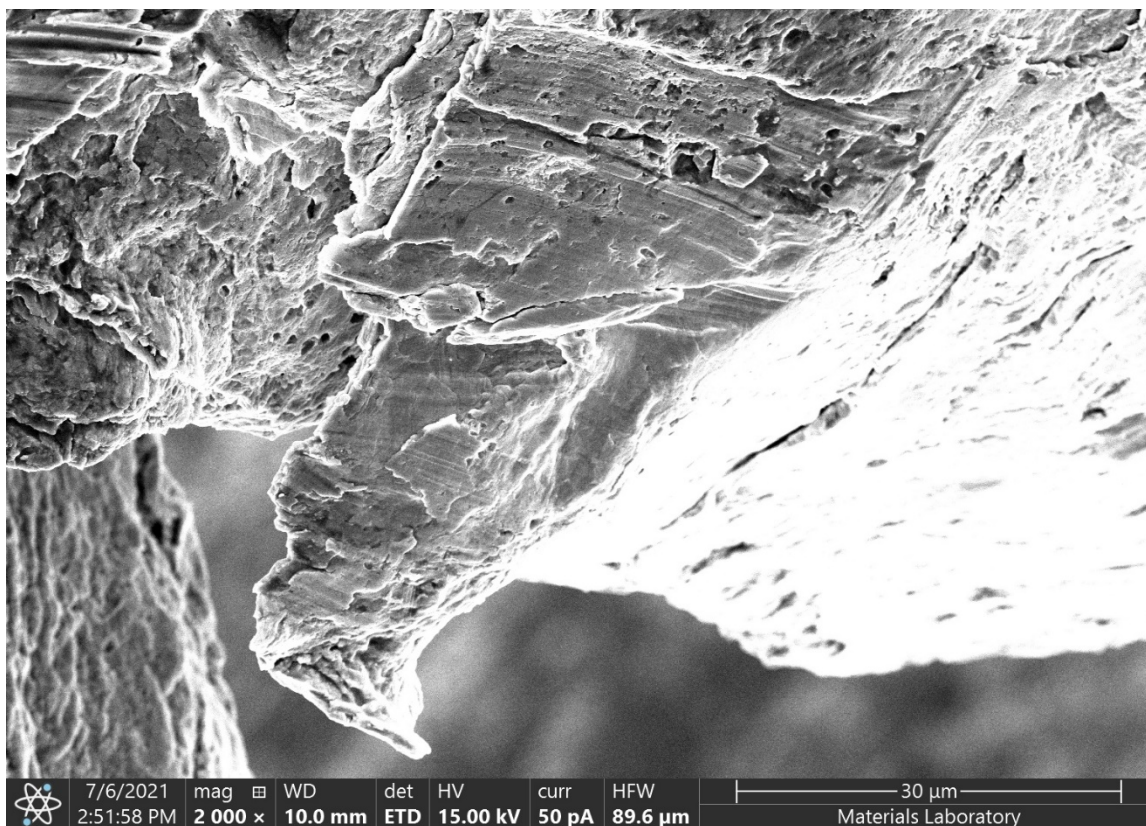
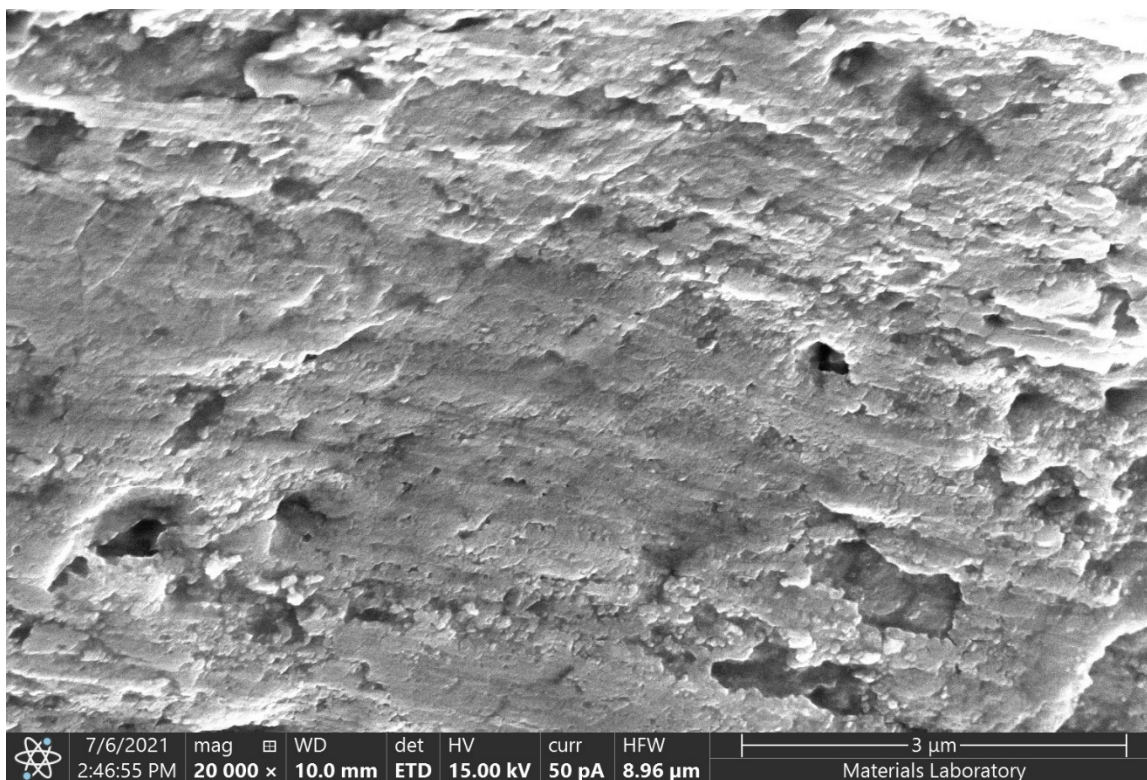
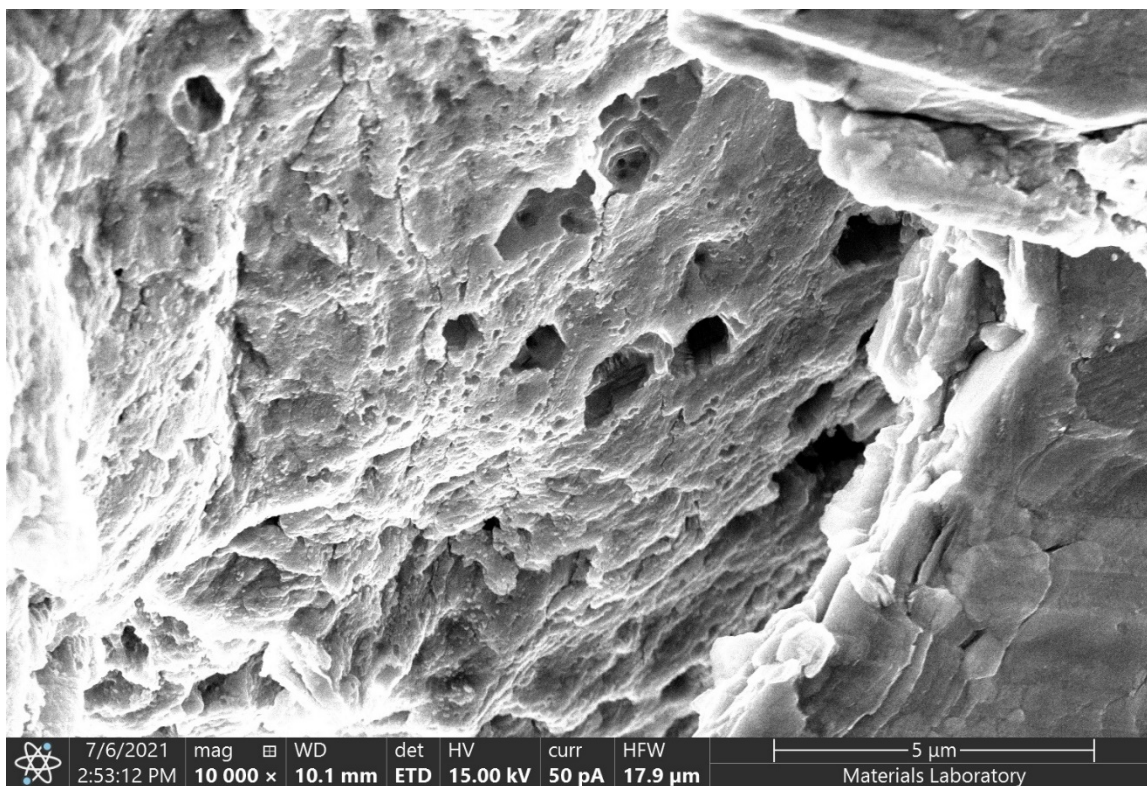
Figure 31 shows an edge area below that seen in Figures 28 and 29. This area exhibited a series of parallel lines. The features of these lines continued along other separated areas of the fracture surface (on the left of Figure 31, opposite the vertical gap). Figure 32 shows a closer view of this area, highlighting some of the parallel streaks. These streaks exhibited similar characteristics as those features often observed in fractures with propagating cracks. However, a closer view of the areas on the streaks found dimpled rupture, as typified in Figure 33. These features were consistent with post-fracture smearing following overstress fracture.

Figure 31 – SE micrograph of parallel marks on the sheath coil fracture surface.

Figure 32 – SE micrograph of a closer view of the marks in Figure 31.

Figure 33 – SE micrograph of dimpled rupture amongst the parallel marks in Figure 31 through Figure 32.

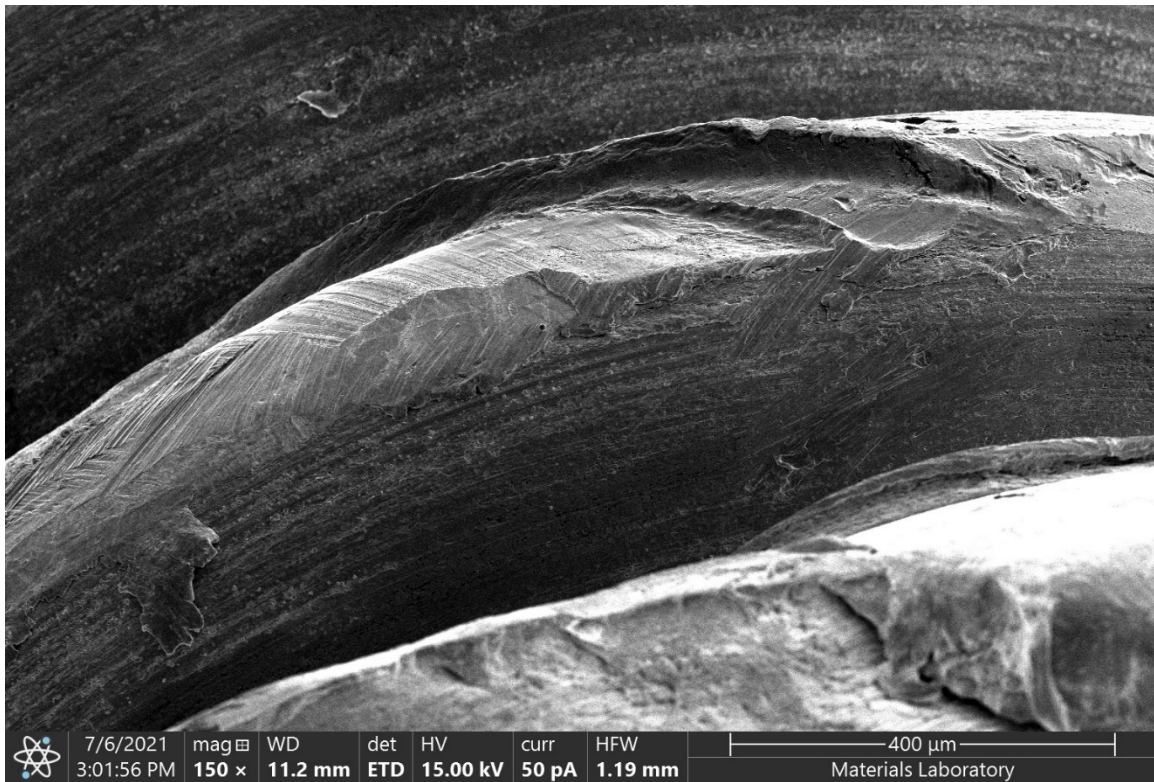
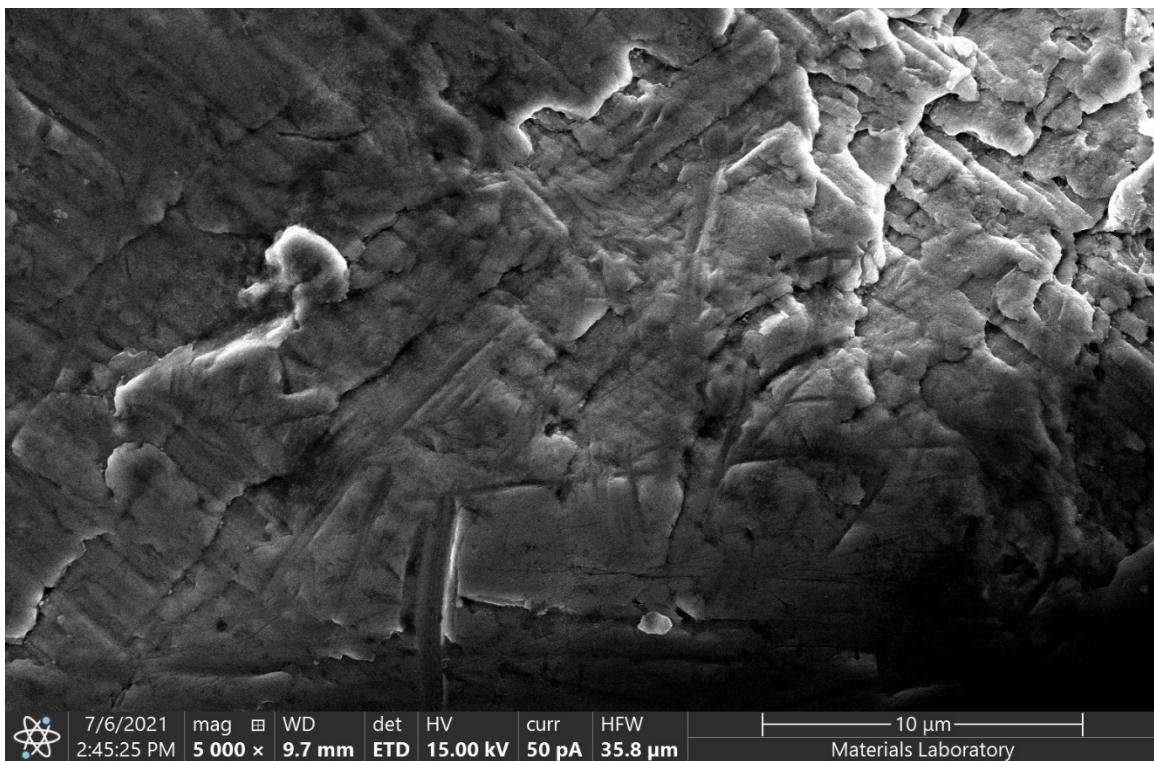
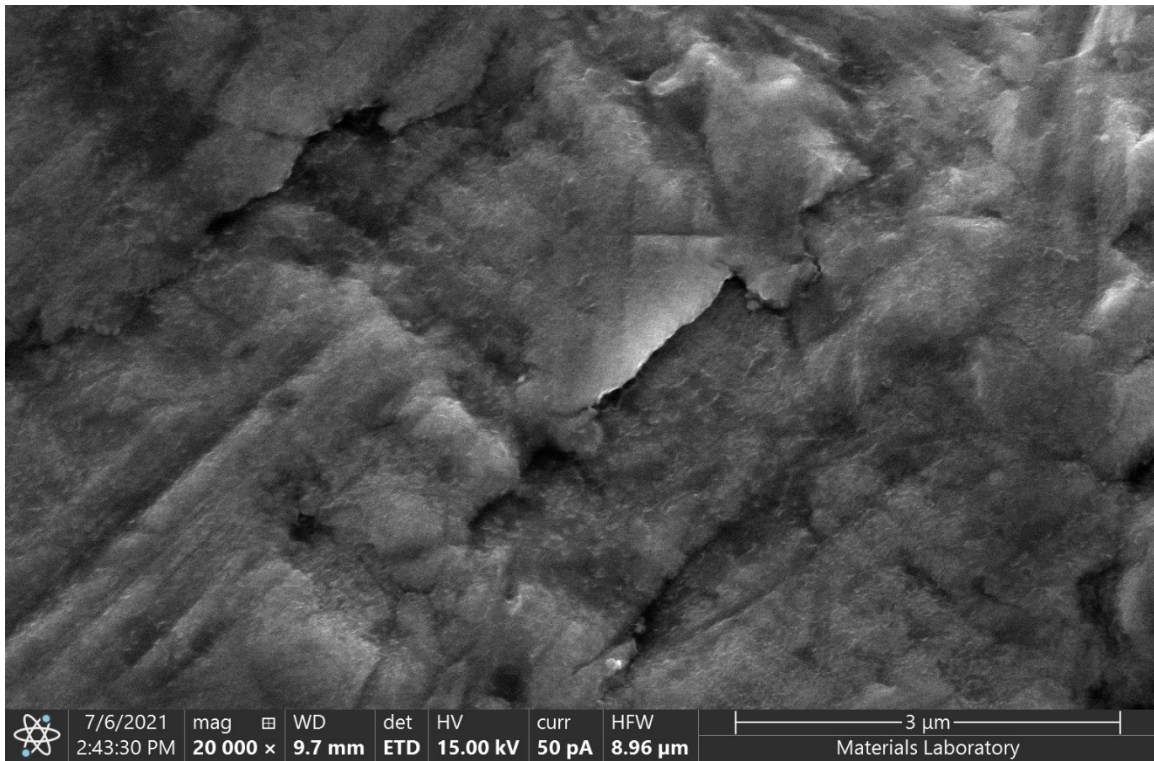
Figure 34 shows the wear and impact damage on a sheath coil below the fractured sheath coil (shown in the upper area of Figure 25). Figure 34 shows erratically oriented streaks on the sheath surface, and a lower area of material deformed outward, manifest as a ridge. A closer view of this region is shown in Figures 35 and 36. These regions exhibited intersecting or crossing streaks, oriented in random directions. These features

were consistent with an impact with an adjacent component, as well as rubbing against another component.

Figure 34 – SE micrograph of the secondary wear marks on the adjacent coil near the sheath fracture surface.

Figure 35 – SE micrograph of a closer view of the wear damage in Figure 34.

Figure 36 – SE micrograph of the marks in Figure 35, showing intersecting linear features.
