# National Transportation Safety Board

WPR21FA048

## **ELECTRONIC DEVICES**

Specialist's Factual Report

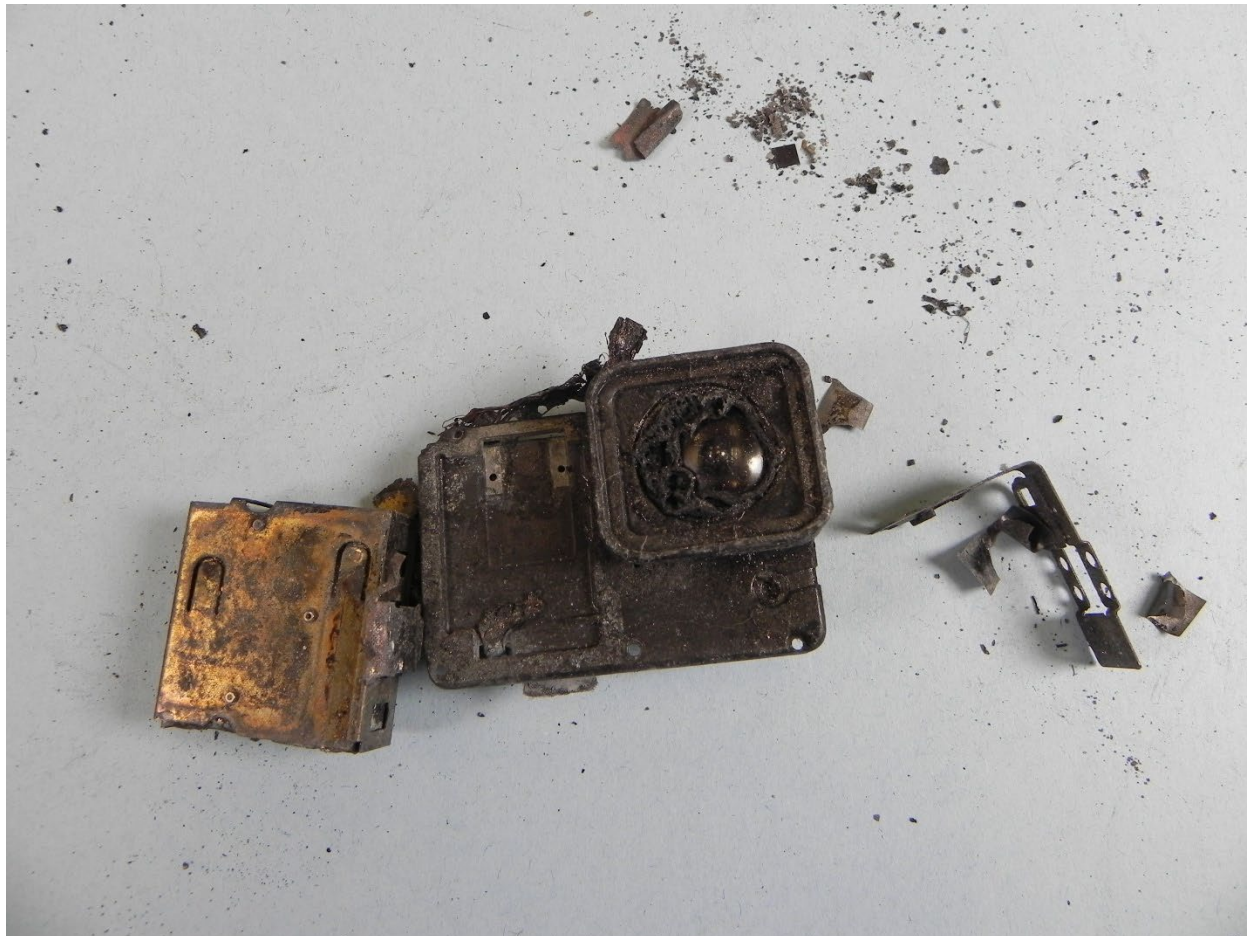
Upon arrival at the Vehicle Recorder Division, the GoPro was noted to have sustained severe thermal damage, as shown in figure 1. The micro-SD card found on the GoPro was burned, as shown in figure 2. The extent of the damage precluded normal and advanced recovery procedures and additional attempts were unsuccessful in yielding usable data. Therefore, no data pertinent to the event were recovered.

**Figure 1.** GoPro as received.

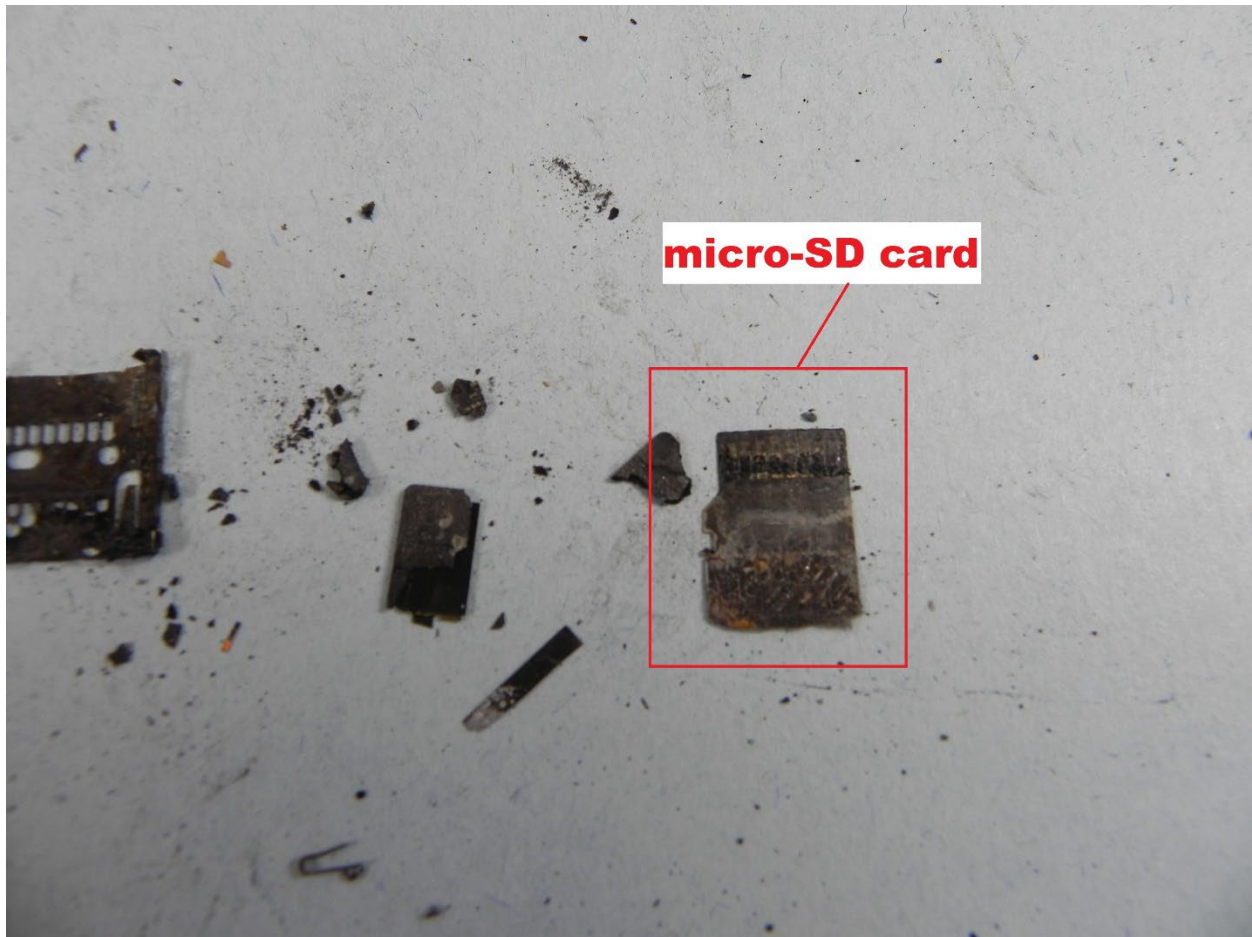
**Figure 2.** Micro-SD card found on the GoPro.

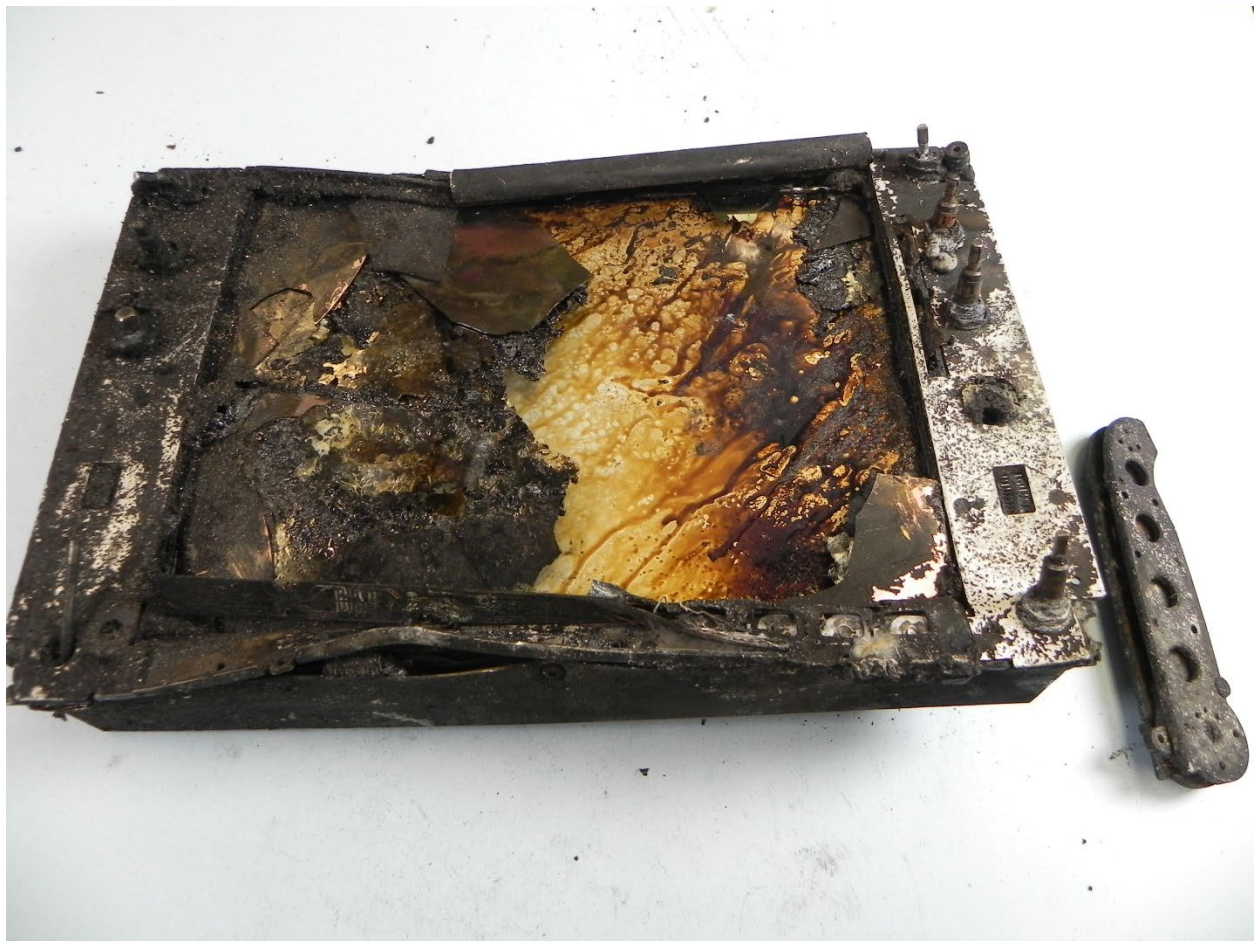
## **2.1 Garmin G1000 Condition**

**Figure 3.** Garmin G1000 as received.

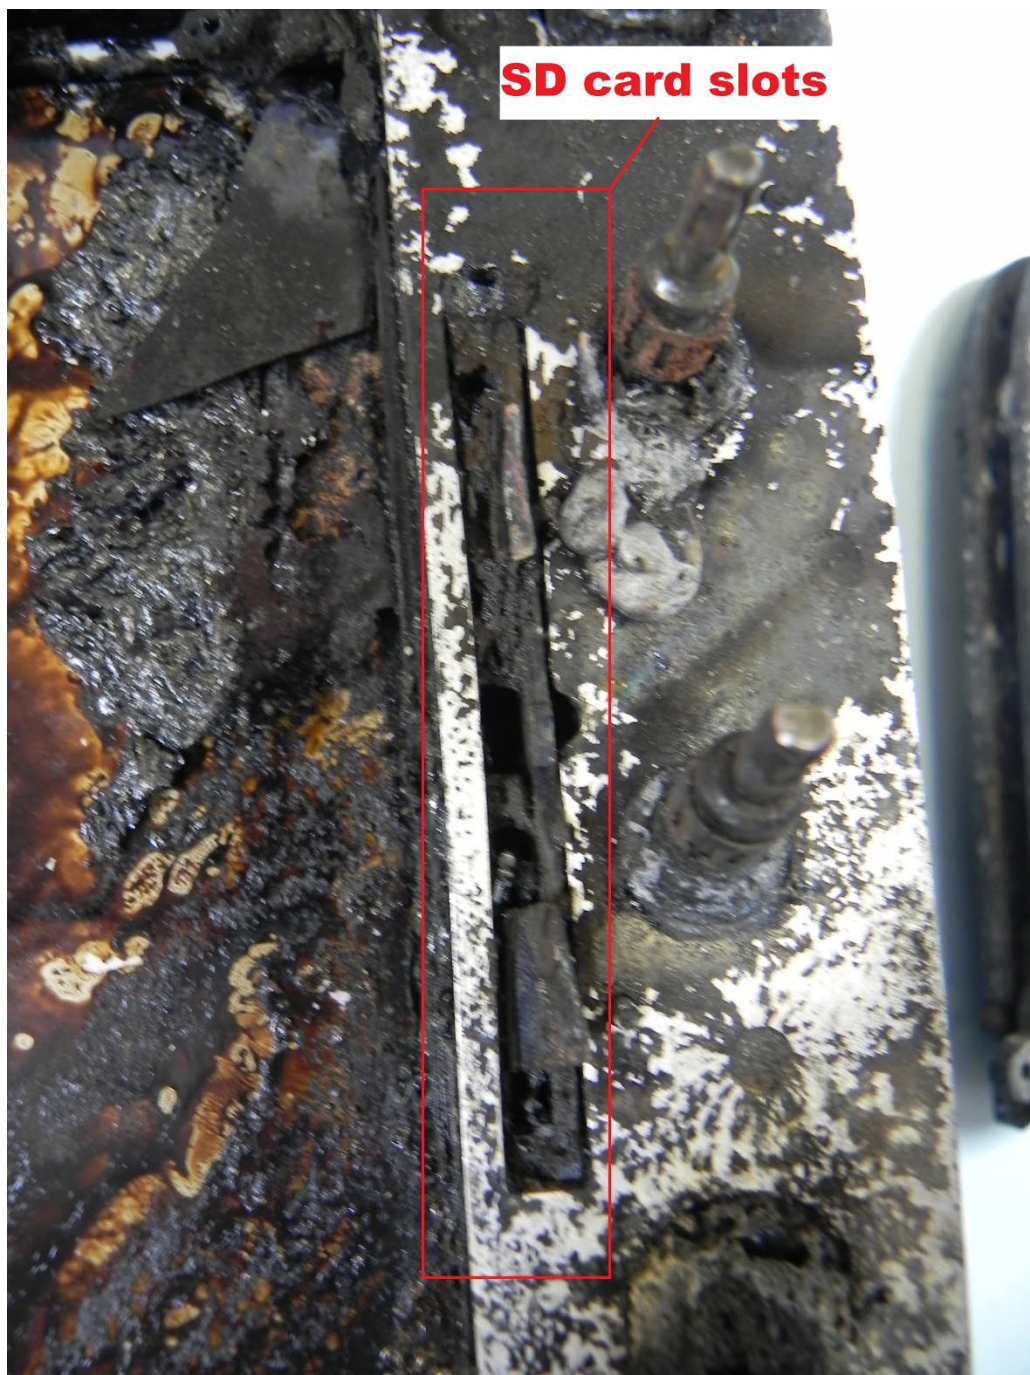
**Figure 4.** View of Garmin G1000 SD Card slots.
