## **NATIONAL TRANSPORTATION SAFETY BOARD**

### **ONSITE EXAMINATION NOTES**

**WPR21FA048**

Location: Los Angeles, CA  
Date: November 12, 2020  
Aircraft: N939CP  
NTSB IIC: Albert Nixon

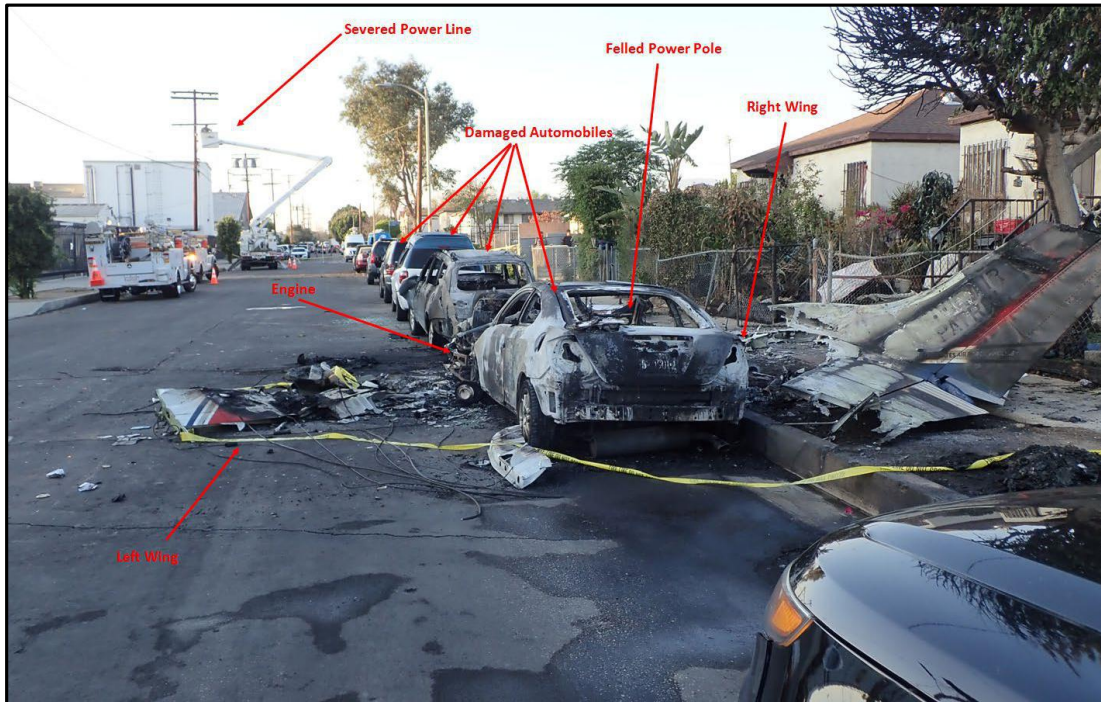
Accident site viewed to the Northwest.

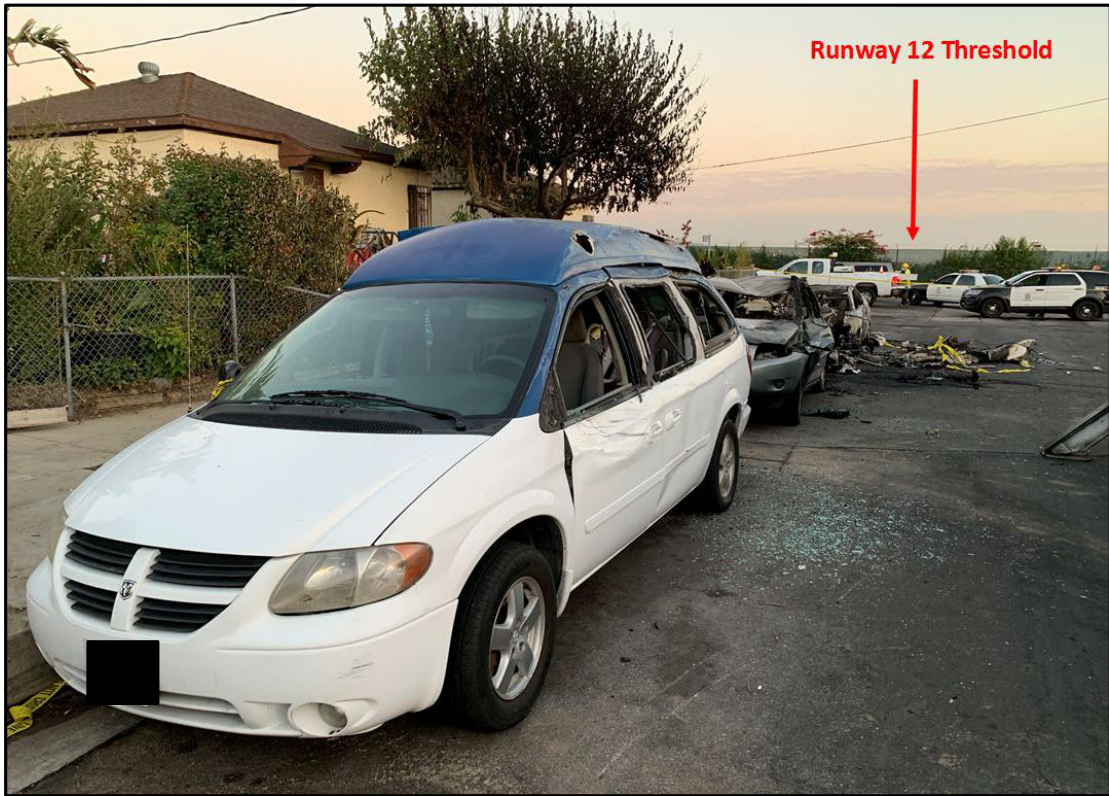
**Accident site viewed to the Southeast.**

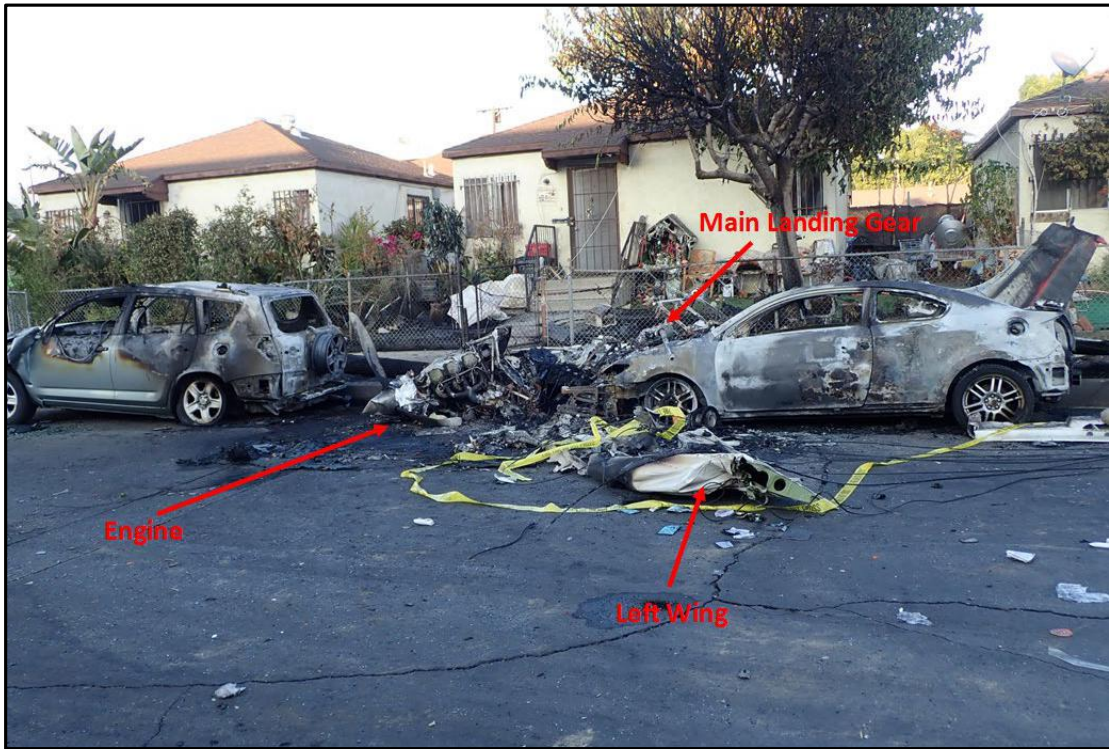
Accident Site viewed to the East.

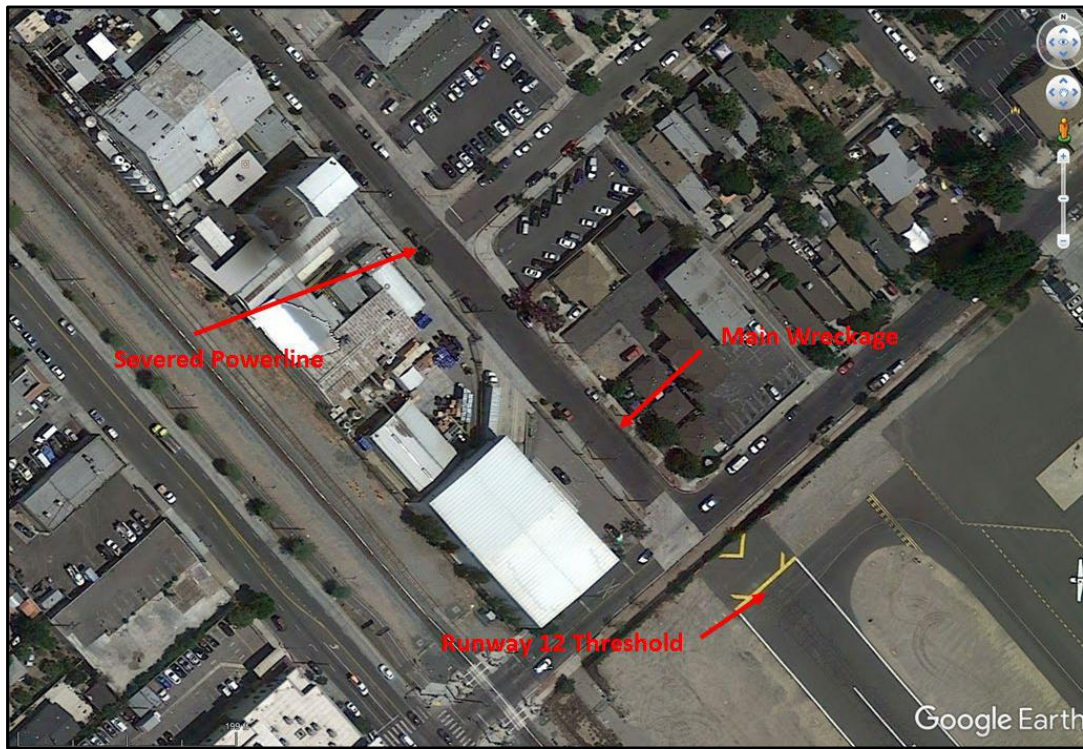
Accident Site from above.
