## **NATIONAL TRANSPORTATION SAFETY BOARD**

# **AIRFRAME AND ENGINE EXAMINATION SUMMARY**

**WPR21FA048**

| Aircraft: | N939CP, Cessna 182T |

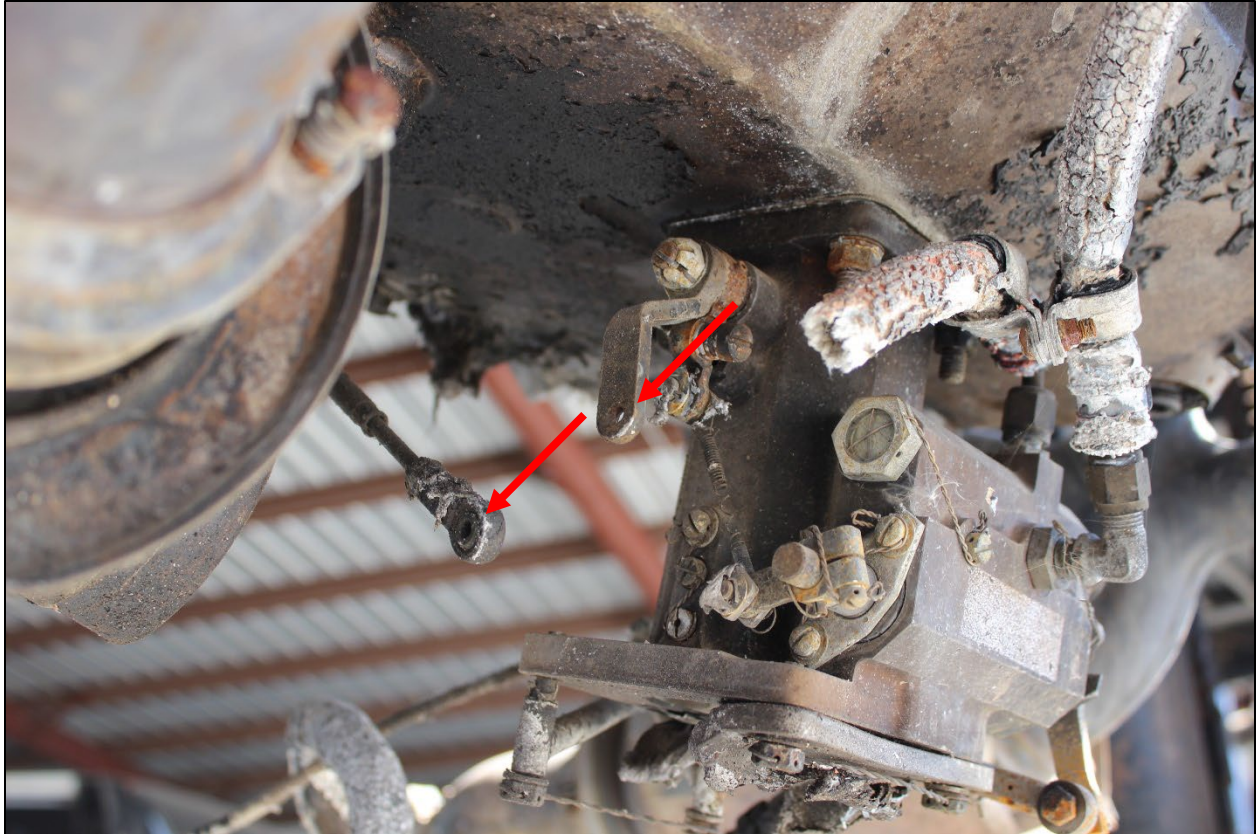
The fuel injection servo was securely attached to its mounting pad. The idle mixture adjustment linkage was attached to the respective control arm of the fuel servo and sustained thermal damage. The throttle linkage lever control rod end was found separated from the throttle plate control arm of the fuel control servo. The attachment hardware was not found (AN bolt, flat washer, castellated nut, and cotter pin). No evidence of impact or other damage was noted in the control arm and control rod end. Additionally, soot was present on the entire assembly, including the bolt opening where it attached. When cleaned of soot, observation of the control arm and control rod end revealed no damage or deformation.

**Figure 1: The throttle linkage control lever rod end disconnected to the control arm of the fuel servo.**

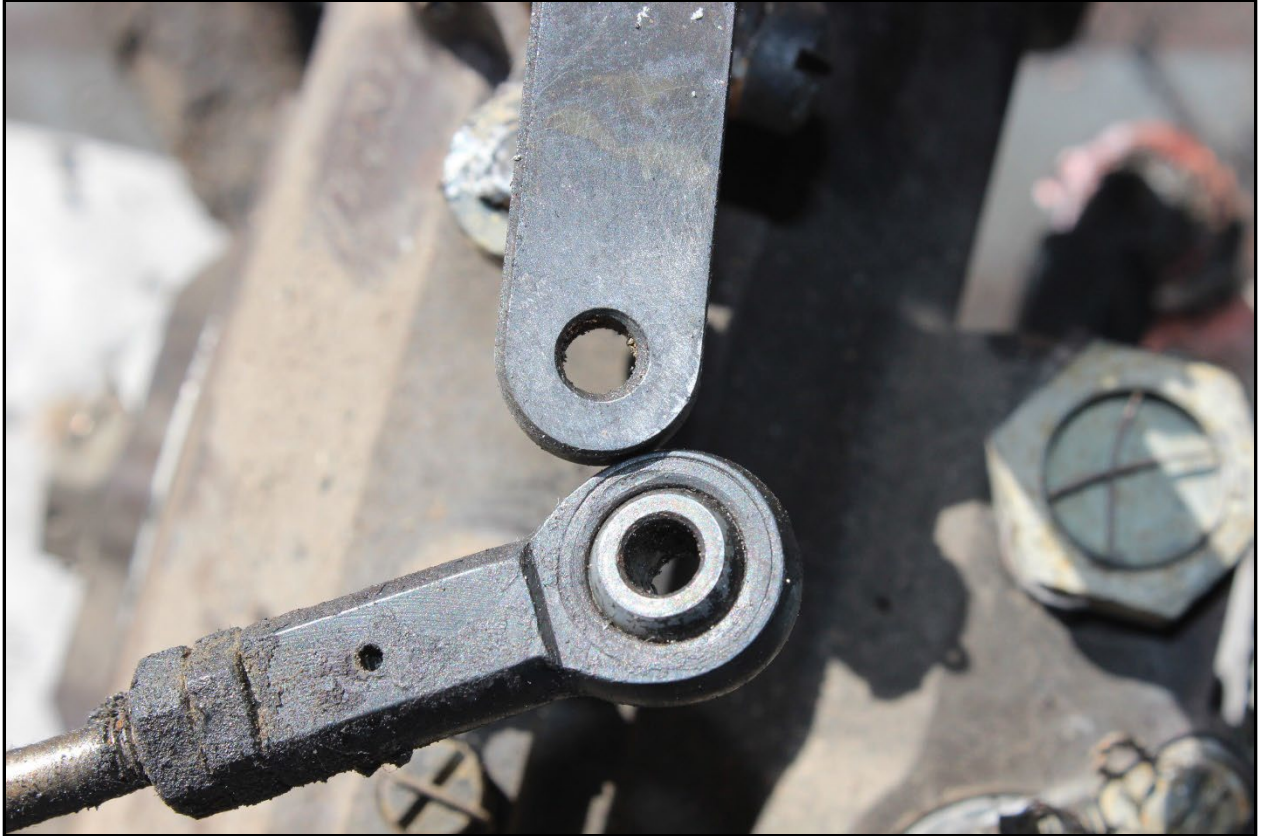
**Figure 2: The throttle linkage control lever rod end and control arm with soot cleaned off.**
