## **NATIONAL TRANSPORTATION SAFETY BOARD**

# **AIRFRAME AND ENGINE EXAMINATION**

**WPR21FA057**

| Aircraft: | Blevins Kamron Odyssey, N562TB |

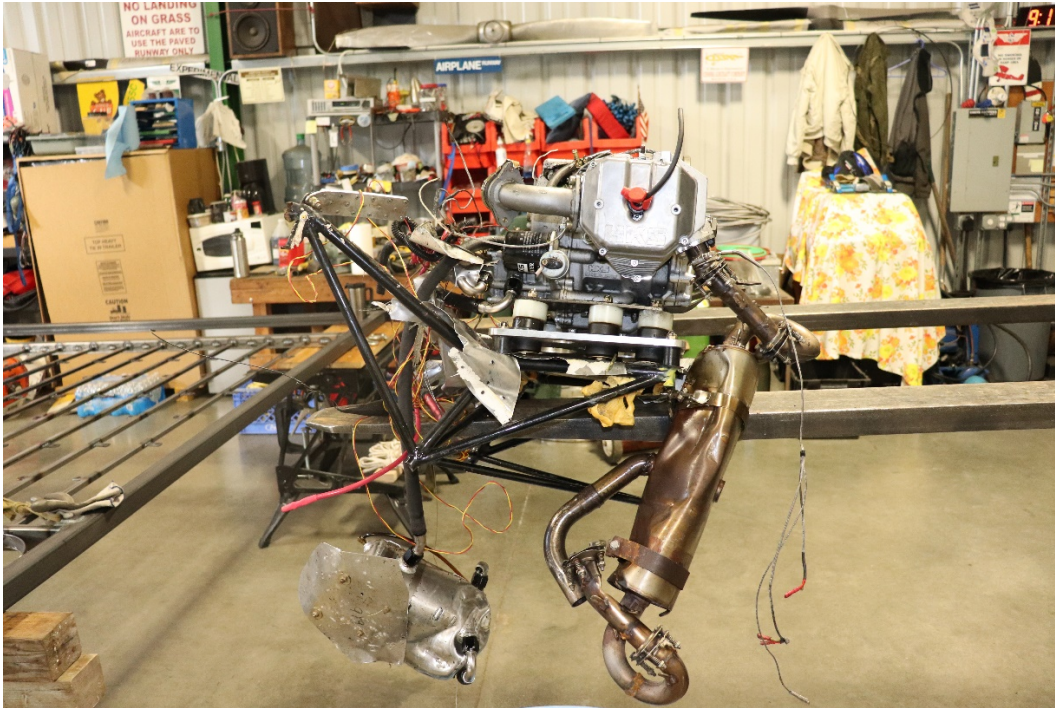
Examination of the recovered engine revealed that, the engine mount had impact separated from the fuselage, but the engine remained attached to the engine mounts. The two cylinders and the engine accessories case remained attached. The carburetor's and the starter had impact separated. The right cylinder exhaust remained attached but had impact damaged throughout. The left cylinder exhaust had impact separated. The top flywheel cover and the top accessories case had impact damage. The top of the engine crank case had impact damage near the flywheel cover and accessories case. Additional impact damage was observed to the upper area of the left cylinder and the cylinder rocker box cover.

**Figure 1. View of engine from the right-side cylinder**

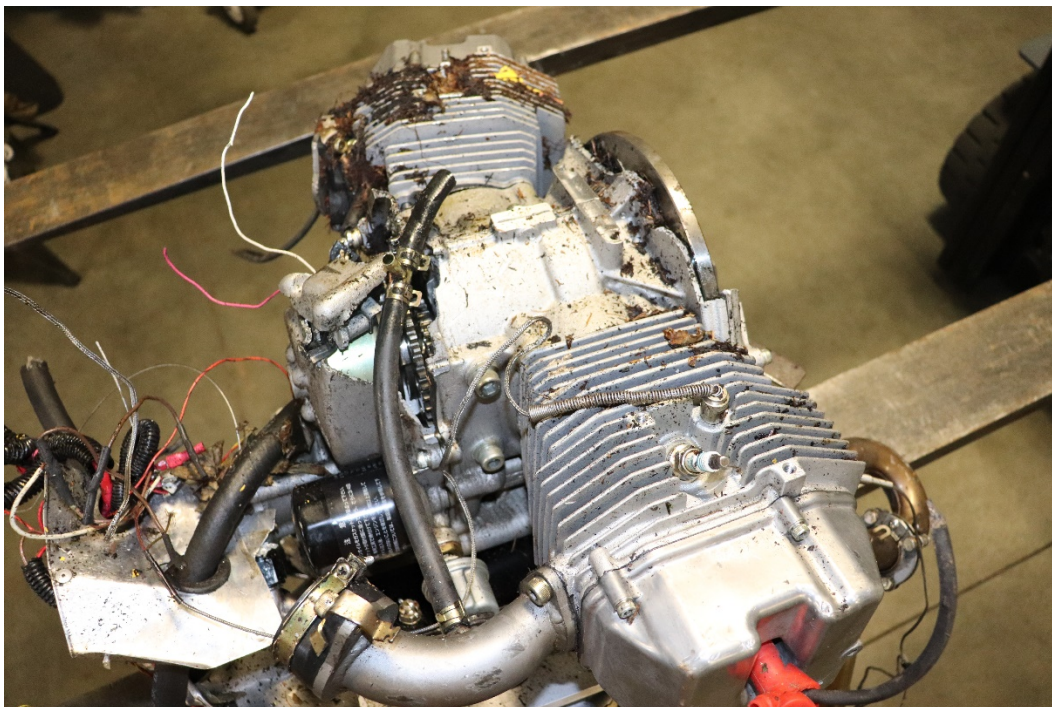
**Figure 2. View of the engine from above**

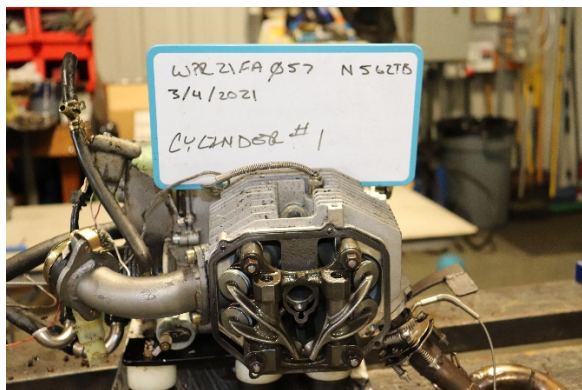
The rocker box covers were removed. The intake and exhaust rocker arms were intact and oil coated on all cylinders. All intake and exhaust valve springs were in place and visually appeared to be undamaged.

Figure 3. View of right cylinder rocker arm and valves

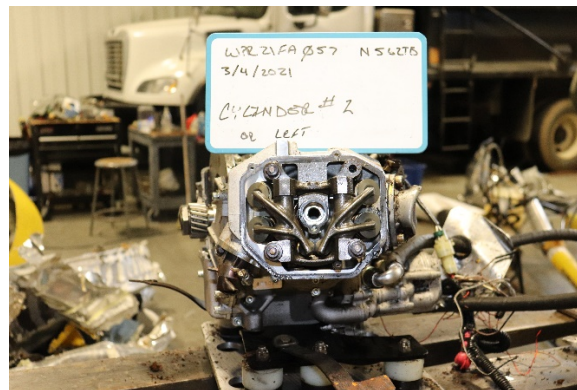
Figure 4. View of left cylinder rocker arm and valves

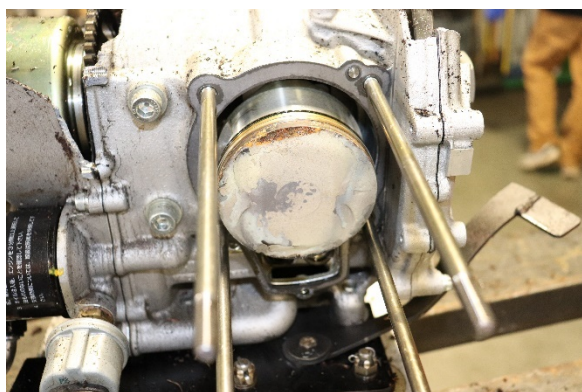
Both cylinders were removed and examined internally. A normal amount of combustion deposits was observed within the combustion dome of each cylinder and piston face. All of the intake and exhaust valves were unremarkable.

Figure 5. View of right cylinder piston face

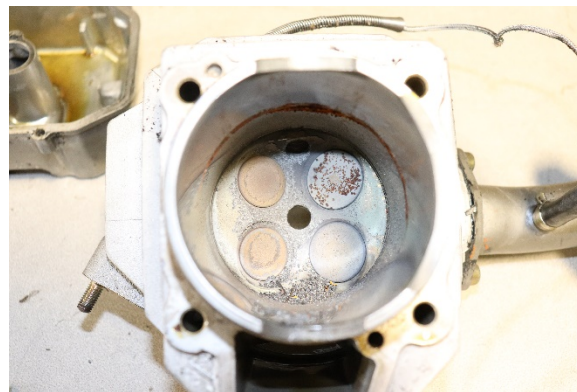
Figure 6. View of right cylinder combustion dome

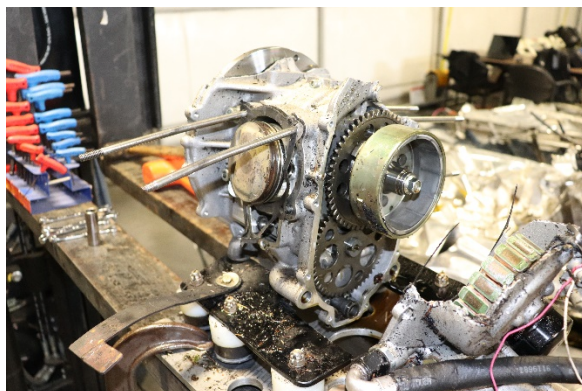
Figure 7. View of left cylinder piston face

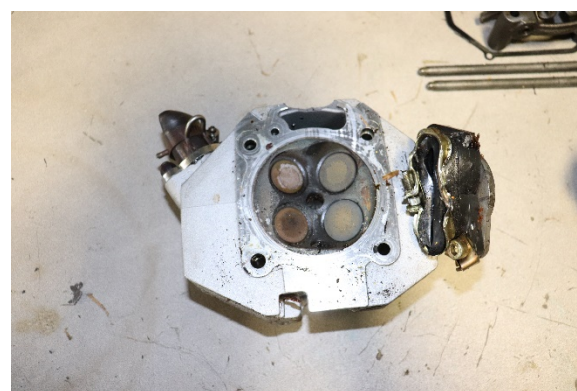
Figure 8. View of left cylinder combustion dome

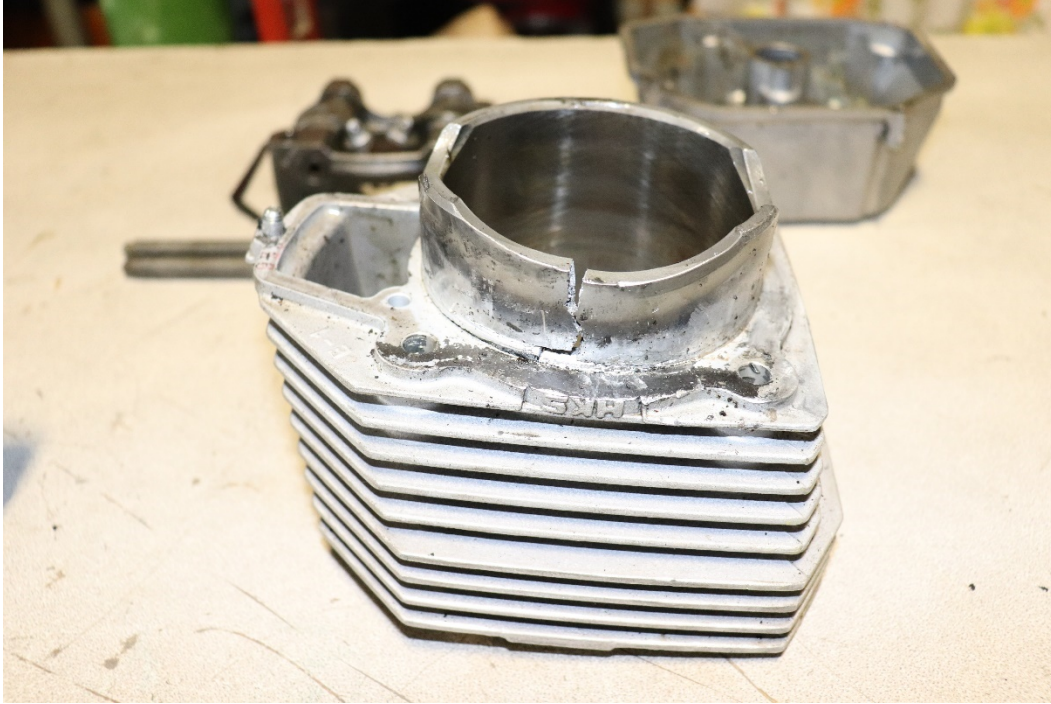
The left cylinder had fracture on the bottom area. The fracture was consistent with impact damage to the top of the cylinder.

**Figure 9. View of left cylinder fracture**
