# NATIONAL TRANSPORTATION SAFETY BOARD

## MATERIALS LABORATORY FACTUAL REPORT

Report No. 21-101

Place : Los Angeles, California  
Date : February 19, 2021  
Vehicle : Piper PA-32-260, N57014  
NTSB No. : WPR21FA114  
Investigator : Zoe Keliher, ASI-WPR

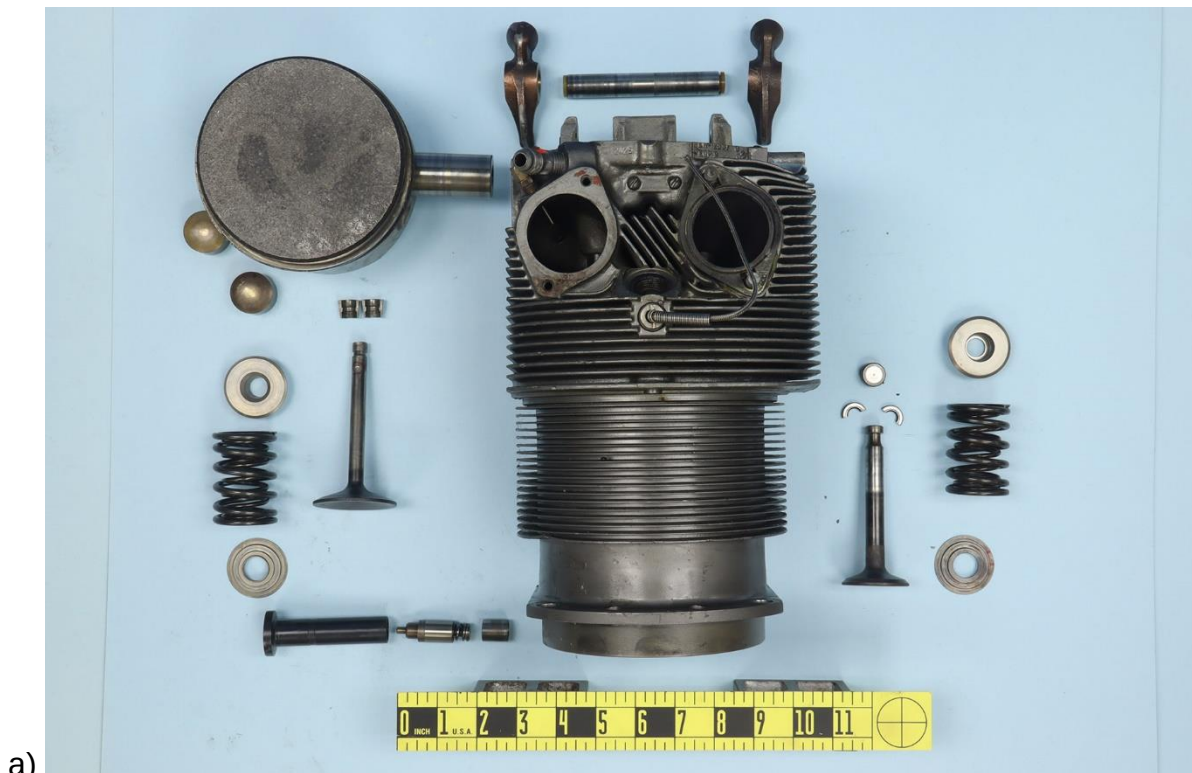
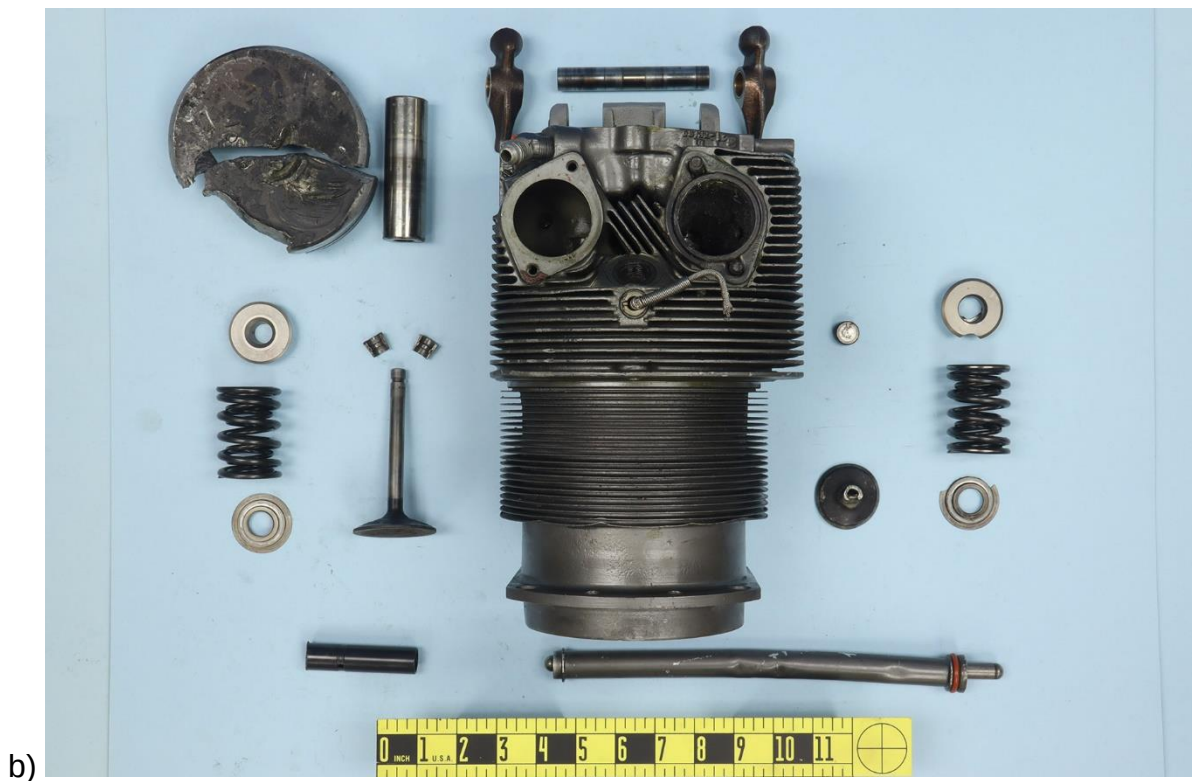
Multiple components from the numbers 5 and 6 cylinder-assemblies from a Lycoming O-540-E45B engine were submitted to the NTSB Materials Laboratory for examination, as shown in figures 1a and 1b, respectively. Components without identifying part numbers included: piston pins, piston pin plugs (No. 5 only), rocker arm shafts, intake and exhaust valve springs, intake and exhaust valve spring seats, intake valve keys, exhaust valve keys (No.5 only), exhaust valve rotator caps, push rod socket (No.5 only), and a pushrod shroud tube (No. 6 only). The remaining components and their observed part numbers, if any, are listed in table 1 below.

Multiple components from the number 6 cylinder-assembly were mechanically damaged. The number 6 piston was fractured into multiple pieces, two crown pieces being shown in figures 2a and 2b. There were impact marks on the crown, as indicated in figure 2a. Additional impact marks were observed on the interior surface of the cylinder head (figure 3), around the exhaust valve guide through-hole (figure 4a, also compare to the valve guide from the number 5 cylinder-assembly shown in figure 4b), and on the inboard end of the valve guide (also figure 4a). The exhaust valve guide had been extruded outward approximately 0.5 inch, lifting the valve guide boss off its seat on the cylinder head, as shown in figure 5a (also, see the number 5 exhaust valve guide in figure 5b for comparison). The cam follower on the number 6 exhaust tappet body had been worn leaving just the cylindrical shaft (figure 1b).

**Figure 1:** a) Components from number 5 cylinder assembly and associated hardware as received and b) components from number 6 cylinder assembly and associated hardware as received.

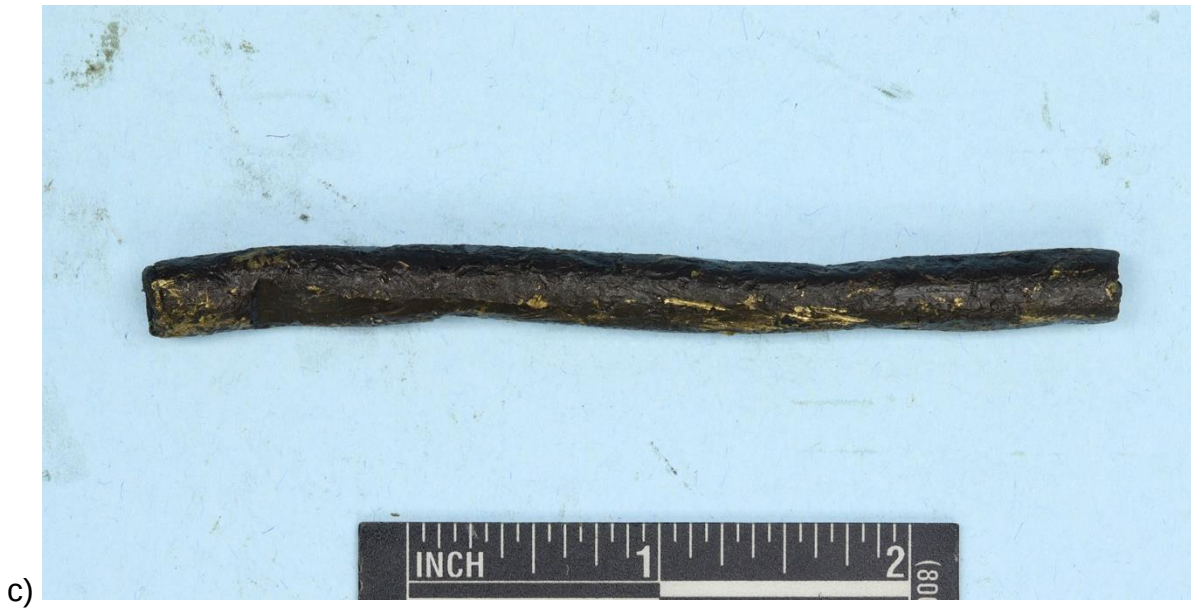
In addition, an unidentified rod that was found in the oil sump, shown in figure 1c, was submitted to the lab for identification. The rod was hollow, had a gold color, and was coated with a dark brown/black layer. One end of the rod appeared fractured and battered while the other end of the rod had a comparatively flat end. At the flat end, the inner diameter exhibited features similar to thread marks or thread impressions. The rod was cleaned in accordance with standard laboratory protocols and then examined in a scanning electron microscope (SEM) equipped with an energy dispersive x-ray spectrometer (EDS). In the gold-colored regions, the material composition consisted of copper and zinc, consistent with a brass alloy. In the dark regions, the composition was similar, but with the addition of an abundant oxide peak, consistent with the alloy oxide.

**Figure 1 (cont.):** c) piece of rod found in oil sump.

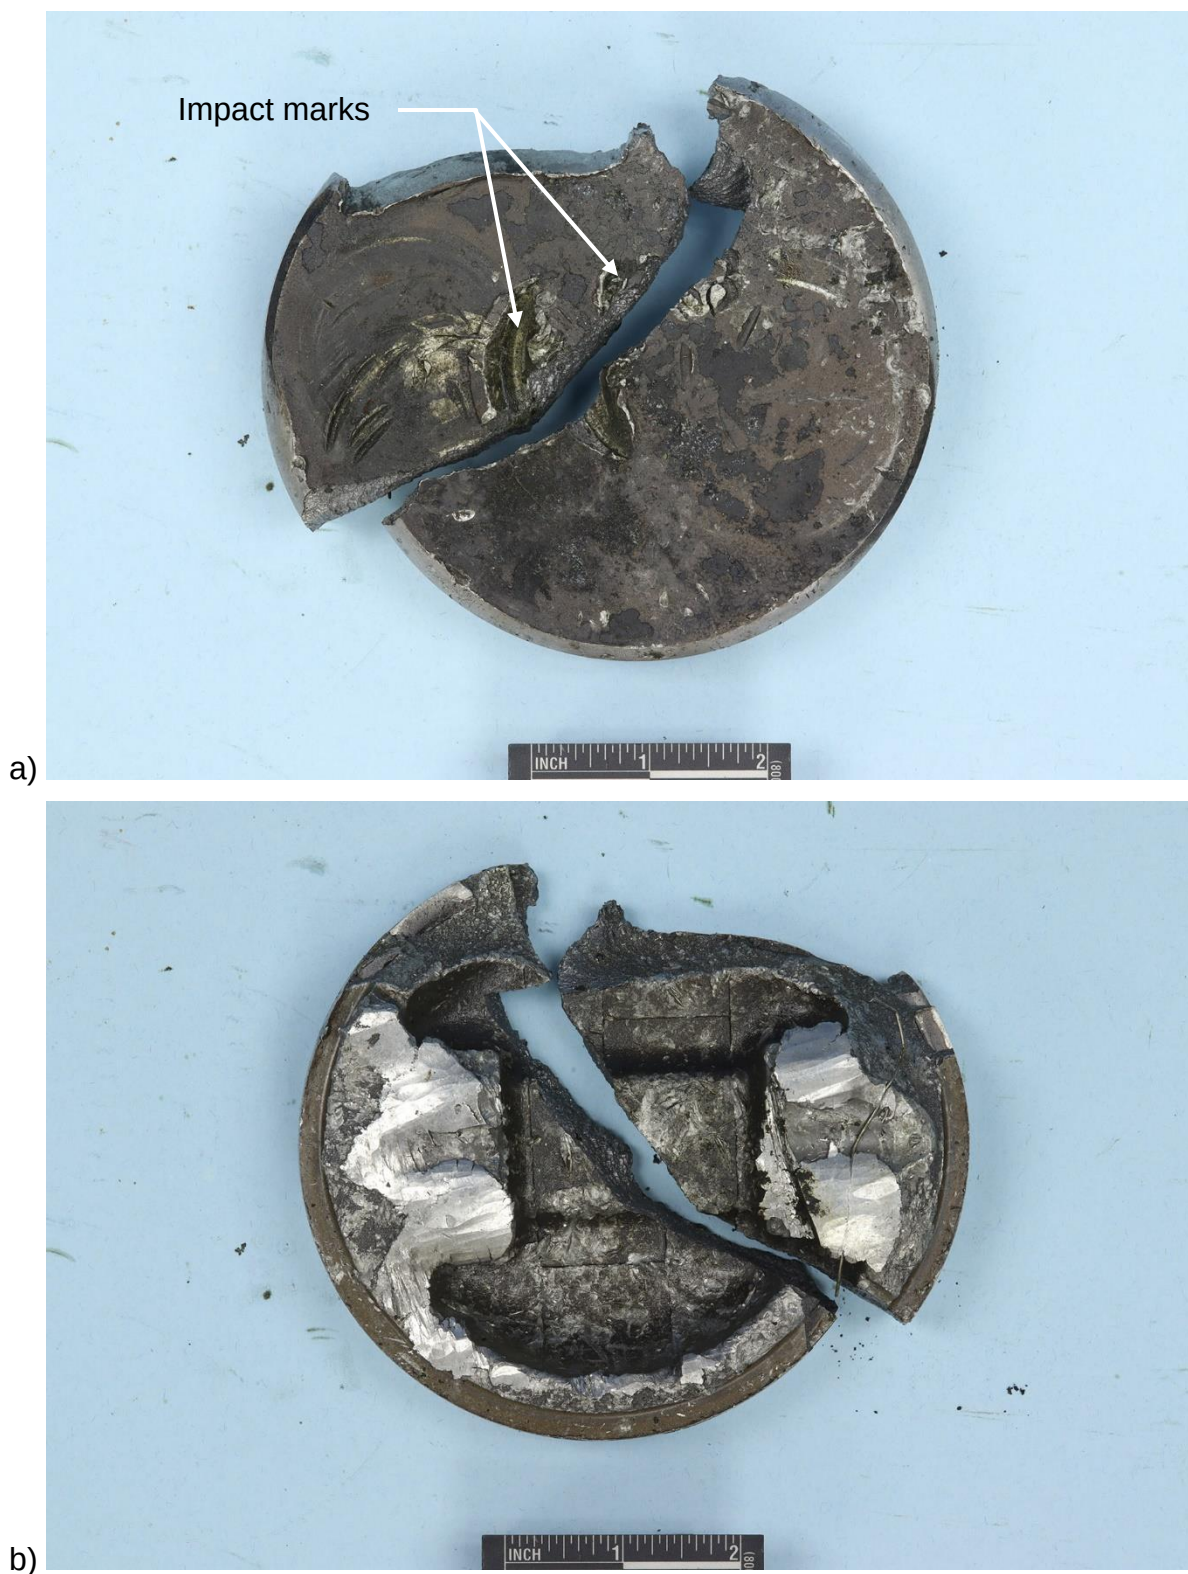
**Figure 2:** Images of fractured piston; a) piston-crown side and b) inward side showing fracture in-plane with the pin bosses.

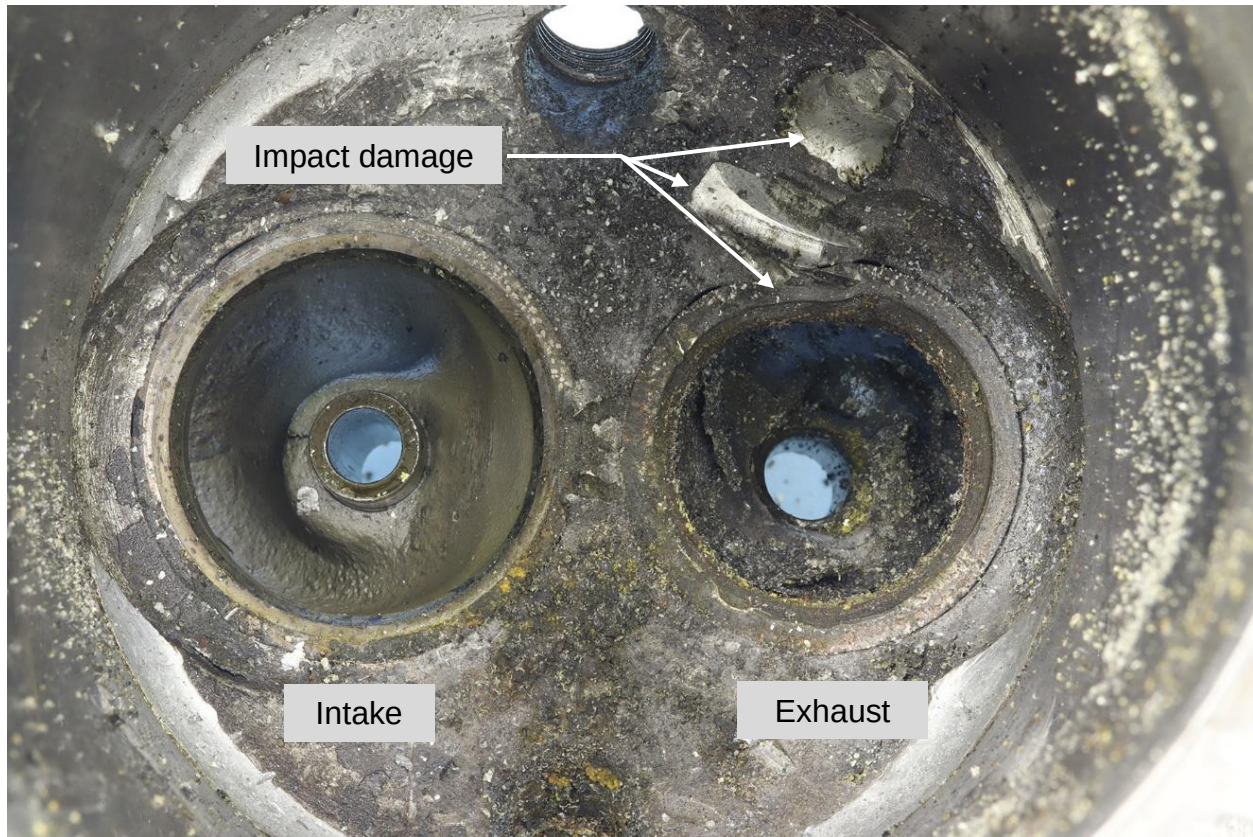
**Figure 3:** Inside view of number 6 cylinder head showing damage to the exhaust valve seat and surrounding material.

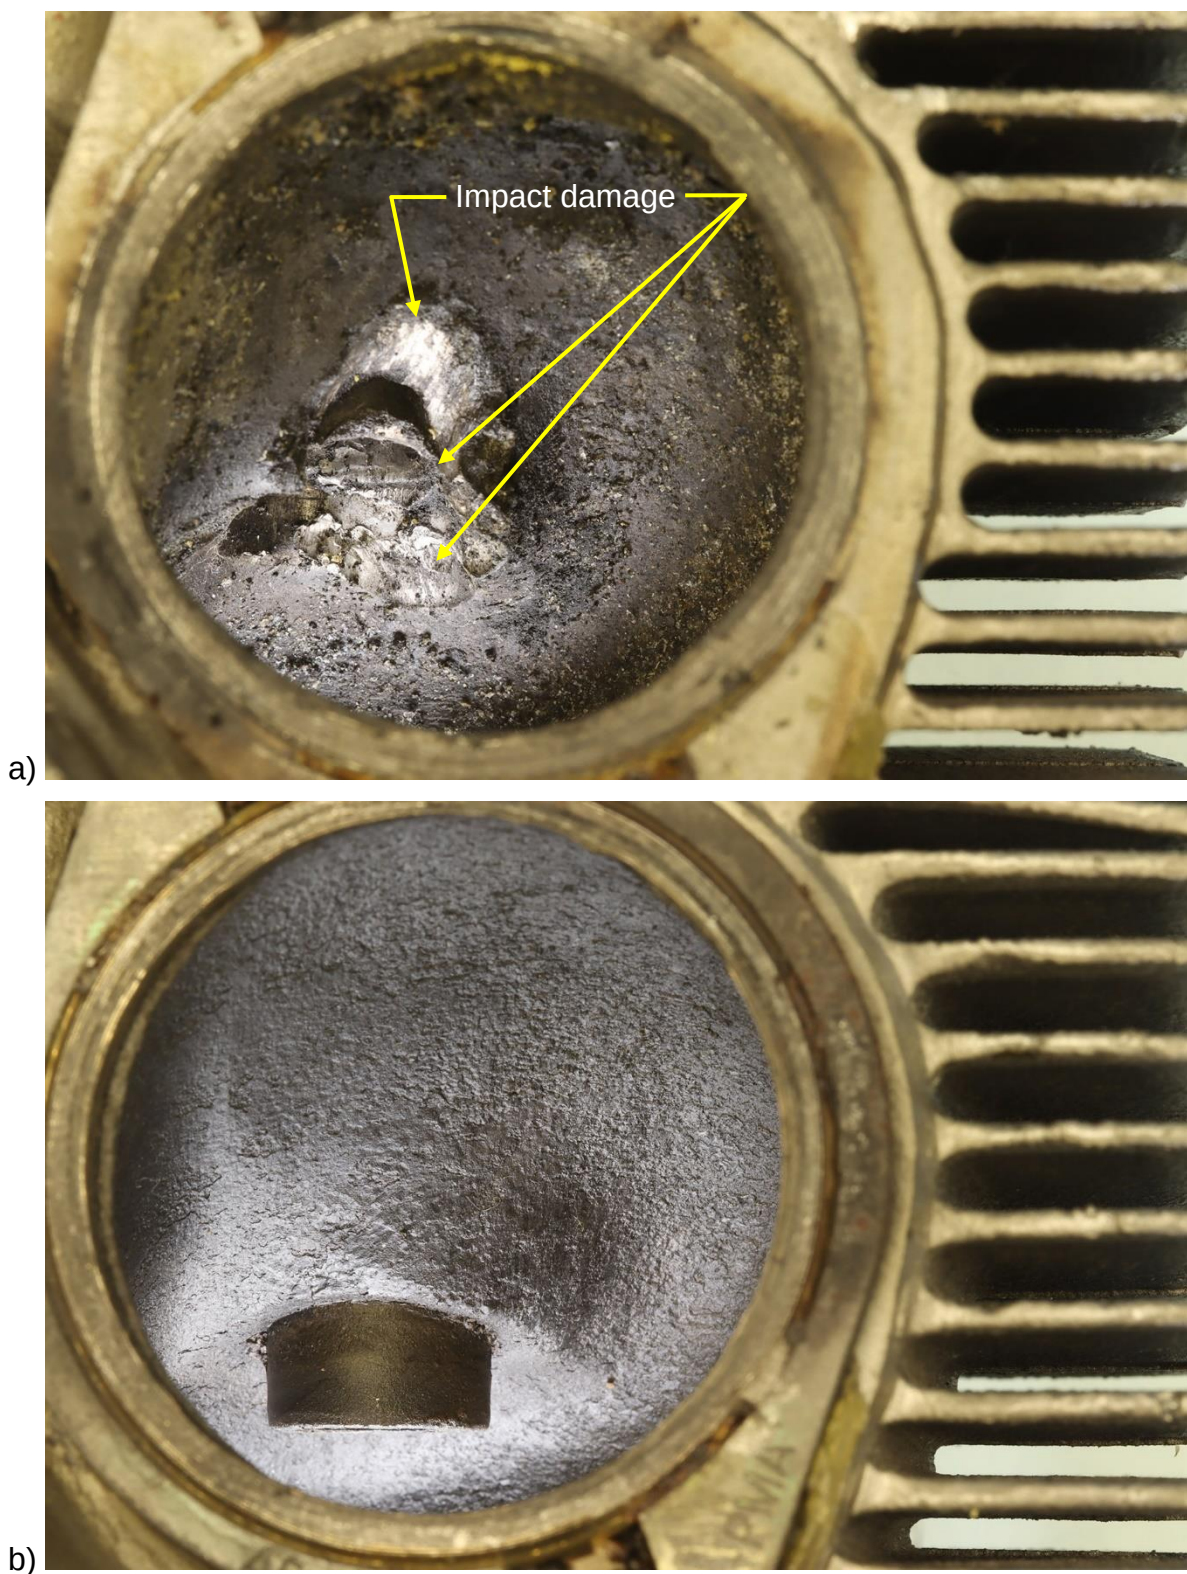
**Figure 4:** Image of exhaust valve guides as seen from the exhaust port; a) number 6 cylinder and b) number 5 cylinder. The valve guide and surrounding material on the number 6 cylinder exhibited features consistent with impact damage.

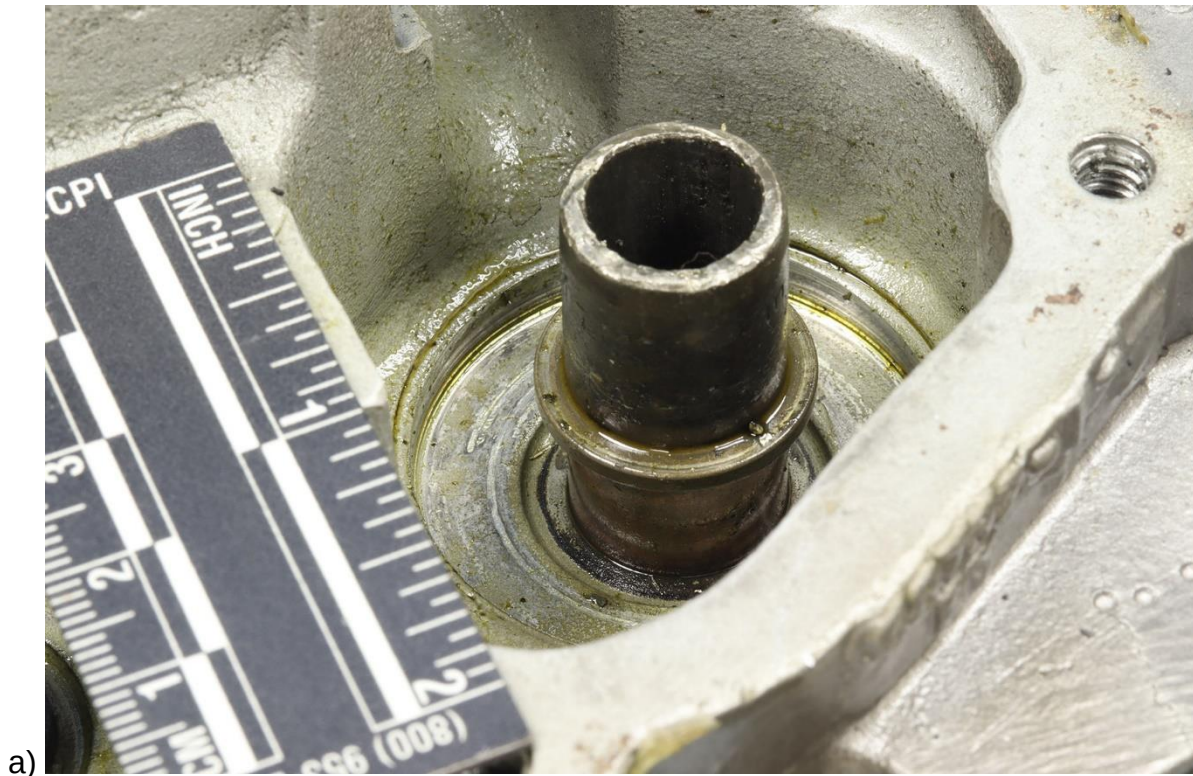
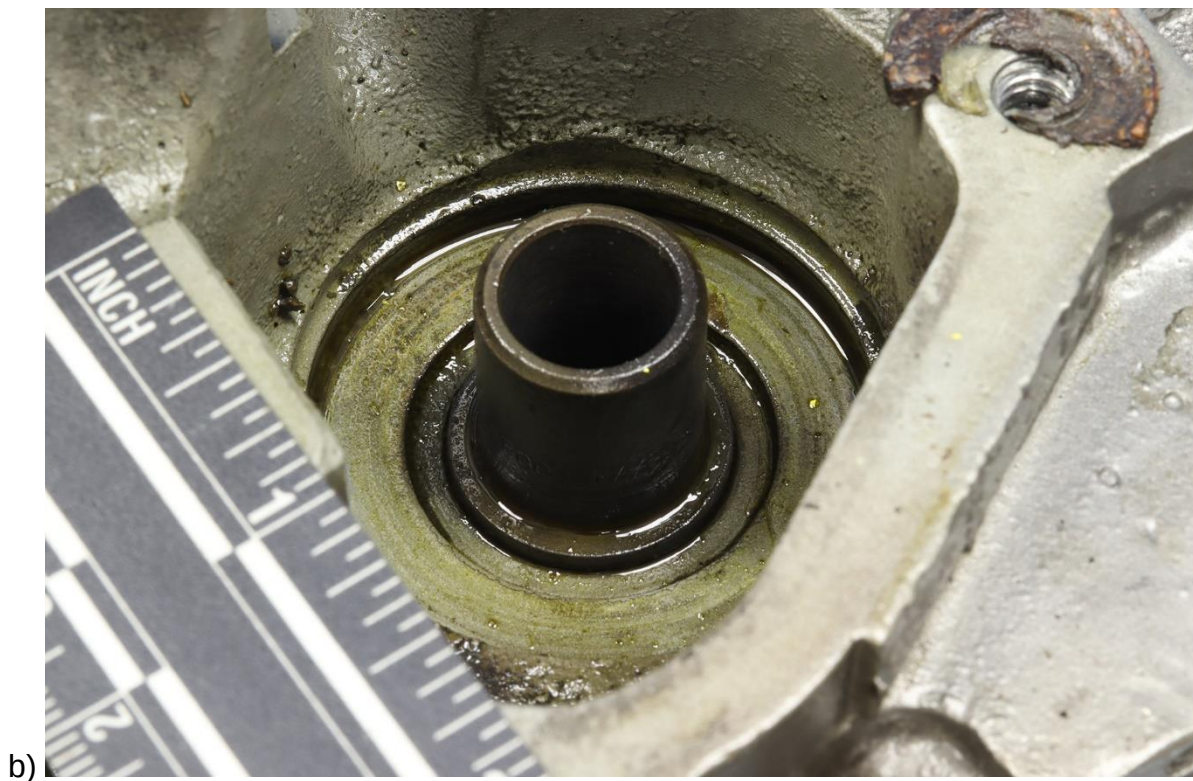
**Figure 5:** Images of the exhaust valve guides; a) number 6 cylinder and b) for comparison, number 5 cylinder.

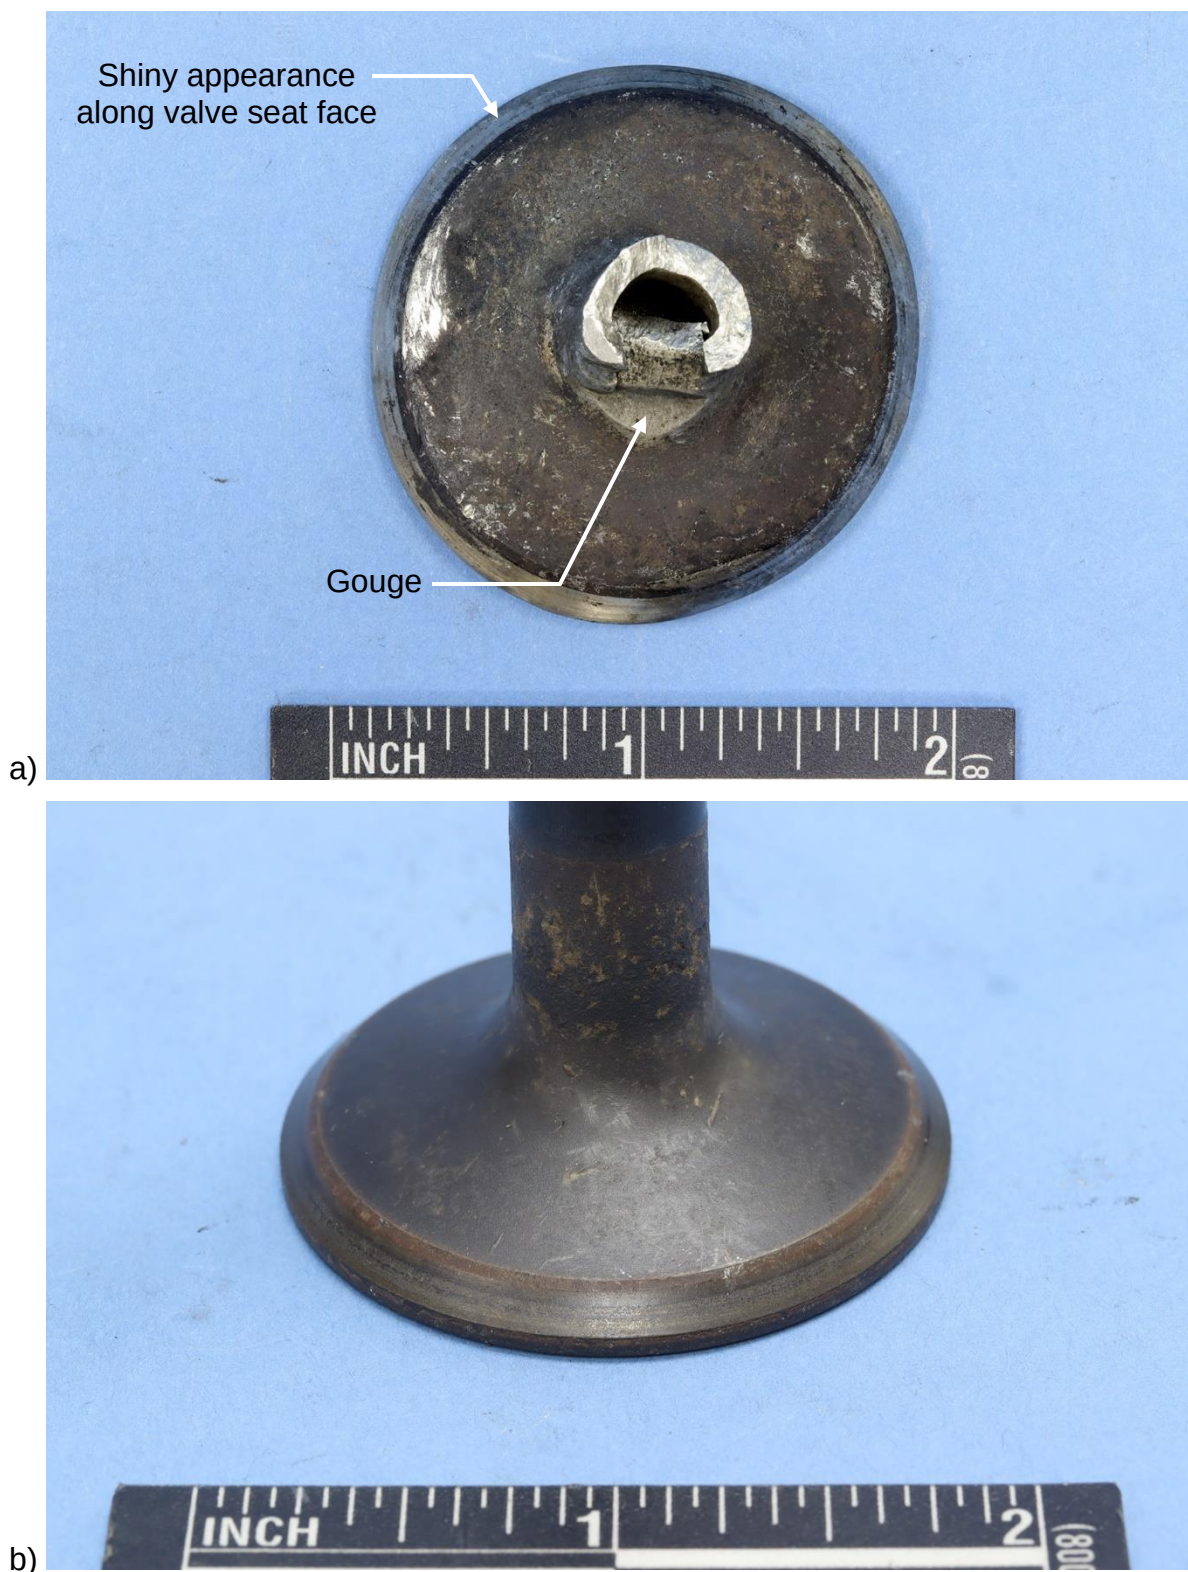
The number 6 cylinder exhaust valve was fractured through the stem near the stem-to-fillet transition, as shown on the remaining valve head fragment in figure 6a. An arc segment of the stem adjacent to the fracture was deformed radially inward and there were longitudinal tears along the stem on either side. At the base of this segment, in the fillet region, the valve head was gouged. The valve seat face exhibited a shiny metallic appearance (figure 6a), in contrast to the number 5 exhaust valve head, which exhibited a dark heat-tinted appearance (figure 6b). The stem fracture surface (figure 6c) exhibited parallel transverse lines and when viewed from the side (figure 6d) the stem exhibited shear deformation in the same transverse direction. The features were consistent with a shear overstress fracture of the exhaust valve stem. The stem adjacent to the fracture had a pitted/corroded appearance and the combustion face (figure 6e) was comparatively free of combustion products or residues. The valve stem was not located with the wreckage and could not be examined.

**Figure 6:** a) Image of the number 6 exhaust valve showing the fractured stem, outer face of the valve head and valve seat face; b) image of the number 5 exhaust valve;

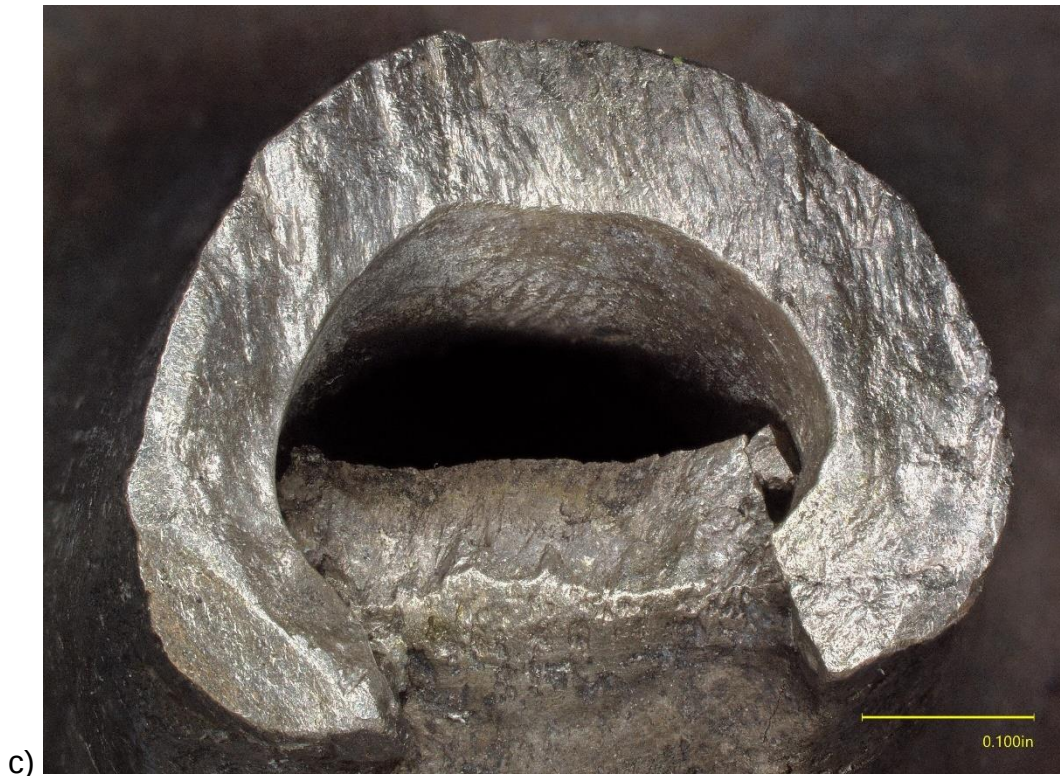
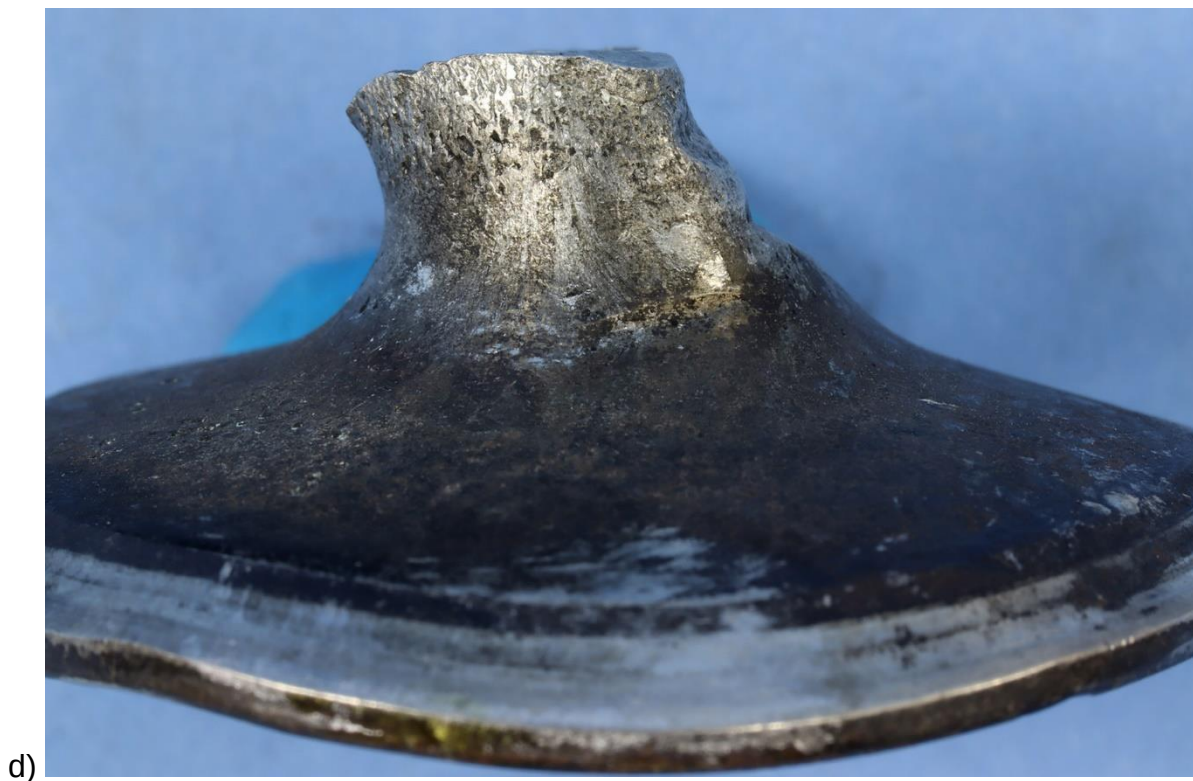
**Figure 6 (cont.):** c) higher magnification image of the stem fracture; d) side view showing shear deformation of stem adjacent to fracture; and

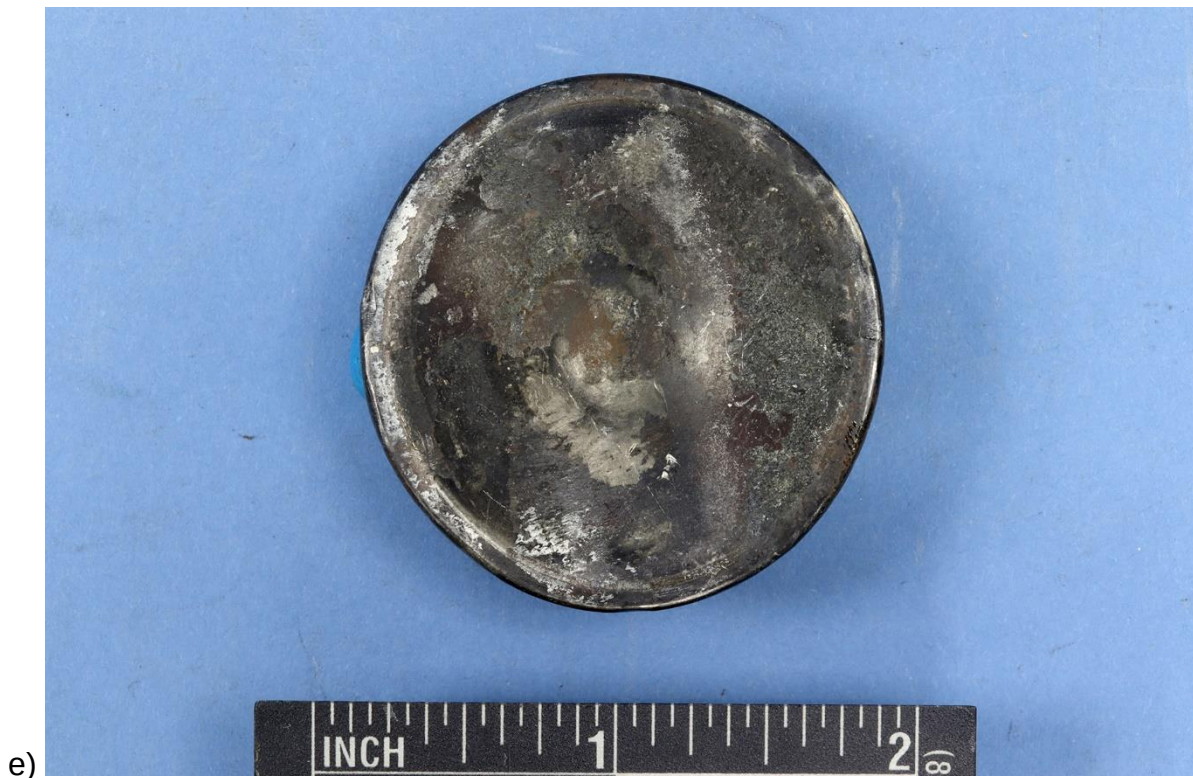
**Figure 6 (cont.):** e) image showing the combustion face of number 6 exhaust valve.

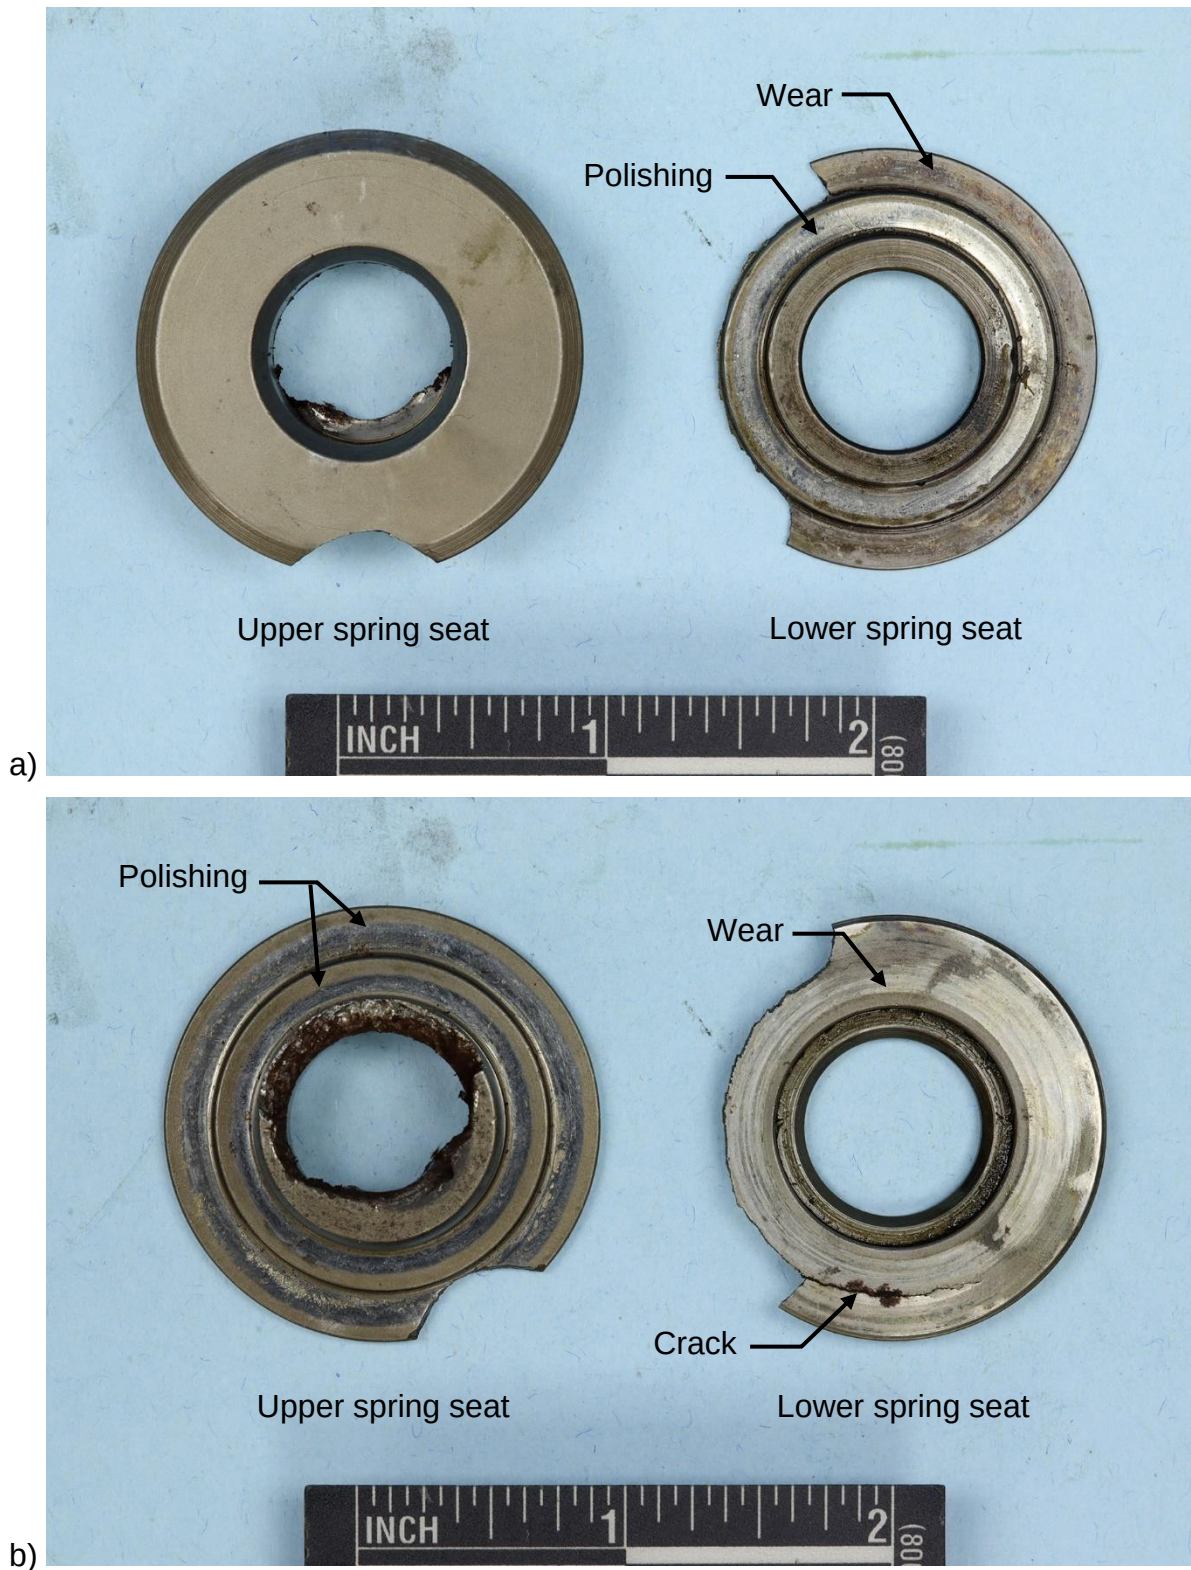
The number 6 exhaust valve spring seats exhibited wear and fracture features, as shown in figures 7a and 7b. The lower spring seat exhibited wear of the gold heat tinting on the outer seat, polishing of the inner seat, and wear of the tint on the inboard-facing (cylinder head-facing) side. An approximately 127° arc segment of the outer seat was

fractured, and a crack extended an additional 60° (approx.) beyond one end of the fractured region, as indicated in figure 7b. The fracture was examined by SEM (not shown) and exhibited an intergranular morphology near the inner and outer surfaces. Elsewhere, it exhibited dimple features that were consistent with overstress. The upper spring seat exhibited polishing of the outer and inner seats as indicated in figure 7b. A thumbnail-shaped region had fractured from the seat along its outer circumference. The region was similar in location and size to contact marks observed on the exhaust valve rocker arm, as indicated in figure 8.

**Figure 7:** Images of the number 6 cylinder exhaust valve spring seats; a) outboard-facing sides of upper and lower seats and b) inboard-facing sides.

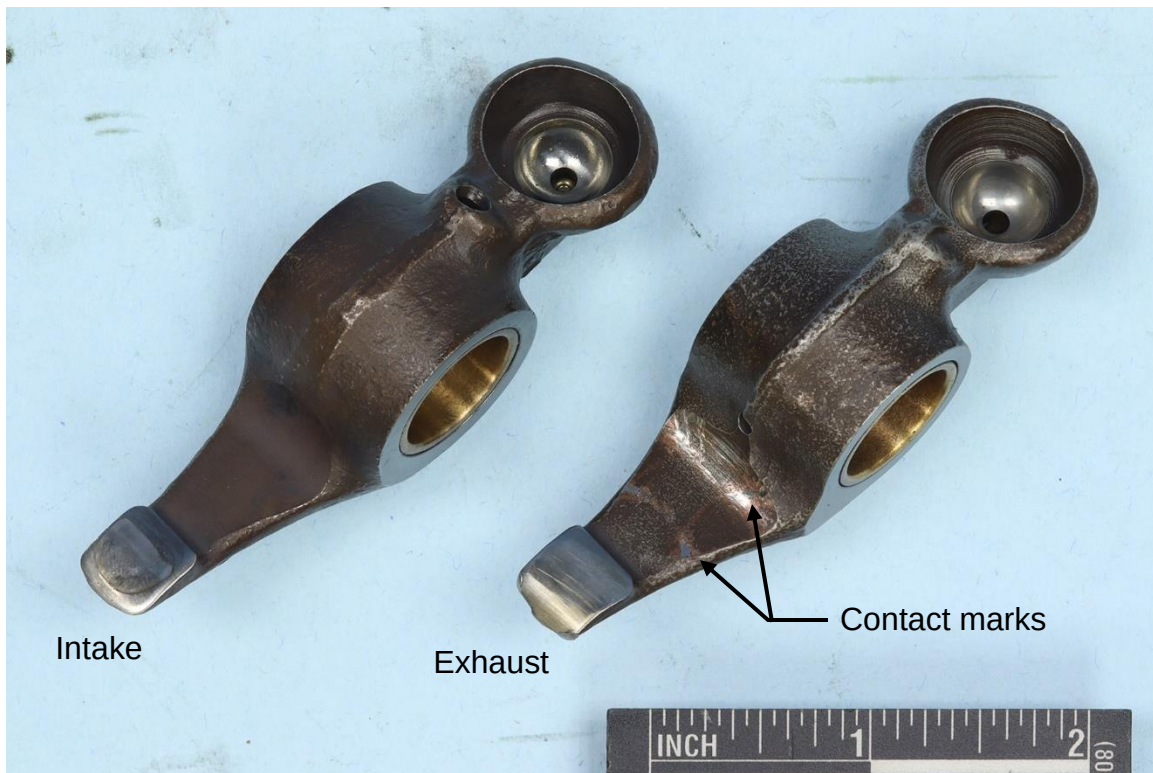
**Figure 8:** Number 6 cylinder intake and exhaust valve rocker arms. The exhaust valve exhibited contact marks as indicated.

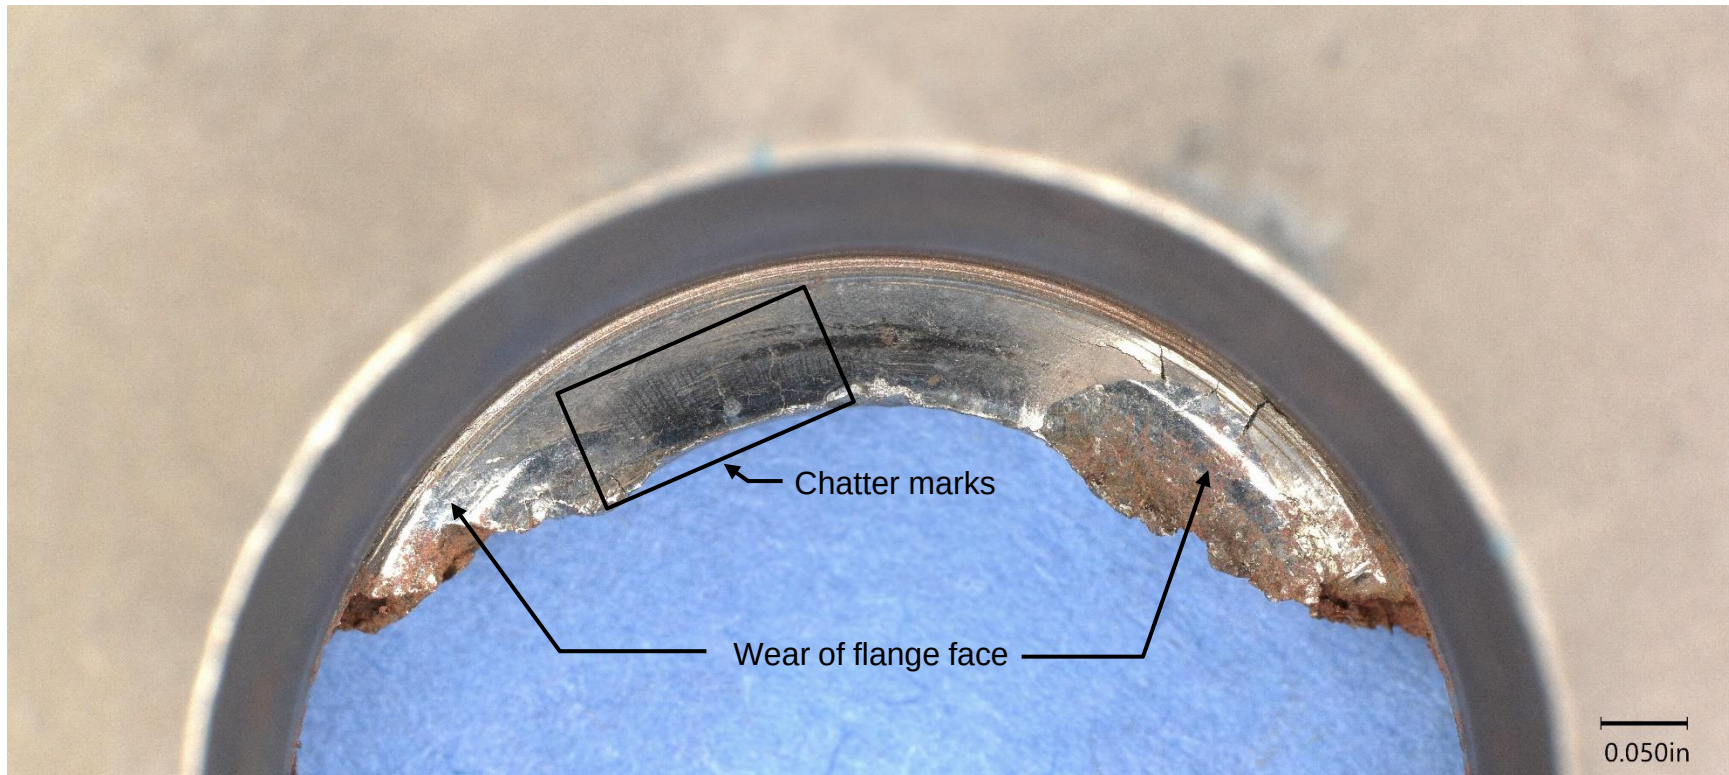
The flange at the base of the number 6 exhaust valve spring seat had fractured along an approximately 225° arc segment. The remaining segment is shown in figure 9. The key-facing side of the flange segment exhibited polishing and radially oriented chatter marks. The ends of the segment were beveled and wear was observed into the original flange face. The sidewall of the cup was polished at the level of the keys, as shown in figures 10a – 10d. Approximately 180° (opposite) from the flange segment, there was an additional wear mark and linear mark on the sidewall of the cup closer to the cup's outer entrance, as indicated in figure 10c. For comparison, an image of the number 5 exhaust upper spring seat is shown in figure 11, where no comparable wear marks were observed.

**Figure 9:** Image showing the remaining flange segment at the base of the number 6 exhaust valve upper spring seat cup.

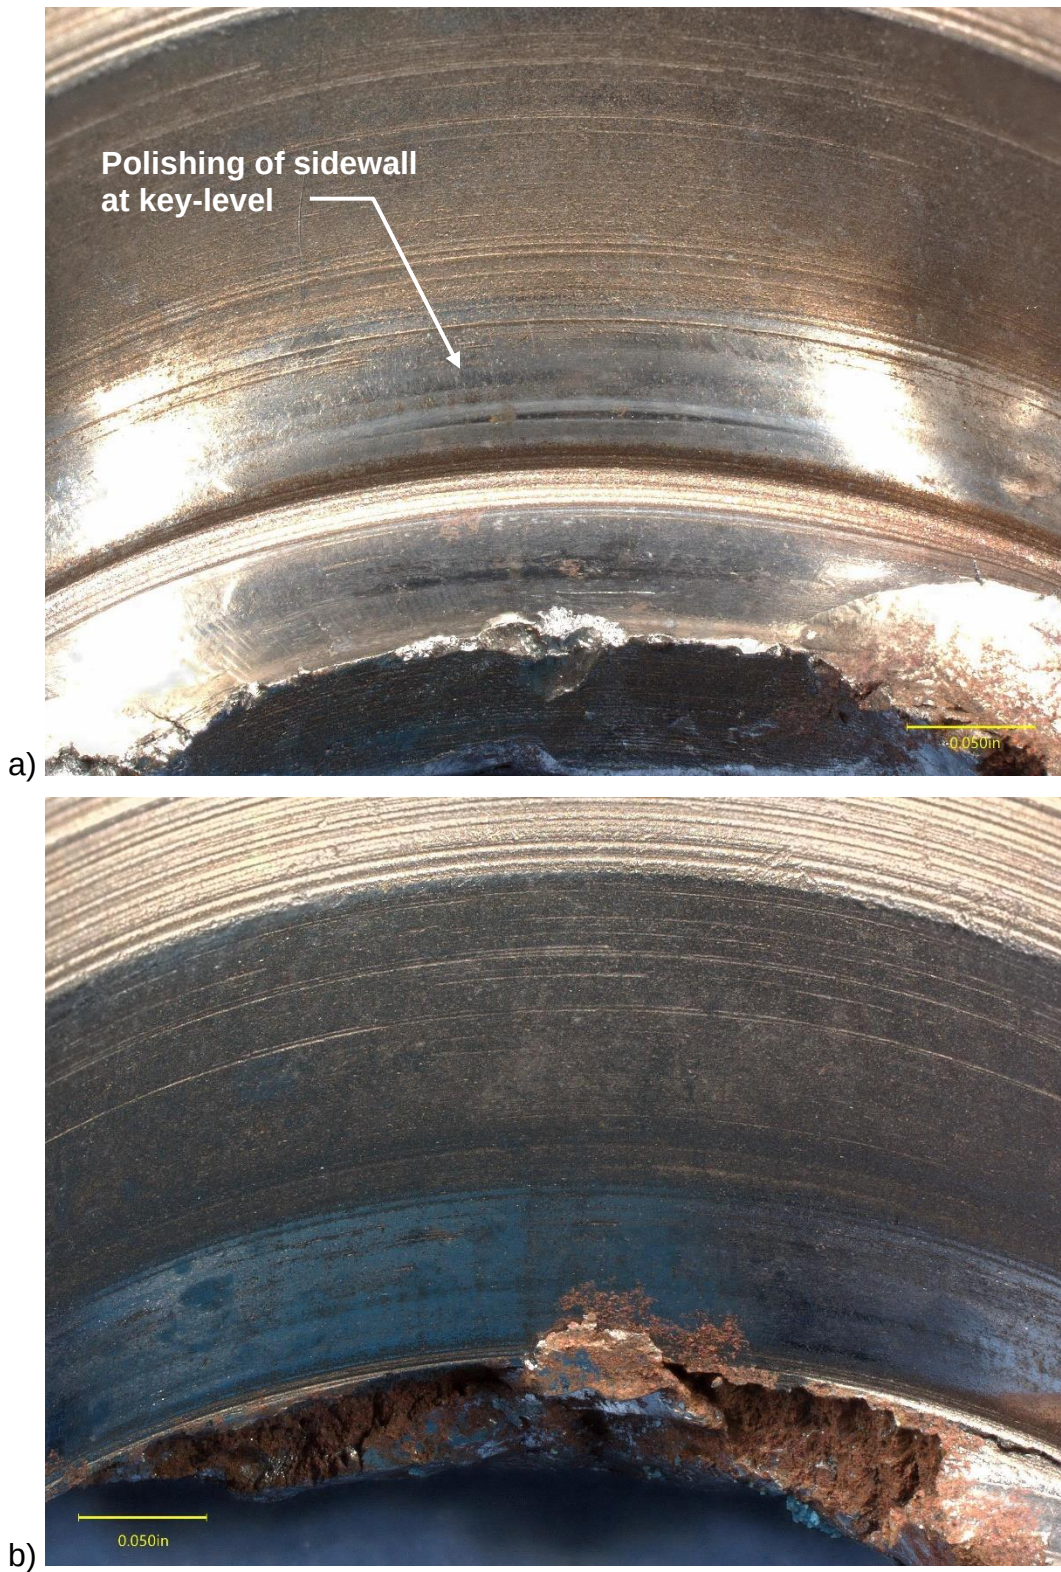
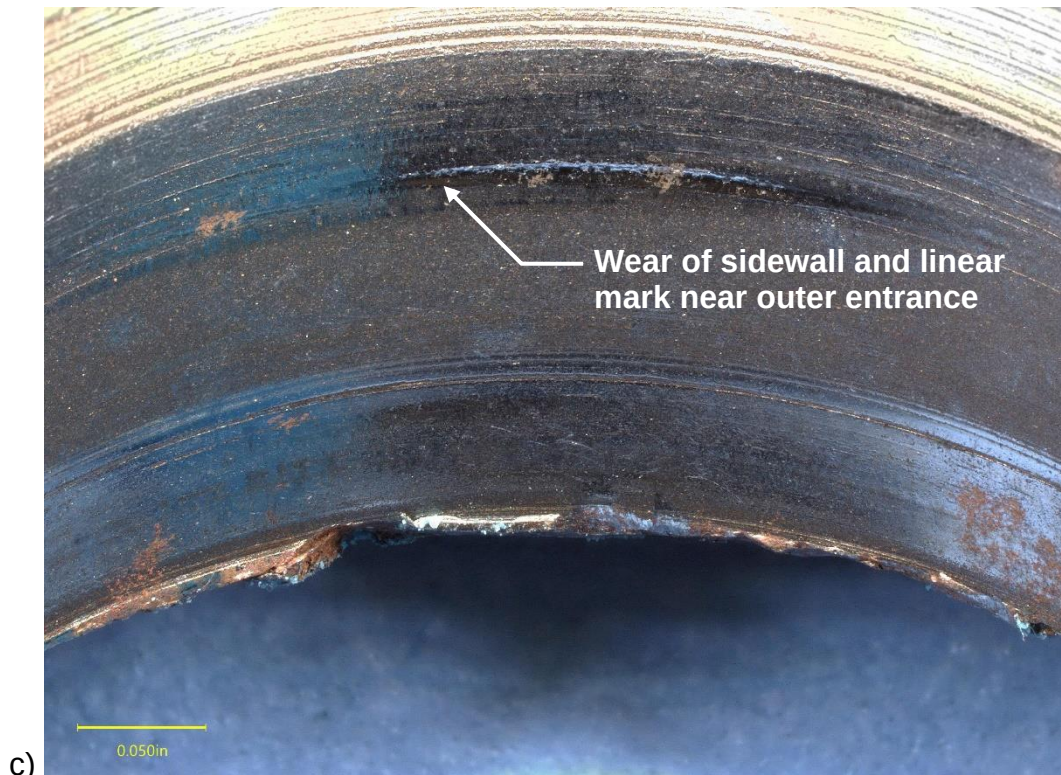
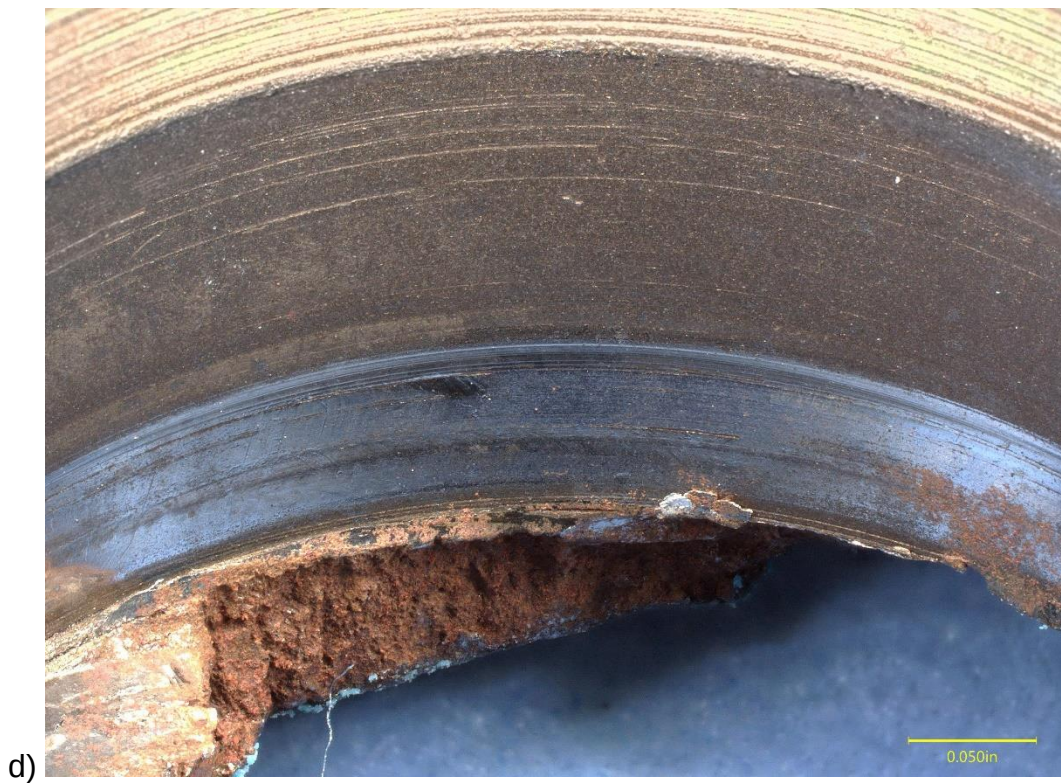
**Figure 10:** Images of the number 6 exhaust valve upper spring seat cup sidewall; a) 0°; b) 90°;
