# NATIONAL TRANSPORTATION SAFETY BOARD

## MATERIALS LABORATORY FACTUAL REPORT

Report No. 21-101

Place : Los Angeles, California  
Date : February 19, 2021  
Vehicle : Piper PA-32-260, N57014  
NTSB No. : WPR21FA114  
Investigator : Zoe Keliher, ASI-WPR

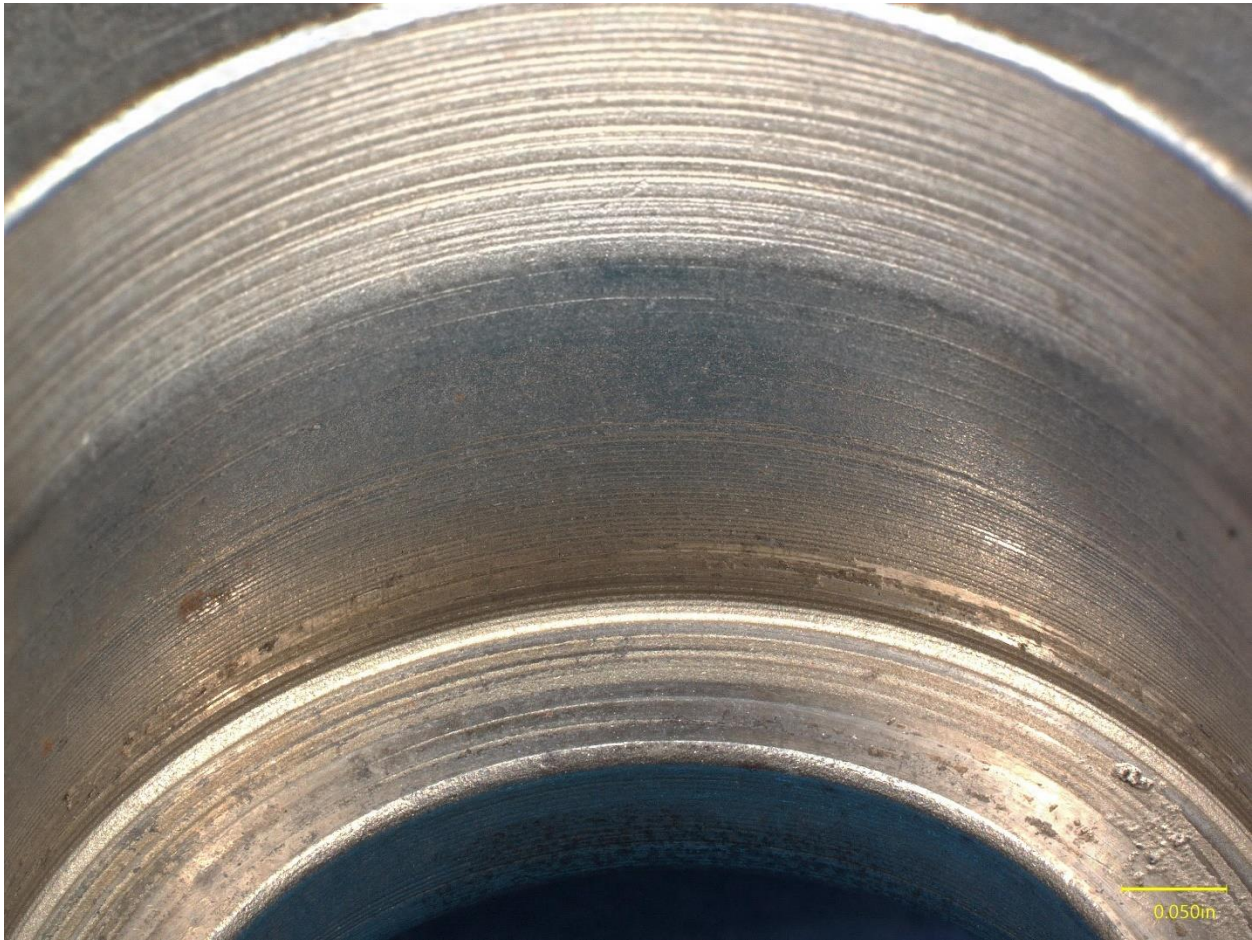
**Figure 11:** Image of the number 5 exhaust valve upper spring seat cup.

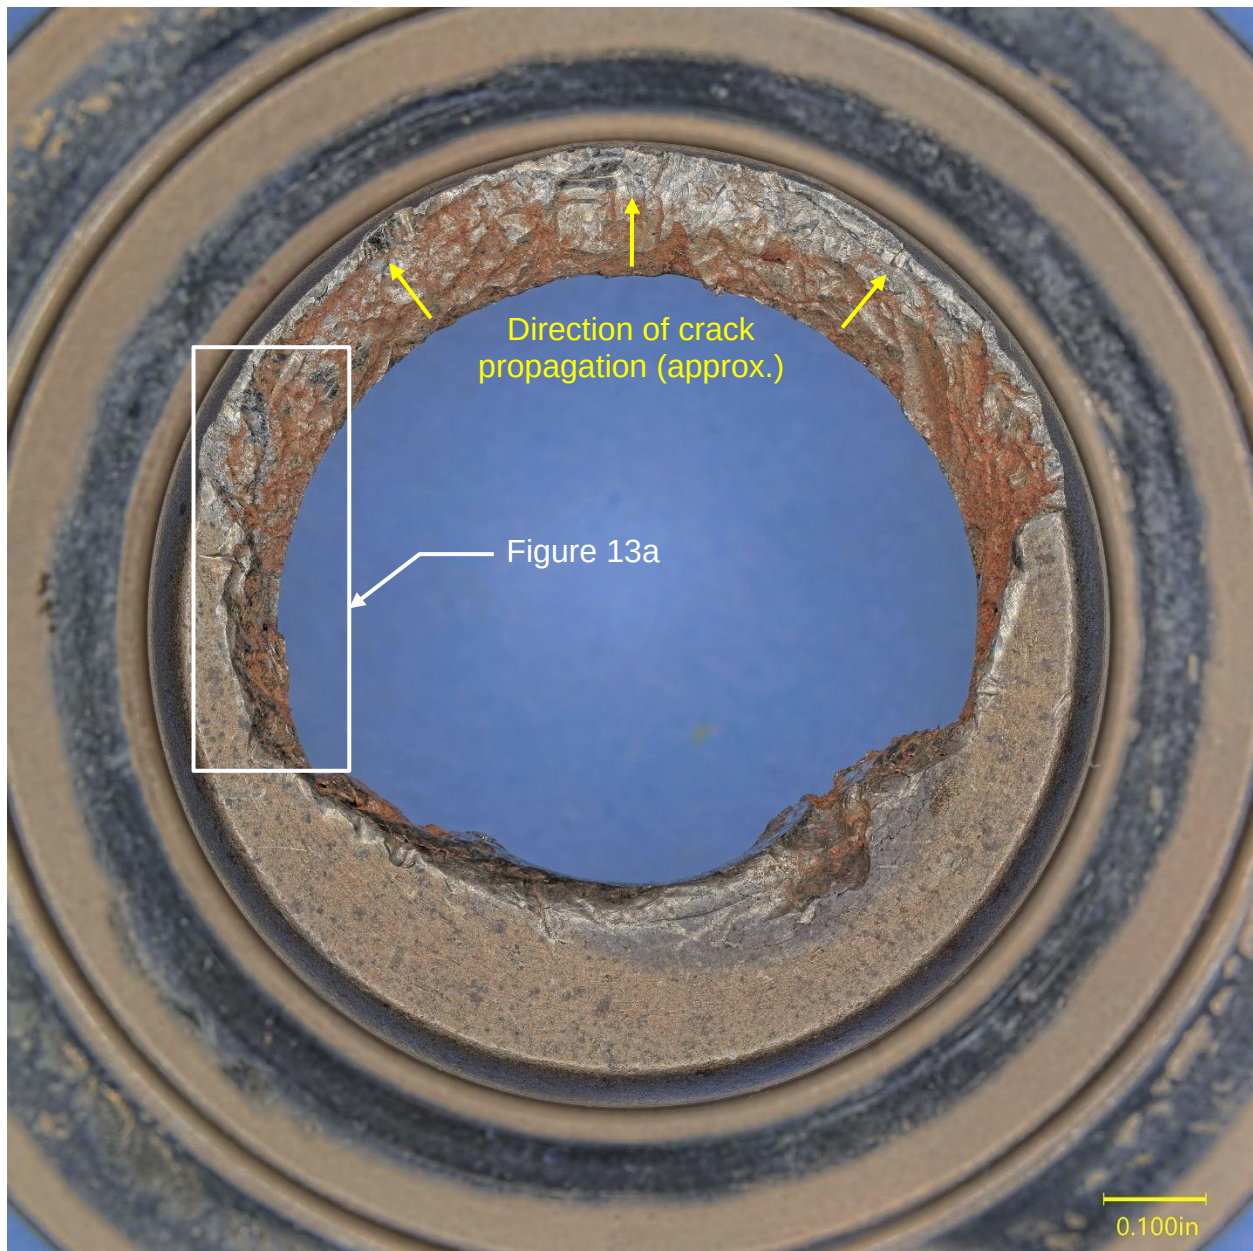
The compression-spring-facing side of the seat is shown in figure 12. The flange fracture had initiated at the fillet radius of the flange to sidewall transition and progressed radially outward and toward the base of the seat. Much of the fracture surface exhibited impact damage and rust-colored wear debris. However, near the edges of the fracture, there were regions that were comparatively undamaged. One region is indicated in figure 12 and shown in figure 13a. The spring seat was cleaned using an alkaline detergent and sonicated in an acetone bath, in accordance with standard laboratory practices. The seat was then examined in the SEM. At the location indicated in figure 13a, the fracture surface exhibited striated features, as shown in figure 13b, consistent with fatigue crack progression. The direction of crack progression, indicated by the yellow arrows, was also consistent with the crack initiating at the fillet transition.

**Figure 12:** Compression-spring-facing side of number 6 exhaust valve upper spring seat showing extent of fracture at the base of the cup as well as impact damage and rust colored wear debris.

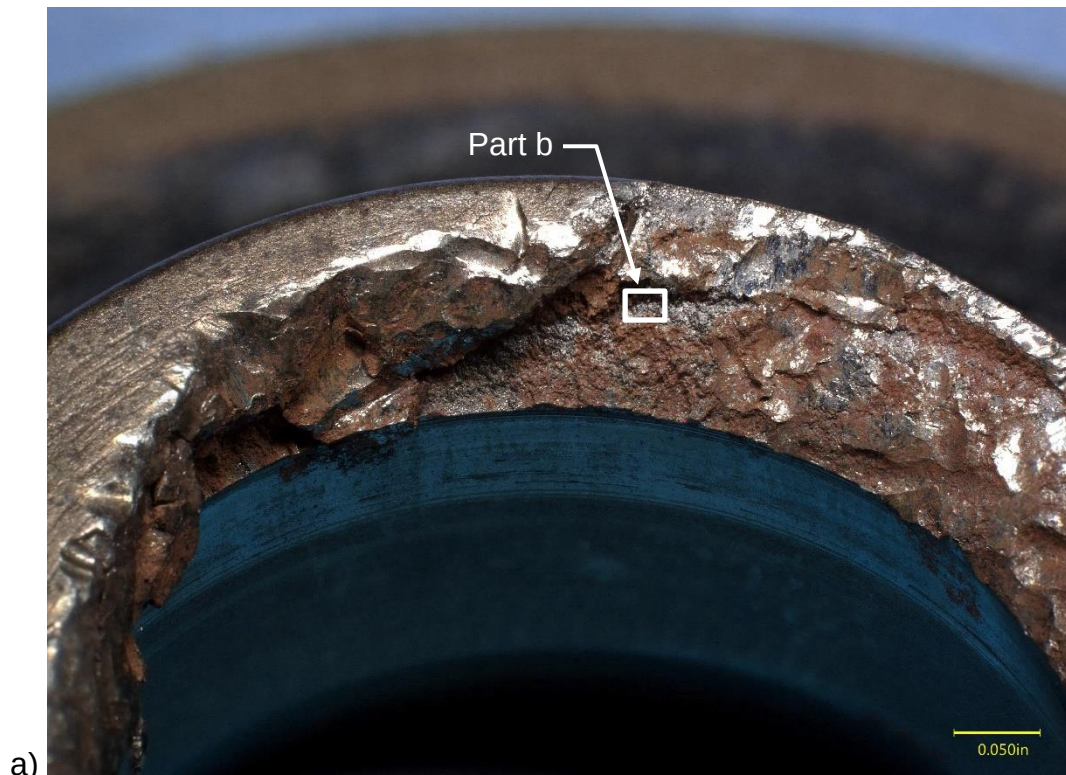
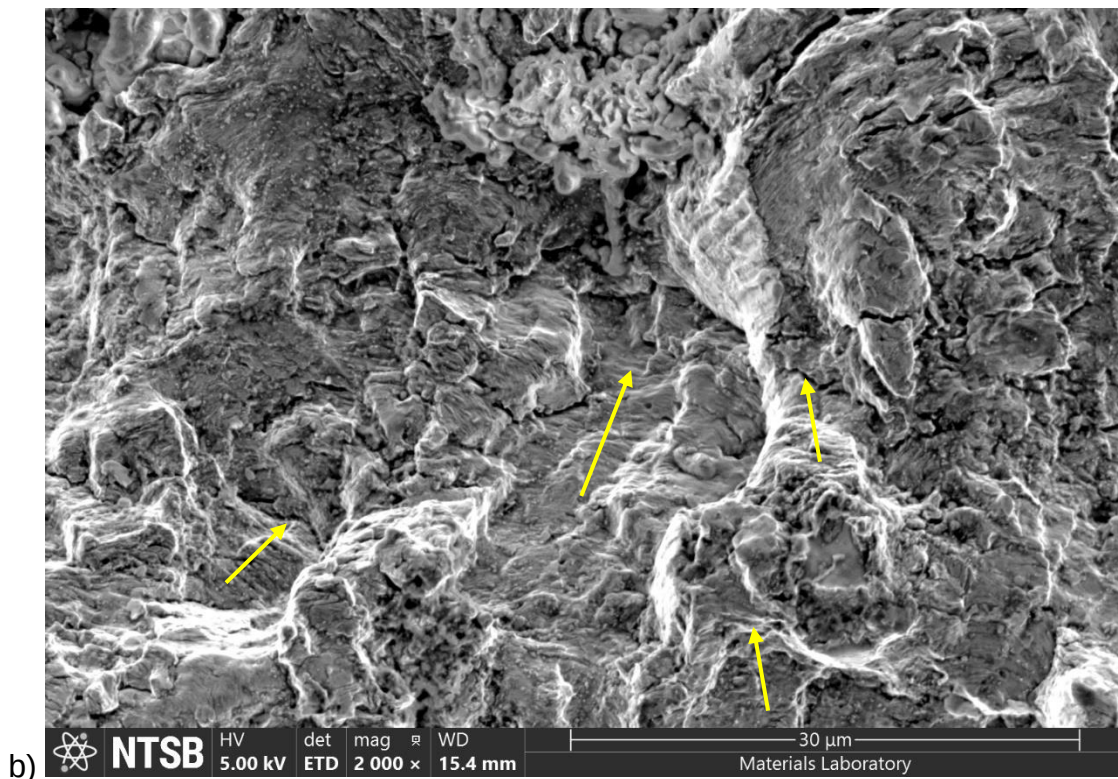
**Figure 13:** a) Image of fracture as indicated in figure 12 and b) SEM image in the area indicated in figure 13a exhibiting striated features, consistent with fatigue crack propagation.

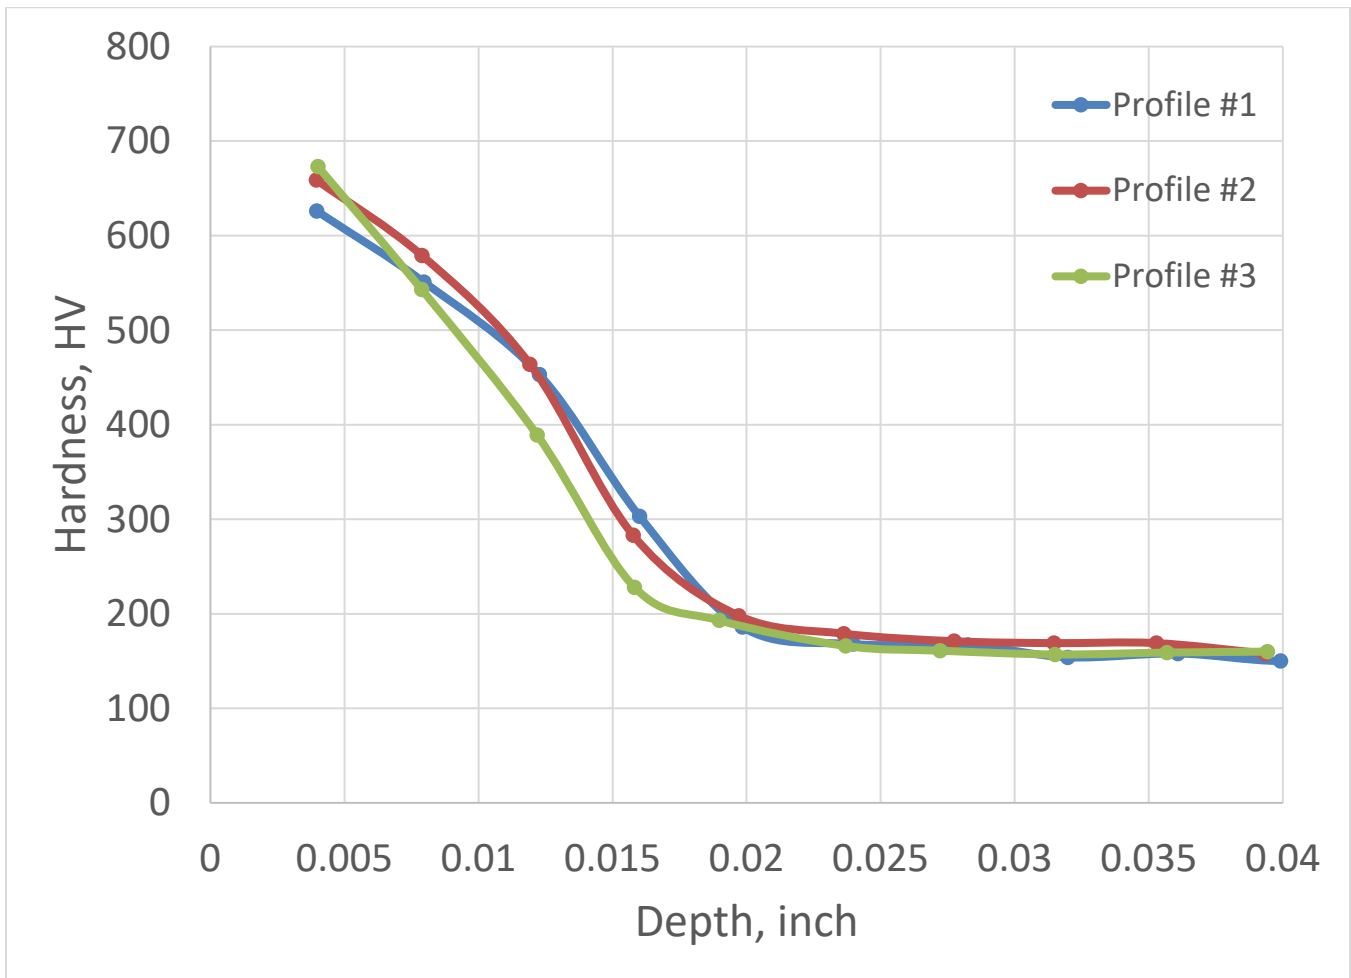
The case hardness depth profile on the number 6 exhaust valve upper spring seat was examined and was found to be in accordance with the material requirements. A wedge-shaped piece of the seat was extracted using a wet abrasive saw and mounted in a block of diallyl phthalate resin with one of the wedge faces oriented downward. The mounted section was then ground and polished in accordance with standard laboratory procedures. Microhardness testing was performed using an automated hardness tester equipped with a Vickers indenter and a 500 g load. Hardness depth profiles were measured along the cup sidewall at three locations. The profiles started at the surface

and proceeded inward at 0.004-inch intervals (the first indent was placed at a depth of 0.004 inch) and the indents were staggered laterally to avoid overlapping one another. The three hardness profiles are shown in figure 14. The measured case depths were in accordance with the material requirement.

**Figure 14:** Case depth profiles on the number 6 exhaust valve upper spring seat. Vickers hardness with 500 g load.
