## INVESTIGATIVE MATERIAL SUPPLEMENT

On February 19, 2021, about 1158, a Piper PA-32-260 Cherokee Six airplane, N57014, was substantially damaged when it was involved in an accident in Los Angeles, California. The pilot was fatally injured and a person on the ground sustained minor injuries. The airplane was operated as a Title 14 *Code of Federal Regulations* (CFR) Part 91 personal flight.

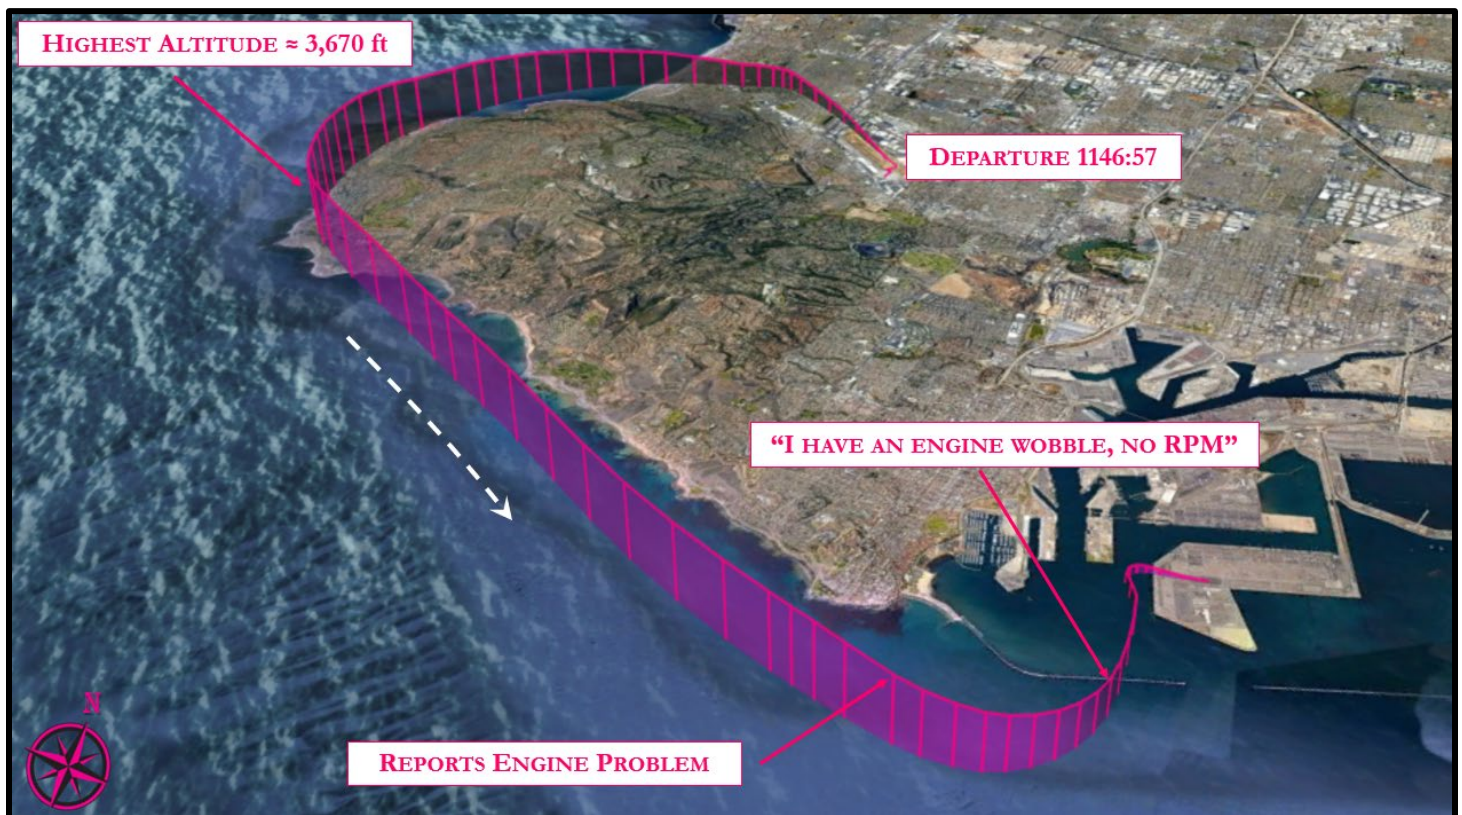
Figure 1: Accident Flight Path

Investigators reviewed flight track data covering the area of the accident during the time surrounding the accident using Federal Aviation Administration (FAA) provided Automatic Dependent Surveillance-Broadcast (ADS-B) data. The airplane had been assigned a discrete transponder code of 0242 by the FAA's Southern California Terminal Radar Approach Control (SCT TRACON). The data was consistent with the airplane departing Torrance at 1146 and proceeding south-southeast along the coastline while climbing, reaching an altitude of about 3,400 ft mean sea level (msl).

The pilot was in communication with SCT air traffic controllers during the flight receiving visual flight rules (VFR) flight following. At 1155:29, the pilot reported to the SCT Harbor radar controller that he was experiencing engine problems. After the controller queried about the nature of the problem, at 1156:30 the pilot stated, "I have an engine wobble; no RPM's." About 20 seconds later, the pilot added, "I think I have to make an off-airport landing." Several seconds later he transmitted his final communication that the Long Beach harbor appeared to be the best place to land and that "I am going to see if I can make it." The radar indicated that the airplane proceeded toward Terminal Island and aligned for an emergency landing to a paved area.

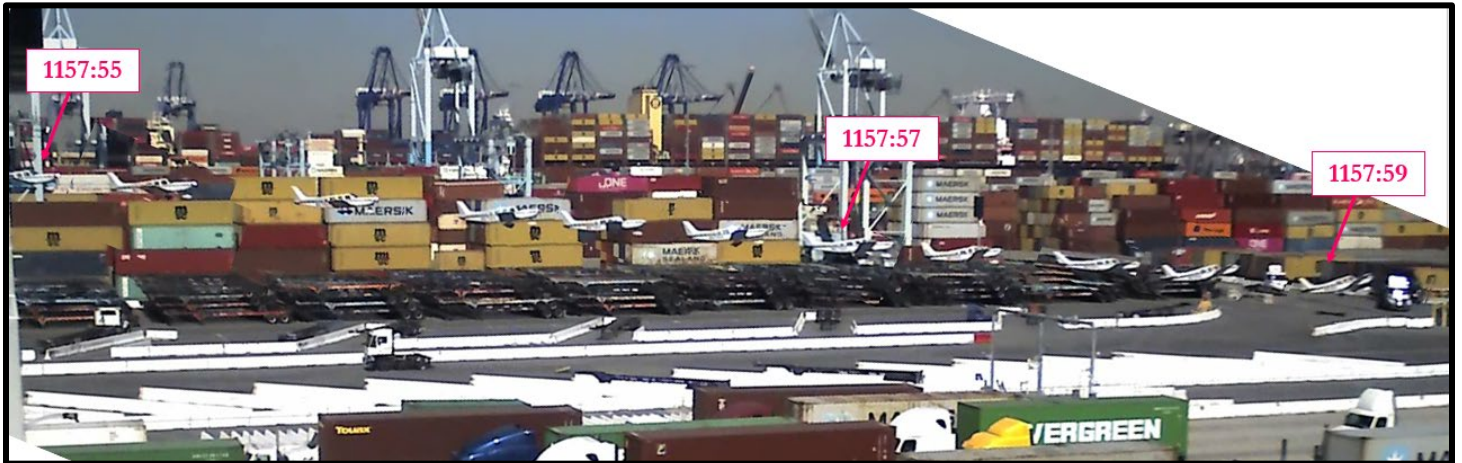
*Figure 2: Security Camera Footage (compilation prior to impact)*

Video footage was obtained from numerous security cameras at the terminal. A review of the footage revealed that the airplane descended configured in a relatively flat pitch attitude. The left wing collided with a semi-truck

followed by the airplane impacting a concrete barrier in a left-wing low attitude. The airplane rotated over itself in a cartwheel type motion and came to rest upright.

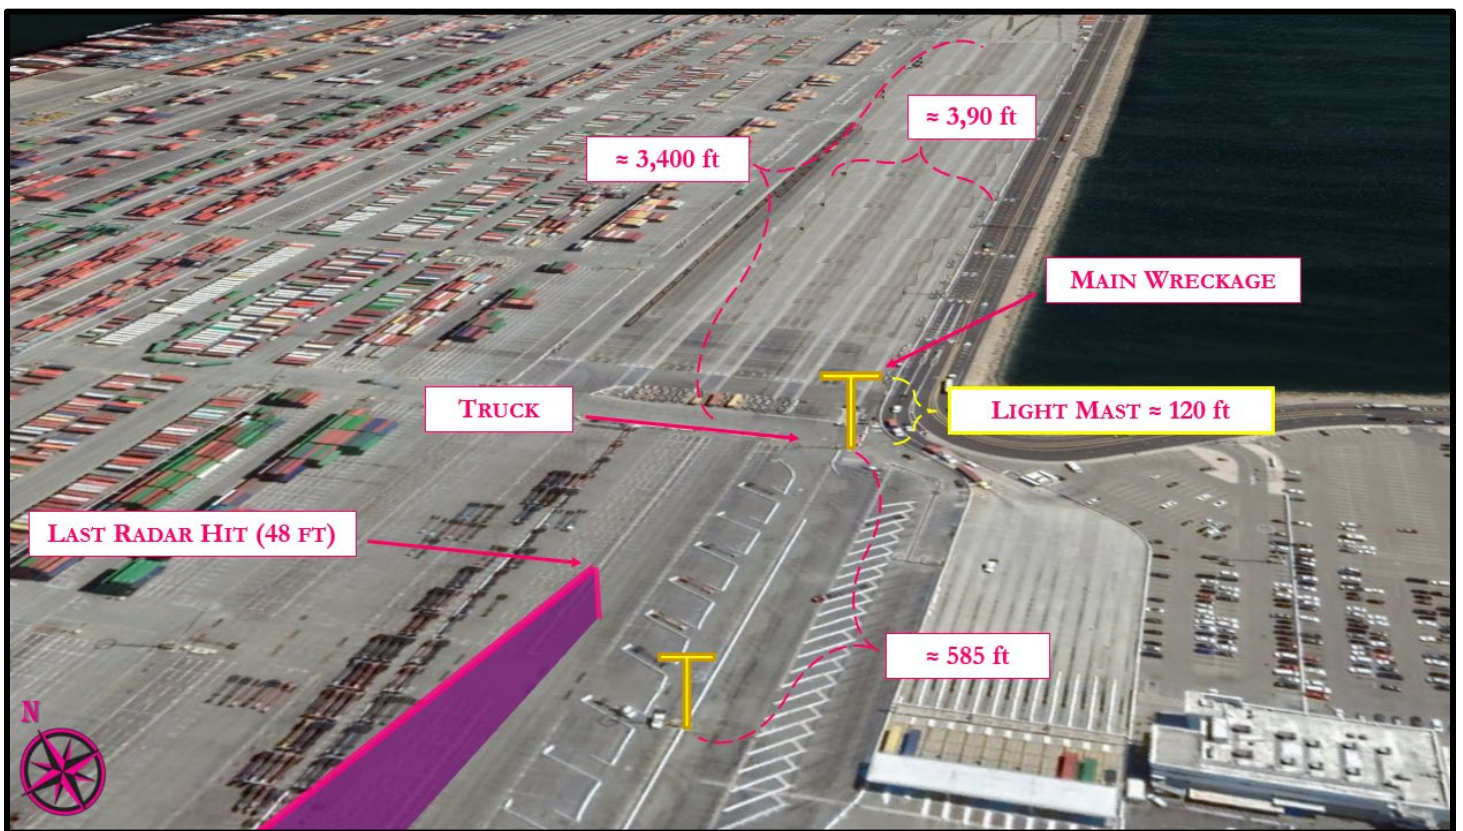
Figure 7: Accident Site

The accident site was located in a container shipping yards about 6.5 nautical miles (nm) southeast of Torrance at the following coordinates: 33.723995, -118.251341. The wreckage was found distributed over about 200-feet on a median magnetic bearing of about 79°.

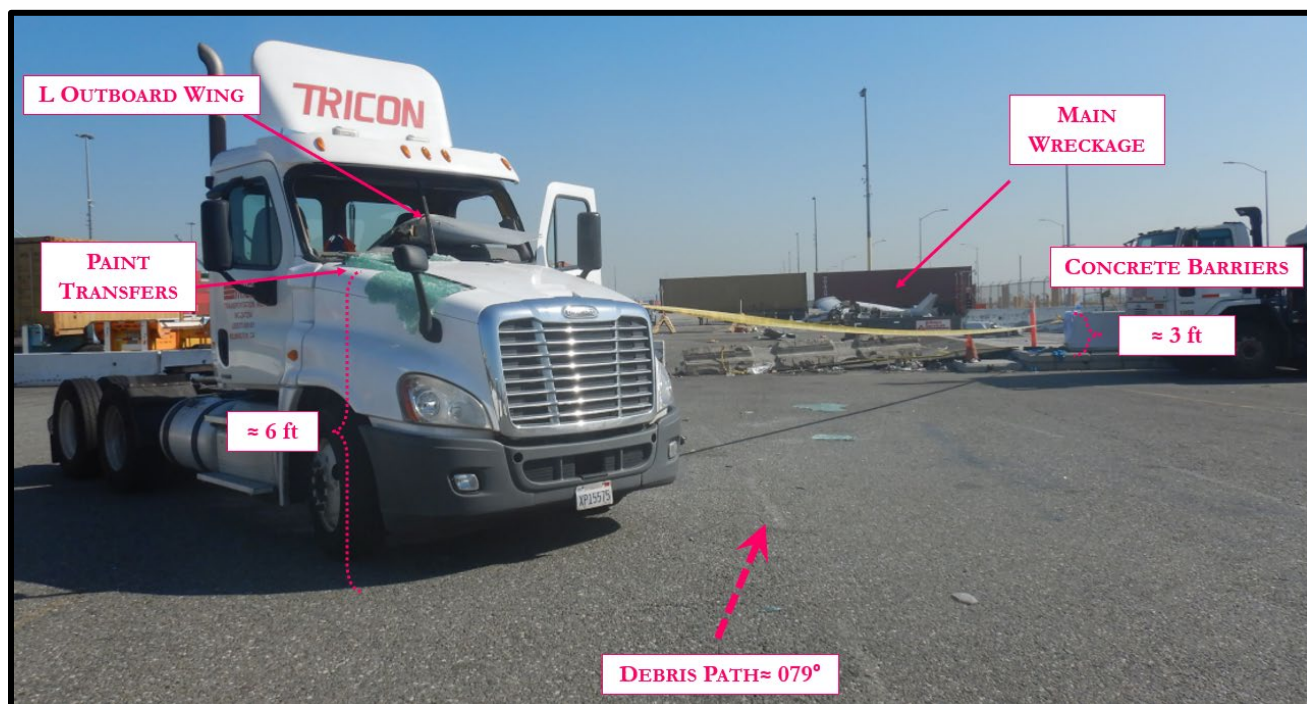
Figure 9: First Identified Point of Impact

The first identified piece of debris was the outboard left wing that had come to rest in the truck cab. The hood of the truck, about 6 feet above ground level (agl), had paint transfers, consistent with the tip of the left wing contacting cab in a left-wing low attitude. Adjacent to the truck was a 120 feet tall light post, which is where security cameras were located.

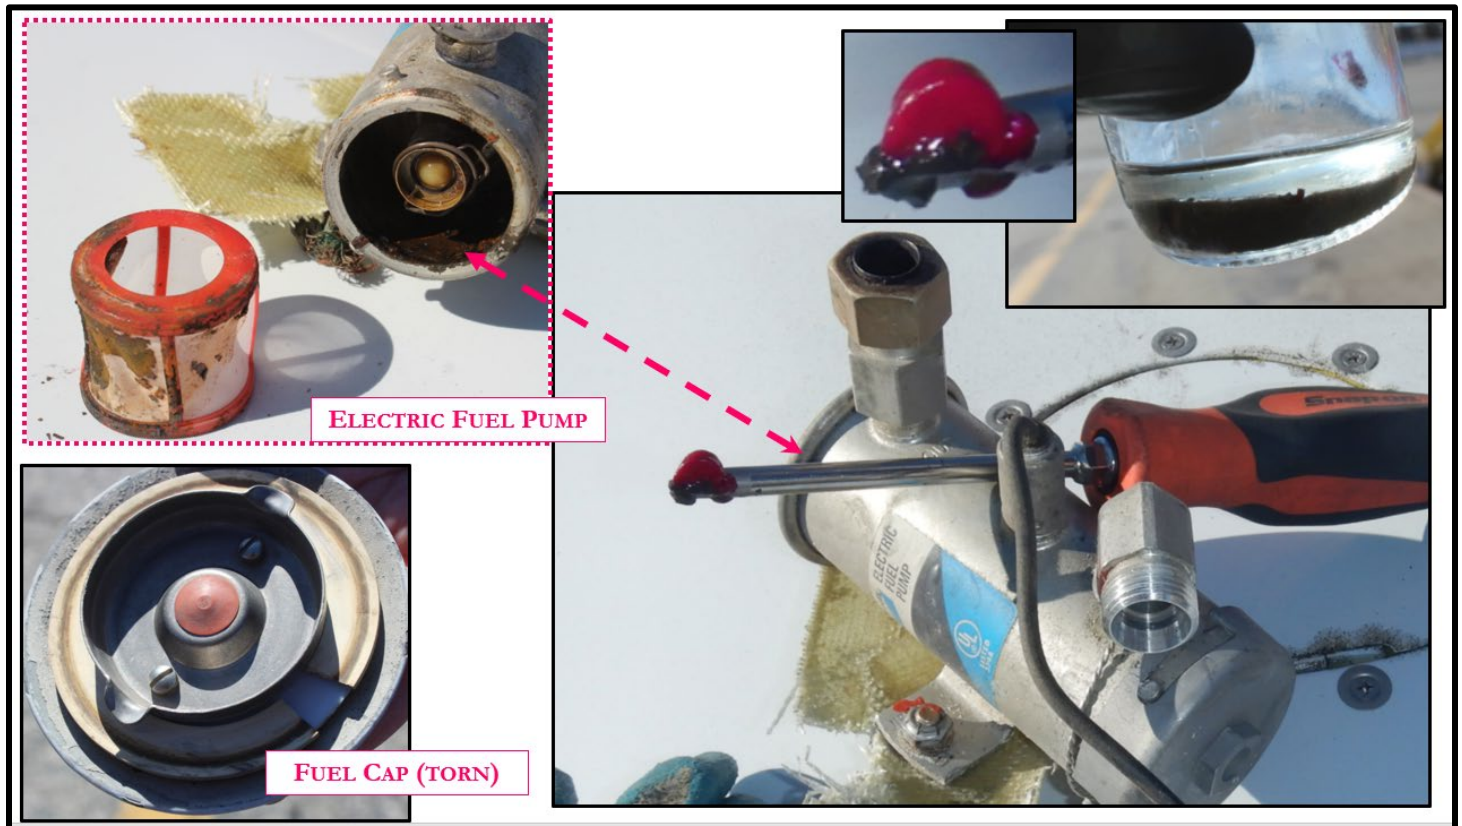
*Figure 13: Electric Fuel Pump*

The electric fuel pump remained mounted within the cabin floor and the external examination revealed no evidence of mechanical anomalies. The inlet line remained installed on the pump, however the copper outlet line was pulled from the "B" nut. Upon removal of the pump, investigators collected liquid in a glass jar. There was about an ounce of liquid consistent in appearance and odor with that of AVGAS. In the fuel was also a substantial amount of sediment and a submersing water-detecting paste indicated that water was additionally

present in the sample. Removal of the fuel screen revealed that it was brittle and covered in the same looking sediment and rust.

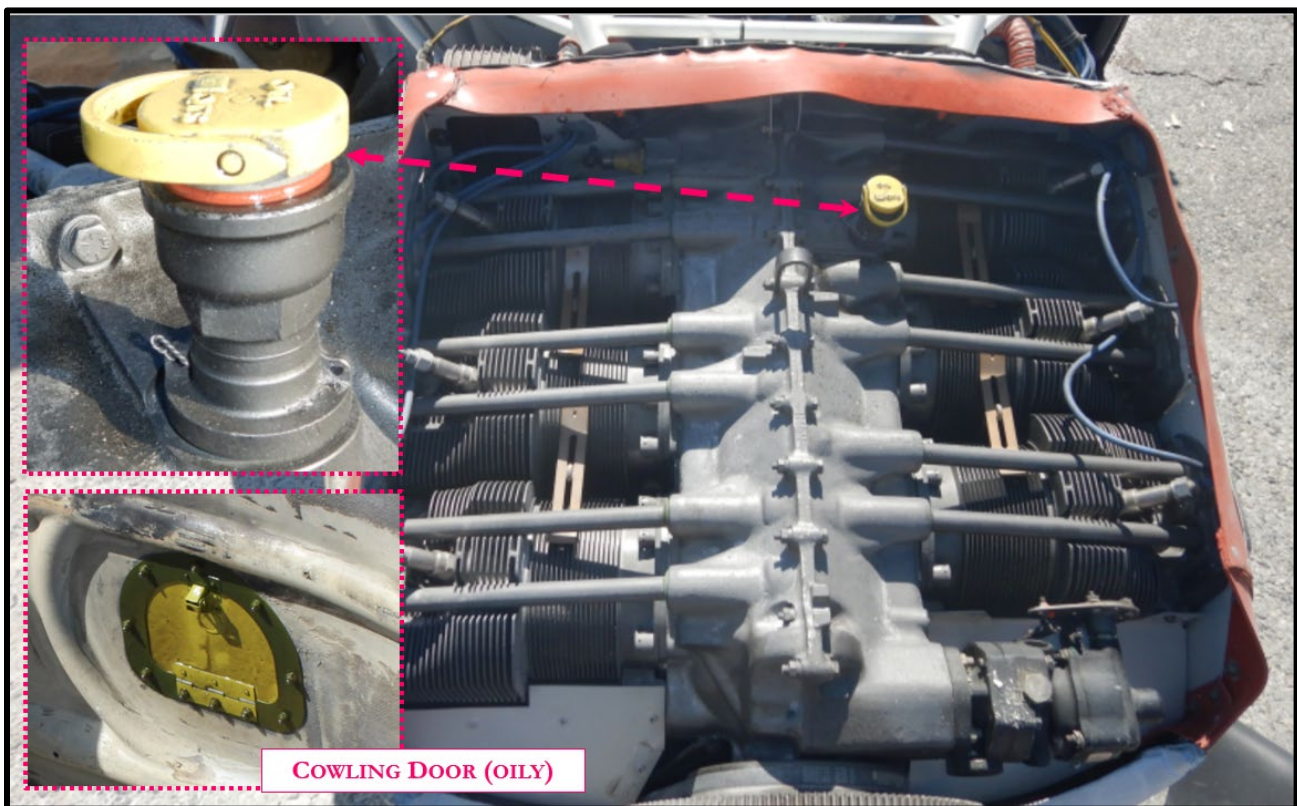
Figure 15: Oil Dipstick

An external examination of the engine revealed that the oil dipstick was not secured and loosely floating in the oil filler hole with the o-ring visible. The engine case immediately adjacent to the oil filler was wetted with oil and removal of the upper cowling revealed that the underside of the oil filler door contained an oil film. The oil indicating dip stick showed 9 quarts.

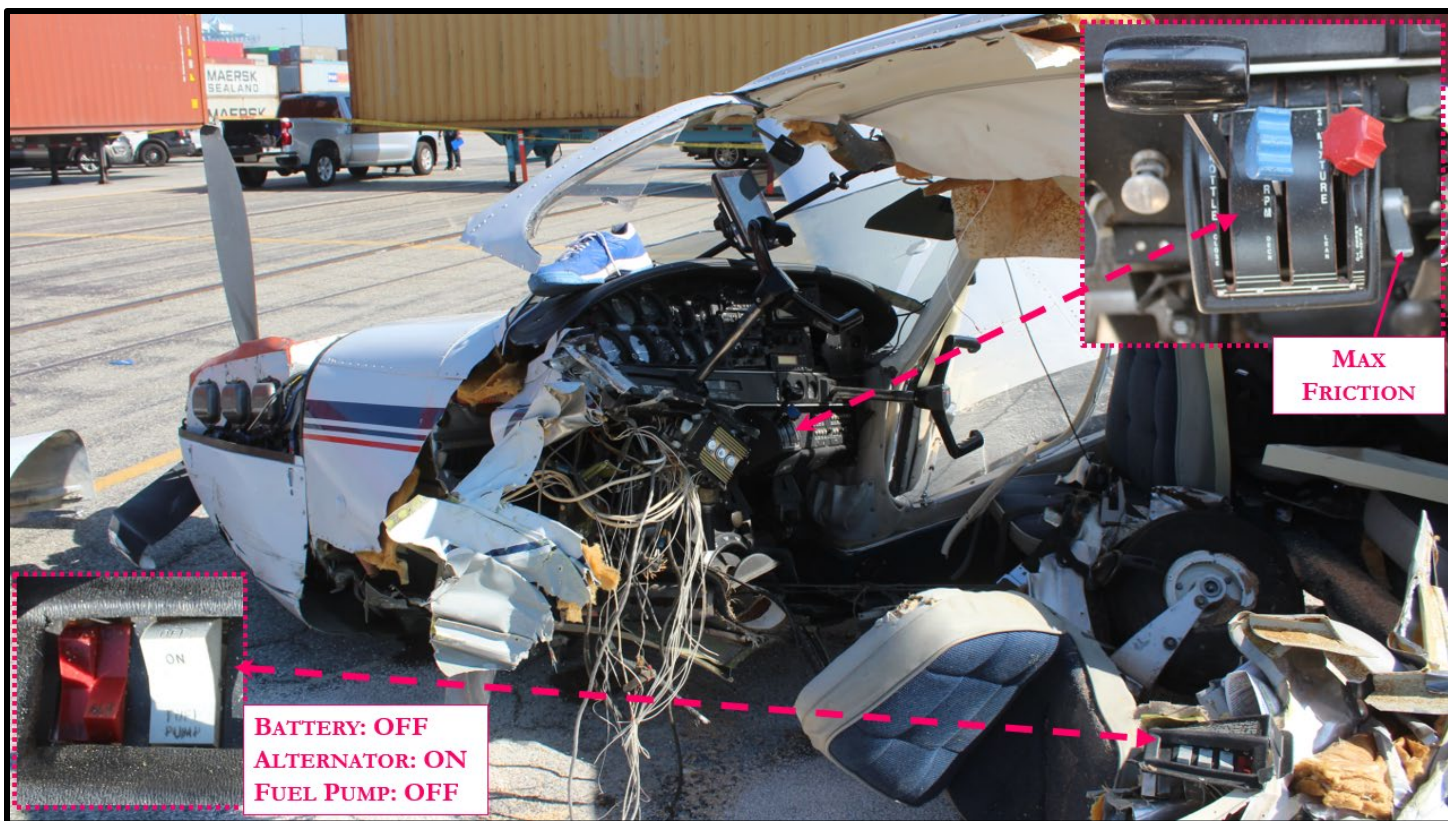
Figure 16: Throttle/Mixture/Propeller at Accident Site

Investigators established continuity from the throttle and mixture controls from the controls in the cockpit to the arms on the carburetor. The controls were located in the full forward position and after moving the friction arm (relieving the tension), manipulation of the controls moved the respective arms from stop to stop. The carburetor heat control could not be verified which was likely because the cable was bound in the nose compartment area because of impact.

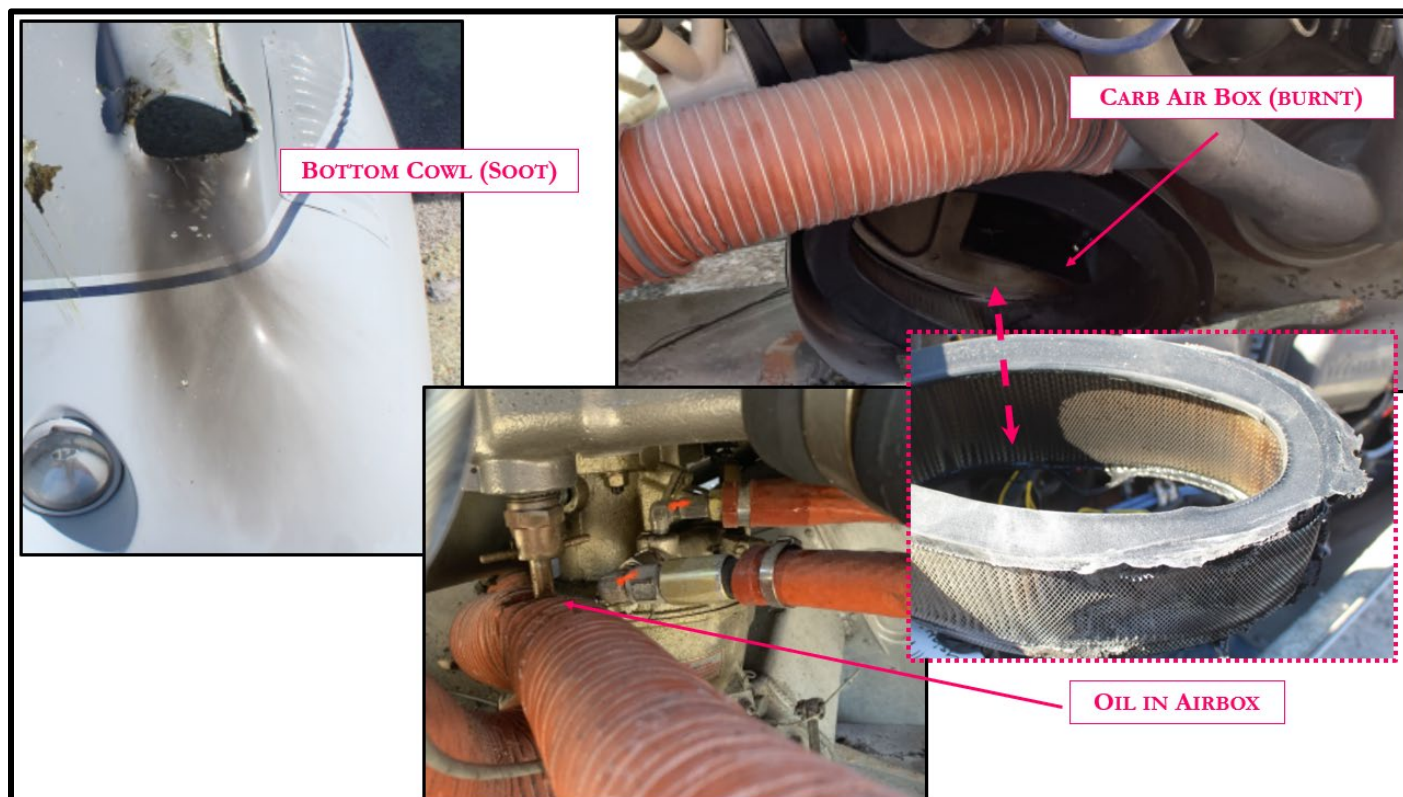
Figure 17: Carburetor Air Box and Filter

The oil sump drain had penetrated the scat tube from the cabin air; oil was draining in the scat tubing to the carburetor airbox. Disassembly of the carburetor airbox revealed that the filter had sustained burn damage, consistent with a carburetor fire. The lower cowling had corresponding soot marks at the vent. The carburetor was disassembled, revealing intact plastic floats and liquid resembling Avgas in the bowl.

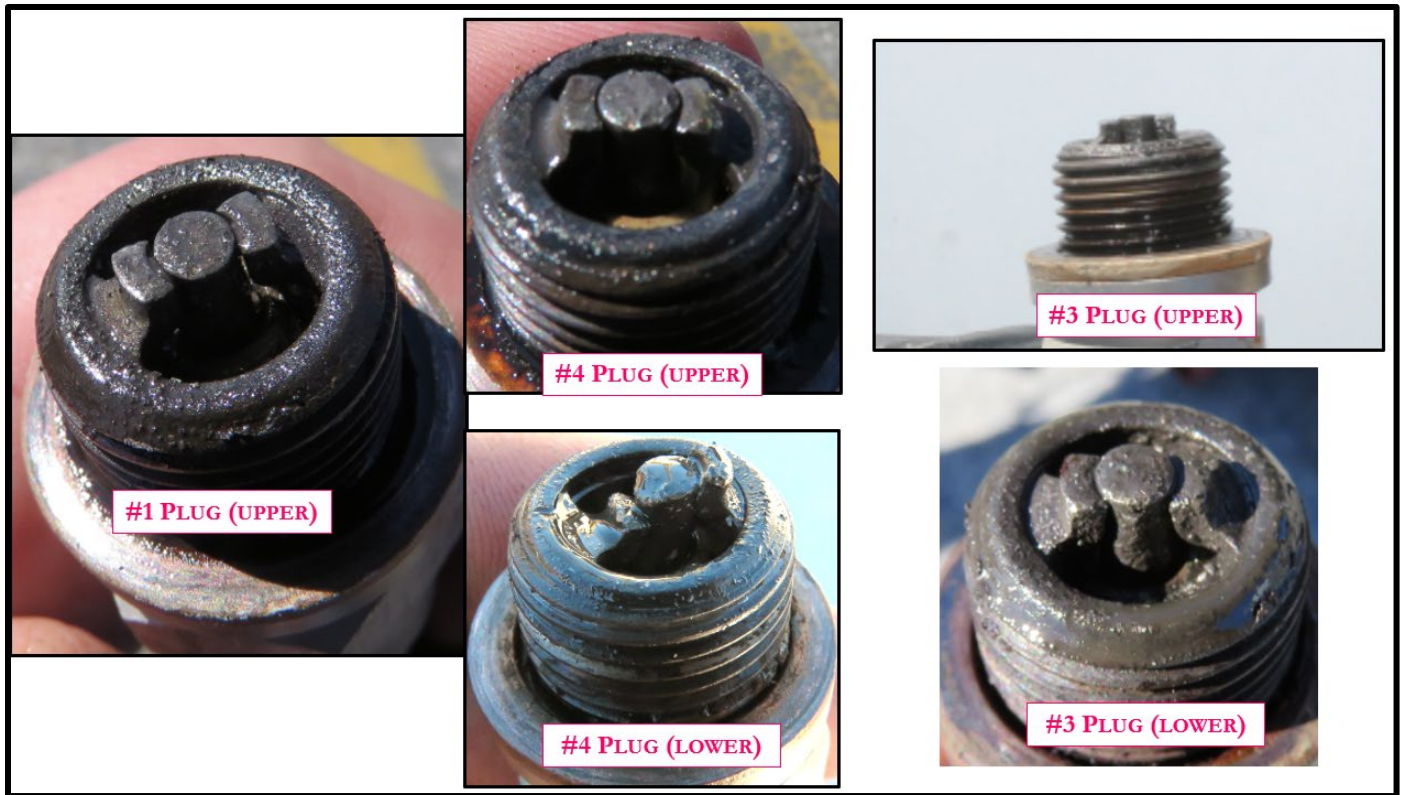
*Figure 18: Upper Spark Plugs*

Investigators removed the upper spark plugs, all of which had an oily film and were dark. The No. 3 spark plugs did not have a gap between the post electrodes, but no damage was visible; the Nos. 4 and 1 plugs did not have a gap between the posts that would be expected. Removal of the bottom spark plugs disclosed that the Nos. 3, 4 and 6 were damaged.

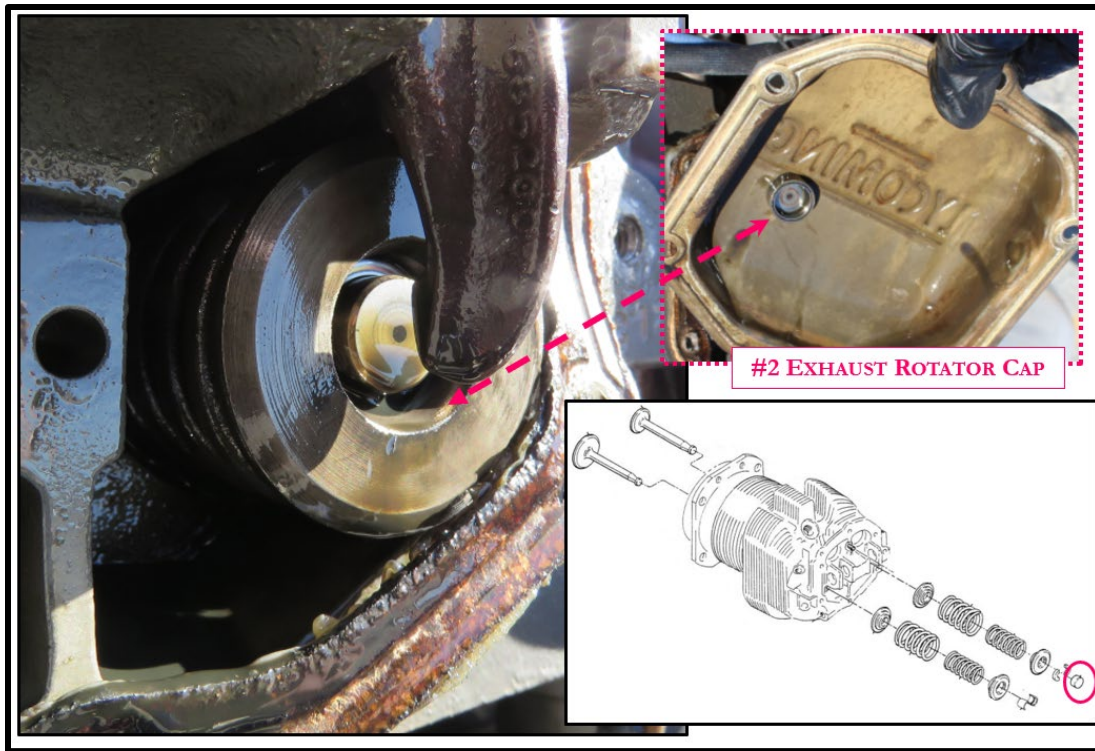
Figure 19: Cylinder No. 2 Exhaust

Removal of the rocker box valve covers revealed that the exhaust rotator cap on the No. 2 cylinder was loosely lying in the cover.

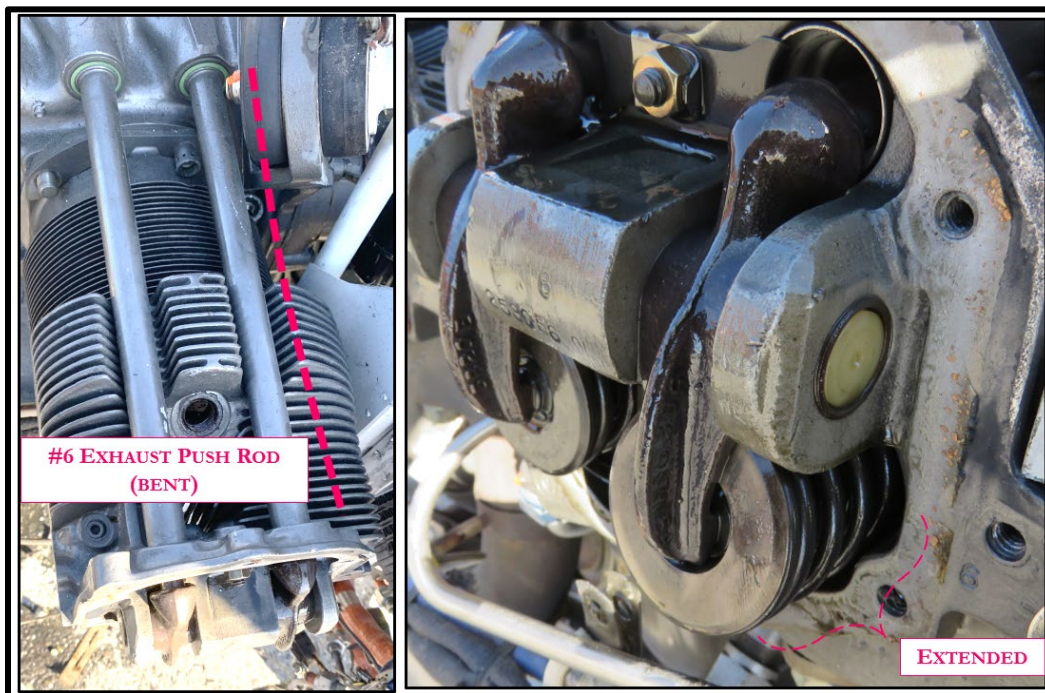
Figure 20: Cylinder No. 6

The exhaust valve spring on the No. 6 cylinder was protruded out at an angle with the rocker arm holding it the retainer. The exhaust pushrod was bent.

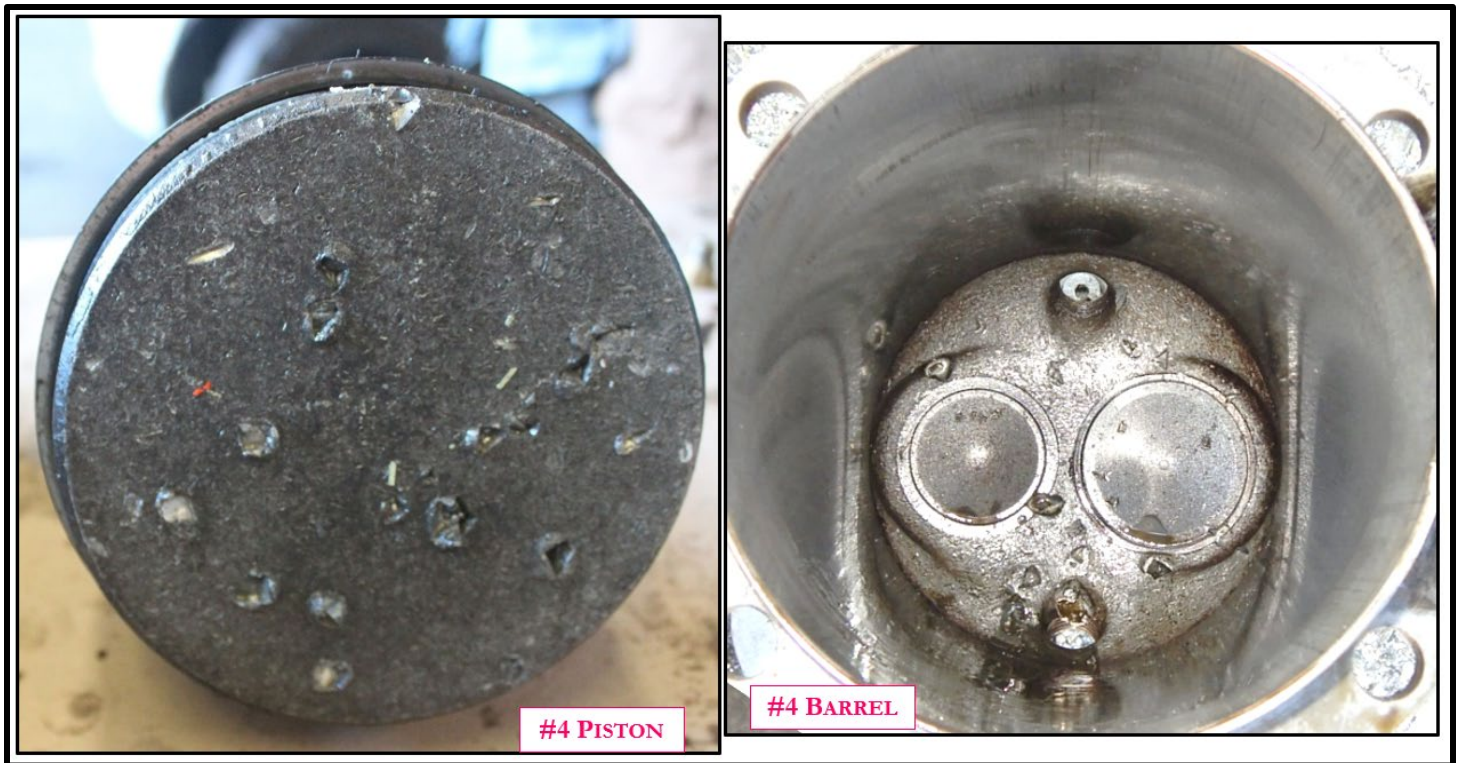
Figure 21: Cylinder No. 4

Removal of the No. 2 cylinder revealed that there was numerous pieces of metal in the engine crankcase. Removal of the No. 4 cylinder revealed that the piston face had numerous gouges consistent with metal consumption in the barrel. There were pieces of worn metal found in the intake and exhaust pipes.

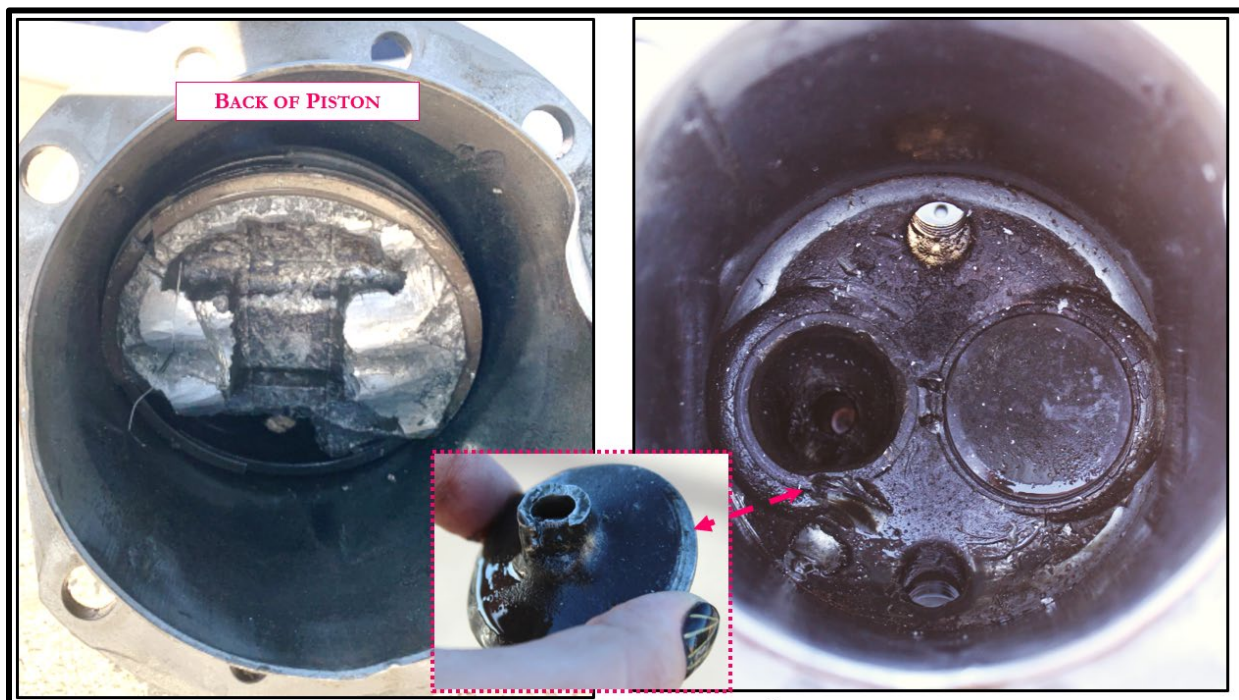
Figure 22: Cylinder No. 6

Removal of the No. 6 cylinder revealed that the upper portion of the piston was trapped forward inside the barrel and dislodged from the wrist pin. The head of the exhaust valve was dislodged and was buried into the head area adjacent to seat. The exhaust valve stem and keepers were not located. There were numerous pieces of metal were found throughout the crankcase and over a pint of metal pieces were recovered from the oil sump.

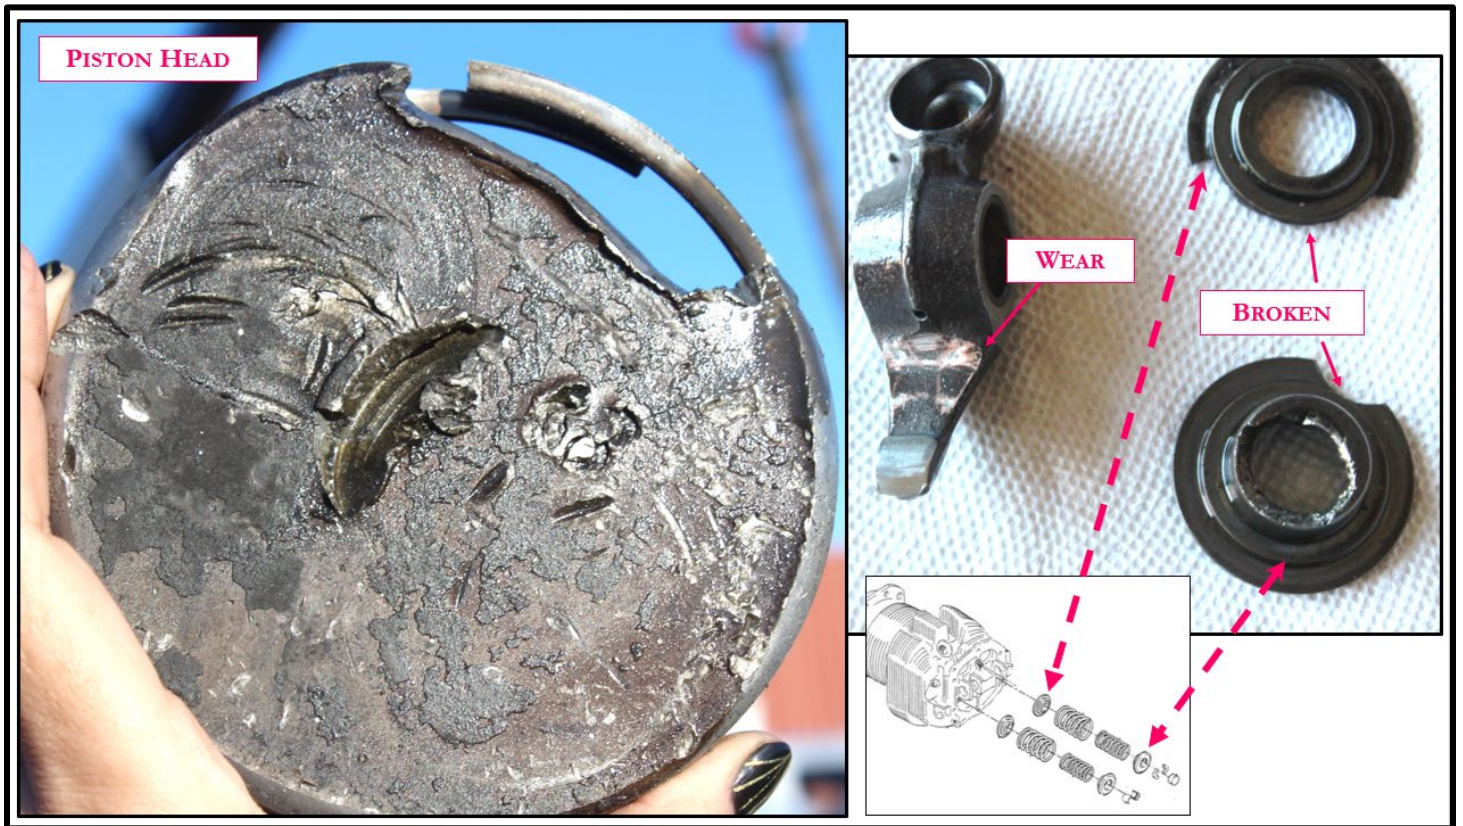
Figure 23: No. 6 Piston Head

Further examination of the No. 6 cylinder revealed that the rocker arm was gouged on its surface adjacent to the engine under the rocker arm shaft. The exhaust valve spring seats (both upper and lower) had pieces broken off.

The upper spring seat was chipped where the rocker arm was resting. The base of the seat contained wear marks consistent with repetitive contact. The piston rings were not present.

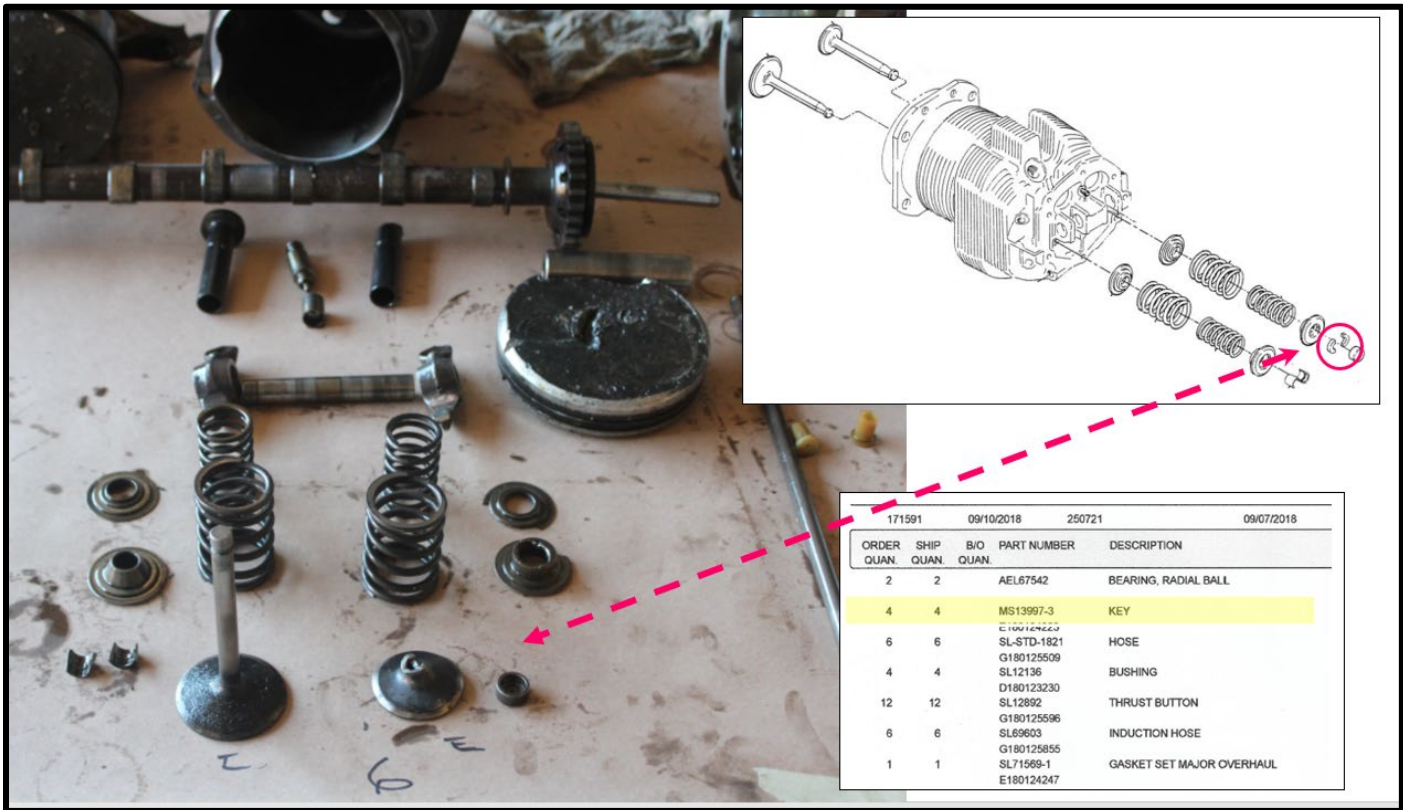
Figure 26: Invoice

The invoice from the maintenance performed as part of the rebuild in 2018 revealed that purchases were made for new parts. In pertinent part, the mechanic purchases 4 (2 sets) exhaust valve keepers (p/n MS13997-3); the part’s catalogue 17C21191. There were 12 thrust buttons purchased that are fitted at the ends of the rocker shaft and a seal and gasket overhaul set.

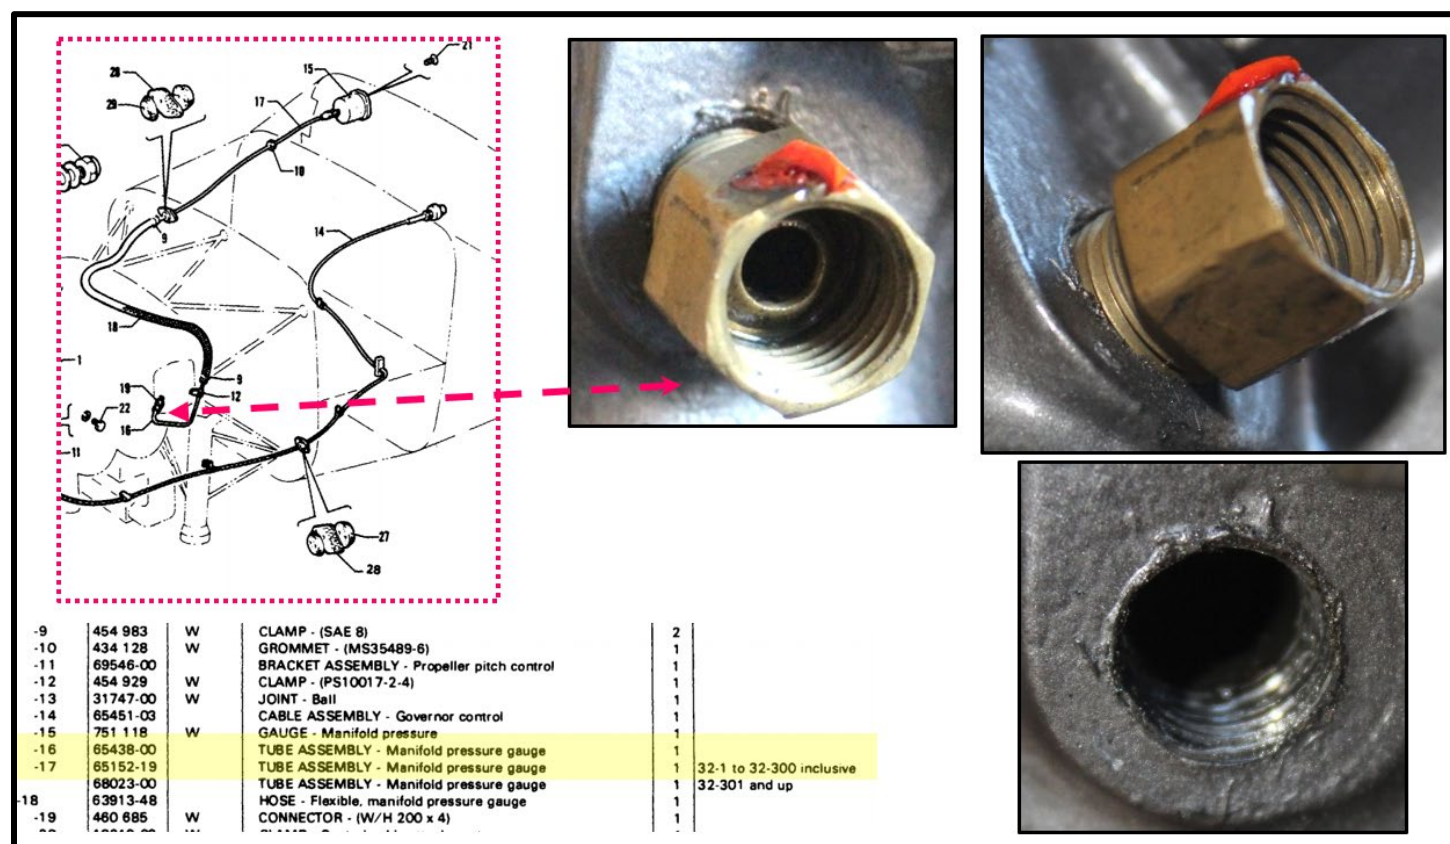
Figure 27: Brass Manifold Pressure Fitting

The last annual, recorded as being completed in August 2020, show that the a “kinked brass manifold pressure line” was replaced. One of the owner’s stated that he took the removed line and fabricated his own from stainless steel.
