# National Transportation Safety Board

WPR21FA203

Airplane Performance Study

Location: Las Vegas, Nevada  
Date: May 24, 2021  
Time: 1417 Pacific daylight time (PDT)  
2117 Universal coordinated time (UTC)  
Aircraft: Dassault Aviation Mirage F-1, N567EM

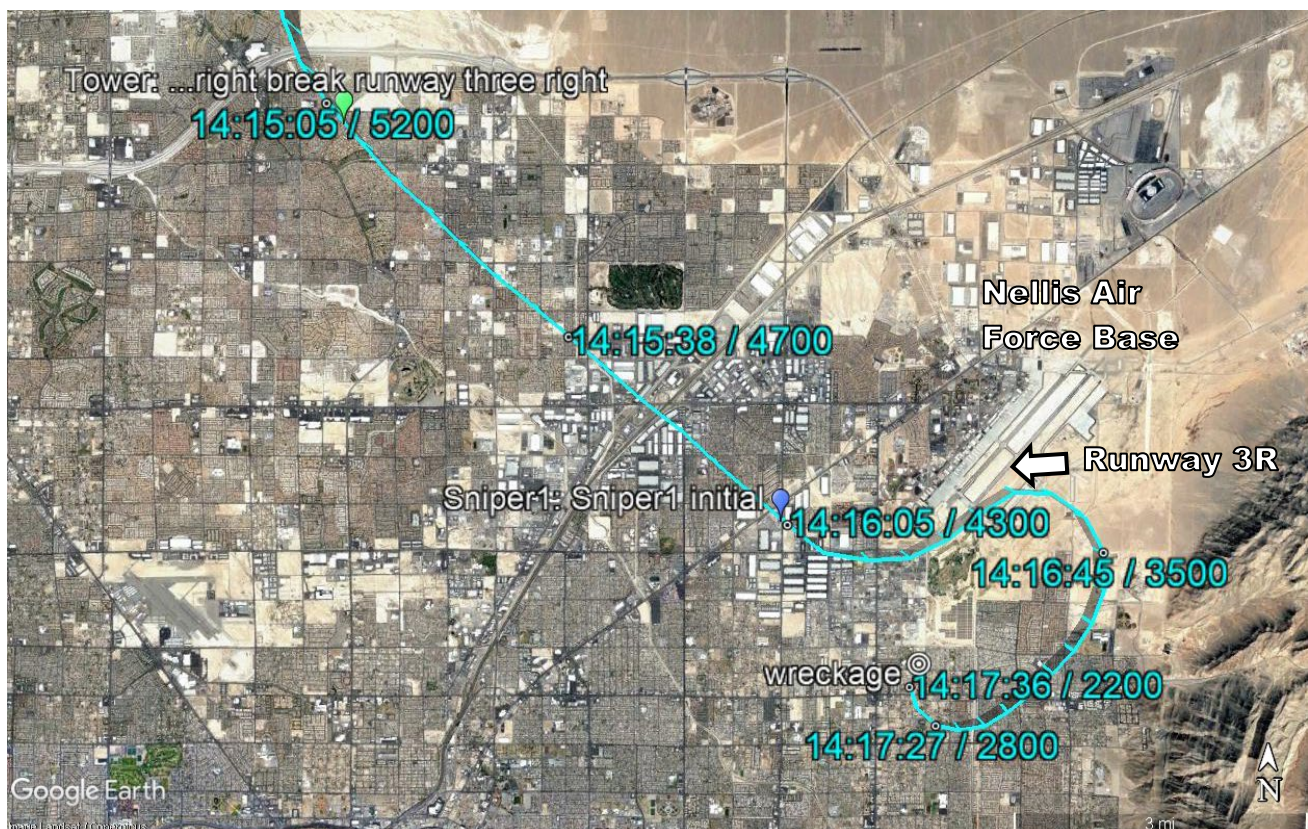
Figure 1 shows the end of the accident flight with time and altitude above mean sea level (msl) indicated for selected points, along with some ATC communications. The airplane was attempting to land on runway 3R at Nellis Air Force Base (LSV). At 14:15:08 Nellis Tower instructed the pilot "right break runway three right". The overhead break, or run and break, maneuver is used by high-performance aircraft to avoid spending too long at low speed in an airport's traffic pattern. The pilot aligns the airplane with the runway then "breaks" and performs a 180° turn downwind, configures the airplane for landing, and then then performs a second 180° turn to land on the runway. Drag during the turns causes a rapid deceleration to a safe speed for landing.

**Figure 1.** Flight path with time and altitude (msl) for selected points and some ATC communications.

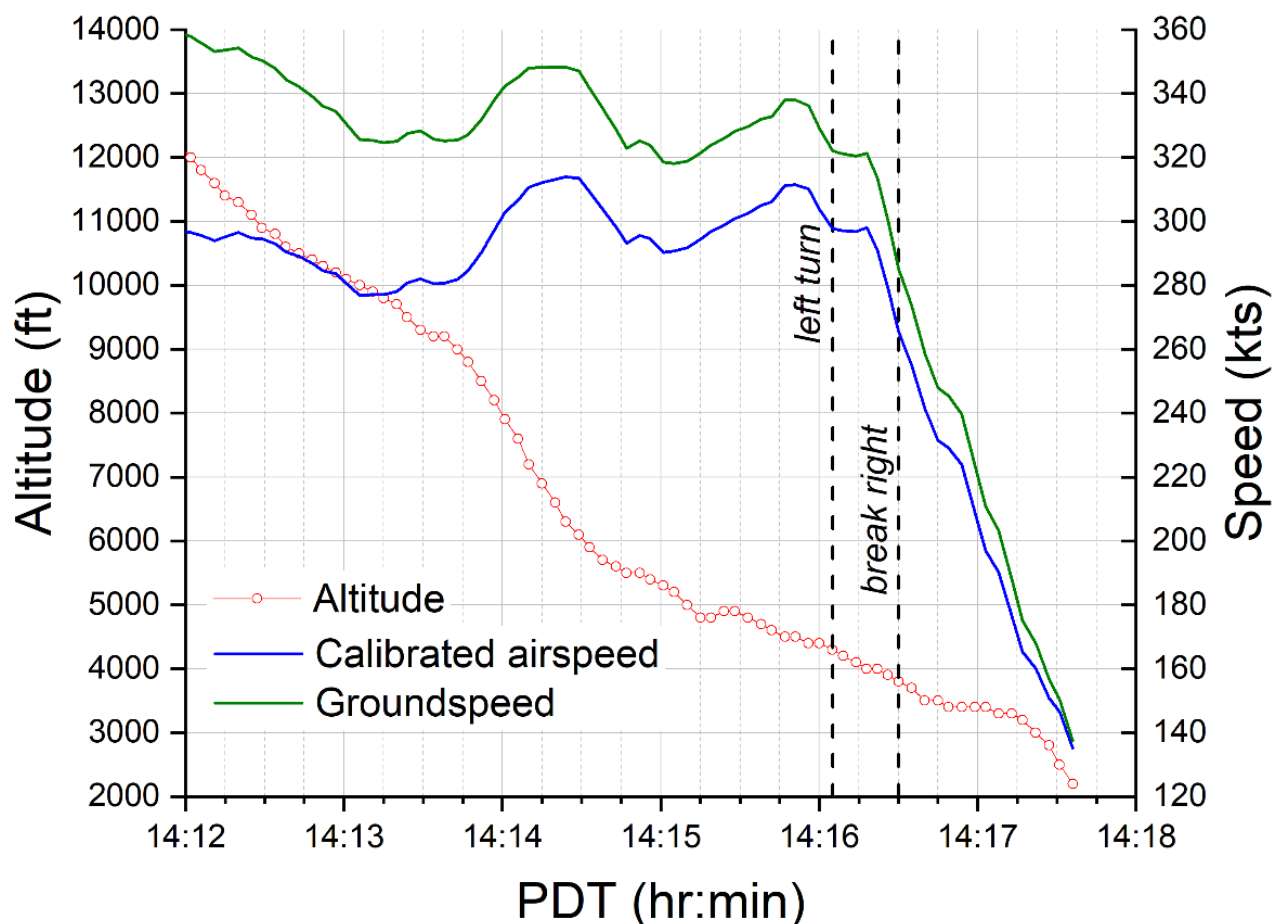
The pilot called "initial" at 14:16:05 just before beginning a left turn onto the heading for runway 3R. At 14:16:26 the airplane aligned with runway 3R while 2,000 ft above ground level and at an airspeed of about 260 kts (Figure 2). The airplane broke right, and speed decreased. At 14:17:12, the pilot radioed "Tower Sniper1 is gonna be a low approach and ugh proceed out to Flex" as the airplane began the final 180° turn toward the intended runway heading. The airplane was approximately 1,400 ft above the terrain and at a calibrated airspeed of 170 kts and slowing. Shortly after, the

**Figure 2.** Altitude (msl), calculated groundspeed, and calibrated airspeed for end of flight.

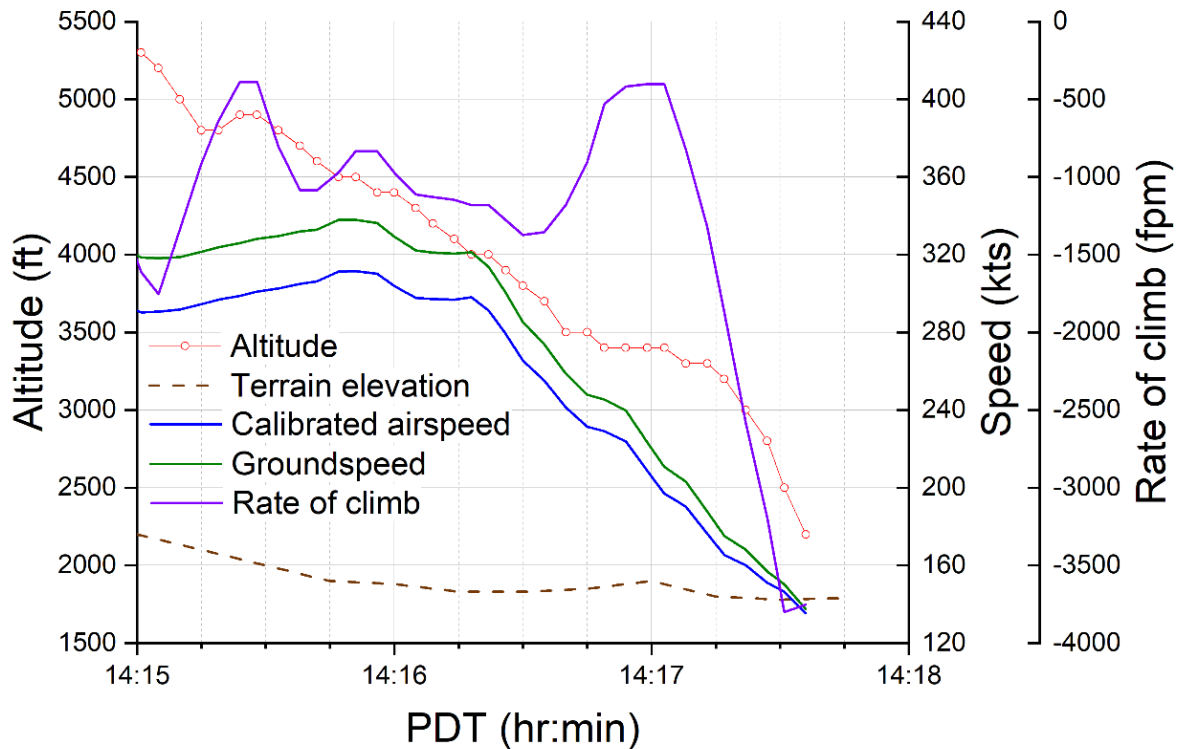
airplane's descent rate increased from the previous 1,000 fpm to more than 3,000 fpm (Figure 3).

The Flight Manual [1] reports the airplane's low-speed limitations as 160 kts without flaps and 130 kts with flaps. Additionally, the Flight Manual advises that if the flaps do not lower, to land at a speed between 195 and 215 kts. At 14:17:20 the pilot said "...we are having a ugh flap issue" and the tower responded "...are you declaring [an emergency]" to which at 14:17:28 the pilot responded "Sniper1 affirm". At 14:17:20 and the airplane's calibrated airspeed dropped below 160 kts and its final calculated airspeed at 14:17:36 was 135 kts and slowing. Because of the post-crash condition of the airplane and the absence of onboard recorded data, the nature of the flap issue reported by the pilot could not be determined, but the airplane was slower than the listed low-speed limitation without flaps for the final 14 seconds of flight and slowing to below the low-speed limitation with flaps. The final radar altitude was 400 ft above the ground. The wreckage location was about 1,300 ft to the northeast of the final radar location.

**Figure 3.** Altitude (msl), calculated groundspeed and calibrated airspeed, and calculated rate of climb for end of flight.

Returning to Figure 3, the first turn, while the widest, was also the fastest. Winds at the time of the accident were calm, so true airspeed was equal to groundspeed. At 14:16:14 the airplane's groundspeed or true airspeed was 320 kts which resulted in a needed bank angle of  $51^\circ$  and a load factor of 1.6. The break over the runway was at a speed of 285 kts, needing a bank angle of  $63^\circ$ , and a load factor of 2.2. The final turns

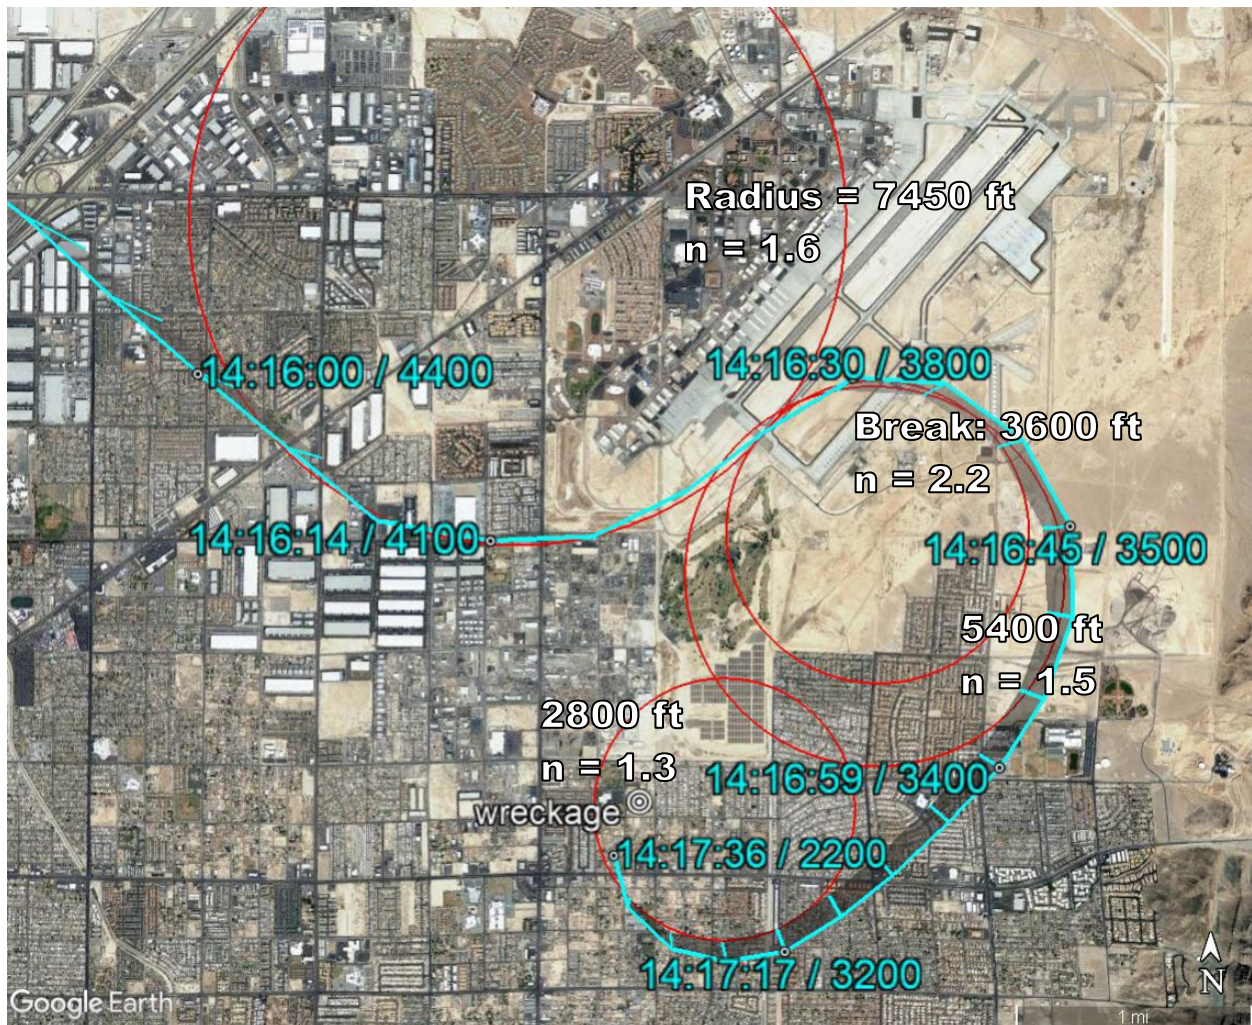
Of interest was the loading of the airplane during the final series of turns. Figure 4 shows the end of the flight path and the radius of four turns: the initial turn onto the runway heading (radius of 7,450 ft), the break over the runway (3,600 ft), the turn onto the downwind leg (5,400 ft), and the airplane's final turn (2,800 ft). Airplane load factor,  $n$ , often called g-loading is a function of the airplane's bank angle,  $\phi$ ,

were at true airspeeds of 259 and 170 kts and resulted in bank angles and load factors of 47° (1.5 g) and 41° (1.3 g) respectively.

**Figure 4.** Radius of final four turns with flight path.
