**NATIONAL TRANSPORTATION SAFETY BOARD**

**Flight Data Recorder**

**Group Chairman's Factual Report  
By Charles Cates**

Location: Las Vegas, NV  
Date: May 24, 2021  
Aircraft: Mirage F-1  
Registration: N567EM  
Operator: Draken International  
NTSB Number: WPR21FA203

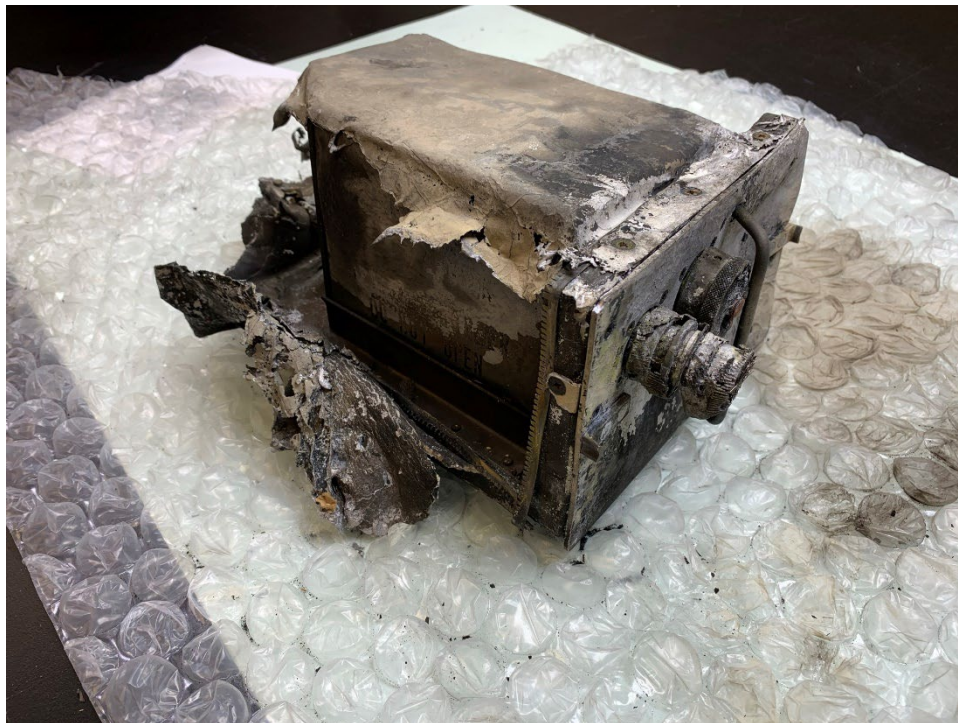
Upon arrival at the Vehicle Recorder Laboratory, it was evident that the recorder had suffered mechanical impact and thermal damage. See figure 1 for the as-received condition of the recorder.

Figure 1. As-received condition of ESPAR recorder.

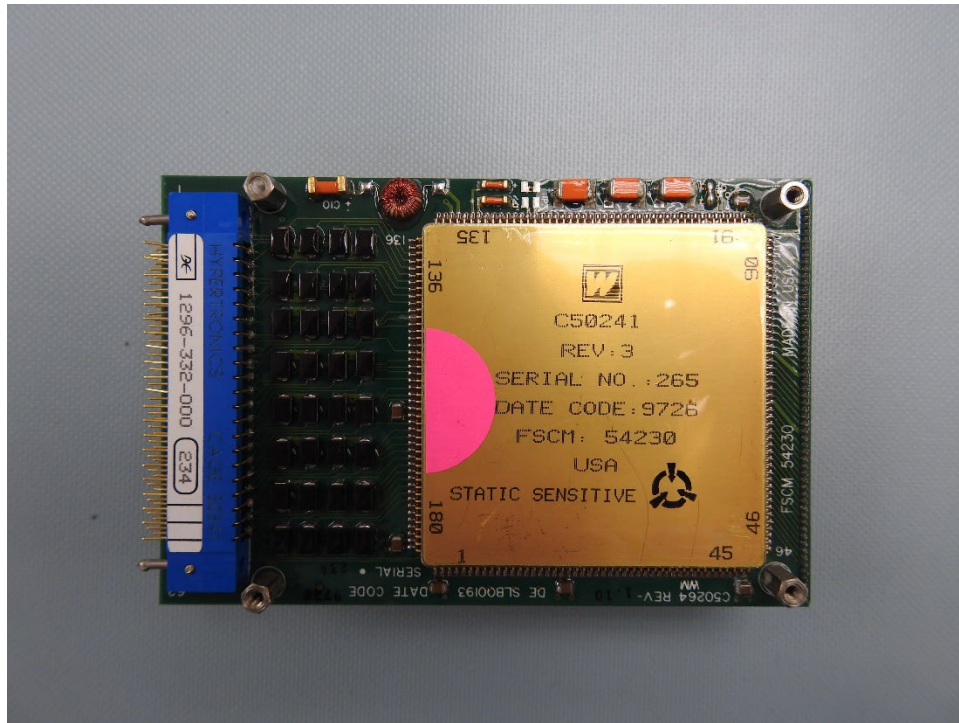
The recorder was disassembled, and the crash-survivable memory module was removed and inspected. Preliminary examination of the memory module showed that the module appeared to be fully intact with no heat or impact damage to the circuit boards. See figures 2 and 3 for pictures of the module extracted from the recorder. Following the removal and examination of the board, it was placed in a protective package and stored in a secure facility until the group activities began.

Figure 2. Memory module from accident recorder, top view.

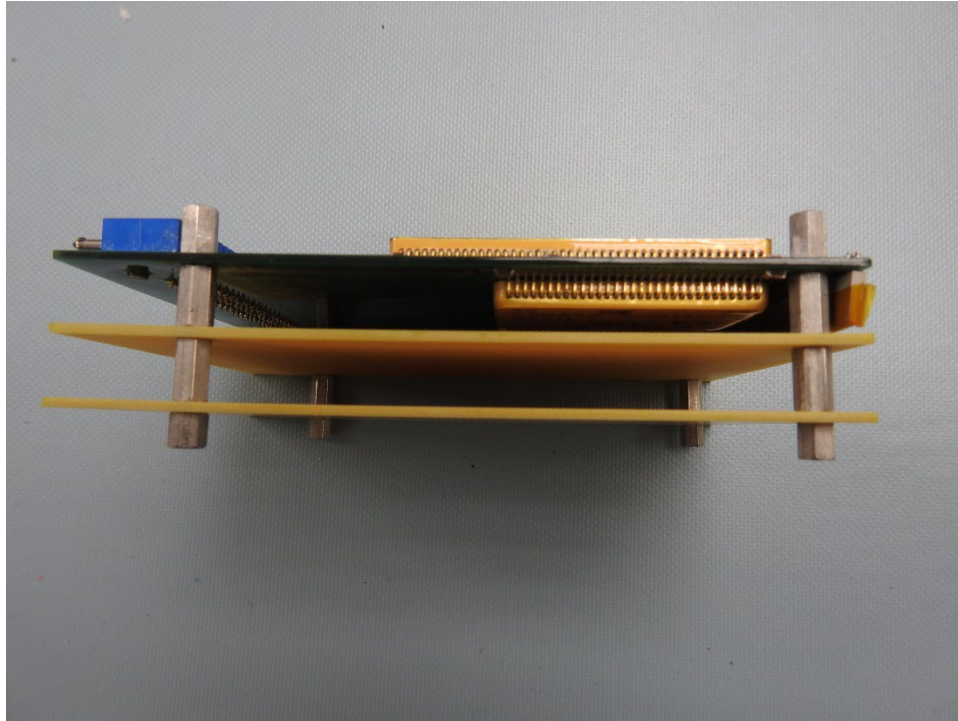
Figure 3. Memory module from accident recorder, profile view.

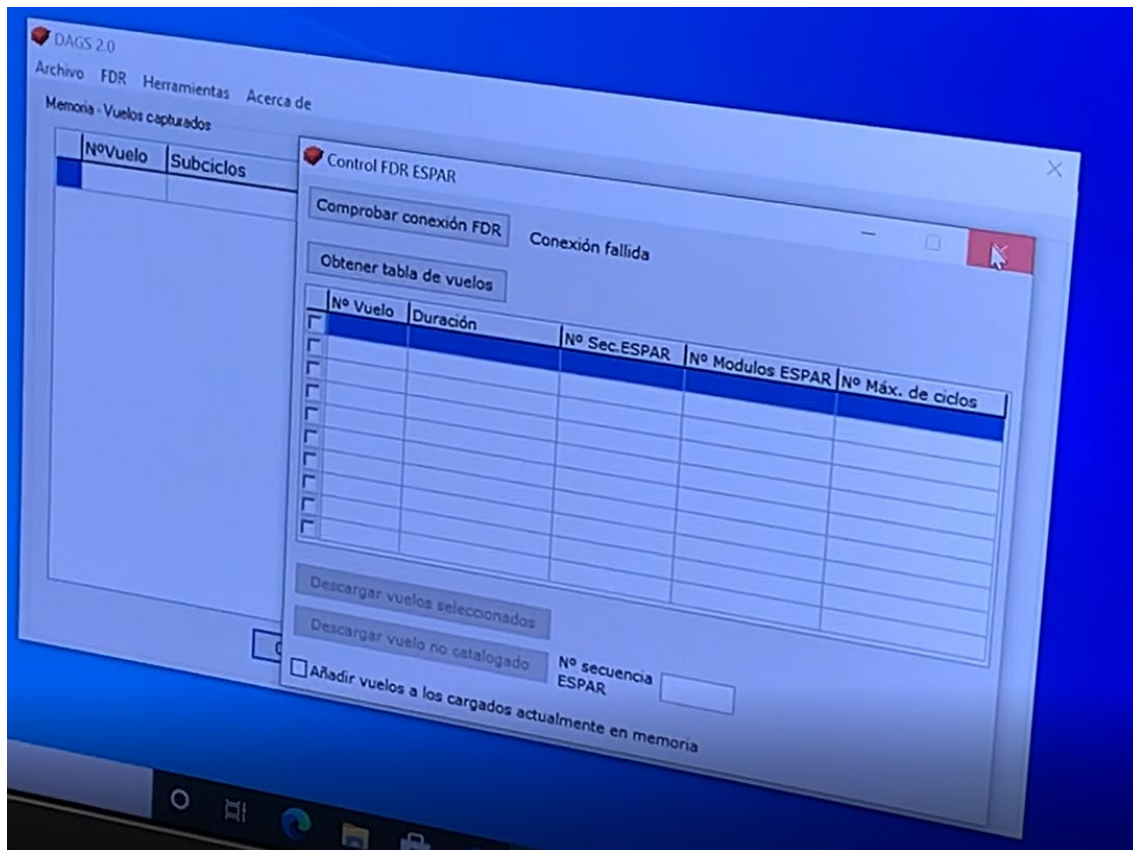
The accident memory module was installed in the golden chassis to download in the same manner as the test module. Three attempts were made to connect to the recorder. In each attempt, the indicator showing successful connection between the computer and electronics interface illuminated as expected, however the interface was unable to successfully connect to the recorder and the connection would fail. Without a valid connection from the interface to the recorder the download attempts were unsuccessful. Between each attempt the power and data interface connections were checked and the memory modules were re-seated for verification. Every time the download failed, the software displayed a message about communication error (refer to Figure 7).

Figure 7. Readout software reporting the connection to the recorder memory failed.

With this result it became clear that the memory chips in the accident module were likely failed at the time of the accident, and no data could be extracted from them.

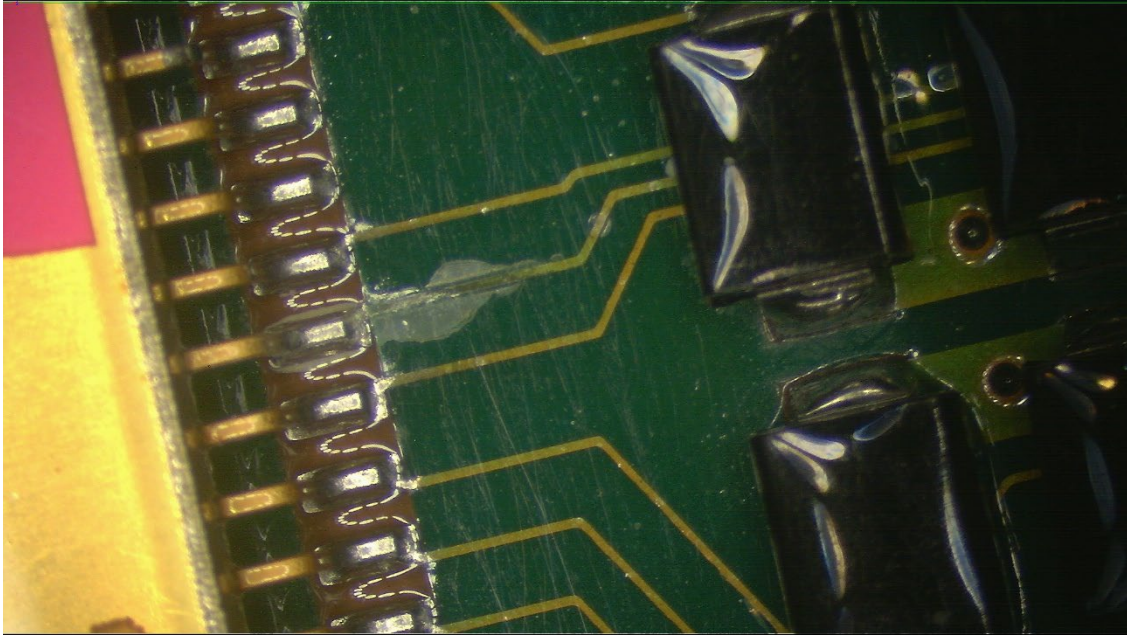
On the second day of group activities a detailed memory component visual examination was conducted under microscopic-level magnification. Two minor findings were discovered. The first was possible delamination around a trace leading to the main processor. The second was that three board capacitors had signs of corrosion underneath the conformal coating of the board. The working memory module did not have similar corrosion. See Figures 8 and 9 for details.

Figure 8. The sign of delamination on the trace (main board).

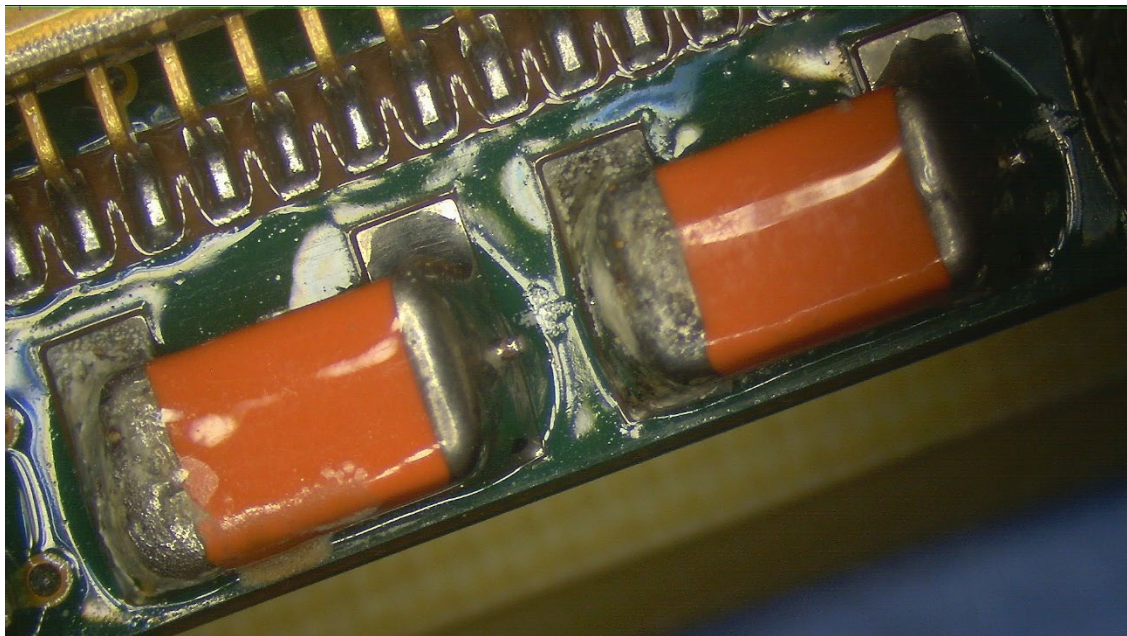
Figure 9. Capacitors with signs of minor corrosion.

capacitors, they were removed from the board, tested, and found to be faulty. The bad capacitors were determined to be a part of the power conditioning circuit on the board and are not necessary in a laboratory environment with a clean power supply. It was hoped that their removal would then allow the board to power on for download so the first subgroup meeting to attempt another download of the accident board was arranged for July 13, 2021.
