# National Transportation Safety Board

WPR21FA203

## **ACCIDENT SITE SUMMARY**

Location: Las Vegas, Nevada  
Date: 05/24/2021  
Time: About 1417 PDT  
2117 UTC  
Airplane: N567EM, Mirage F1

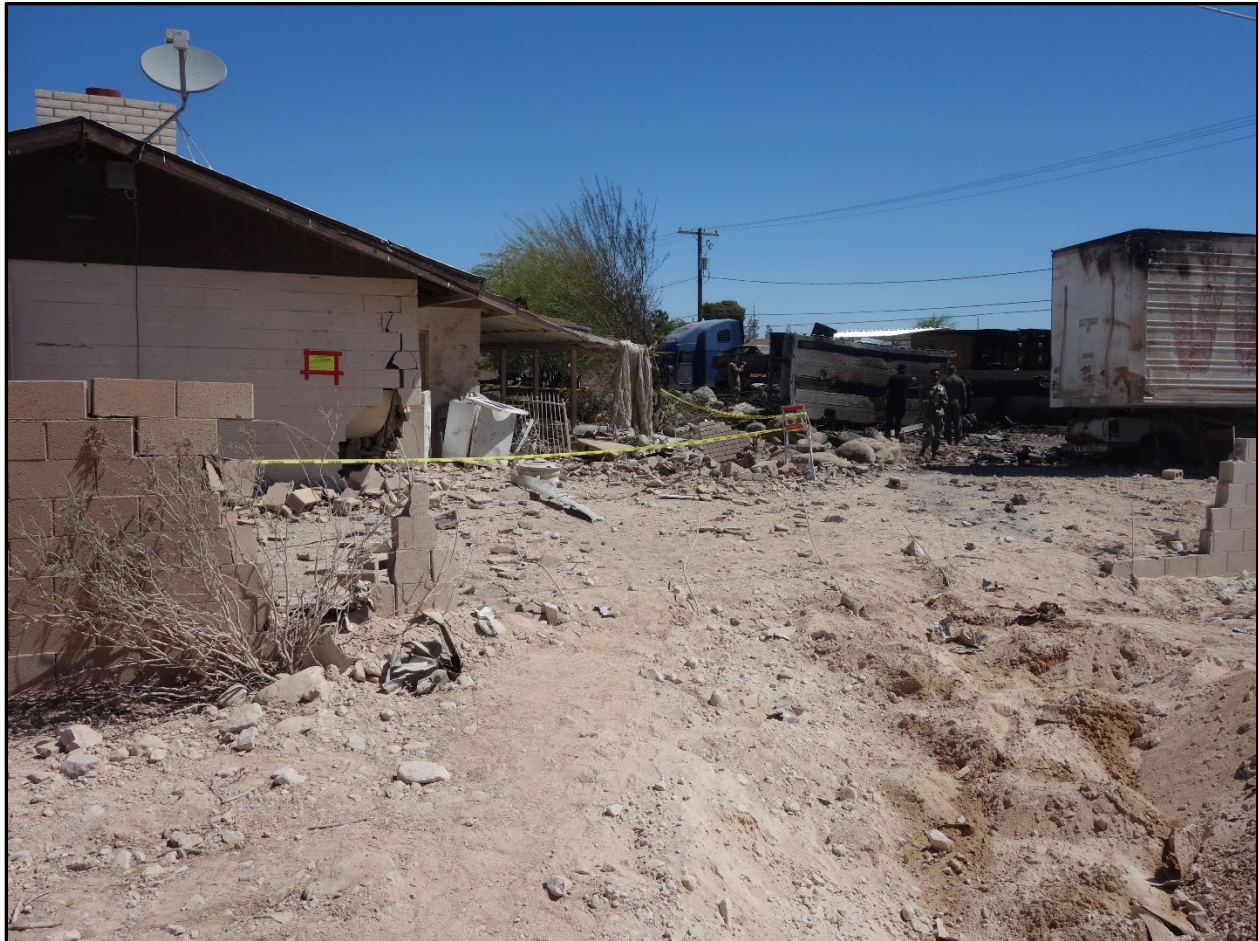
Examination of the accident site revealed that the jet airplane impacted desert terrain in the back yard of a private house in a residential area about 1.5 miles south southwest, short of the approach end threshold of runway 03R at Nellis Air Force Base. A ground disturbance consistent with the initial impact of the airplane was observed in the ground that led to the main wreckage. The debris path was on a heading of about 040°. The disturbance started with about a 2 ft wide by 20 ft long marking that led to a large disturbance that was about 10 ft wide by 16 ft in length and about 3 ft deep. The airplane and debris struck then breached a cylinder block fence and subsequently struck the back corner and awning of the back porch area of the house. The airplane came to rest in the back yard almost parallel to one of the several 18-wheel truck trailers stored and parked there that was against the back

**Figure 1: Large ground disturbance that led to the main wreckage.**

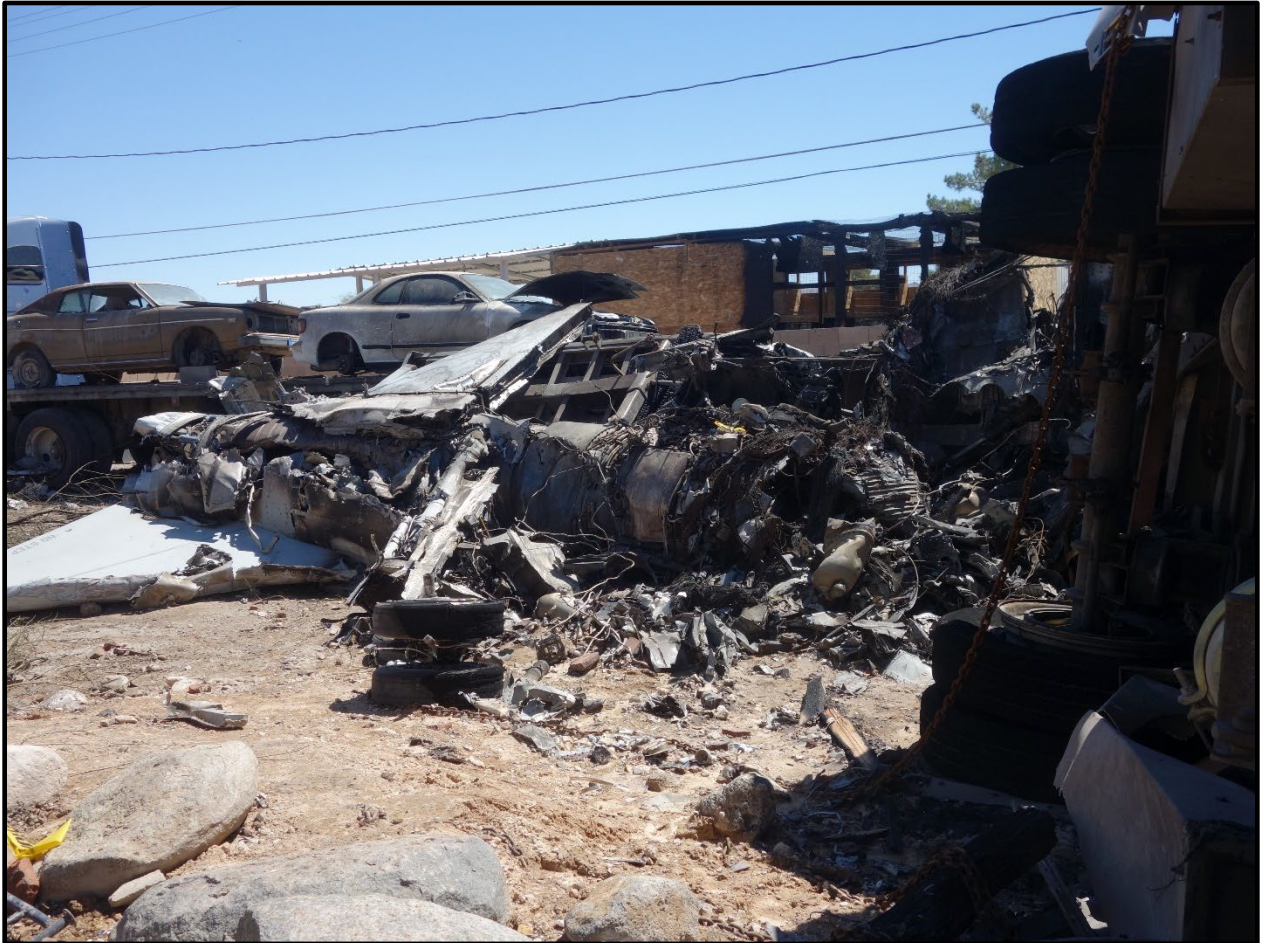
All major components of the airplane were contained at the main wreckage site. A flatbed trailer for an 18-wheel semi-truck was on its side and sustained thermal damage. The main portion of the fuselage consisting of the engine and tail section came to rest by another flatbed semi-truck trailer that had two cars lying on top of it. The vertical stabilizer was separated and laid next to the engine. Numerous aircraft debris was scattered throughout the yard and the

neighborhood. A post-crash fire consumed most of the main wreckage. The tail section was the only relatively intact section of the airplane.

**Figure 2: Main portion of airplane wreckage that came to rest near the truck trailer.**

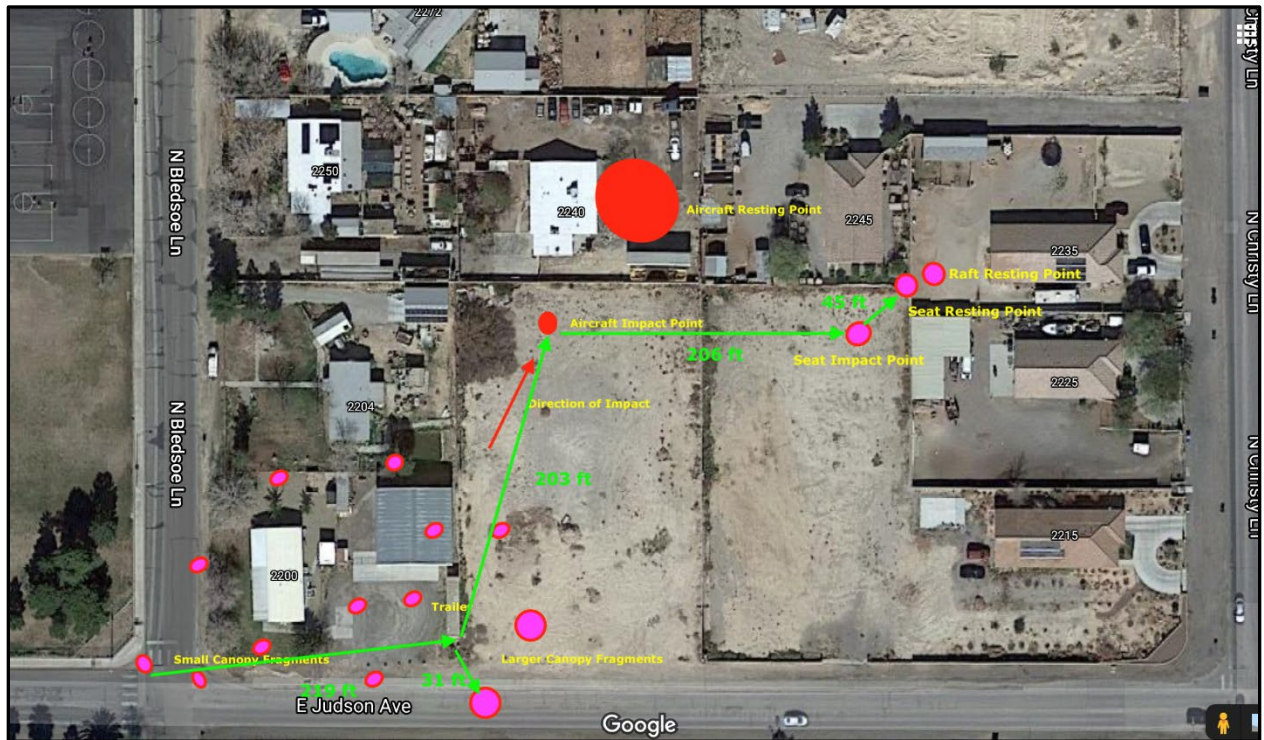
Figure 3 Accident site diagram.

The ejection seat and parachute were found about a block away to the east, southeast. Examination of the ejection seat and associated components revealed no anomalies. Numerous canopy fragments were found nearby,

particularly to the southwest.
