**From:** McAtee Nancy  
**Sent:** Thursday, July 6, 2023 3:06 PM  
**To:** Nixon Albert  
**Cc:** Budinski Michael  
**Subject:** WPR21FA203 Email report (Master Caution Light and other components)

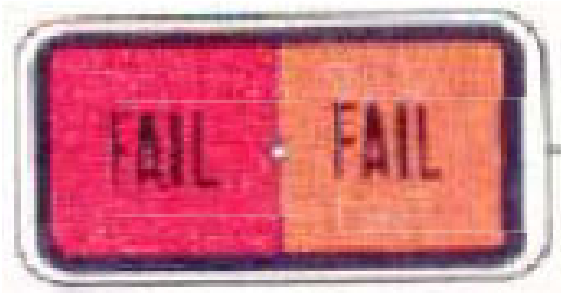
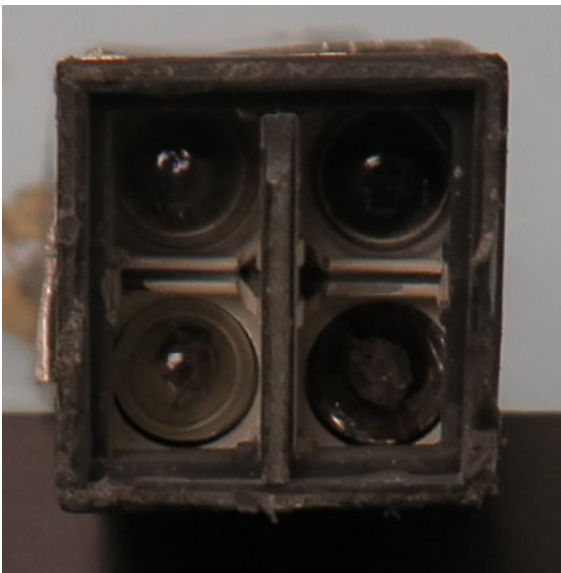
The following components from the accident aircraft were submitted to the Materials Laboratory for examination: 1) RPM gauge, 2) Flap selector, 3) Annunciator panel, 4) G-meter logic box, 5) Landing gear box, 6) Angle of attack (AOA) assembly, 7) Master caution light and 8) An unidentified gauge. All of the components were significantly damaged by impact and fire. The only component that could be examined was the Master Caution Light (MCL). The MCL, according to the aircraft operations manual, the MCL consisted two-sided light-one red (on the left) and one amber (on the right). A diagram with accident MCL in the same alignment are shown below.

**Figure 1. Master caution light layout and accident MCL.**

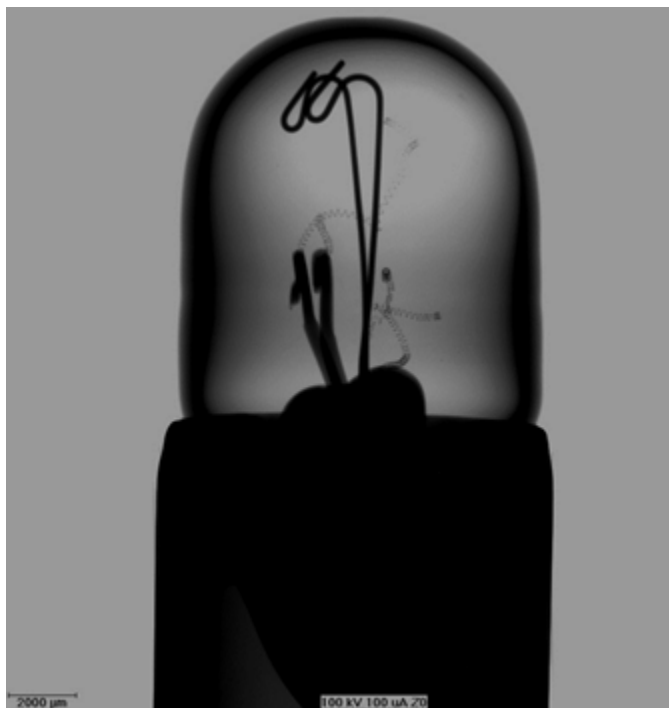
The left side had both bulbs intact. The right side was missing the lower bulb and the upper bulb was intact. The intact bulbs were radiographed to determine the status of the filaments. The two left bulb filaments were broken and unstretched. The remaining right bulb was intact and exhibited hot filament stretch as shown in the radiograph below. Hot filament stretch indicates that the right side of the MCL was illuminated at the time of impact.

**Figure 2. Upper right bulb from master caution light.**
