## **NATIONAL TRANSPORTATION SAFETY BOARD**

### **Field Notes**

**WPR21FA211**

Aircraft: Cessna 172 / N1727T

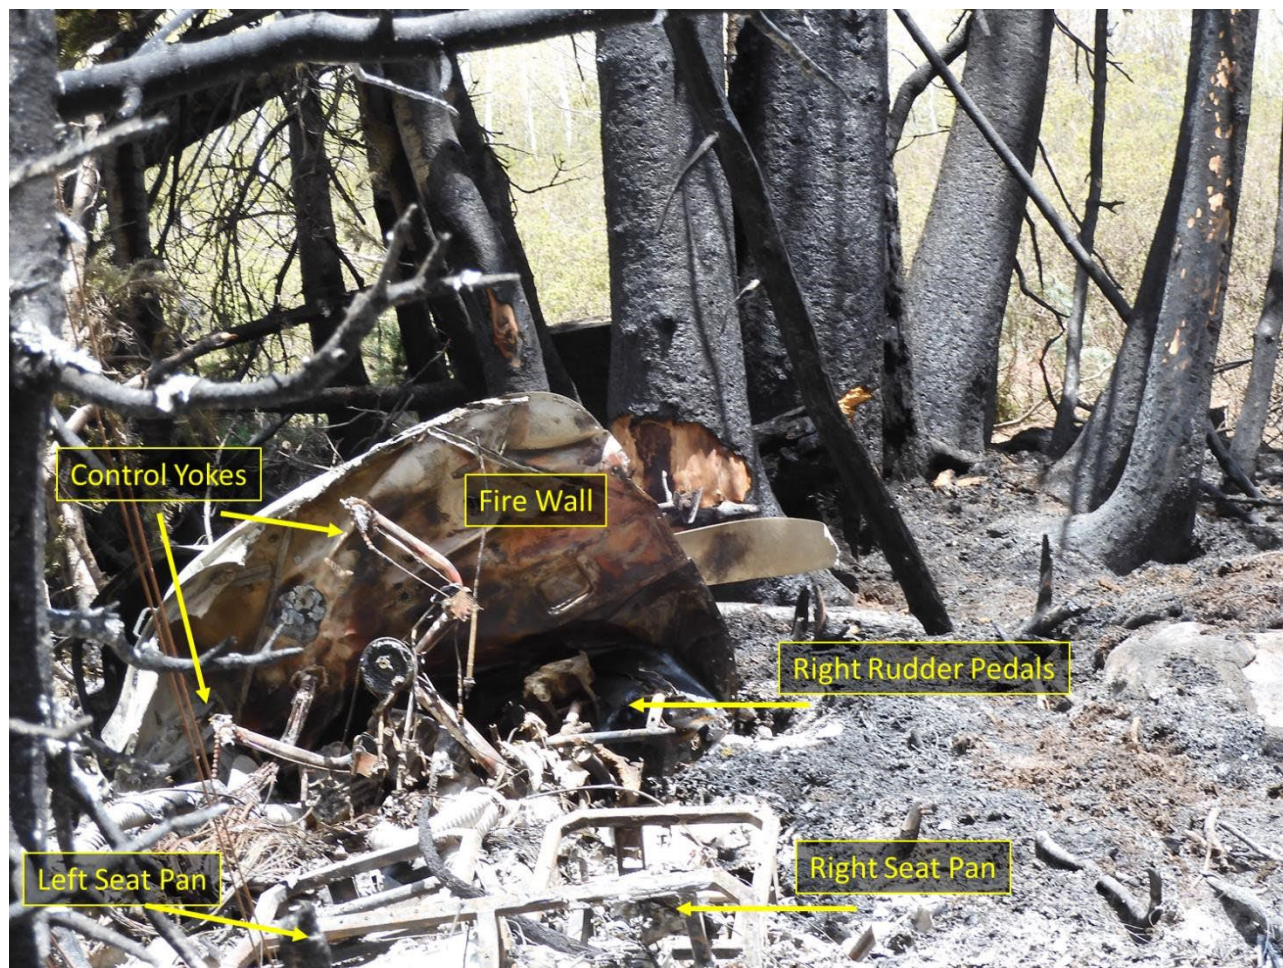
**Figure 5. Cockpit View**

Cockpit Documentation. Most of the cockpit was consumed. Some metal components remained and are noted below. No instruments, radios, switches or circuit breakers remained that could be read or identified. Portions of some instruments were found but could not be read.

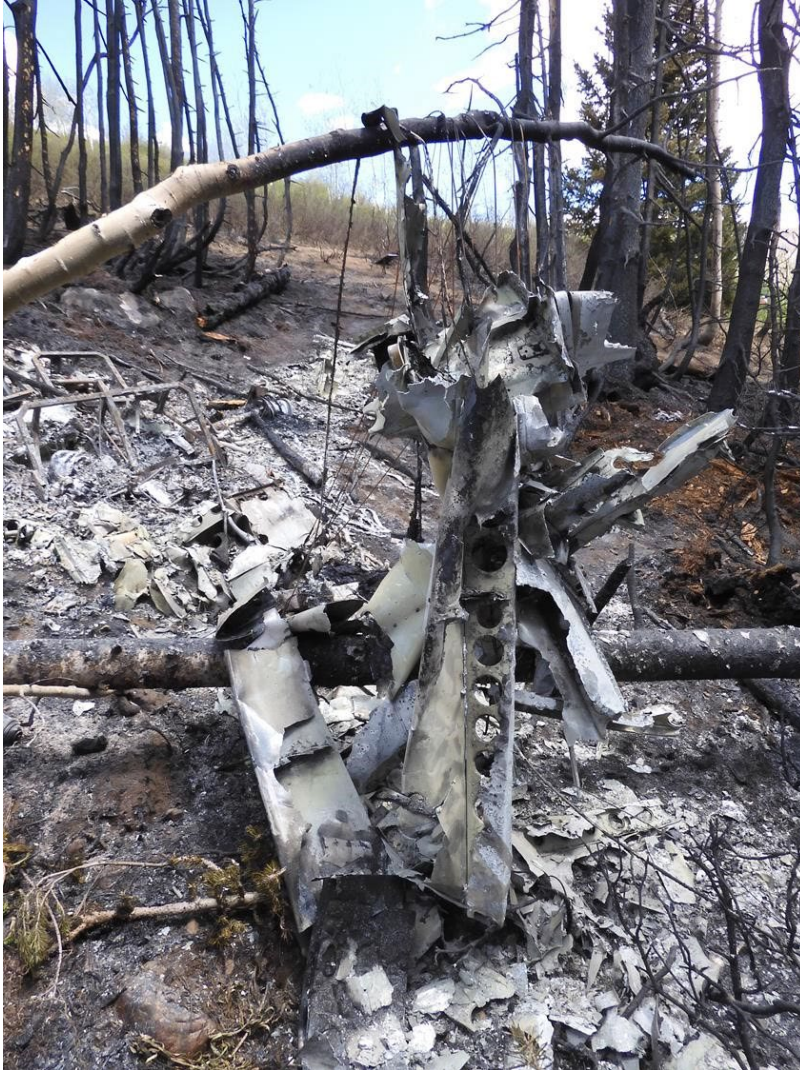
**Figure 6. Empennage View**

Empennage. Most of the empennage was consumed including all the control surfaces. Remnants of the empennage remained and were suspended from a tree by the control cables, and electrical wires.

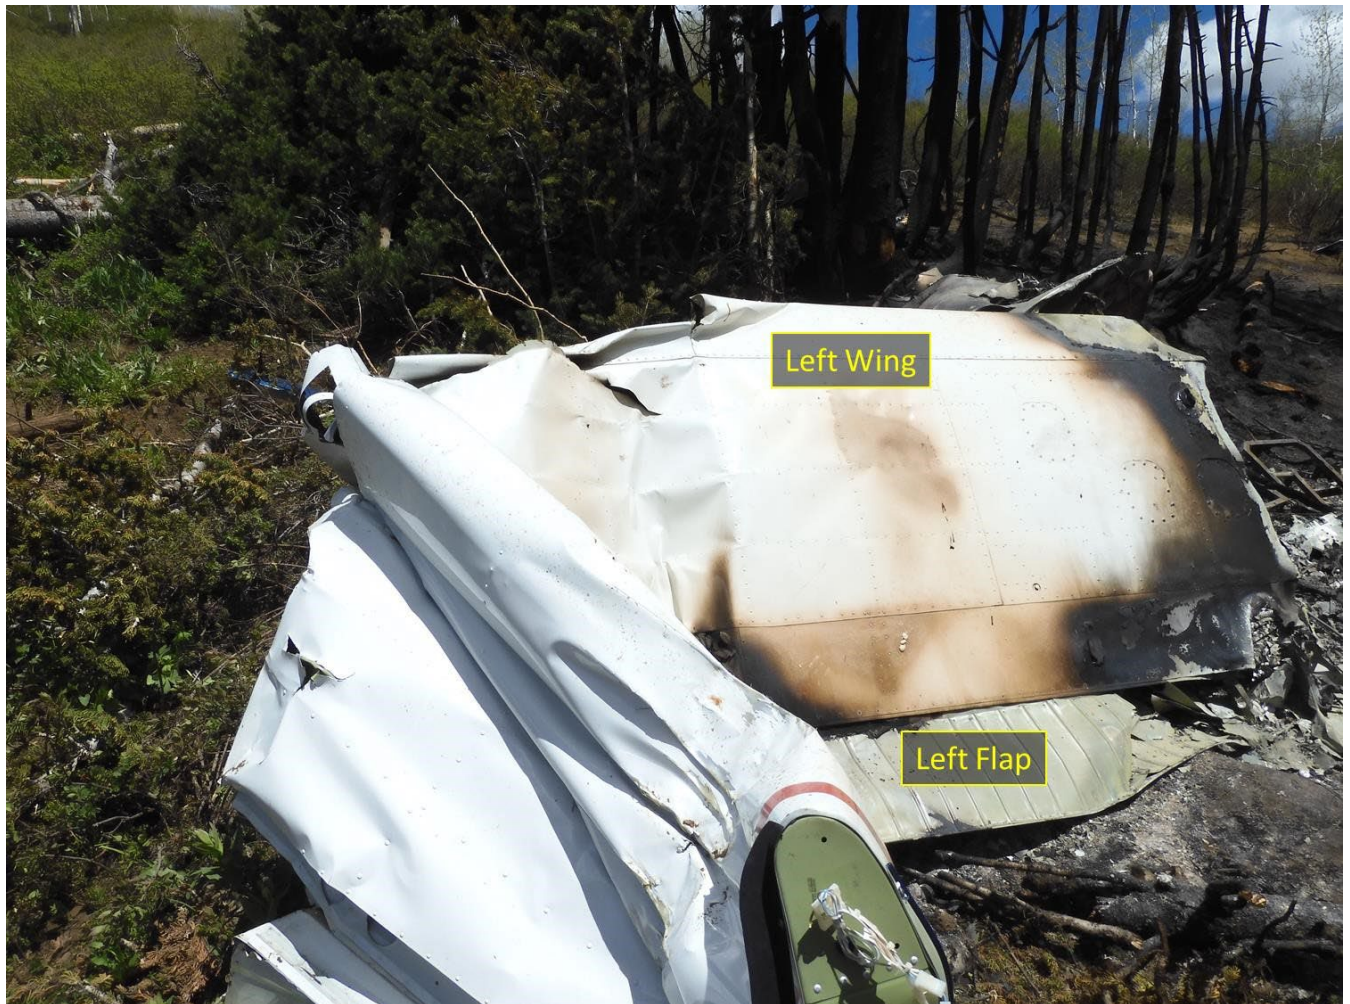
**Figure 8. Left Wing**

Left Wing. The left wing remained and was found in a position, relative to the burned fuselage, that was consistent with it remaining attached to the fuselage after impact. The root of the wing was thermally damaged consistent with the fuselage burning away from the wing. The left strut remained attached to the wing but was thermally separated from the fuselage. The leading edge, from the strut inboard, exhibited minor damage. The leading edge, from the strut outboard exhibited substantial damage. The wing, from the wing tip to the landing light, was bent upwards

90° and exhibited a ten-inch-long indentation, approximately four inches deep, and contained brownish material consistent with contact from the aspen tree, located at the first point of impact. The aileron remained attached and was bent 90° along the same location as the wing. The flap remained attached and was thermally damaged at the root. The left fuel cap was secured and thermally damaged. The wing tip had separated from the wing. A small portion of the left-wing tip, including the position light, was located near the left wing.

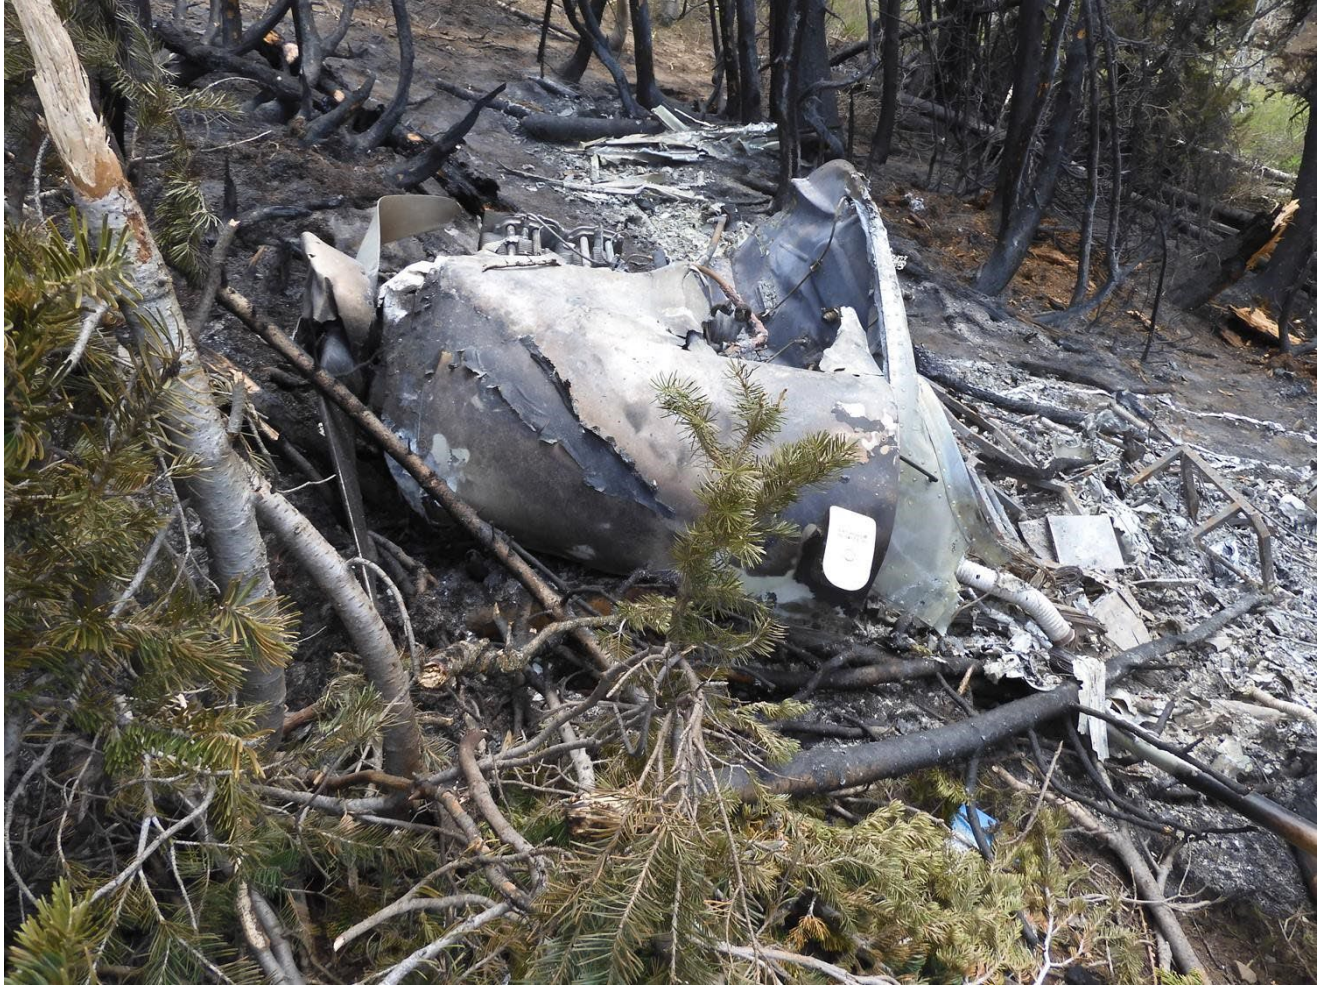
**Figure 10. Left view of Engine Nacelle**

Engine nacelle. The top of the engine nacelle remained but was thermally damaged. The sides and bottom of the nacelle were consumed.

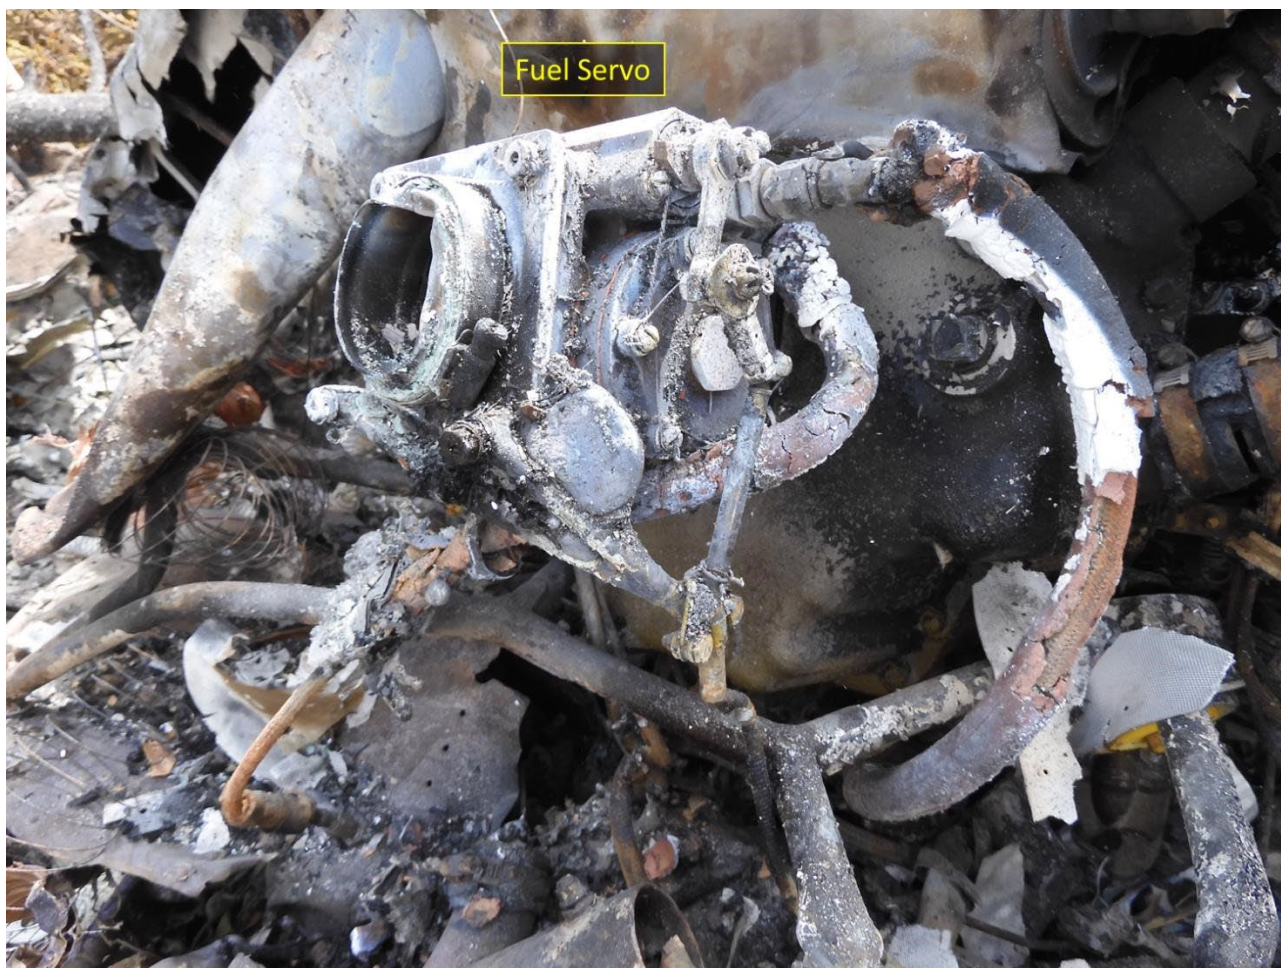
**Figure 11. Engine Fuel Servo**

Engine. The engine remained attached to the damaged engine mounts and the mount was partially attached to the firewall. The engine exhibited thermal damage but did not display large cracks or breaches of the case. All components attached to the rear of the engine received thermal damage. The fuel servo remained attached to the case. The engine would not rotate.

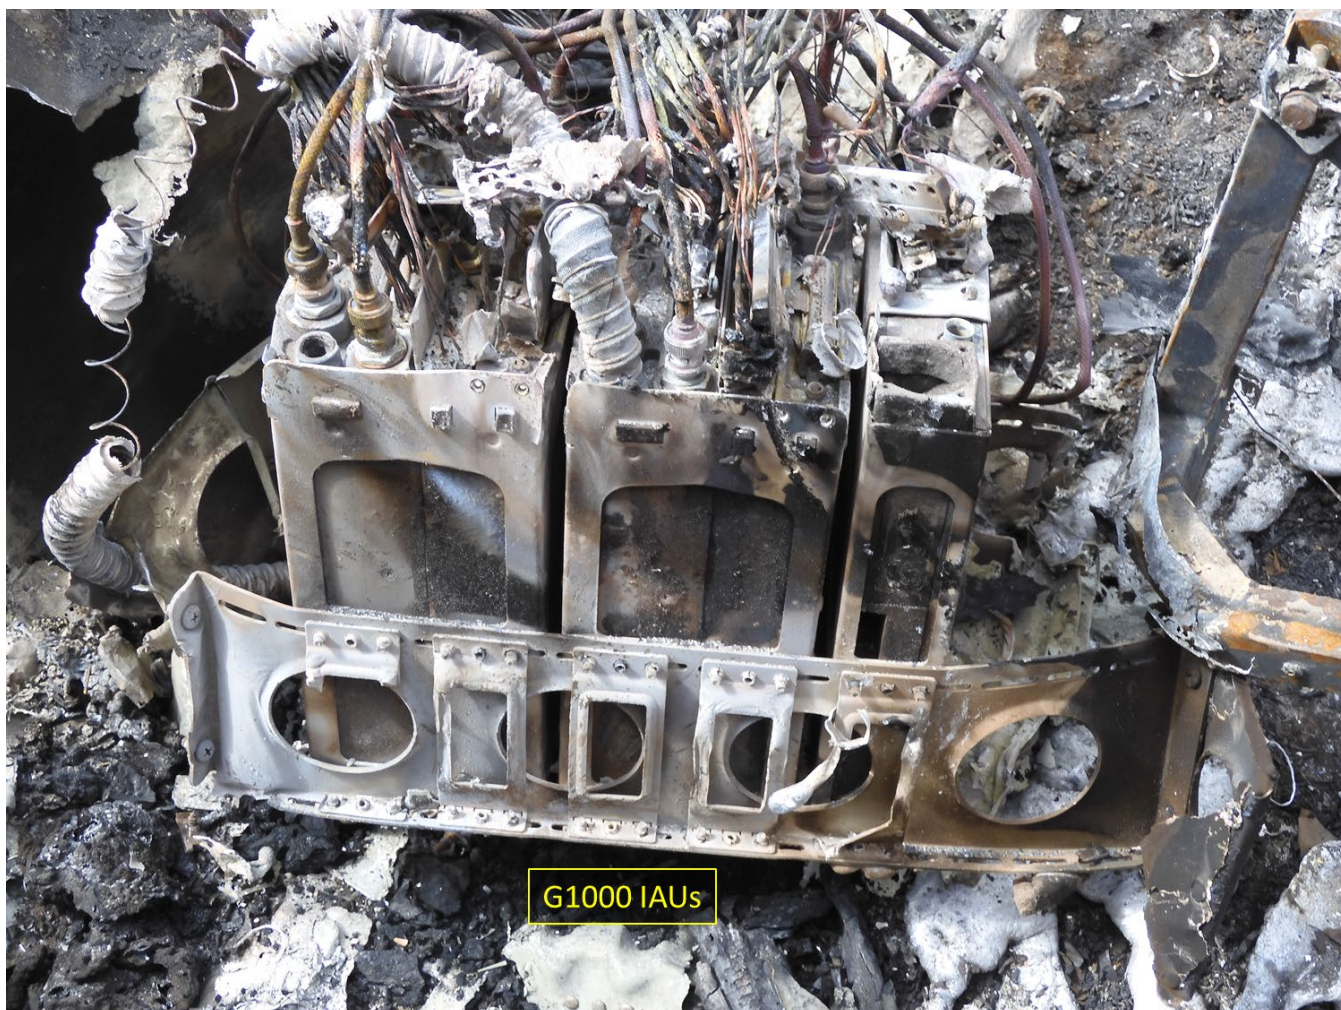
**Figure 13. Garmin Integrated Avionics Units (GIAUs)**

Three black boxes, identified as the Garmin Integrated Avionics Units for the Garmin 1000, were found in the wreckage. The boxes exhibited thermal damage and did not appear likely candidates for downloading.

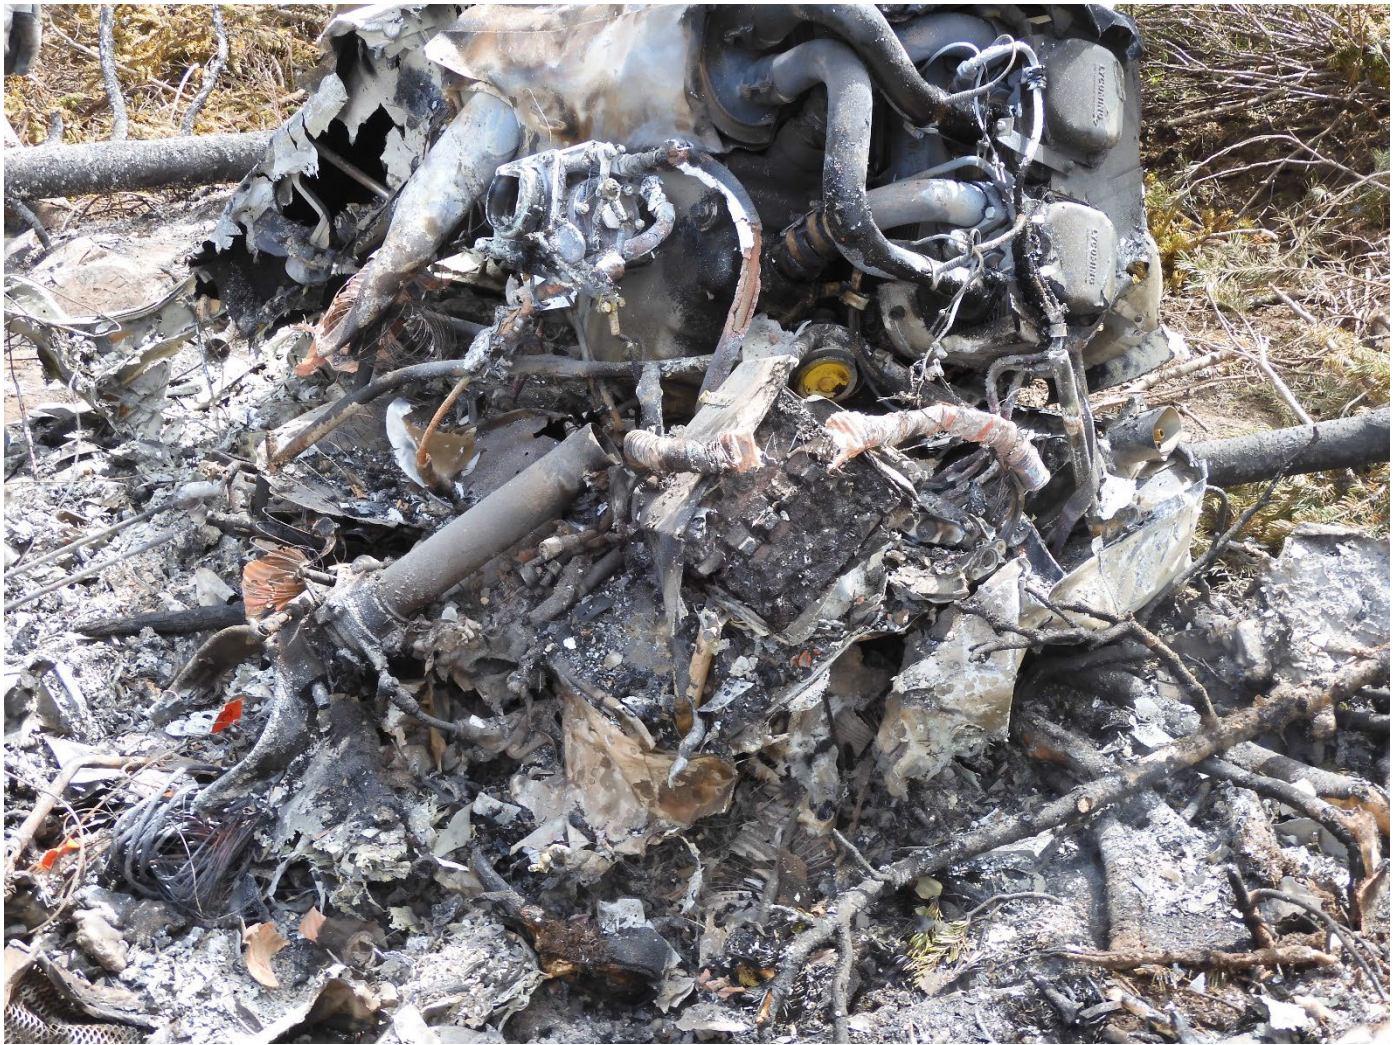
Main Landing Gear (MLG). The MLG was thermally damaged but found near their attachment point of the fuselage. The tires were consumed. The wheels were thermally damaged. The brakes remained attached to the wheels, but the brake lines were consumed. The nose wheel strut separated from the fuselage, and remained near its mount underneath the engine. The nose wheel was consumed with only the axle and wheel bearings remaining.

**Figure 14. Underside of the engine showing the nose wheel strut.**

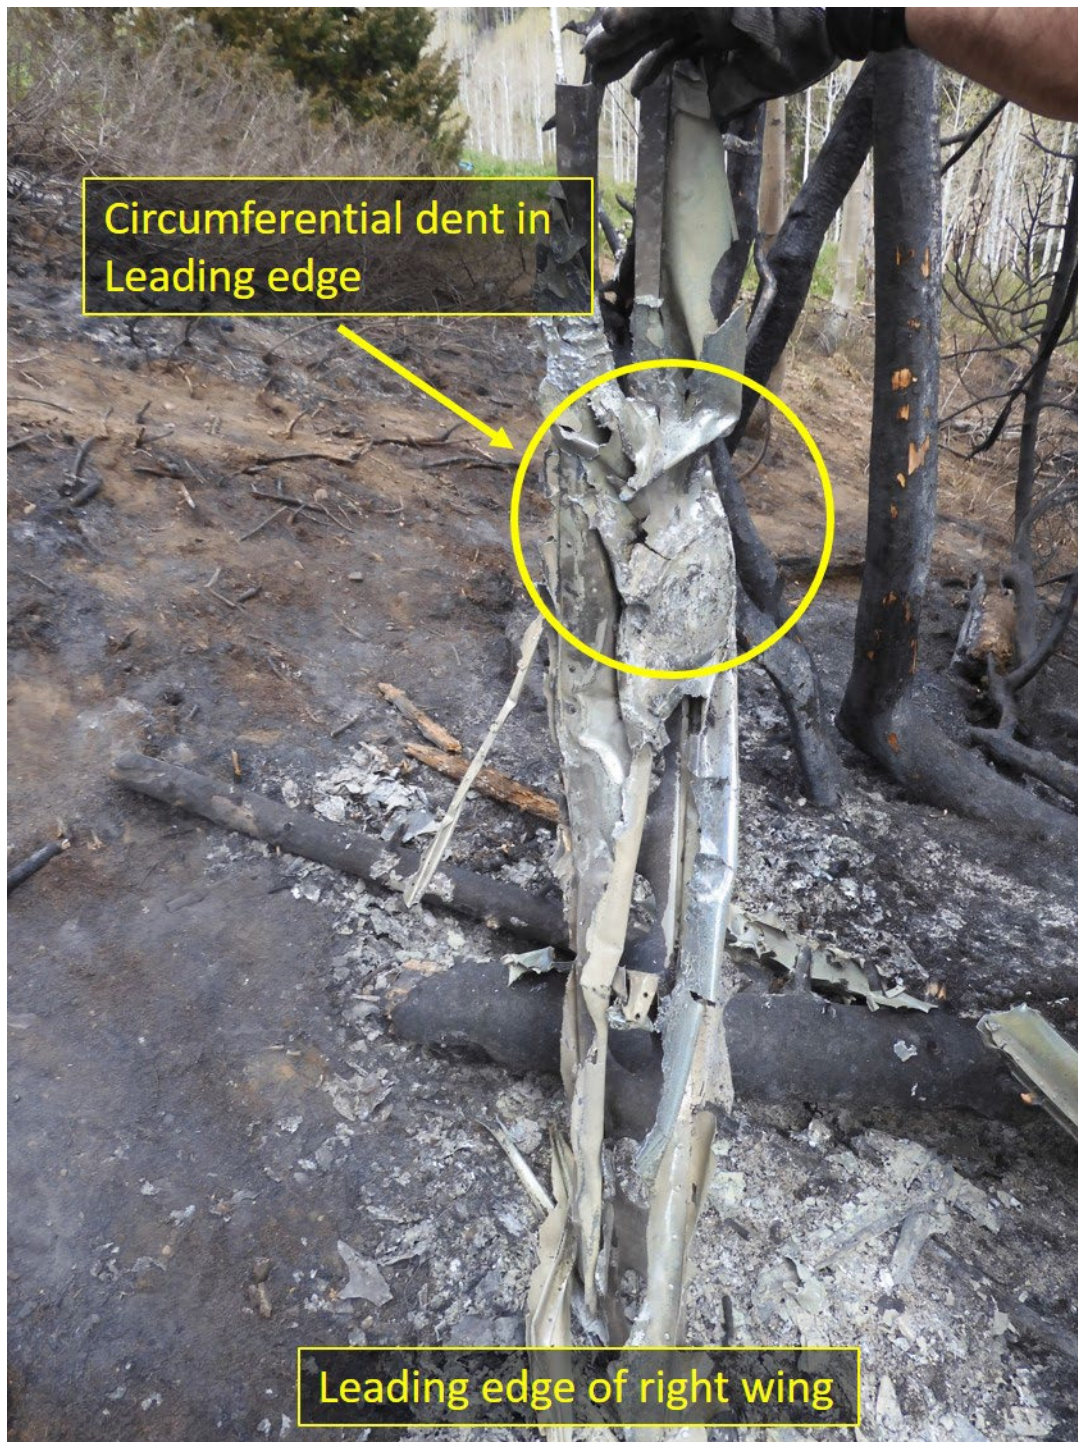
Right Wing. The right wing, except for a small portion of the wing tip, was burned to ash. The control cables remained. The aileron and flap were burned to ash. The flap actuator exhibited threads present, consistent with a position of full up. A portion of the leading edge remained and exhibited a circumferential indentation and contained a brownish material consistent with contact with a pine tree located southwest of the wreckage about 15 feet above ground level.

**Figure 15. Remnant of the right-wing leading edge.**
