**NATIONAL TRANSPORTATION SAFETY BOARD**  
Office of Aviation Safety

**NTSB Wreckage Examination Report**

**A. ACCIDENT      WPR21FA211**

Location: Eden, Utah  
Date: May 29, 2021  
Time: 1000 MDT  
Operator: ATP Flight School  
Aircraft: C172S  
Registration: N1727T

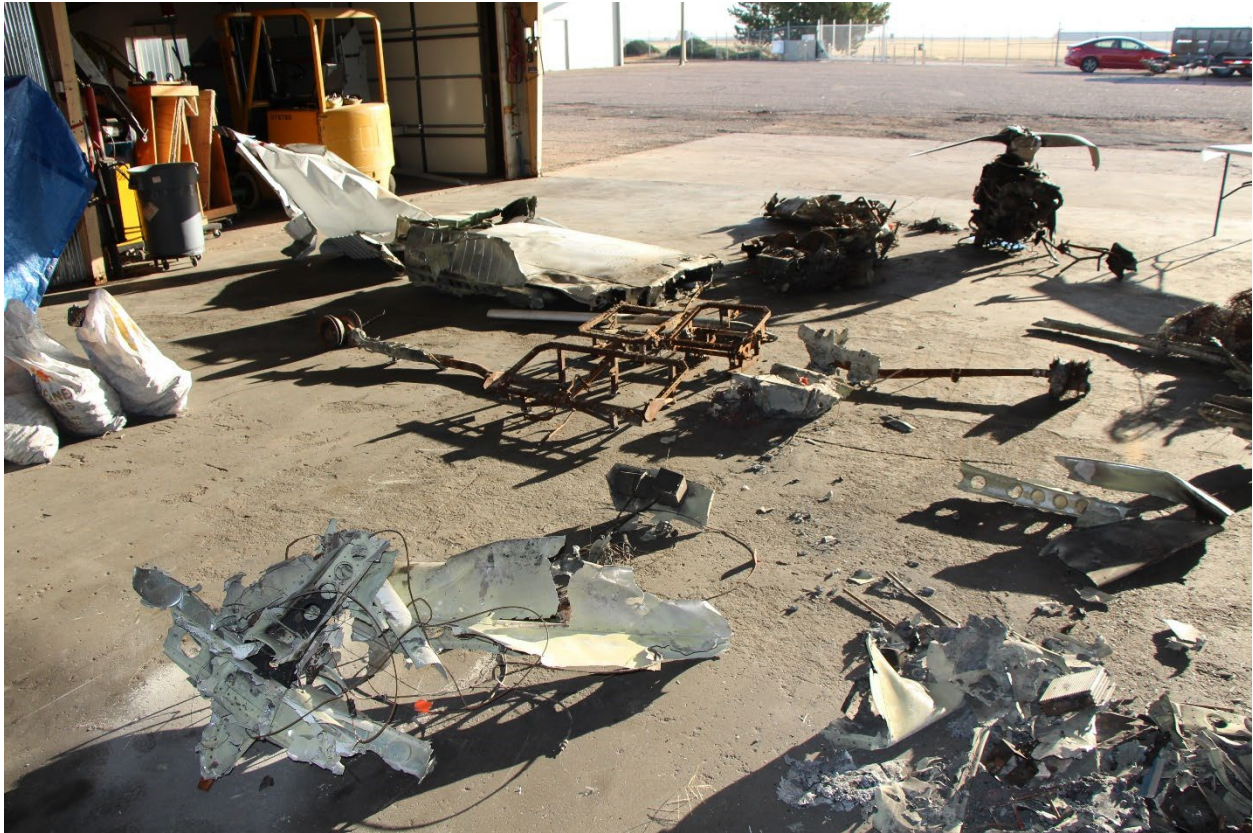
*Photograph 1: Wreckage Layout*

Most of the airplane was consumed by postcrash fire. The cabin, right wing and tail were destroyed while the left wing sustained thermal damage and was cut about midspan by recovery personnel. An approximately 8 inch long depression was observed in the outboard leading edge of the left wing.

The left aileron was attached to the left wing at both hinges and a portion of the flap remained attached to the wing at the outboard hinge. The right wing was consumed by fire, but the flap actuator and motor remained intact, but were damaged by fire.

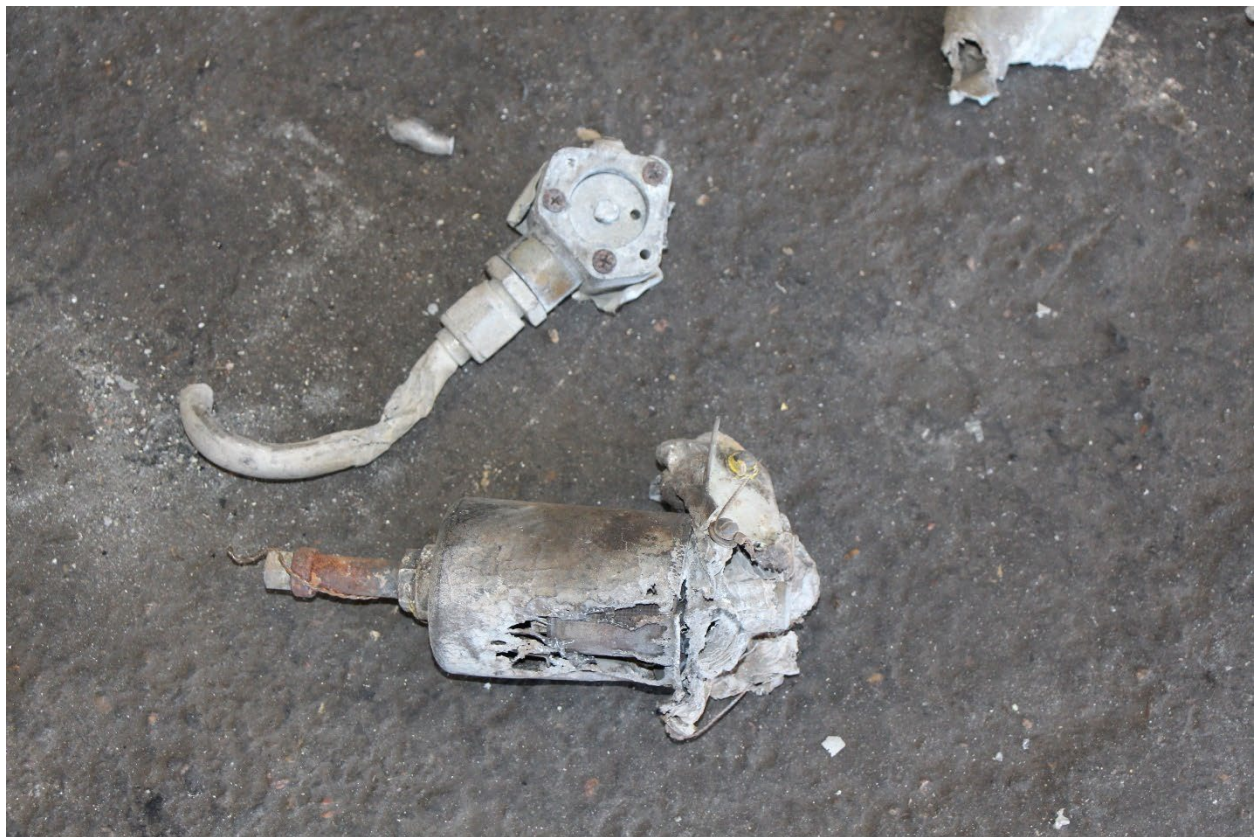
*Photograph 2: Gascolator and Fuel Selector*

The fuel selector and the gascolator were damaged by fire. The gascolator bowl was partially melted. The auxiliary fuel pump was also thermally damaged.

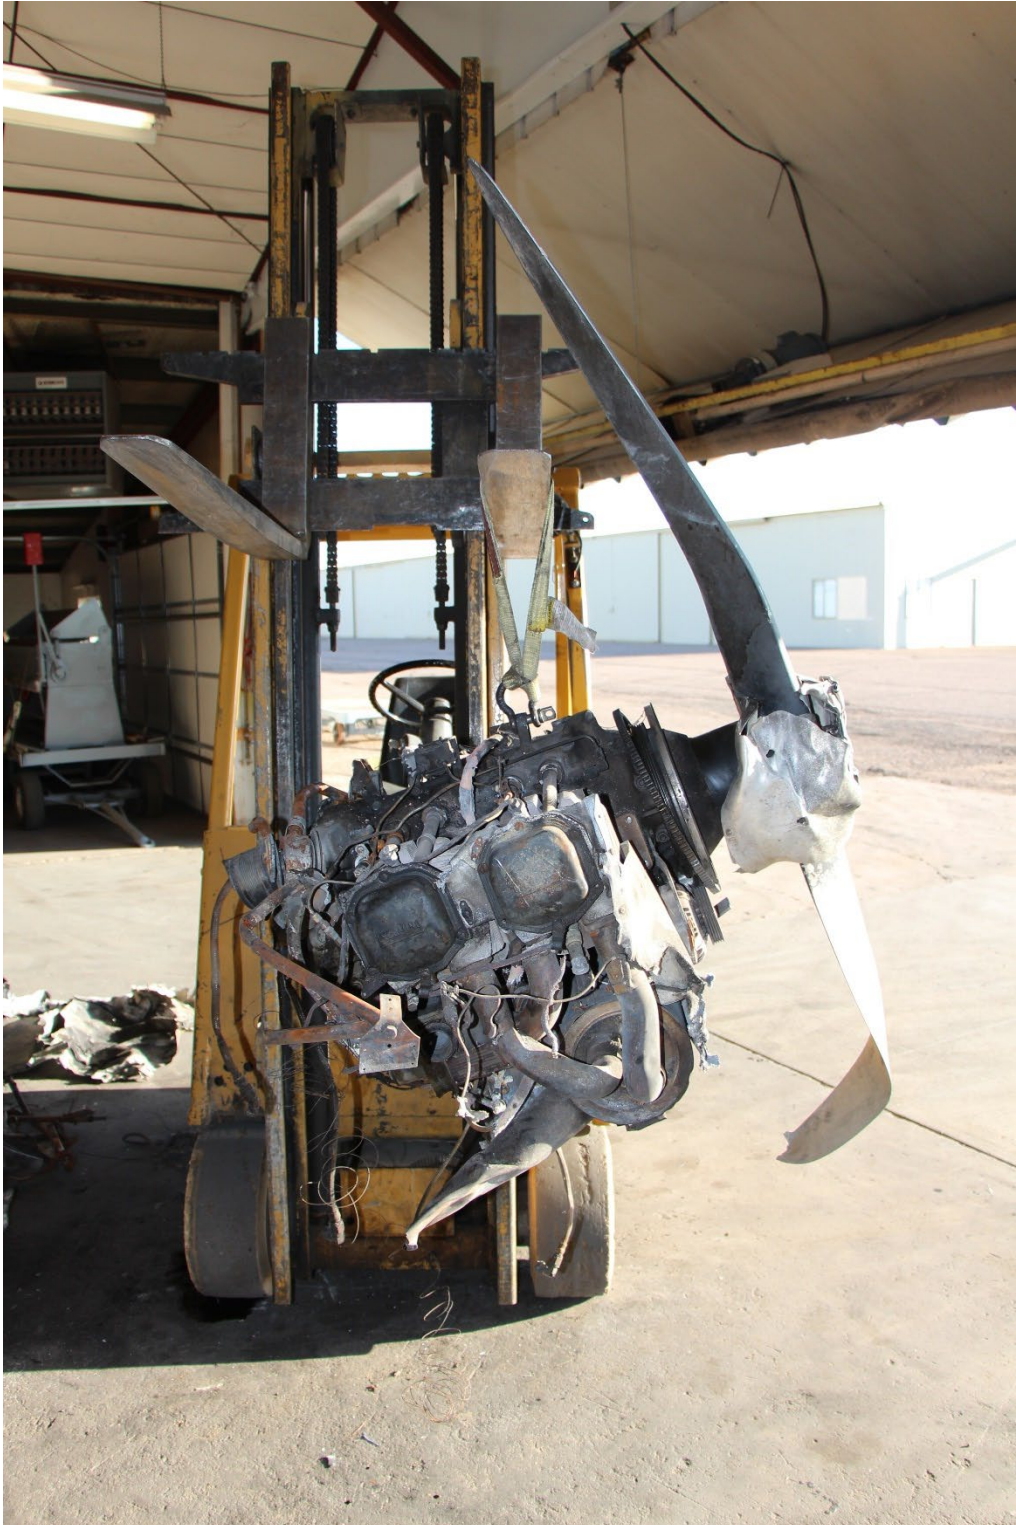
*Photograph 3: Engine Before Exam*

The engine was a Lycoming Engines IO-360-L2A, s/n RL-3186B-51E, an air-cooled, 180 hp reciprocating engine. The engine was thermally damaged by fire. The baffling was damaged, the cylinder 1 and 3 valve push rods shrouds were thermally damaged, and the cylinder 3 fins were bent. The accessory case was intact, but thermally damaged.

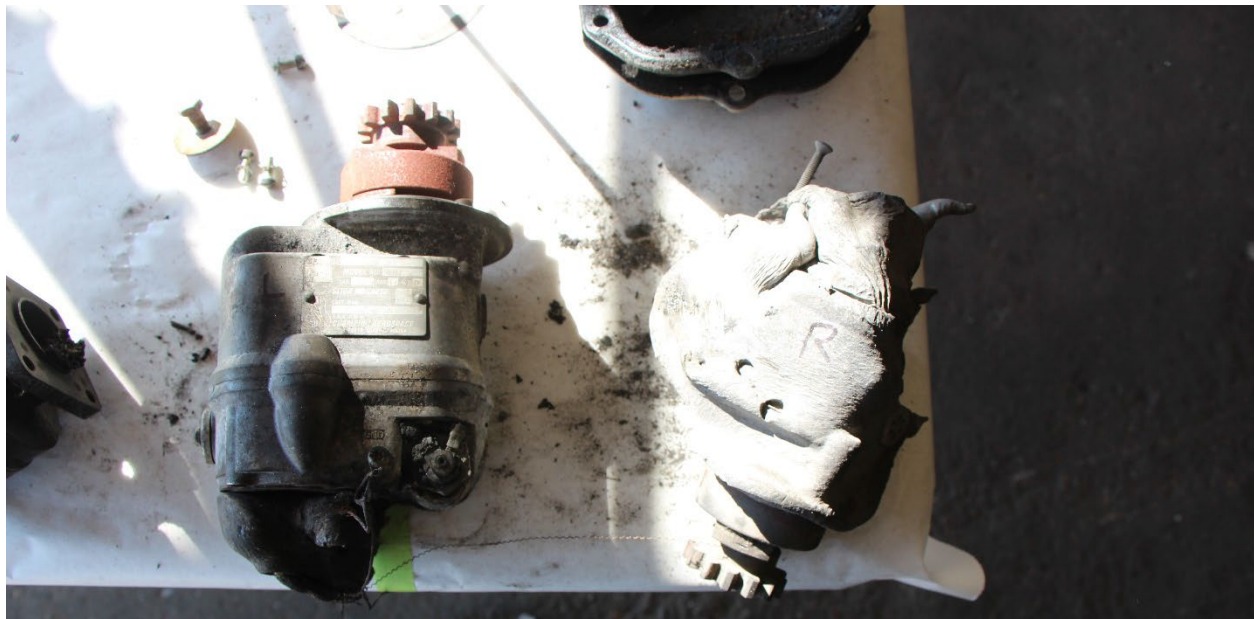
*Photograph 4: Left and Right Magnetos*

The magnetos were damaged by fire and could not be rotated by hand. The left magneto was a Slick model no. 4371, s/n 9595609. The right magneto manufacturer and model could not be obtained as the case was melted. The top spark plugs were Champion, model REM38E massive electrode spark plugs when compared to the Champion Check-A-Plug chart. All four of the top spark plugs were gray in appearance, consistent with normal wear. The bottom 4 spark plugs were also normal in appearance when examined through lighted borescope.

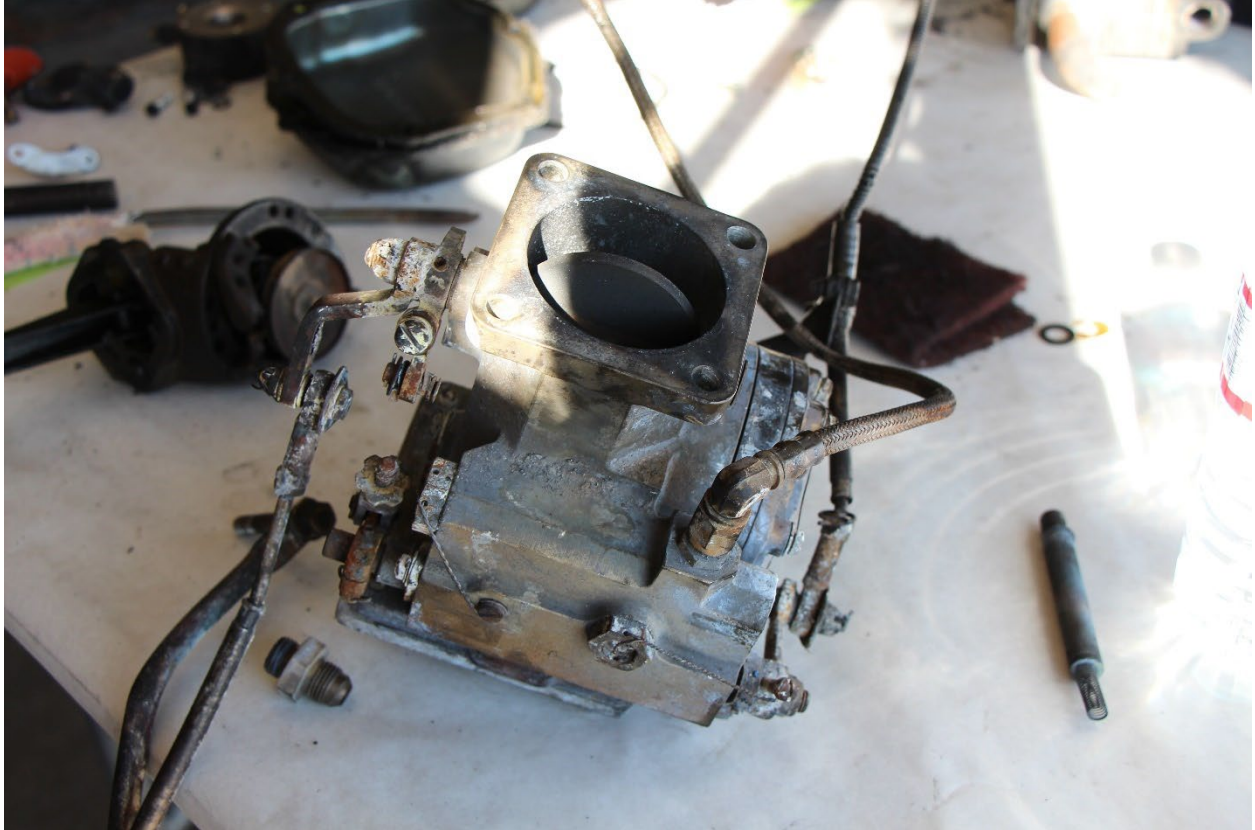
*Photograph 6: Fuel Servo*

The fuel servo was partially fractured at the mount, but remained attached to the engine. The throttle valve moved normally from stop to stop, but the mixture control was seized. The servo screen exhibited a trace amount of debris. The fuel pump case was partially melted, but moved when the pump was actuated by hand. All four of the fuel injectors were free of debris. The fuel flow divider remained attached at the top of the engine case and each injector line remained connected to the fuel flow divider. The divider diaphragm was normal in appearance and no fuel residue was observed within the divider.
