# National Transportation Safety Board

WPR21FA223

## INVESTIGATION MATERIALS SUPPLEMENT

Location: Porterville, California  
Date: 06/07/2021  
Time: 1420 Pacific standard time  
Airplane: Vans RV-6A

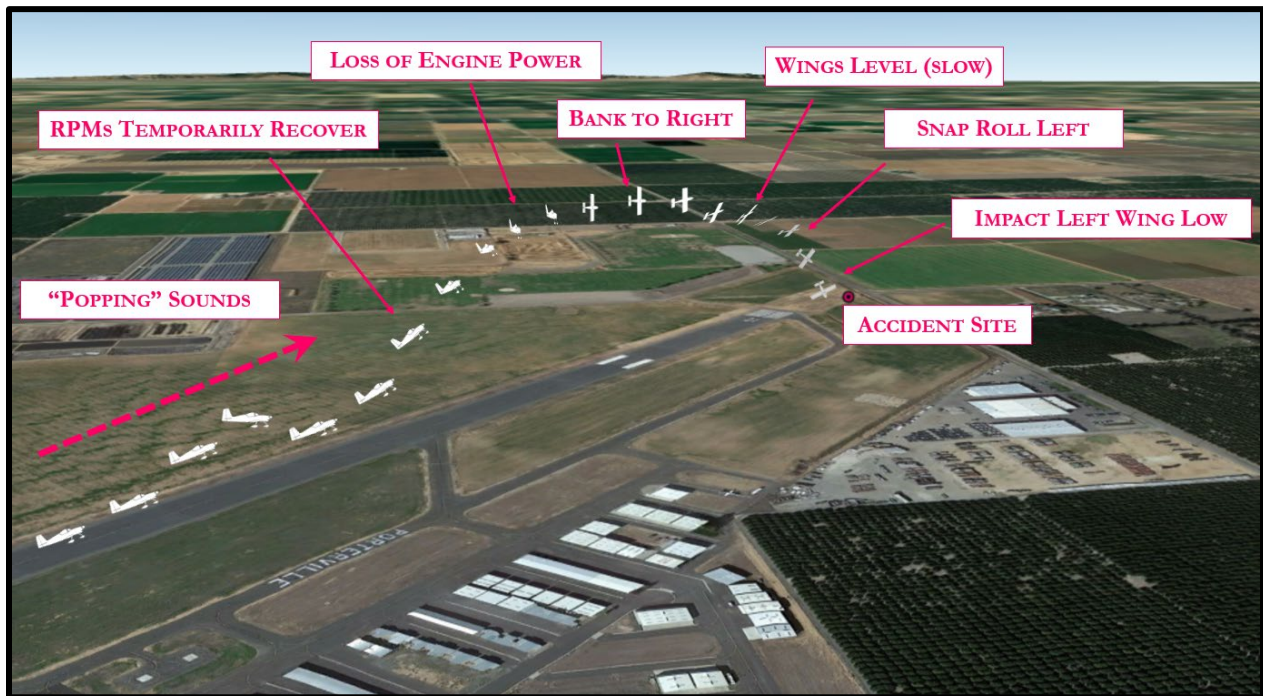
Figure 1: Visual of Witness Reports

Numerous witnesses at the airport observed the pilot refuel and takeoff. They stated that the pilot refueled the airplane with about 17.5 gallons at the self-serve fuel tanks located mid-field. A witness observed the pilot, positioned in the right seat, start the airplane after refueling. The start-up was abnormal and sounded as though it was a “hot start” with the airplane rpm’s immediately accelerating to a near maximum setting. The airplane then continued to the departure end of runway 04 and proceeded to takeoff. The airplane began to climb and the engine was making “popping” sounds while continuing left of centerline. The nose pitched down and the engine momentarily sounded normal as the airplane then climbed to about 300 ft above ground level (agl). The “popping sounds” continued and some witnesses observed that the engine then experienced a loss of power (see Figure 1 below).

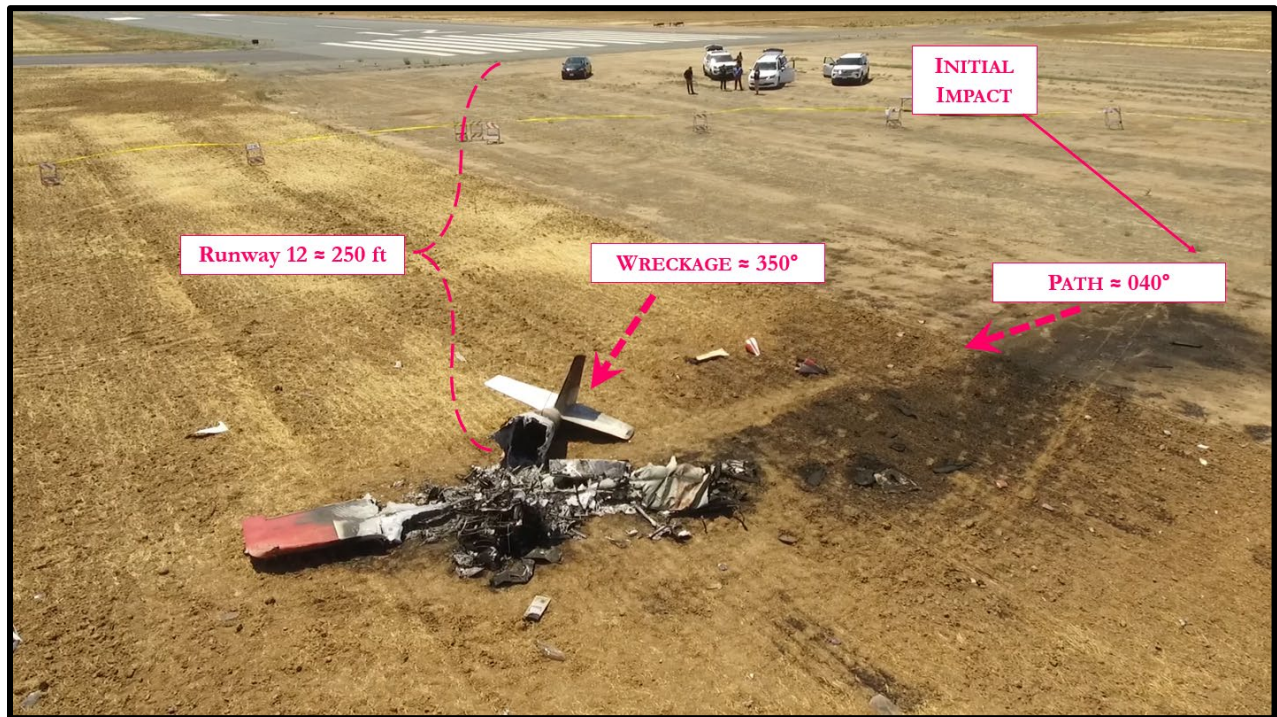
Figure 2: Debris Field (in reference to the runway)

The accident site was located about 250 feet from the beginning of runway 12 at the following coordinates: 36.036104, -119.070189. The wreckage was found distributed over about 100-feet on a median magnetic bearing of about 040°. The nose was pointed on a median magnetic bearing of about 350°. The fuselage and inboard sections of the wings had been consumed by fire. The first identified piece of debris was fragments of red lens, consistent with the tip of the left wing contacting the ground at the beginning of the accident sequence. From the lens fragments was pieces of propeller blades and pieces of the skin.

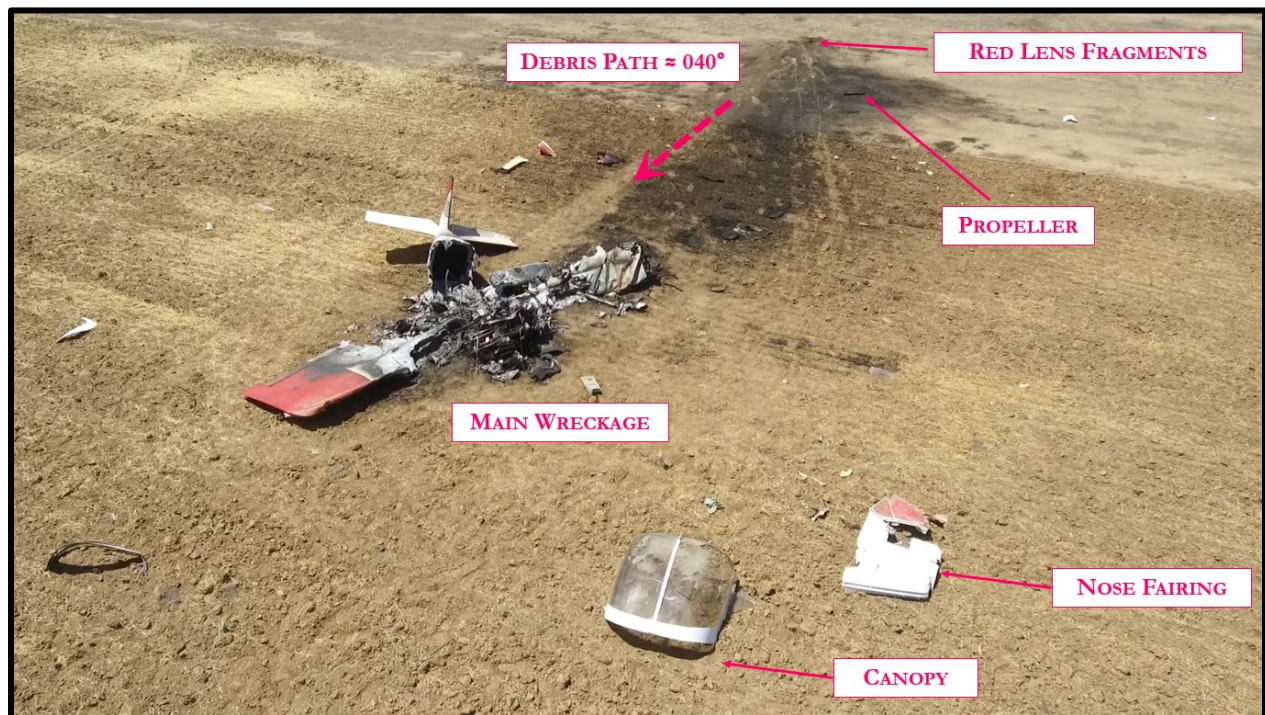
Figure 3: Debris Field

The furthest wreckage was the emergency locator transmitter (ELT), the canopy and the upper cowling, all of which remained unburned. There was no evidence that the ELT activated; the switch was in the "OFF" position.

The canopy and upper nose cowling were forward of the main wreckage. They were clean from oil and soot.

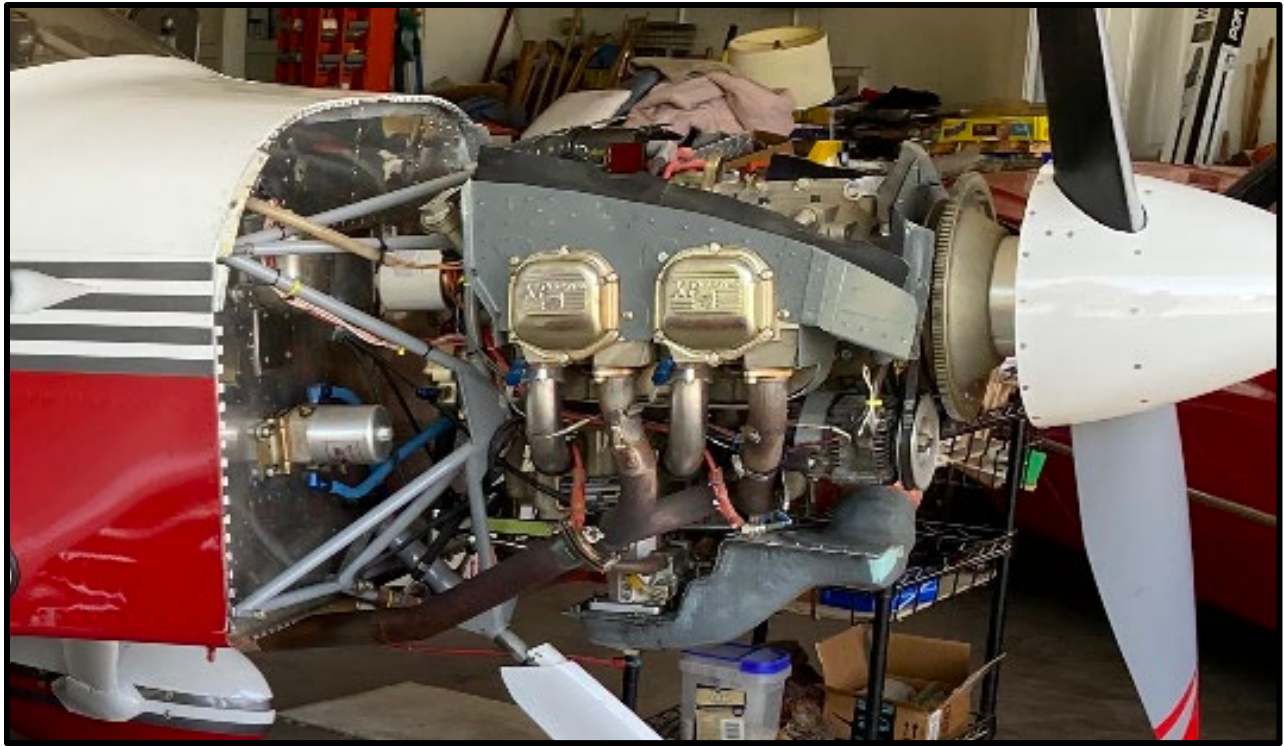
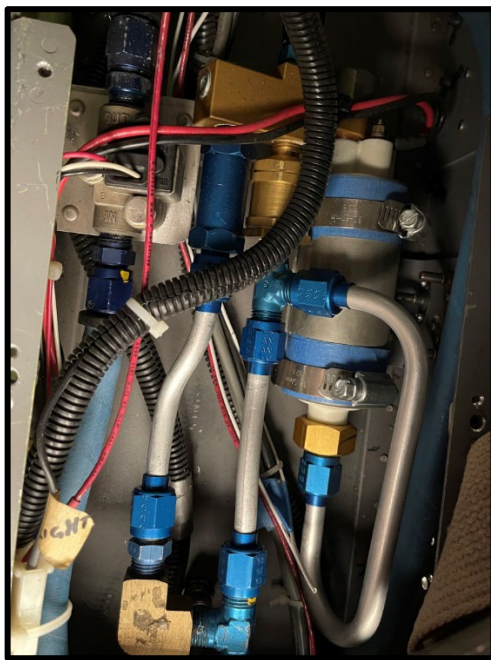
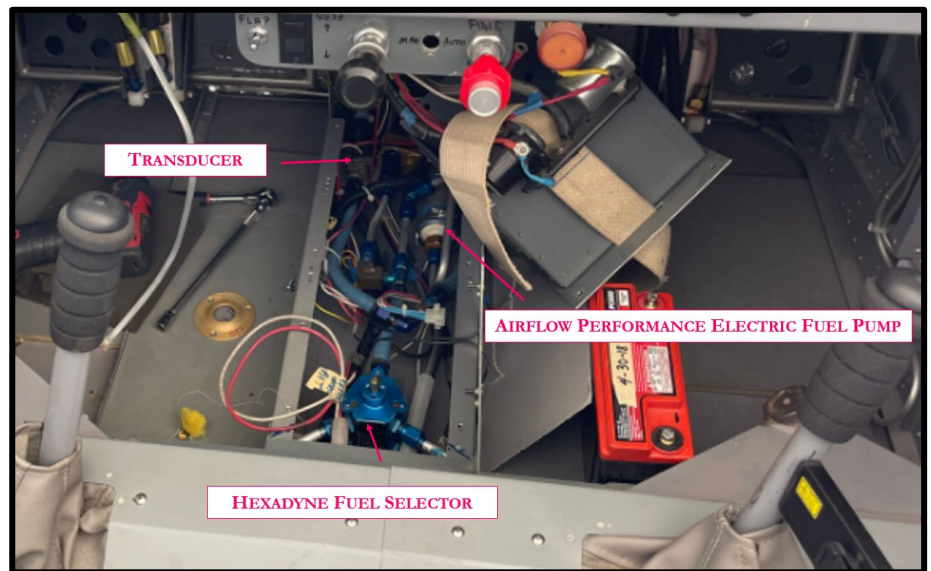
Figure 7: Pictures of the Airplane Prior to the Accident

Several pictures taken prior to the accident revealed that there was rubber lined fuel hoses. Additives in the fuel will deteriorate and erode the rubber liner, creating either a cavitation void for an air leak or a fuel leak; either could cause a starvation or a momentary fuel starvation.

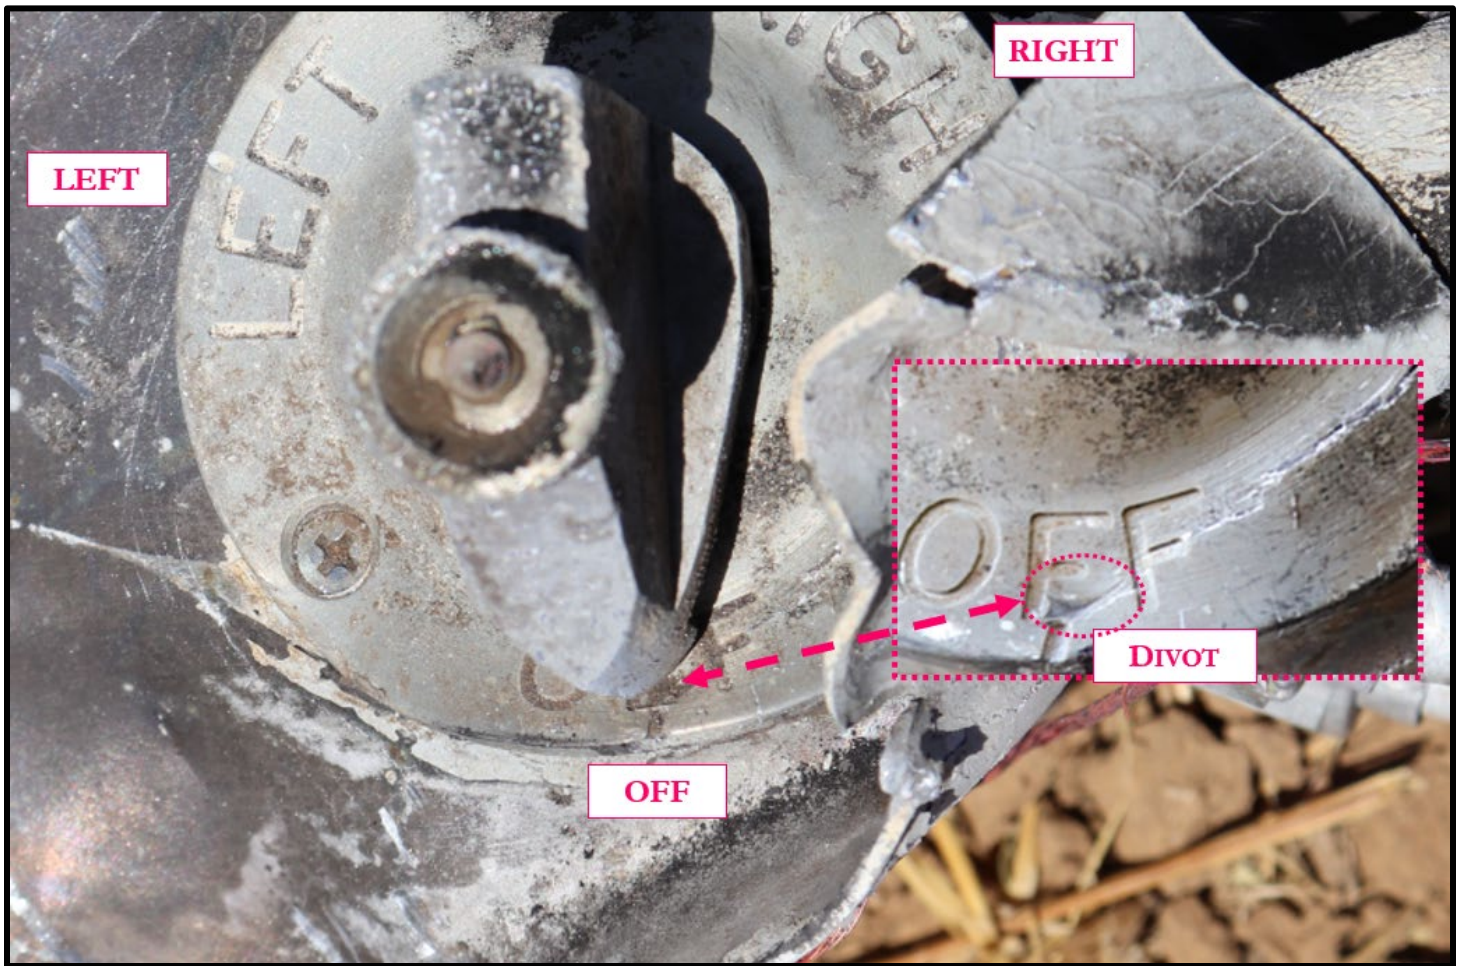
Figure 8: Fuel Selector

The fuel selector handle was attached body and found in the “OFF” position. The selector position plate was affixed to the structure and bent over on the handle. There was a divot in the plate metal consistent with the selector handle being in the “OFF” position at the time of impact. The fuel lines remained installed on the fuel selector, but were melted off at about 1-2 inches outboard of the selector. When routing air through the outlet,

investigators could establish that the air escaped from the intended tank position selected, with a tactile detent at each position. The internals of the assembly were thermally consumed.

There was a white residue in the inside of the lines which was likely a result of one of the following reasons:

- 1)The residue is the oxidation of a non-ferrous component within the steel line. Exposure to heat or a combination of exposure to heat and then to moisture through air or water can result in this type of oxidation.
- 2)Gasoline additive are not all organic and may not necessarily evaporate or burn away.
- 3)Or a combination of all of these things.

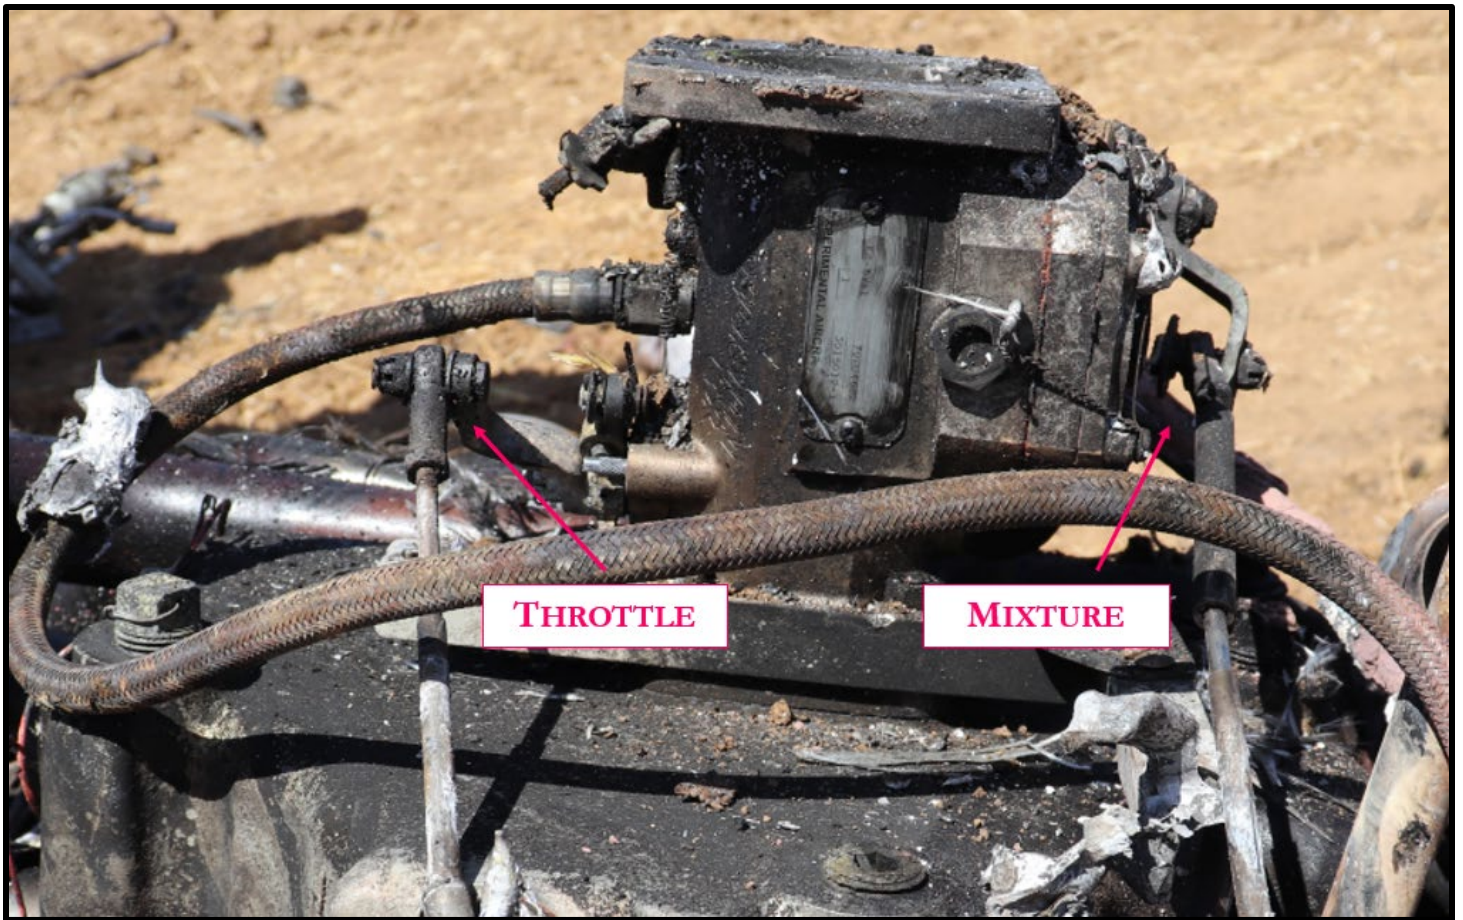
*Figure 9: Fuel Servo*

Investigators established continuity from the throttle and mixture controls from the controls in the cockpit to the arms on the fuel servo; the stop bushing was thermally consumed. The idle screw adjustment was not saftied. The butterfly valve was found in the closed position and the heat marks were consistent with it being in that position during heat exposure. Disassembly of the servo revealed that the diaphragm was burned.

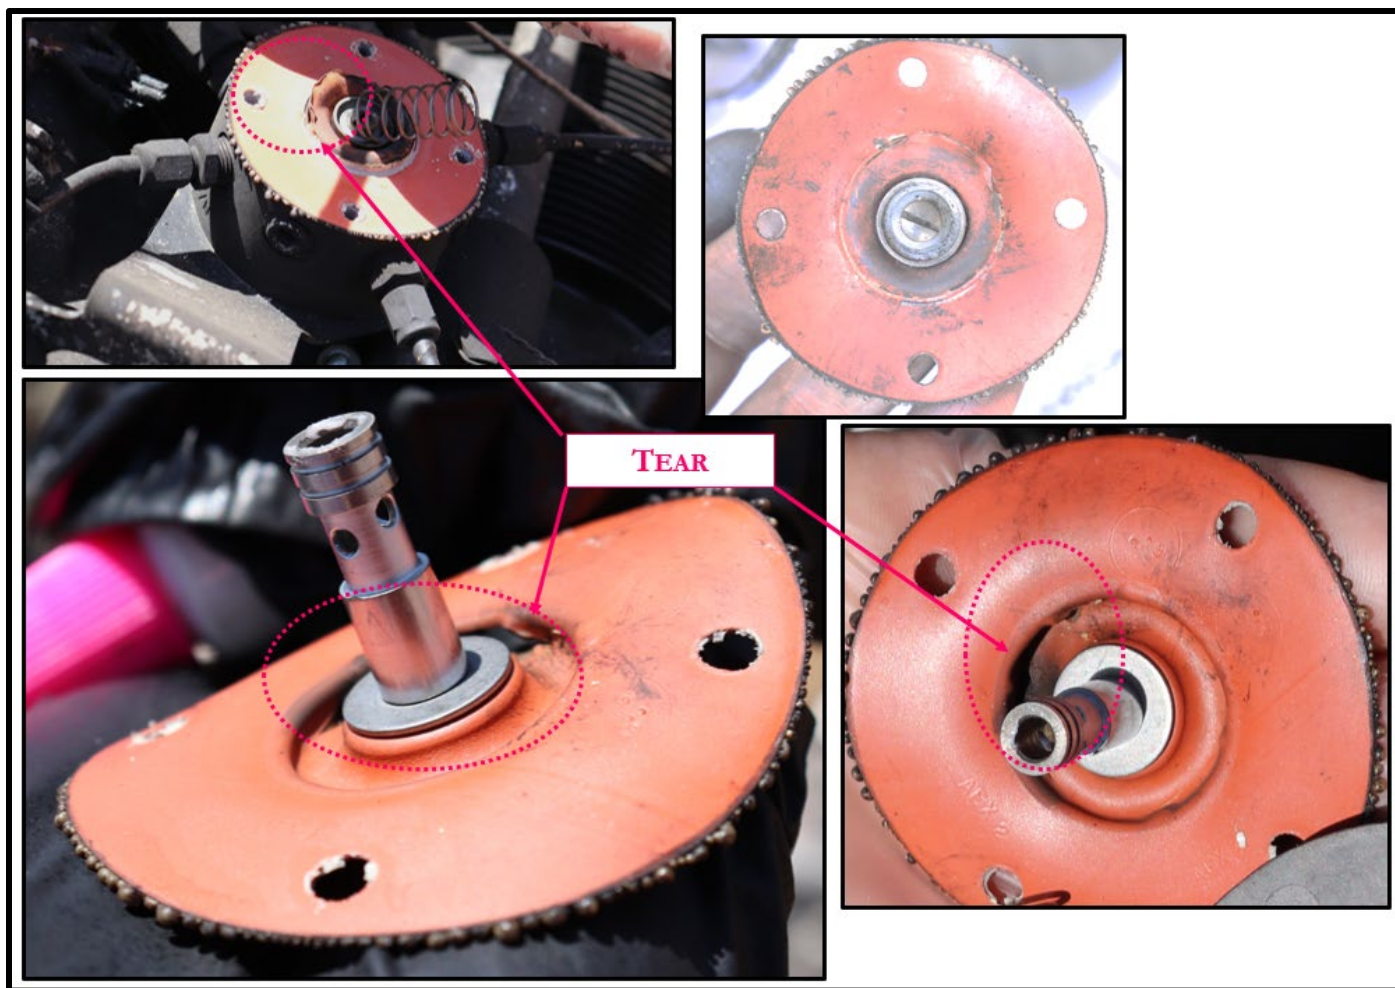
Figure 10: Fuel Manifold (Spider)

The fuel line from the fuel servo to the spider was melted with the fire sleeve partially burned off. The line was completely blocked from the material melting inside. The spider did not contain obvious fuel and several drops of moisture found were positive for water; the post-accident fire was extinguished with water and a chemical suppressant. Disassembly revealed that the diaphragm was torn and burned consistent with a post-impact damage.

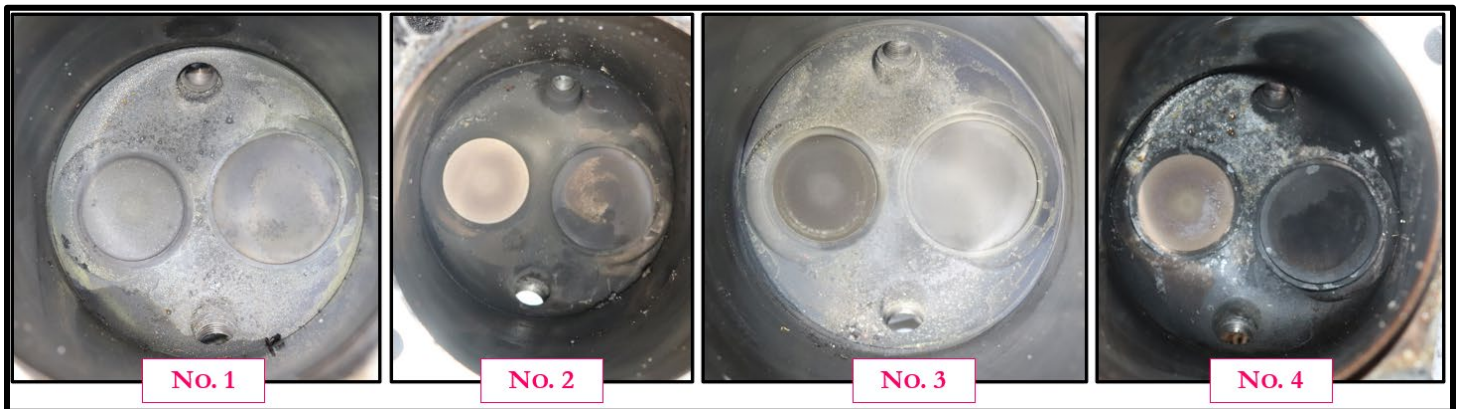
Figure 12: Cylinders and Valve Faces

Investigators removed the cylinders which revealed no evidence of foreign object ingestion or detonation. All valves were intact and the internal cylinder domes and piston crowns exhibited similar combustion deposits with the No. 2 and No. 4 exhaust appearing to be more reddish in color, consistent with hot operation. The valves and guides were examined and no evidence of material transfer was visually apparent.

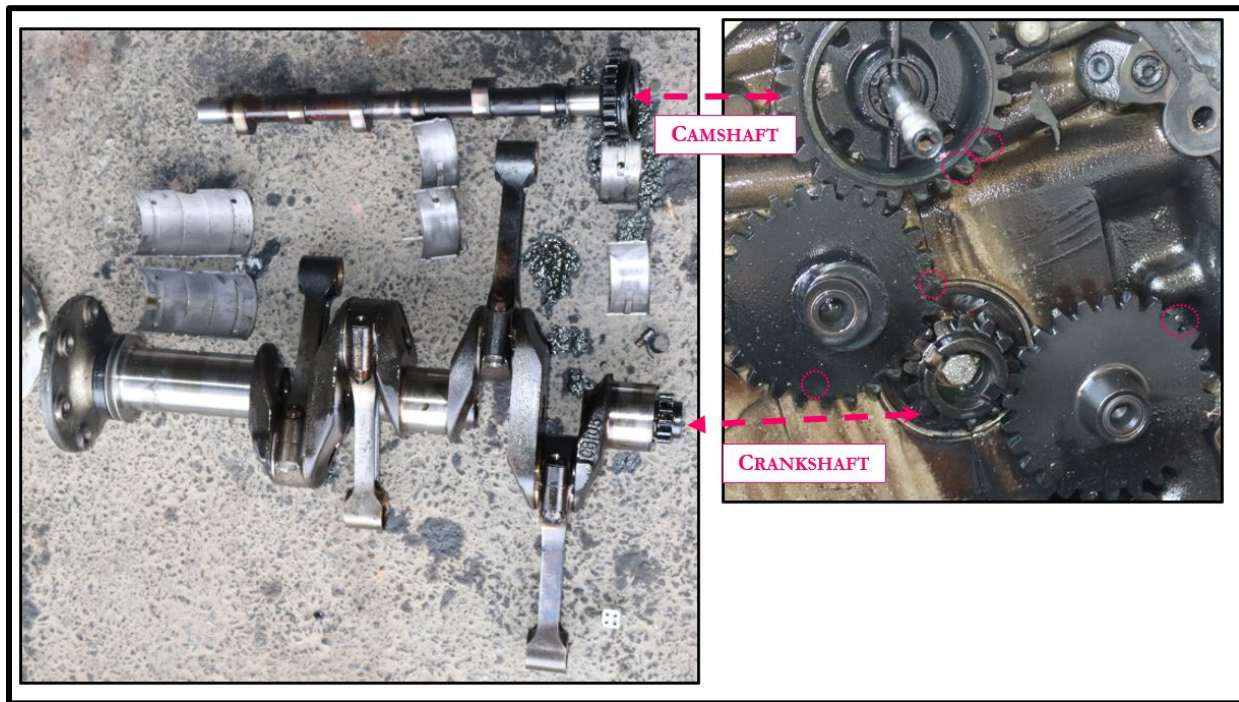
Figure 14: Crankshaft and Camshaft

The thermal exposure appeared to be more extensive on the Nos. 1 and 3 cylinders. The bearings were free of wear and no fretting was observed. The crankshaft was intact and the connecting rods remained secured with a dark coloration consistent with thermal damage.

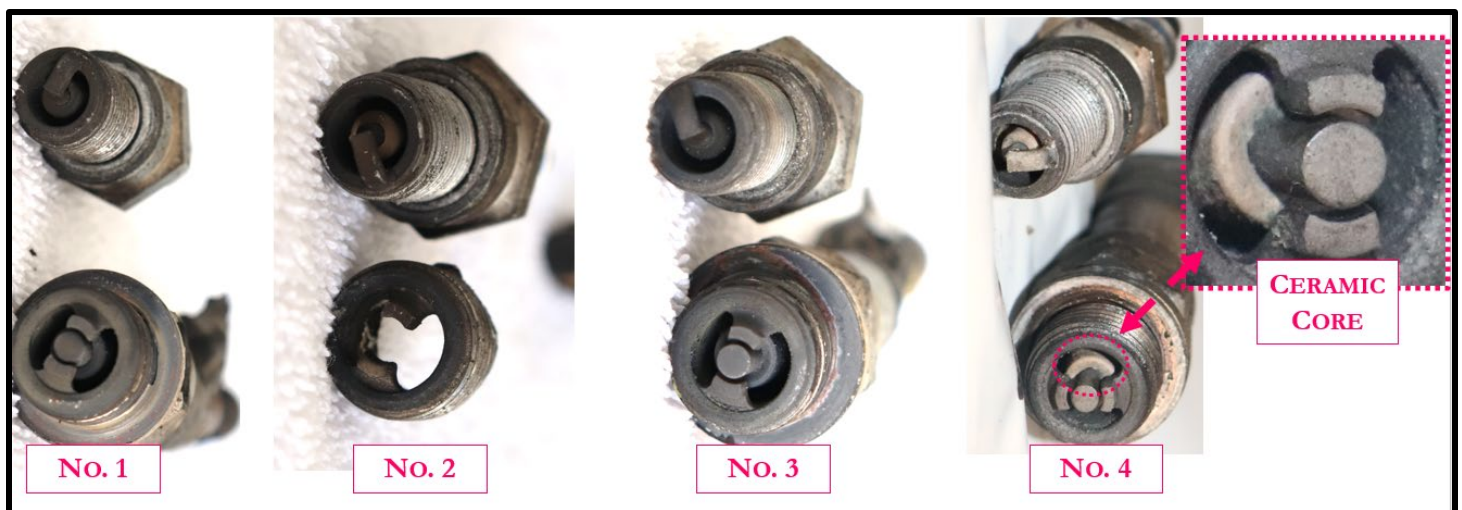
Figure 15: Spark Plugs

The airplane was equipped with a dual ignition system. A Light Plasma III electronic module provided ignition to the upper spark plugs and a Slick magneto was used for the lower spark plugs. The electronic modules found were partially burned and could not be tested. Disassembly of the magneto revealed the internal mechanisms were thermally destroyed. The park plugs were removed revealing a No. 4 plug had a cracked ceramic core.

It further states “DON’T — reuse any plug with cracked porcelain... It will cause serious preignition.”

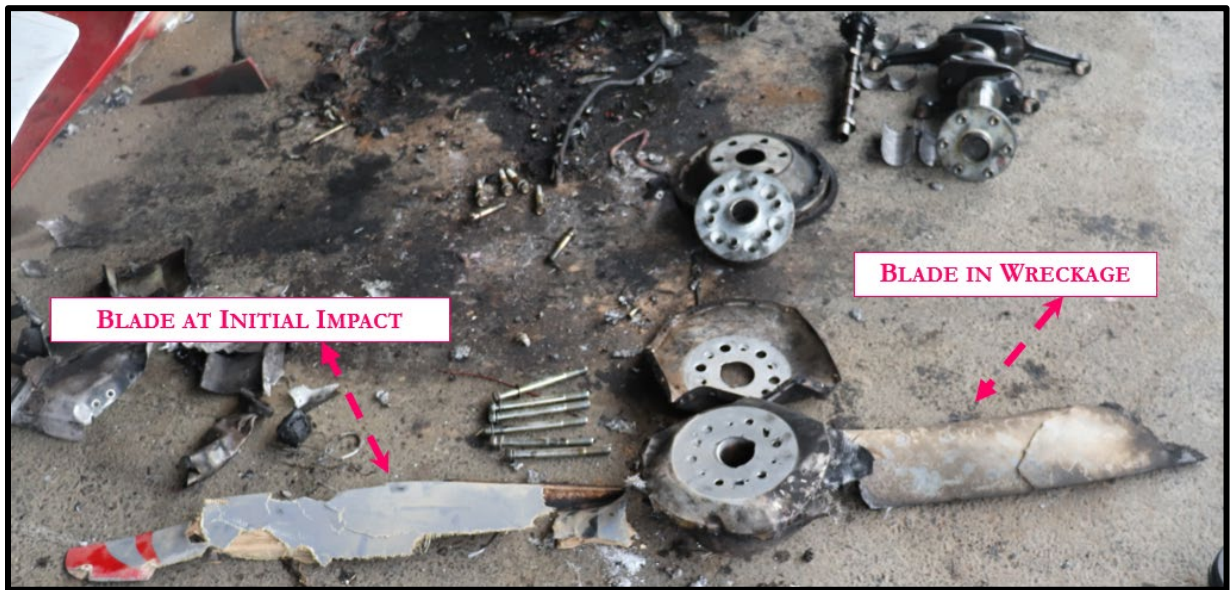
*Figure 16: Propeller*

The Catto two-bladed propeller was a 70in diameter and 78in pitch. One of the wood/composite blades was not attached to the hub; the other blade partially remained in the hub.
