# National Transportation Safety Board

WPR21FA227

## **ACCIDENT SITE, AIRFRAME, AND ENGINE EXAMINATION REPORT**

Location: Gila Bend, Arizona  
Date: June 15, 2021  
Time: 0820 mountain standard time  
Airplane: Experimental amateur built Covey Tri-Quickie, 8054Y

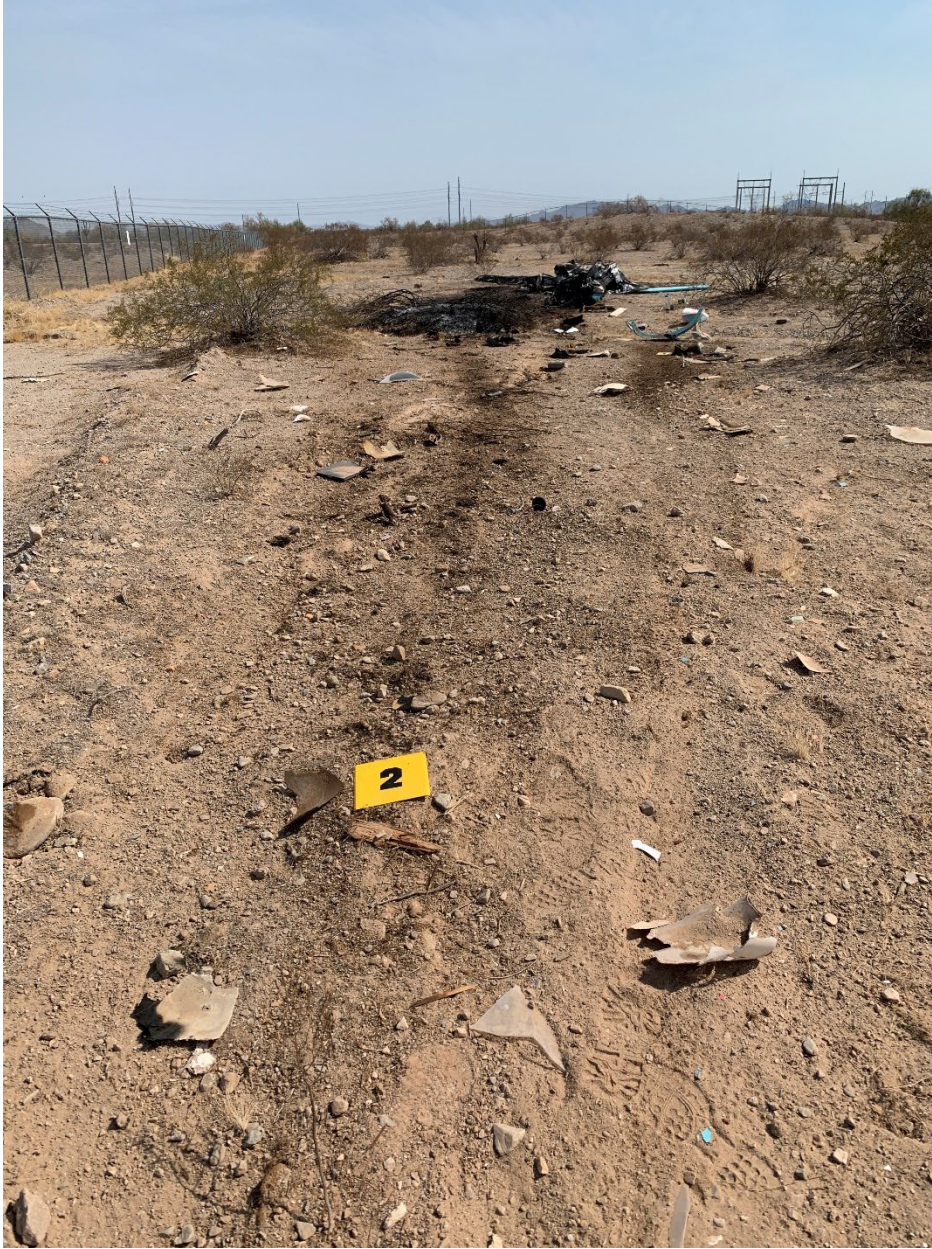
Figure 1: Accident site

The airplane came to rest about 200 ft to the northwest of runway 040 near the airport perimeter fence on a magnetic heading of 020° and was destroyed in the postcrash fire.

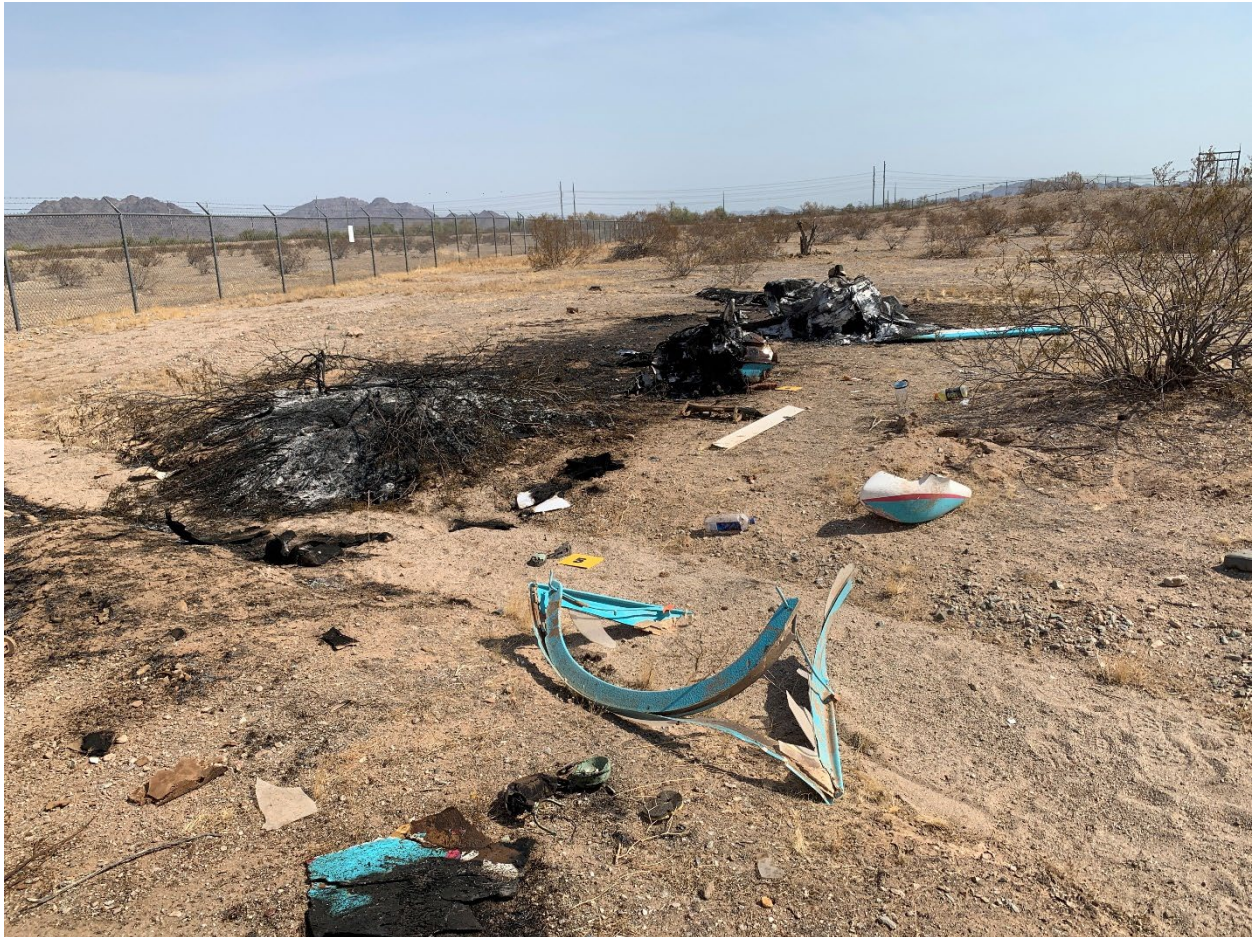
Figure 2: Rear View of Main Wreckage

about 10 ft, but still in the debris path, was a small wash and rise in terrain. The rise had extensive fire damage and it is likely the airplane impacted that during the accident sequence.

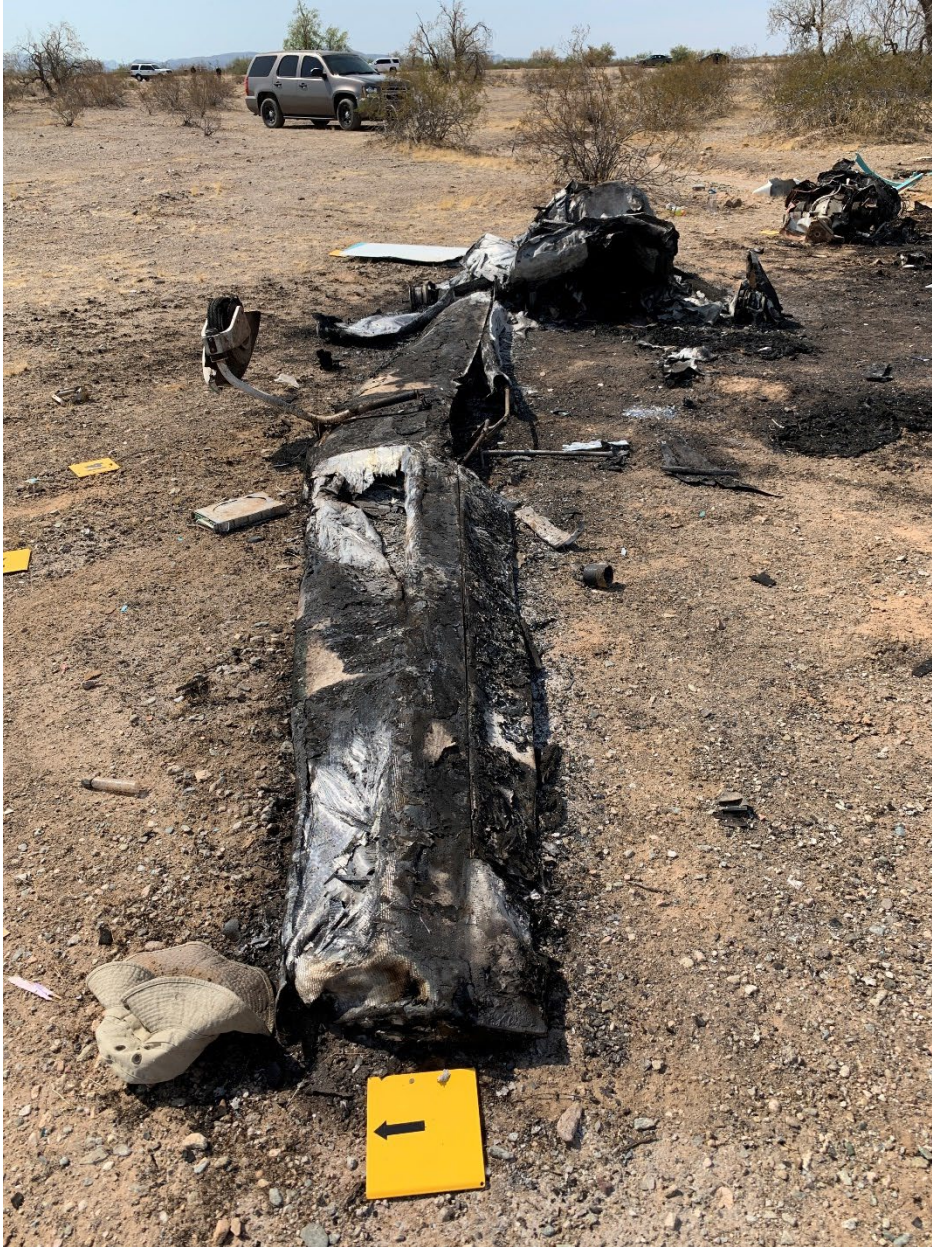
Figure 3: Left Side View of the Main Wreckage

The engine had separated and came to rest upright with no obvious holes in the engine case; it was about 6 ft from the rise. The left side of the engine sustained thermal damage. The exhaust system was deformed with the attach fittings displaced but retained by their hardware in their normal relative positions on the engine. The throttle had separated near the mounting pad with the separation area angular and granular in appearance. All 3 propeller blades separated at the hub. About 10 ft forward of the main wreckage was a portion of the canard, with the remainder thermally destroyed. The wing with the main landing gear was to the left and adjacent to the main wreckage.

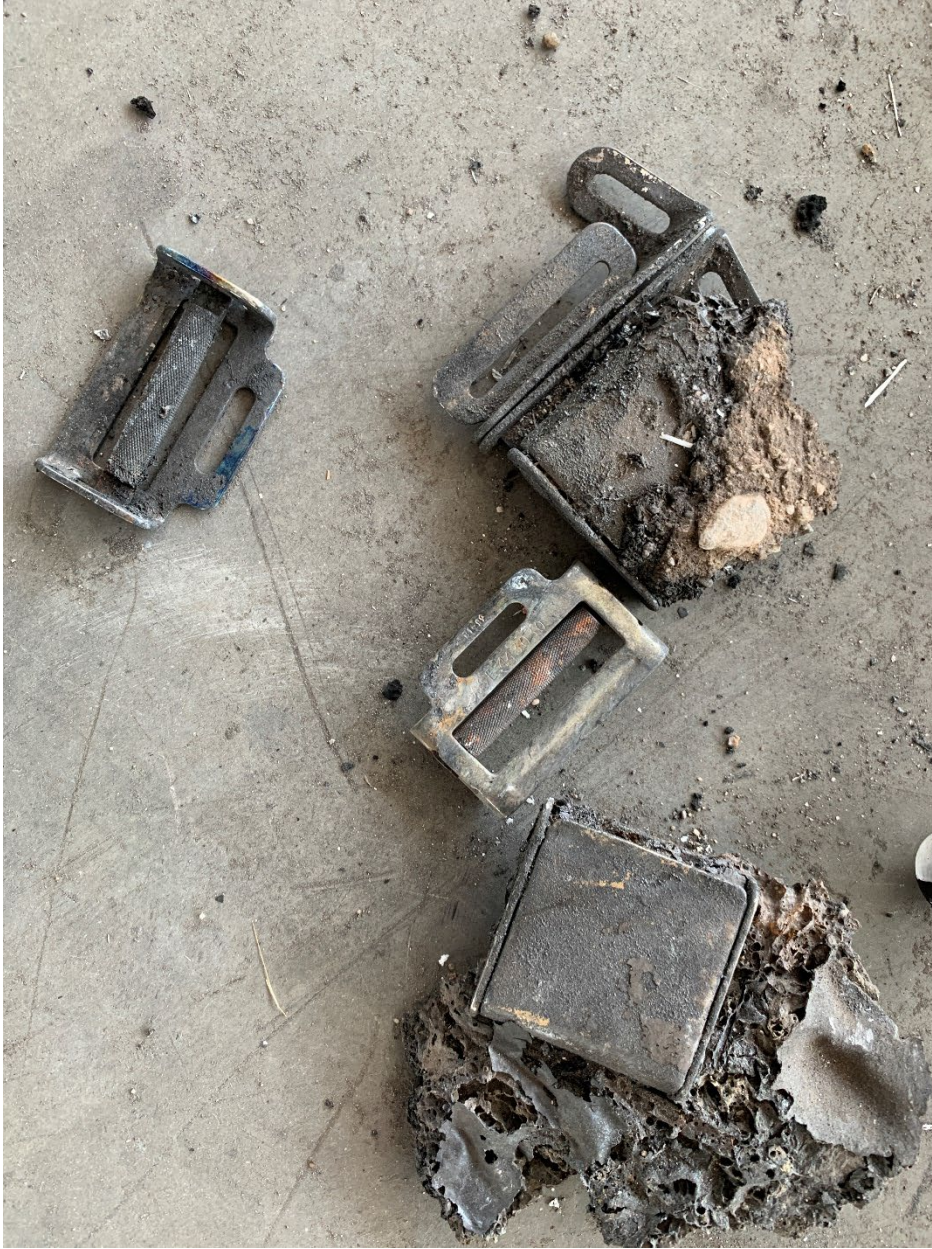
Figure 5: View of Seatbelts

The airframe was thermally destroyed. Flight control cables were identified from the cockpit to each wing and tail section. The instrument panel was thermally destroyed. Flight control hardware was accounted for. Seatbelt hardware was identified.

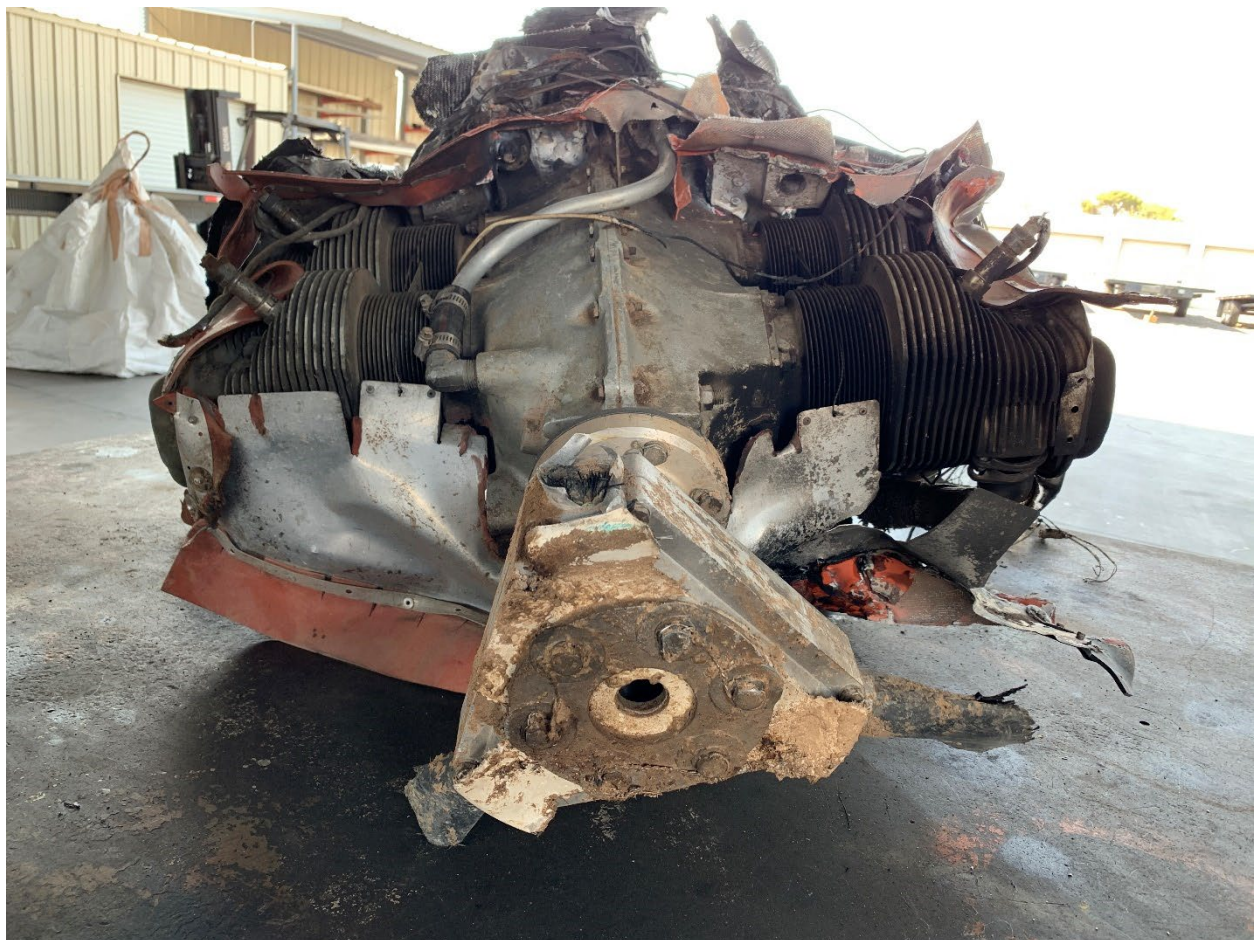
Figure 6: View of the Front of the Engine

The engine separated from the airframe and was lying near the main wreckage. The propeller assembly remained attached to the engine; however, all three propeller blades were separated from the hub.

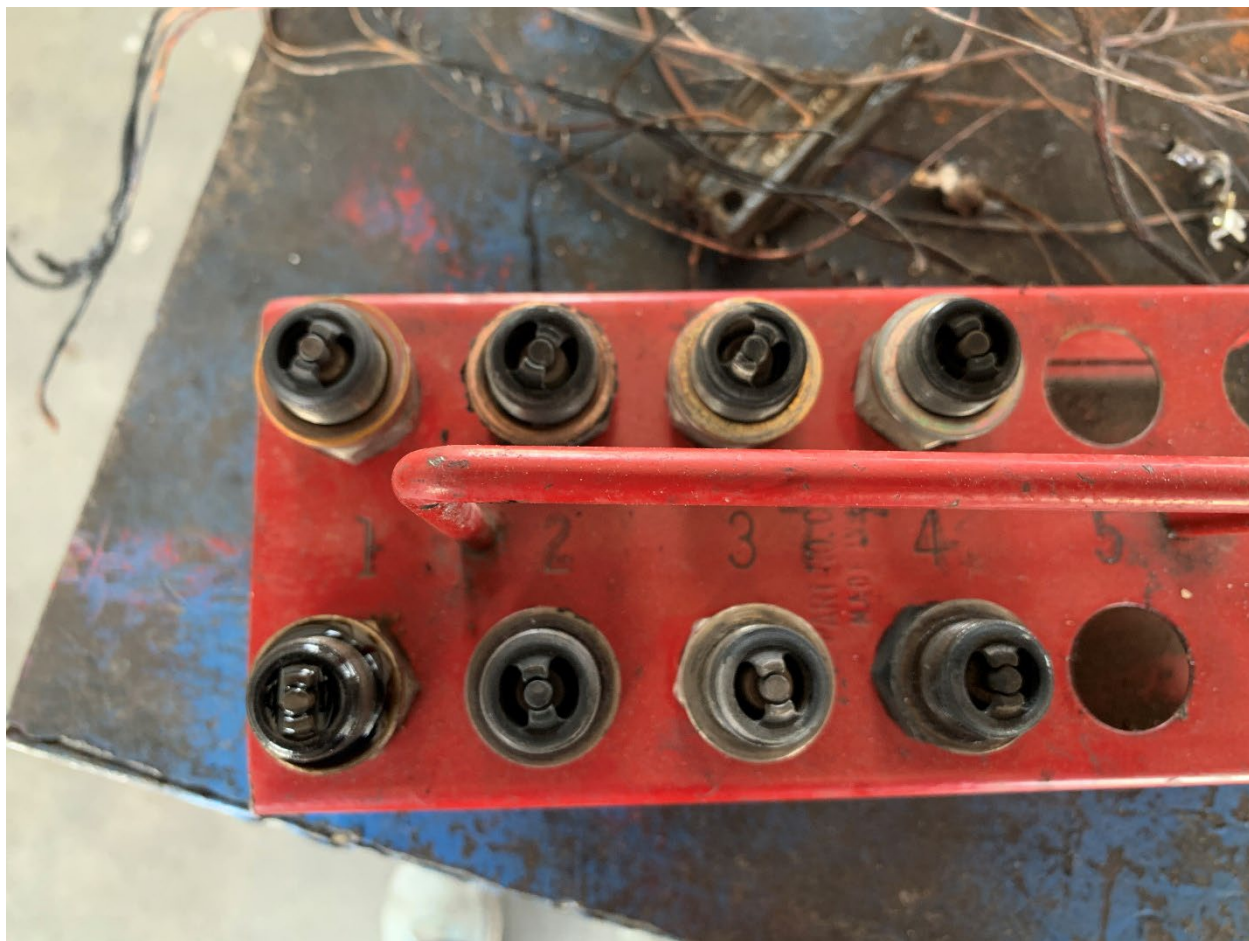
Figure 9: Spark Plugs

There were no holes in the crankcase. An attempt to rotate the engine was unsuccessful and the engine was disassembled. The entire engine sustained varying degrees of thermal and impact damage that precluded testing of any of the components. The spark plugs showed a worn-out condition when compared to the Champion aviation check-a-plug chart. The magnetos remained attached to their respective mounting pads on the engine and were severely damaged/destroyed by fire. The carburetor remained attached to the engine. The accessory section/gears were intact with a black substance that was attributed to the burning of the internal lubrication and had molten metal in various areas. The cylinder chambers and the internal portion of the crankcase showed thermal discoloration. The oil pump gears were intact with thermal discoloration.

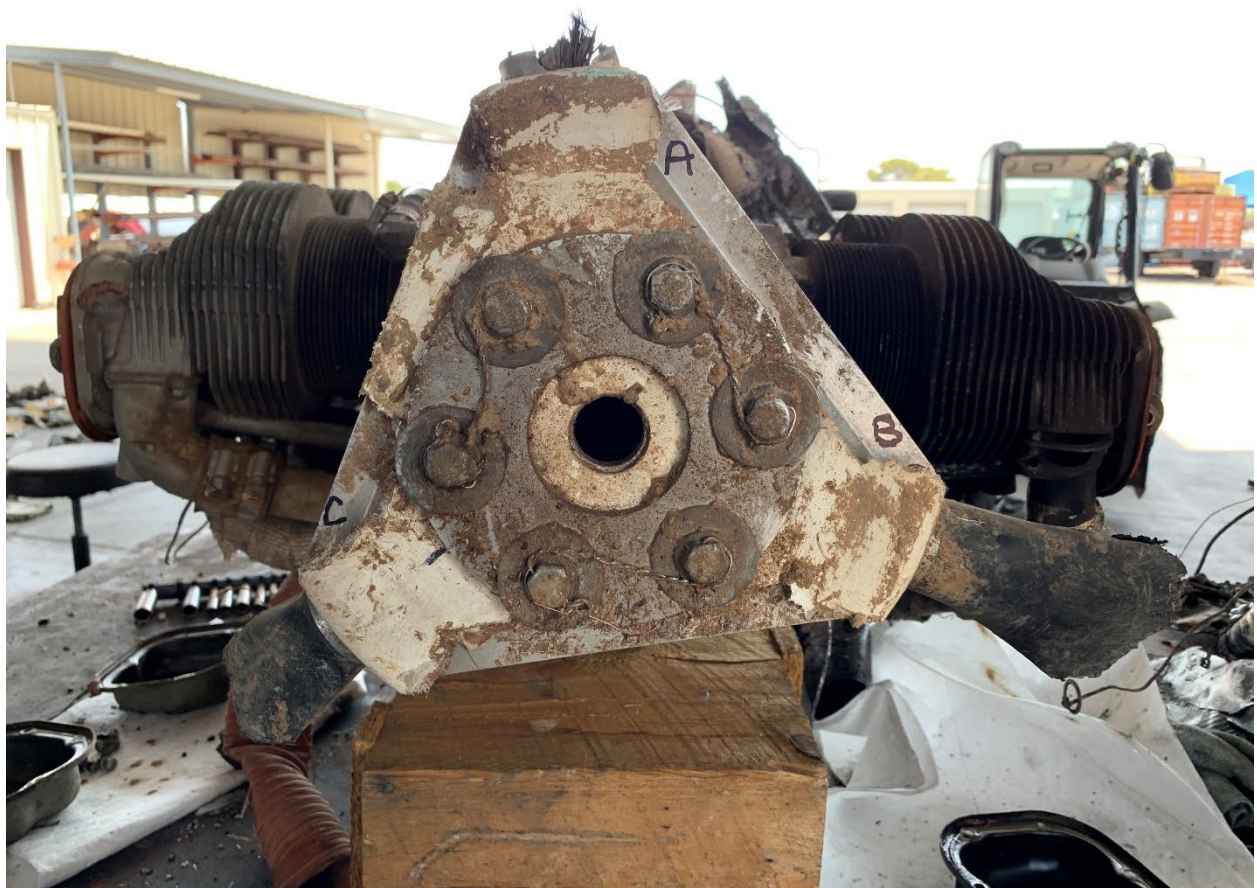
Figure 17: Propeller Hub

Propeller was a Warp Drive and all three propeller blades separated at the hub. All three propeller blades had varying degrees of damage and delamination.
