# National Transportation Safety Board

WPR21FA232

## **ACCIDENT SITE, AIRFRAME AND ENGINE EXAMINATION**

Location: Likely, California  
Date: June 20, 2021  
Time: 0900 Pacific daylight time  
Airplane: Kitfox Series 6, N617Y

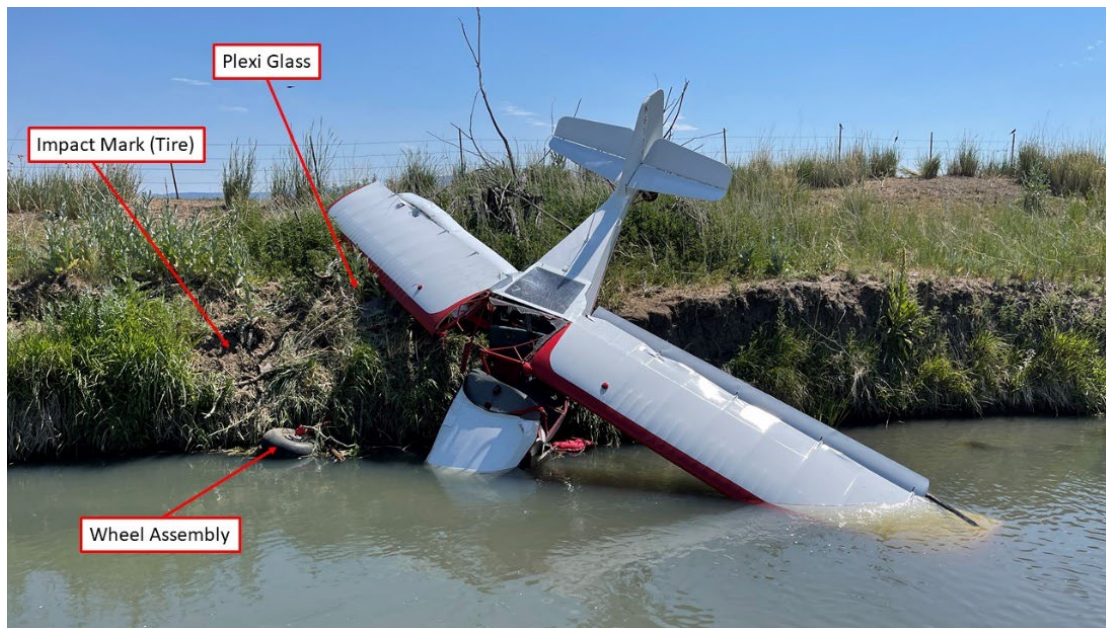
Examination of the accident site revealed that the airplane impacted the eastern edge of an irrigation canal. Debris remained within about 5 ft of the main wreckage and consisted of both main landing gear, one propeller blade, and plexiglass. The fuselage came to rest upright on a magnetic heading of about 243° magnetic, with the engine and left wing partially submerged within water. A ground impression consistent with the size of a tire was observed about 4 ft north of the main wreckage.

**Figure 1: View of the main wreckage.**

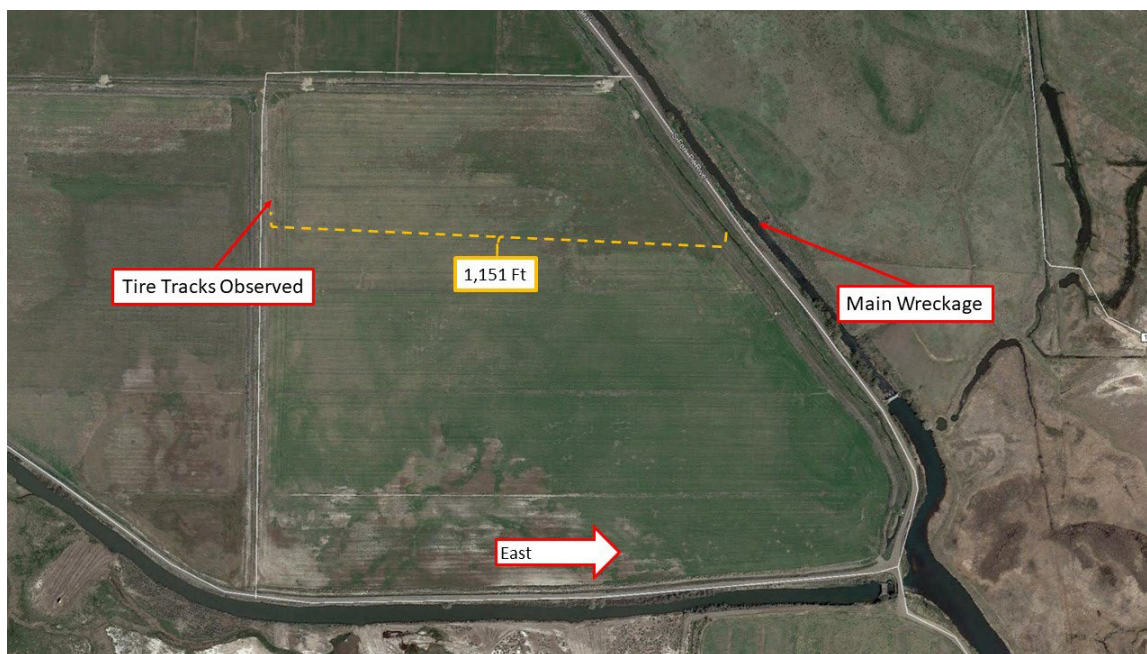
**Figure 2: Overview of the accident site depicted on Google Earth.**

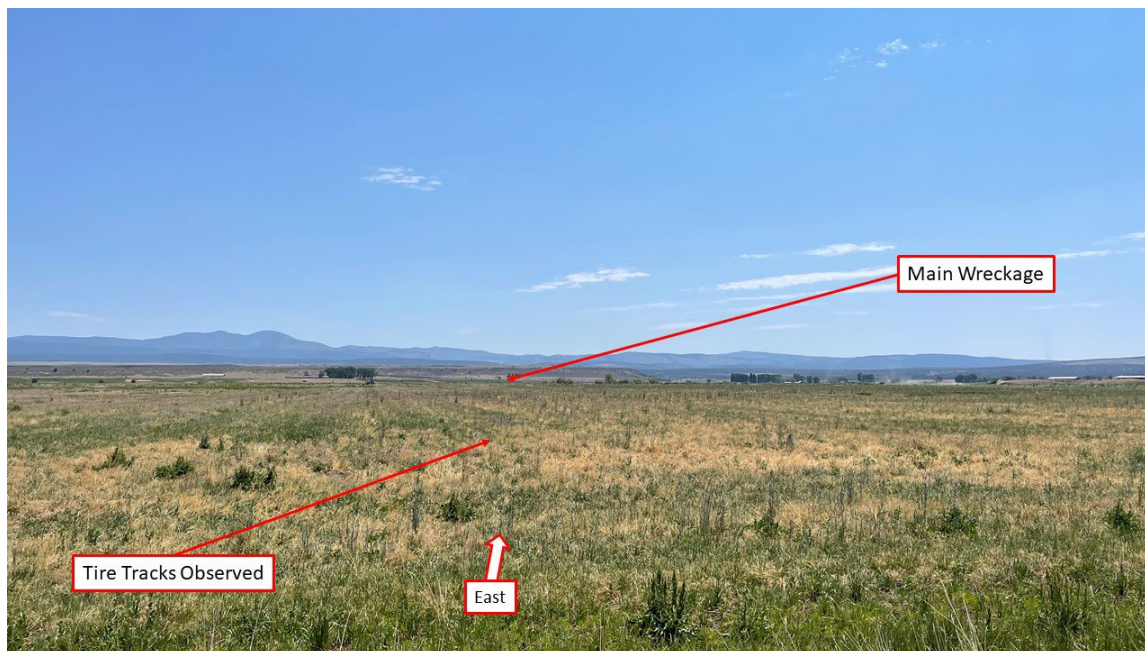
Examination of the field the airplane was departing from revealed flattened grass, consistent with tire tracks extended from the western edge of the field toward the canal. The length of the field from the western edge to the eastern edge was about 1,151 ft and featured rough terrain, with vegetation about 2 to 3 ft in height. Along the eastern edge of a field, was an area of elevated terrain/levy, that was about 10 to 20 ft above the field.

**Figure 3: View of the departure field looking east.**
