## **NATIONAL TRANSPORTATION SAFETY BOARD**

# **AIRFRAME AND ENGINE EXAMINATION**

**WPR21FA243**

Aircraft: N62EF / Progressive Aerodyne, SeaRey LSX, S/N: 1MK480C

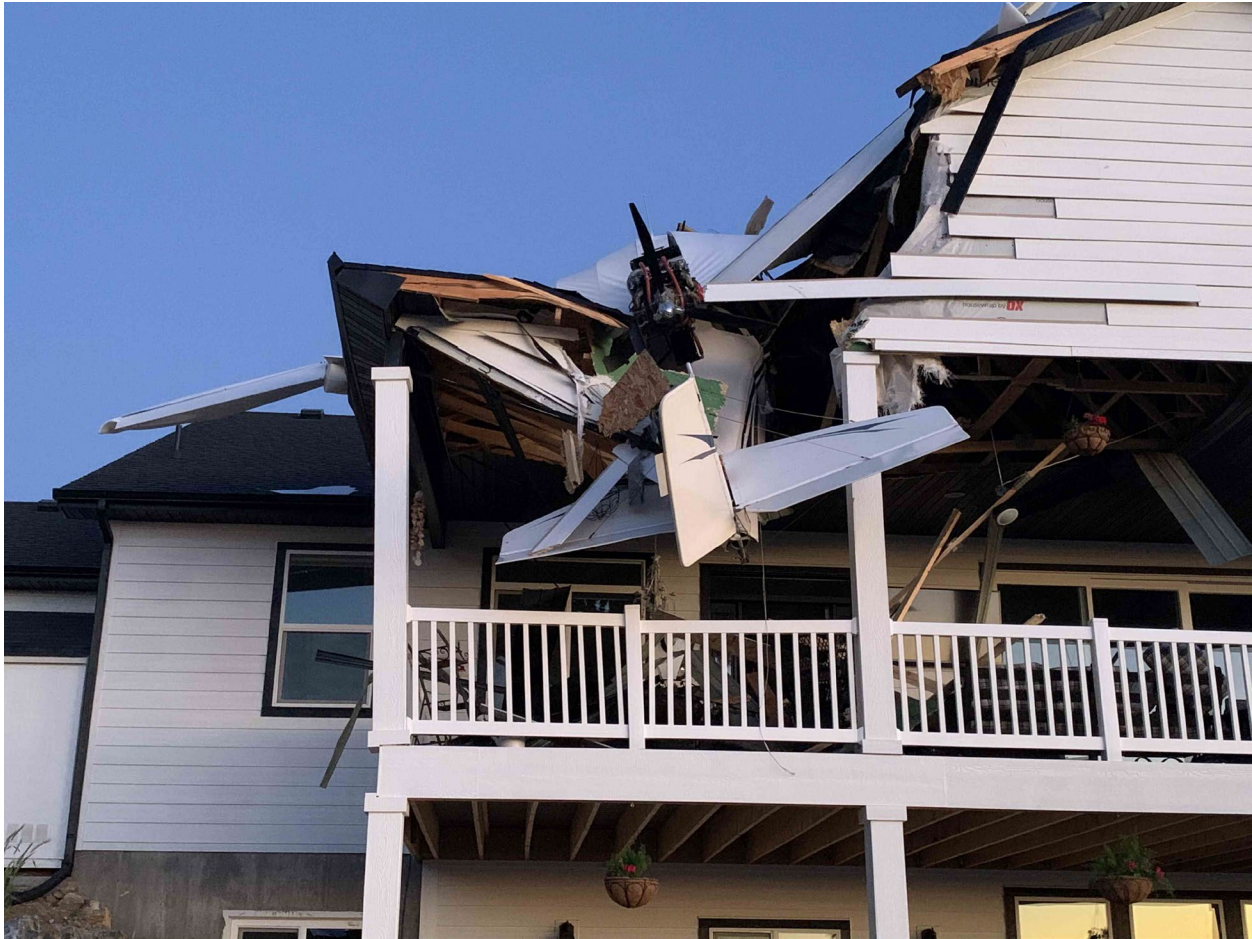
The airplane came to rest in the attic section of a private residence, located in Logan, Utah, on a heading of 175° magnetic, and at an elevation of about 5,320 feet above mean sea level. The airplane was recovered to the back yard of the residence where the examination of the airframe and engine were conducted.

**Figure 1. N62EF, at rest in the attic section of the private residence.**

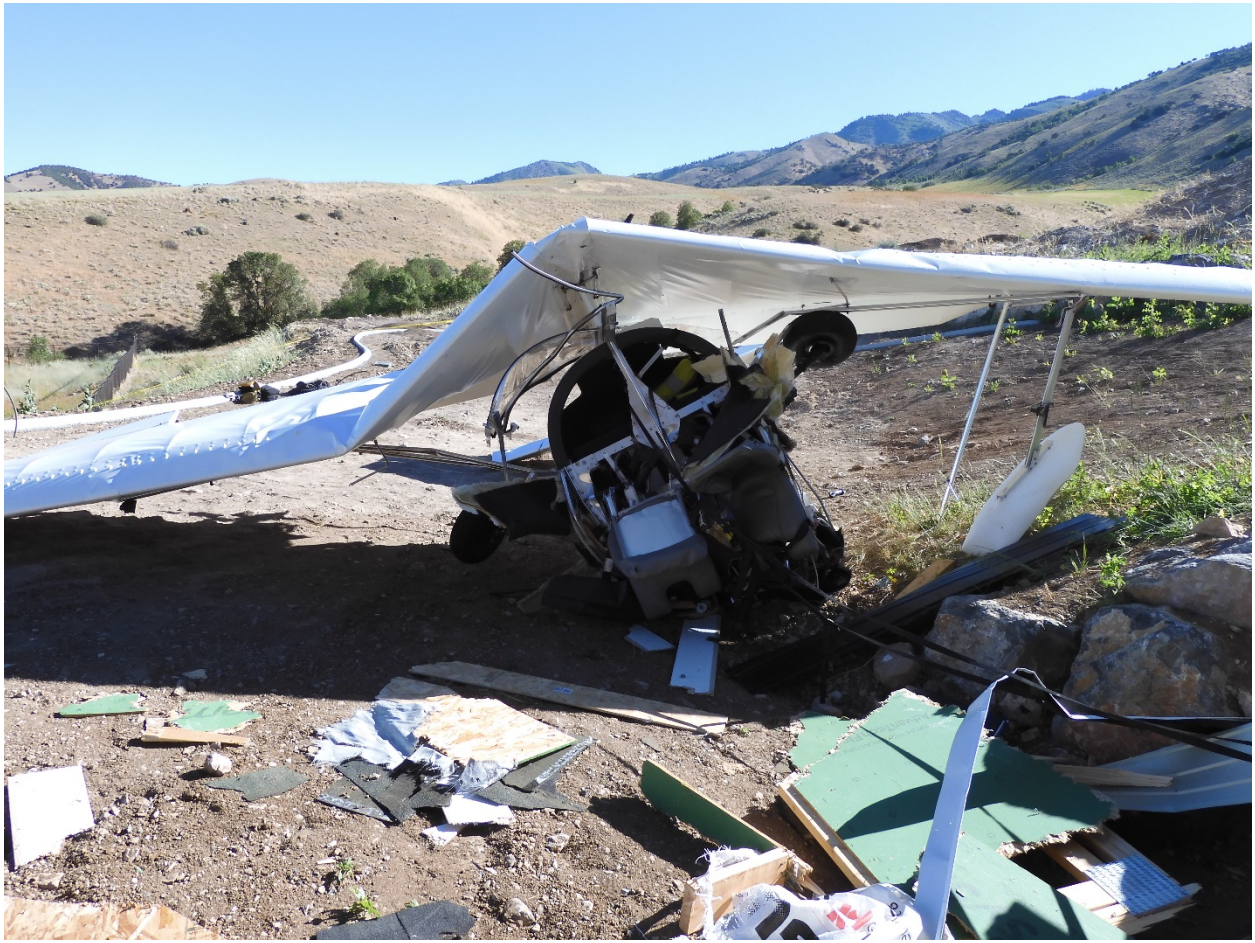
Cockpit Documentation. The instrument panel was partially separated from the fuselage and remained attached by some composite material. The only analog instruments installed were an airspeed indicator and directional gyro.

**Figure 2. Cabin section.**

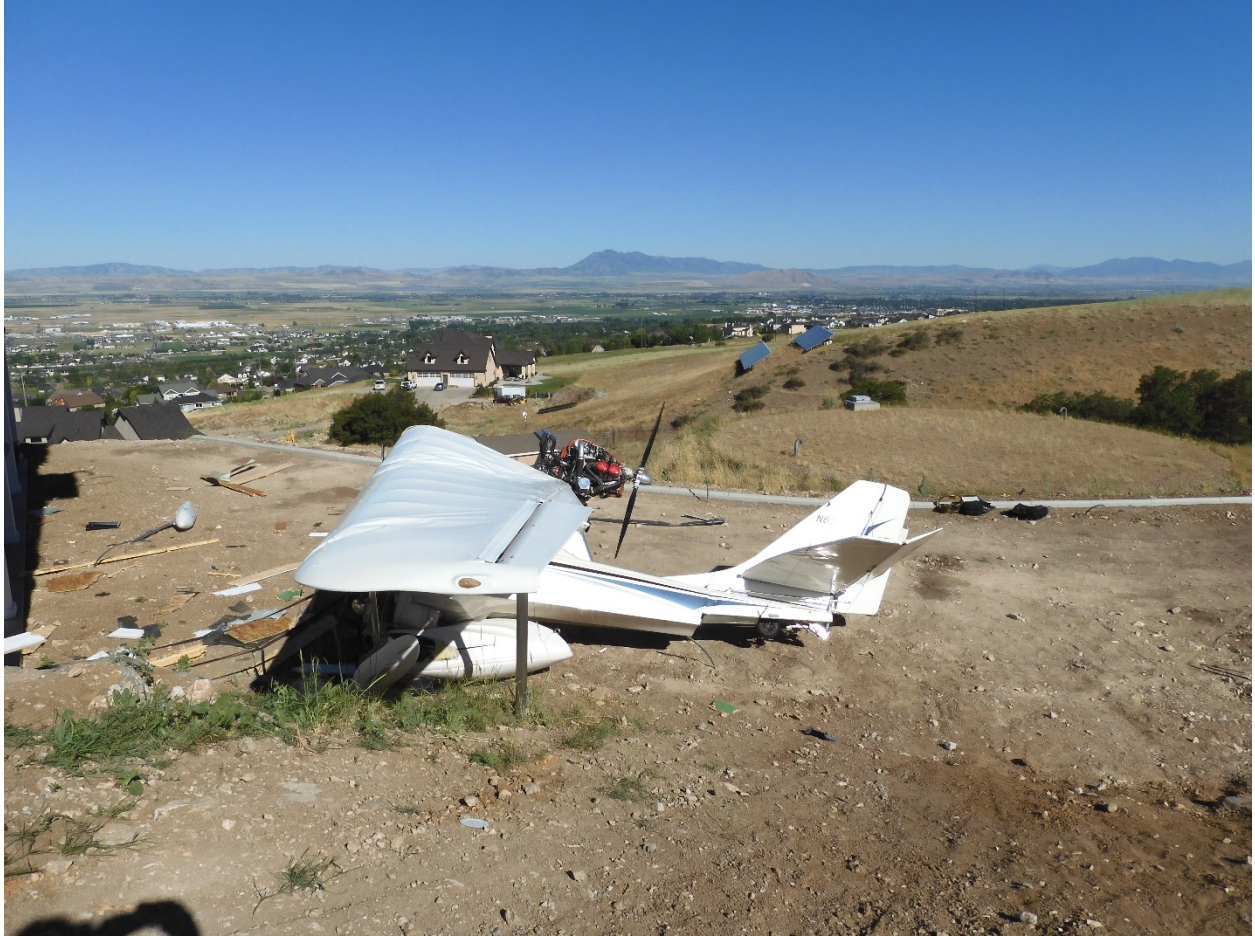
Left Wing. The left wing and all components of the wing remained attached to the fuselage. The upper and lower fabric had wrinkles, tears and small rips throughout. The leading edge displayed multiple dents and deformations. Both wing struts remained attached at the wing but had separated from the fuselage. The left-wing float remained attached to the wing. The left aileron remained attached to the wing and displayed minor damage. The aileron would not articulate up or down. The left flap remained attached to the wing at the hinges and appeared to be about 45° flap extended. The flap had slight bending and surface skin wrinkling.

**Figure 3. Left-side view of N62EF.**

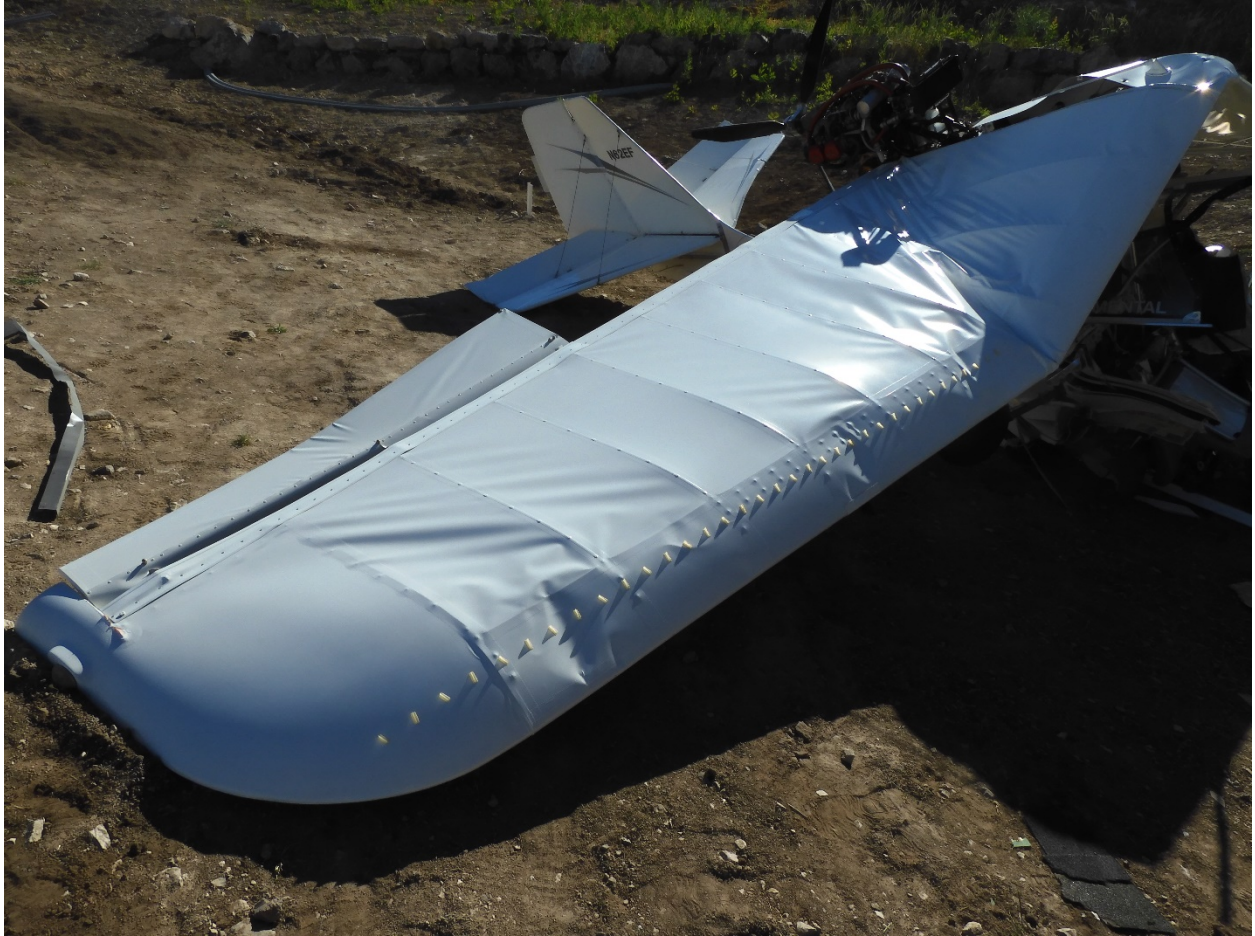
Right Wing. The right wing and all components of the wing remained attached to the fuselage. The upper and lower fabric had tears and small rips. Both wing struts remained attached at the fuselage and wings and had upward bending to them. The right float separated from the wing. The wing displayed wrinkles in the fabric along most of the upper and lower surfaces. The wing bent upwards about 36 inches from the root outboard, and along the leading edge. The right aileron displayed downward bending and would not articulate. One control tube inside the wing had bent, about 36 inches from the wing root, and restricting movement. The right flap remained attached to the wing at the hinges and appeared to be about 45° flap extended. The flap had slight bending and surface skin wrinkling.

**Figure 6. Right-wing top view**

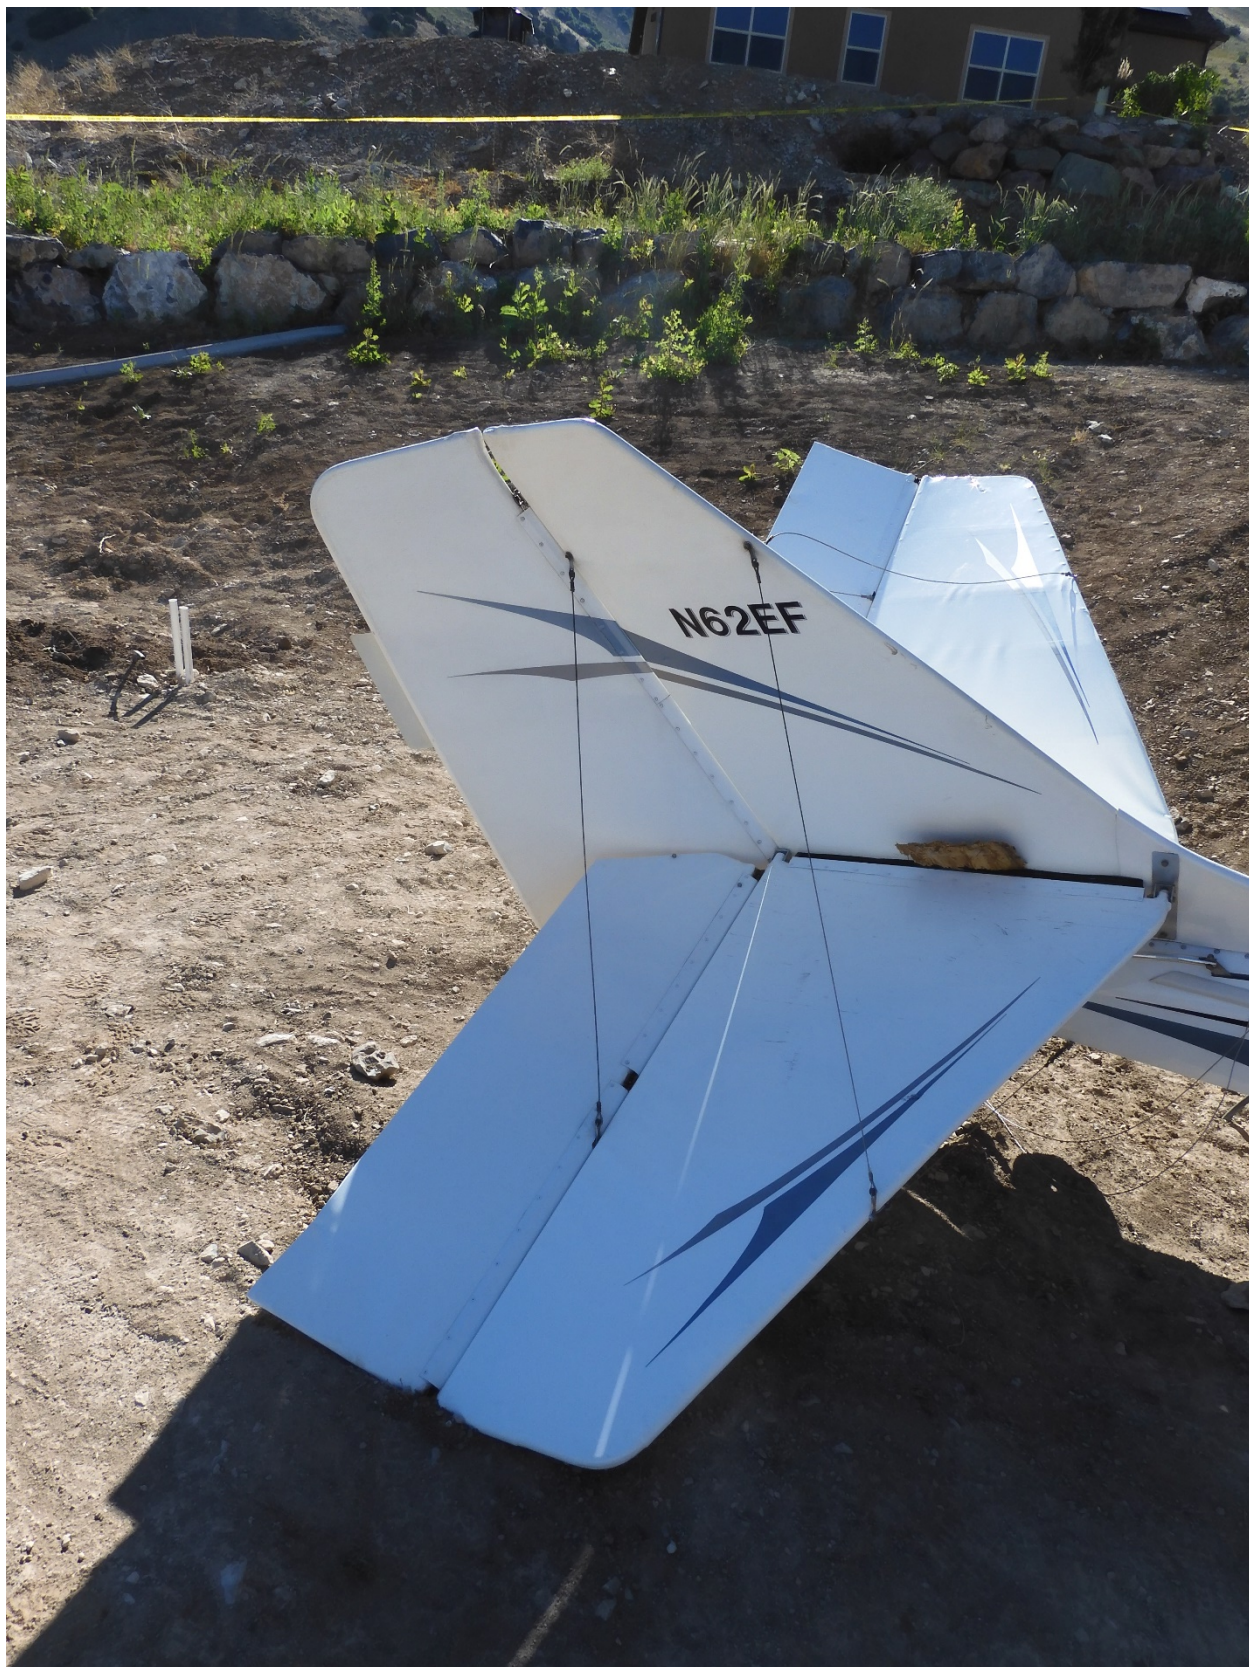
The left horizontal stabilizer remained attached to the empennage. There were minor tears in the fabric. There was an upward bend along the leading edge. The four cables remained attached to the horizontal stabilizer and the fuselage.

The left and right elevators remained attached to the empennage and displayed a bend at the right tip. Both elevators were held in about a 15° up position.

**Figure 7. Empennage view**

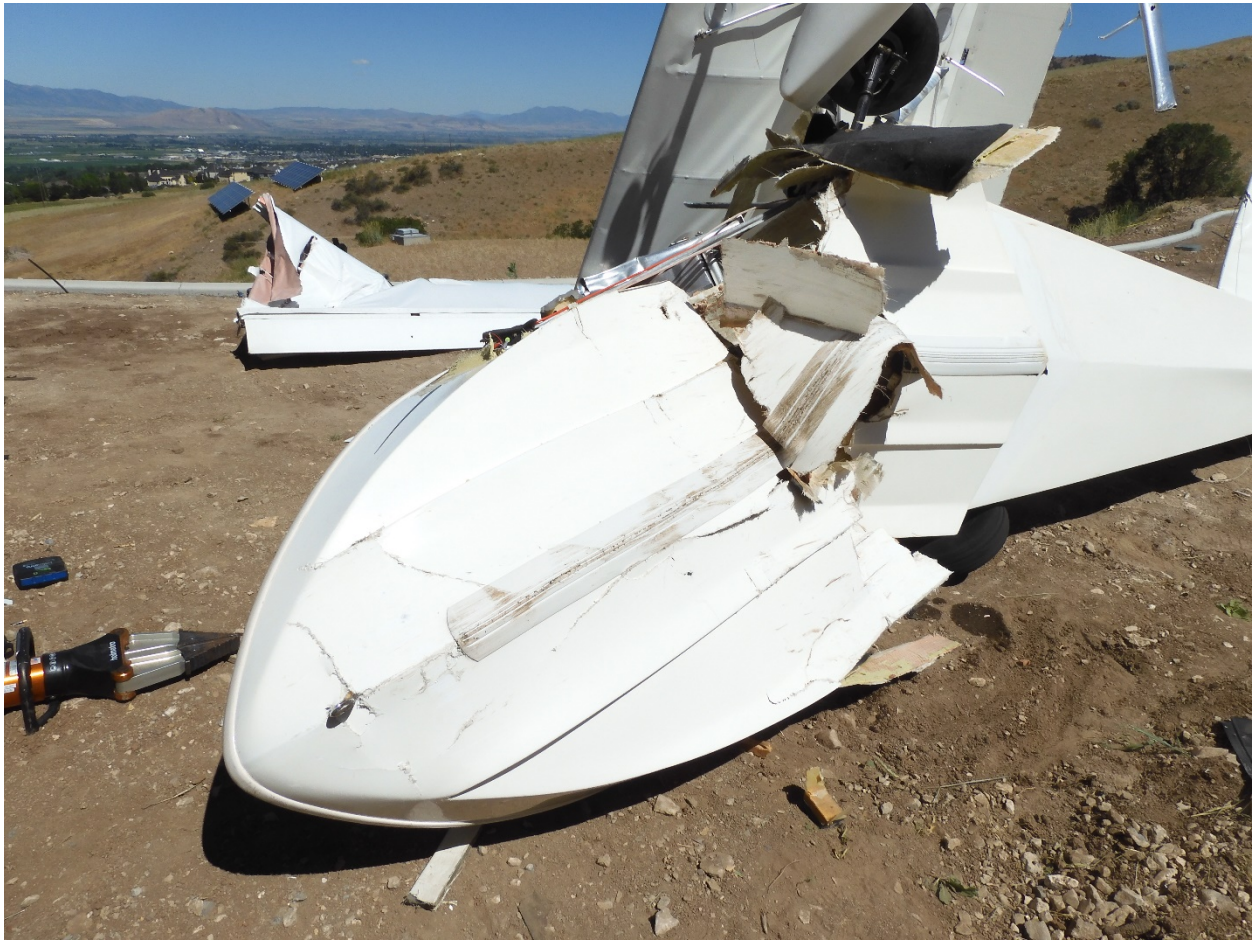
Fuselage. The boat hull fuselage was constructed of composite material and fractured at a point near the bulkhead just aft of the pilot's seats. The forward portion, including the cockpit area was underneath the aft portion of the fuselage and required removal of the right wing to reposition the forward section of the fuselage for examination. There were multiple dents, tears, scratches and deformations near the forward section of the fuselage. The battery remained attached in the forward section of the fuselage and was removed. The aft section of the fuselage, from the break at the bulkhead, to aft, displayed multiple dents and gouges.

**Figure 8. Underside-view of the boat hull.**

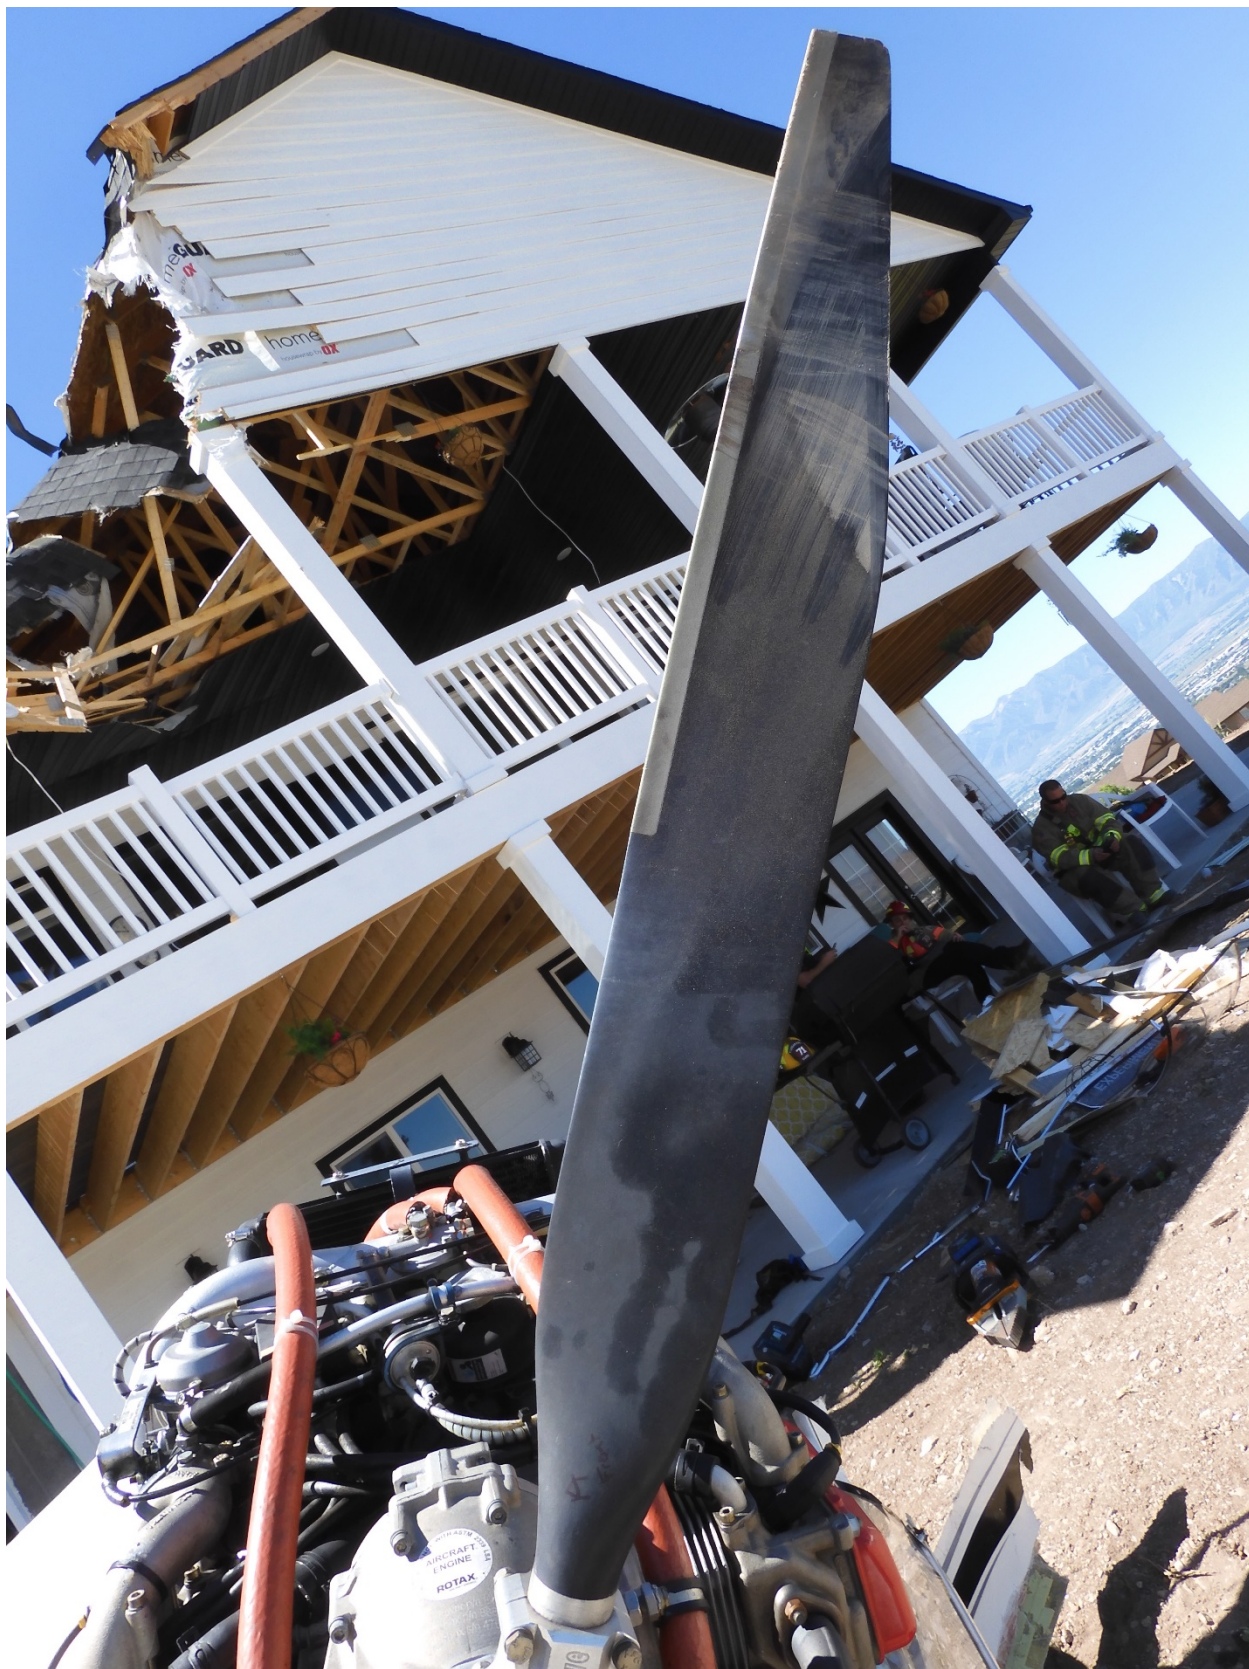
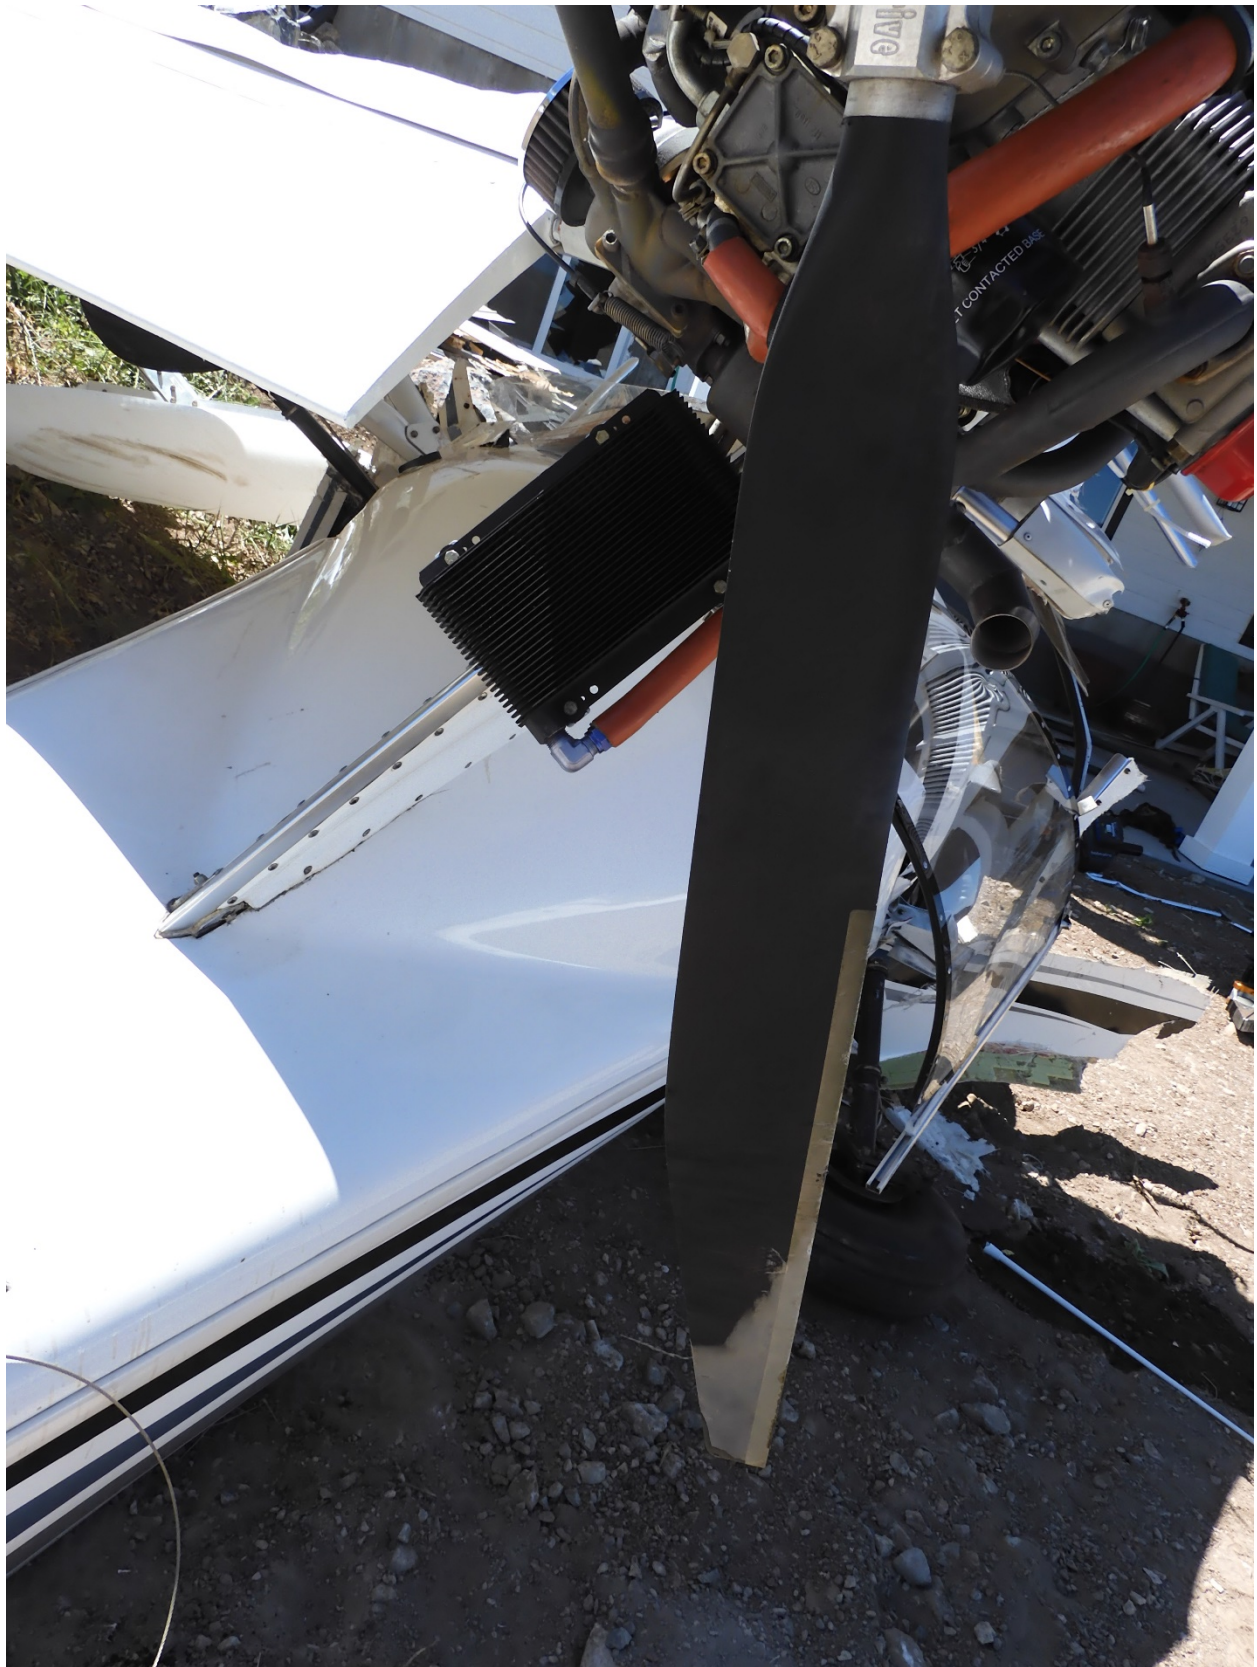
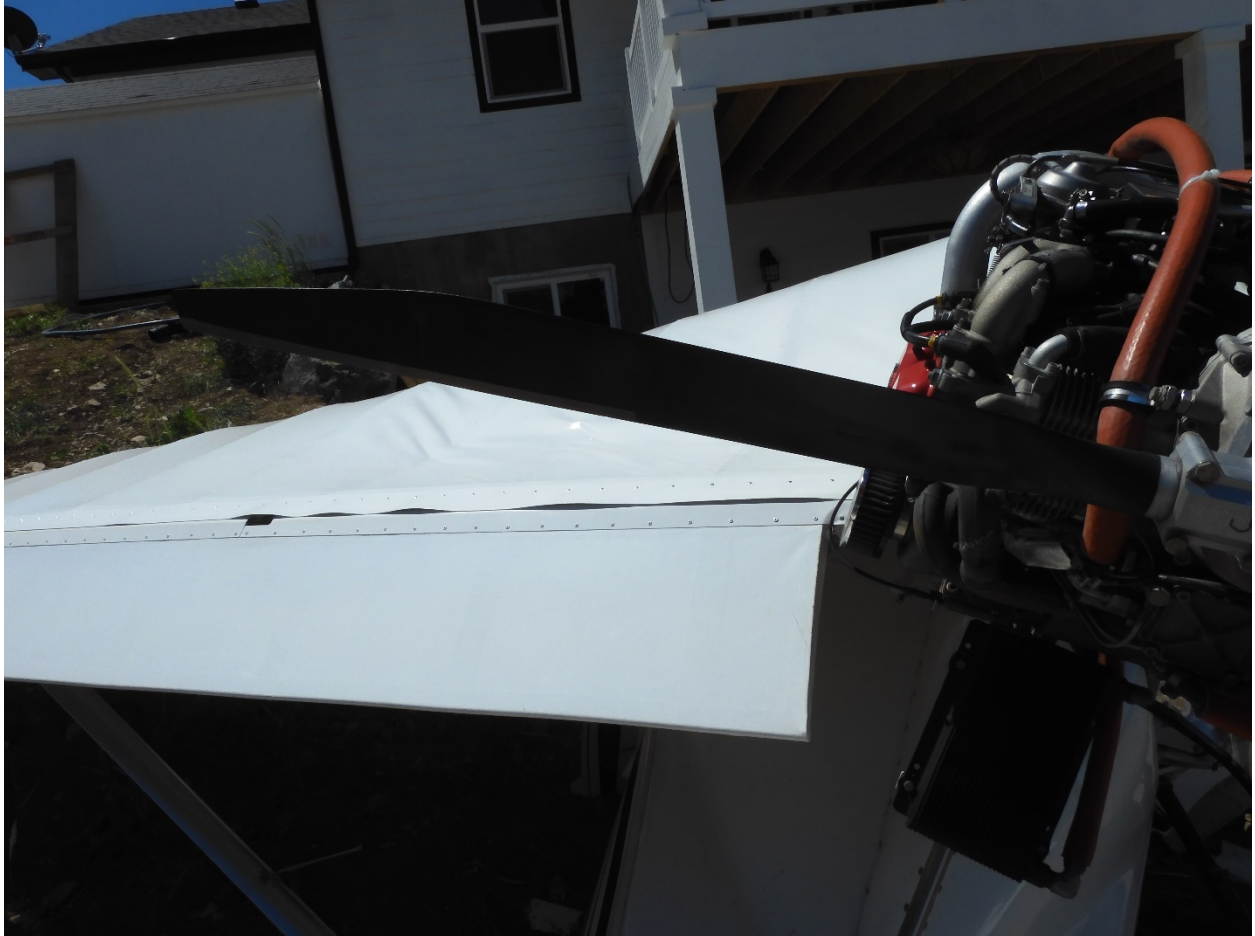
Propeller. The propeller remained attached to the propeller hub and displayed minor contact damage at the tips of the three blades. There was no other blade damage noted.

**Figure 12. Propeller A.**

**Figure 13, Propeller B.**

**Figure 14. Propeller C.**

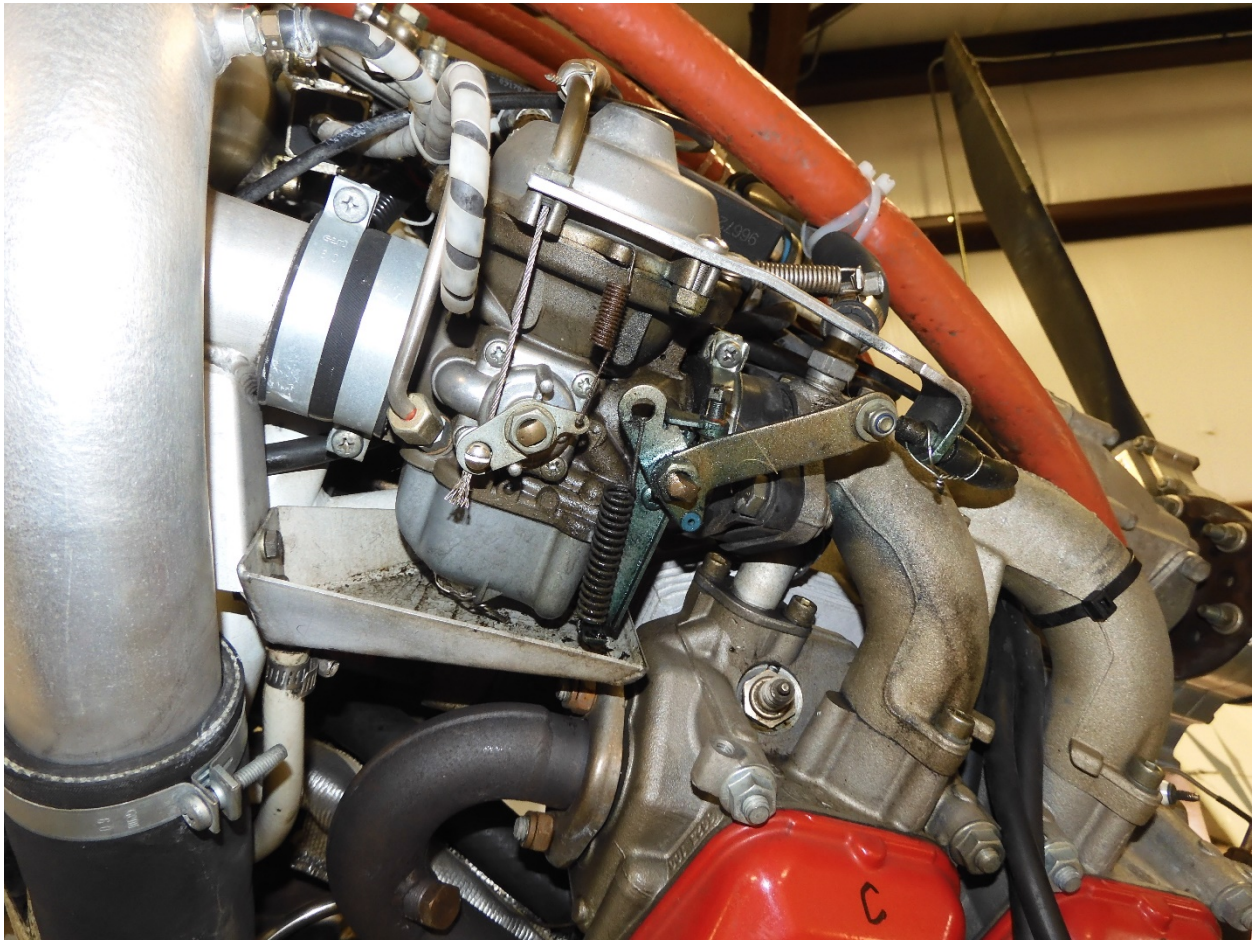
Carburetor for 1 and 3 cylinders. The 1, 3 carburetor was excessively fuel stained on the exterior. The rubber flange assembly, located between the carburetor and the aluminum intake, was torn. The main jet was clear. The two floats were secure and within the allowable weight range. The bottom of the bowl contained a black substance that stuck to the bottom of the bowl. The needle arms were parallel with the bowl edge, as recommended.

**Figure 15. 1, 3 Carburetor showing external fuel staining.**

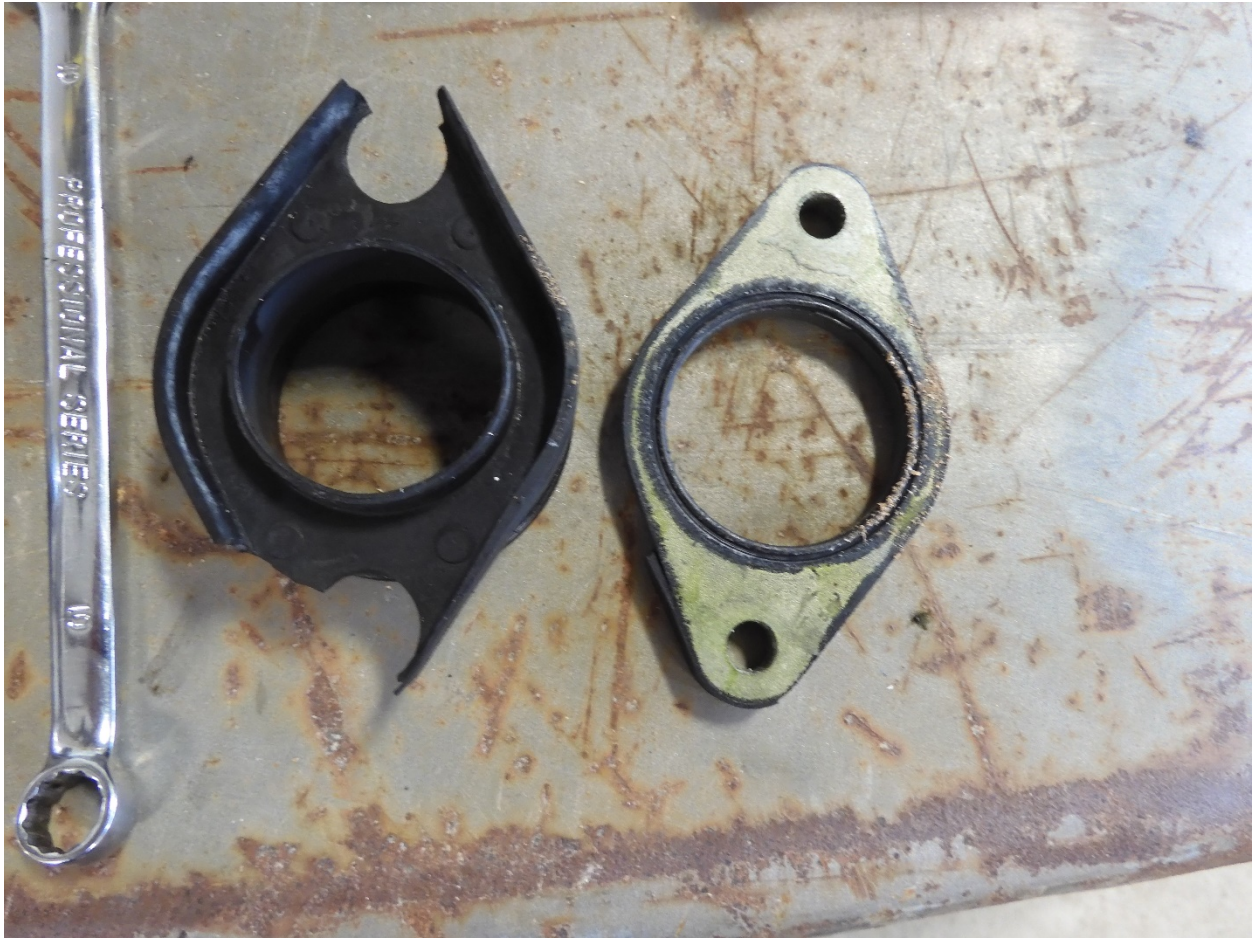
**Figure 16. Torn rubber flange assembly for the 1, 3 carburetor.**

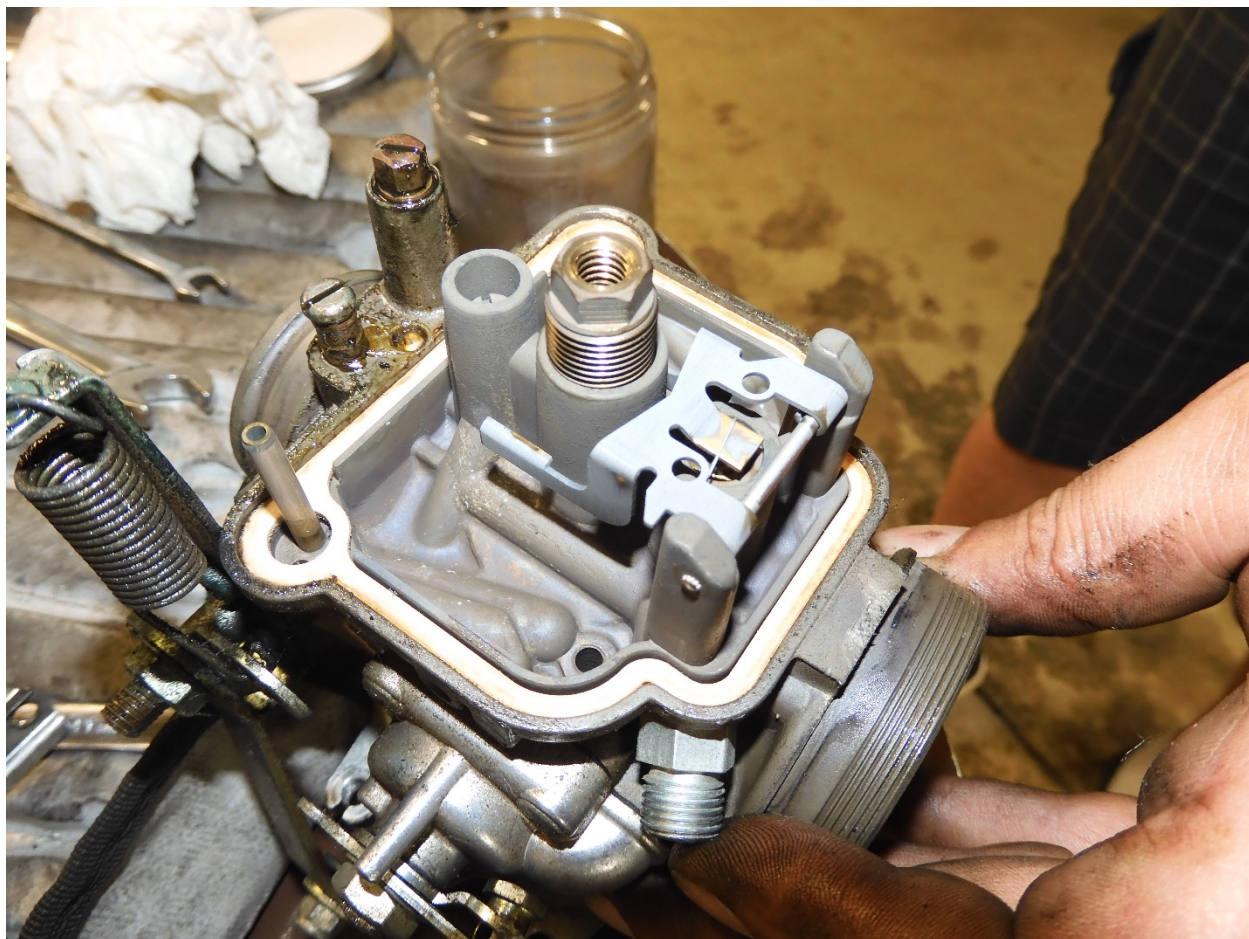
**Figure 17. 1, 3 Carburetor showing internal components.**

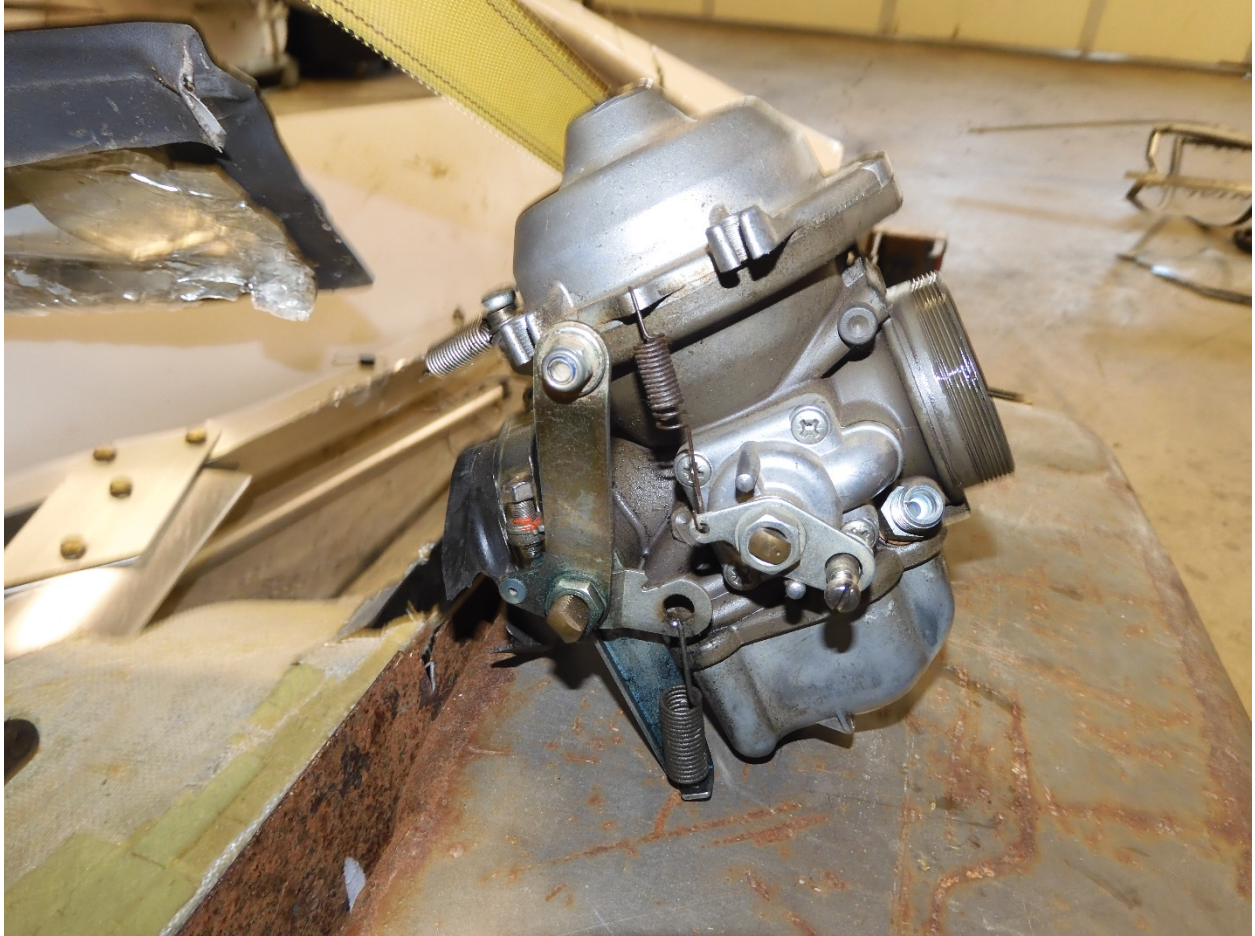
Carburetor for the 2 and 4 cylinders. The 2, 4 carburetor was excessively fuel stained on the exterior. The rubber flange assembly, located between the carburetor and the aluminum intake, was torn. The main jet was clear. The two floats were secure and within the allowable weight range. The needle arms were parallel with the bowl edge, as recommended. The throttle cable had separated from the carburetor consistent with the accident impact.

**Figure 18. 2, 4 Carburetor, showing external fuel staining.**

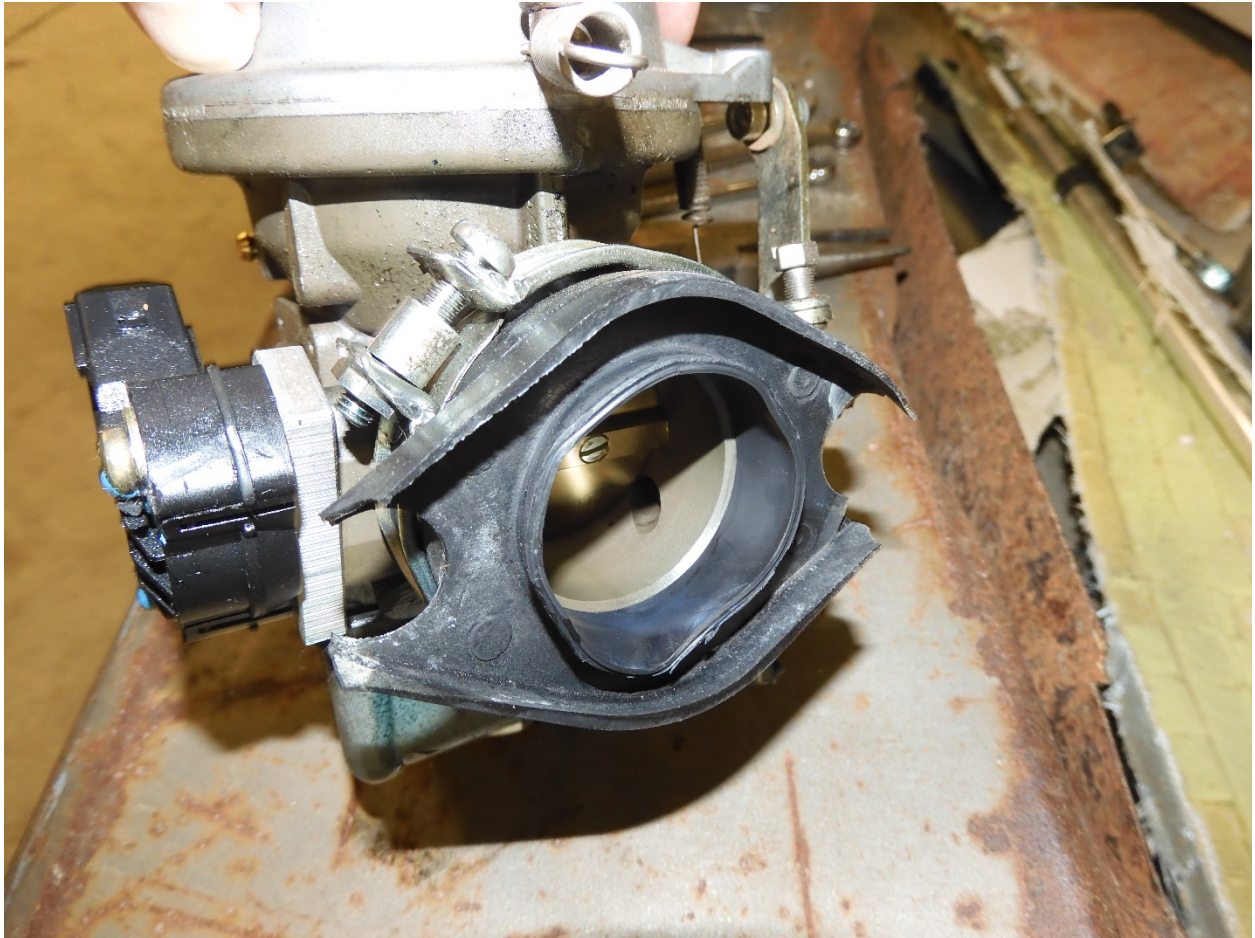
**Figure 19. 2, 4 Carburetor showing the torn rubber flange assembly.**

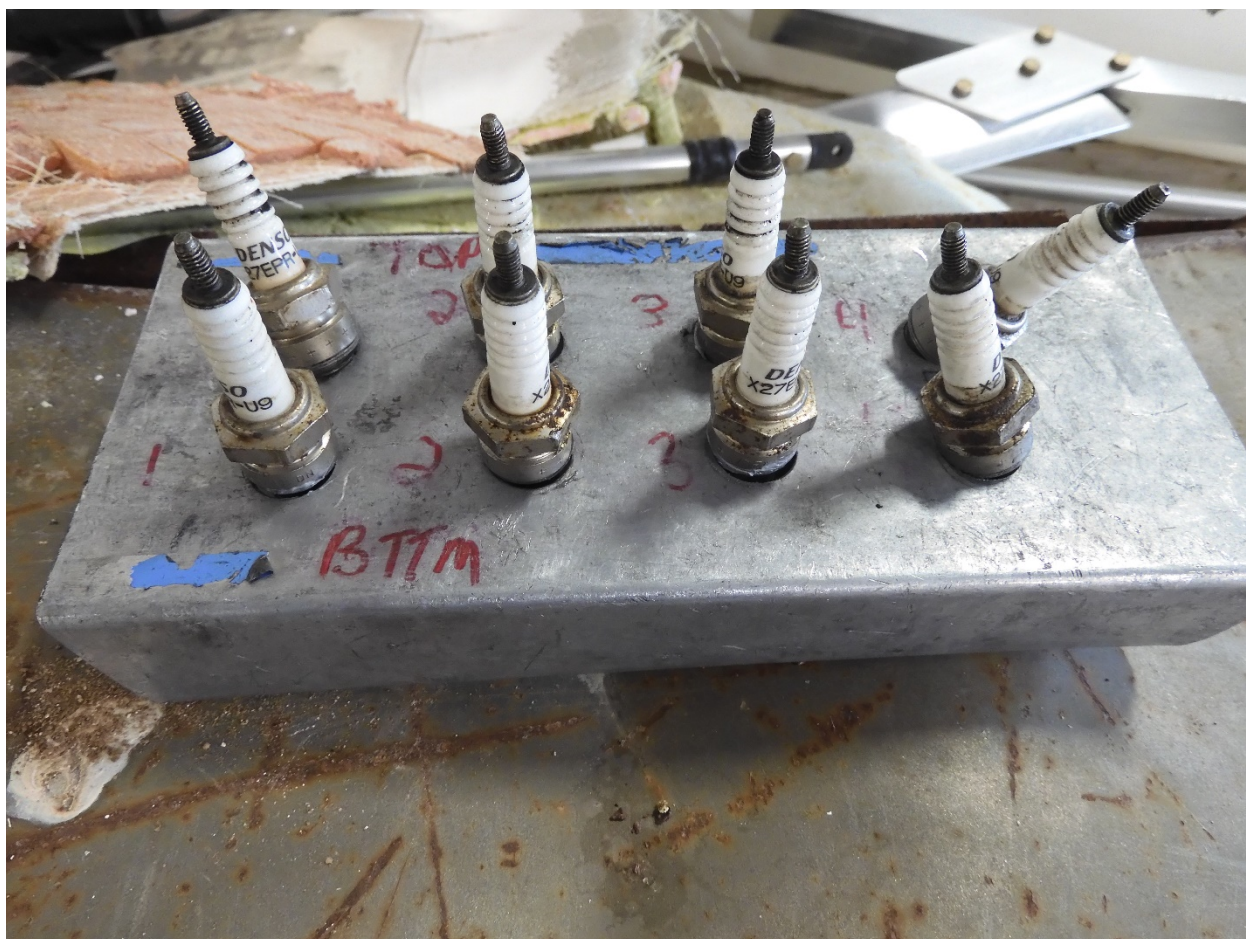
The spark plugs were not correct for the engine application and they were not gapped in accordance with Rotax specifications. The electrodes appeared worn.

**Figure 20. Spark plugs removed from the accident engine.**

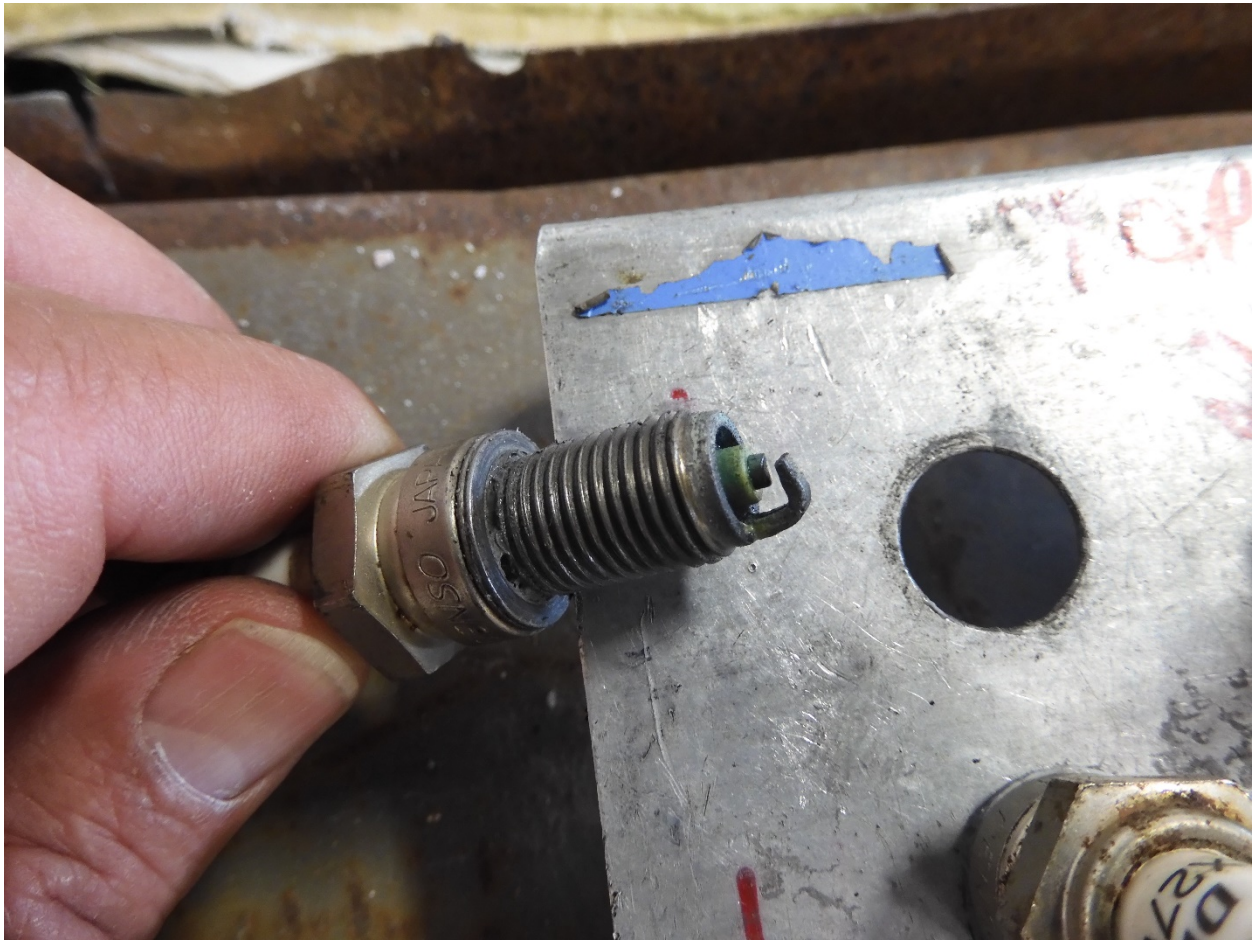
**Figure 21. Example of one spark plug electrode, showing gap and wear.**
