## **NATIONAL TRANSPORTATION SAFETY BOARD**

# **AIRFRAME AND ENGINE EXAMINATION**

**WPR21FA258**

Location: Missoula, Montana  
Date: July 1, 2021  
Aircraft: N2388L / Cessna 172  
NTSB IIC: Fabian Salazar

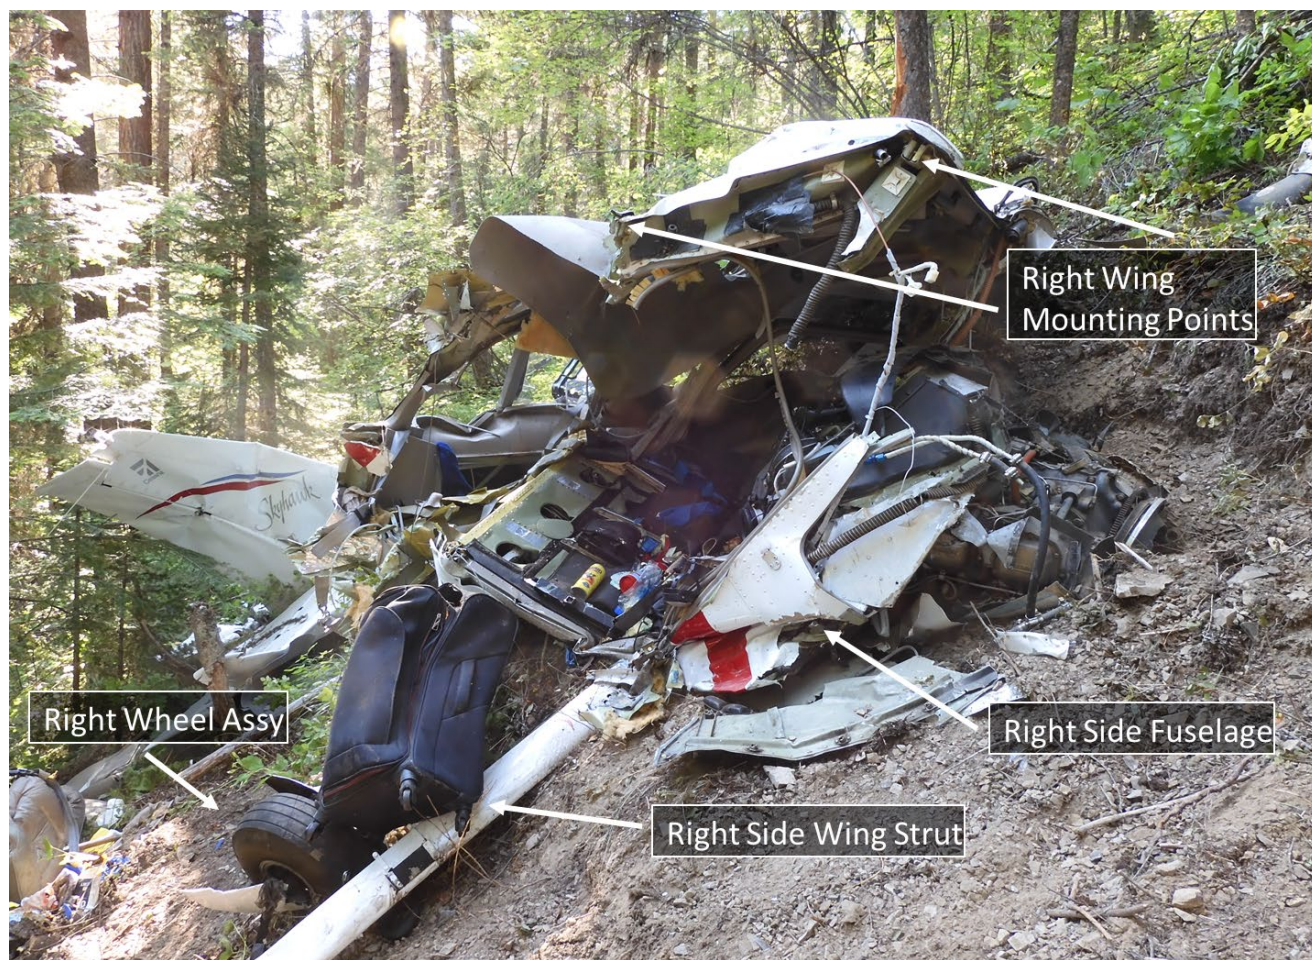
Figure 1. Right-front view showing cabin area.

The cabin area was heavily damaged. There was accordion style crushing of the front cabin floor. The right-side yoke was absent with about 6 inches of the control rod extending from the instrument panel. The left-side control yoke was absent with about 12 inches extending from the instrument panel. Both control yokes may have been cut during the recovery operations.

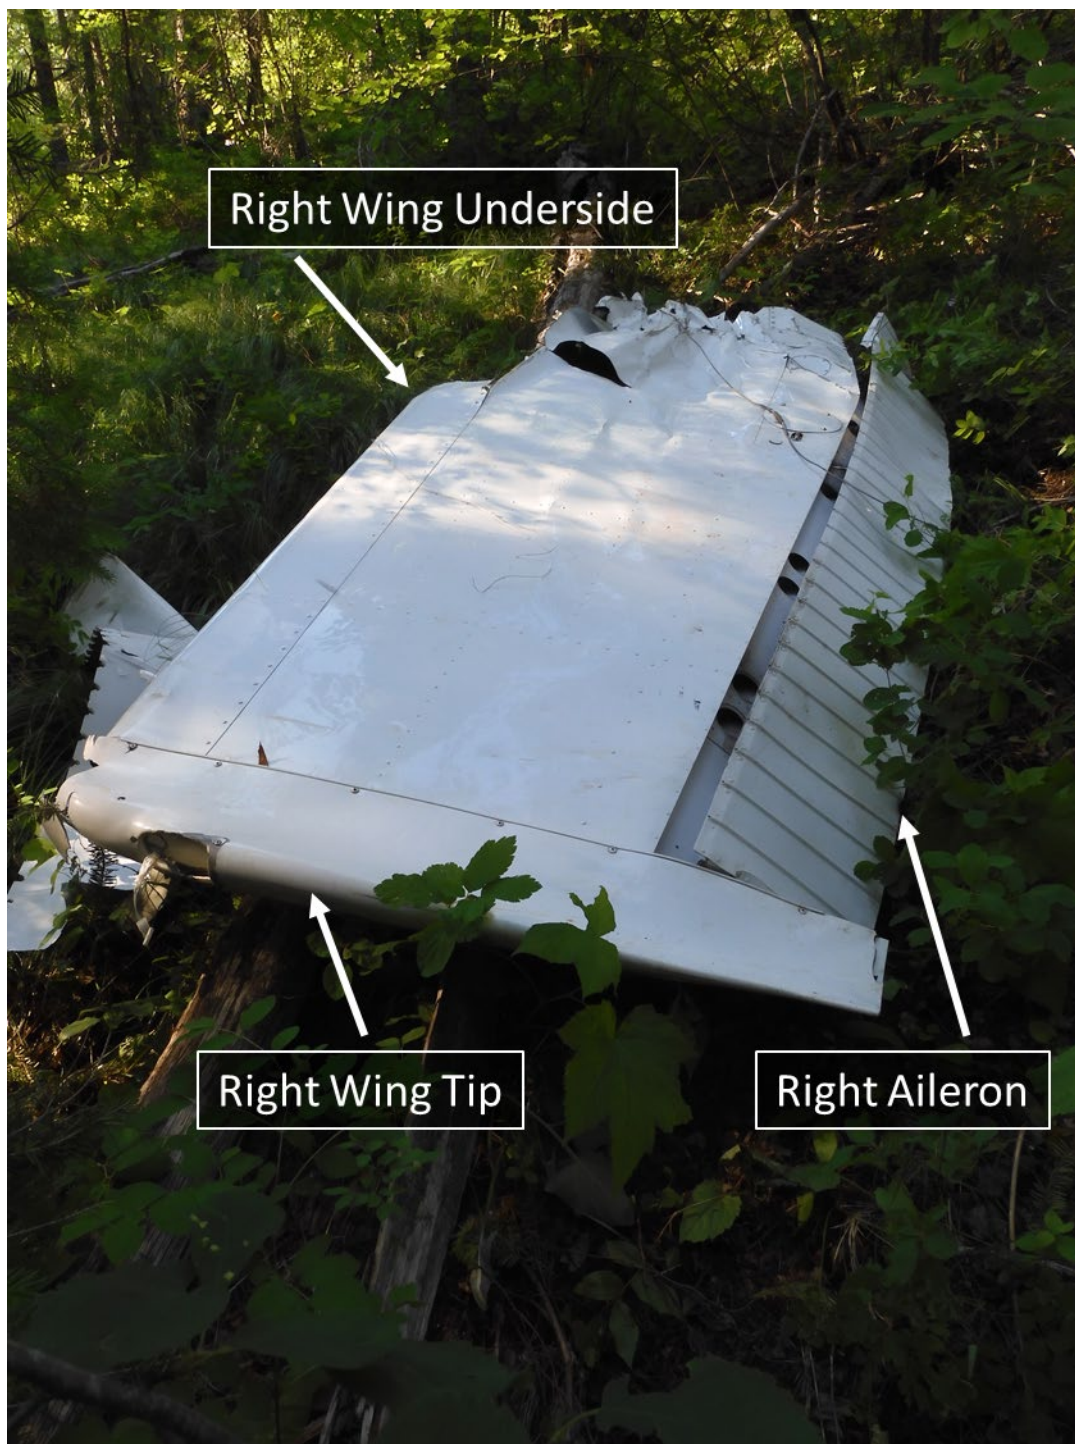
Figure 4. Right wing

The right wing separated from the airplane at the root. The separated wing exhibited extensive damage at the root with aft bending from the leading edge/root area aft to the trailing edge. The leading edge of the right wing exhibited crushing and tearing, with a section near the root separated. The right aileron remained attached to the wing by at least one hinge and exhibited damage in the form of bends and dents along the top surface. The right flap separated from the wing. The right fuel cap remained secured, and the rubber seal was soft and pliable. A section of the right wing and a section of the right flap separated from the wing. The separated flap section remained attached to the wing section by one hinge.

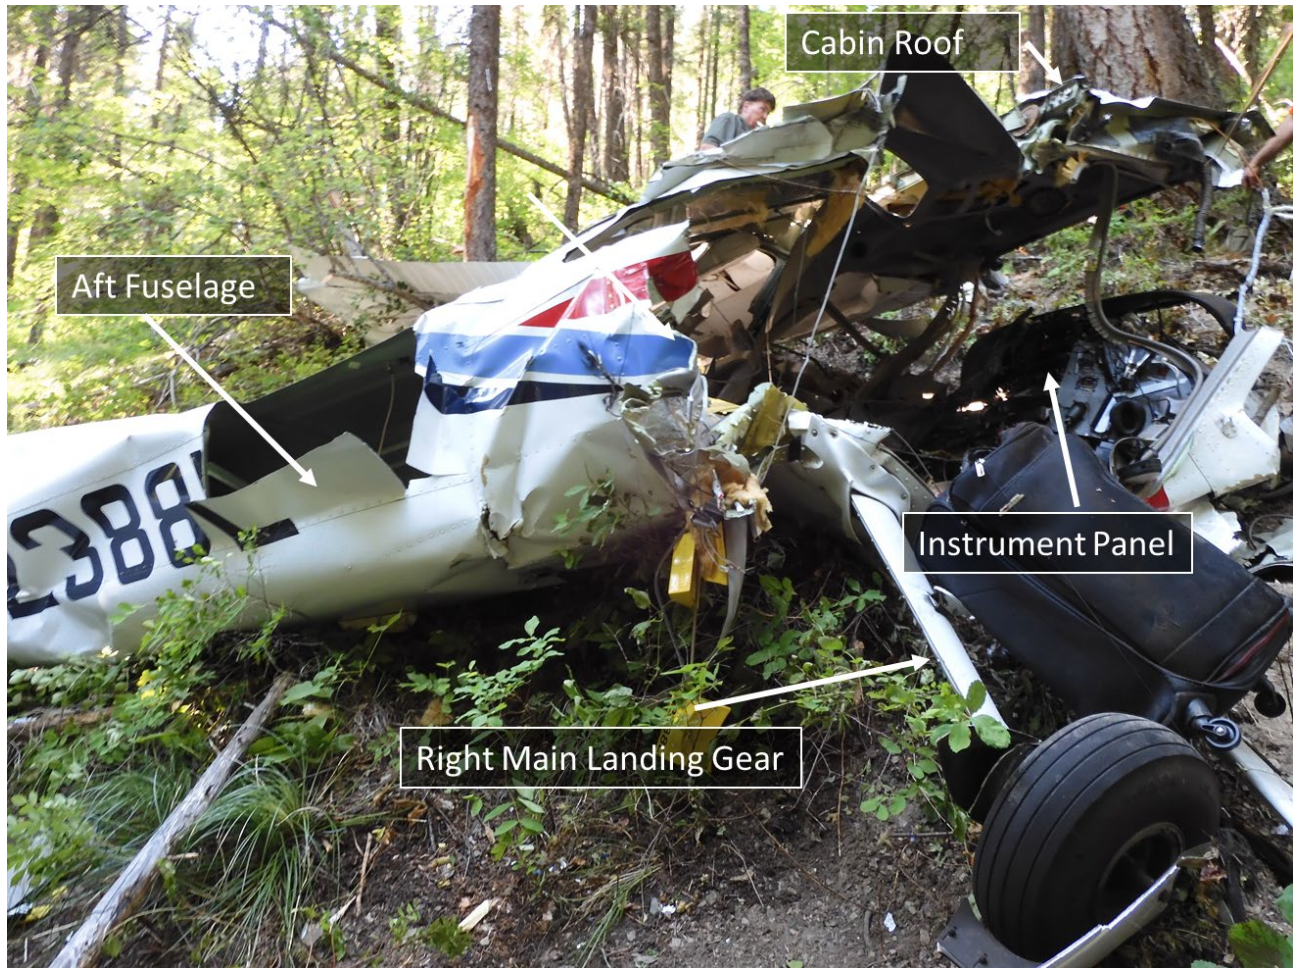
Figure 5. Right side of the fuselage.

The right side of the fuselage, aft of the right main landing gear exhibited damage with wrinkled skin and crushing from the top and bottom. A large cut was made to the right-side aft fuselage area, consistent with recovery efforts to gain access to the interior.

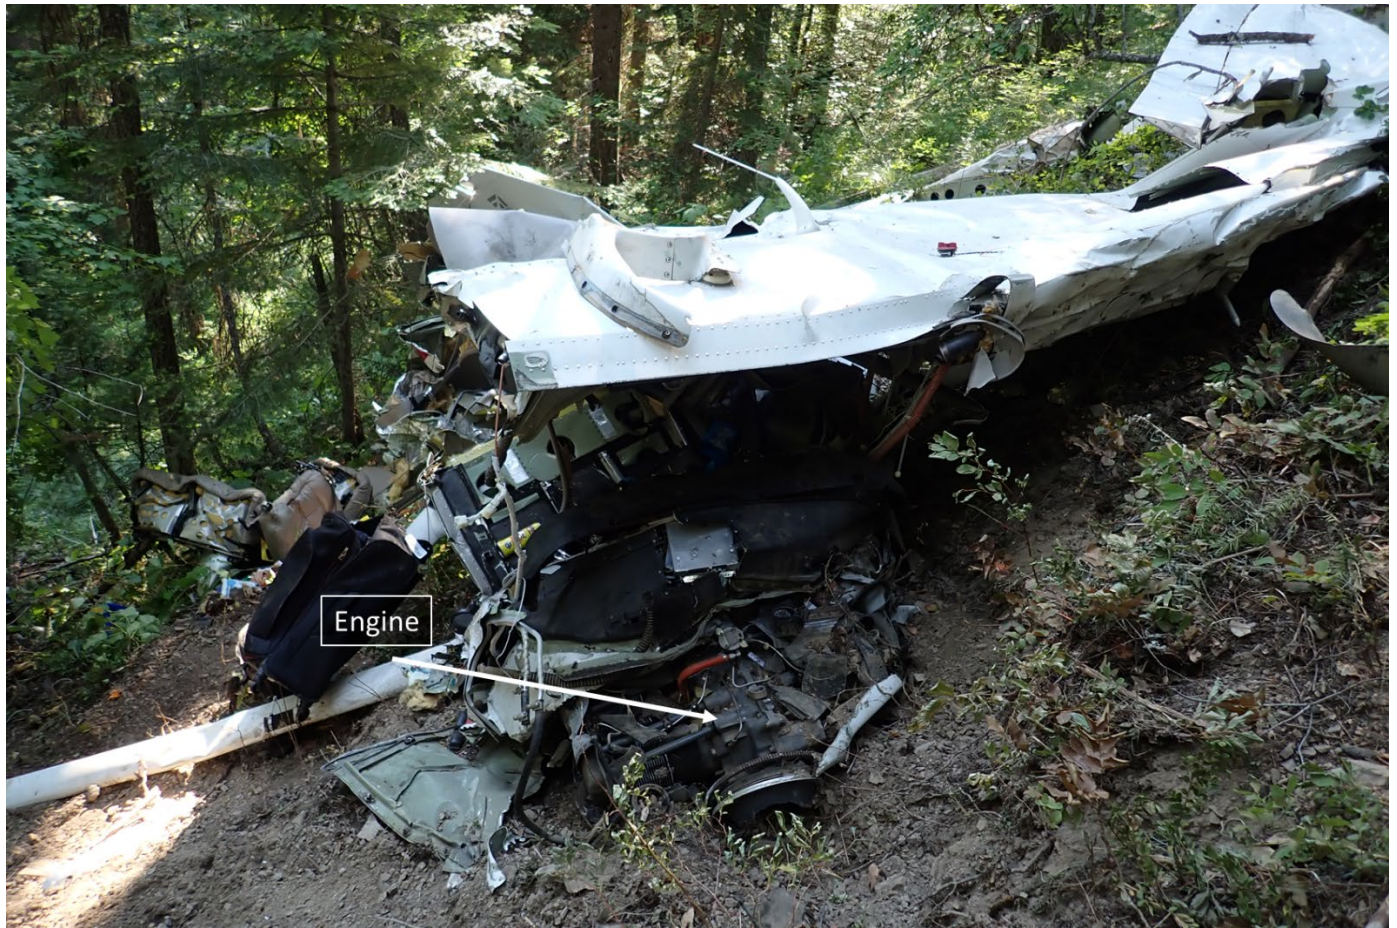
Figure 6. Engine and cabin roof.

The engine cowling had separated exposing the engine. The engine was partially buried in soft terrain and had been pushed aft into the fire wall. The exhaust and intake tubes were bent aft and upwards. The muffler was completely crushed flat. The entire lower engine area was crushed upwards, and the nose gear strut was pushed aft.

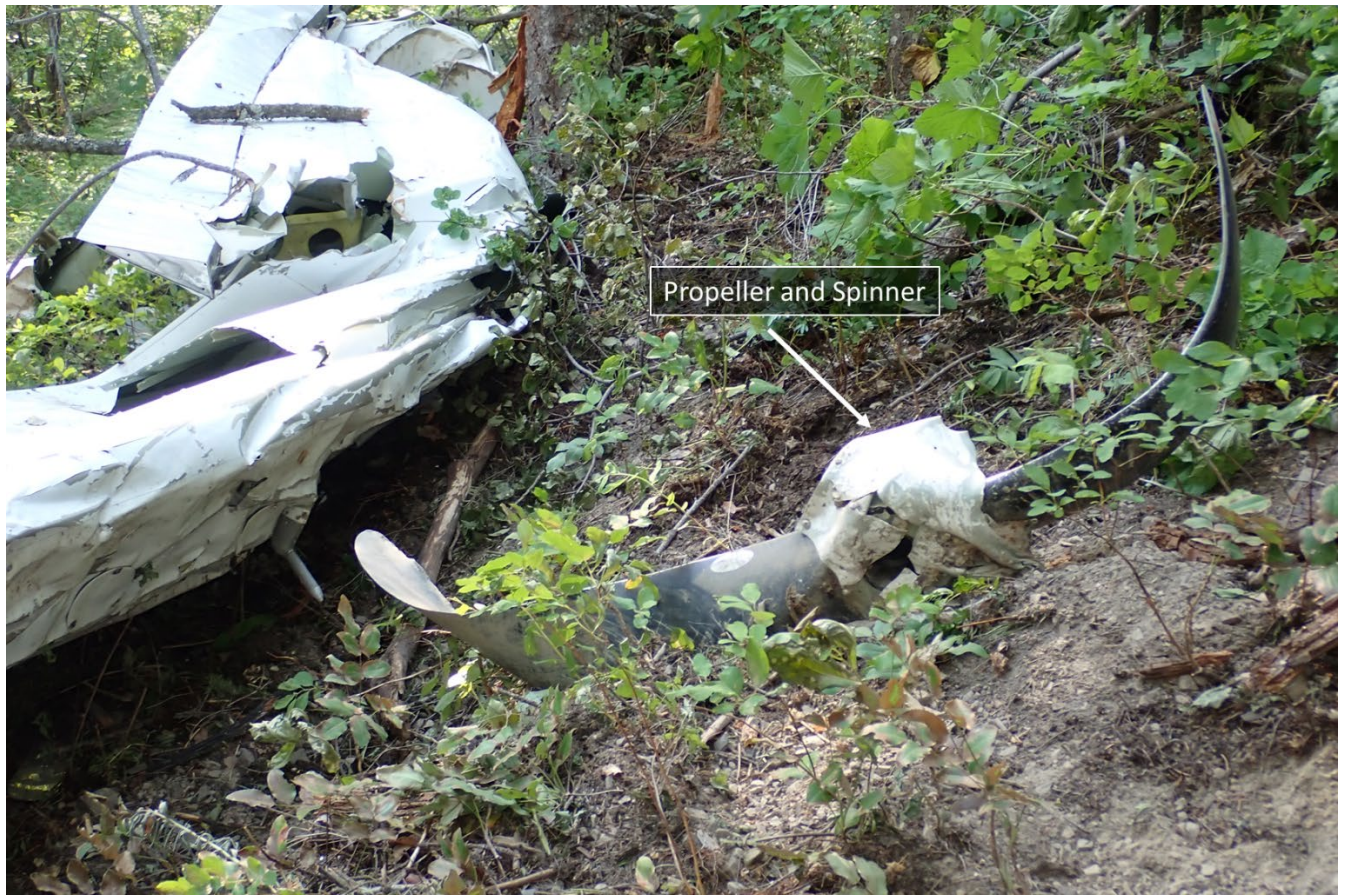
Figure 7. Propeller and spinner

The propeller separated from the engine. Both propeller blades exhibited aft bending about 90°, about mid-span with chordwise scratches present. Both propeller tips remained attached to the blades. The spinner was crushed aft. One blade exhibited twisting and had both leading-edge gouging and chordwise scars. The other blade only had chordwise scars.

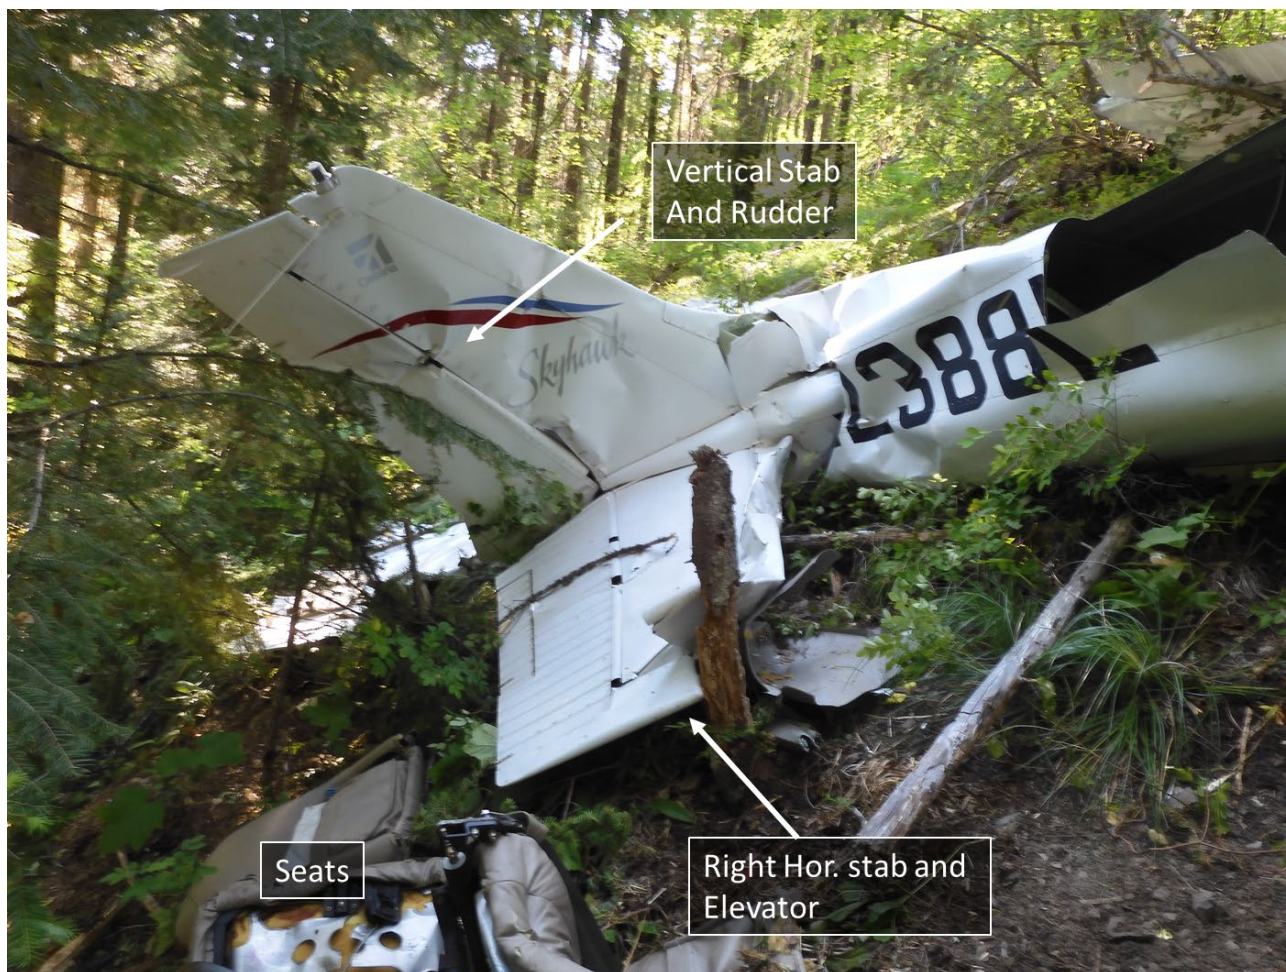
Figure 8. Empennage.

The empennage remained attached to the aft fuselage area and exhibited major bending and wrinkling of the area just ahead of the horizontal stabilizers.

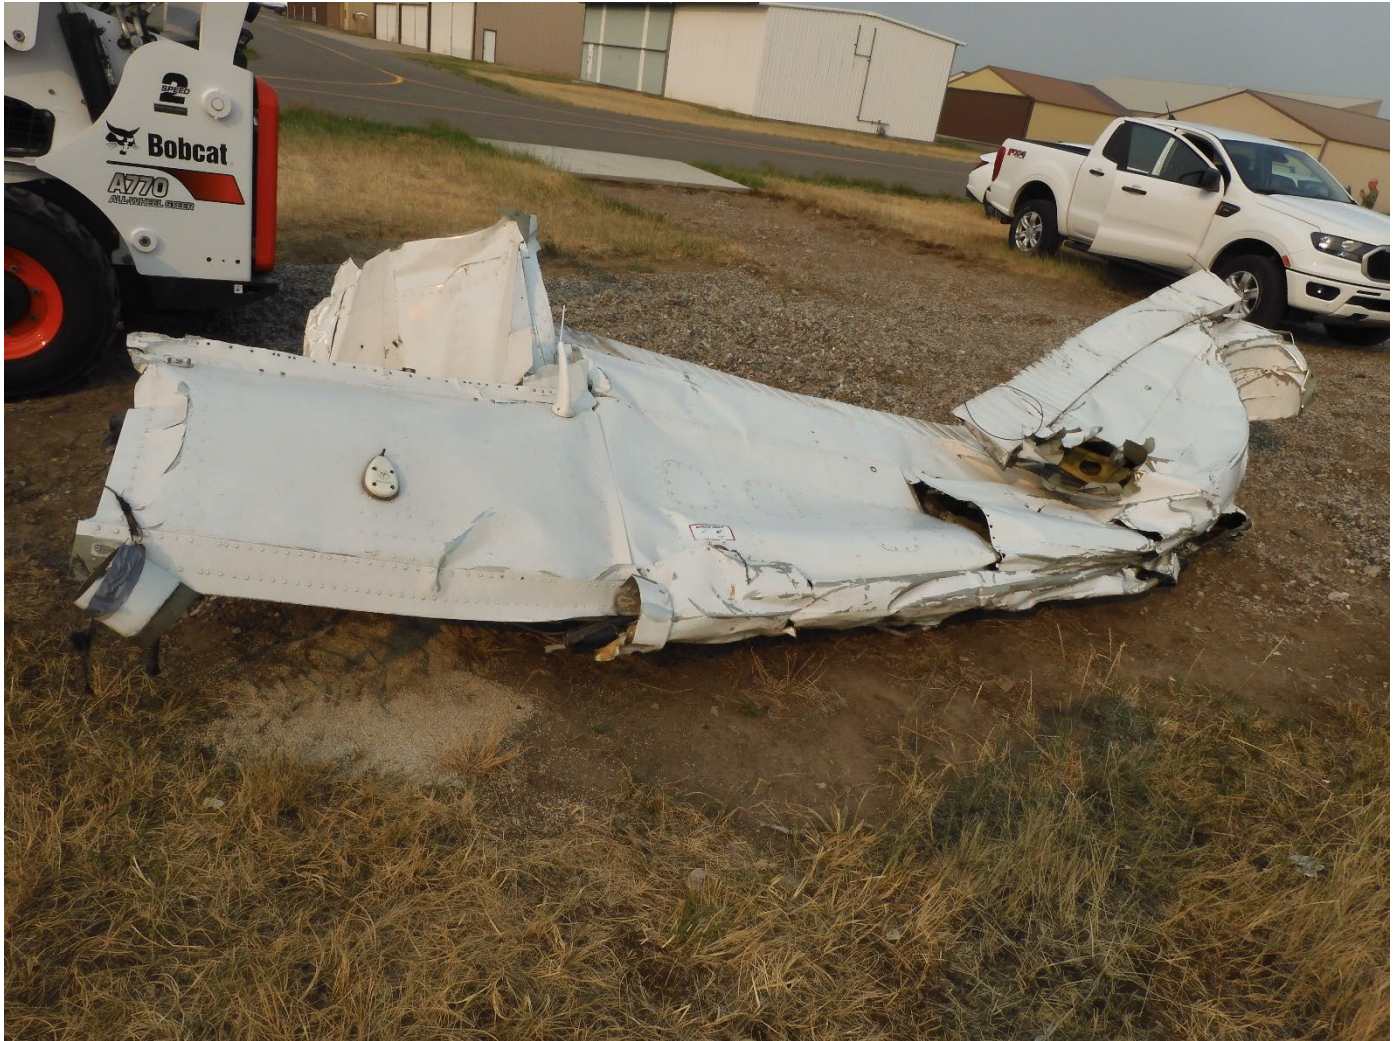
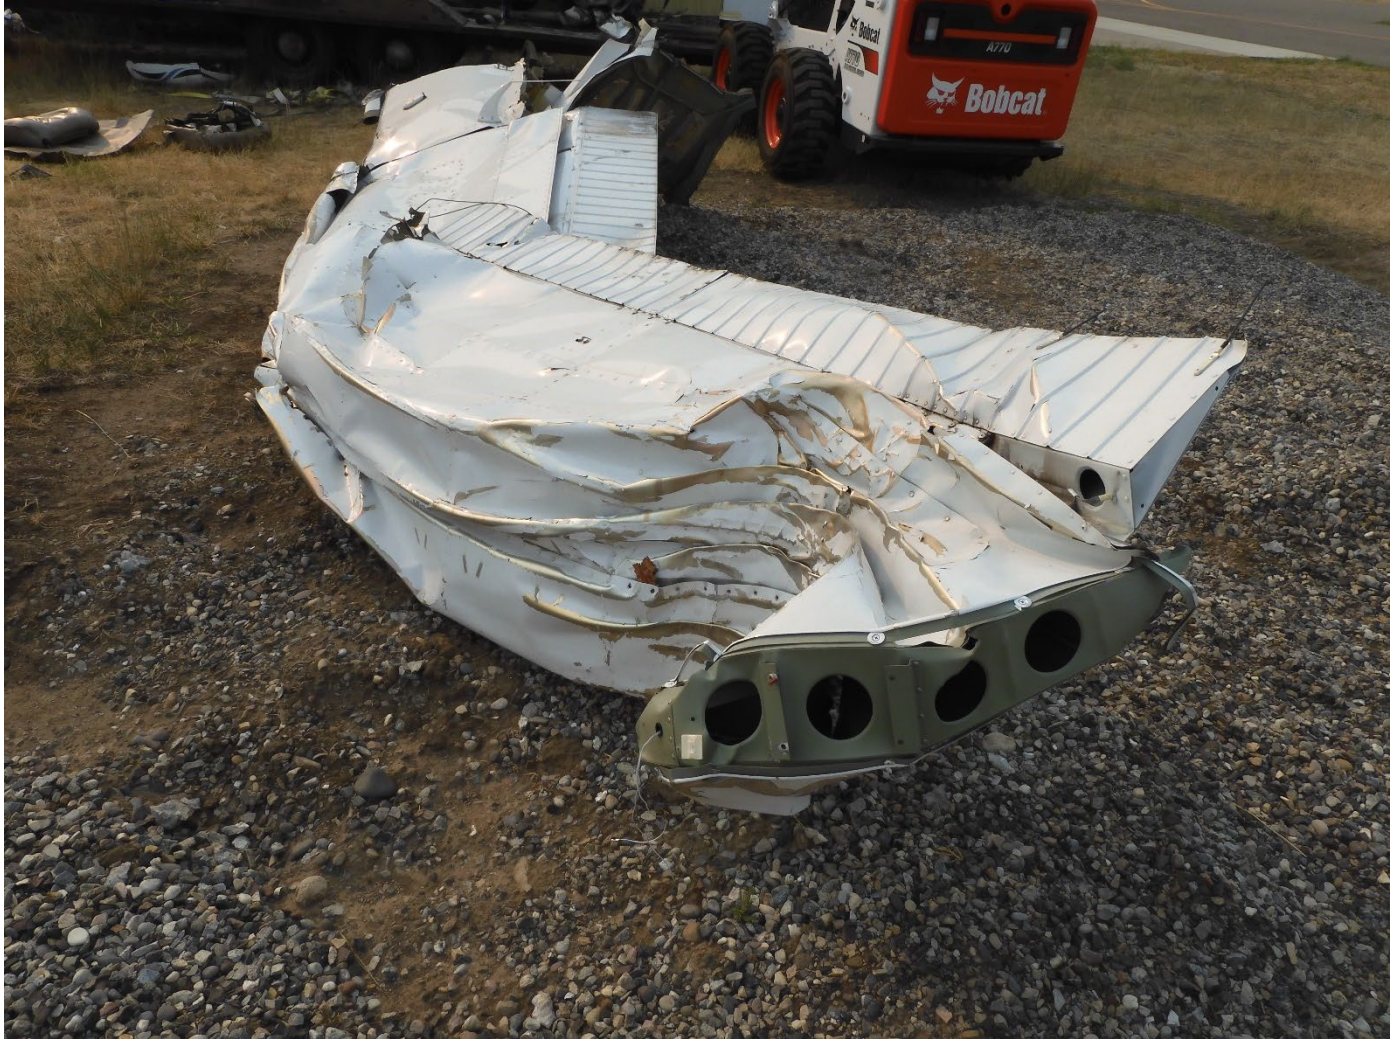
The left wing remained attached to the upper cabin rooftop, and exhibited aft bending about mid-span, near the wing strut. The leading edge was crushed upwards. The outboard section of the leading edge exhibited a large circumferential dent, consistent with contact with a nearby tree that exhibited an impact mark and stripped bark. Based on the impact angle of the tree to the left wing, the airplane was about 30° nose down with little bank angle. The left aileron remained attached to the wing at all hinges and exhibited damage in the form of bends wrinkling and punctures. The left flap remained attached to the fuselage and indicated down about 40°. The left fuel cap remained secured, and the rubber O-seal was soft and pliable. The wing strut remained attached at both upper and lower mounting points.

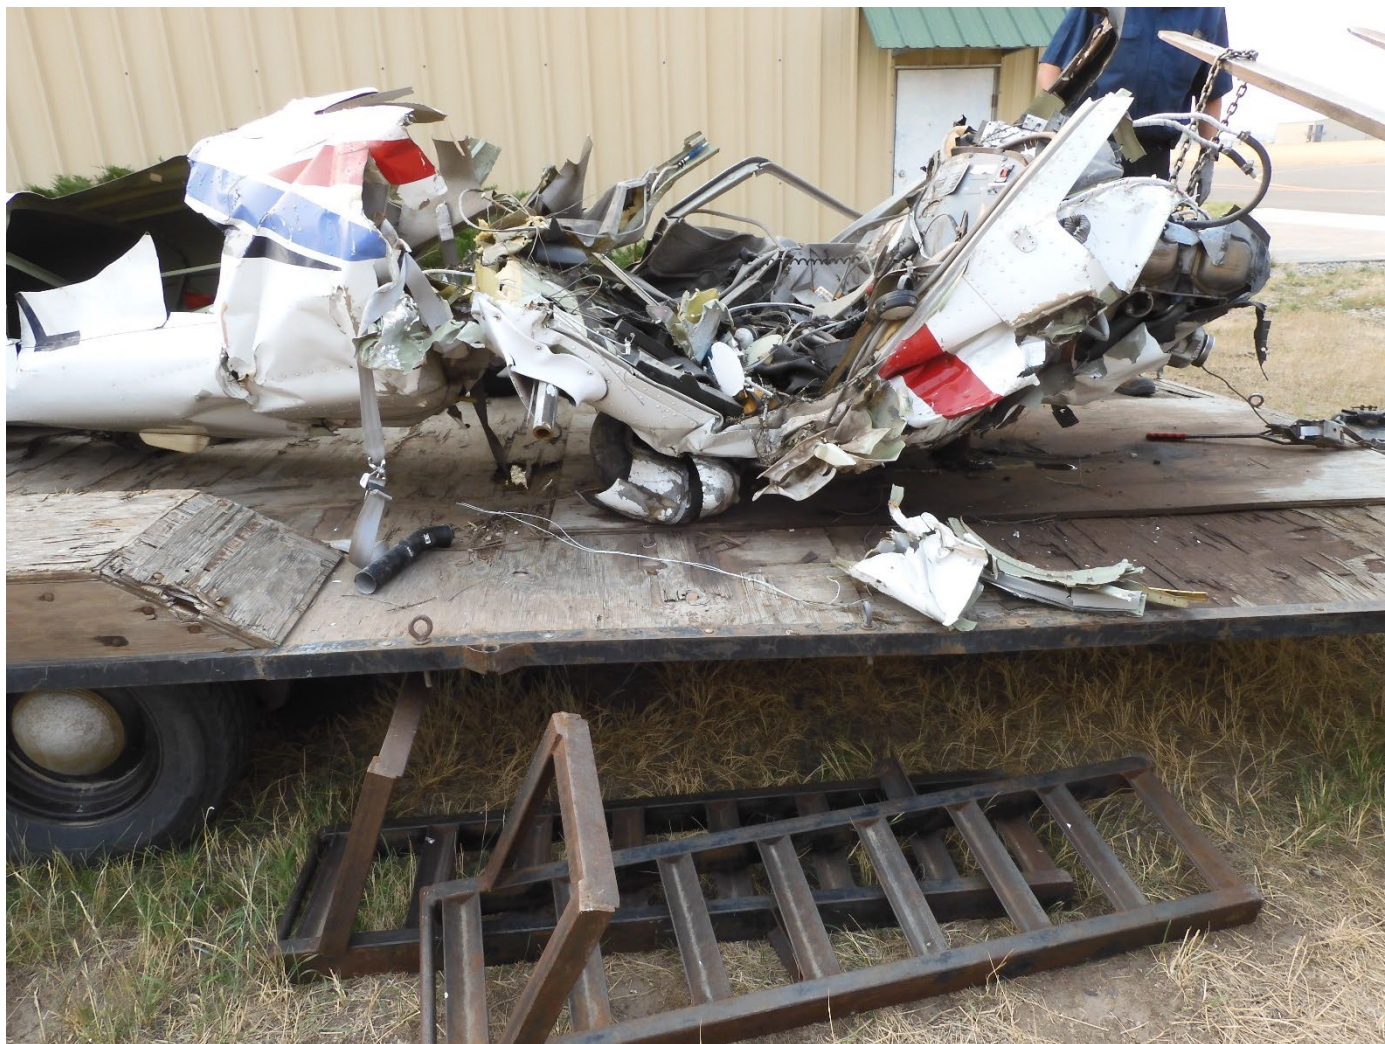
Figure 12. Fuselage, right-side view.

The fuselage was substantially damaged. The right side underneath the wing was cut away during the recovery. The cut away sections, along with the door were separated from the fuselage. The door exhibited crush damage and the locking handle was in the UP position.

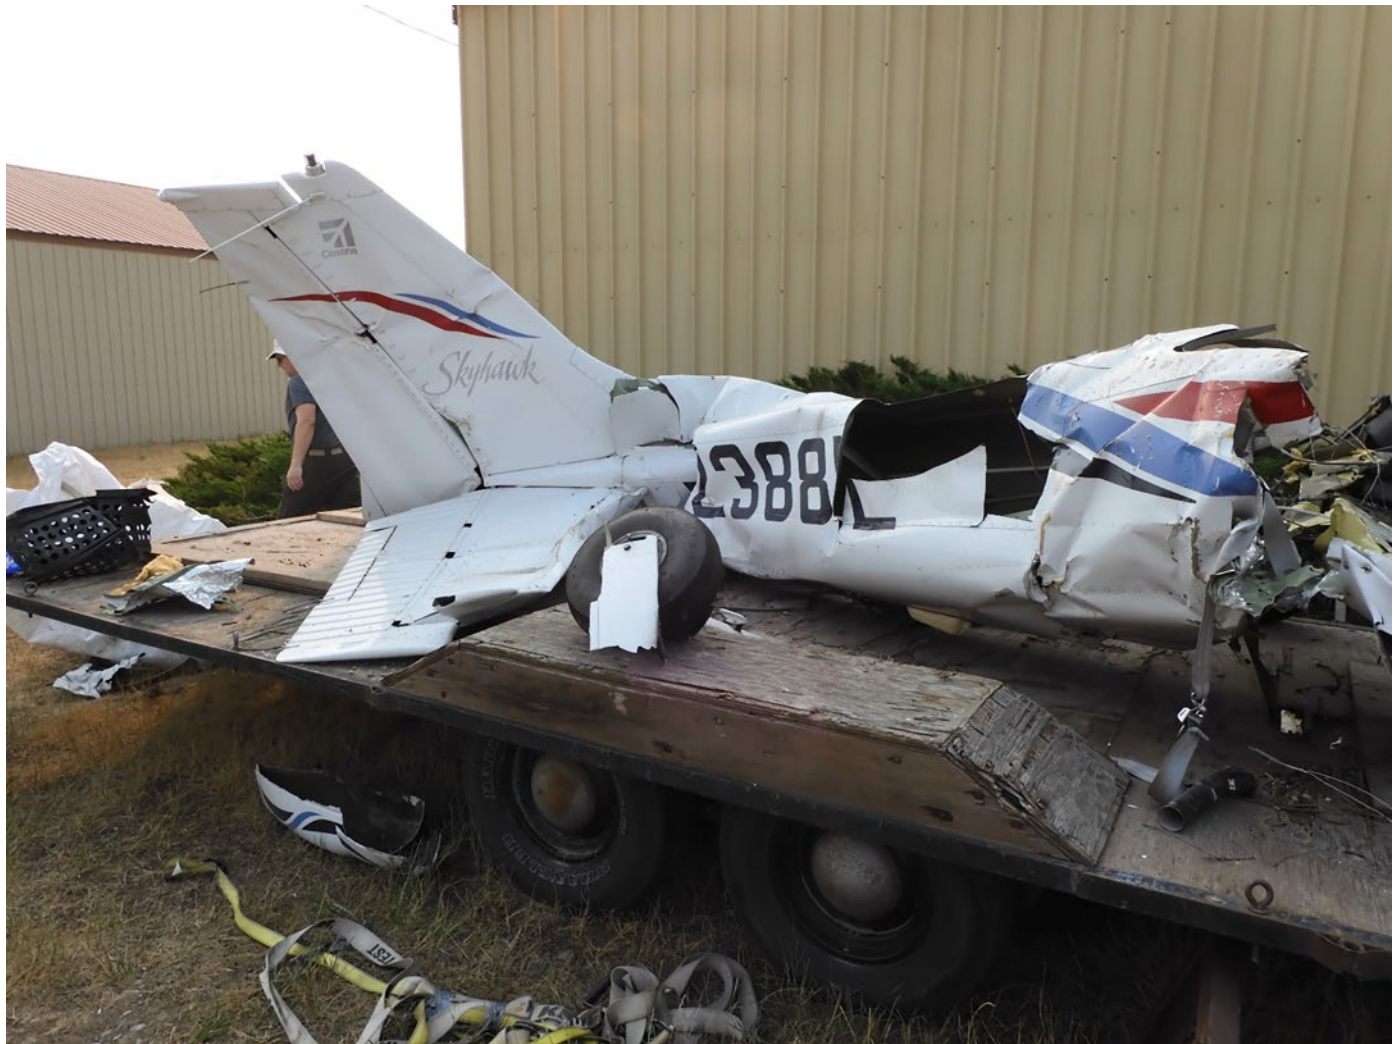
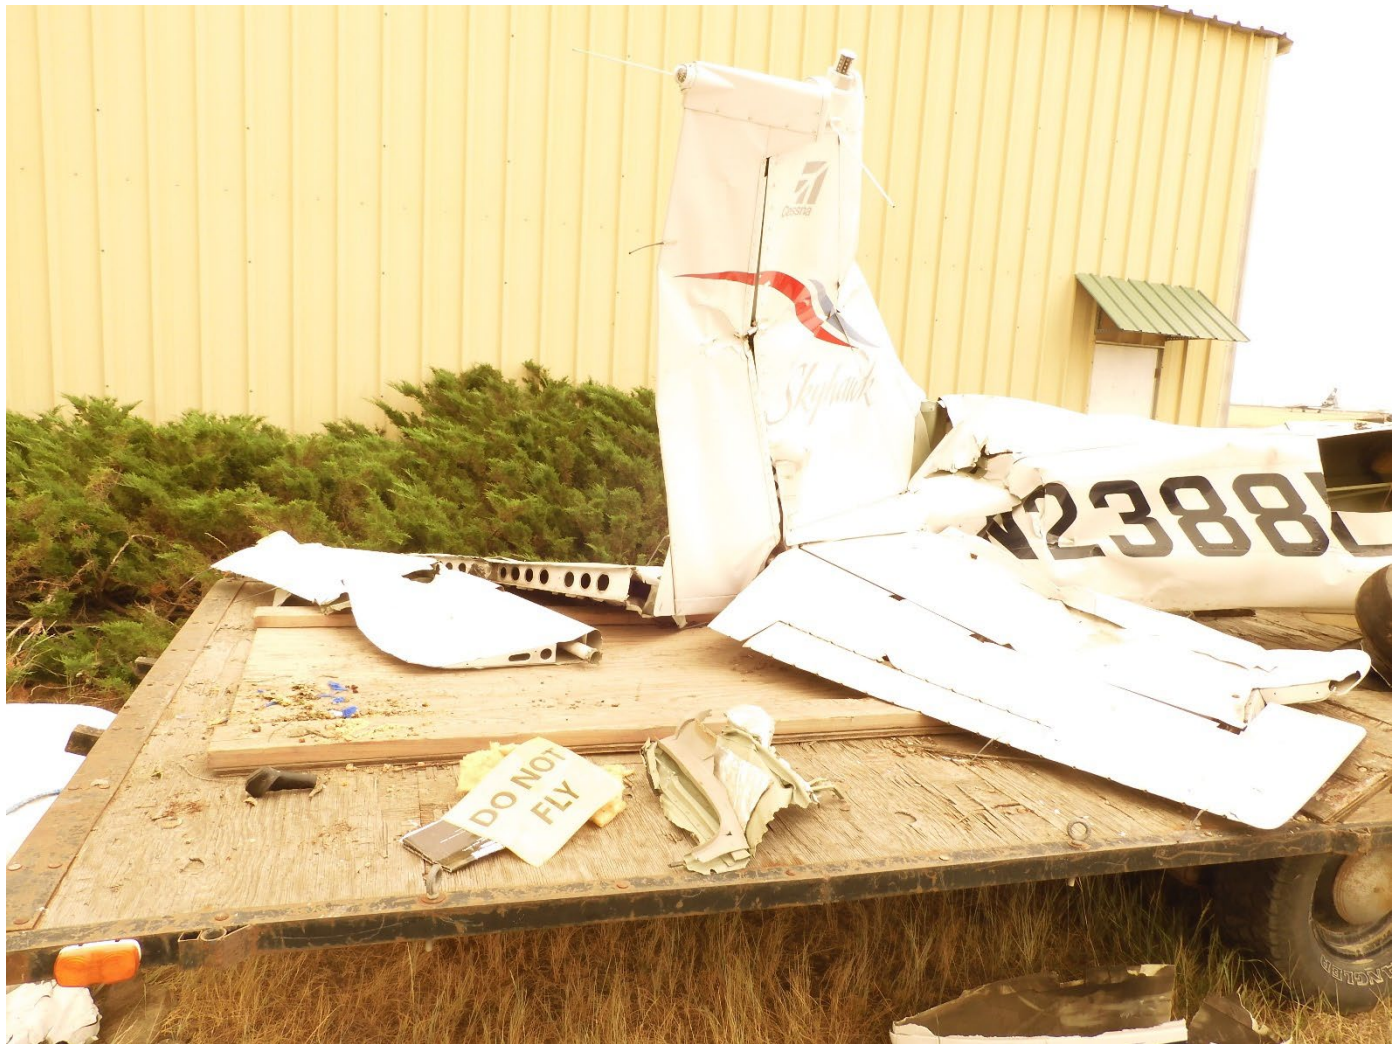
The right horizontal stabilizer remained attached to the empennage and exhibited damage to the leading edge throughout the span. The outer tip of the right horizontal stabilizer appeared pushed upwards by a section of a tree trunk. The right-side elevator remained attached to the horizontal stabilizer and exhibited minor damage on the top side. The right-side elevator trim tab remained attached to the elevator, exhibited minor damage on the top and appeared to be in a near-neutral setting.

The vertical stabilizer remained attached to the empennage and exhibited damage throughout the span, with wrinkled metal and some downward crushing. The dorsal was wrinkled and cracked. The rudder remained attached to the vertical stabilizer and exhibited crushing and wrinkles with bending.

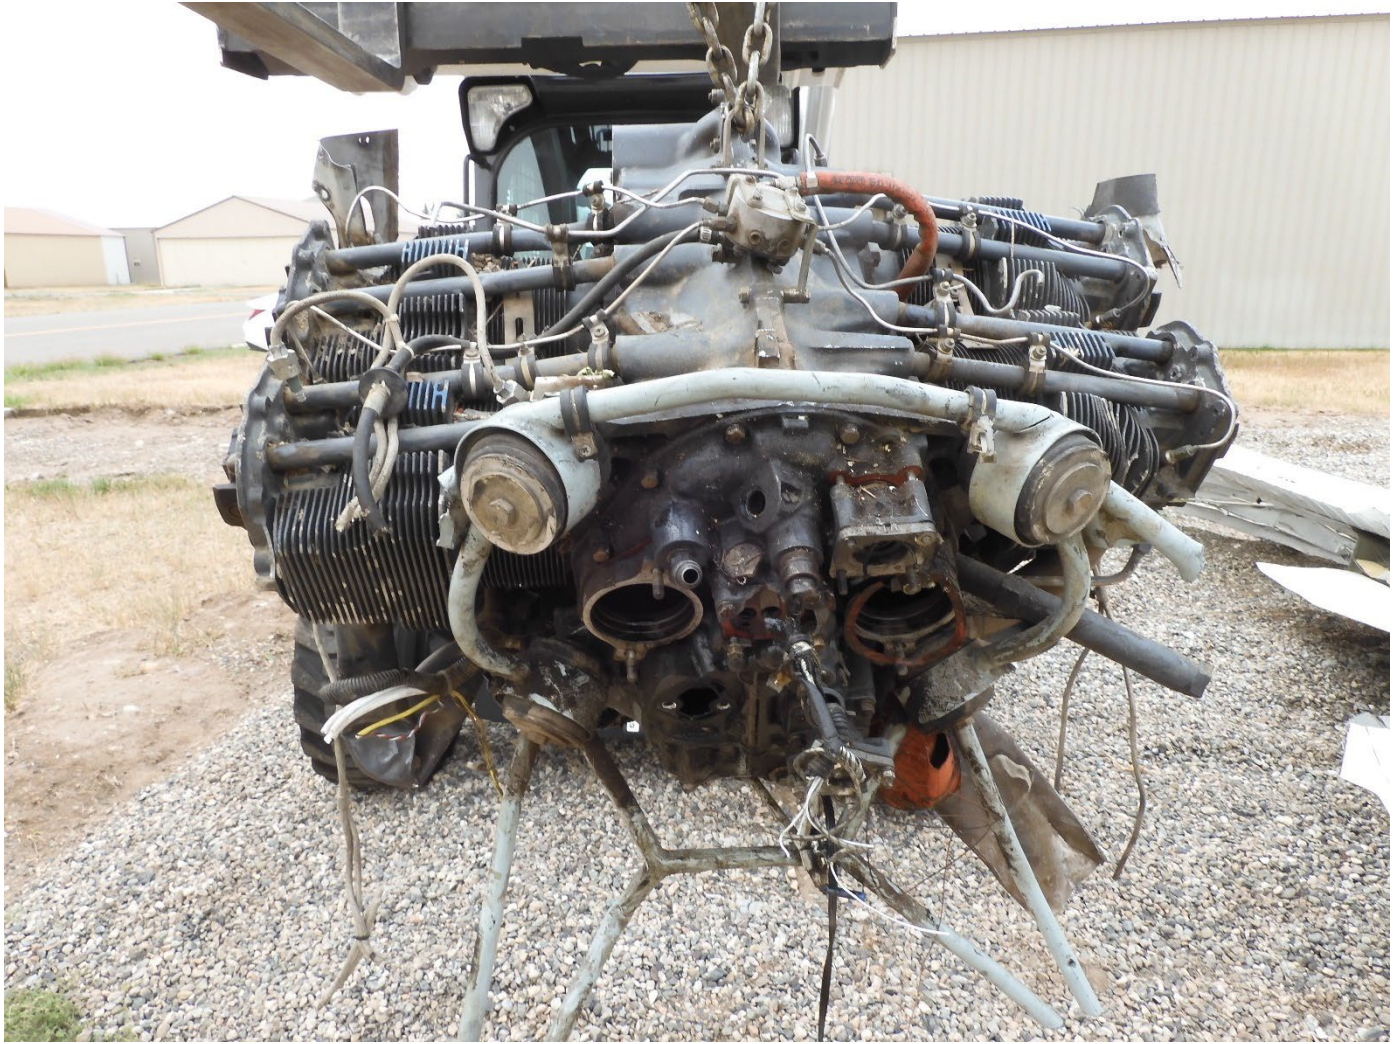
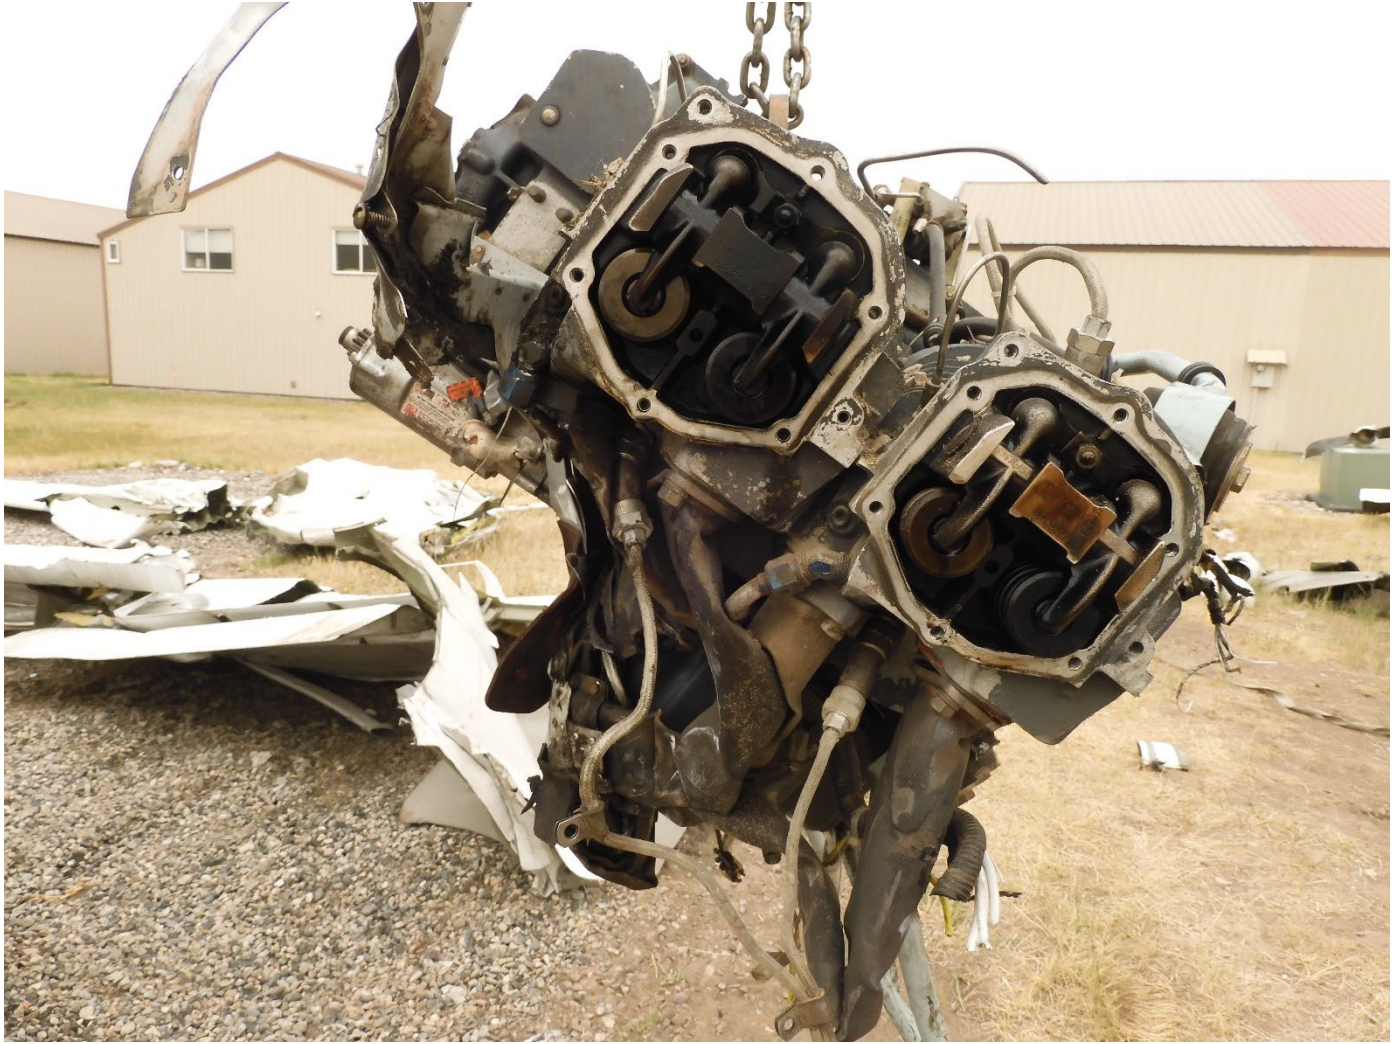
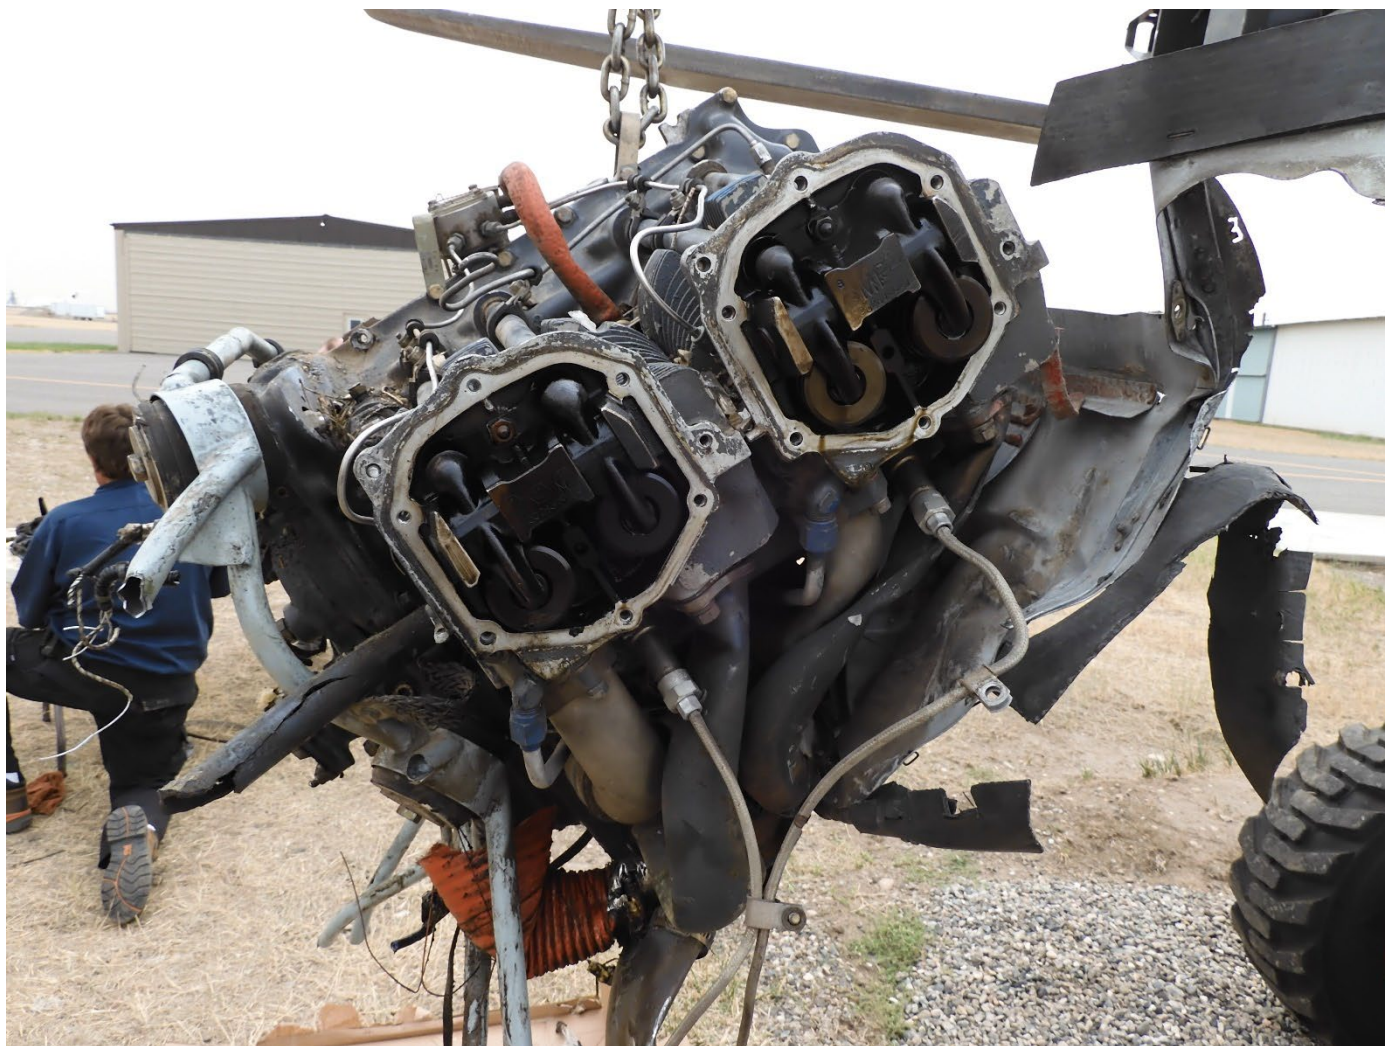
The engine remained partially attached to the fire wall by the mounts. The propeller and starter ring gear separated from the front of the engine.
