## **NATIONAL TRANSPORTATION SAFETY BOARD**

# **AIRFRAME AND ENGINE EXAMINATION**

**WPR21FA258**

Location: Missoula, Montana  
Date: July 1, 2021  
Aircraft: N2388L / Cessna 172  
NTSB IIC: Fabian Salazar

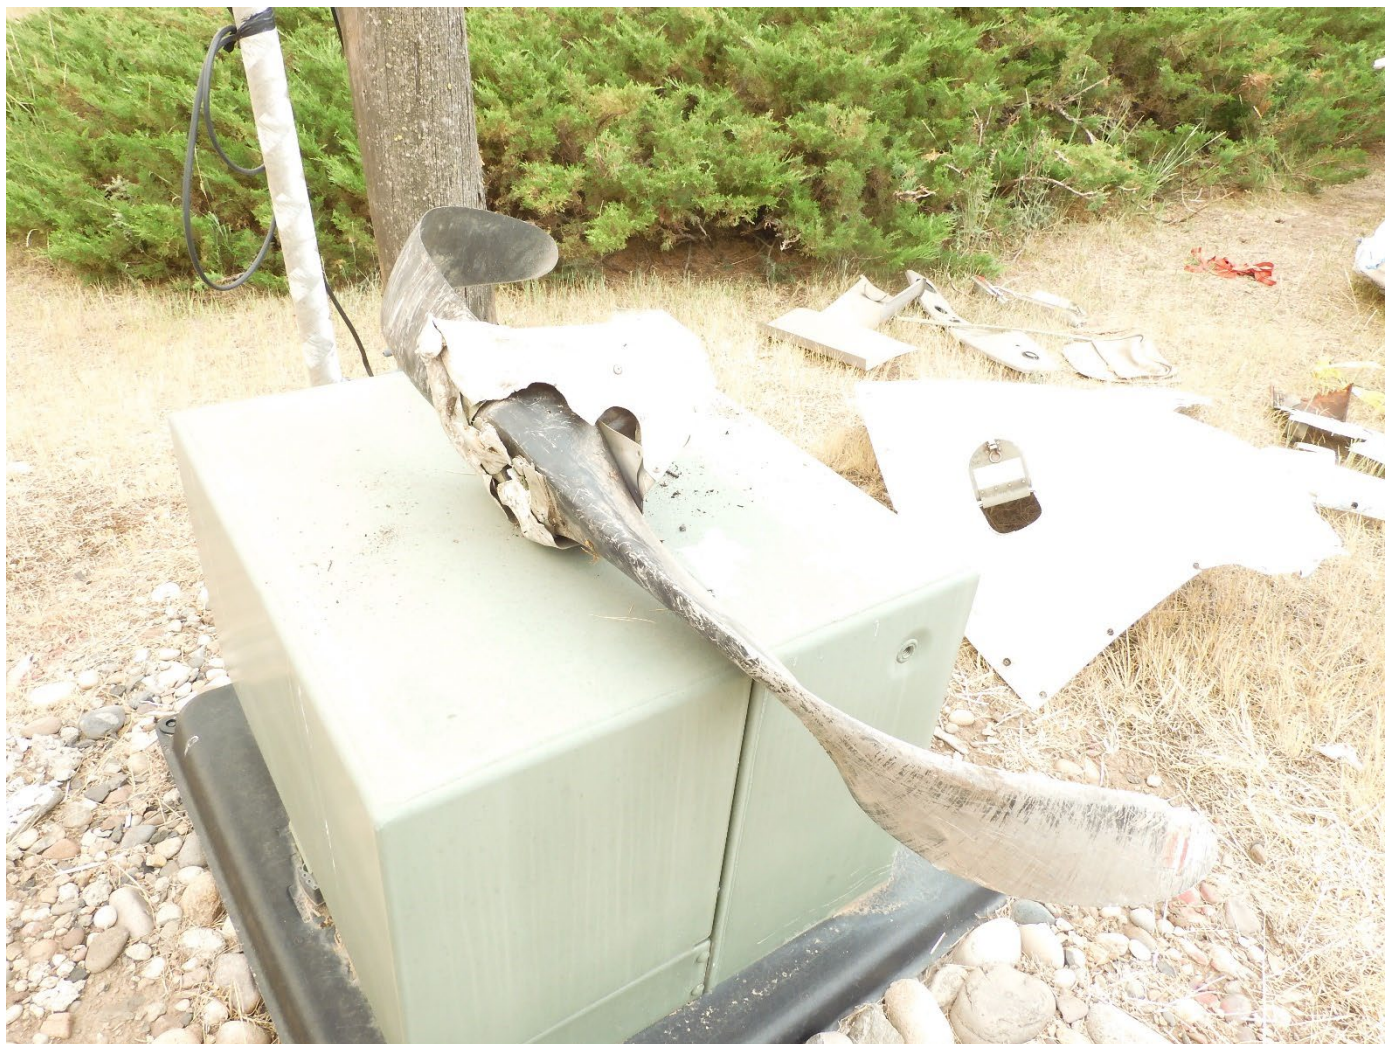
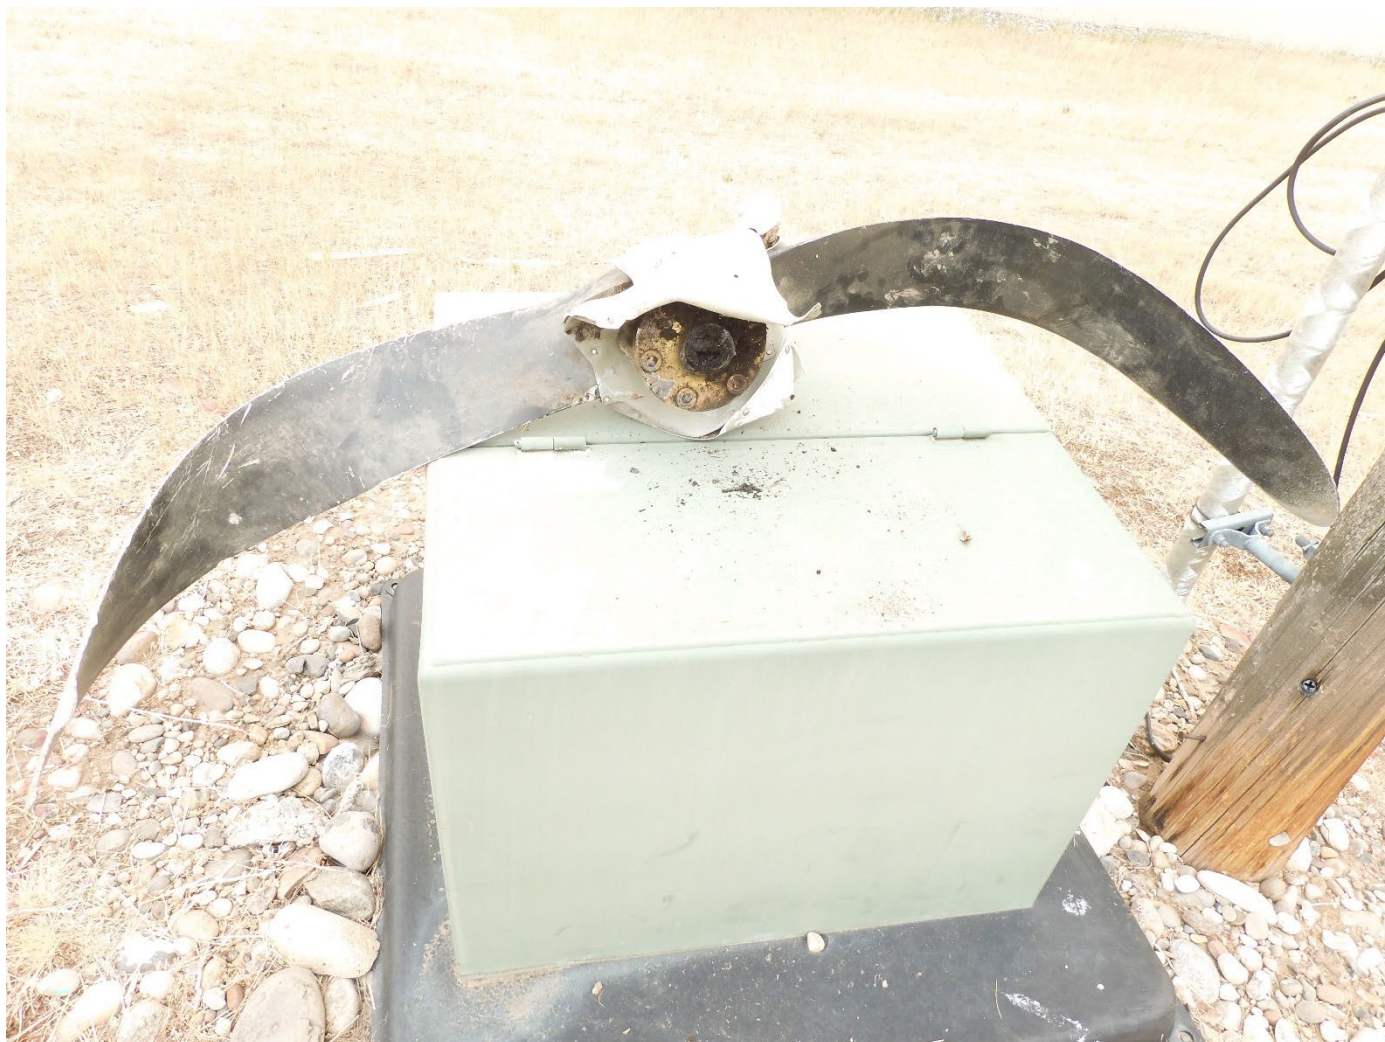
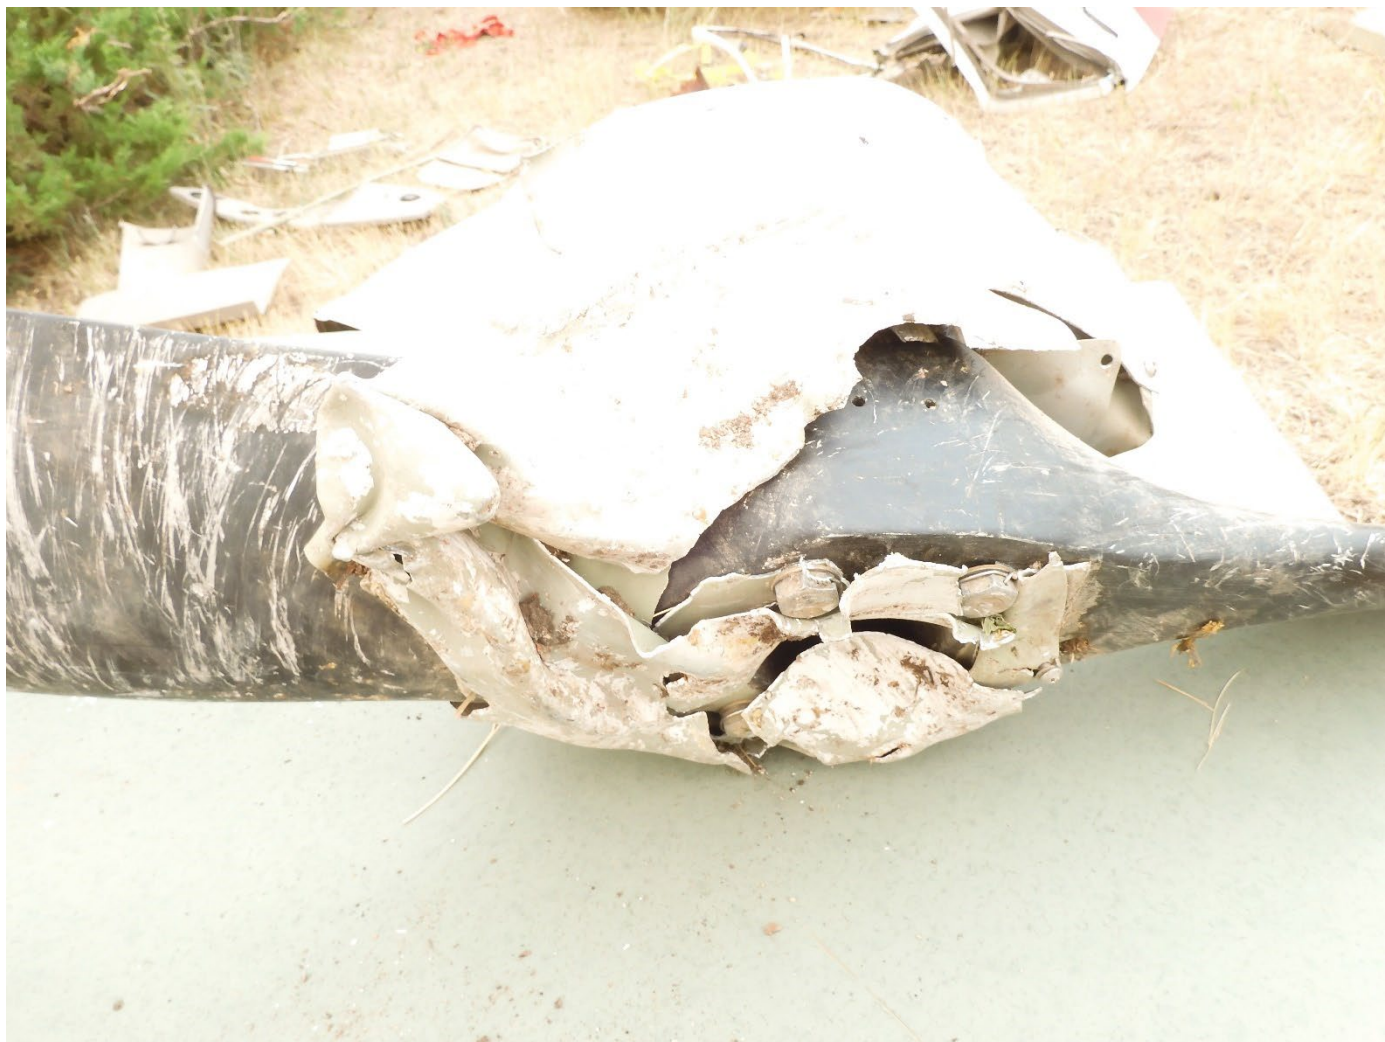
The propeller separated from the engine. Both propeller blades exhibited aft bending about 90°, about mid-span with chordwise scratches present. Both propeller tips remained attached to the blades. The spinner was crushed aft. One blade exhibited twisting and had both leading-edge gouging and chordwise scars. The other blade only had chordwise scars.
