# NATIONAL TRANSPORTATION SAFETY BOARD

## MATERIALS LABORATORY FACTUAL REPORT

Report No. 22-014

Place : Wikieup, Arizona  
Date : July 10, 2021  
Vehicle : Beech C-90, N3688P  
NTSB No. : WPR21FA266  
Investigator : Albert Nixon, AS-WPR

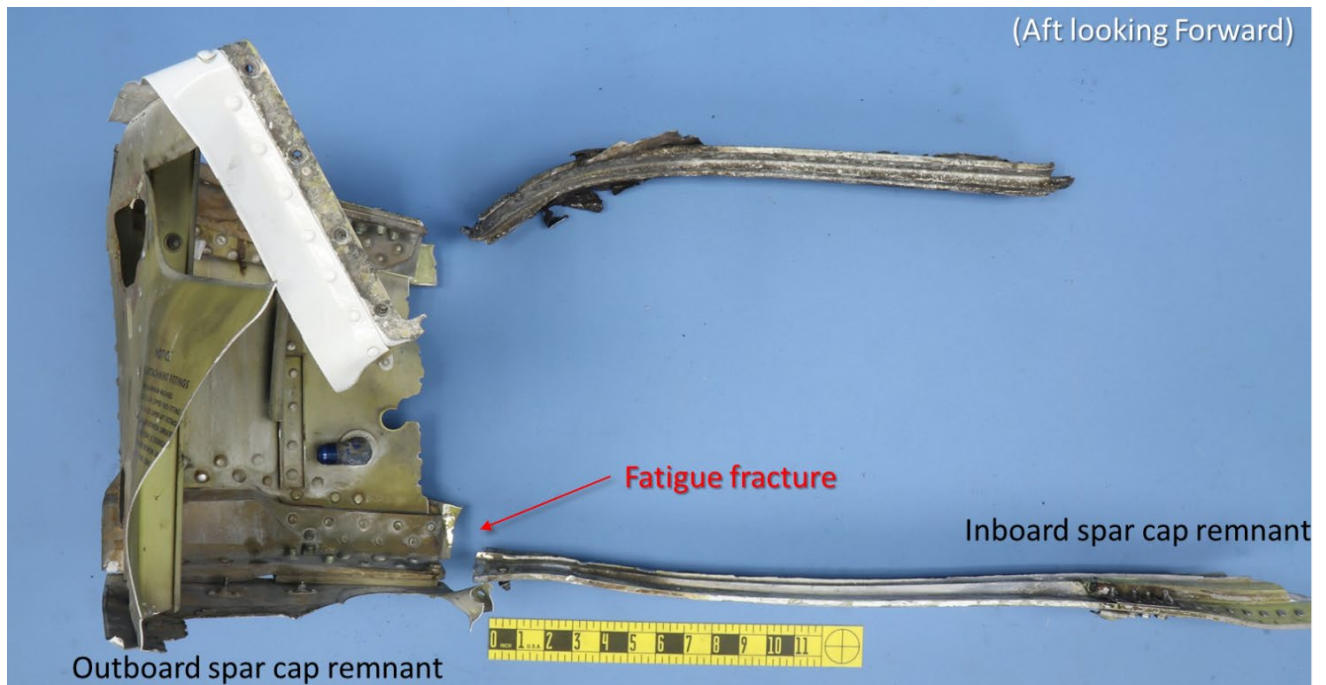
Remnants and sections of the left and right wing spars were received by the NTSB Laboratory. Figures 1 and 2 show the three remnants of the left wing spar, placed in their respective positions. Of note was the flat fracture on the lower spar cap, depicted by the red arrow in both figures—this fracture was later determined to be consistent with fatigue fracture. The upper spar cap exhibited plastic deformation adjacent to its fracture, consistent with downward bending. In contrast, the lower spar cap fracture was flat and perpendicular to the spar direction, with no gross plastic deformation at or near the fracture. The outboard lower spar cap remnant measured 5 inches in length, with the inboard remnant measuring 23.5 inches on the forward side and 28.5 inches on the aft side.

Figure 1 – Reconstruction of pieces of the left wing spar.

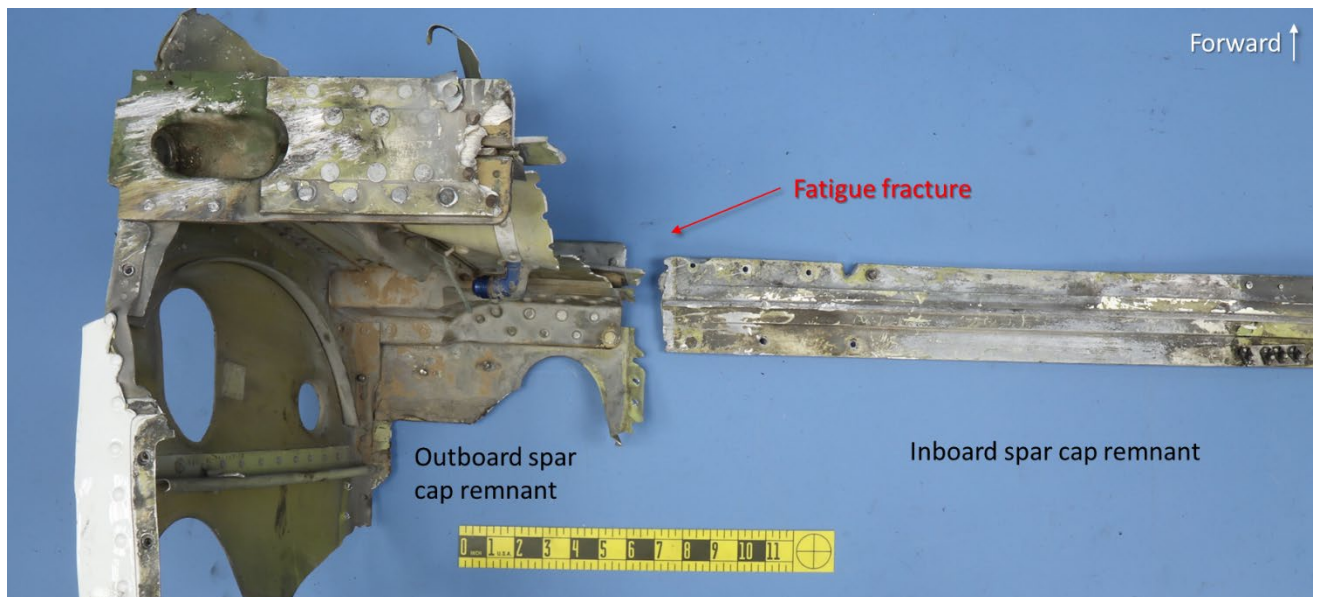
Figure 2 – The left wing lower spar cap reconstruction, viewed from above looking down.

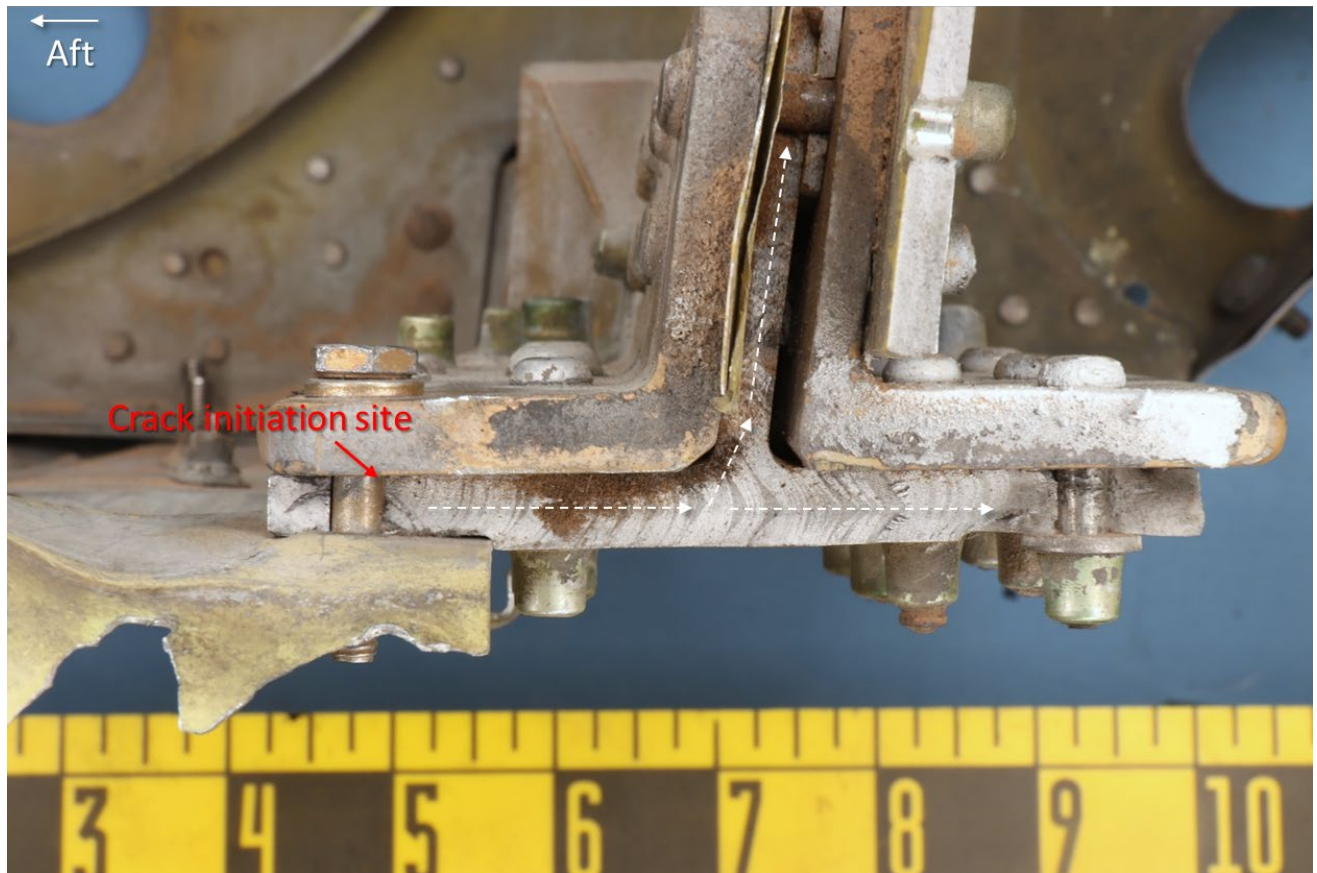
Figure 3 shows the fracture surface of the lower outboard spar cap, which was still constrained by fasteners to the forward and aft tangs of the bathtub fitting, as received. This fracture surface exhibited repeating banded features, consistent with crack arrest

Figure 3 – Fracture surface of the lower outboard spar cap remnant, as received, annotated to show the general crack initiation site and direction of crack propagation.

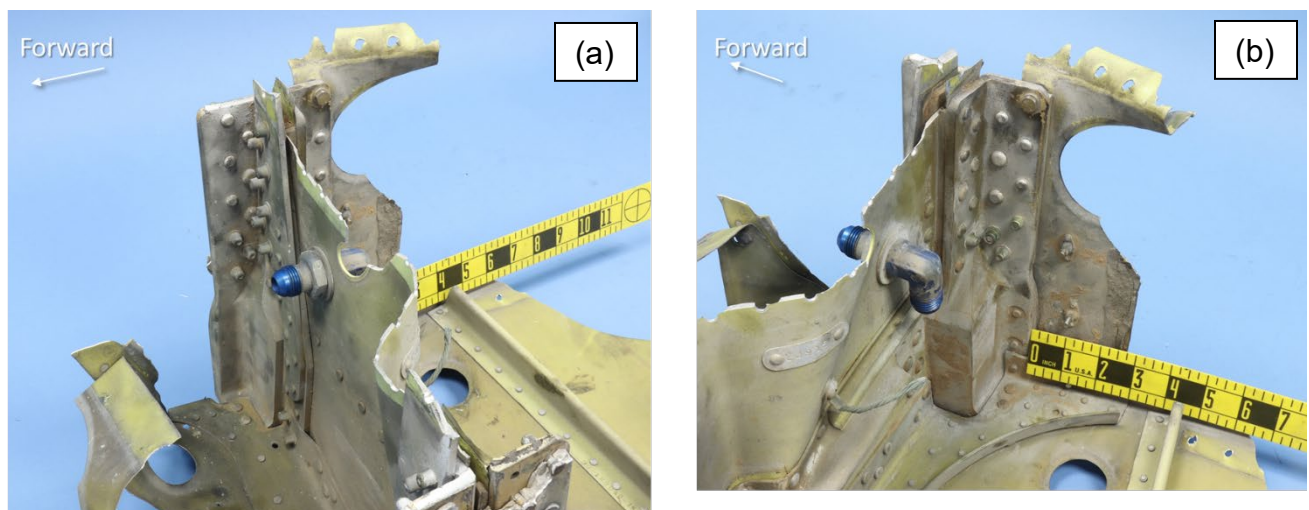
marks from progressive cracking. Figures 4a and 4b, show angled views of the lower outboard spar cap fracture surface. As shown in these figures and in Figure 3, the lower spar cap fracture was located just inboard of the terminal ends of the forward and aft tangs of the bathtub fittings to which it was joined. In addition, while the spar cap fracture was flat and absent local plastic deformation, the nearby fractured components exhibited out-of-plane deformation near the fractures. Located along webs and skins, these erratically oriented fractures were consistent with overstress fractures subsequent to that of the lower spar cap.

Figure 4 – View of the lower outboard spar cap fracture surface, viewed from an (a) down and aft angle and (b) down and forward angle.

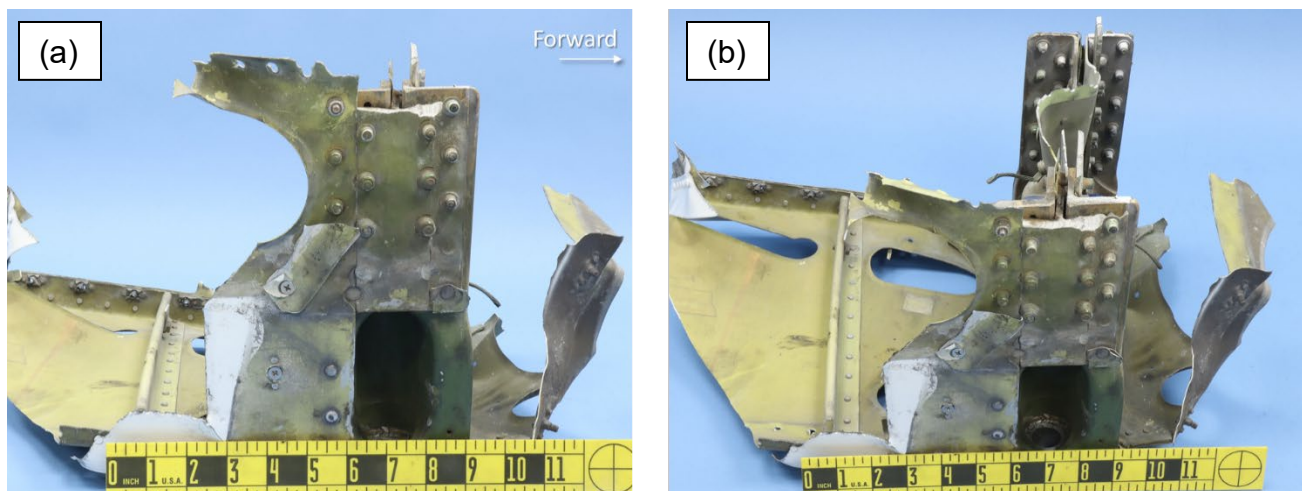
Figures 5a and 5b, show oblique and planar underside views of the left outboard spar remnant assembly, and Figure 6a shows the top-down view, as received. These views demonstrate the location of the fractured lower spar cap relative to the ends of the bathtub fitting tangs, as well as the rivets and bolts used to join these components. Figure 6b shows a closer view of the head of the aft side bolt, which was collocated at the lower spar cap crack initiation location (as shown in Figure 3).

Figure 5 – View of the underside of the lower outboard spar cap fracture looking upward from (a) a planar orientation and (b) an oblique orientation.

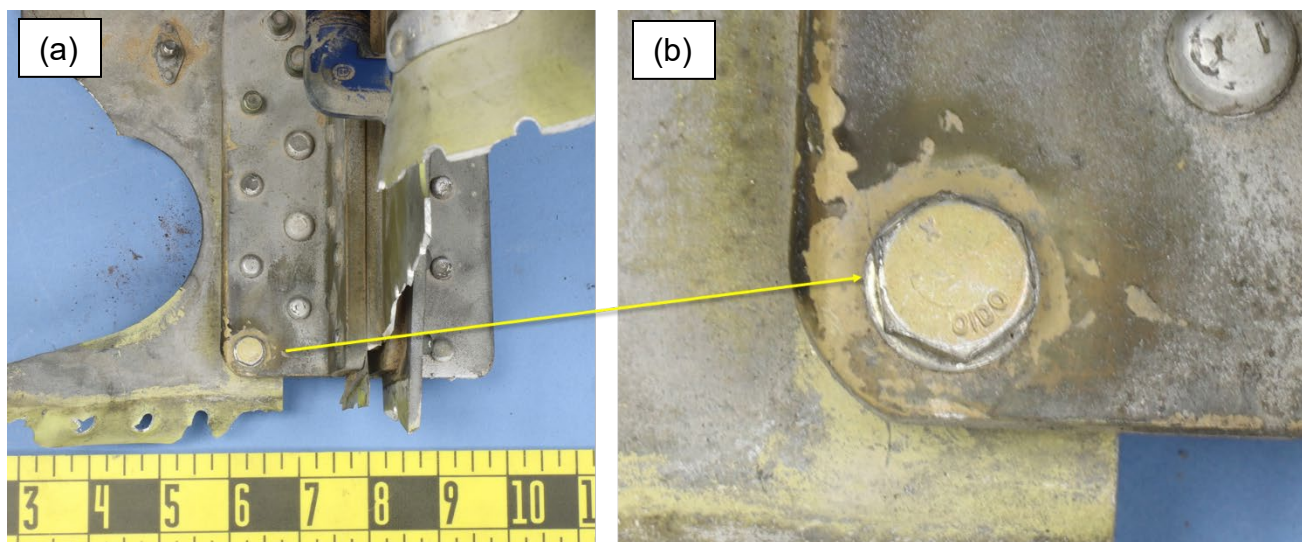
Figure 6 – View of the bolt at the fatigue crack initiation of the lower outboard spar cap fracture surface.

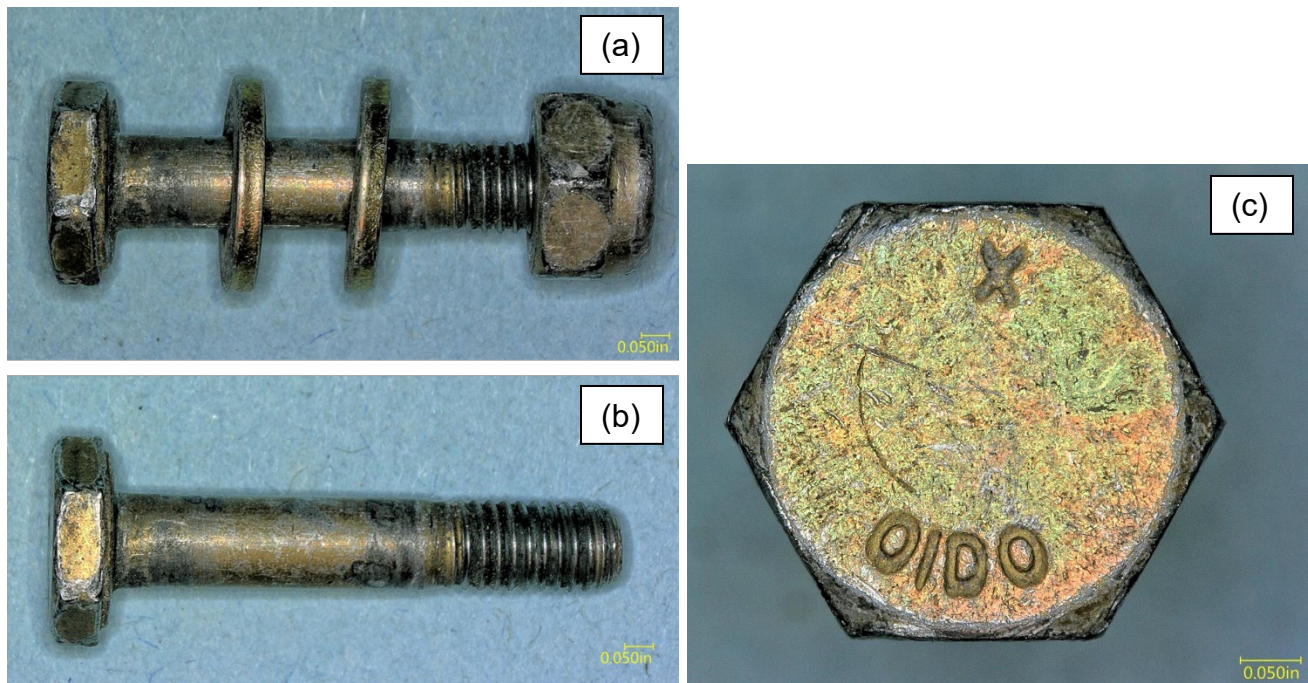
The hex-head bolt is shown in Figure 7, including showing the two washers and nut included in the assembly. The head markings were "01DO X", which indicated it had been manufactured by Mac Fasteners, Inc.<sup>1</sup> Using dial calipers, various dimensions of the bolt were measured. These included:

- Shank diameter = 0.1875" (3/16")
- Thread pitch = 33 threads/inch
- Shank length = 1.035"
- Threaded length = 0.345"
- Head height = 0.121"
- Head width = 0.3725" (3/8")
- Grip length = 0.690"

Figure 7 – View of the fastener bolt from Figure 6, after removal (a) showing the two washers and nut (b) from the side, and (c) from the head face.

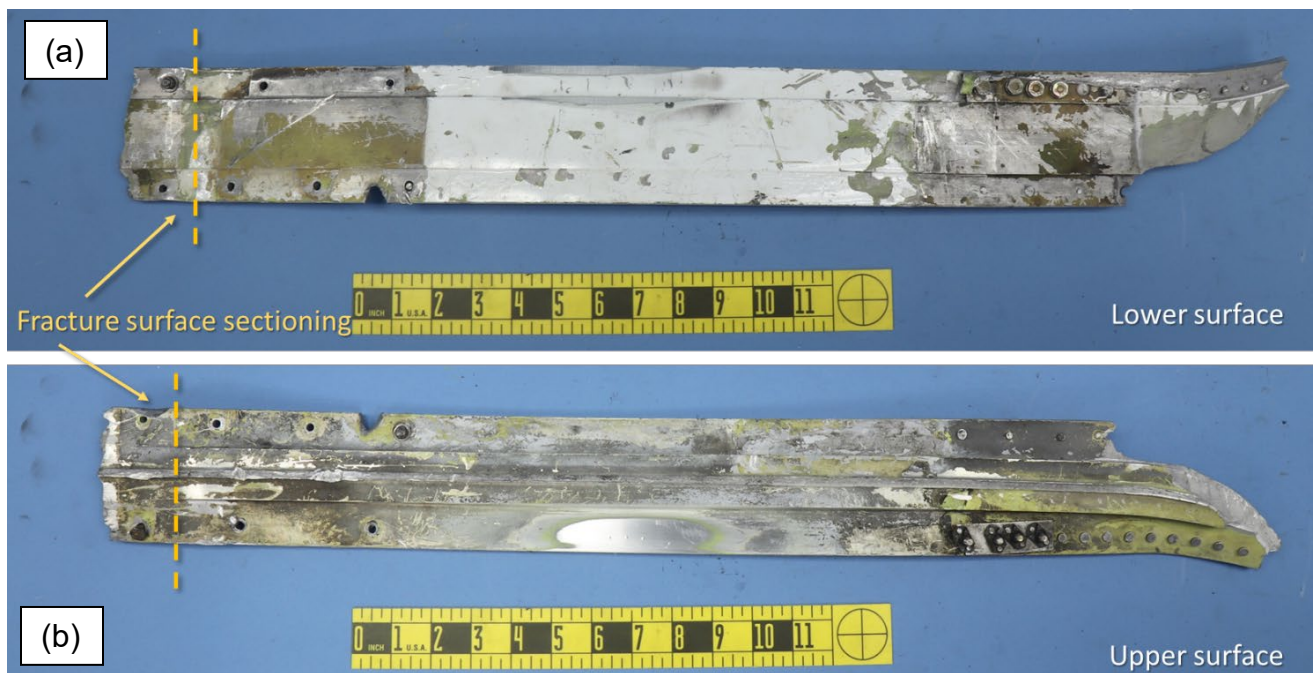
Figure 8 shows the opposite lower and upper sides of the lower inboard spar cap remnant, as received. This spar cap remnant had been separated from any adjacent components, with most of the rivets and fasteners having been removed. The inboard fracture surface, located on the left in the figures, was sectioned two inches from the fracture to facilitate microscopic examination.

Figure 8 – View of the lower inboard spar cap remnant from (a) the lower and (b) upper surfaces.

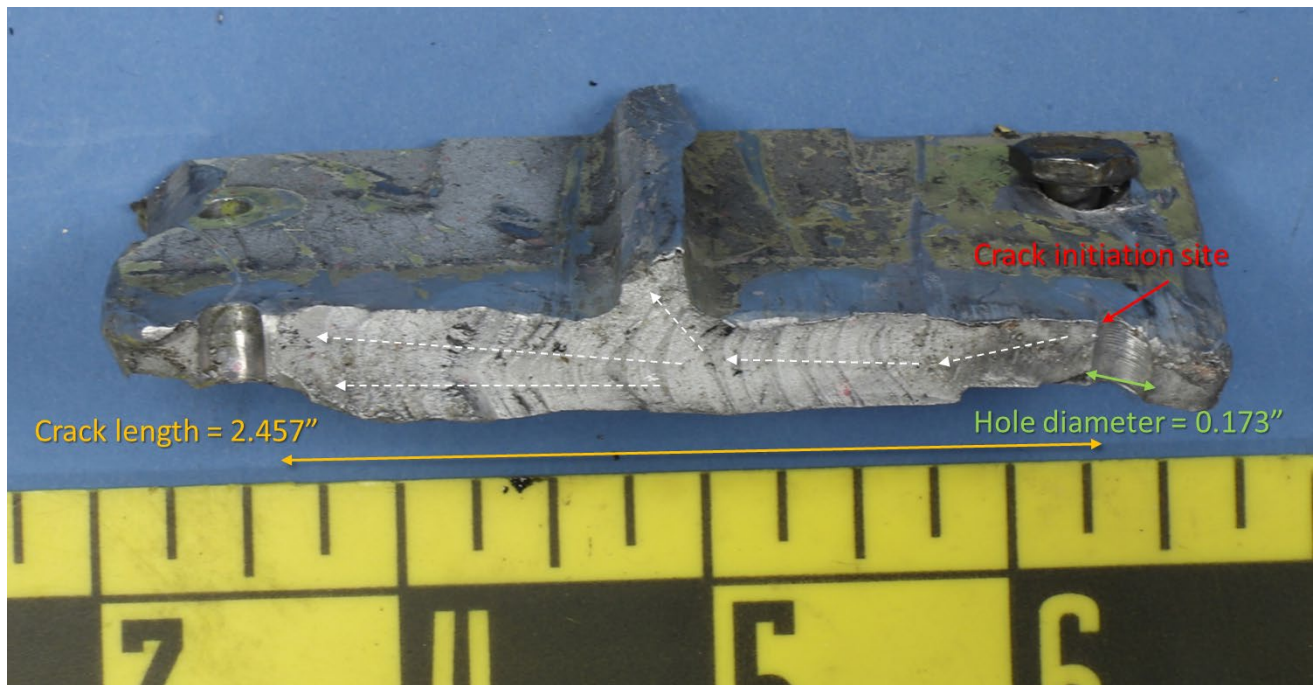
Figure 9 shows the sectioned lower inboard spar cap fracture surface. Many of its features mirrored those of the outboard fracture surface (see Figure 3), although this side exhibited more post-fracture damage, apparent on not only the fracture surface but also the upper and lower surfaces. The fracture surface shows convex crack arrest marks,

consistent with having emanated from the aft fastener hole where the bolt had been positioned. The hole diameter measured 0.173 inches, and the crack length between fastener holes measured 2.457 inches long. As denoted in Figure 9, and shown in a closer view in Figure 10, the crack appeared to have initiated towards the upper forward side of the bolt fastener hole (upper left corner in Figures 9 and 10).

Figure 9 – View of the fracture surface of the inboard lower spar cap fracture surface, after sectioning.

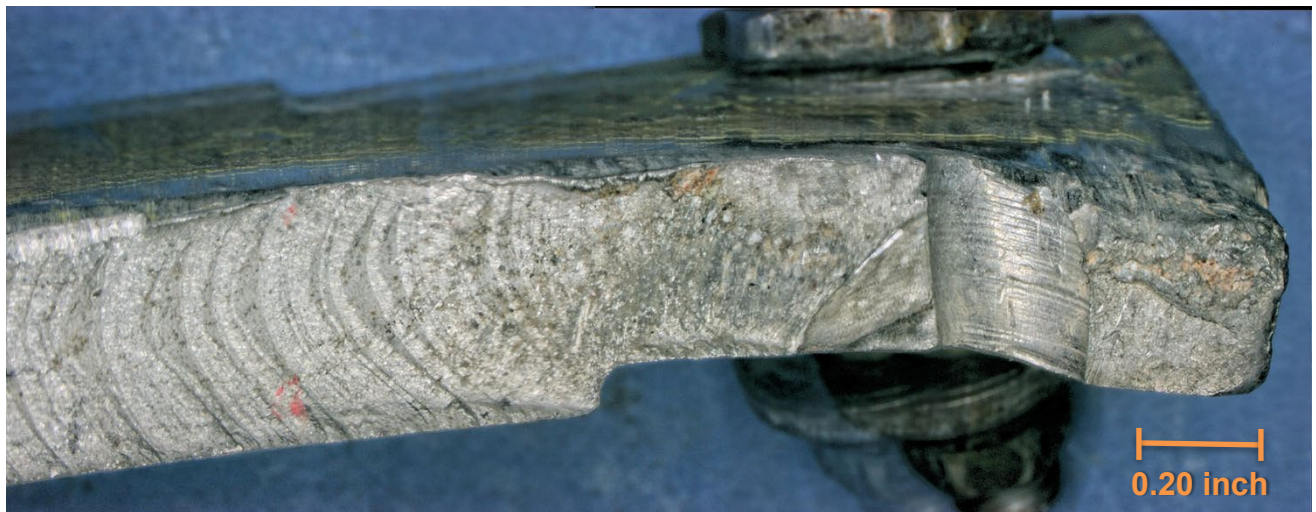
Figure 10 – Close view of the inboard lower spar cap fracture surface near the fastener hole initiation site.

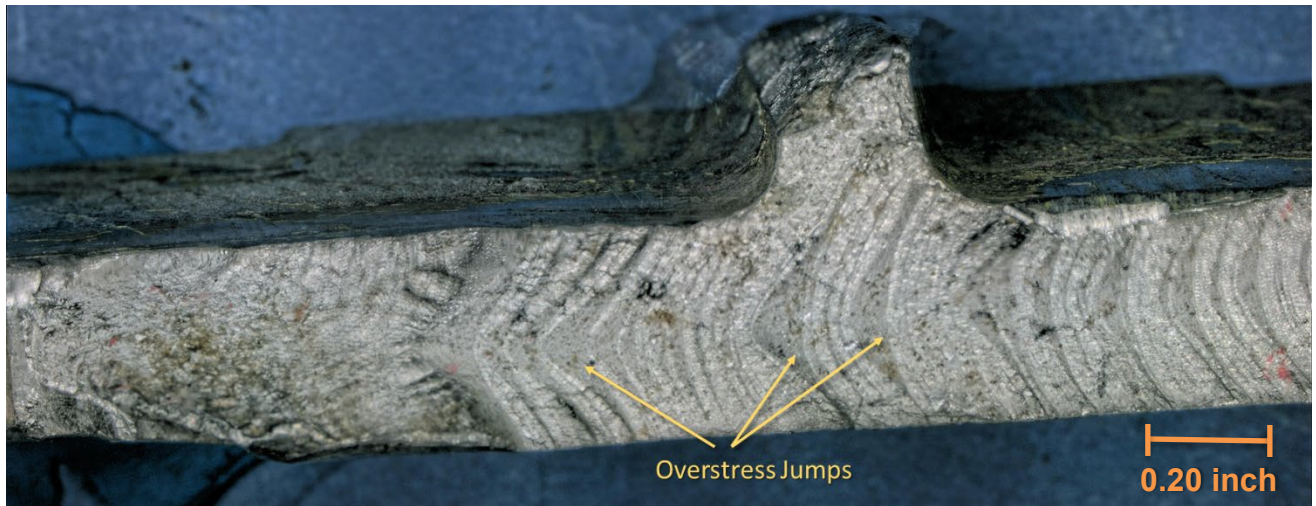
Figures 11 and 12 show the middle and end of the lower inboard spar cap fracture surface. More pronounced than in Figure 10, there were alternating features of smoother, more reflective bands among rougher, duller bands. As demonstrated in Figures 12 and 13, these features were consistent with overstress 'jumps' that can occur from intermittent higher loads during prolonged crack propagation under cyclic loading.

Figure 11 – View of the inboard lower spar cap fracture surface near the T-remnant, showing intermittent overstress jumps along the fatigue crack face.

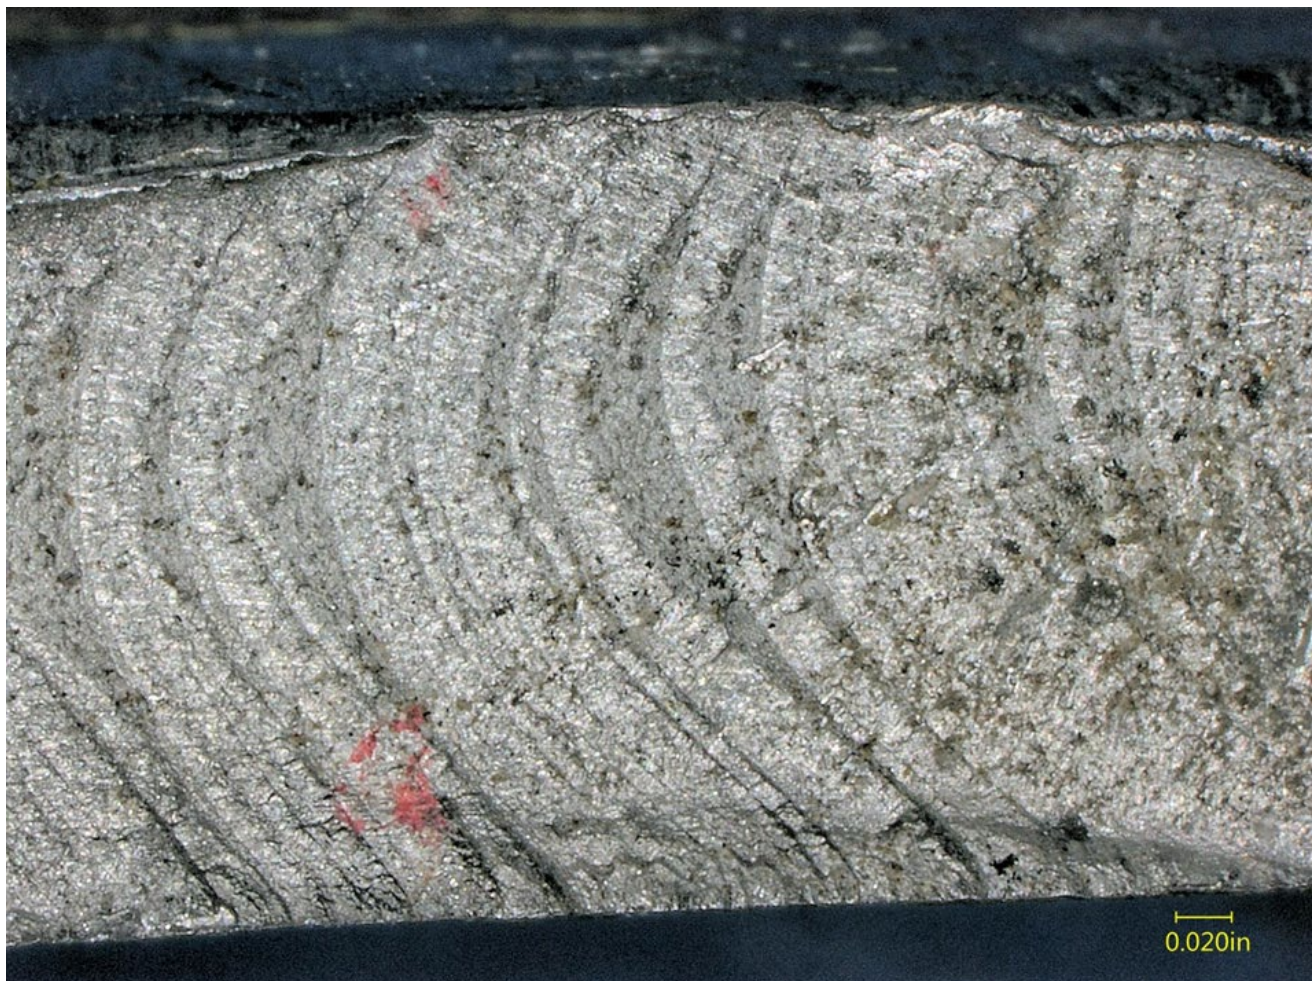
Figure 12 – Fracture surface of the inboard lower spar cap closer to fastener hole.

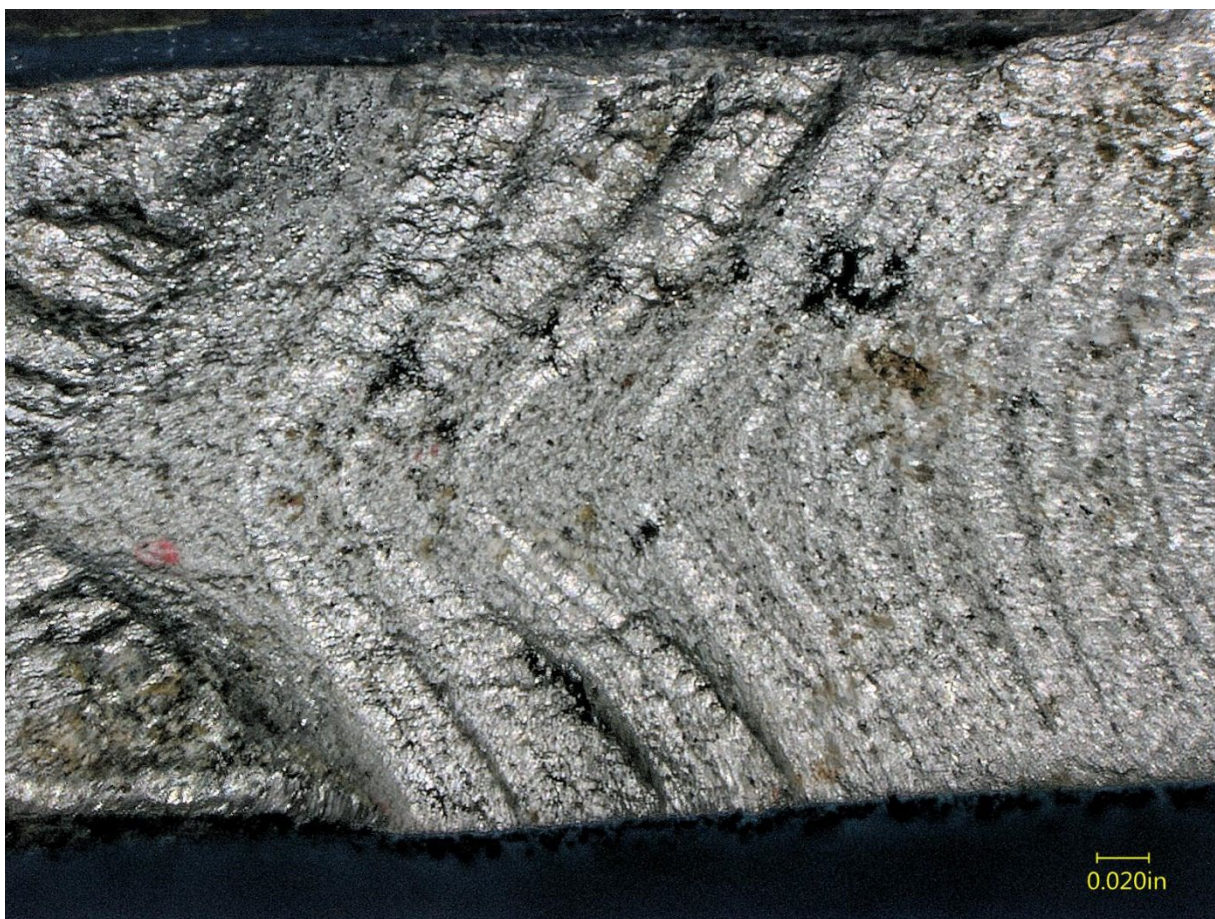
Figure 13 – Fracture surface of the inboard lower spar cap away from fastener hole

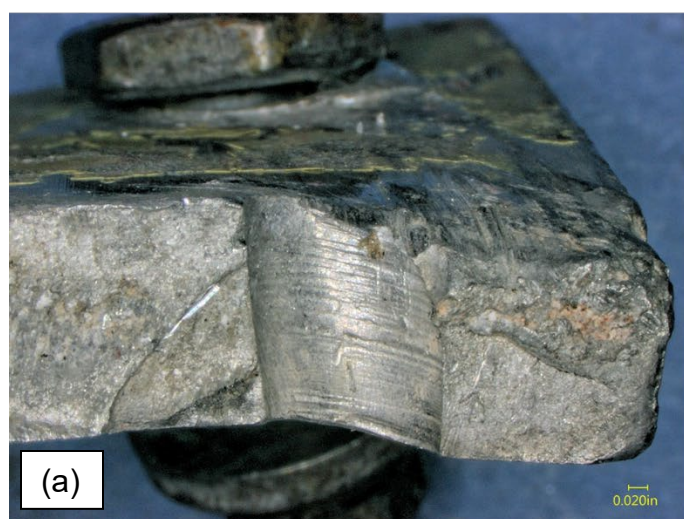
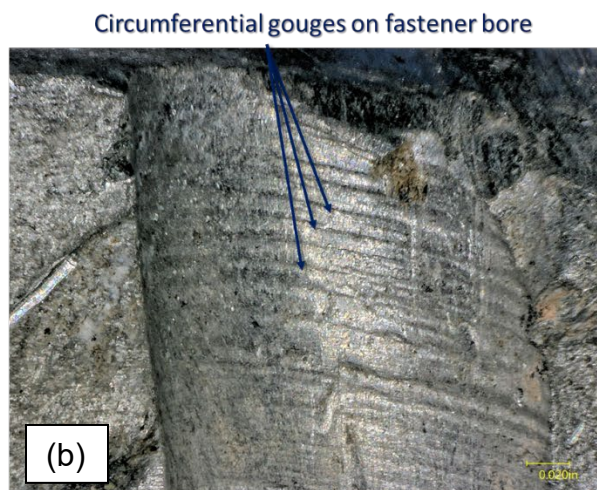
Figure 14 shows two views of the aft fastener hole, where the lower spar cap crack had originated. Cracks were observed emanating from each side of the hole, having propagated in opposite directions. The aftmost portion of the spar cap remnant and fastener hole had been deformed downward, consistent with deformation subsequent to cracking and fracture. The fastener hole did exhibit several parallel circumferential gouge marks, as highlighted in Figure 14b.

Figure 14 – View of the fastener hole in the inboard lower spar cap (a) overall and (b) closer, showing circumferential gouges on the surface.

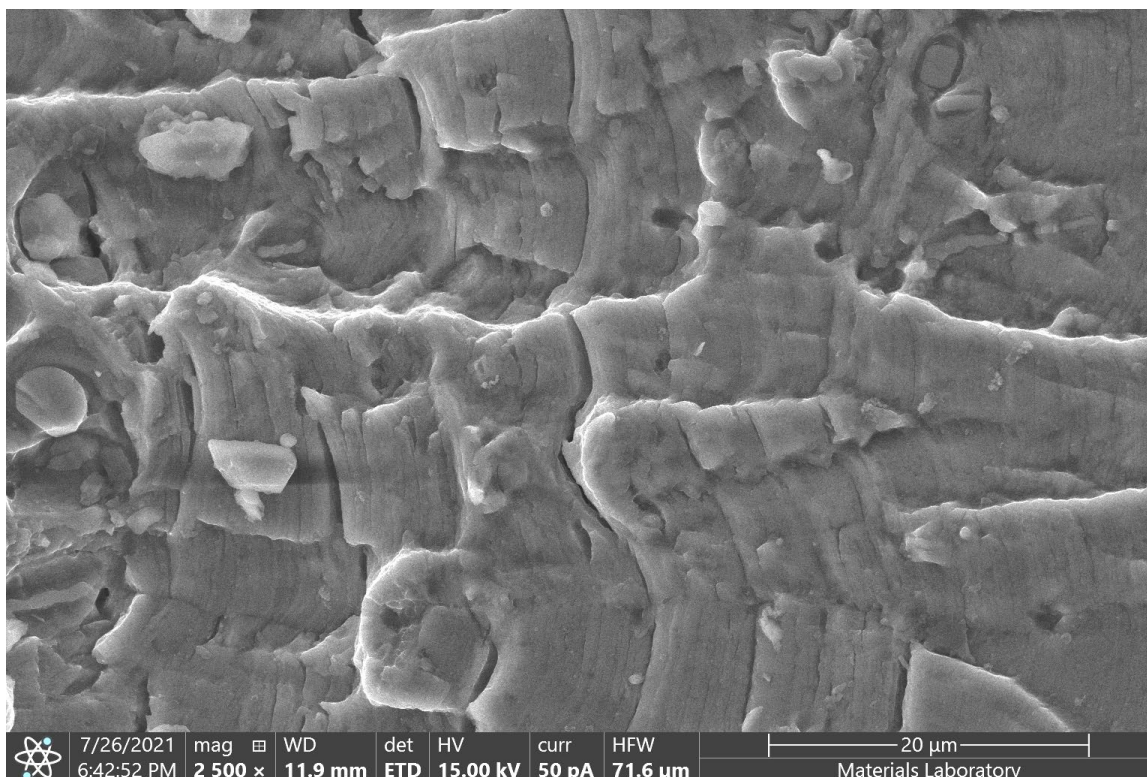
The fracture surface was examined in a field emission scanning electron microscope (SEM) after mild ultrasonic cleaning with acetone. Figure 15 and Figure 16 show typical areas of the lower spar cap fracture surface, exhibiting striations. These striations were consistent with fatigue crack propagation. The striations were not equally spaced, but rather exhibited larger jumps or gaps, with smaller-spaced striations in between. These features, as illustrated in Figure 16, were indicative of crack propagation under spectrum loading.

Figure 15 – Secondary electron (SE) micrograph of fatigue striations near the crack initiation site of the inboard lower spar cap fracture in Figure 12.

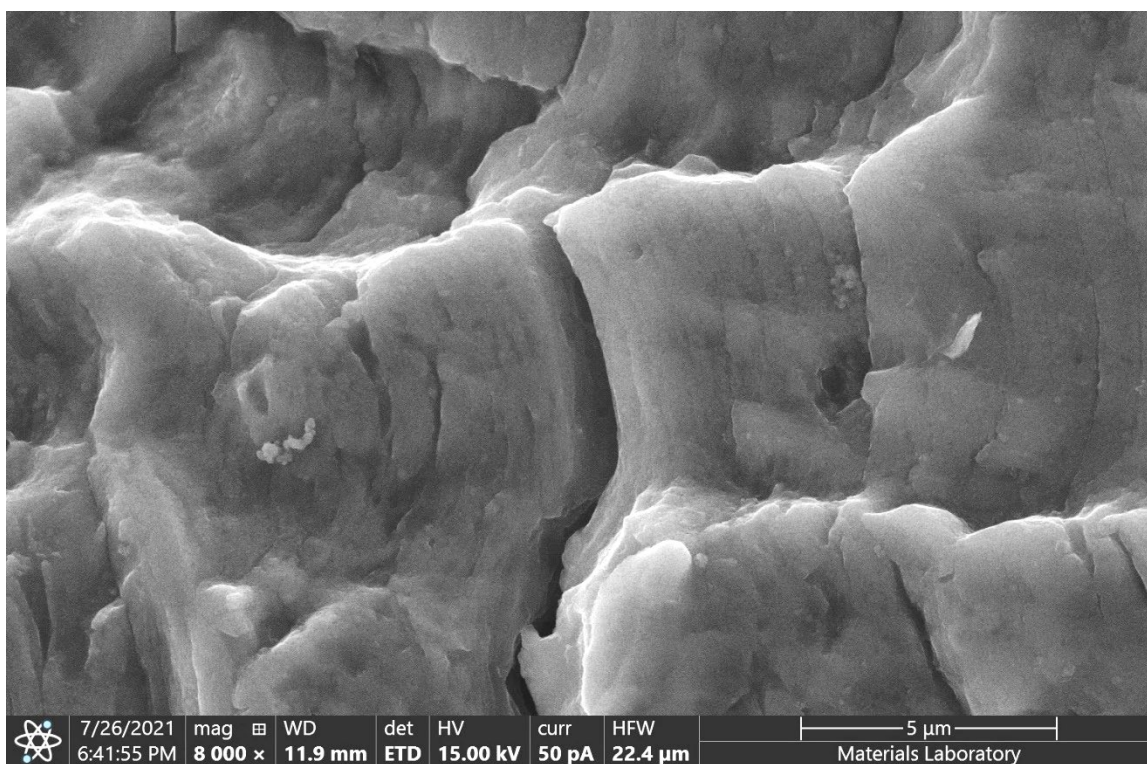
Figure 16 – SE micrograph of striations in Figure 15, showing smaller striations among larger ones along the fracture.

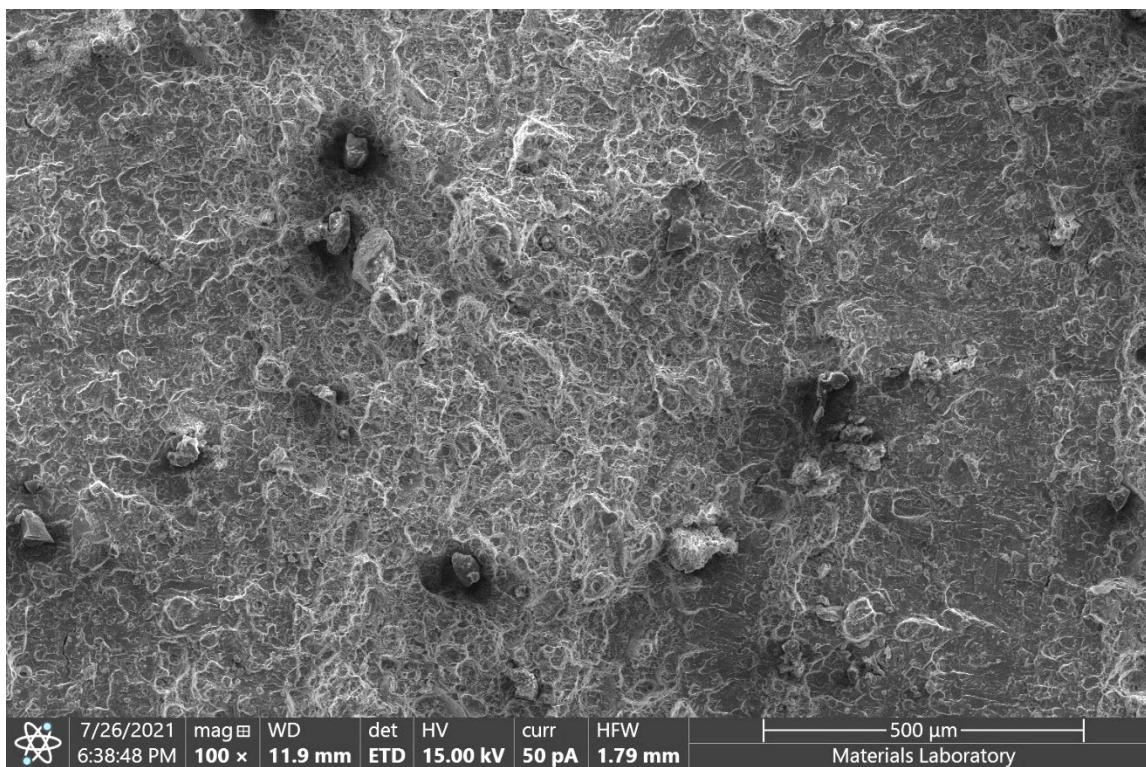
The areas with overstress 'jumps,' shown in Figures 11 through 13, exhibited a rougher surface with features different than fatigue striations. As demonstrated in Figure 17 and Figure 18, the bands consisted of dimpled rupture, consistent with localized overstress fracture. The presence of intermittent overstress bands was consistent with elevated loading in short durations, such that the remainder of the cap cross section did not completely fracture.

Figure 17 – SE micrograph showing the overall topography of an overstress jump on the inboard lower spar cap fracture surface.

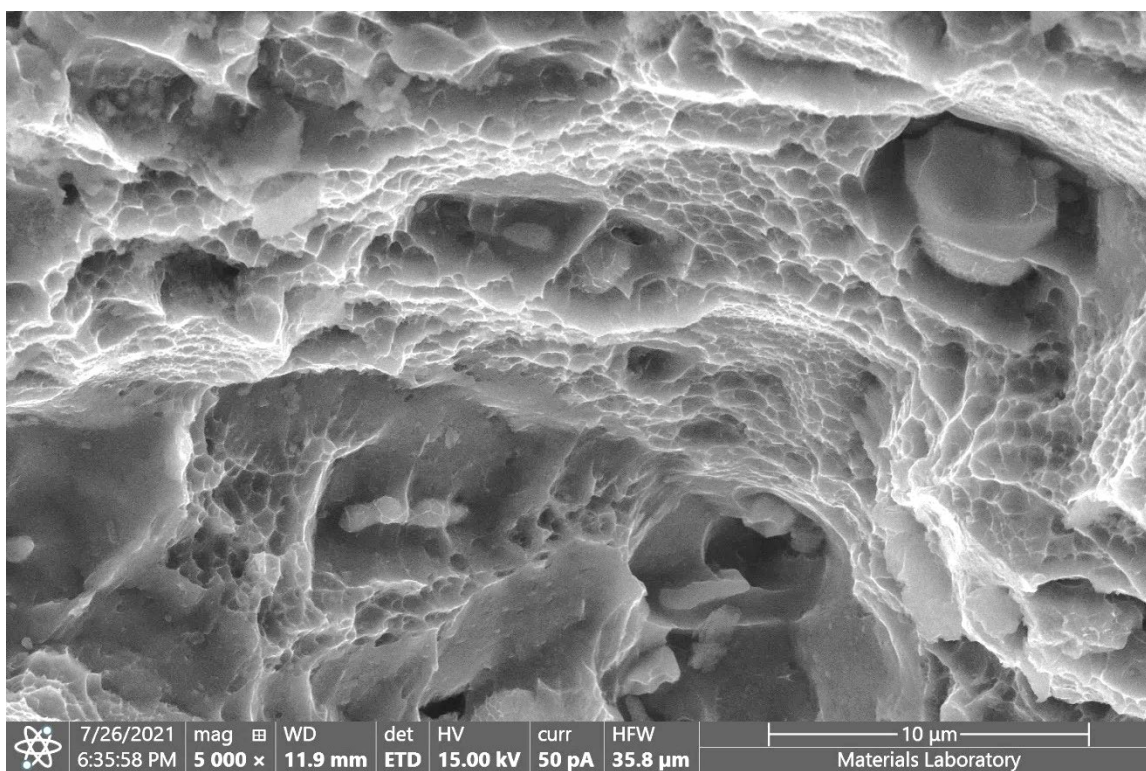
Figure 18 – SE micrograph of typical dimpled rupture features in Figure 17.

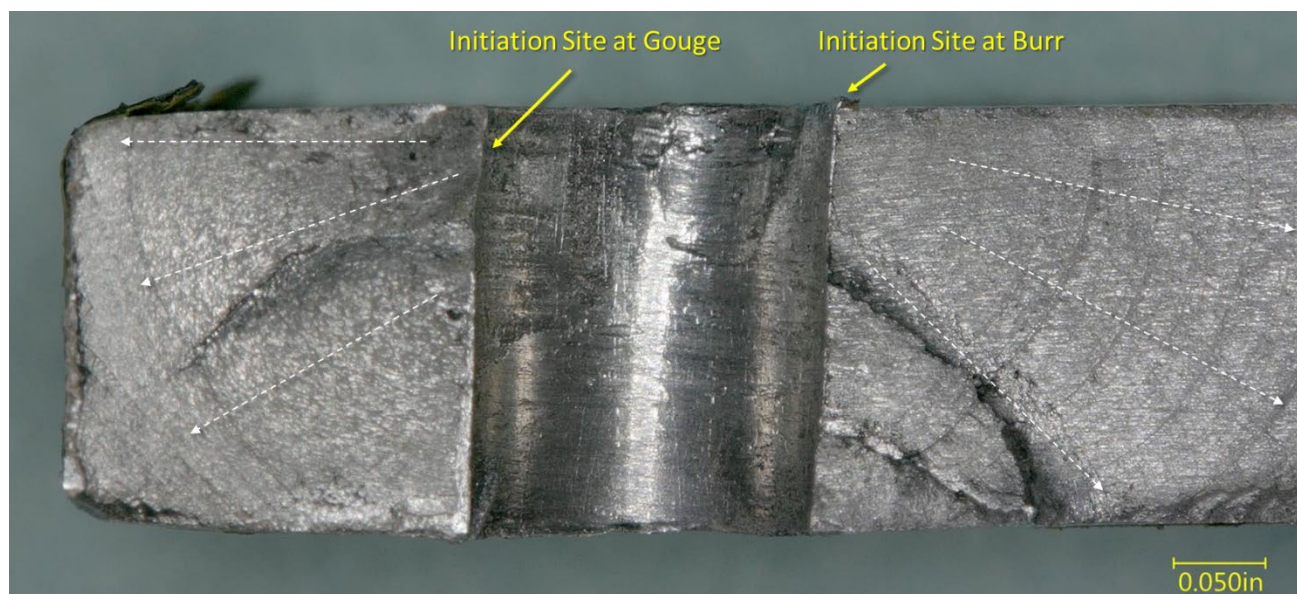
The lower outboard spar cap was disassembled and then sectioned to allow for microscopic examination. This fracture surface had not been deformed or damaged following fracture and was used as a more representative surface for examination once disassembled. Figure 19 shows an overall view of the aft fastener hole where the bolt had been located. This figure was annotated to show the locations of the crack initiation sites for the smaller aft fatigue crack and the main forward-propagating fatigue crack. The main fatigue crack had initiated at a burr at the edge or forward corner of the fastener hole, whereas the aft crack had initiated at two gouges along an indent on the hole bore wall (see Figure 20).

The total length of the main crack, located between the two fastener holes was 2.484 inches, with the smaller crack to the left in Figure 19 being 0.312 inches long. The

Figure 19 – View of the mating outboard lower spar cap fracture surface near the bolt hole, showing two specific initiation sites on opposite sides.

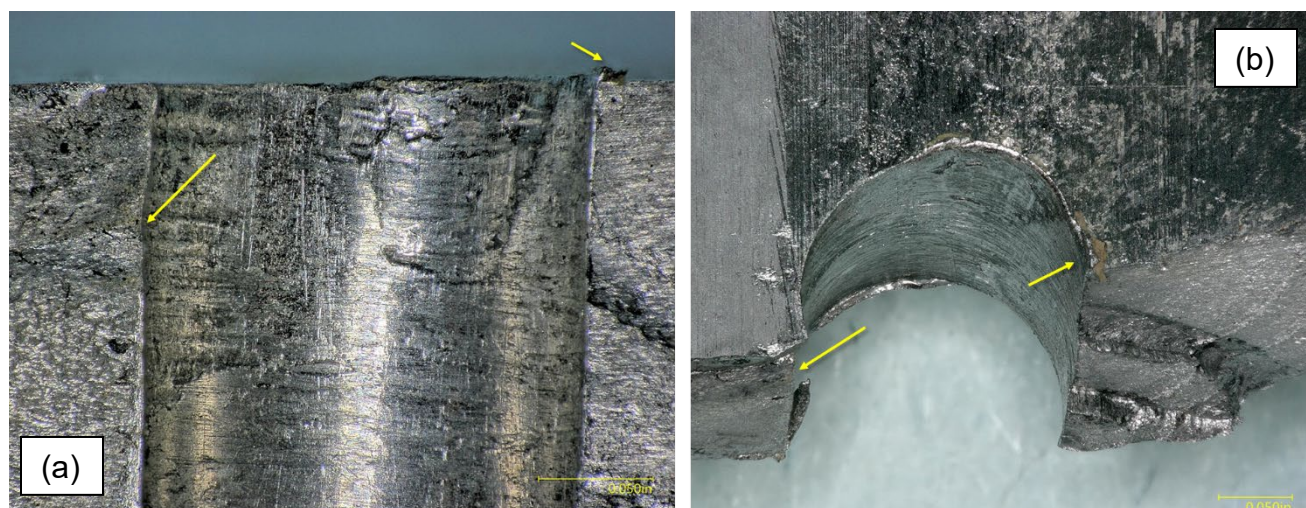
Figure 20 – Closer views of the outboard lower spar cap fracture surface initiation sites around the fastener hole from (a) the fracture surface and (b) the upper surface, showing the upward burr.

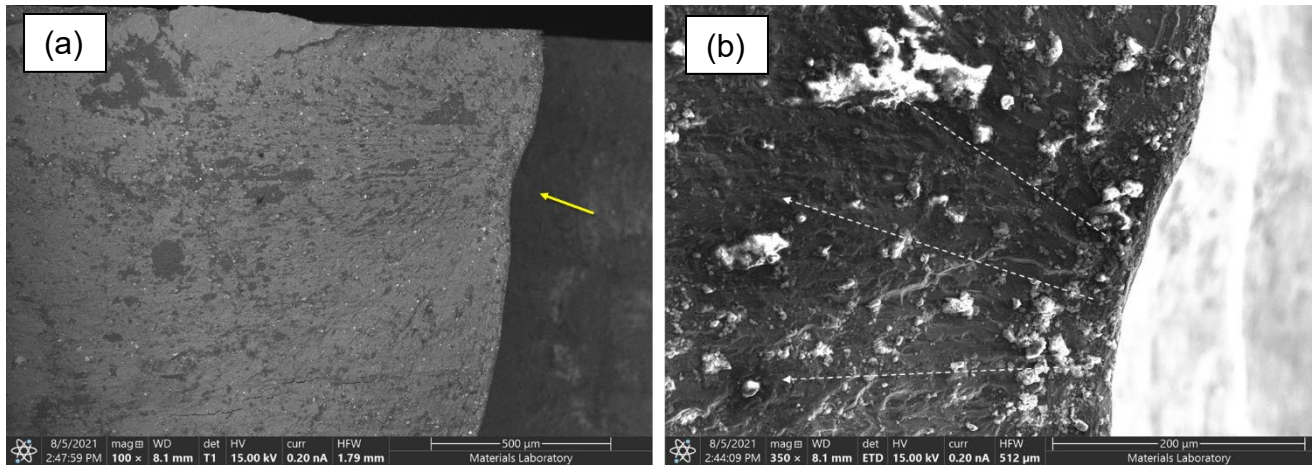
Figure 21 shows a closer view of the aft fatigue crack initiation sites. There were no indications of a materials defect such as a corrosion pit or inclusion. Rather, the feature was an indent at a mechanical gouge. Such a feature would be able to act as a stress concentrator during cyclic loading, initiating a crack. Similarly, Figure 22 shows the crack initiation site of the main fatigue crack, located at the corner with upward-displaced material, consistent with a burr from machining. This exhibited material that had deformed upward and then been folded back under itself, which can act as a stress concentrator.

Figure 21 – Views of the aft fatigue crack initiation sites at the fastener bore edge using (a) backscattered mode (BE) and (b) secondary mode (SE). The dashed white arrows demonstrate the crack growth direction and the yellow arrow denotes the initiation site location.

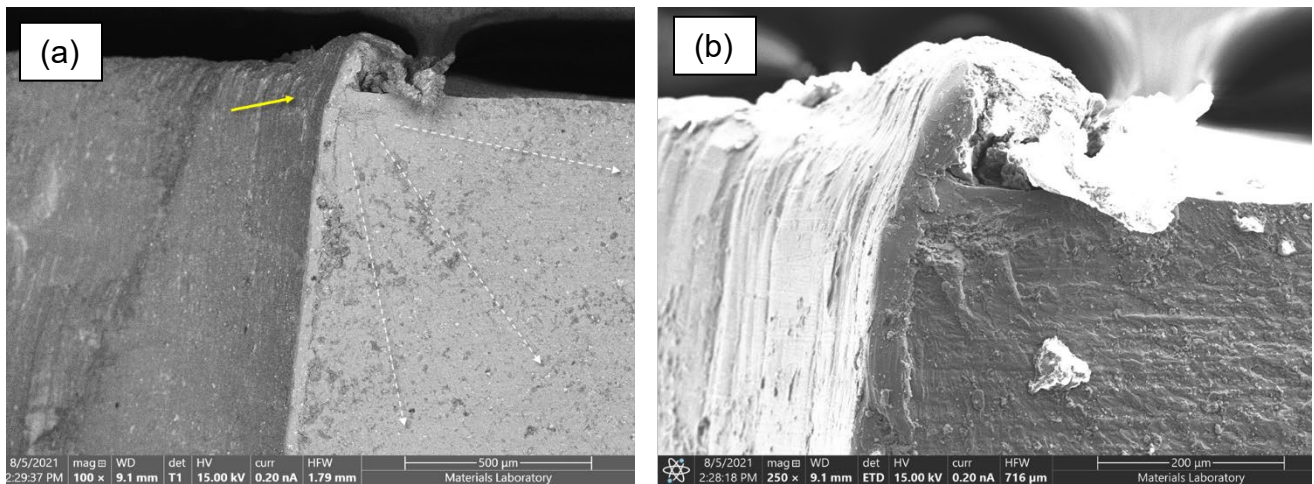
Figure 22 – Views of the forward or main fatigue crack initiation site at the fastener bore corner using (a) backscattered mode and (b) secondary mode. The dashed white arrows demonstrate the crack growth direction and the yellow arrow denotes the initiation site location.

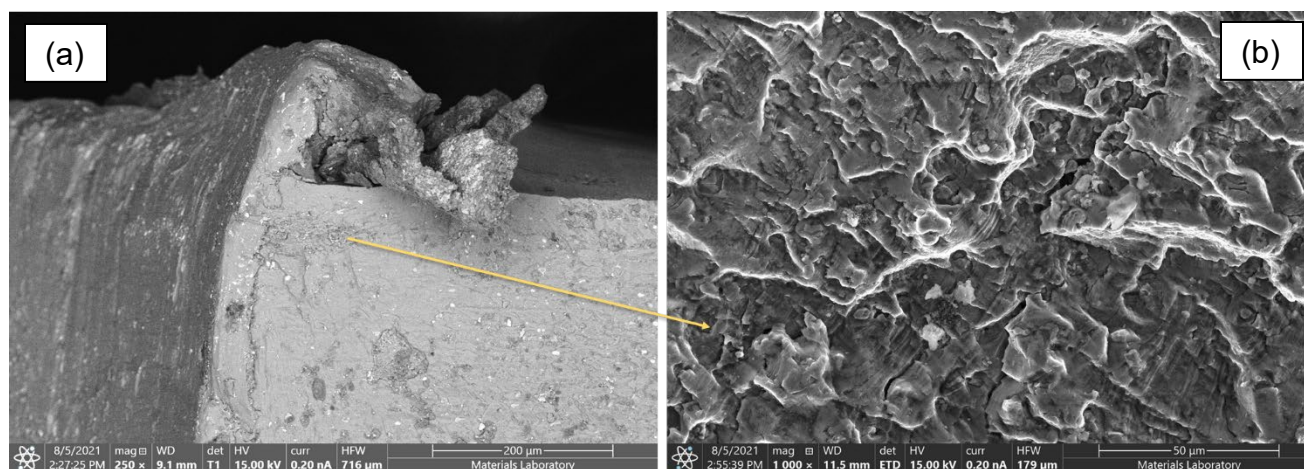
Figure 23 shows a closer view of the main fatigue crack initiation site, showing fatigue striations emanating from the feature. In addition, the backscattered electron examination showed no dissimilar material, such as an inclusion in the area. Figure 24 shows another view of the crack initiation site, after further cleaning with a proprietary chromic acid-based aluminum cleaner. This figure shows river patterns emanating from the corner, as well as the striations and crack arrest marks consistent with the direction of crack propagation toward the forward direction. In addition, there was a small (~140  $\mu\text{m}$  long) subsurface area with faceted features. Figure 25 shows a closer view of this area, showing the small, rounded facets.

Figure 23 – BE micrograph of the forward crack initiation site, (a) showing a burr at the corner of the fastener bore and surface, with (b) an SE micrograph showing striations adjacent to the surfaces.
