# NATIONAL TRANSPORTATION SAFETY BOARD

## MATERIALS LABORATORY FACTUAL REPORT

Report No. 22-014

Place : Wikieup, Arizona  
Date : July 10, 2021  
Vehicle : Beech C-90, N3688P  
NTSB No. : WPR21FA266  
Investigator : Albert Nixon, AS-WPR

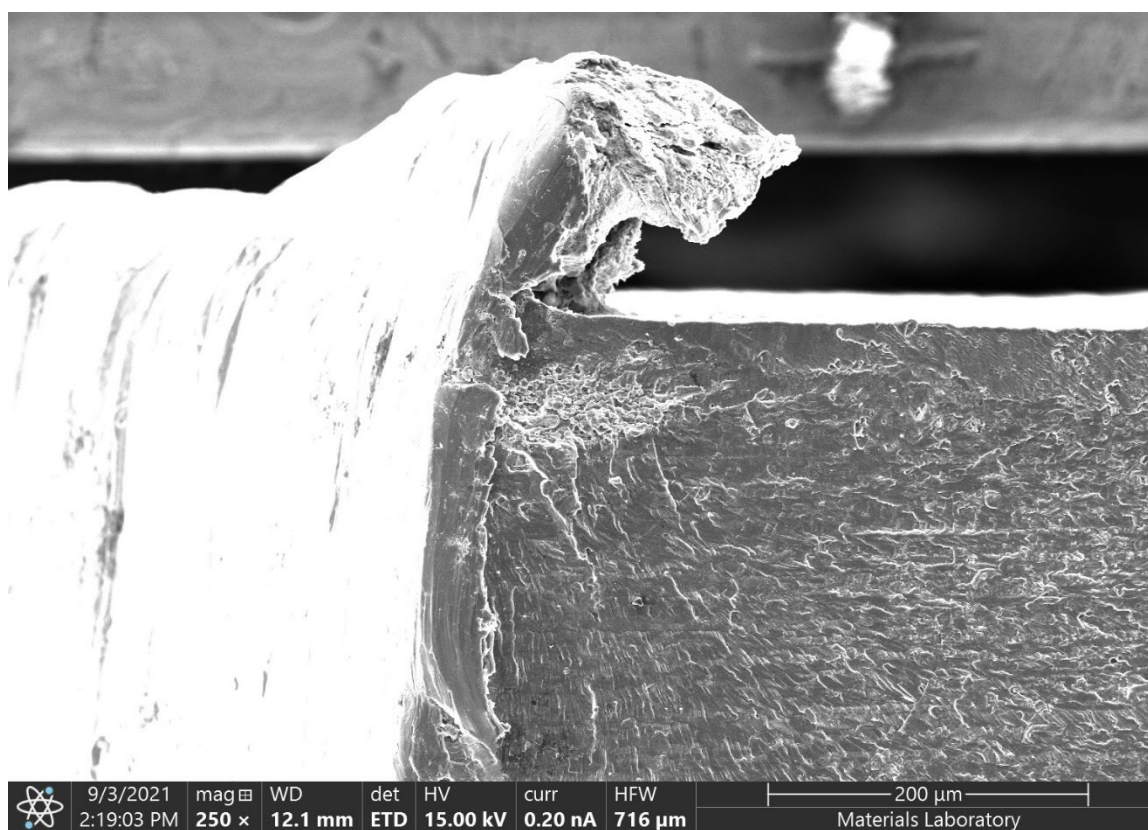
Figure 23 shows a closer view of the main fatigue crack initiation site, showing fatigue striations emanating from the feature. In addition, the backscattered electron examination showed no dissimilar material, such as an inclusion in the area. Figure 24 shows another view of the crack initiation site, after further cleaning with a proprietary chromic acid-based aluminum cleaner. This figure shows river patterns emanating from the corner, as well as the striations and crack arrest marks consistent with the direction of crack propagation toward the forward direction. In addition, there was a small (~140  $\mu\text{m}$  long) subsurface area with faceted features. Figure 25 shows a closer view of this area, showing the small, rounded facets.

Figure 24 – SE micrograph showing a closer view of the machining burr at the forward fatigue crack initiation site.

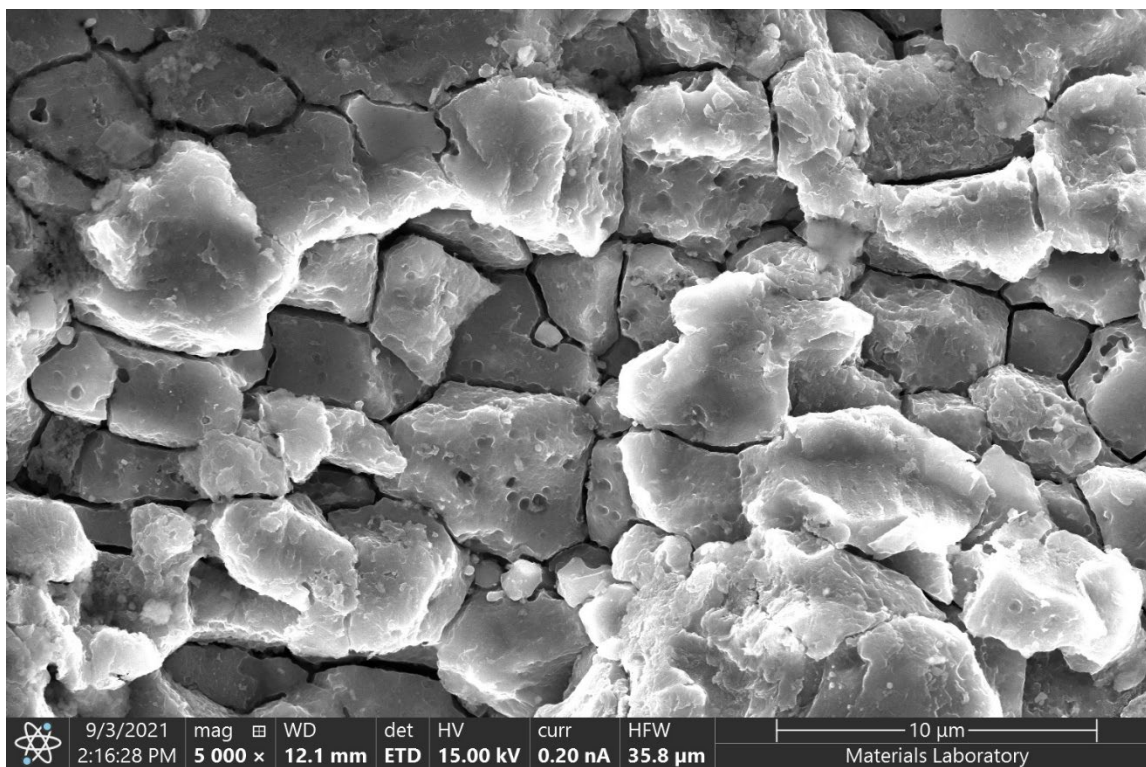
Figure 25 – SE micrograph of intergranular facets at the crack initiation site in Figure 24.

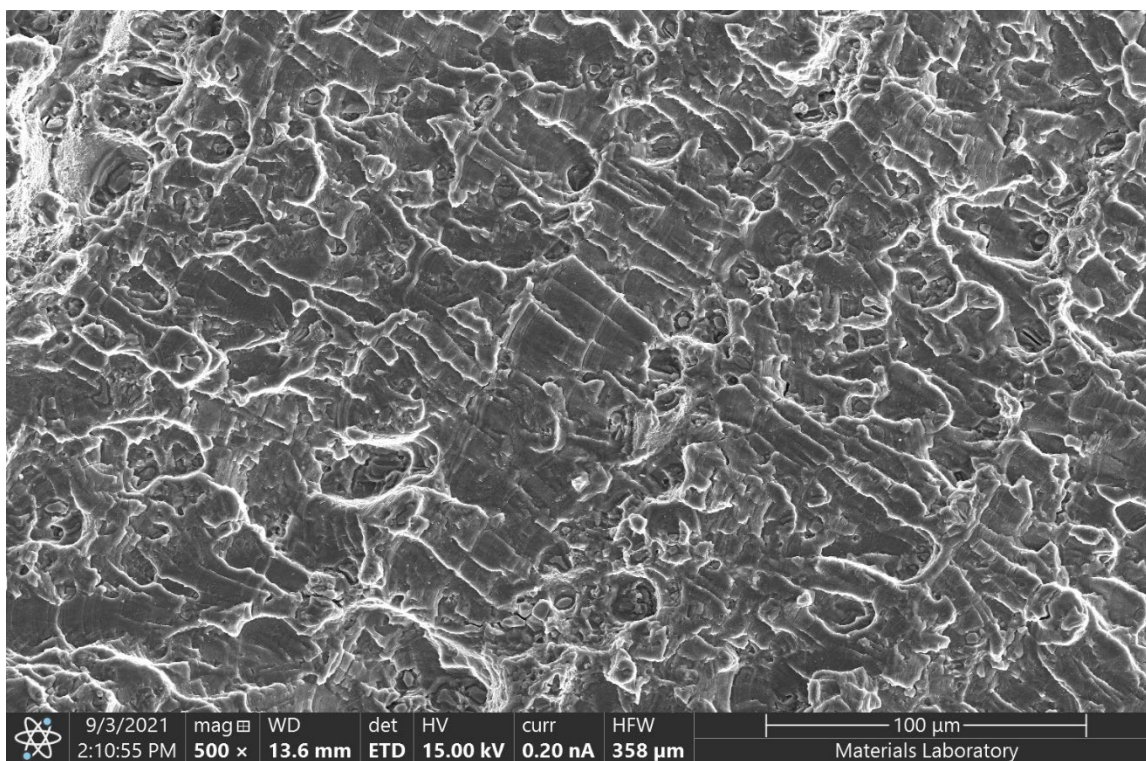
Figure 26 shows a typical area of fatigue striations on the lower outboard spar cap fracture surface. As stated earlier, the surface exhibited regularly spaced smaller striations, and irregularly spaced larger striations. This is shown in Figure 27 from the outboard side. In addition, there were 151 overstress jumps counted along the outboard fatigue crack. These features were quantified in detail as discussed in *Materials Laboratory Addendum Report 22-014B*.

Figure 26 – SE micrograph of fatigue striations on the outboard fracture surface, after cleaning.

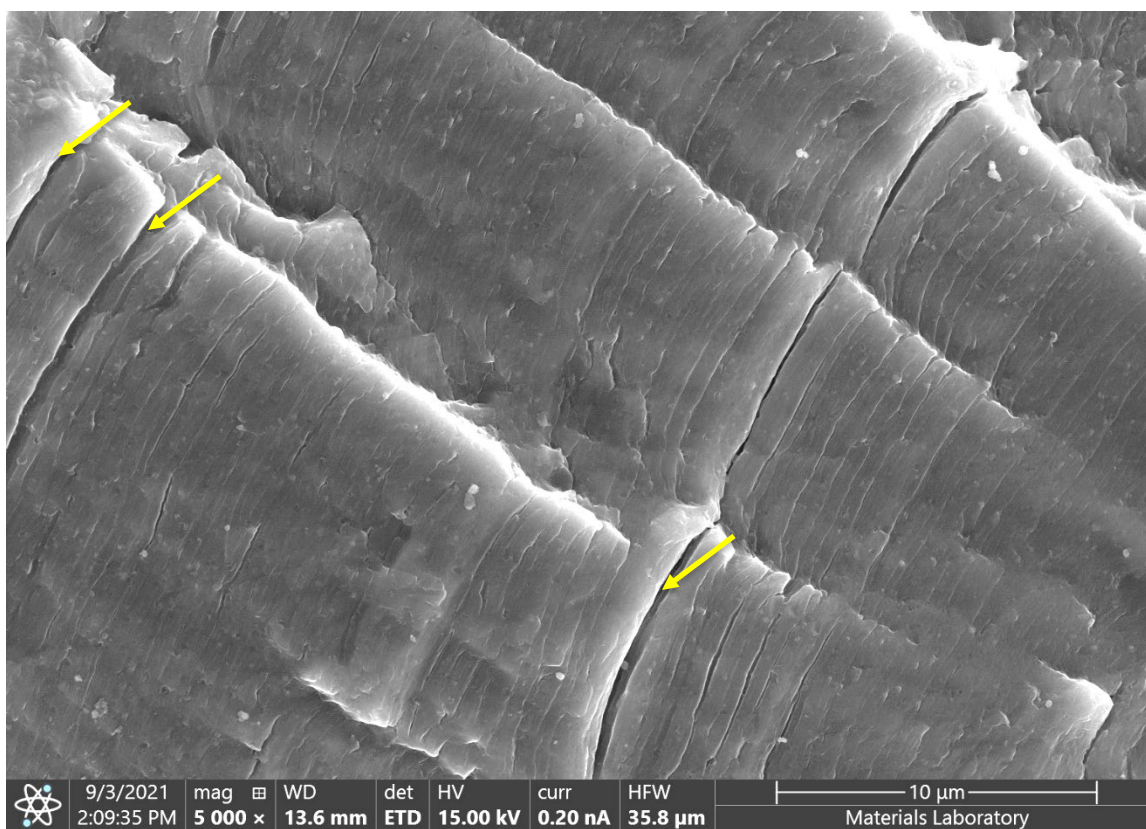
Figure 27 – SE micrograph highlighting the striations in Figure 26, with yellow arrows denoting the larger or deeper features.

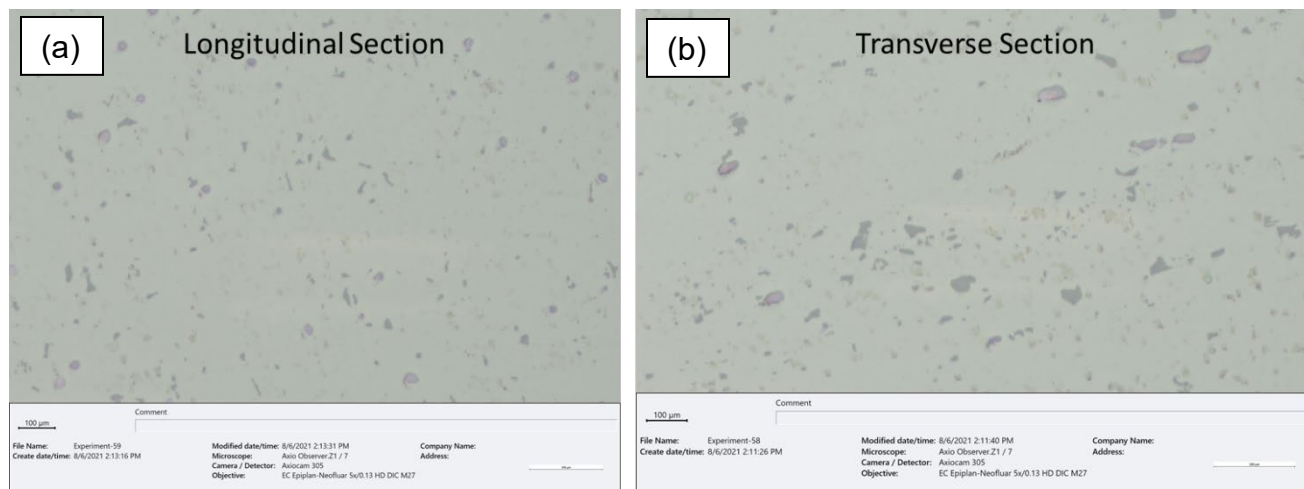
The lower spar cap was cross sectioned in different directions, mounted, and polished. Figure 28 shows the spar cap microstructure from the longitudinal and transverse directions. There were no indications of cracks or intergranular defects or phases in the microstructure. The chemical composition was examined using energy dispersive x-ray spectroscopy (EDS) and x-ray fluorescence (XRF). The chemical composition was consistent with AA 2014 aluminum alloy. This indicated the bluish constituents in Figure 28 were consistent with copper-rich precipitates typical of this alloy. The hardness was examined per ASTM E18.<sup>2</sup> The hardness averaged 82 HRBW. The electrical conductivity was examined using ASTM E1004.<sup>3</sup> The conductivity averaged 39.2 %IACS. These data were consistent with a T6 or peak-aged temper for this alloy.

Figure 28 – Bright field (BF) optical micrographs of the wing spar cap cross sectioned through (a) the longitudinal and (b) transverse directions (~1000X, as-polished).

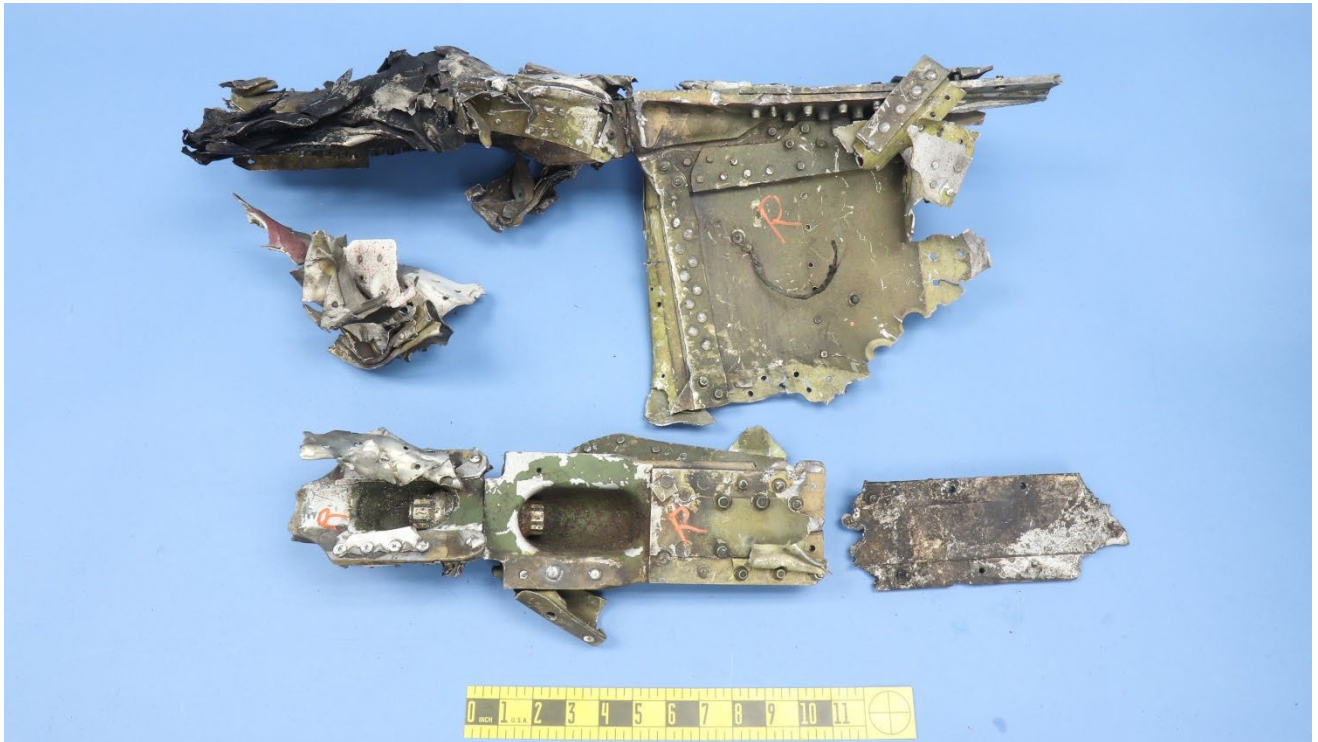
Figures 29 and 30 show the right side wing spar components, as received. These include the lower wing spar cap fragments where it was attached to the wing fittings. The

Figure 29 – View of the wing spar components from the right side.

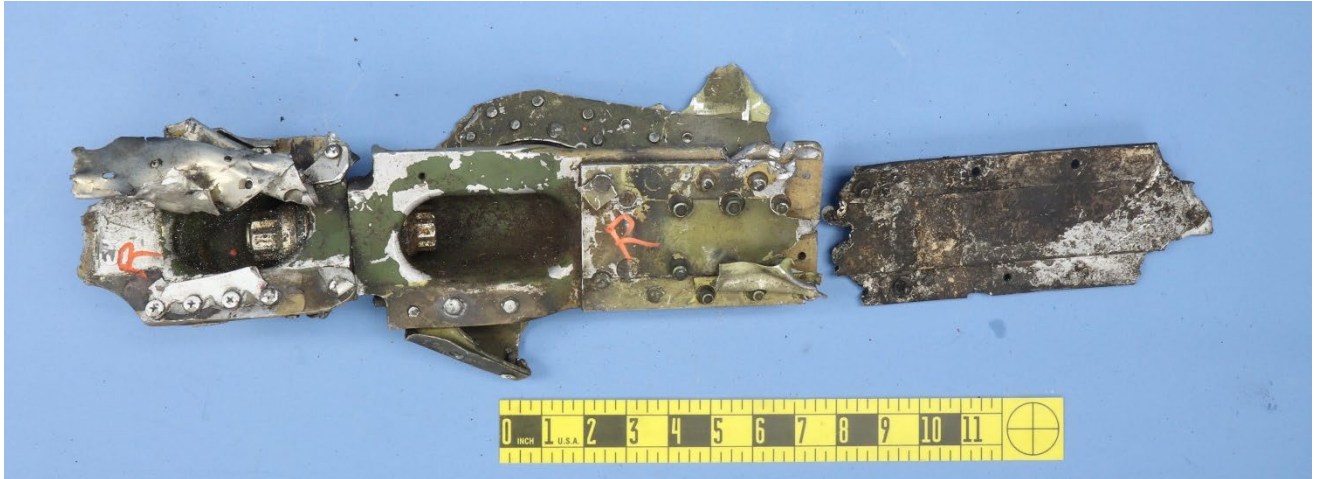
Figure 30 – Reconstruction of the lower wing spar cap and wing fittings.

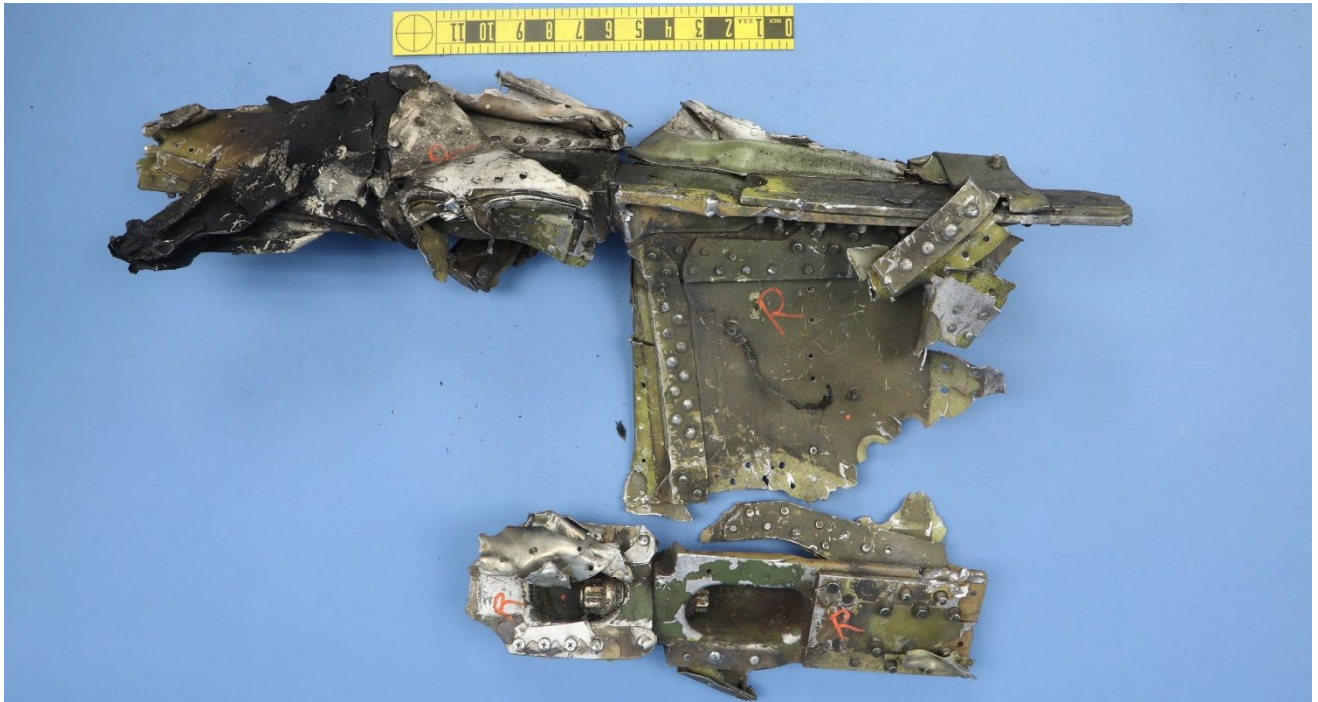
location of these components relative to the other right side spar remnants is illustrated in Figure 31. For the most part, the fractures of the skins, webs, and spar pieces exhibited out-of-plane deformation and jagged fracture surfaces. These features were indicative of subsequent fracture of the structure. This lower wing spar cap did not exhibit out-of-plane deformation, but did have a tortuous fracture surface, with some localized flatter areas (see Figure 32). Much of the inboard fracture surface exhibited post-fracture smearing, which was generally absent on the outboard side. Later examination of this fracture surface found only overstress features, with no indications of cracks or fatigue features prior to fracture.

Figure 31 – Reconstruction of right wing spar fragments.

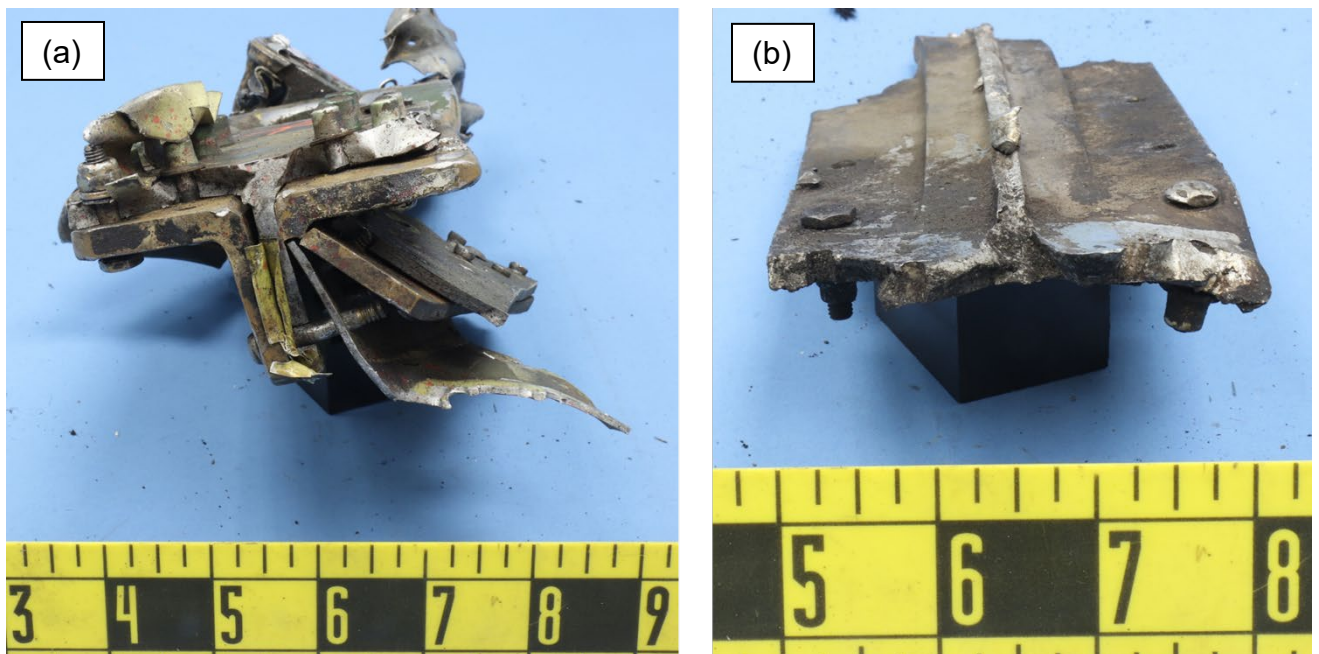
Figure 32 – Views of the fracture surface of the lower spar cap from the right side, showing the fracture from (a) the outboard and (b) inboard sides.

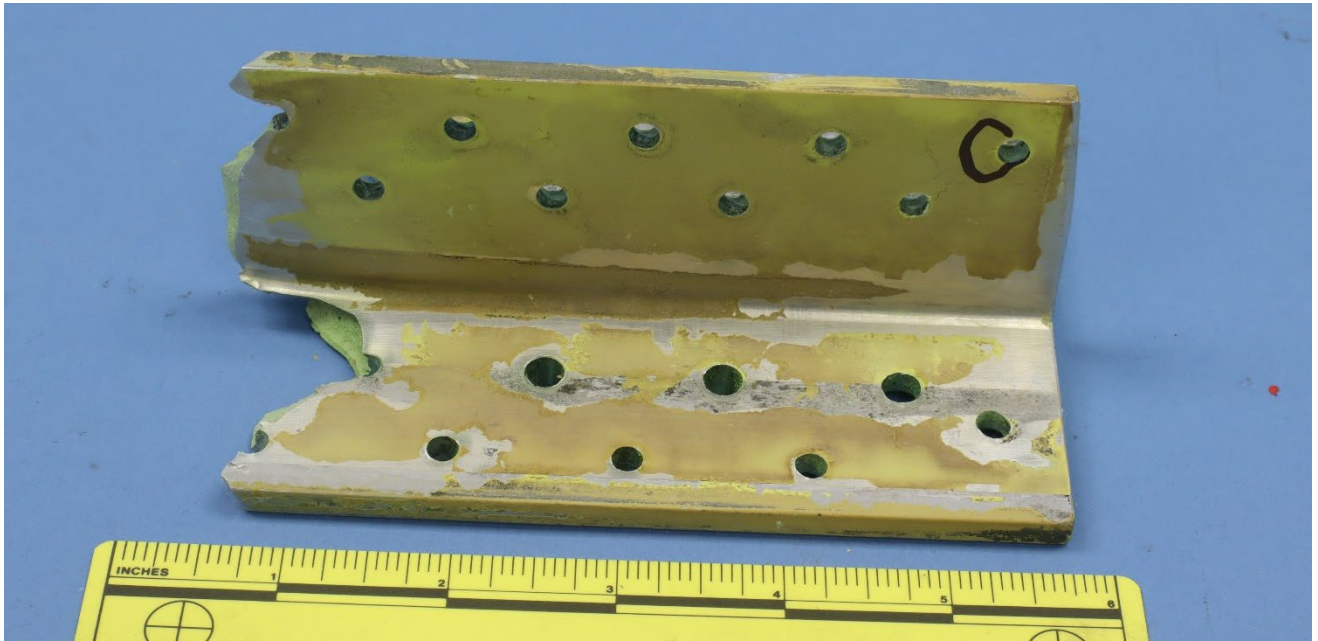
None of the fastener holes exhibited an indication except for the one location on the outboard right wing lower spar cap, shown on the upper right in Figures 33 and 34. Figure 35 shows the two indications under exposure to ultraviolet (UV) light. These features were isolated by backcutting towards the indications and intentionally overstressing them to reveal any potential subsurface features (laboratory opening). Figure 36 shows one of the mating laboratory-opened fracture surfaces, which did not reveal any fatigue cracking—the features of the opened surface were consistent with overstress. The indications were determined to be cracks in the surface primer, rather than the spar material itself.

Figure 33 – View of the outboard wing spar cap from the right side after removal of the fasteners and cleaning. The circled area in the upper left exhibited FPI indications.

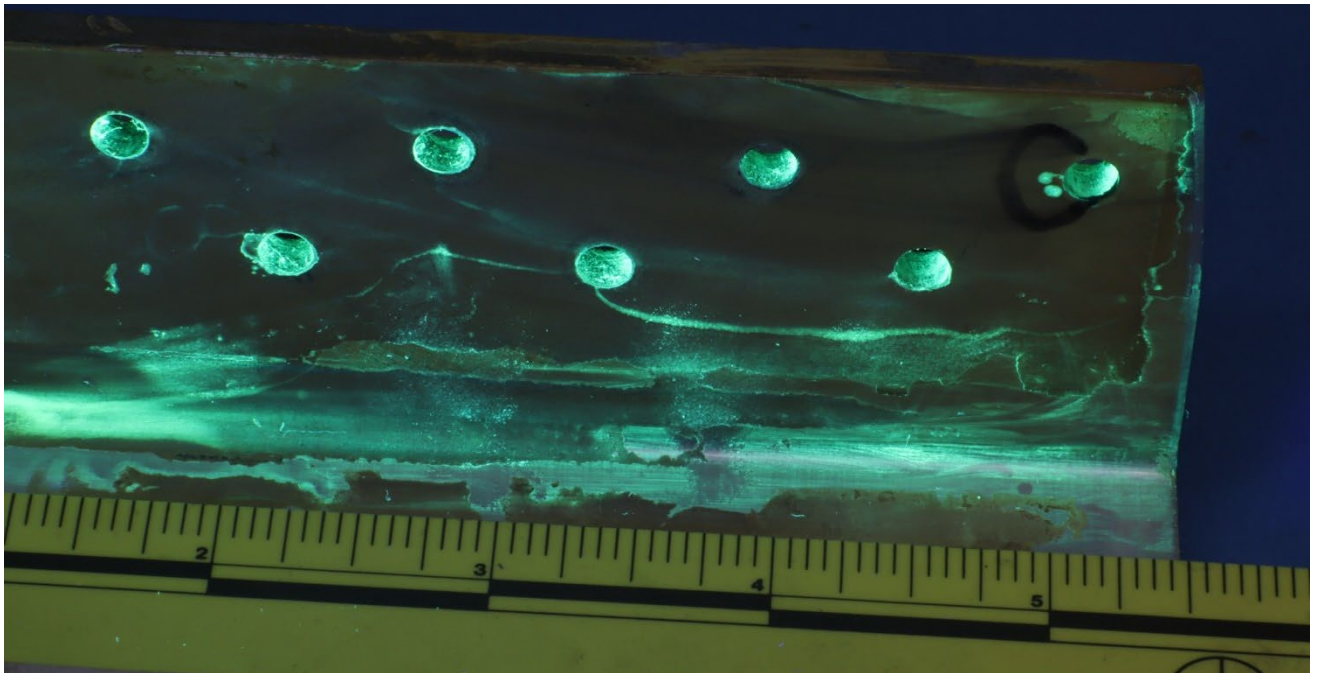
Figure 34 – UV light composite exposure of the spar cap remnant in Figure 33, showing the two indications in the upper right.

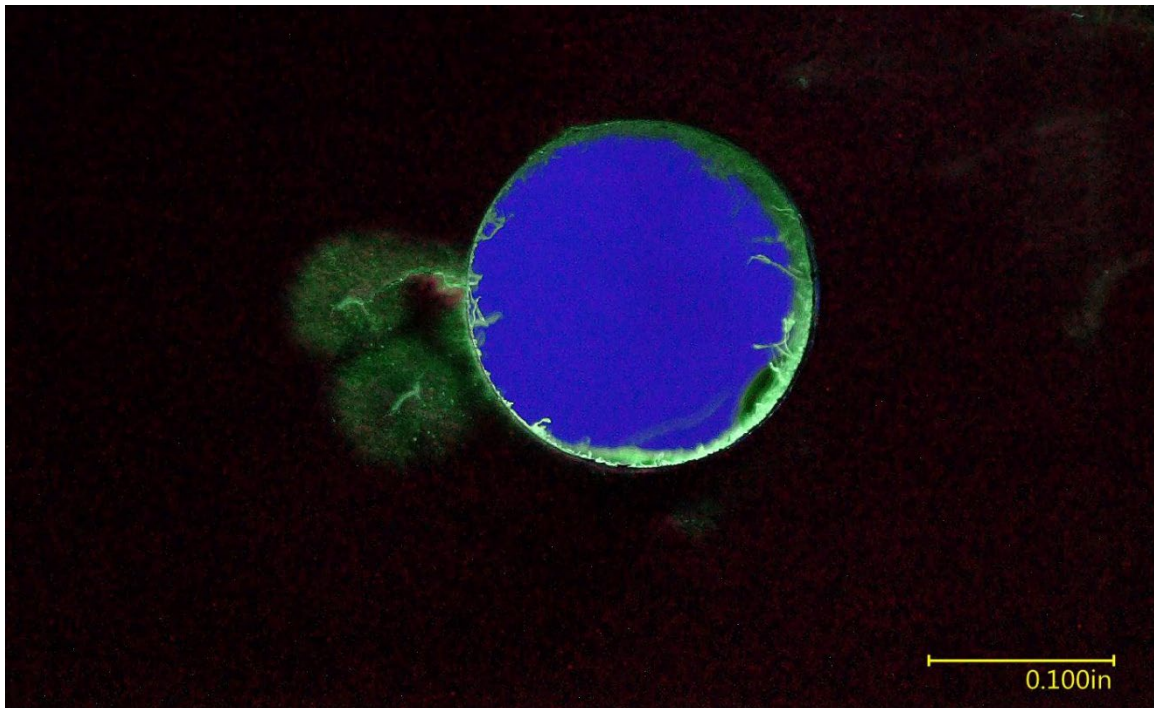
Figure 35 – Closer view of the indications near the fastener hole in Figure 34, under UV lighting.

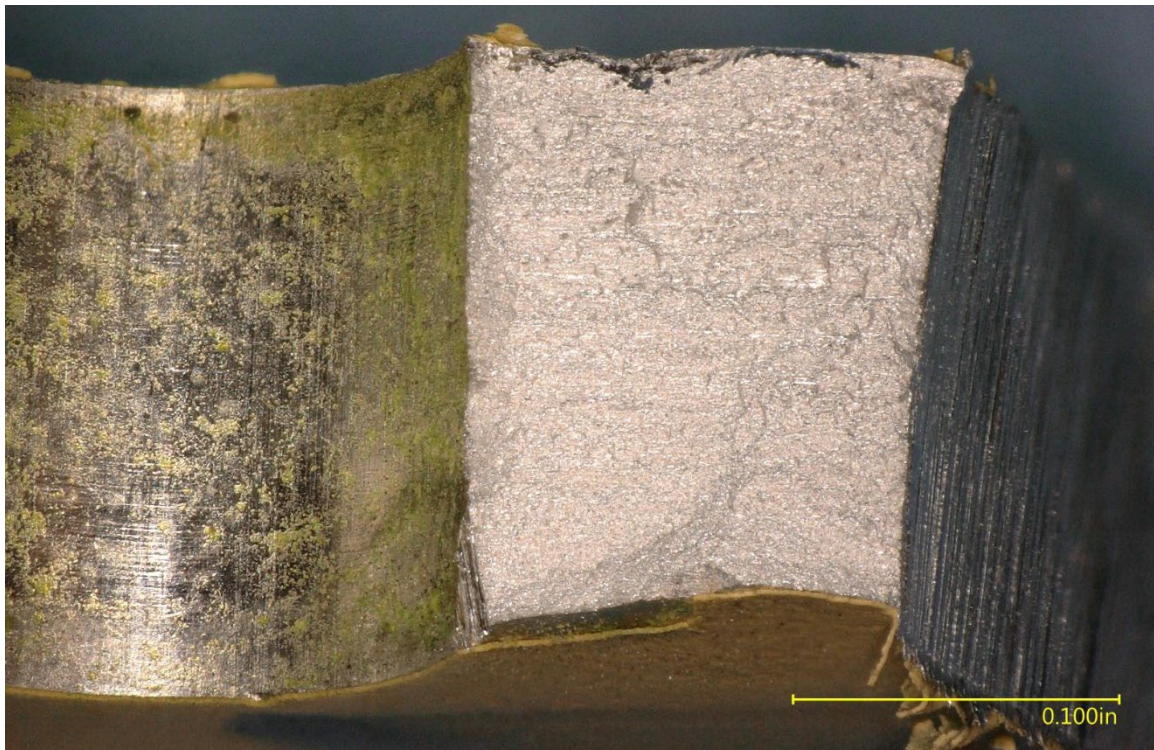
Figure 36 – View of the laboratory-opened indications in Figure 35, revealing no cracks or voids along the surface.
