## **NATIONAL TRANSPORTATION SAFETY BOARD**

### **ONSITE EXAMINATION NOTES**

**WPR21FA266**

Location: Wikieup, AZ  
Date: July 10, 2021  
Aircraft: N3688P Beech C90  
NTSB IIC: Albert Nixon

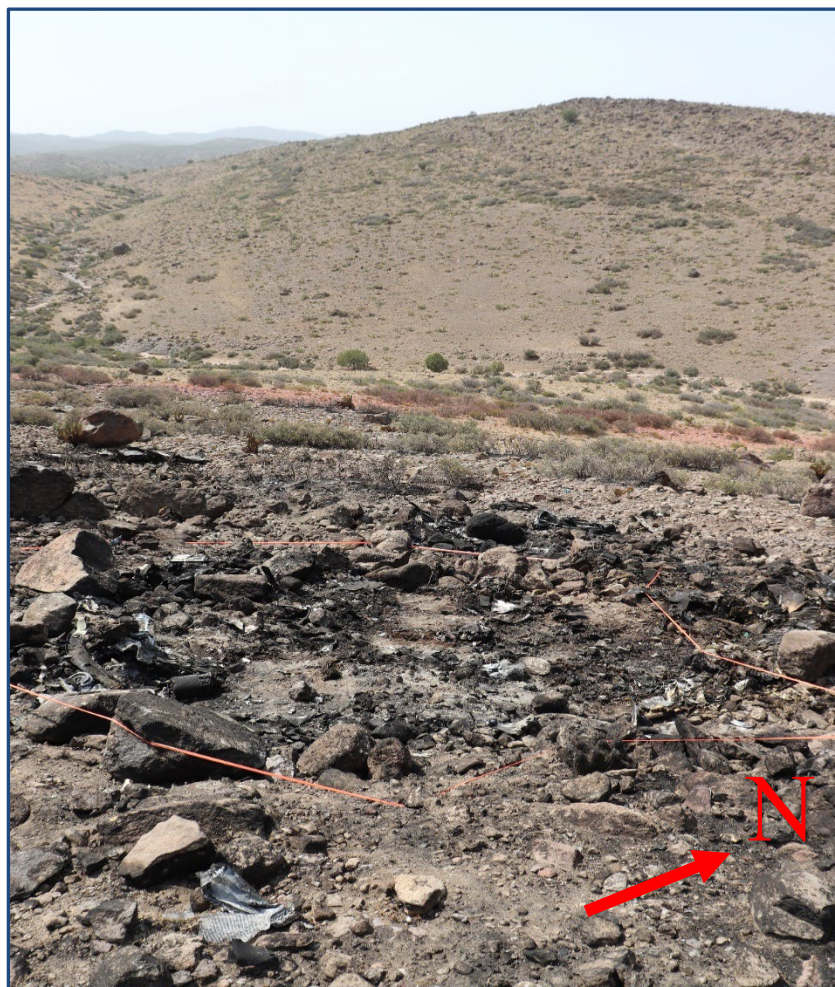
The main wreckage was about 465 ft away from the ridgeline, with the slope gradually increasing from 15° at the main wreckage site to 30° at the end of the debris path (figure 1). The main wreckage area contained a section of the cockpit, of which was consumed by fire. The main wreckage was located about 34.8173000°, -113.3887333° with an elevation of about 4,510 ft.

Figure 1. Main wreckage area

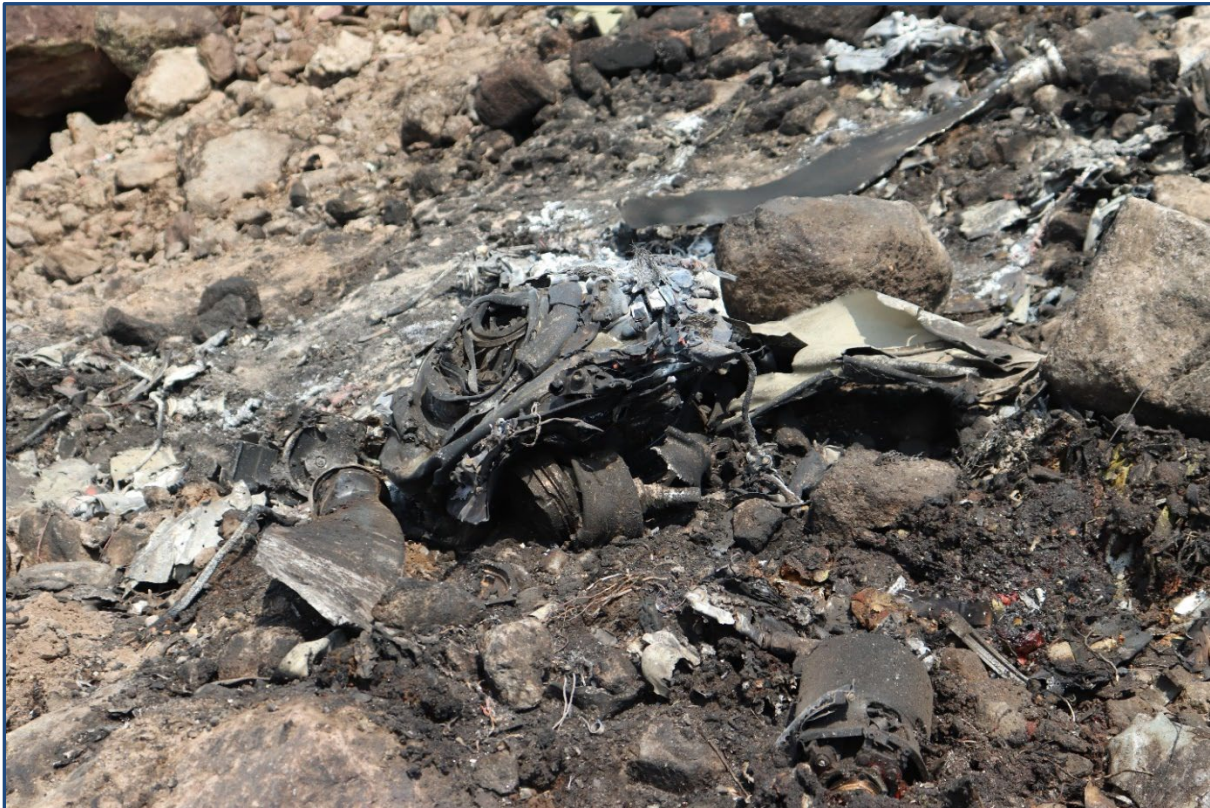
Situated about 25 ft downslope north from the main wreckage site is engine A (figure 2). Engine A showed thermal and compression damage from impact. Adjacent to the engine were 3 propeller blades and all sustained thermal damage. Blade A1 was separated from the hub with a fractured blade tip and chordwise scratches. Blade A2 was separated from the hub and had trailing edge gouges and twisting deformation. Blade A3 was separated from the hub with

leading and trailing edge gouges and a fractured blade tip. Blade A4 was separated from the hub with leading and trailing edge gouges and a fractured blade tip.

**Figure 2. Engine A and 3 blades within the main wreckage site.**

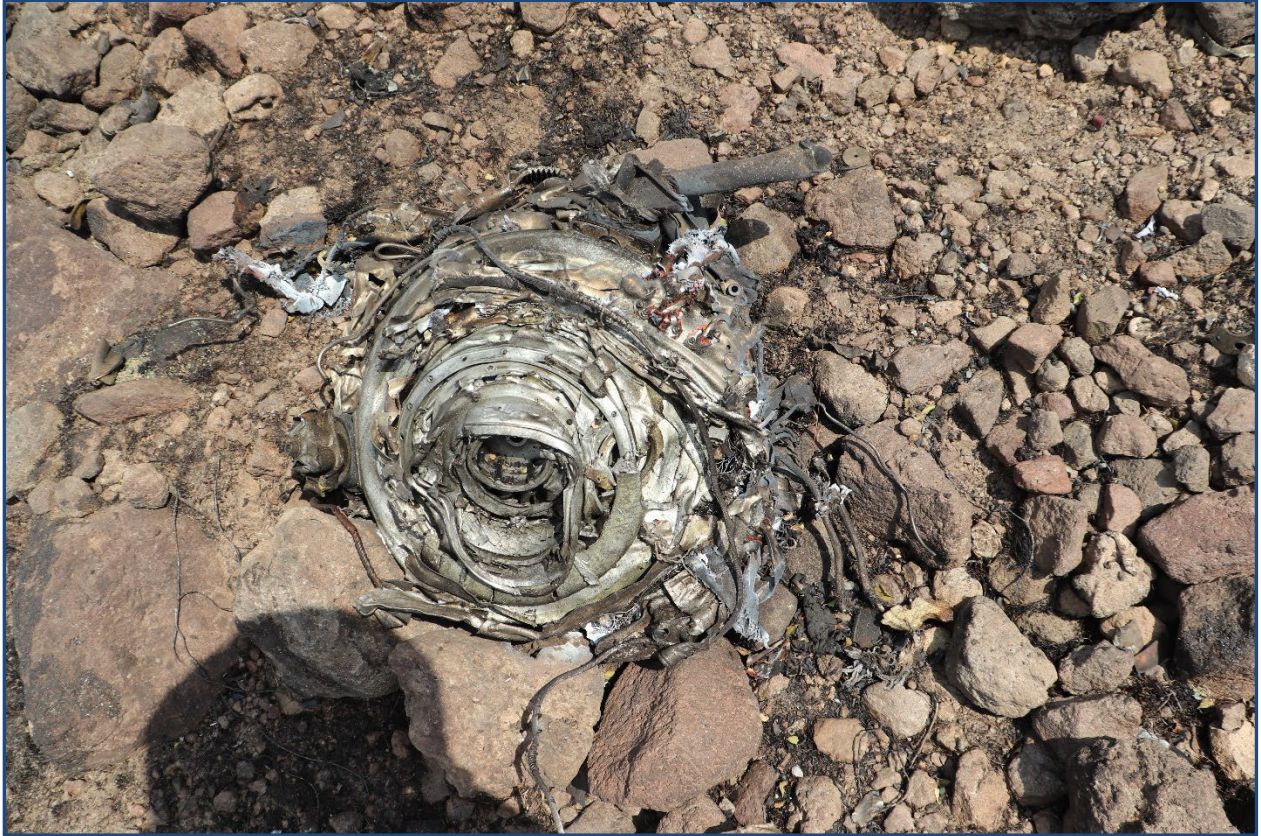
Engine B was located about 69 ft downslope southwest of the main wreckage (figure 3). Engine B sustained thermal and compression damage from impact. The blades were found in various positions. Blade B1 was downslope, about 85 ft southwest of engine B. Blade B1 was separated from the hub and sustained substantial leading-edge gouges with twisting deformation about midpoint to the blade tip. Blade B2 was downslope, about 20 ft northeast from engine B. Blade B2 separated from the hub and sustained face chordwise scratches and leading and trailing edge gouges with twisting deformation from midpoint towards the blade tip. Blade B3 was upslope, about 50 ft east from engine B and was separated from the hub. Blade B3 sustained chordwise scratching, leading and trailing edge gouges. Blade B4 was upslope, about 7 ft south from blade B3 and was separated from the hub. Blade B4 sustained leading and trailing edge gouges with a fractured blade tip.

**Figure 3: View of Engine B.**

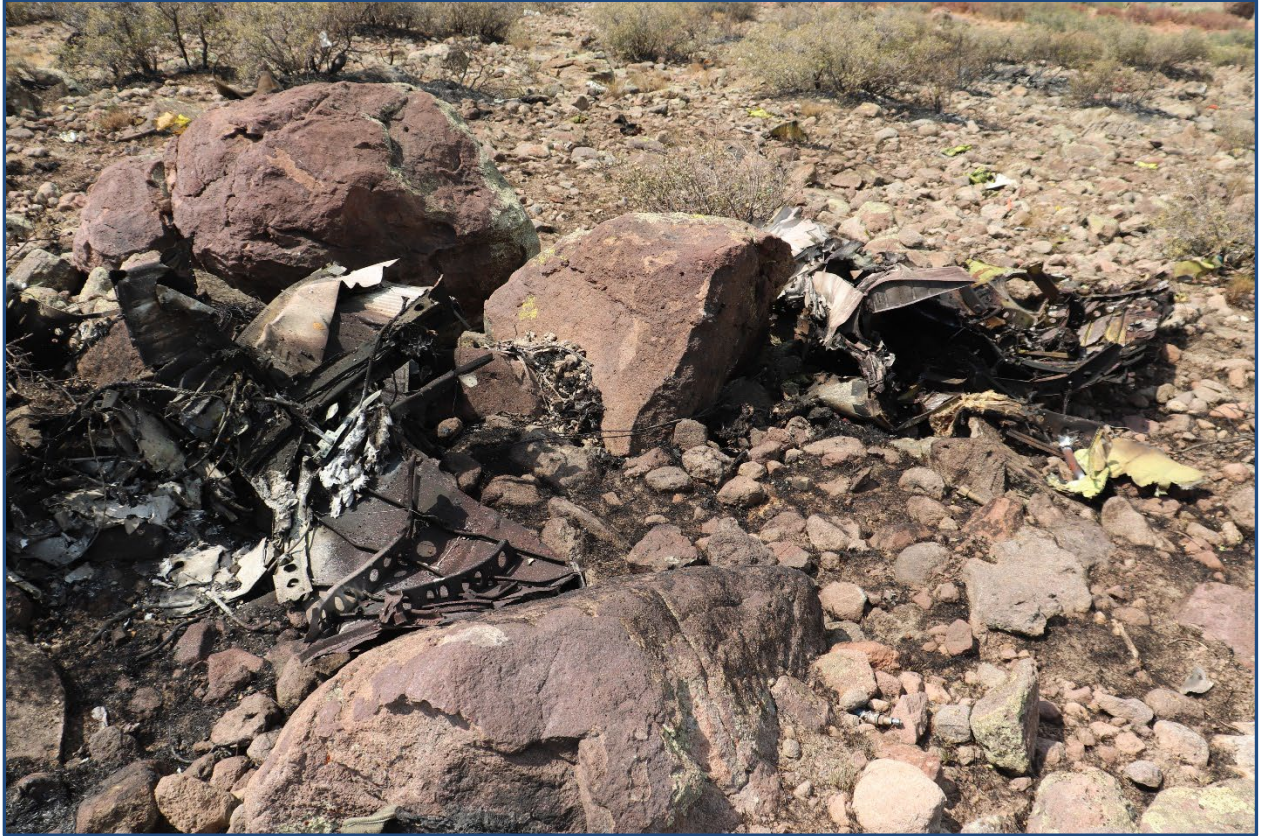
Most of the right wing was downslope, about 134 ft southwest from the main wreckage. The right wing was divided into 2 major sections connected only by the cables to the flight controls. The first section (inboard portion) of the wing sustained thermal and impact damage throughout. Separating the first section to the second section was a boulder. The second section (outboard portion) of the right wing sustained impact and thermal damage. The outboard flap was attached and sustained impact damage. A section of the aileron was found downslope, about 50 ft northwest away from the right wing. A main landing gear was found about 10 feet east from the right wing and sustained thermal and impact damage. Adjacent to the outboard section of the right wing was part of the right side of the fuselage, with which sustained impact and thermal damage.

**Figure 4: Two sections of the right wing.**

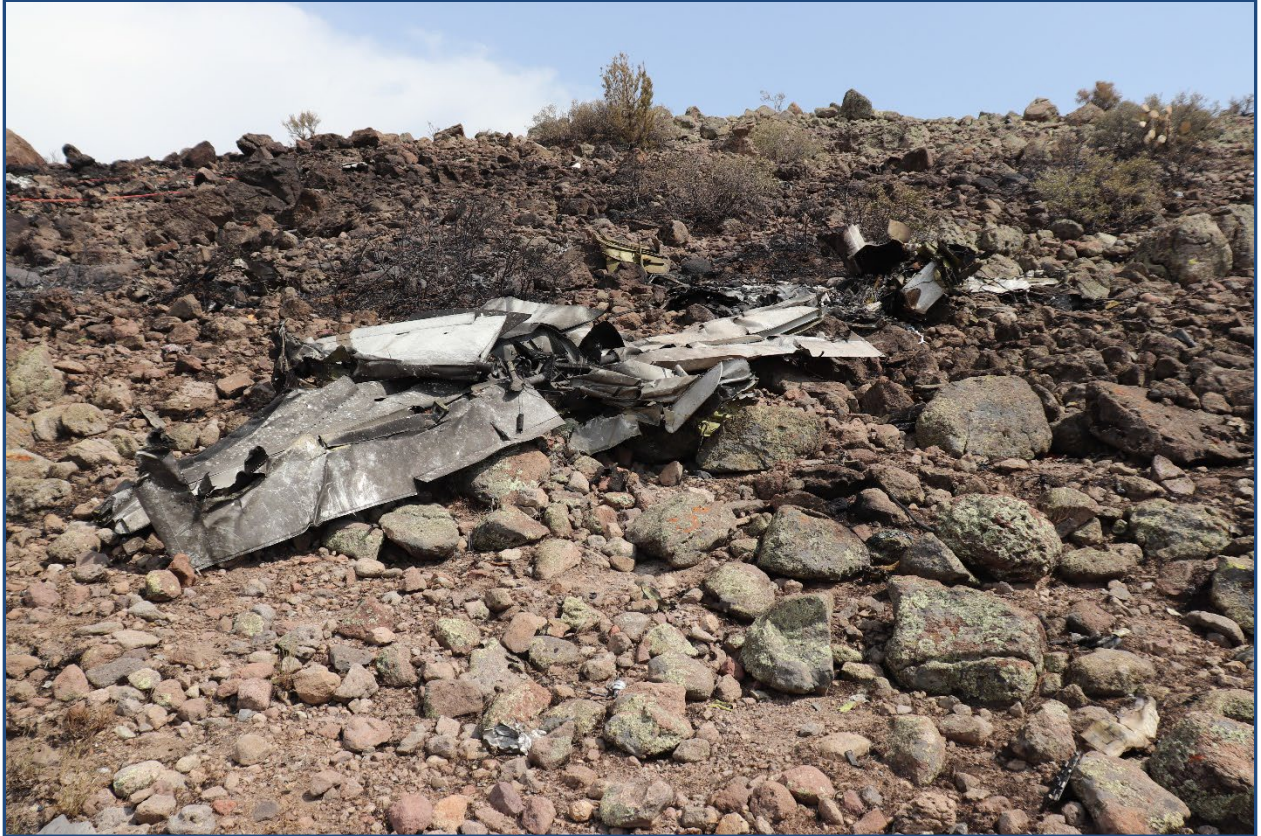
The empennage was downslope, about 89 ft northwest from the main wreckage. The left horizontal stabilizer sustained impact damage. The left elevator remained attached however, it sustained impact damage. The left and right elevator trim tabs were attached. The right horizontal stabilizer was attached and sustained impact damage. The right elevator was partially separated from the stabilizer. The vertical stabilizer separated but was found on top of the empennage consistent with impact damage. The top portion of the vertical stabilizer sustained leading edge damage. The rudder remained attached and sustained minimal impact damage.

**Figure 5: Empennage as viewed upslope.**

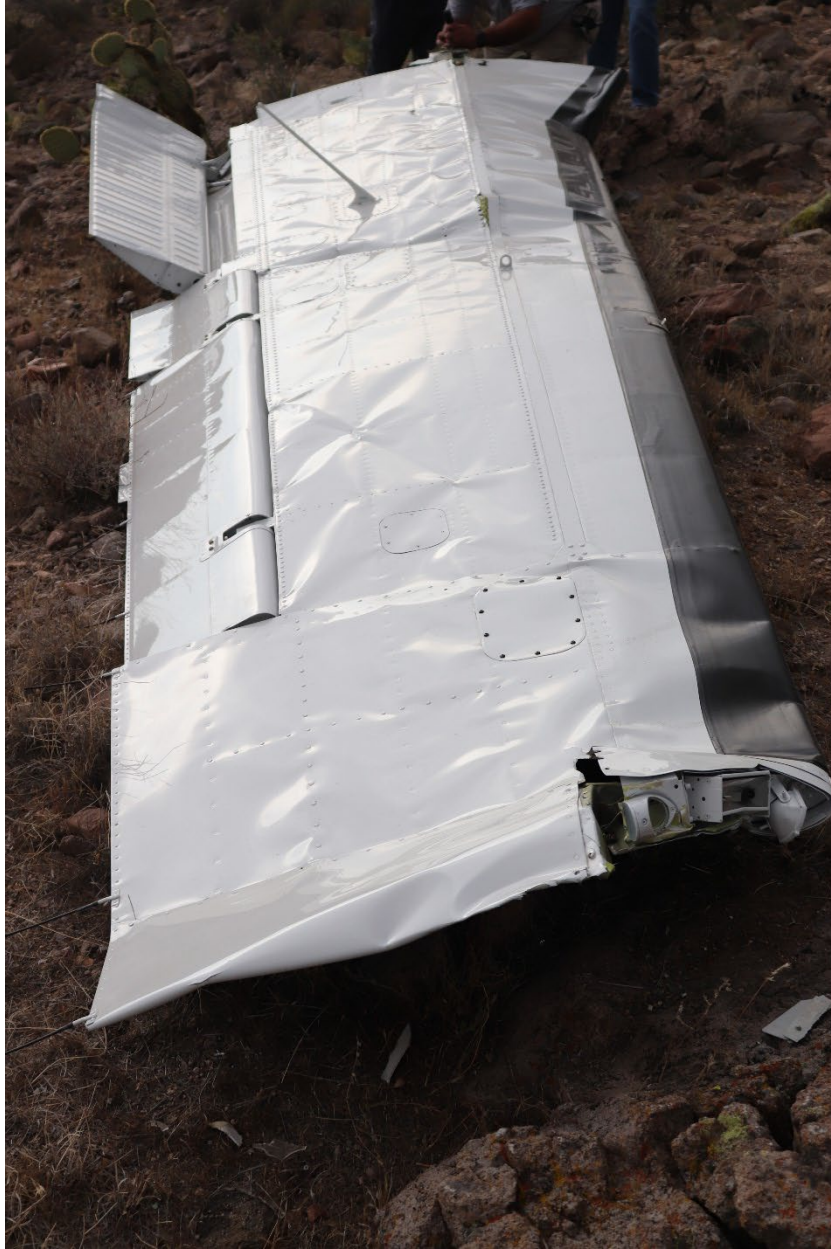
The left wing was about 0.79 miles northeast from the main wreckage site. The left wing came to rest inverted with wrinkling throughout consistent with impact damage. The left-wing tip impacted terrain and was bent upward, as seen from its resting point. The aileron, inboard and outboard flaps were intact. When the left wing was moved upright, observation of the fuel tank revealed that the tank was close to full. Bulging across to the upper surface leading edge of the wing was observed, consistent with the fuel causing the damage during impact.

**Figure 6: Left wing as located at the accident site viewed from the outboard section.**
